Proposed monitoring  
program to assess bank  
erosion at Yellow Water,  
Kakadu National Park,  
Northern Territory

M Saynor

January 2008

Work and report completed December 2002

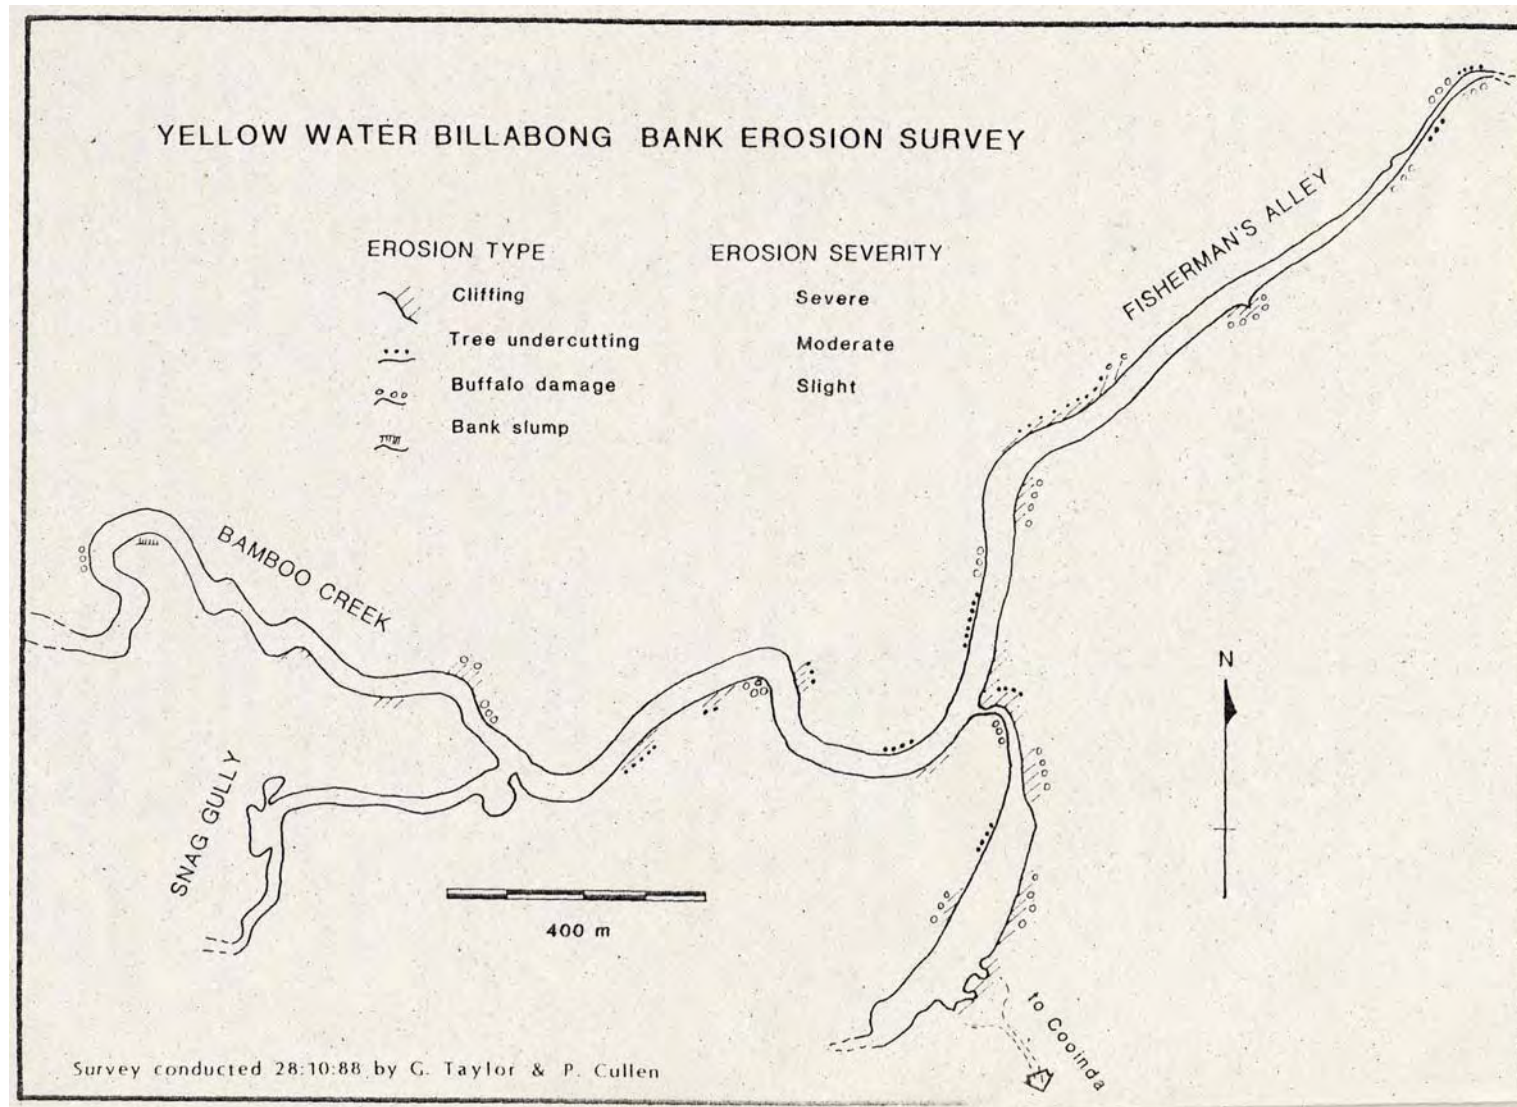
**Figure 2** Map showing erosion locations and severity (source – Cullen & Taylor 1988)

In the 1998 Cullen and Taylor report, a map (Figure 2) was produced showing locations along the banks where erosion was occurring. It was recommended that an extensive review of Yellow Water be undertaken every three years and the map of erosion updated every three years. To my knowledge this map has not been reviewed; if possible, it would be good to repeat this map to determine what changes have taken place since 1988.

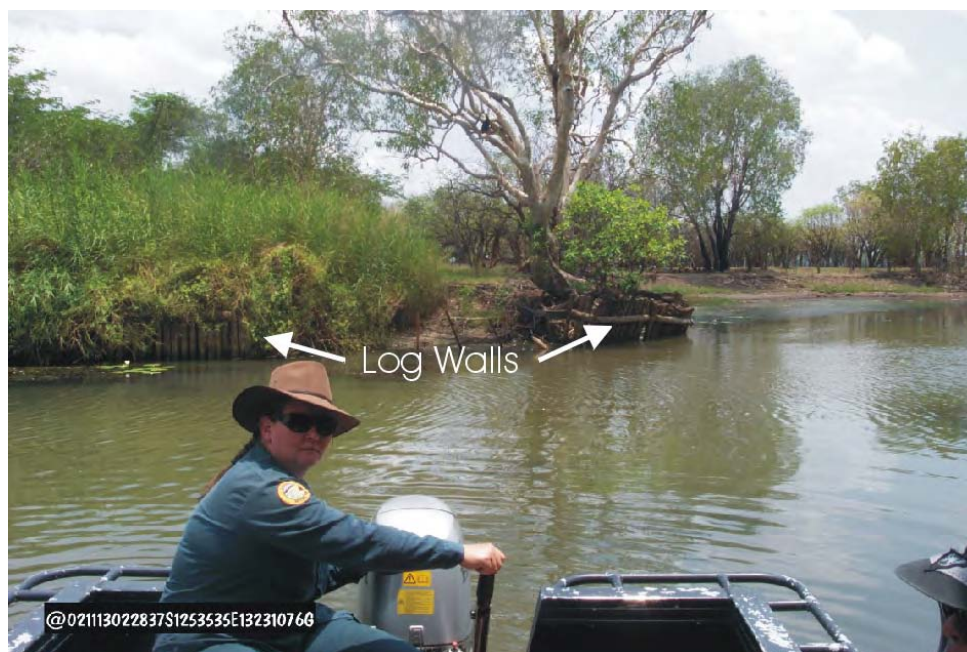
This site is where Jim Jim Creek joins the main South Alligator River channel and there is evidence of bank disturbance on the right bank.<sup>1</sup> Figure 3 shows logs that have been placed

along the bank to try and reduce erosion. The logs on the right of the image were installed during the mid 1980s and those nearer the middle of the image (showing signs of falling into the river) were installed in 1994. Peter Christopherson said that the area behind the logs that were falling over had been left empty of material when it was installed because it was hoped that sediment from the wet seasons would gradually fill in this areas. This has not been the case. All boats accessing the main part of Yellow Water pass this point because the loading point for the boat tours and the boat ramp is just upstream. The GPS location of this site is 12° 53.535' S and 132° 31.076' E.

**Figure 3** Site 1 - Junction of Jim Jim Creek and the South Alligator River

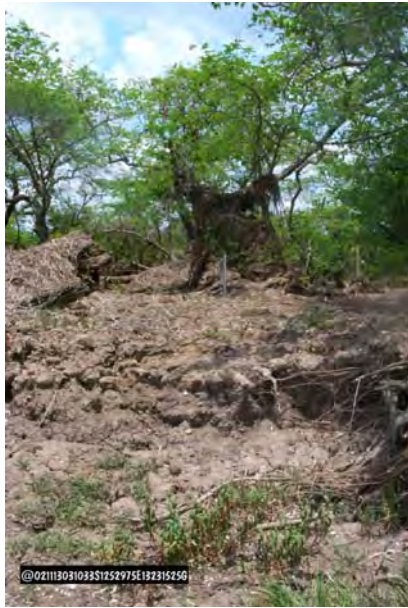
This site is located at the end of Fisherman’s Alley as boat traffic is limited by water depth. There was a discussion about the state of the left bank where bare earth and a visible steep slope could be seen towards the top of the bank (Figure 4). The opposite bank (right bank) was well vegetated and there was a discussion about the wet season water flows flowing over the left bank. The GPS location of this site is 12° 52.970' S and 132° 31.525' E.

**Figure 4** Star Picket EMP1

It was decided to install a star picket at this location for photographic monitoring. A star picket was driven into the top of the left bank and a tag placed on it called EMP1 (for Erosion Monitoring Pin 1). Figure 4 shows the erosion pin at the top of the bank and Figure 4 shows a close up of the installed star picket.

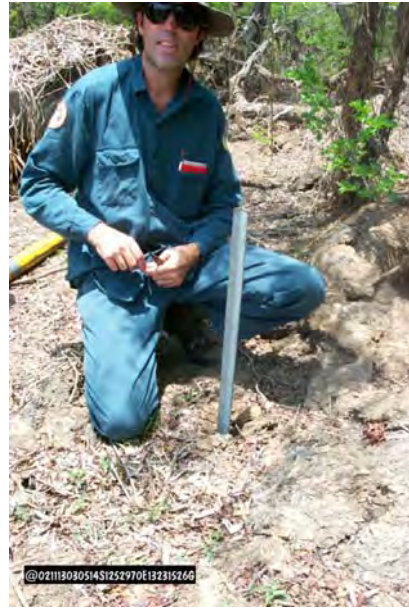
**Figure 5** Close up of Star Picket EMP1

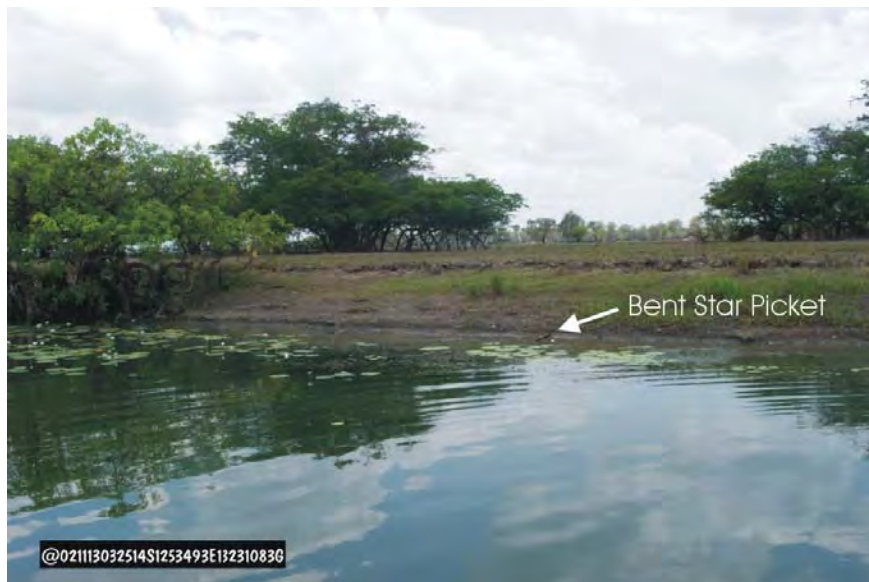
Several sites closer to the junction with Jim Jim Creek was also identified as possibly eroding and had a stump on the floodplain not far from the top of the bank. This stump was placed in the floodplain by Dave Lindner and would also serve as a good photograph point. Approximately 50 m upstream towards the junction the boat was nosed in towards the bank to look at a small steep area. A bent rusty star picket was noticed in the bed of the river and it was suggested that it was part of an old fence. Figure 6 shows the bank and also the star picket at this site. The GPS location of this site is 12° 53.493' S and 132° 31.083' E.

**Figure 6** Bank and star picket on right bank near junction with Jim Jim Creek

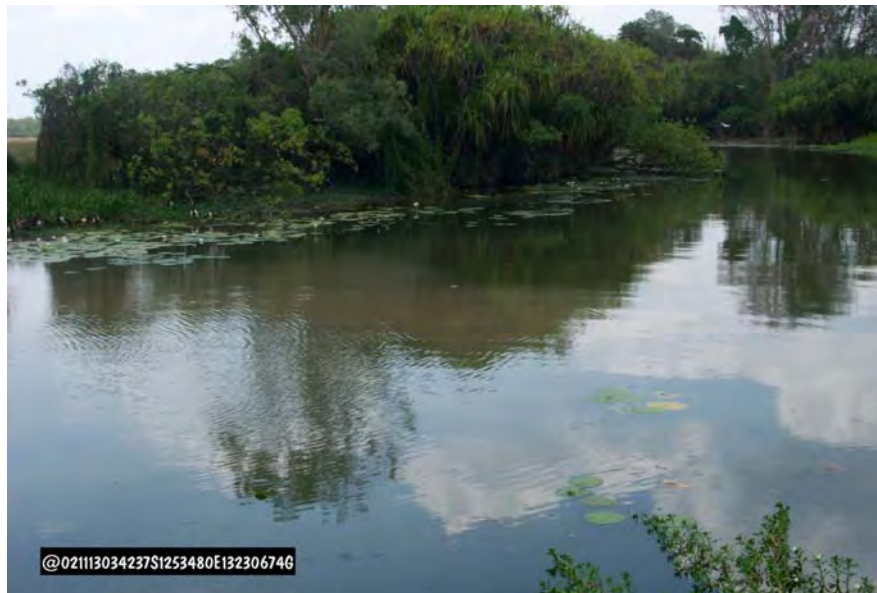
into the bank, a sediment plume could be seen in the middle of the channel (Figure 7). During lunch many magpie geese were observed foraging in the shallows of the opposite bank and disturbing the water and creating small sediment plumes (Figure 8). Figure 8 also shows the wake behind the boat that we were travelling in at a relatively slow speed. The GPS location of this site is 12° 53.480' S and 132° 30.674' E.

**Figure 7** Sediment plume in the channel near the lunch spot

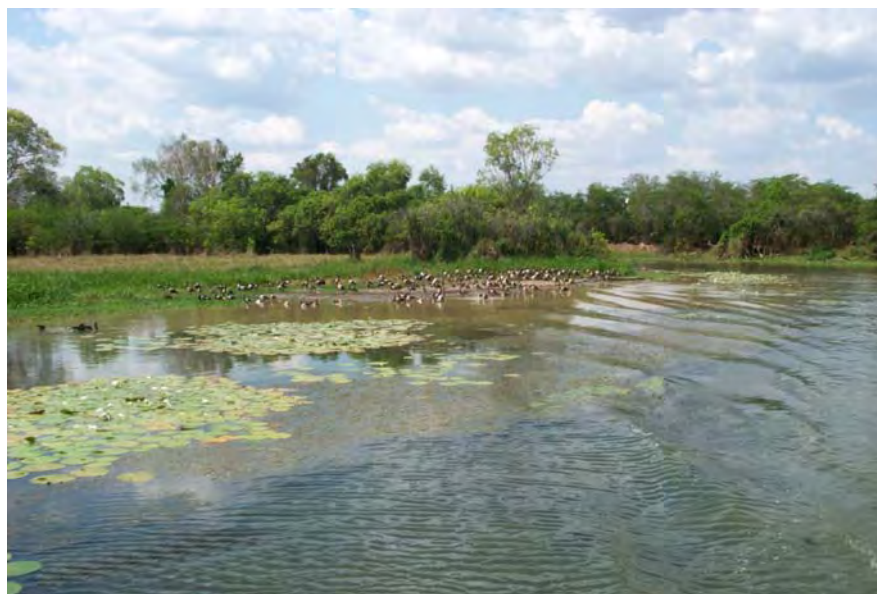
**Figure 8** Magpie geese foraging in the shallows and waves from the boat that we were travelling in at slow speed

could be seen foraging in the shallows and there were a visible sediment plumes. An example of this is shown in Figure 8.

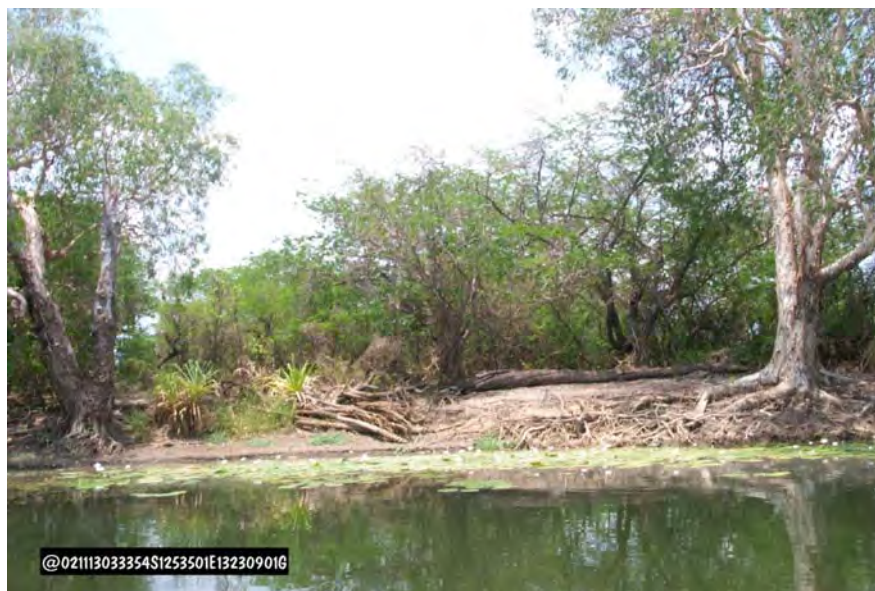
During the fieldwork there were trees with exposed roots in the banks. Although none of these were examined closely an example of one of these trees is shown in Figure 9. The GPS location of this site is 12° 53.501' S and 132° 30.901' E.

**Figure 9** Tree with exposed roots in the bank

Observations from the trip suggest that areas of bare bank might be susceptible to erosion from boat wakes and that the presence of vegetation helps to reduce the effects of waves caused by boats. In general, when there was a bank on one side of the channel devoid of any vegetation, the bank on the other side of the channel appeared to have vegetation. This suggests that boat wakes are not the sole cause of any bank erosion because they were erosion should be present on both banks. In some areas, cattle (owned by the Traditional Owners) were grazing on the adjacent floodplains.

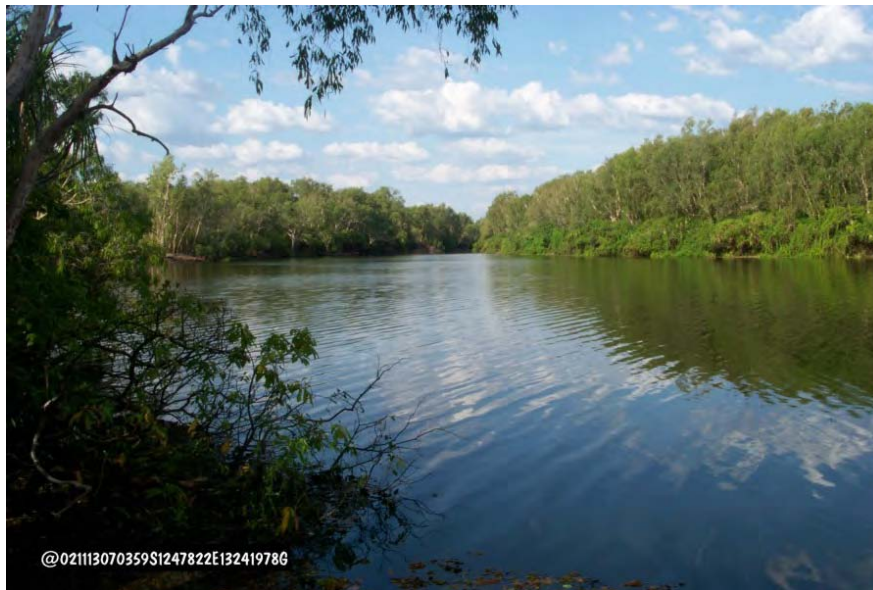
Observations from the boat ramp at Binji Water indicate that the waterbody is virtually all tree lined (Figure 10) with much larger melaleuca trees than at Yellow Water. There is no visible clear areas or grasslands as there were at Yellow Water. The form of the banks cannot be commented on as the boat could not be launched. There was, however, root material from the trees on the banks near the boat ramp that could be helping bind and stabilise the banks. *Salvinia* was present against the bank near the boat ramp; it is not present at Yellow Water. The trees near the boat ramp had recently (within the last month) been affected by fire.

**Figure 10** Binji Water Billabong
