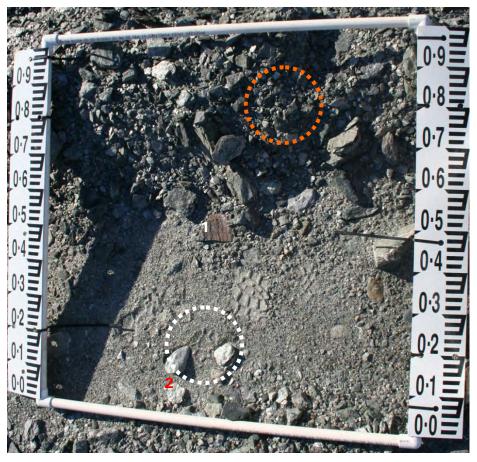
Surface material sample EWLS site 9 in 2009 prior to samples being collected.

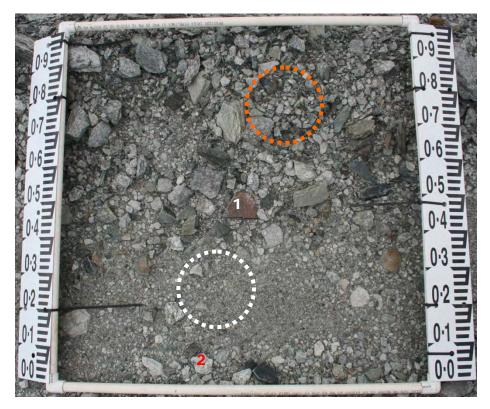
Surface material sample EWLS site 9 in 2010.

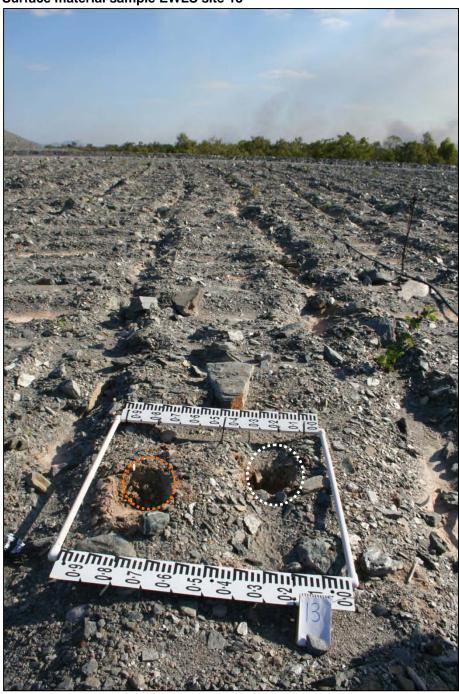
Surface material sample EWLS site 13

**Surface material sample EWLS site 13.** Oblique image of the samples collected in 2009. The image is taken looking north east across the landform.

Treatment: Waste Rock & lateritic material (5 m) with planted tube stock.

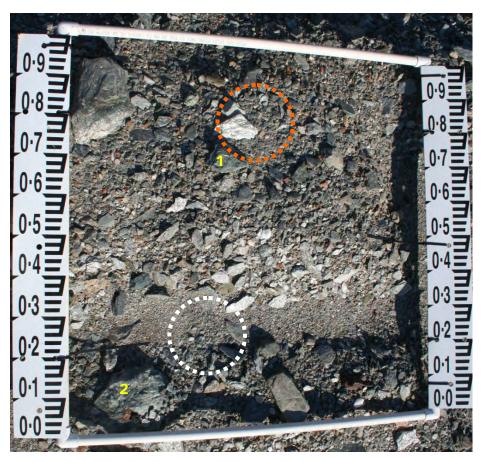
Surface material sample EWLS site 13 in 2009 prior to samples being collected.

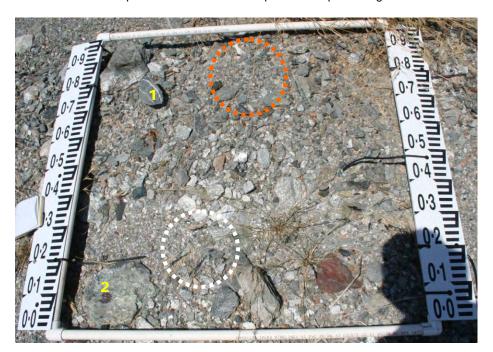
Surface material sample EWLS site 13 in 2010.

The white circle has a large rock where the hole was. Rock 1 has been shifted during the year. Several tufts of grass (dead) are present in the 2010 image.

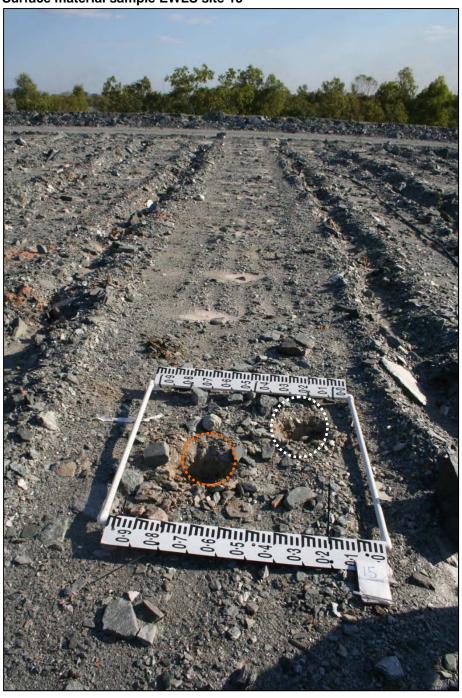
Surface material sample EWLS site 15

**Surface materials sample EWLS site 15.** Oblique image of the samples collected in 2009. The image is taken looking south west across the landform.

$\textbf{Treatment:} \ \ \textbf{Waste Rock \& lateritic material (5 m) with planted tube stock.}$

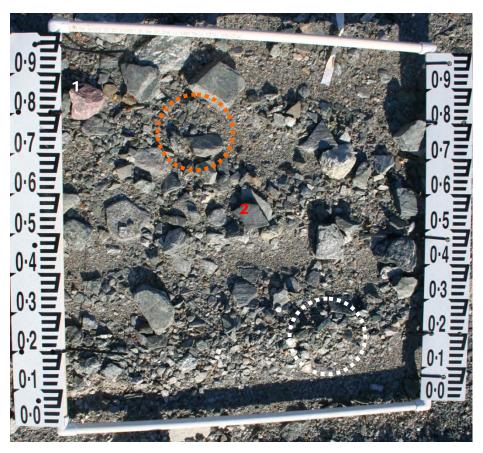
Surface material sample EWLS site 15 in 2009 prior to samples being collected.

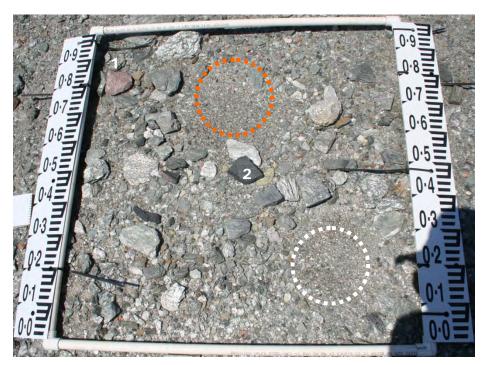
Surface material sample EWLS site 15 in 2010.

Both of the samples were collected between the mounds created by ripping and both have been filled with fine material.

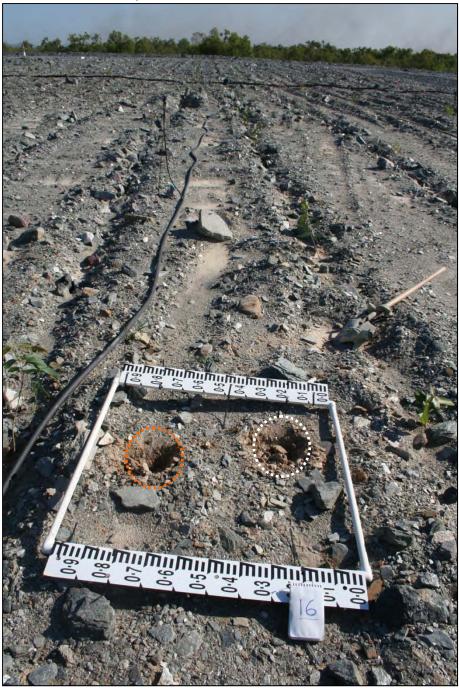
Surface material sample EWLS site 16

**Surface material sample EWLS site 16.** Oblique image of the samples collected in 2009. The image is taken looking south west across the landform.

Treatment: Waste Rock & lateritic material (2 m) with planted tube stock.

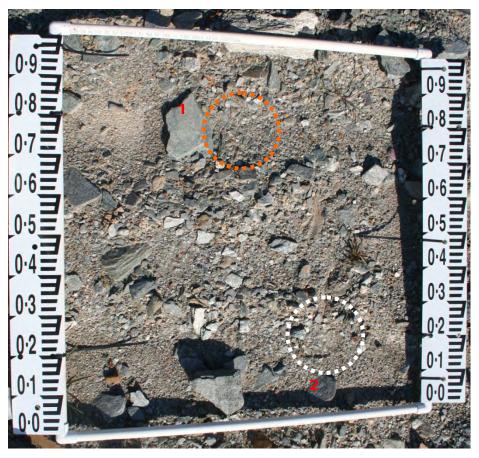
Surface material sample EWLS site 16 in 2009 prior to samples being collected.

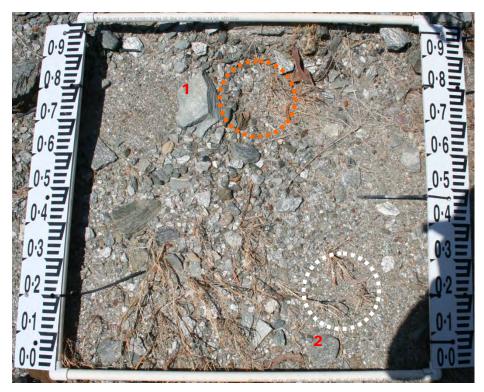
Surface material sample EWLS site 16 in 2010.

There are tufts of grass (dead) present in the 2010 image.

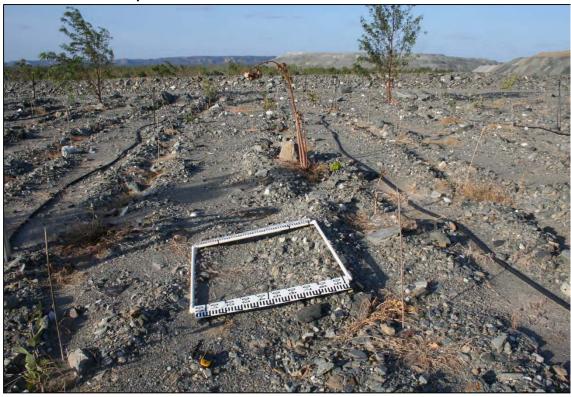
Surface material sample EWLS site 18

**Surface material sample EWLS site 18.** Oblique image of the sample location in 2010. No image was taken in 2009 after the samples had been collected so it is not able to determined where the hole locations were. The image is taken looking north east across the landform.

Treatment: Waste Rock & lateritic material (2 m) with planted tube stock.

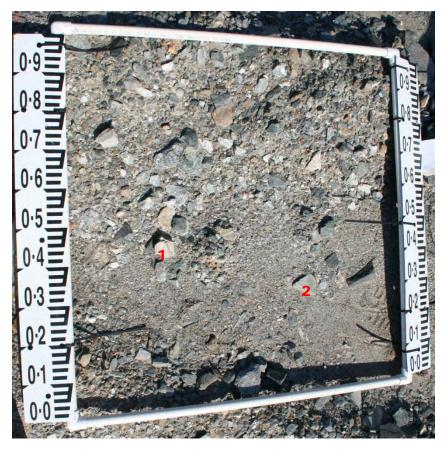
Surface material sample EWLS site 18 in 2009 prior to samples being collected.

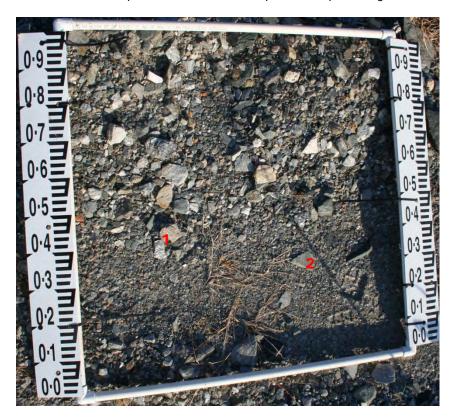
Surface material sample EWLS site 18 in 2010.

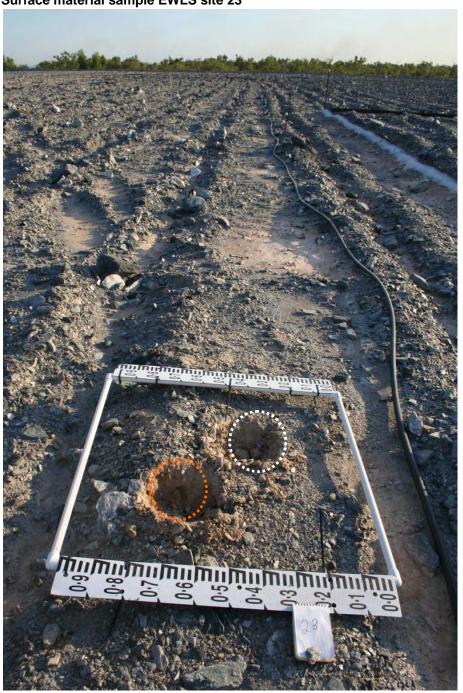
Surface material sample EWLS site 23

**Surface material sample EWLS site 23.** Oblique image of the samples collected in 2009. The image is taken looking south west across the landform.

Treatment: Waste Rock & lateritic material (2 m) with direct seeding.
