Appendix 21: Road barriers to fish passage

The following is an extract from the executive summary of the report *Reducing the Impact of Road Crossings on Aquatic Habitat in Coastal Waterways – Northern Rivers, NSW* (DPI 1006). The location of known road barriers to fish passage and the priorities for remediation are shown in **Figure 1**. A large format, detailed map showing the exact location of these barriers to fish passage is on the enclosed CD (**Figure 37**). Please refer to **Section 6.1.2** of the main report regarding the best way to view these maps. These maps were generated from the data provided in Appendix 1 of the fish road barriers report (DPI 2006).

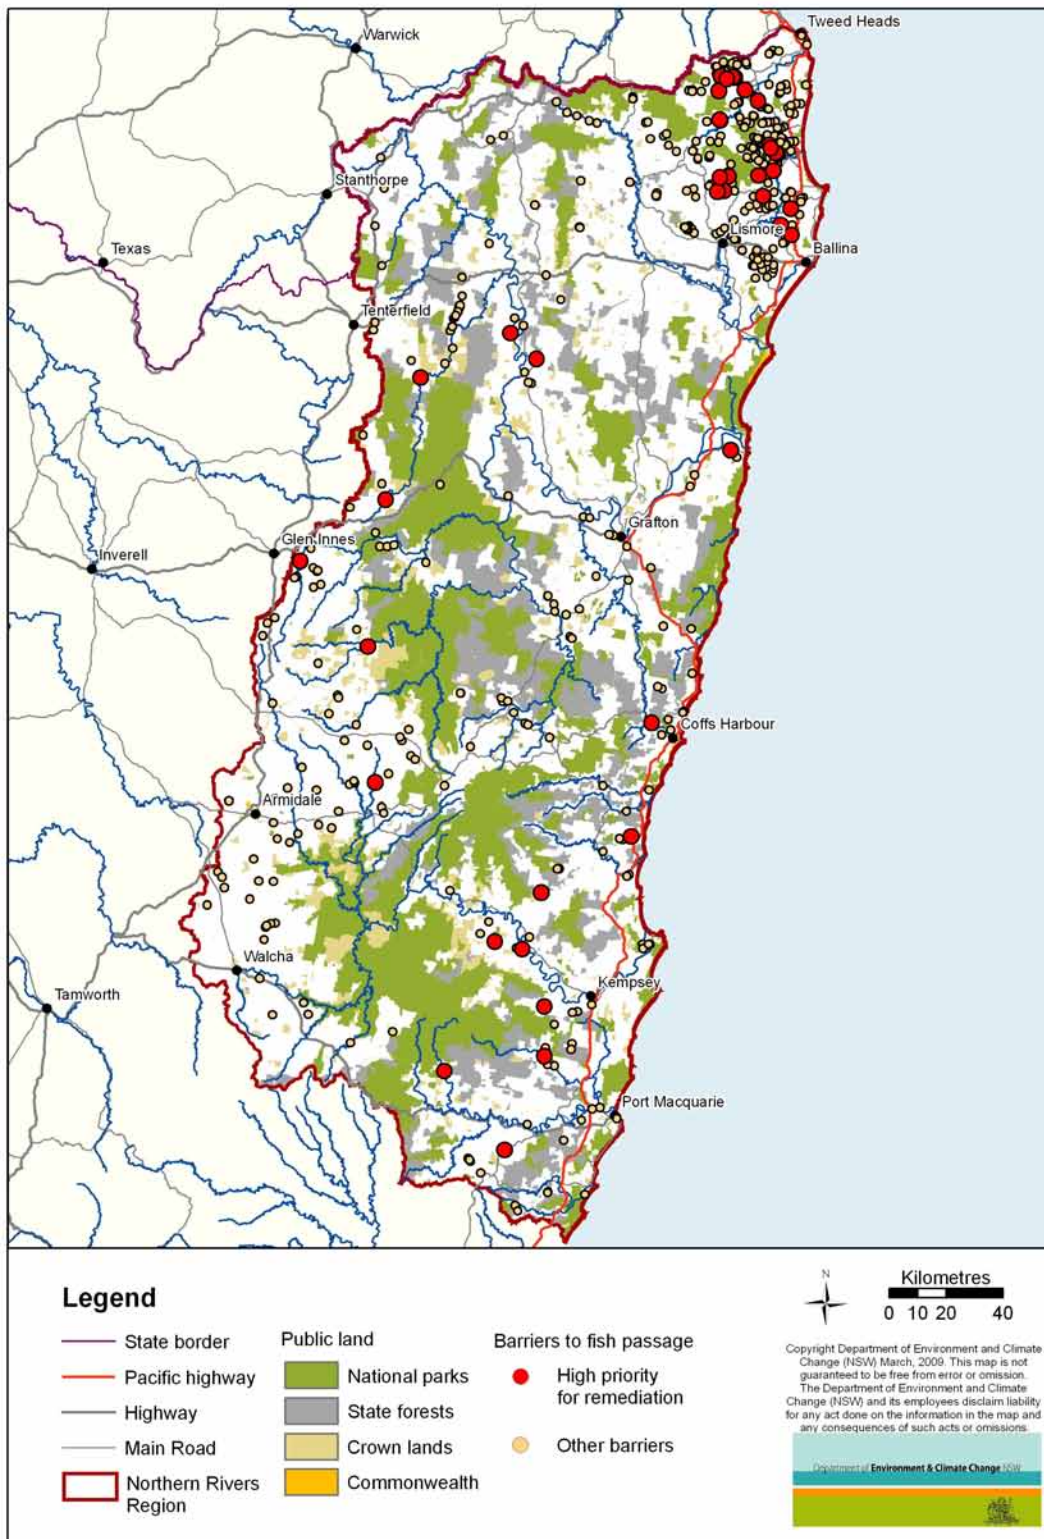
Figure 1 Road barriers to fish passage

- 1500 bridges were assessed, none of which were barriers to migrating fish species.
- 524 (20%) crossings were identified as obstructions to fish passage, with the majority of barriers being located in the Northern Rivers subregion.
- Pipe culvert crossings were the most common structure inhibiting fish passage in the region (51% of obstructions assessed).
- Causeways (28%) and box culvert (18%) crossings were also commonly found to restrict fish passage.

- Excessive head-loss (i.e. > 100 mm) was the most prevalent barrier type recorded at waterway crossings (64%), with a mean head-loss of 500 mm being recorded for barrier structures across the Region.
- High flow velocities (51%) and shallow flow depth (38%) were frequently observed at crossing barriers. Moreover, multiple barriers types (e.g. head-loss, high velocity, and shallow flow depth) were commonly recorded at a single site over the full range of hydrological flows.
- Grazing (74%) was the primary landuse recorded at crossings in the Northern Rivers CMA region, with crossings located in national parks, State forest, and rural (non-grazing) settings accounting for less than 25% of barriers identified.

A ranking scheme for waterway crossing sites was developed to determine remediation priorities for the improvement of fish passage in the Region. Crossings were ranked as either high, medium-high, medium, medium-low or low priority, with 63 high priority and 38 medium-high priority structures identified—the majority of which were found within the Northern Rivers subregion. Remediation recommendations for barriers identified in the report included:

- maintenance of sites (e.g. removal of sediment and debris blockages, improved floodgate management)
- modification of structures (e.g. retrofitting low-flow channels, installing fishways)
- complete replacement of structures (e.g. causeways replaced with bridges)
- permanent removal of redundant obsolete structures.
