Subject: TAILING SPILL CLEAN-UP

MEMORANDUM

TO : Peter Woods
COPIES : Allan Wade, Holger Topp, David Toohey
FROM : Paul Bryers
SUBJECT : RP2 Water Quality
DATE : 09 November 1998
REF :

SUBJECT : Notification (Non-Infringement)

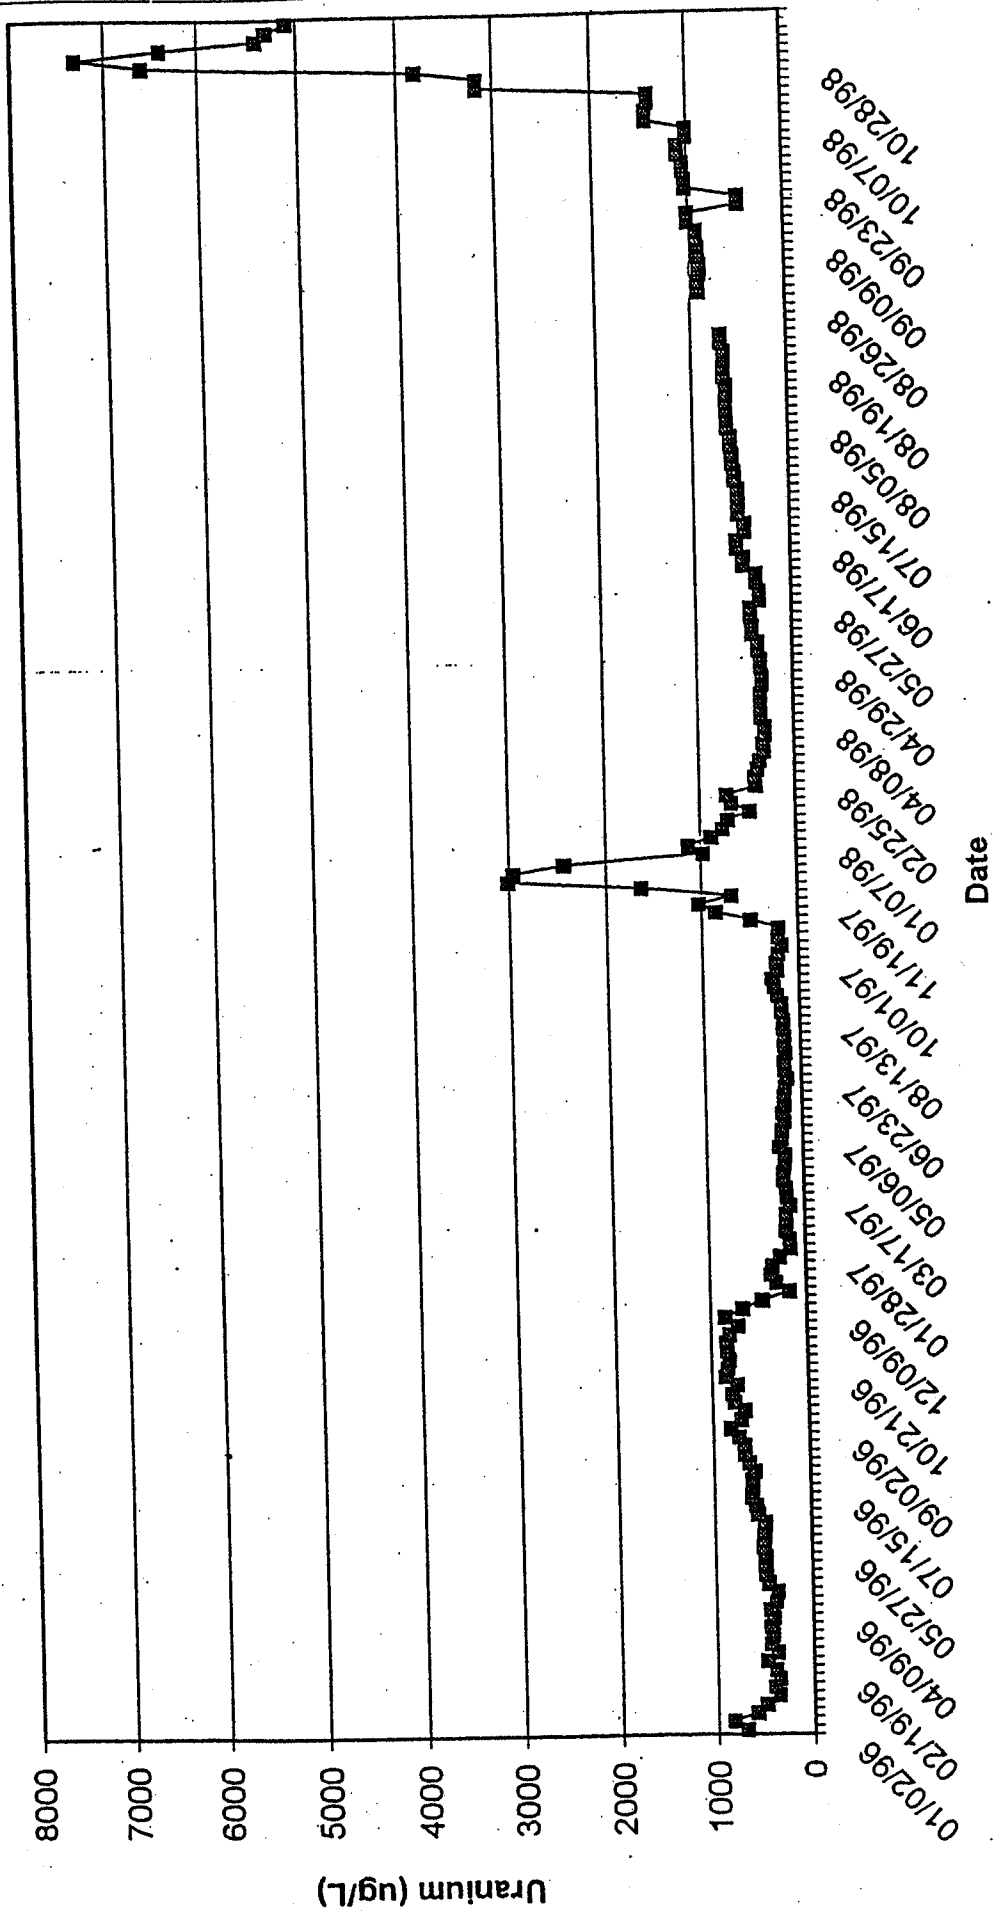
Retention Pond 2 Water Quality

Following is a summary of all the information I have to date on the increase in uranium in RP2.

On the 28 October it was noted that the U level in RP2 had increased substantially and a sample was taken and analysed on the 29th to confirm the high value. This was confirmed and subsequently the samples were assayed by a different technique for further confirmation which did further qualify the results.

Water resources were then contacted and conducted a water balance on RP2 and calculated a 340 Kg load of U which could not be accounted for.

The diagram on the following page shows sample sites and corresponding U concentrations.
