**Evaluation of alleged
deficiencies in
management of the
Ranger Uranium Mine
between 1996 and 1998**

**Supervising Scientist &
Northern Territory Department
of Business, Industry and
Resource Development**

Supervising Scientist & Northern Territory Department of Business, Industry and Resource Development 2002. *Evaluation of alleged deficiencies in management of the Ranger Uranium Mine between 1996 and 1998*. Supervising Scientist Report 171, Supervising Scientist, Darwin NT.

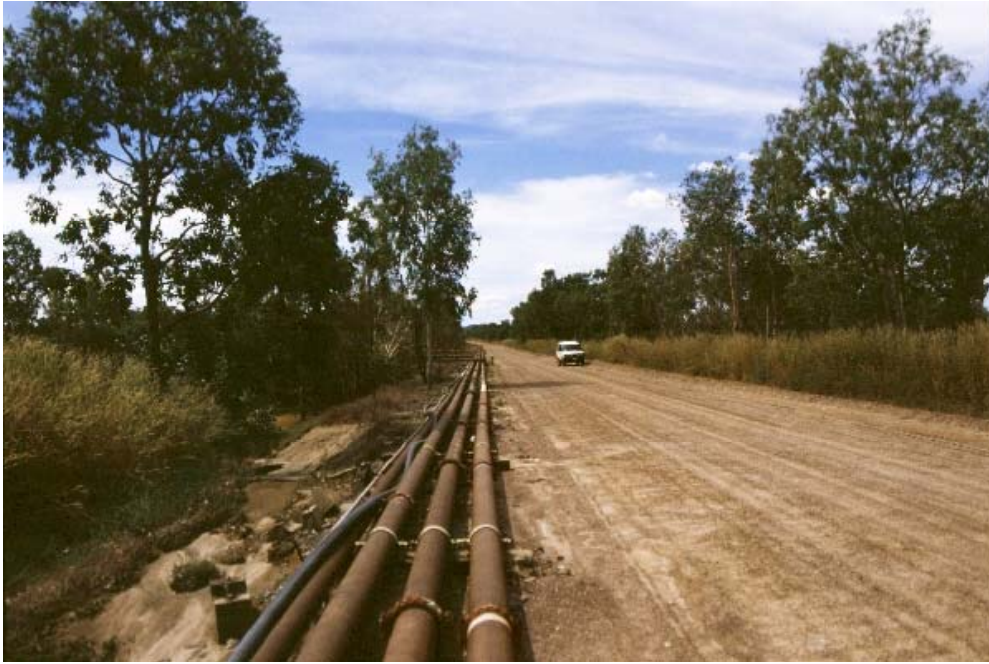
Most of the spilled material from the tailings pipeline leak of 17 December 1997 was released onto the tailings corridor road and into the RRZ drain and corridor road sump (figures 2 & 3). ERA's then Senior Environmental Scientist, Dr P. Woods, reported the leak to both *oss* and the then NT Department of Mines and Energy (DME), now NTDBIRD, by fax at 1822 hours on 19 December 1997. The leak was thought to have occurred between 1600 and 1700 hours from a joint failure due to partial blockage of the pipe near the Pit 1 offtake pipe.

Figure 2 Tailings corridor road in April 2002 near the site of the spill on Friday 19 December 1997. The sump shown in figure 3 is located to the middle left of the photograph (WD Erskine photograph).

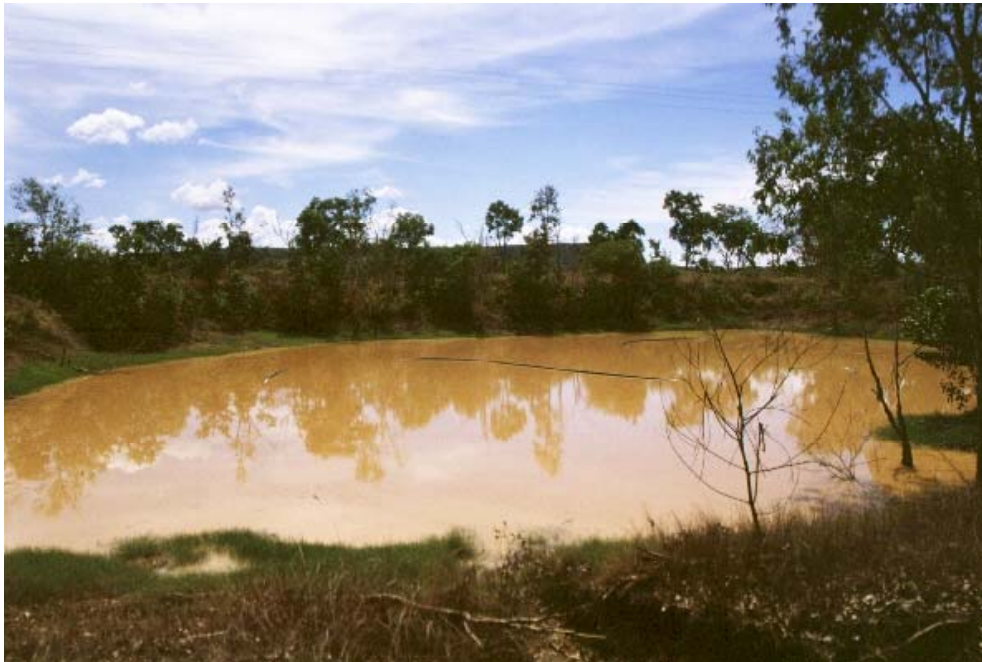
Figure 3 Sump for the tailings corridor road in April 2002. This sump was the immediate sink for the tailings spilt onto the tailings corridor road and drain on 19 December 1997 before they were finally transferred to, and permanently stored in, pit #1 (WD Erskine photograph).

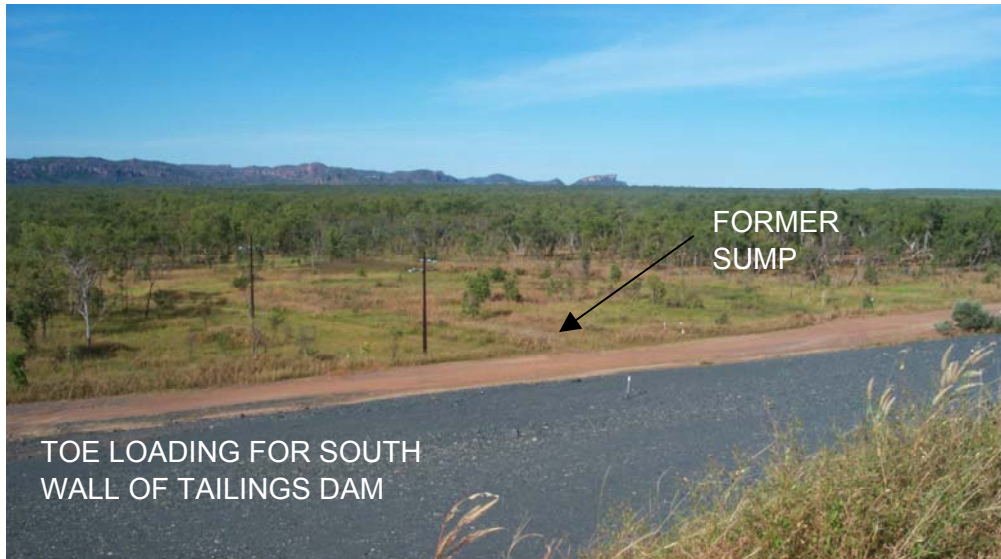
Water draining from the outside walls of the tailings dam or the toe loading area (see fig 6) arises from rainfall that either runs off the surface of these areas or which infiltrates the surface and emerges further downslope. As noted by Coffey Geosciences above, a contribution can also arise from elevated ground water due to groundwater mounding around the dam. Natural groundwaters in the region of the dam do not have concentrations of constituents, particularly uranium, as high as those found in the TDSRC. However, water which passes through the dam wall or the toe loading area has the opportunity to interact with the constituents contained in the rock and thus to leach out constituents that are chemically available. The concentrations of uranium in water that comes in contact with fresh waste rock are generally higher than in water in contact with rock that has been exposed for some years. This is because the first contact of water with fresh rock removes most of the available uranium.

Figure 6 Area immediately below the south wall of the Tailings Dam on 4 May 2000 showing the toe loading and remains of the tailings dam south wall sump. Seepage from this area may flow into Gulungul Creek. When inspected on 17 April 2002 conveyance losses resulted in seepage water extending only 50 m downstream of the former sump before all surface flow had infiltrated and hence stopped (OSS photograph).

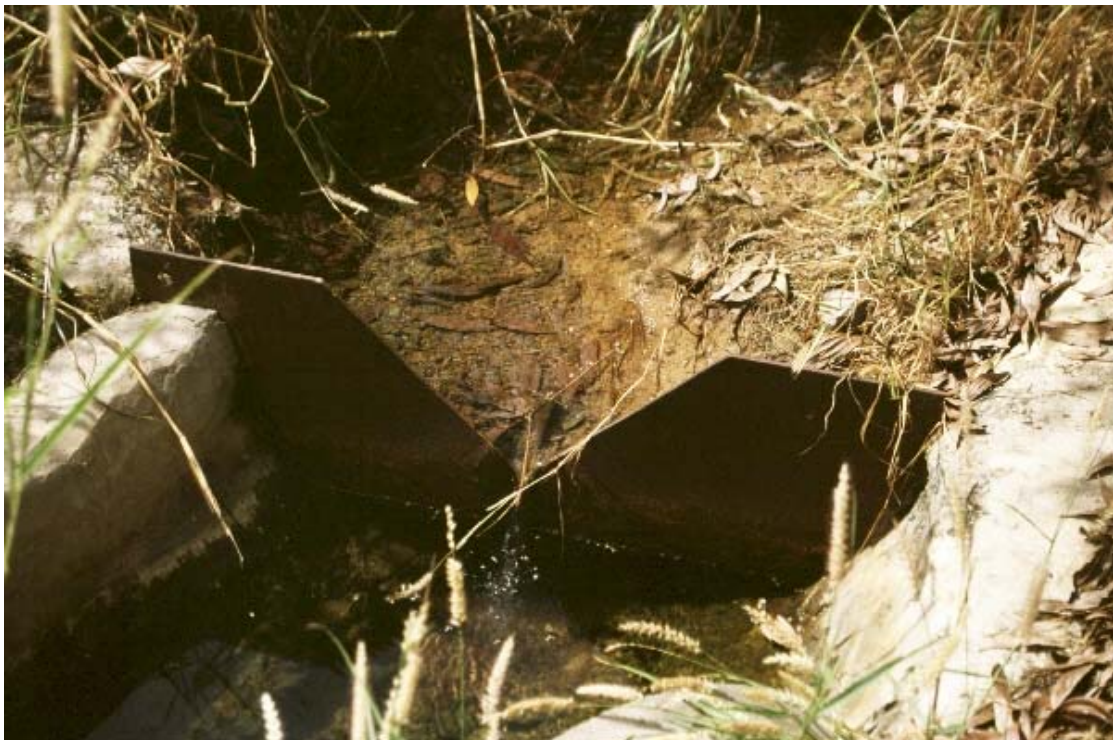
Thus, the toe loading of the south wall of the tailings dam during the 1997 dry season directly resulted in an increase of uranium concentration in water that passed through TDSRC, as concluded by Dr Woods in his email to Mr Kyle on 23 February 1998 (figure 1.6 in Mr Kyle's supporting documents). Water from the toe loading areas to the east and west of TDSRC passes through small sharp-crested V-notch weirs before mixing and being piped under a roadway to TDSRC (figures 7 and 8).

Figure 7 Weir discharging seepage from the south wall toe loading area of the tailings dam generated to the east of TDSRC in April 2002 (WD Erskine photograph)

It is also recommended that the Ranger MTC consider, within the context of Best Practicable Technology, whether or not uncontrolled discharges of water from TDSRC to the Gulungul Creek system should continue.

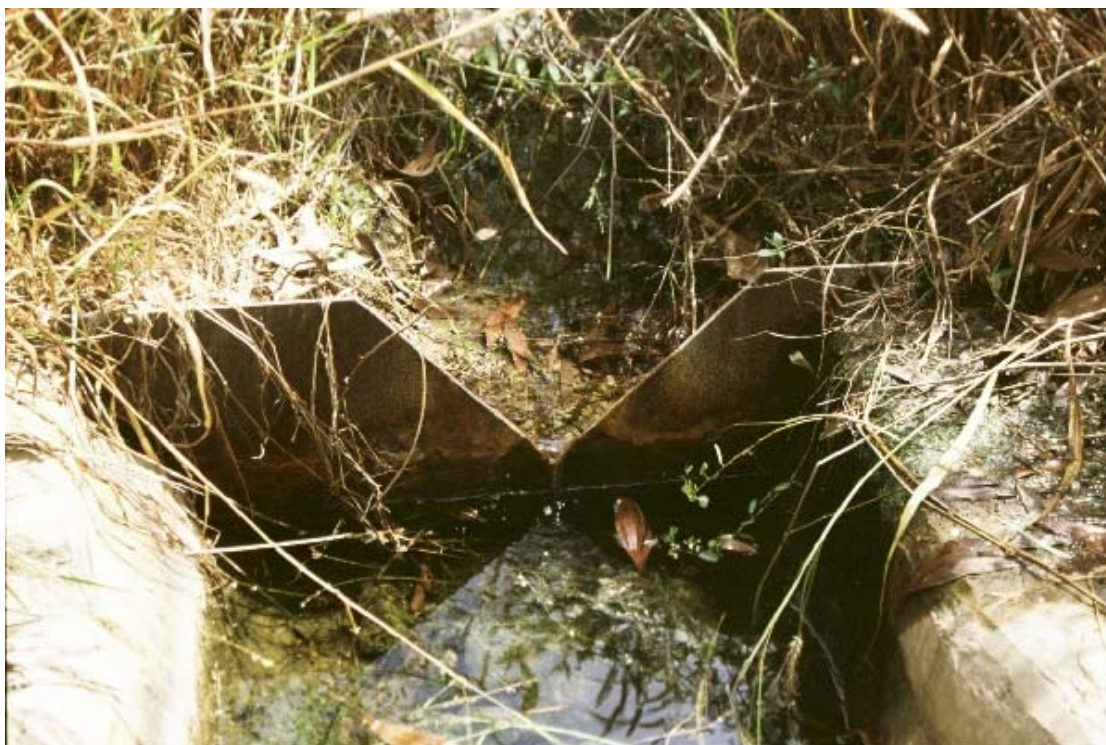
Figure 8 Weir discharging seepage from the south wall toe loading area of the tailings dam generated to the west of TDSRC in April 2002 (WD Erskine photograph)
