Investigation of radiation  
clearance procedures for  
vehicles leaving the  
Ranger mine

Supervising Scientist

Supervising Scientist 2004. *Investigation of radiation clearance procedures for vehicles leaving the Ranger mine*. Supervising Scientist Report 185, Supervising Scientist, Darwin NT.

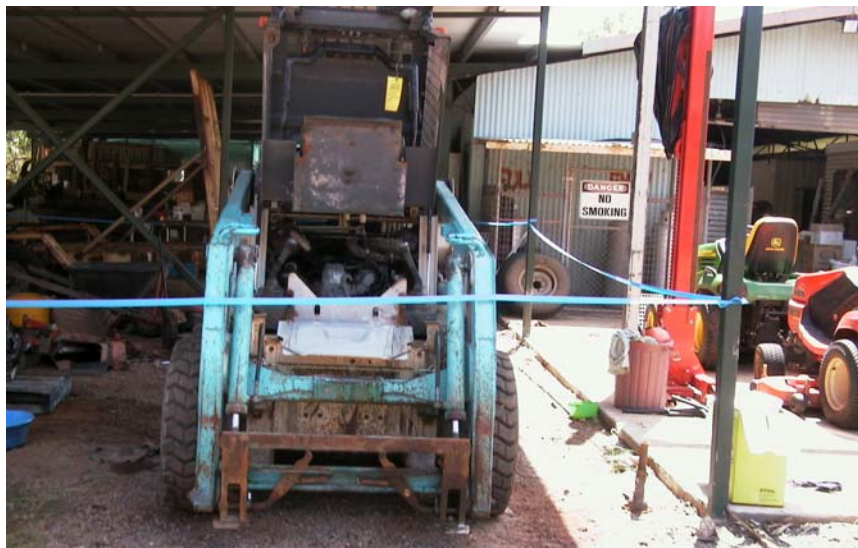
Soon after its return to the CDEP yard, probably on 29 November 2003, the bobcat was moved from the carport to the workshop area in the CDEP yard. The CDEP mechanic removed the engine of the bobcat, washed it down, and sent it into Darwin for repair. The CDEP mechanic continued to work on other elements and systems of the machine until the engine was returned to Jabiru shortly after completion of its repair on 18 December 2003. These activities resulted in more material, estimated to be up to 100 L, falling to the ground in the workshop area. The mechanic refitted the engine during January 2004, after the Christmas break. The exact date is unclear. Following installation of the repaired engine, the bobcat was removed from the workshop area to the carport where it remained until 5 February 2004.

**Figure 3** Bobcat partially dismantled in CDEP yard, 30 March 2004

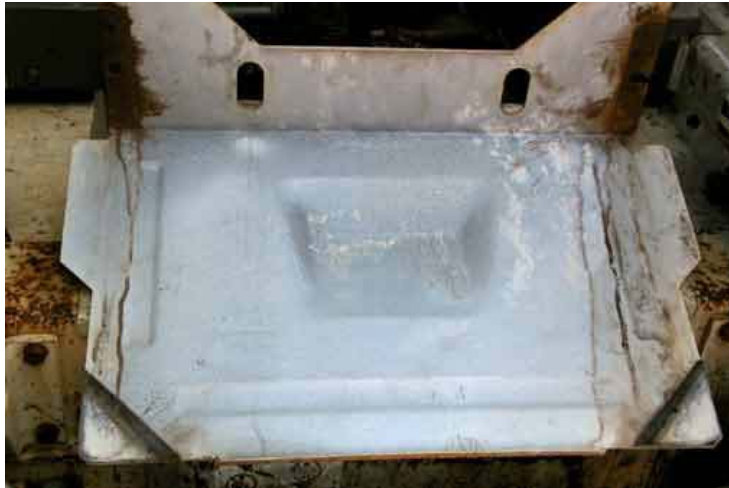
**Figure 4** Close up of material deposited inside bobcat cabin

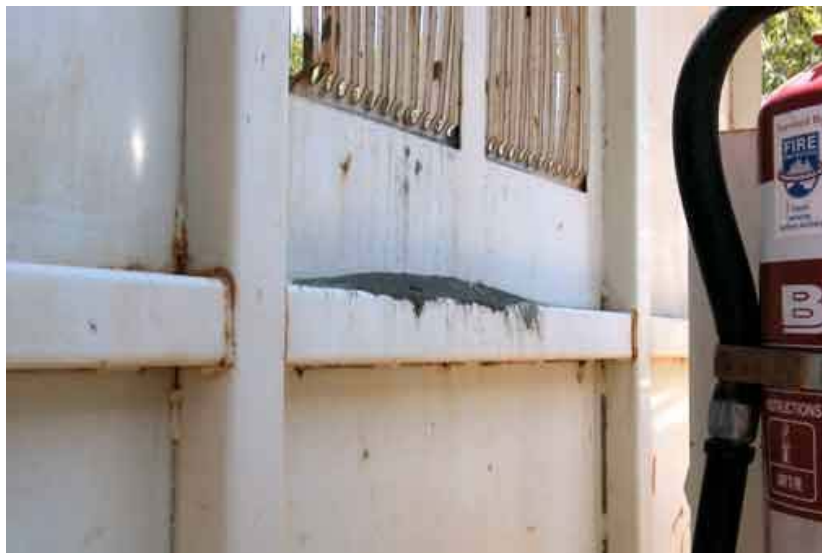
During the inspection of the bobcats in the CDEP yard on 30 March 2004 by SSD staff, the Hino truck was returned to the yard. The visual appearance gave rise to concerns that it had not been adequately cleaned (see figure 5) although it did have a radiation clearance certificate issued on that day. A check by SSD personnel showed that there was detectable radioactive contamination in the cab and on other parts of the truck as well as the visible contamination. The truck was returned to Ranger for further cleaning. Subsequently the truck failed to obtain a radiation clearance on two occasions, despite further washing. Eventually it was necessary to modify the truck to assist the cleaning of internal parts and the tray was sandblasted before radiation clearance was obtained.

**Figure 5** Contamination on CDEP Hino truck, 30 March 2004

During the SSD inspection and survey of the CDEP Yard on 30 March 2004 (~1230 hrs), a Hino tip truck returned to the CDEP yard from Ranger and was observed to be dirty, both externally (see figure 5) and on the floor of the driver's cabin. Radiation scanning of the truck by SSD staff confirmed that contamination was present. Samples were collected from the exterior of the truck and from the floor of the driver's cabin and were sent to the *eriss*

The results of these analyses are also presented in table 1. The results show that the material collected from the exterior of the truck (sample JT04004) and the material collected from the floor of the driver's cabin (sample JT04005) was partially leached uranium ore. It has been concluded that the radiation clearance process for this vehicle had also been inadequate.

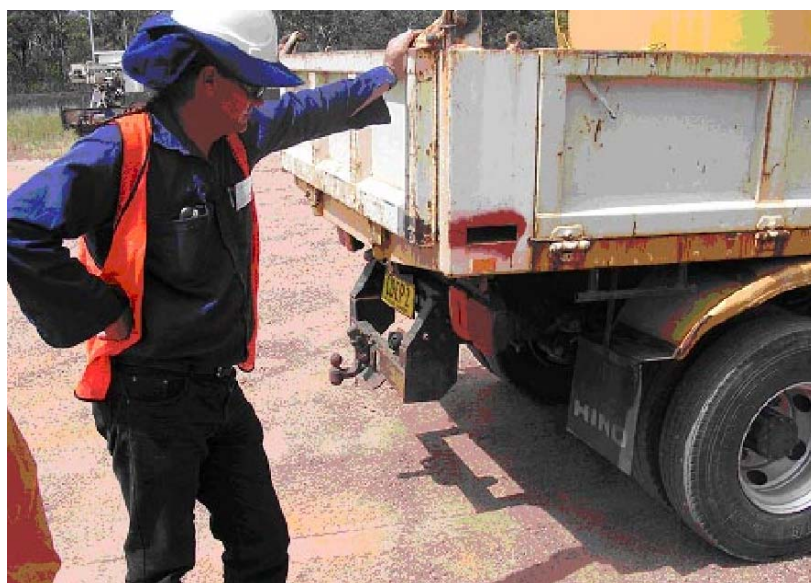
**Figure 6** Modifications on Hino truck to facilitate internal cleaning, 16 April 2004

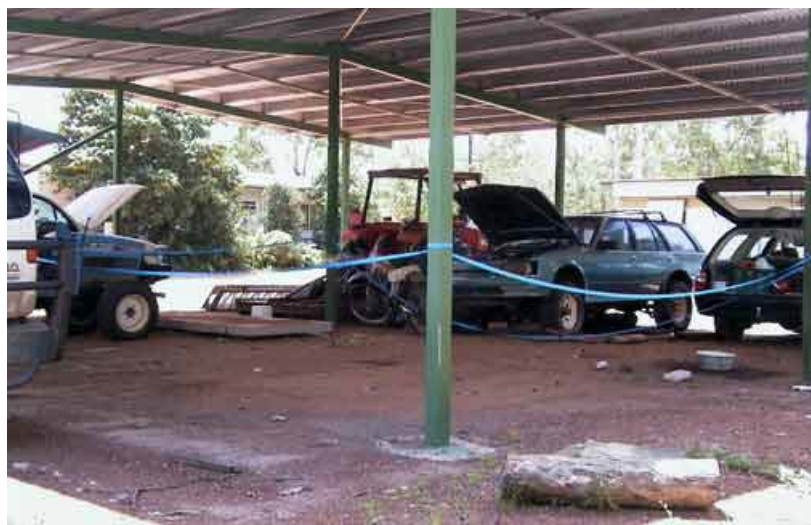
**Figure A1** Area A survey site

Undercover work area, some hydrocarbon contamination, machinery and car parts litter site. Small 1 metre by 1 metre portion of area where work was carried out slightly elevated (see table position 0,3)

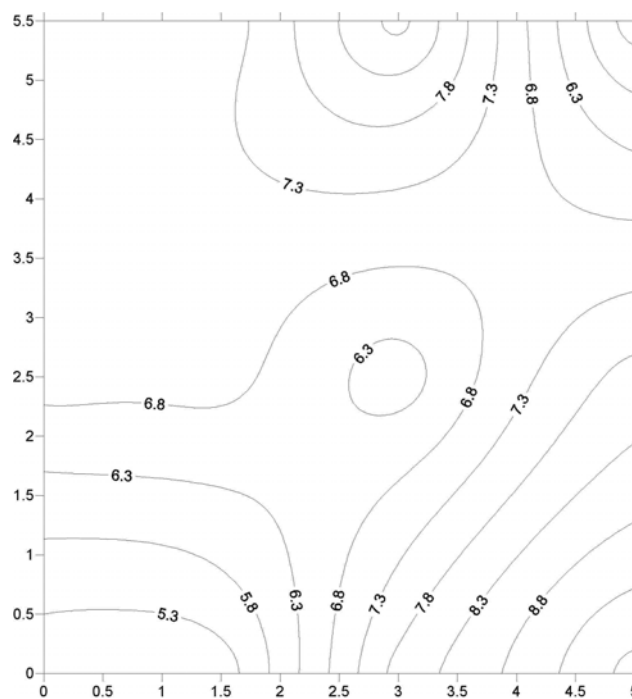
**Figure A3** Surface counts per second alpha and beta radiation, survey area A

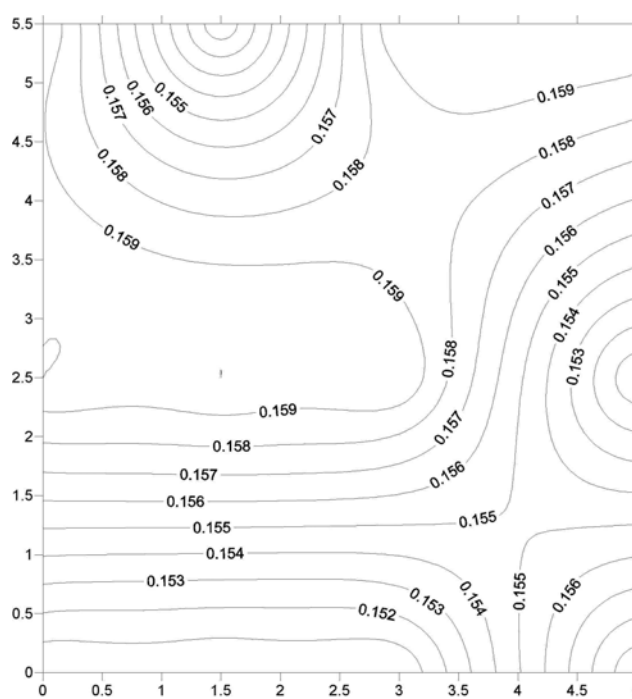
**Figure A4** Gamma dose rate ( $\mu\text{Gy/hr}$ ) in air at survey area A

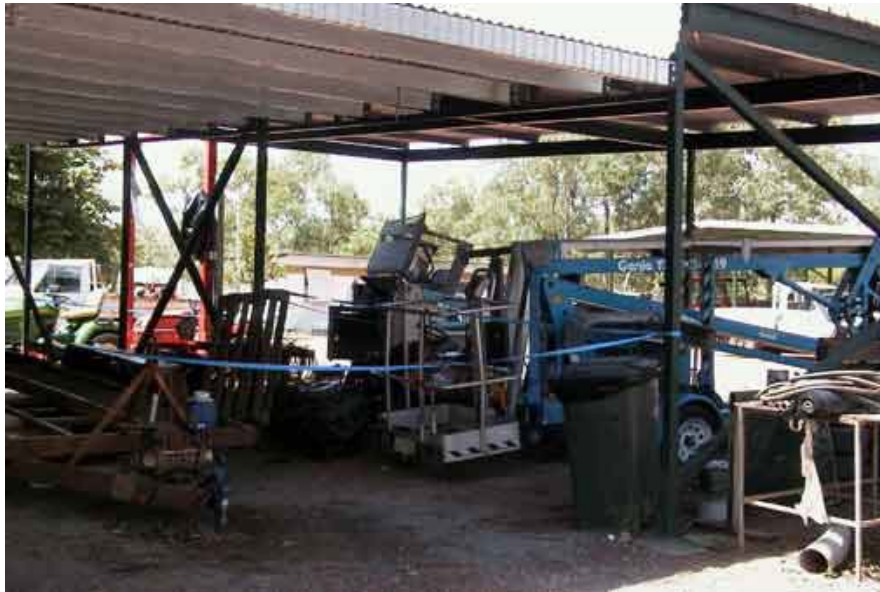
**Figure A5** Area B survey site

Undercover work area, more hydrocarbon contamination than Site A, machinery, trailers and car parts litter site. Two small 1 metre by 1 metre areas where work was carried out slightly elevated (see table position 0,3) and some material left < 100 grams – removed to Labs.

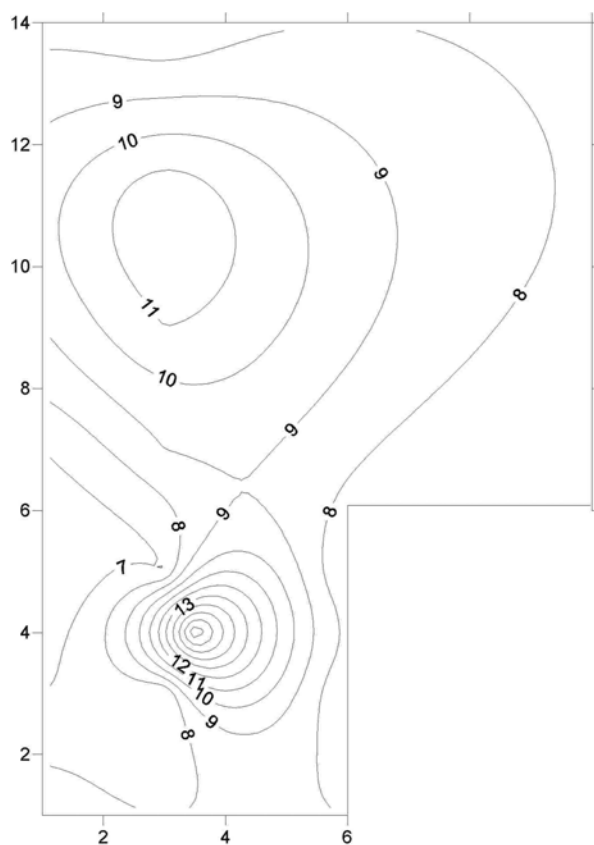
**Figure A7** Surface counts per second alpha and beta radiation, survey area B

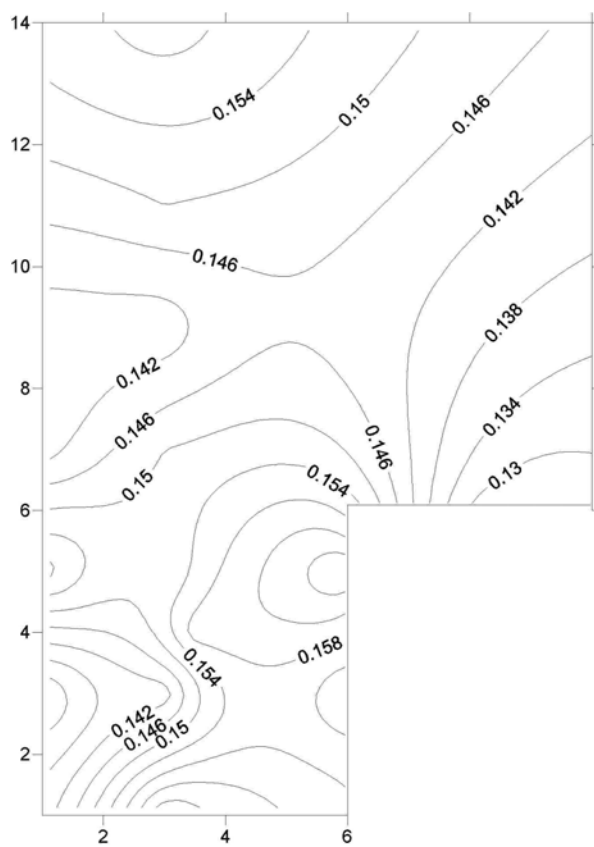
**Figure A8** Gamma dose rate ( $\mu\text{Gy/hr}$ ) in air at survey area B

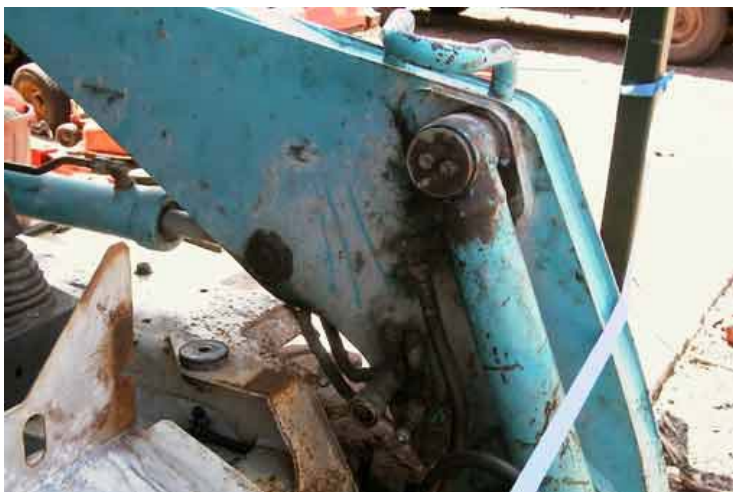
**Figure A10** Grey material on bobcat

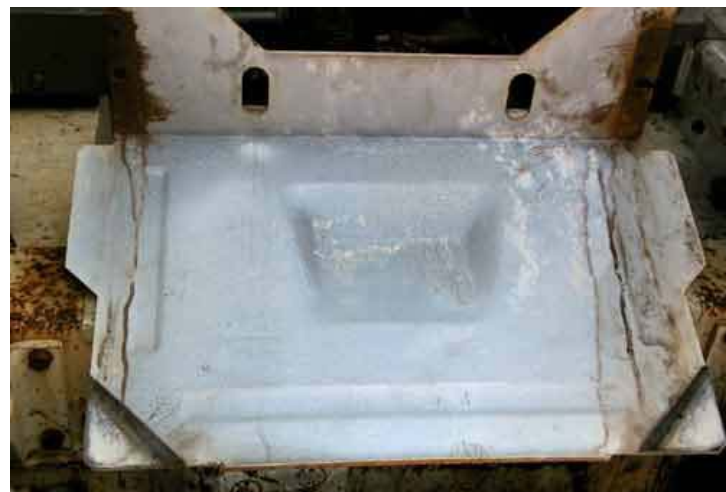
**Figure A11** Grey material on bobcat

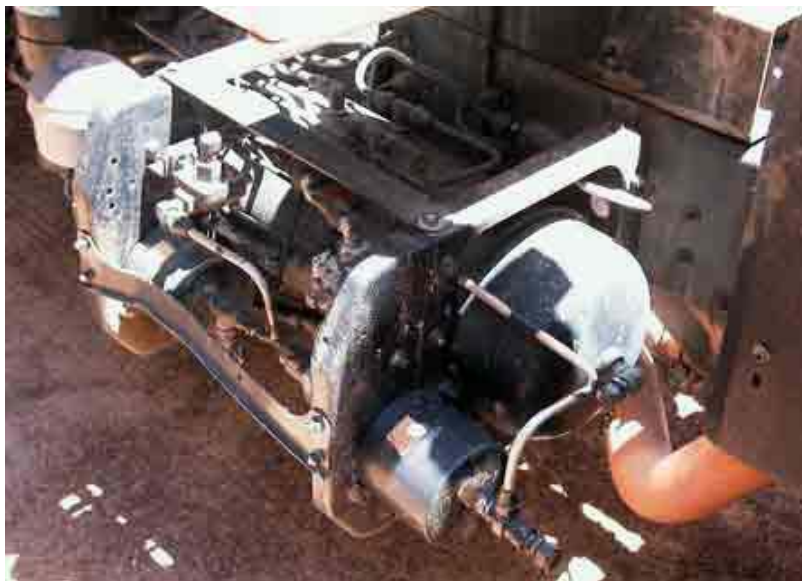
**Figure A12** Grey material on CDEP Hino tip truck

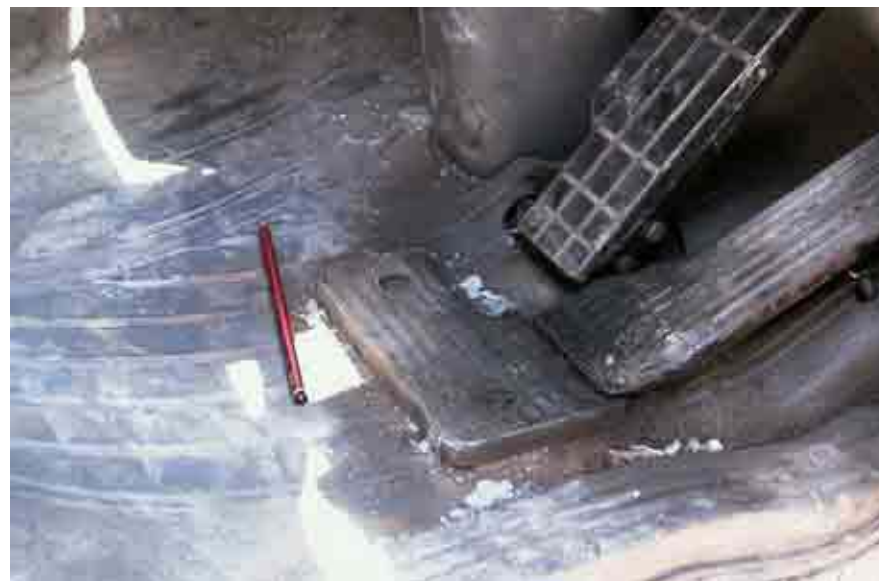
**Figure A13** Grey material on CDEP Hino tip truck floor

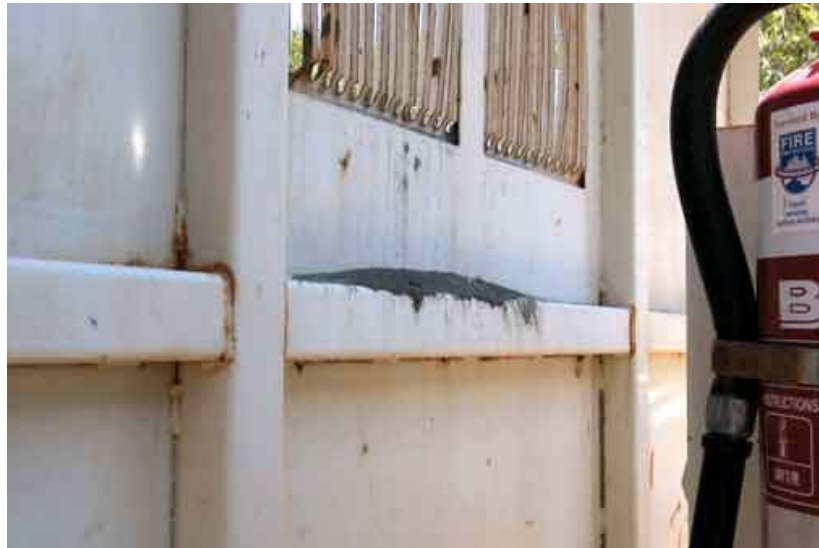
**Figure A14** Grey material on CDEP Hino tip truck tray

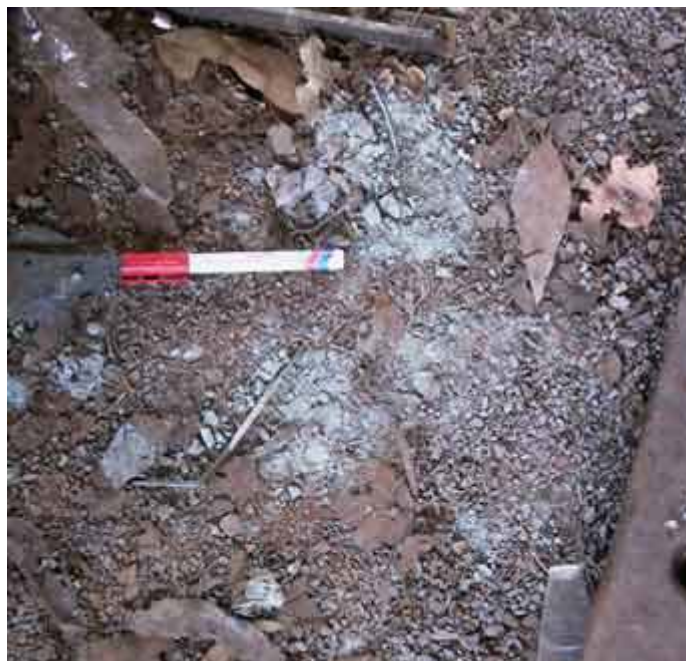
**Figure A15** Residual material taken to SSD laboratories for analysis from survey site B
