Part 5: General Alligator Rivers Region

Assessing the success of remediation works at former uranium mining and milling sites in the South Alligator River valley

C Doering, B Ryan, A Bollhöfer, J Sellwood, T Fox & J Pfitzner

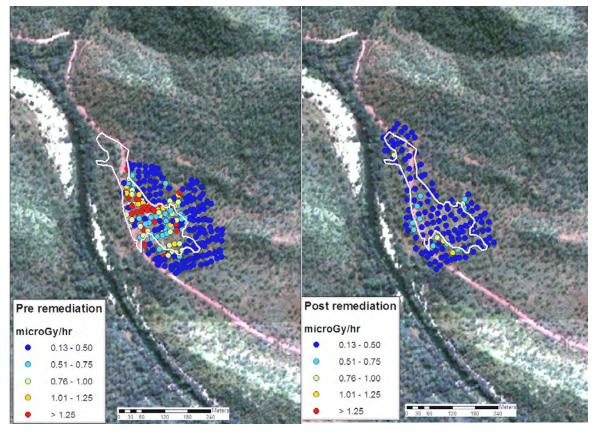
Figure 2 shows the location of the individual measurement points and the magnitude of the calculated absorbed gamma dose rates (including the cosmic component) at the Rockhole Residues site before and after remediation. The figure also shows the visual boundary of the remediated area, overlaid on a Quickbird satellite image of the area acquired in 2004. It can be seen that absorbed gamma dose rates have been substantially reduced following remediation of the area.

The total area that was remediated at the Rockhole Residues site in 2009–10 was approximately 2.5 ha. None of the 150 dose rate measurements taken across the area in 2010 exceeded the specified radiological threshold value of $1.25 \pm 0.25 \,\mu Gy \cdot hr^{-1}$. Figure 3 provides a frequency and probability plot for the dose rates measured at the site. The dose frequency

Figure 2 Pre- and post remediation gamma dose rates at the Rockhole Residues site overlaid on a Quickbird satellite image. The white line shows the approximate outline of the remediated area.

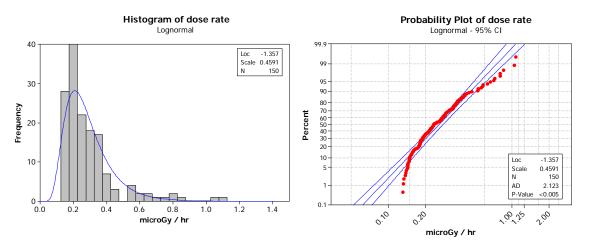
plot for the Rockhole Residues site (Figure 3) exhibits a lognormal distribution. From the probability plot it can be concluded, with 95% confidence, that 99.9% of the dose rates measured at the site were below the guideline value.

Figure 3 Histogram and probability plot of the dose rates measured at the remediated Rockhole Residues site

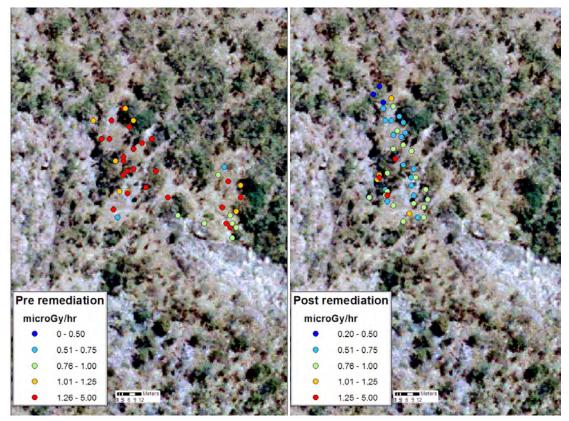
Figure 4 shows the pre- and post-remediation gamma dose rates measured at the Palette site in 2008 (Bollhöfer et al 2009b) and 2010, respectively. Whereas in 2008 the lower bench was easily accessible, the track to the lower bench was not accessible in 2010 due to the

remediation works and the presence of large boulders. Consequently, only the top bench (to the west or left of image) was surveyed as it was considered unlikely that the lower bench will be accessed by people for habitation for extended periods of time.

Figure 4 Measured pre- and post remediation gamma dose rates at Palette mine overlaid on an aerial photograph of the area

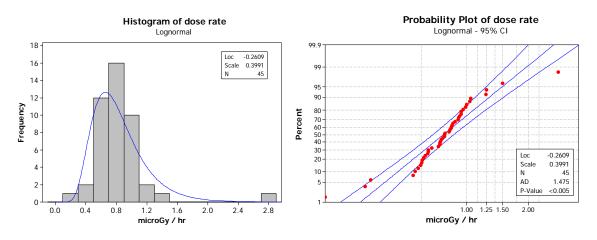
The dose rate frequency plot for Palette (Figure 5) appears to define a lognormal distribution. The probability plot for the site indicates that 90% of the locations measured post remediation have gamma dose rates less than the guideline value of $1.25 \pm 0.25 \,\mu\text{Gy}\cdot\text{hr}^{-1}$, compared to only 25% pre-remediation (Bollhöfer et al 2009b). Generally, readings above 1 $\mu\text{Gy}\cdot\text{hr}^{-1}$ correspond to locations near the cliff face on the top bench. There was one measurement above the guideline value, which was due to the presence of a single small piece of mineralised material (approximately 5 cm³), believed to be pitchblende, lying on the ground surface.

Figure 5 Histogram and probability plot of the dose rates measured at the remediated Palette mine

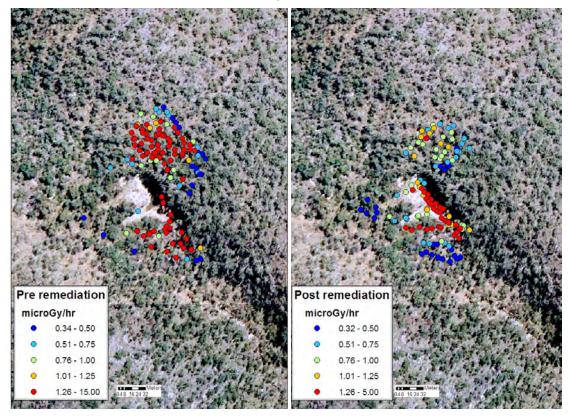
The highest pre-remediation dose rate on top of the El Sherana pit (to the north) in 2008 was 14 μ Gy·hr⁻¹, measured over a concrete pad that had supported a battery used to crush some of the high grade ore mined at the site. The next highest readings were obtained from an area without noticeable infrastructure but containing a number of rock and rubble piles (see Bollhöfer et al 2009 for details). Figure 6 compares pre- and post-remediation gamma dose rates measured at El Sherana. Gamma dose rates on top of the pit were substantially reduced after remediation. Only one reading in 2010, at 2.7 μ Gy·hr⁻¹, was above the guideline value and was associated with a number of small fragments of mineralised material.

Figure 6 Measured pre- and post remediation gamma dose rates at El Sherana mine overlaid on an aerial photograph of the area

The bottom of the pit was surveyed in 2008 prior to remediation, and some areas were found to have elevated gamma signatures. These areas consisted of two waste piles and four benches in the pit wall to the southeast of the pit. The bench on top of the pit wall exhibited gamma dose rates of approximately $1 \mu Gy \cdot hr^{-1}$. The remaining three benches, the bottom of the pit, and the two waste piles exhibited average gamma dose rates of about $2 \mu Gy \cdot hr^{-1}$ or more. In particular and prior to remediation, there was a small area of mineralisation accessible from one of the benches that exhibited absorbed gamma dose rates of above $7 \mu Gy \cdot hr^{-1}$. As part of the remediation at El Sherana, the material from the two waste piles was shifted and pushed against the benches to the southeast of the pit, thereby covering the small area of mineralisation and reducing average gamma dose rates in the area.

Figure 6 shows that post-remediation gamma dose rates were lower after removal of the two waste piles south of the pit. However, dose rates were still generally higher in the pit and along the upper small access track compared with other areas, due to remnant mineralised material. The highest dose rates $(3-4 \mu Gy \cdot hr^{-1})$ were measured immediately to the southeast of the pit, in an area that was not subject to remediation.

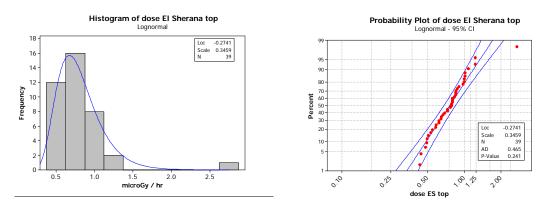
Figure 7 Histogram and probability plot of the dose rates measured on top of the remediated El Sherana mine

Figure 7 shows frequency and probability plots of the dose rates measured on top of the remediated El Sherana mine. Assuming a log-normal distribution of the absorbed gamma dose rate measured on top of the El Sherana pit, approximately 95% of the locations investigated post remediation are characterised by levels below the 1.25 \pm 0.25 $\mu Gy \cdot hr^{-1}$ guideline value, compared with only 40% pre-remediation (Bollhöfer et al 2009b).

The average gamma dose rate on top of the pit has been reduced substantially and typical post remediation values are 0.7–0.8 μ Gy·hr⁻¹. At the bottom of the pit and on access tracks not subjected to remediation, values have not changed and are typically around 1.2–1.4 μ Gy·hr⁻¹.
