| Vessel Name: | Patriarch |
| New Construction / Maintenance: | Maintenance - full hull recoat, 8,000 sq/ft |

## **Crowley “Patriarch” Dry docking In Jacksonville, Florida - January 2014**

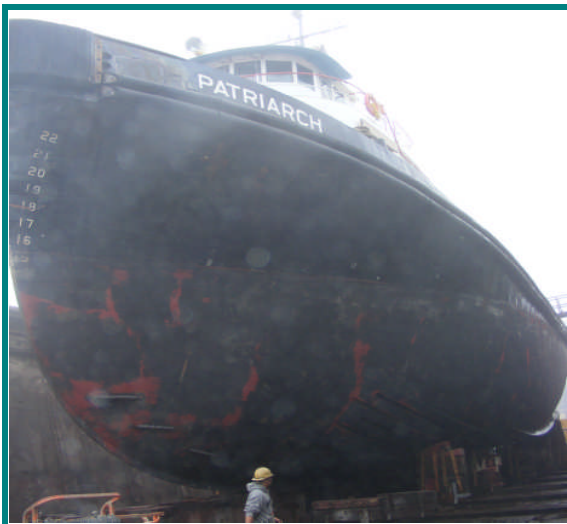
Prior to surface preparation and coatings

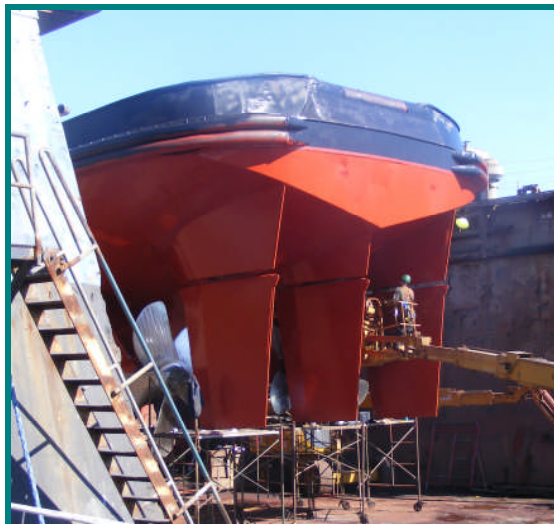
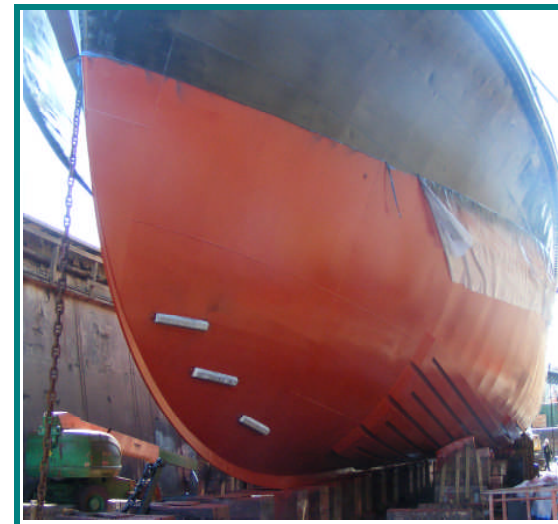
Duplex Fouling Release Red Silicone

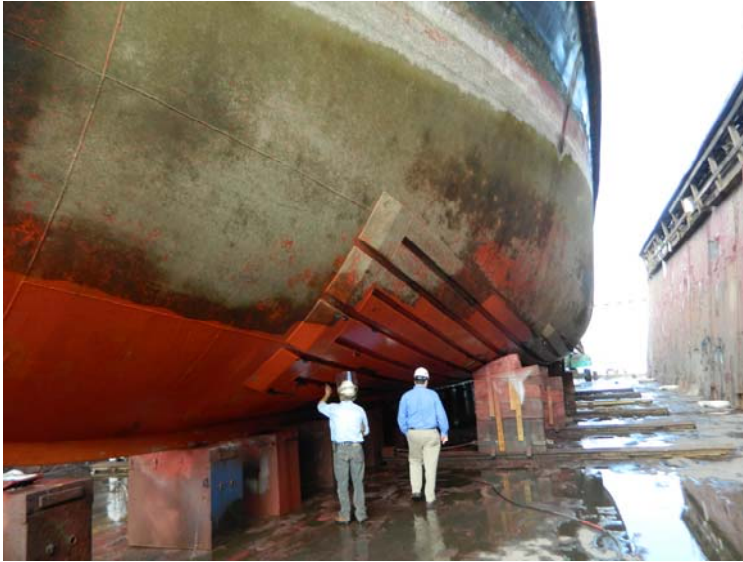
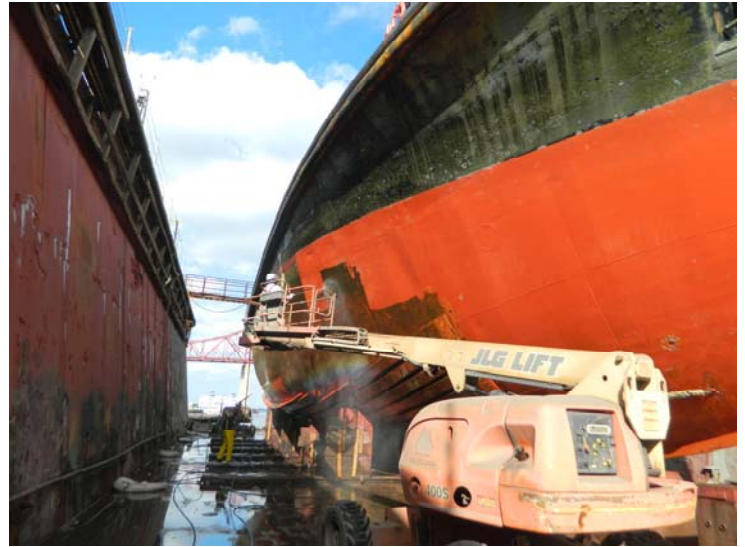
**High pressure water washing to remove “soft fouling” that occurred while sitting idle for over a week in the Saint Johns River. This fouling was easily removed at 1900 / 2000psi. No Hard Fouling was evident after 5 yrs of active coating service.**

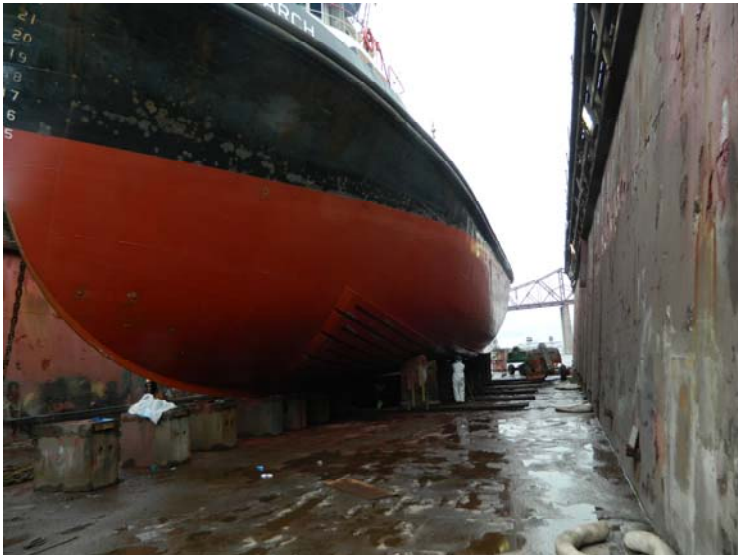
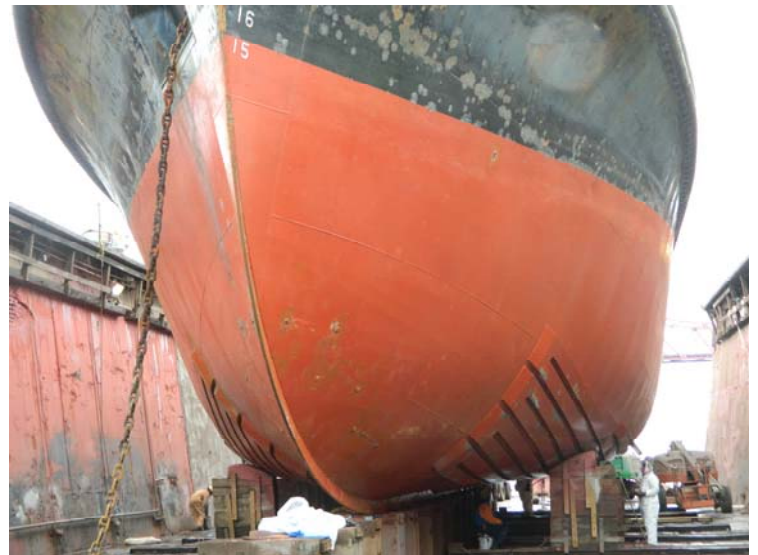
**After water washing was completed, minor areas required coating touch ups.**
