Independent Observer summary report on *MV Yangtze Harmony*

Cattle exported to China in December 2018

Report 56, August 2019

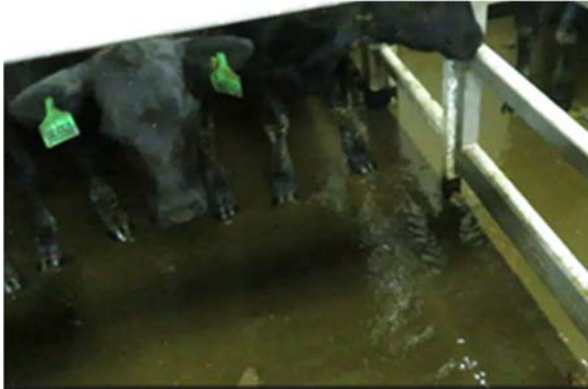
The condition of the pad in the majority of pens were acceptable on the voyage. Wood shavings were laid on the floors before loading. Water logging of pens caused by leaks of the water supply system were normally quickly repaired and wood shavings used to improve the conditions. On day two, several pens on deck one had water inundation caused by overflow of the bilge.

Day 2 Cattle in pen – water in pens

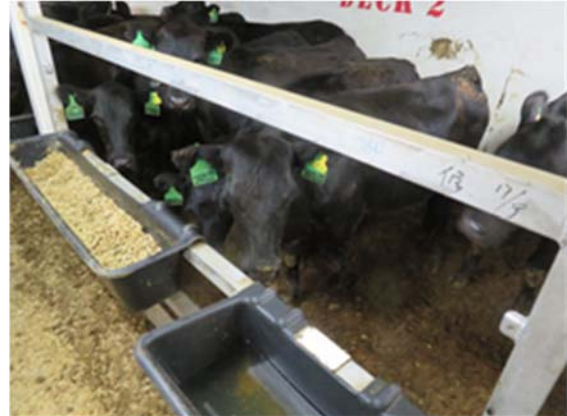
Day 7 Cattle in pen – no issues identified

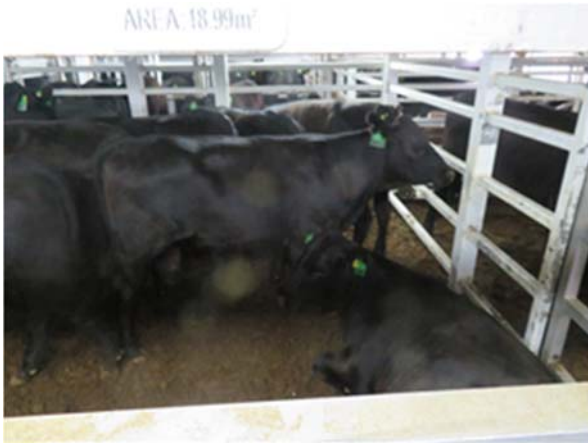
Day 8 Cattle in pen - no issues identified

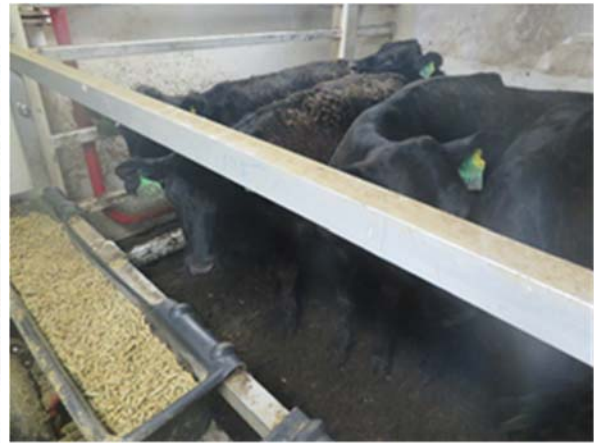
Day 15 Cattle in pen – no issues identified

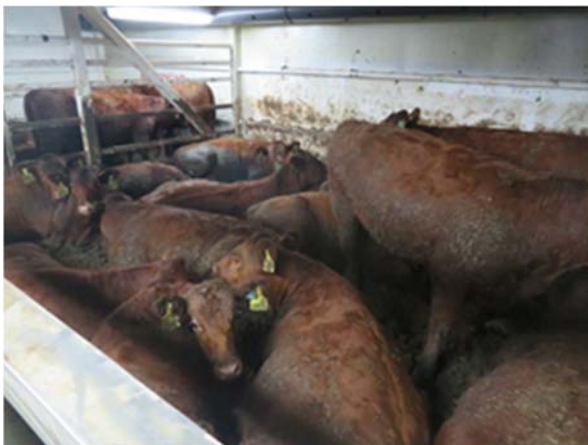
Day 15 Cattle in pen – no issues identified

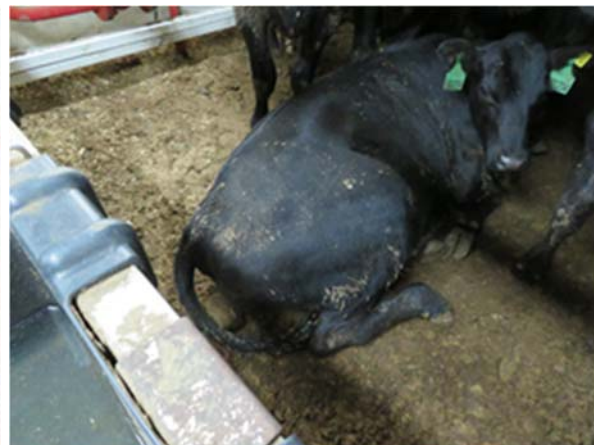
Day 17 Cattle in pen – no issues identified
