Investigation of

tailings water leak

at the Ranger

uranium mine

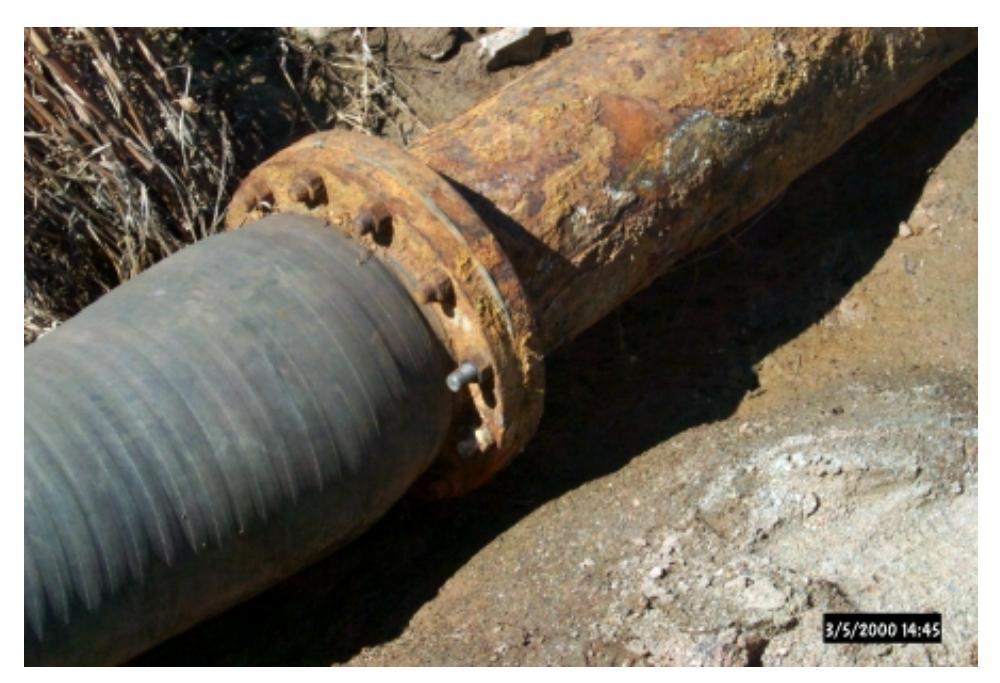
The cause of the leak was corrosion and subsequent failure of three bolts that secure the jointing of two flanges in the pipeline. The principal cause of corrosion was the burial, under moist conditions for up to 6 months of the year, of the relevant section of the pipeline under silt derived from erosion in the vicinity of the tailings corridor roadway. A contributing factor to the failure may have been the use of undersized bolts.

The leak occurred at a flange joint in the 250 mm diameter Tailings Water Return Pipeline which transports water from the tailings dam to the processing plant at Ranger. Figure 1 is a photograph of the flange joint after it was repaired. The Tailings Water Return Pipeline (TWRP) is approximately 2.5 km long and runs alongside the Tailings Dam Corridor road within a bunded area on the Ranger site (the Tailings Dam Corridor) designed to collect and contain any spillages that occur. The Tailings Dam Corridor drains to a sump near Pit 1 (the Tailings Dam Corridor Sump). Water collected in this sump is pumped, as required depending on rainfall, to a retention pond on the Ranger site.

Figure 1 Photograph of the flange joint in the Tailings Water Return Pipeline that transports water from the tailings dam to the processing plant after it was repaired

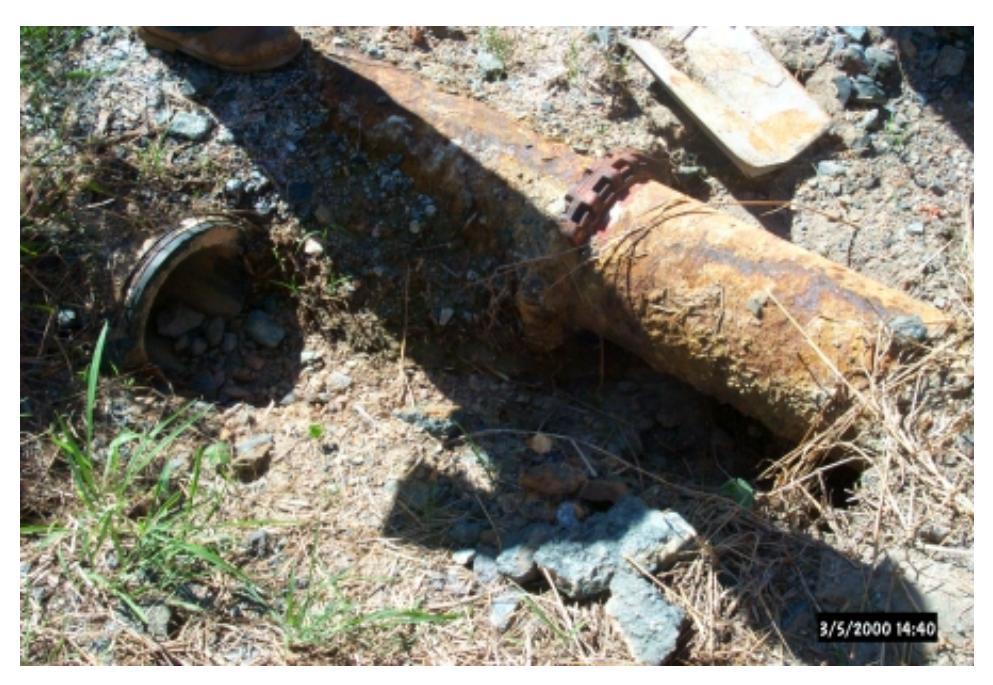
Buried by silt near the leaking flange joint, and also passing under the Access Road Culvert, was a disused pipe segment approximately 10 m long. One end of the disused pipe segment was located within one or two metres of the leaking flange. The top of the other end of the disused pipe segment abutted the surface within the Tailings Dam Corridor on the eastern side of the Access Road Culvert. A photograph of this end of the disused pipe segment after it was uncovered is shown in Figure 2. Figure 4 is a schematic representation of the Access Road Culvert showing the TWRP and the disused pipe segment.

Tailings water which escaped from the leaking flange traveled underground for one or two metres, entered one end of the disused pipe segment flowing within it to emerge at the opposite end before upwelling to the surface. Once on the surface, the tailings water joined the surface flow of rainfall runoff within the Tailings Dam Corridor. Surface water within the Tailings Dam Corridor flows to the Tailings Dam Corridor Sump. It has now been established

Figure 2 End of the disused pipe segment after it was uncovered

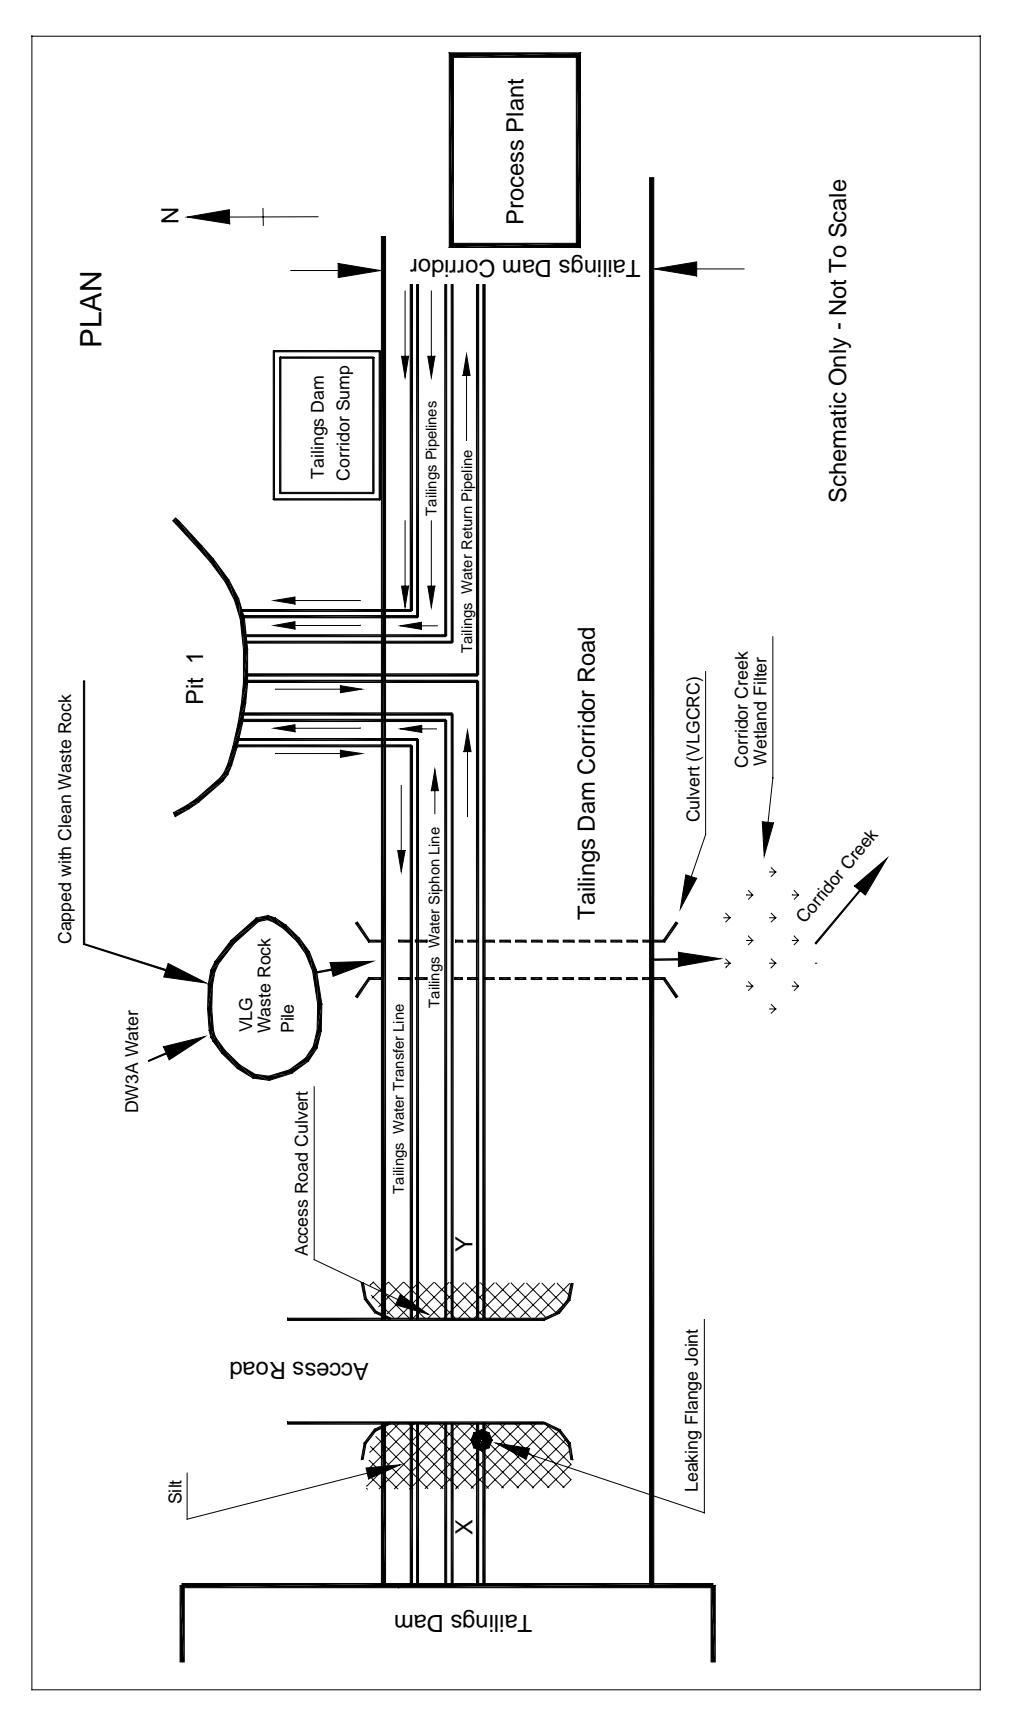
Figure 3 Schematic representation of the pipelines in the Tailings Dam Corridor

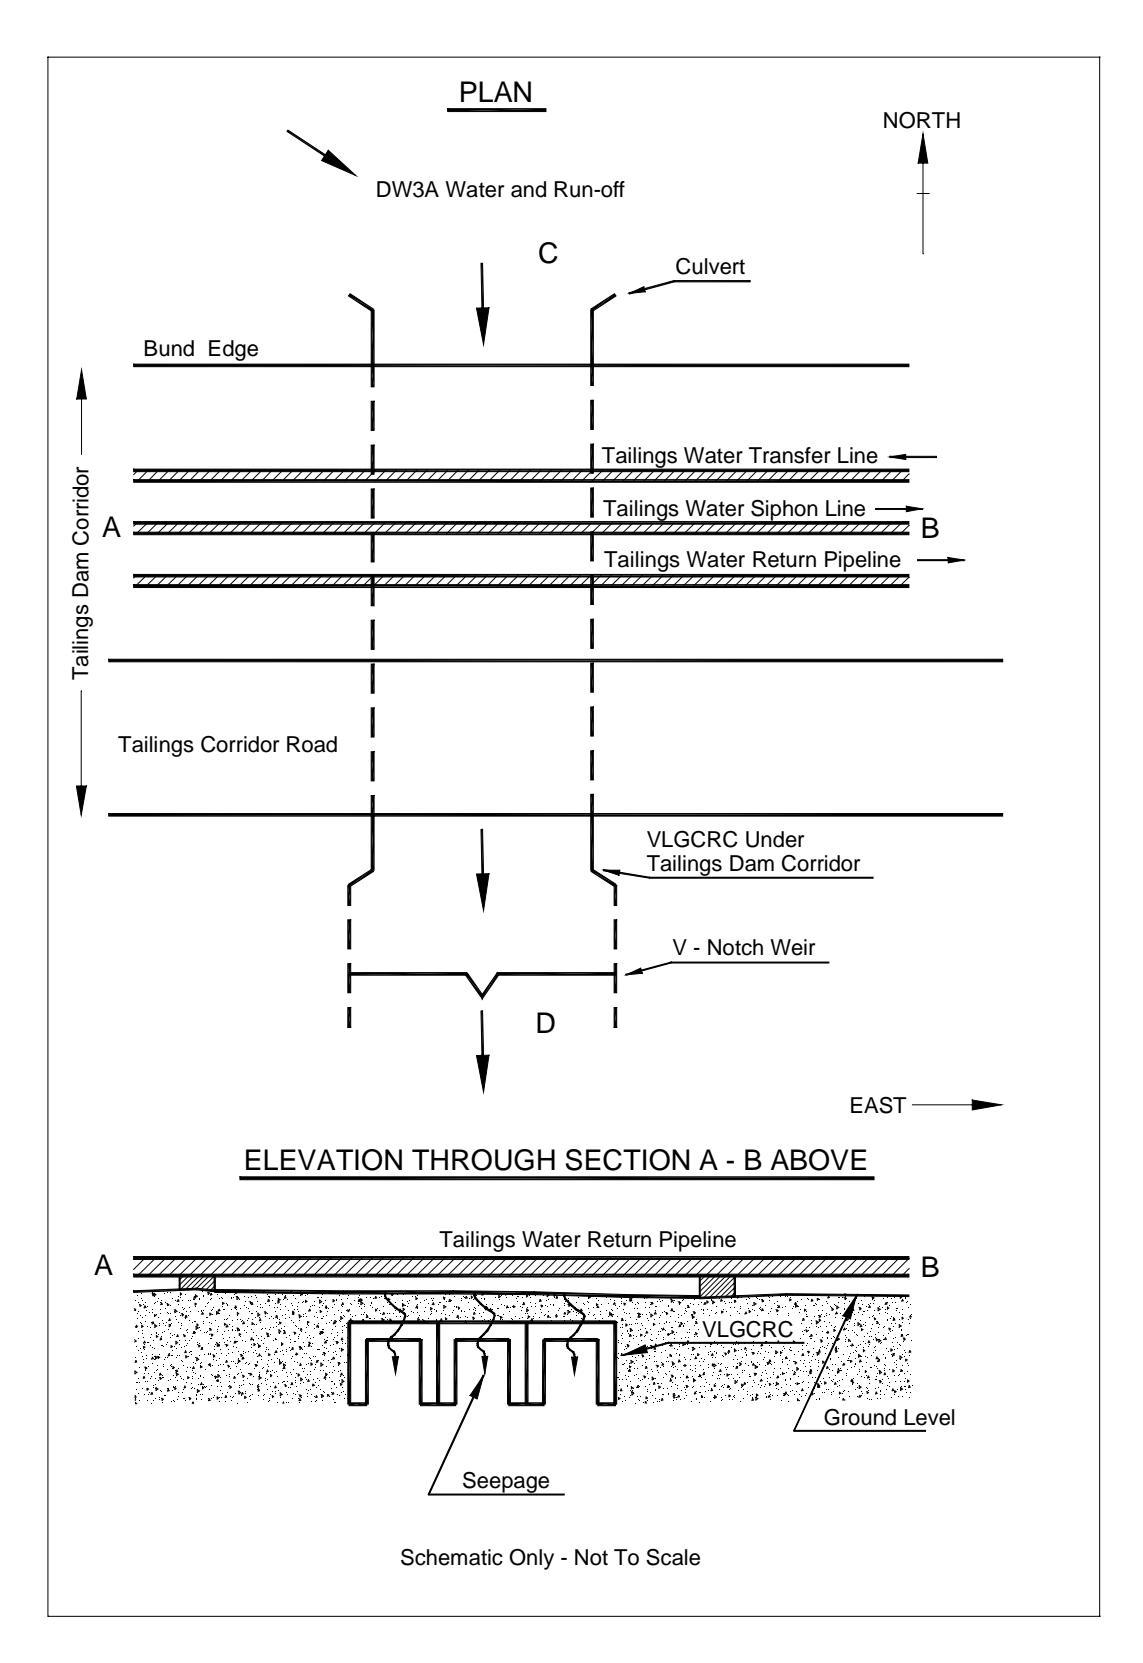
that a proportion of the water seeped into the VLGCRC which flows under the Tailings Dam Corridor, approximately 250 m from the leaking flange. Figures 5 and 6 are schematic representations of the Tailings Dam Corridor at the VLGCRC. Figures 7 and 8 are photographs of the VLGCRC looking south and north respectively.

Figure 5 Schematic representation of the Tailings Dam Corridor at the VLGCRC

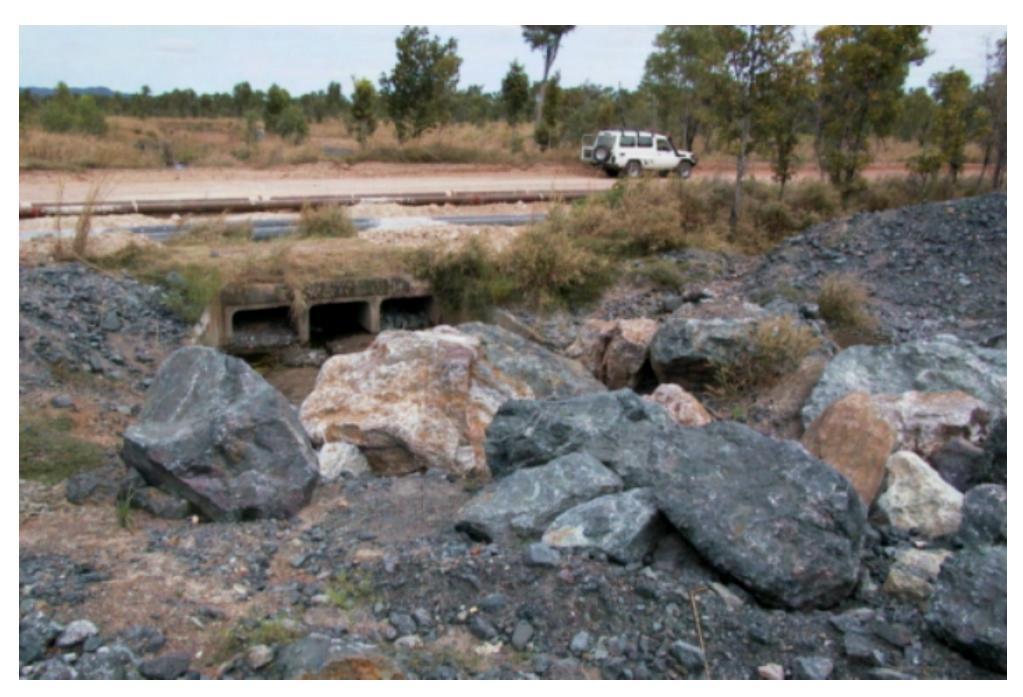
Figure 7 VLGCRC looking south

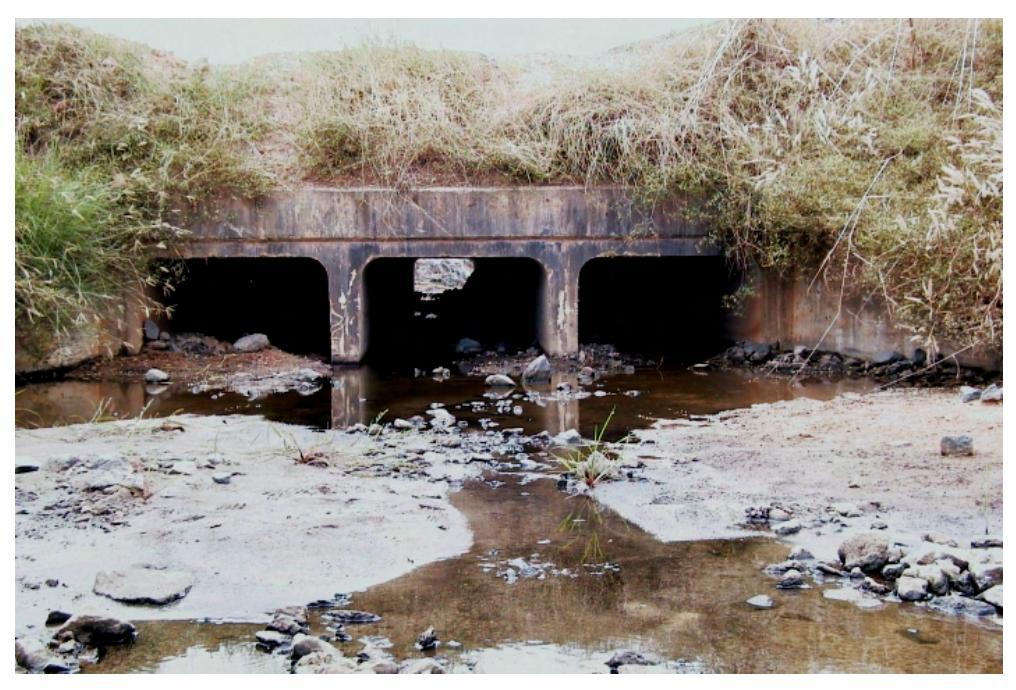
Figure 8 VLGCRC looking north

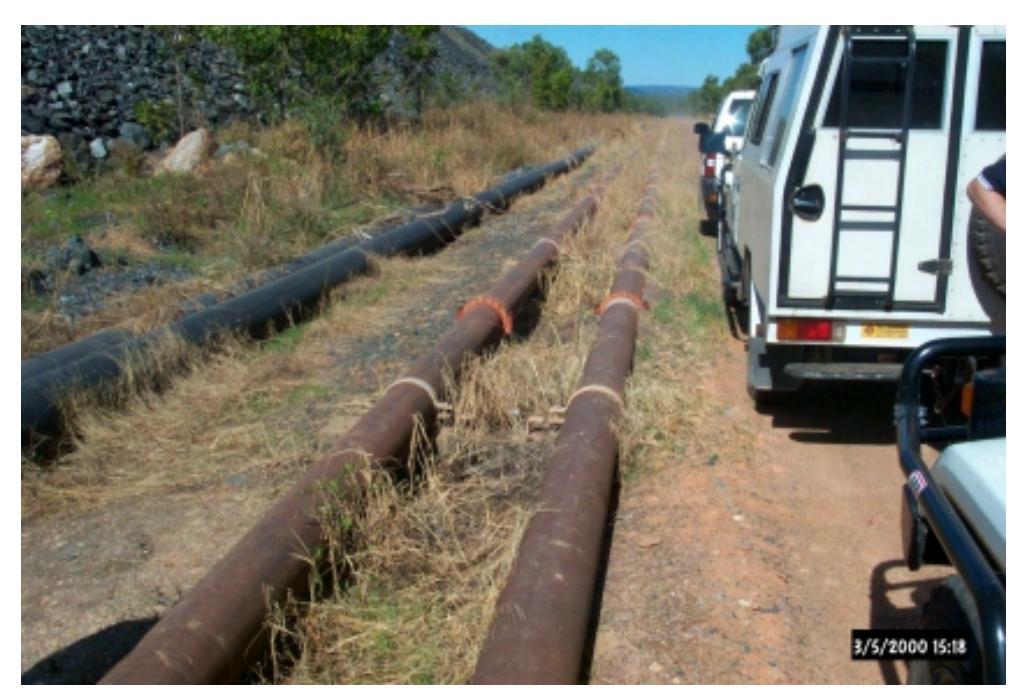
- The maintenance practice of applying herbicides to the Tailings Dam Corridor to prevent the growth of grass around the pipelines has ceased resulting in the extensive growth of grass and weeds around the pipelines. Some cold burning has been used to control grass however this practice carries with it a risk of damaging the internal linings of pipes, compromising their integrity.

- There is some evidence that the side embankment heights/integrity might in a few locations not be as originally designed.
- The pipelines in the Tailings Dam Corridor are located very close to waste rock stockpiles in places. There is a risk of falling rocks from the stockpile damaging the pipelines.

Figure 17 Tailings Dam Corridor looking east before remedial works

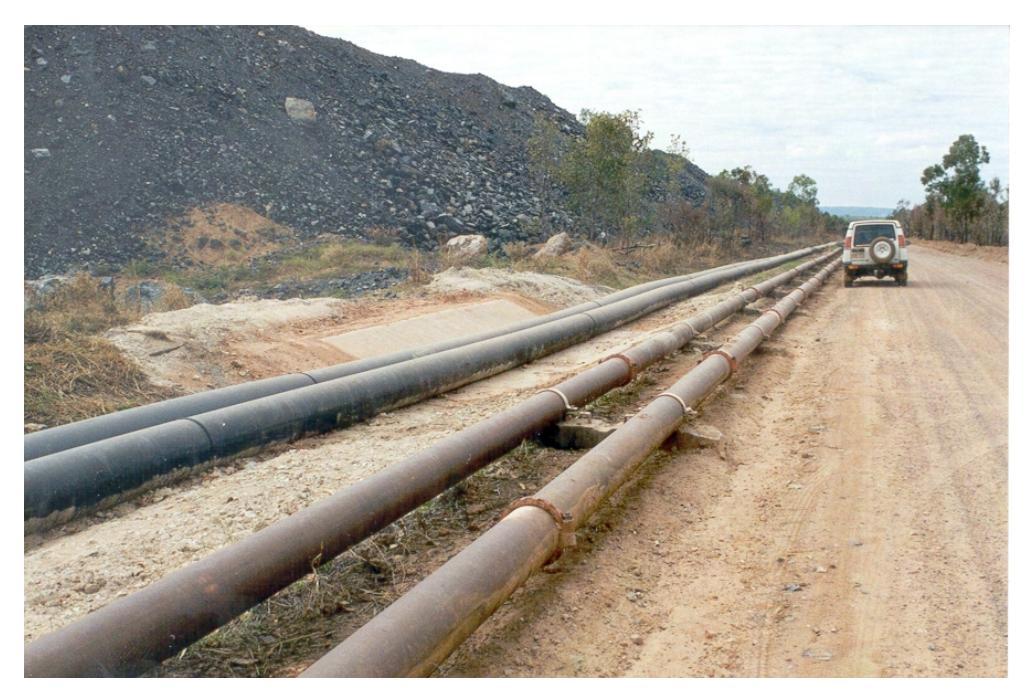
Figure 18 VLGCRC culvert after remedial works had been completed showing concrete pad over the culvert (looking east)

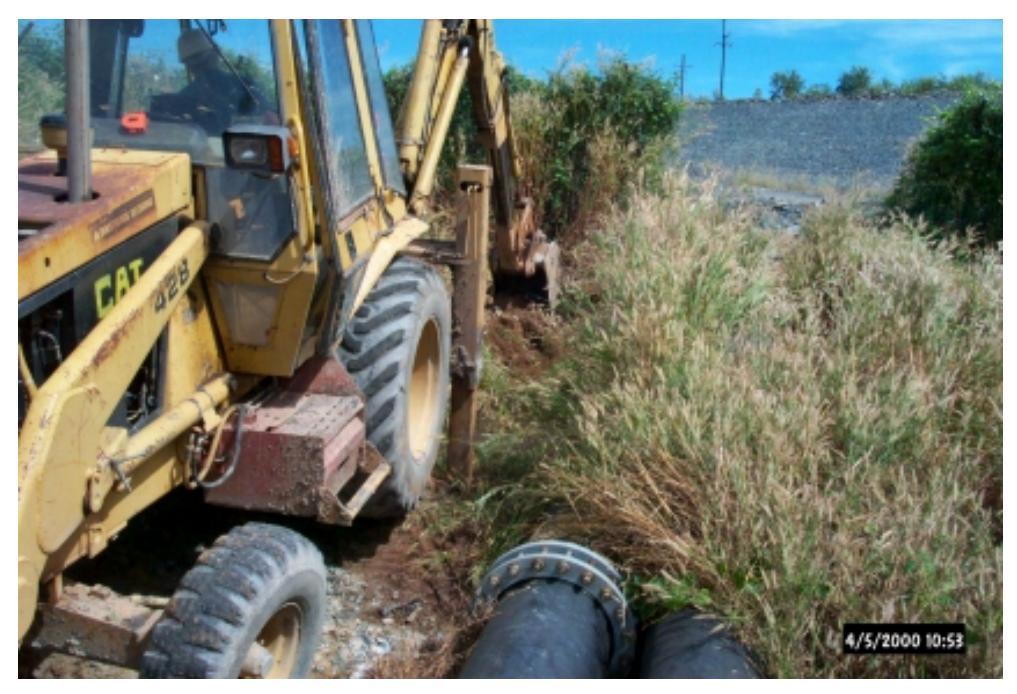
Figure 19 Tailings Dam Corridor pipelines in the vicinity of the leak before remedial works (looking west)

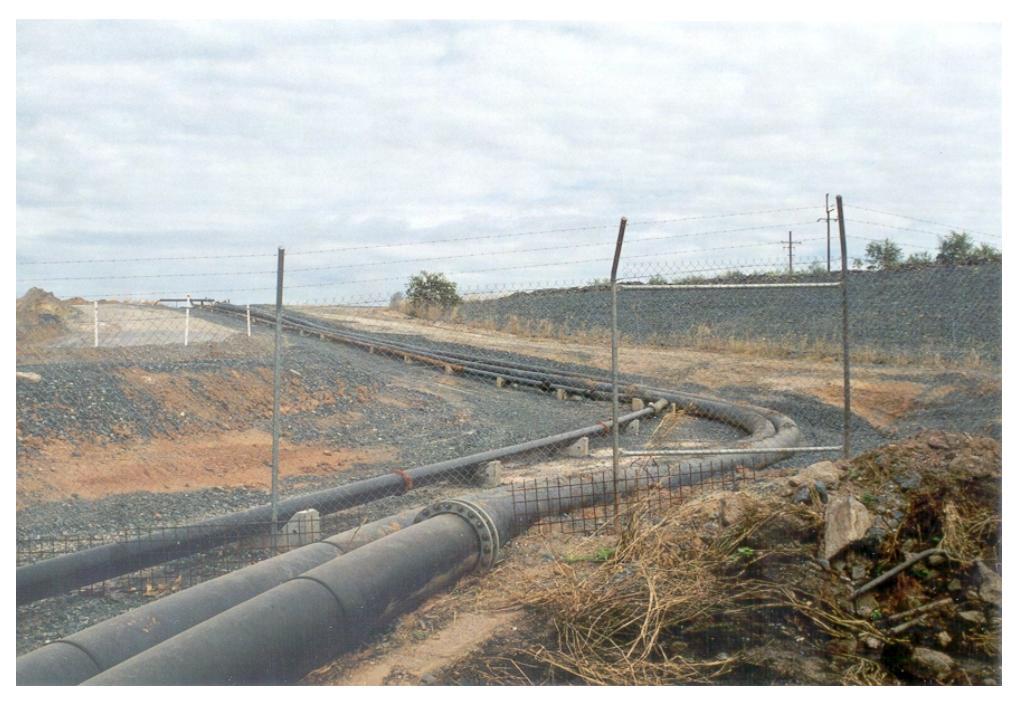
Figure 20 Tailings Dam Corridor pipelines in the vicinity of the leak after remedial works (looking west)
