# Appendix F: Pool Refugia (Contingency Monitoring)

## 1 Introduction

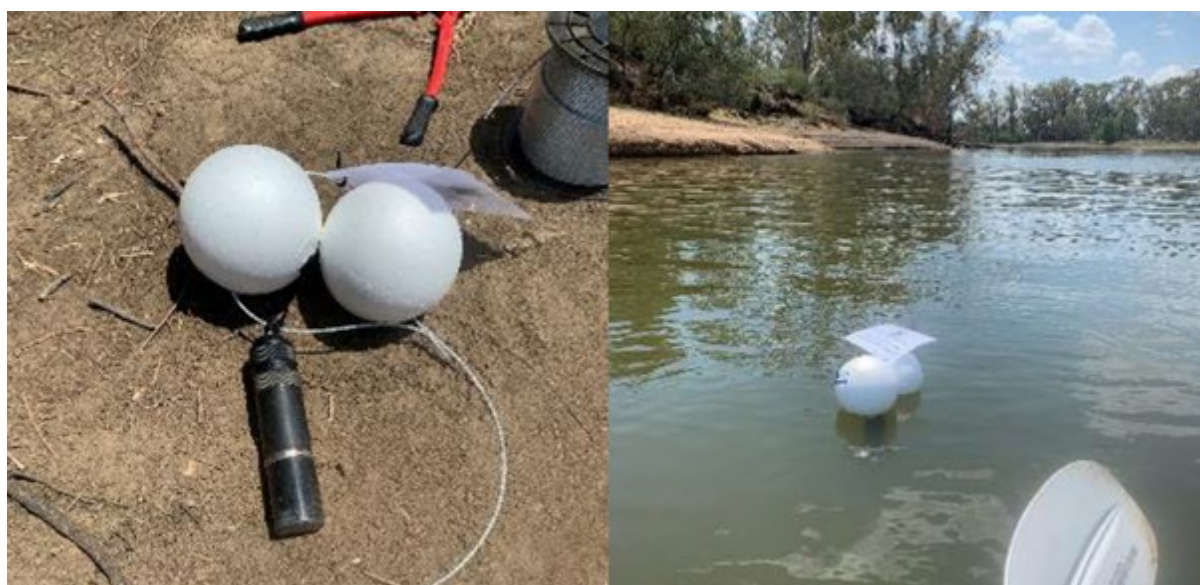
*Figure 7 Dopto dissolved oxygen/temperature logger secured under floats by wire (left) and deployed in Tareelaro weir (right).*

Six sites were chosen for pool refuge monitoring in the Gwydir and Mehi rivers, Carole Creek and Gingham Watercourse (Figure 6, Table 2). These represent some of the larger more permanent pools in the lower Gwydir system. Sites were established on 21-22 October 2019, and were visited four times until March 2020 to download loggers and collect data. At each site, spot water quality measurements (temperature °C, DO mg/L, specific conductivity  $\mu\text{S}/\text{cm}$ , salinity ppt, pH, turbidity NTU) were taken using a Hydrolab multi-probe water meter. Water samples were also collected for nutrient (nitrogen and phosphorus) analysis in the laboratory. Both macroinvertebrates and microinvertebrates were sampled at each site and later identified in the laboratory following the standard methods presented in Hale *et al.* (2014). In addition, at each site, time lapse cameras were set with a photo interval of six hours to capture changes in water level and habitat conditions over time. At five sites (Table 2), DO and temperature loggers were deployed at the surface of these pools, recording measurements every 10 minutes, to allow tracking of diurnal and long-term changes in these parameters. A mixture of D-opto and Mini-Dot DO and temperature loggers were deployed and suspended off a buoy using wire and tethered to a besser block to keep them in place at each location (Figure 7). Enough slack was left in the wire during initial deployment to allow for variation in water levels over time. Due to the close proximity to town and the heightened chance of theft, smaller HOBO temperature only loggers were installed at the Mehi River at Moree. Here, one logger was suspended near the surface and a second approximately 20 cm from the river bed by a cord attached to a log in the river. Temperature recordings were logged every 10 minutes. Due to the very low water levels at Gingham Waterhole on the Gingham channel, no loggers were deployed at this site.

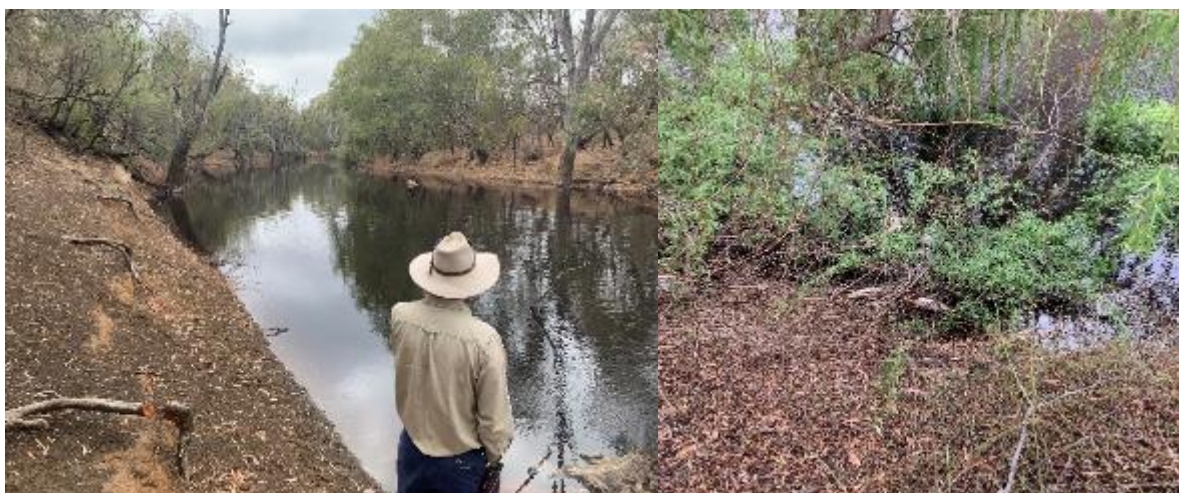
*Figure 9 Combadello weir pool at 10am on the 4 November 2019 showing blackwater (left) and dead fish floating on the surface of the pool (right).*

Very low dissolved oxygen (0.54 mg/L, Figure 8) was observed at Combadello Weir on the morning of 4 November 2019 following the arrival of the pool maintenance flow into the weir pool the previous night. The water had a distinct black appearance and there were dead fish visible on the surface and schools of smaller fish mouthing for oxygen at the surface of the pool (Figure 9). All other parameters measured were within acceptable ranges (Appendix B: Food Webs). Sampling downstream of the Combadello regulator suggested that dissolved oxygen levels were slightly higher but still relatively low, at 4.26 mg/L directly below the regulator (influenced by localised aeration through the regulator), then dropping to between 1.65 and 2.44 mg/L, 1.2 and 2 km below the regulator respectively (Figure 8). Sampling further upstream towards Moree showed improved dissolved oxygen conditions (5.75–8.56 mg/L, Figure 8) suggesting the poor quality water was confined to the front of the flow pulse around Combadello Weir. Given the low dissolved oxygen concentrations below Combadello, and the improved quality water upstream, Combadello regulator was closed mid-morning on 4 November to allow water in the weir pool to mix and improve in quality before flows were again passed downstream.

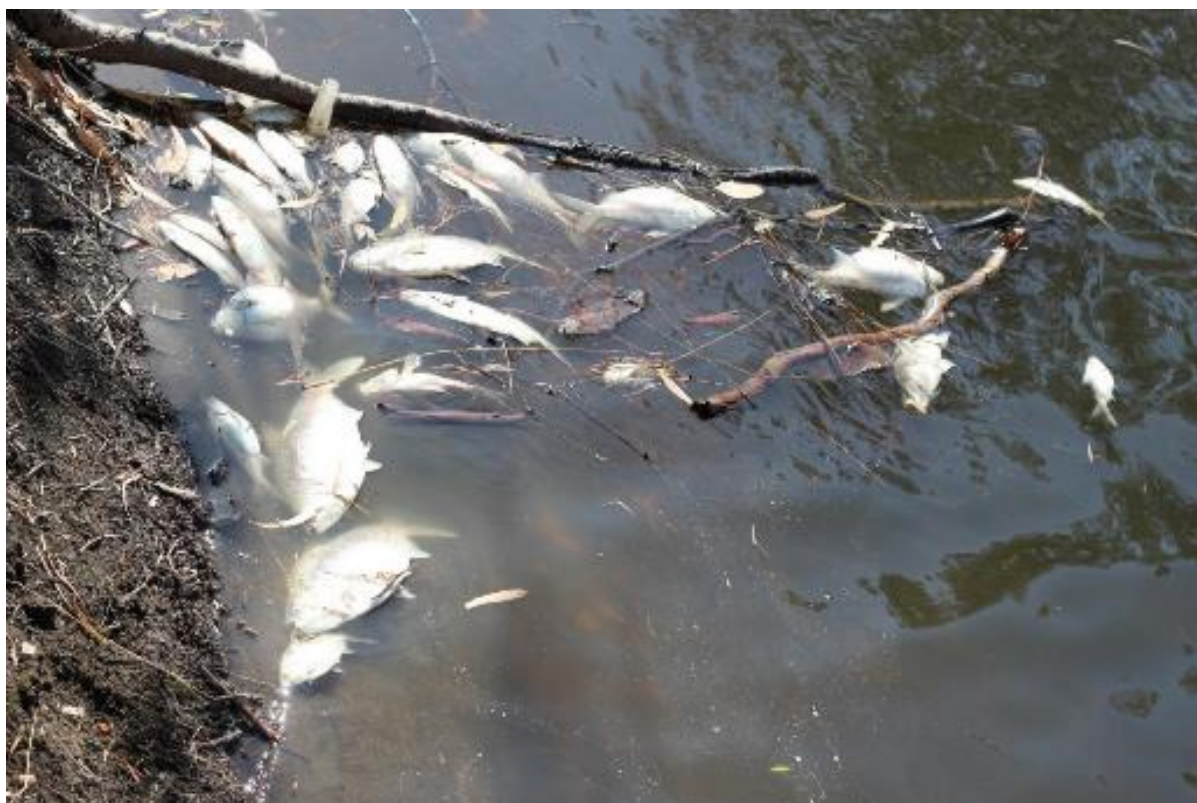
Figure 11 Dead fish that had collected in Combardello weir pool 5 November 2019.

upstream (Figure 10). By 12 noon on 5 November, DO concentrations had risen to between 5.37 – 6.31 mg/L and were relatively consistent throughout the weir pool. By the morning of the 5 November, a large number (200-300) dead fish were observed in the Combadello weir pool. These consisted mainly of Bony herring, but also Murray cod, golden perch and carp of various sizes (Figure 11). No small bodied native fish species were observed. It is likely that these fish were a combination of fish killed by hypoxic water within the weir pool, plus fish that had died upstream and were washed down into the weir pool with the flow.

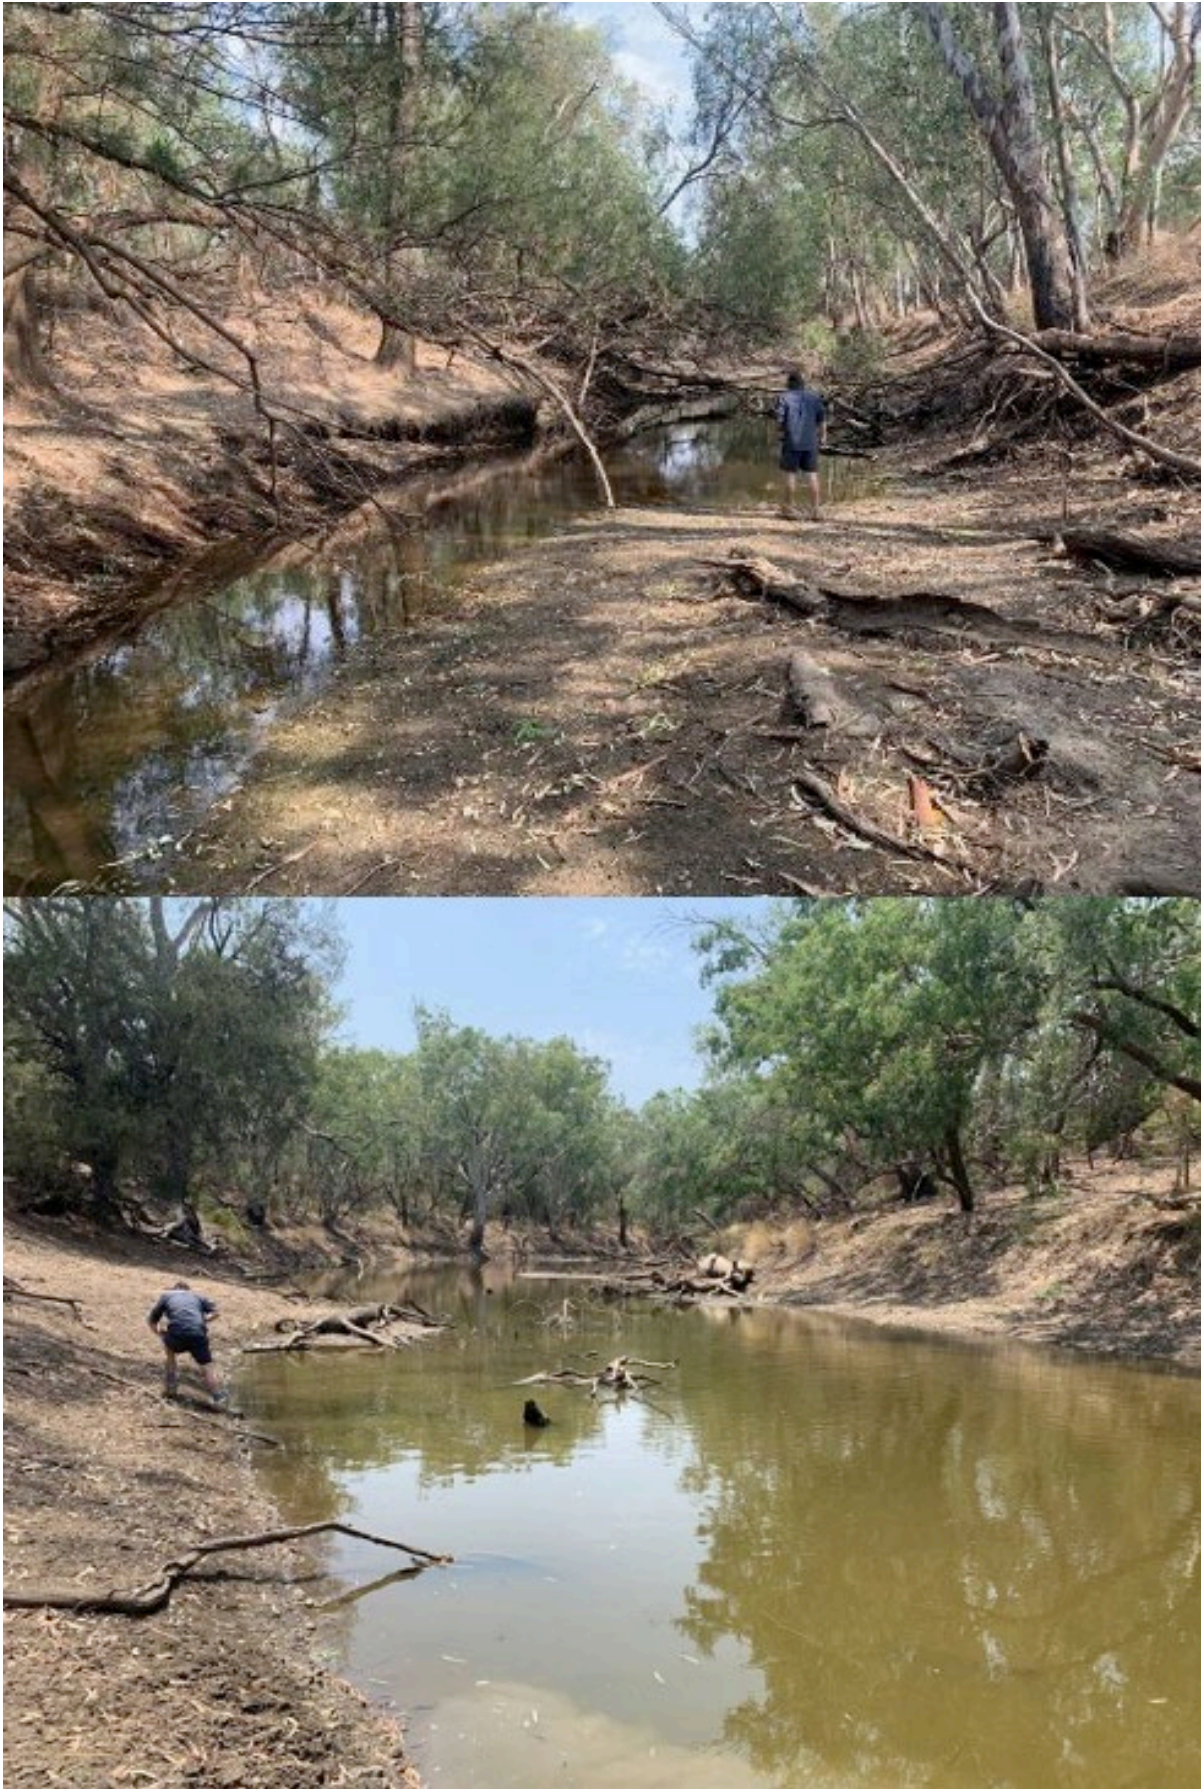
*Figure 13 Pool 4 located in the vicinity of Tarawingee Road (top) and Pool 7 located further downstream on the 'Morton Plains' property (bottom).*

A number of pools downstream of the flow front were sampled to explore the extent and water quality of existing refuge pools in the reach down to the Combadello regulator. The pools surveyed tended to be smaller and more fragmented upstream of the regulator, being less than 30 m in length and 1m deep (Pools 1-6, Table 3), whereas downstream through the Morton Plains property and into Combadello weir pool, pools were longer (>100 m) and generally deeper (0.5–2.6 m, Figure 5, Figure 13).

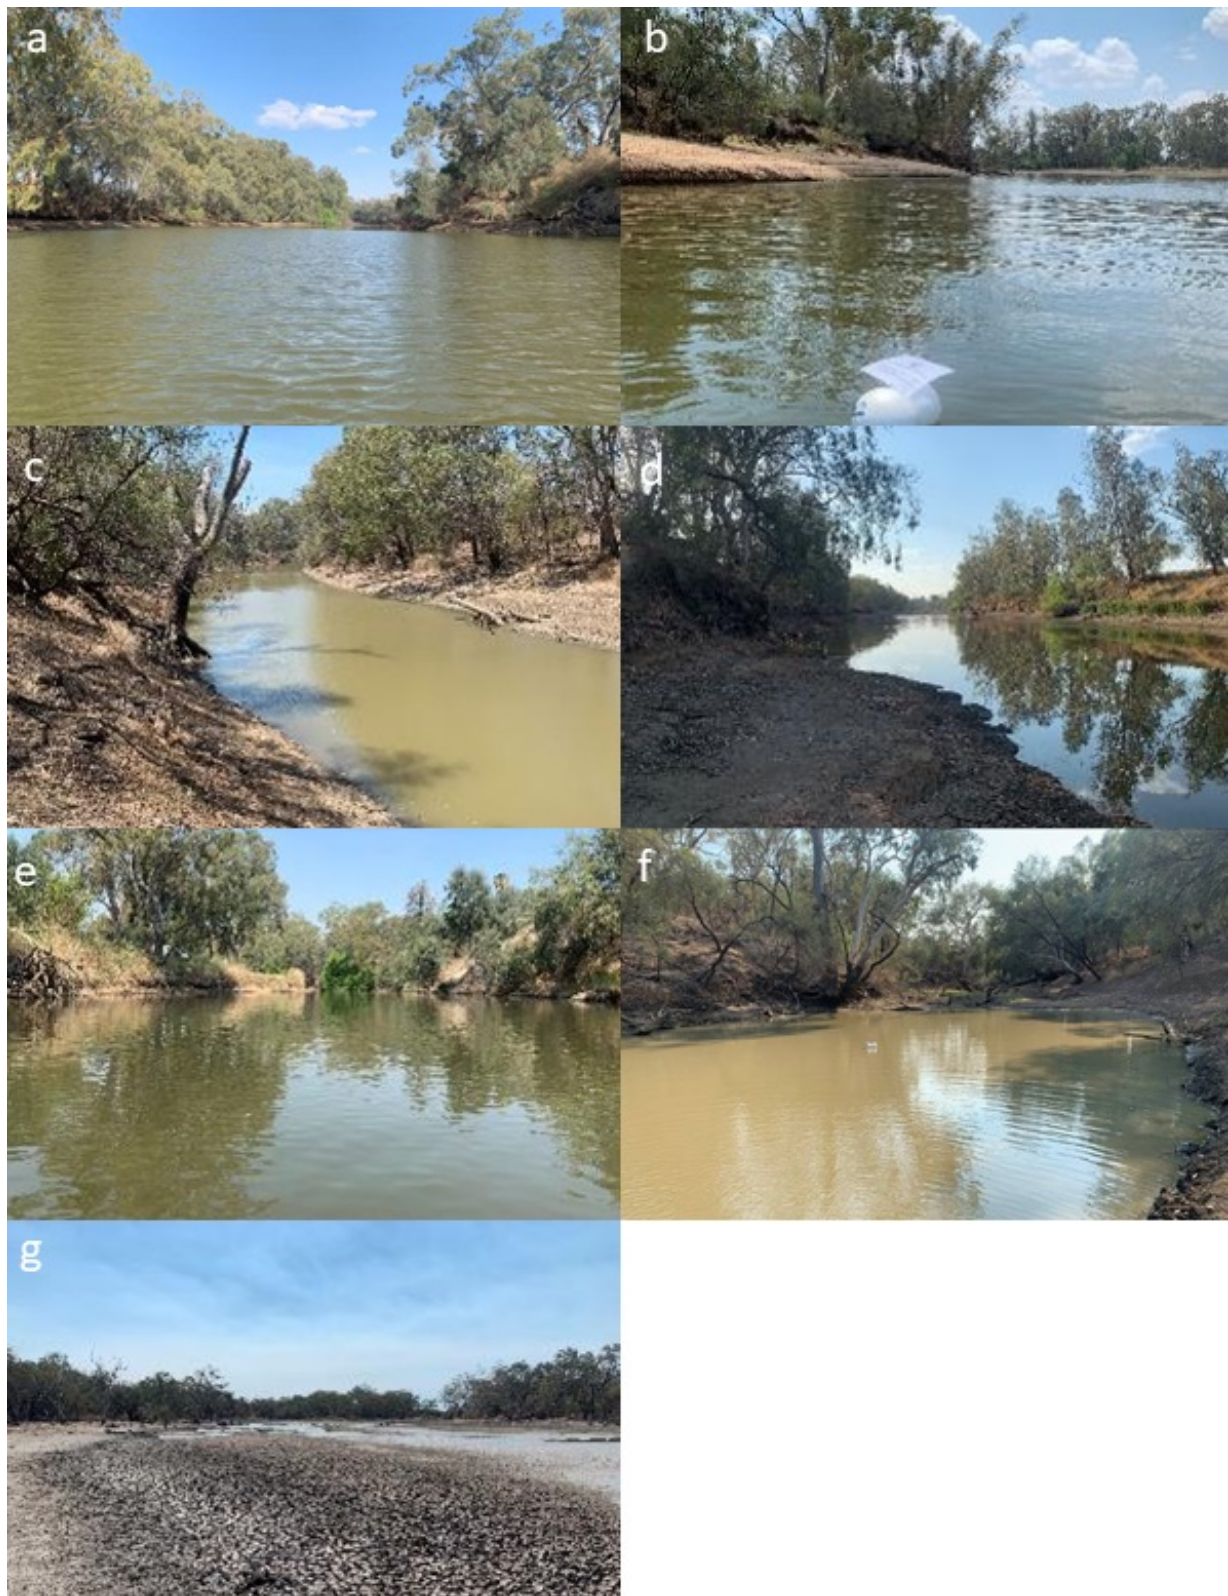
*Figure 16 Pool refuge sites on the 21-22 October 2019. a – Tyreel weir, Gwydir River, b – Tareelaroi Weir, Gwydir River, c – Combadello weir, Mehi River, d – Boolooroo weir, Gwydir River, e – Mehi River at Moree, f – Round hole, Carole Creek, g – Gingham Waterhole, Gingham Watercourse.*

During the survey on 21-22 October 2019, all sites were disconnected waterholes (Figure 16). The largest pools surveyed were Tareelaroi and Tyreel Weirs on the Gwydir River and Combadello Weir on the Mehi River. These pools were over 600 m in length and over 2 m in depth. The sites at Boolooroo Weir on the Gwydir and the Mehi River at Moree were medium sized pools up to 200 m in length and between 1-2 m deep (Figure 16), while Round Hole on Carole Creek and the Gingham Waterhole were smaller in size at around 50 m in length and less than 1 m deep.

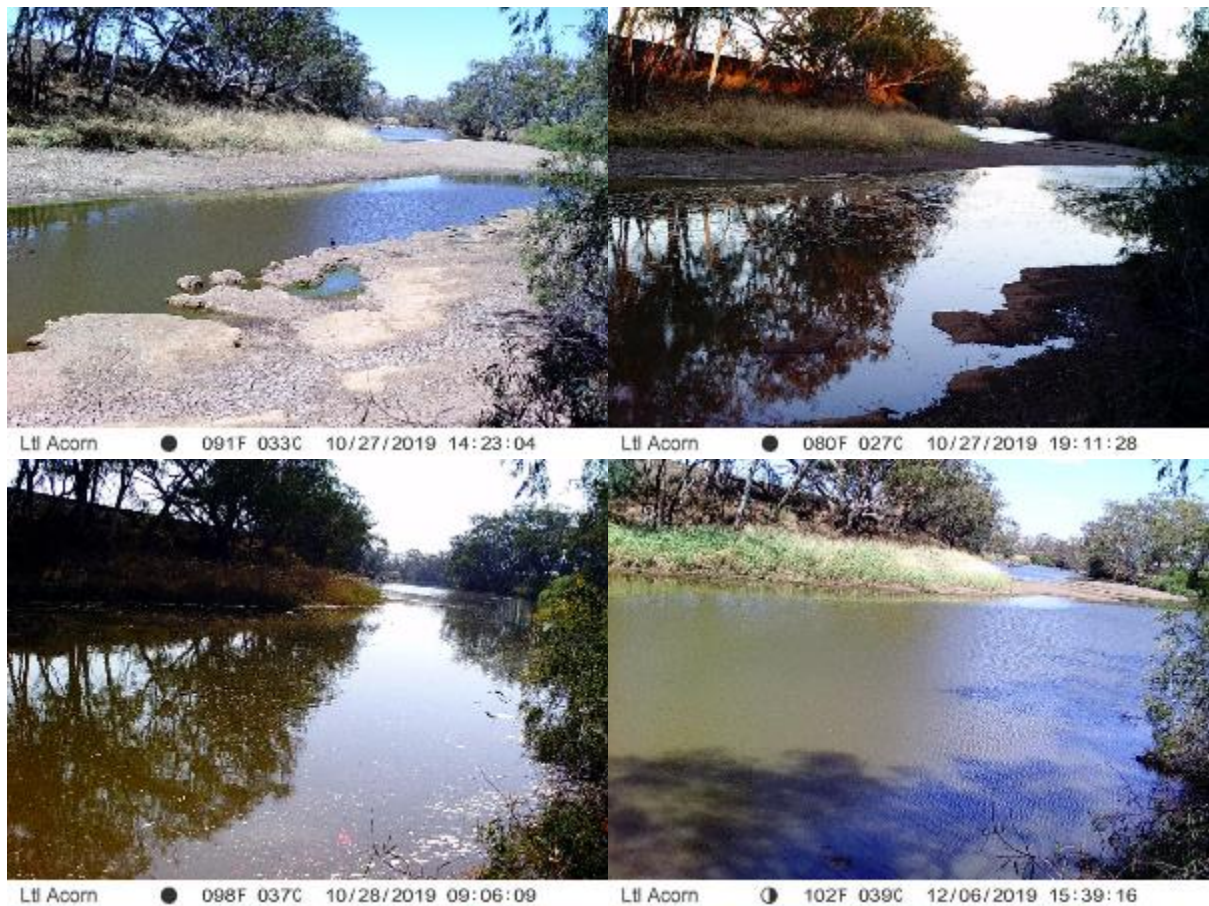
Figure 17 Photo sequence at Boolooroo weir site on the Gwydir River showing the arrival of the November pool replenishment flow on the 27 October 2019.

Available habitat increased at all sites except Gingham Waterhole with the arrival of the November pool replenishment flow. Noticeable changes in the colour of the water were observed at most sites in response to reduced dissolved oxygen associated with leaf litter input, but returned to more normal conditions within several days (Figure 17- Figure 19). Gingham Waterhole was not targeted in the pool replenishment flow as it was unfeasible to deliver water that far down the Gingham system. This site completely dried in late December, before filling again due to a natural flow event in mid-February (Figure 20).

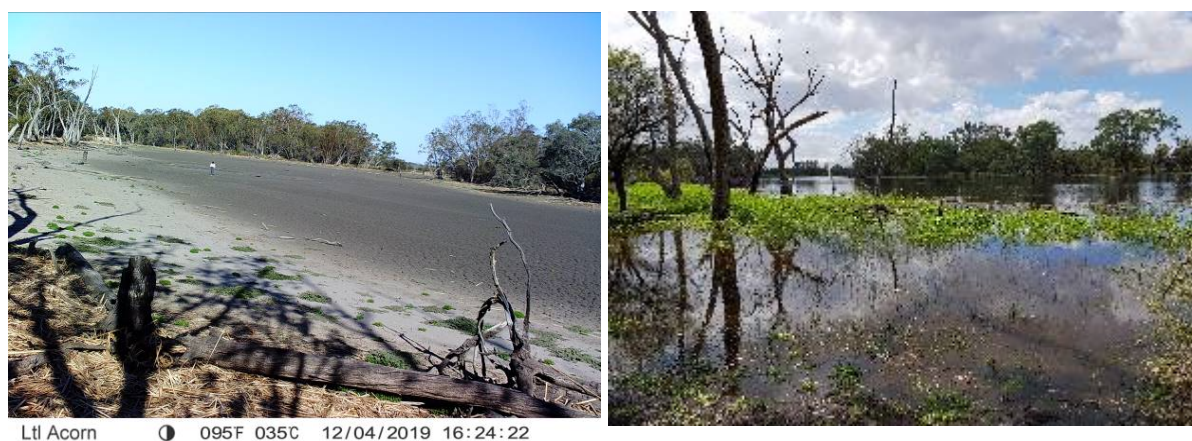
Figure 20 Drying of Gingham Waterhole in December and then full in March from a natural filling event.

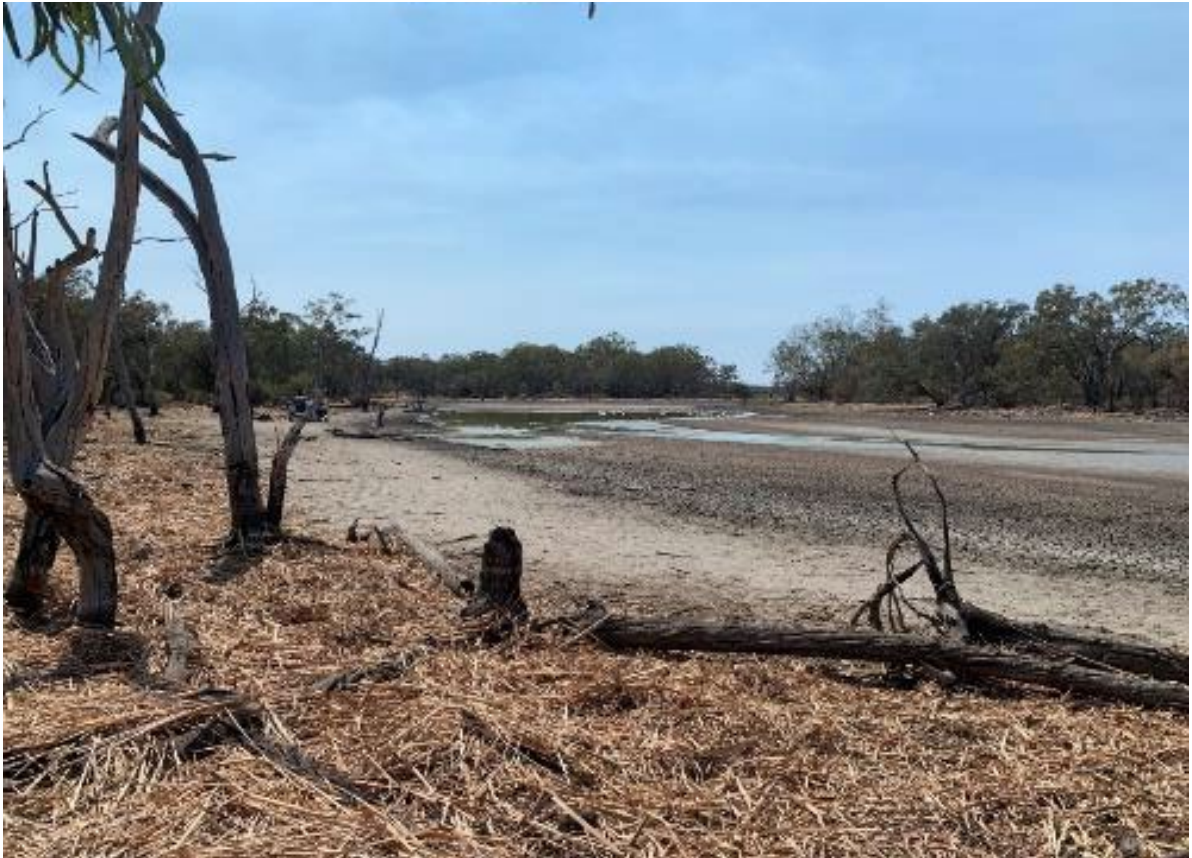
*Figure 21 Low water levels remaining at Gingham Waterhole during October 2019 sampling visit.*

Spot sampling was undertaken in October, November and April of 2019 during site visits. For the majority of the time, all parameters were within ranges considered habitable for aquatic biota (Appendix B: Food Webs). Temperatures ranged from 16.2 °C at Gingham Waterhole in April to 27.5 °C measured on the surface at Boolooroo Weir on the Gwydir River in April. Dissolved oxygen levels varied greatly between sites and over time, ranging from 5.67 mg/L in the Mehi at Moree in October, to 20.93 mg/L in Gingham Waterhole in October. Supersaturated oxygen levels (>100% or > 8.5 mg/L) were recorded at sites during all sampling visits, but were more prevalent in October 2019 with 5 of the 7 sites visited showing high oxygen levels (Appendix B: Food Webs). This was driven by very high algal biomass, especially at Gingham Waterhole as this pool dried down (Figure 21, Figure 22).

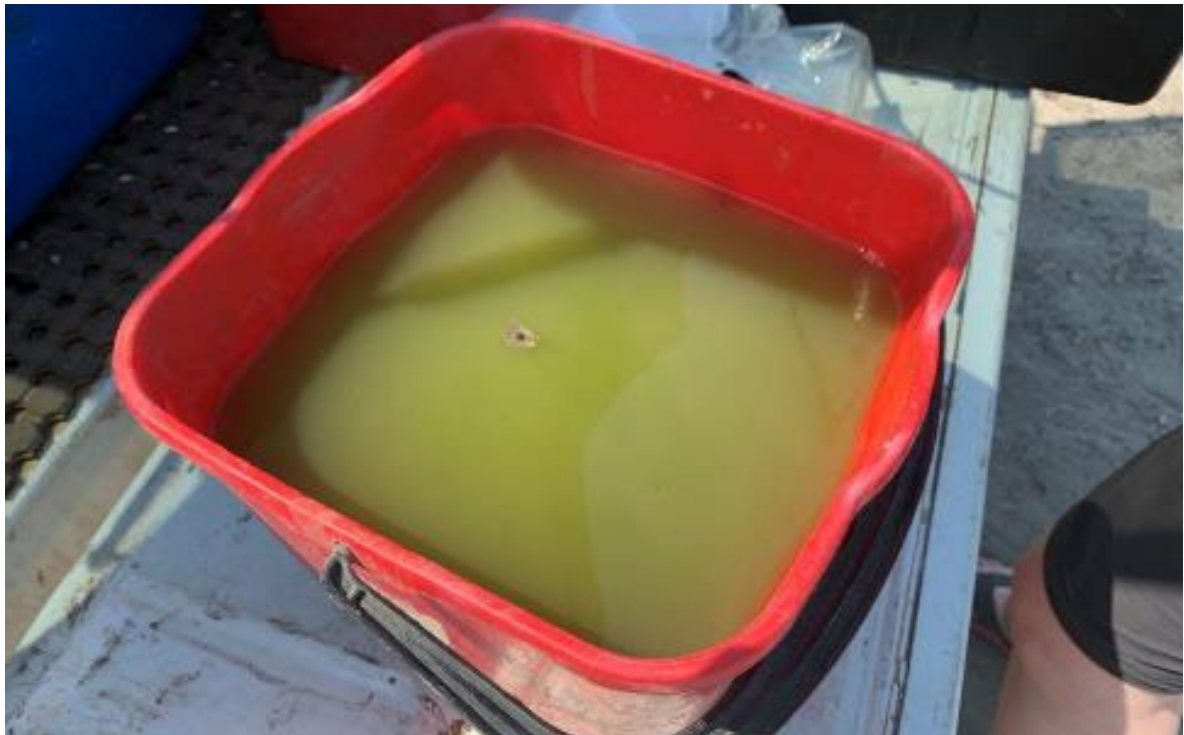
*Figure 22 High algal content of the water at Gingham Waterhole during the October 2019 sampling visit.*
