3.0 Field Trial Results

Monitoring Gully Formation

3.2 Gully Development

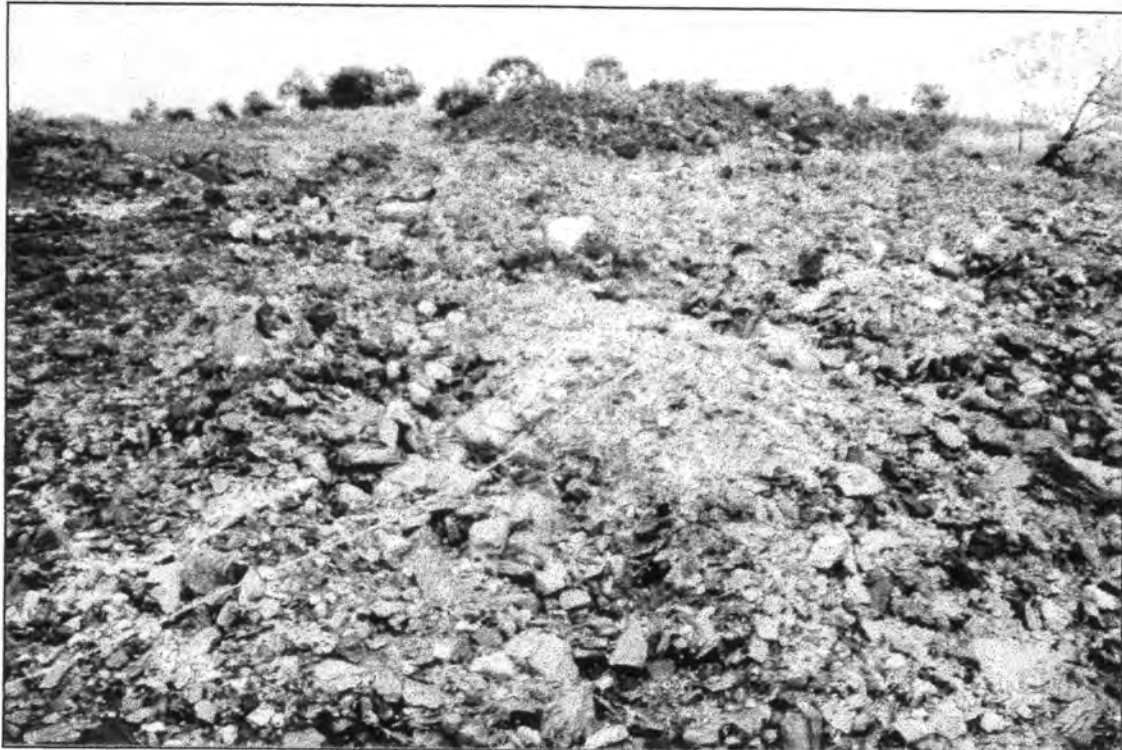
Figure 3.2.8: The first storm was estimated to be 30 to 40 mm, in total with incomplete installation of monitoring equipment resulting in no hydrological data obtained. However little emphasis was placed on this event, given the magnitude of the first significant event on 261296.

The nature of the waste rock material below the finer grade of material is evident in Figure 3.2.8 and Figure 3.2.9, with the relatively finer material seen centrally. The two arms of the gully were separated at the top of the batter slope due to the very large rock fragments encountered only several centimetres below the surface. The paths of the two arms crossed again below Row D with another tributary to the right of Figure 3.2.10.

The disturbed sections of the batter slope were cleared of fine particles, resulting in dramatically reduced erodibility. From Figure 3.2.8, the disturbed material could be used to easily identify the path of the minor tributary, with erosion pins dislodged and transported downstream below transect Row D. Below the trees in the middle ground of the photo, a pathway linking the two major arms of the gully crosses. Overburden from this intersection deposited during the end of the initial event, as well as that of the 010197 storm event, with significant scouring observed during the final event.

Some sections of the gully, once breached eroded quickly with soft earthen material excavated from just above the mined ore, being exposed in Figure 3.2.8. A combination of surface layers has been used to design the batter slope, (pers com. Willgoose, 1997) making excavation to this depth, of some concern.

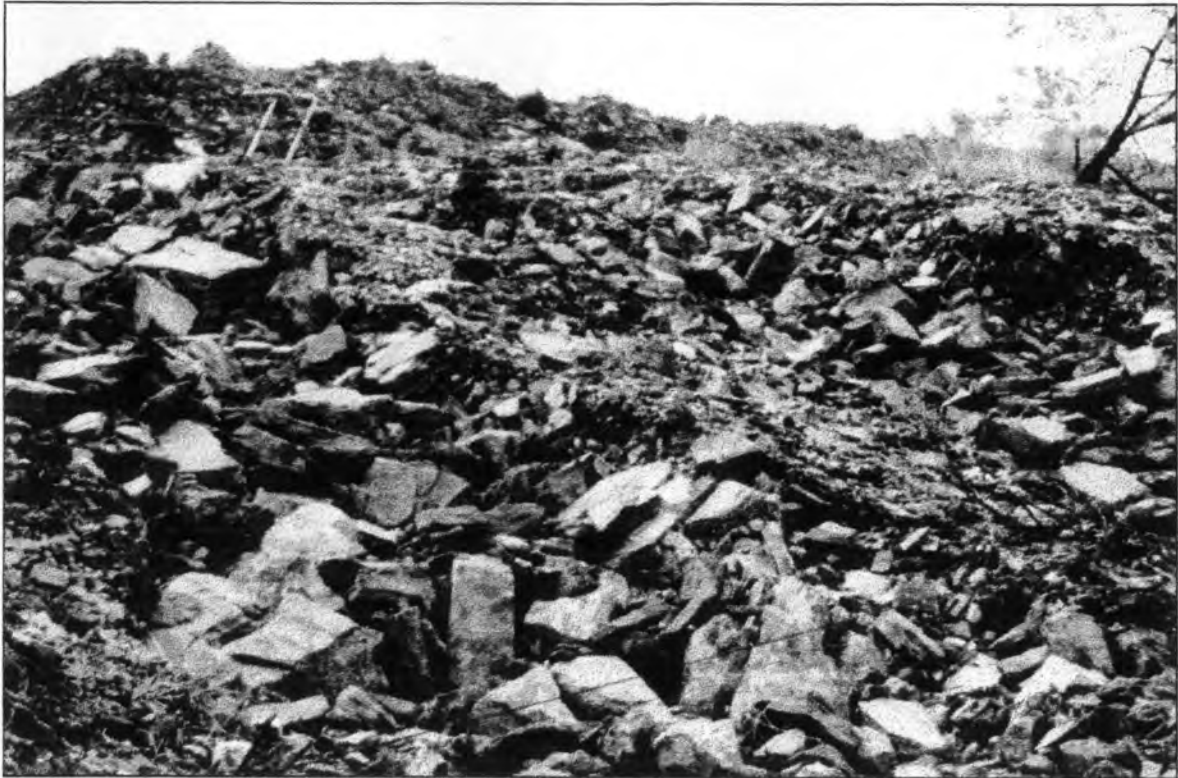
Figure 3.2.9: The profile of the upper section was established by the first major storm event. Complete removal of fine material is evident in this figure and comparison is made to Figure 3.2.8 above.

Figure 3.2.9 illustrates the divide between each of the two major arms of the gully after the first major storm event, due to nature of inlet point, and armouring encountered within several centimetres of the upper surface.

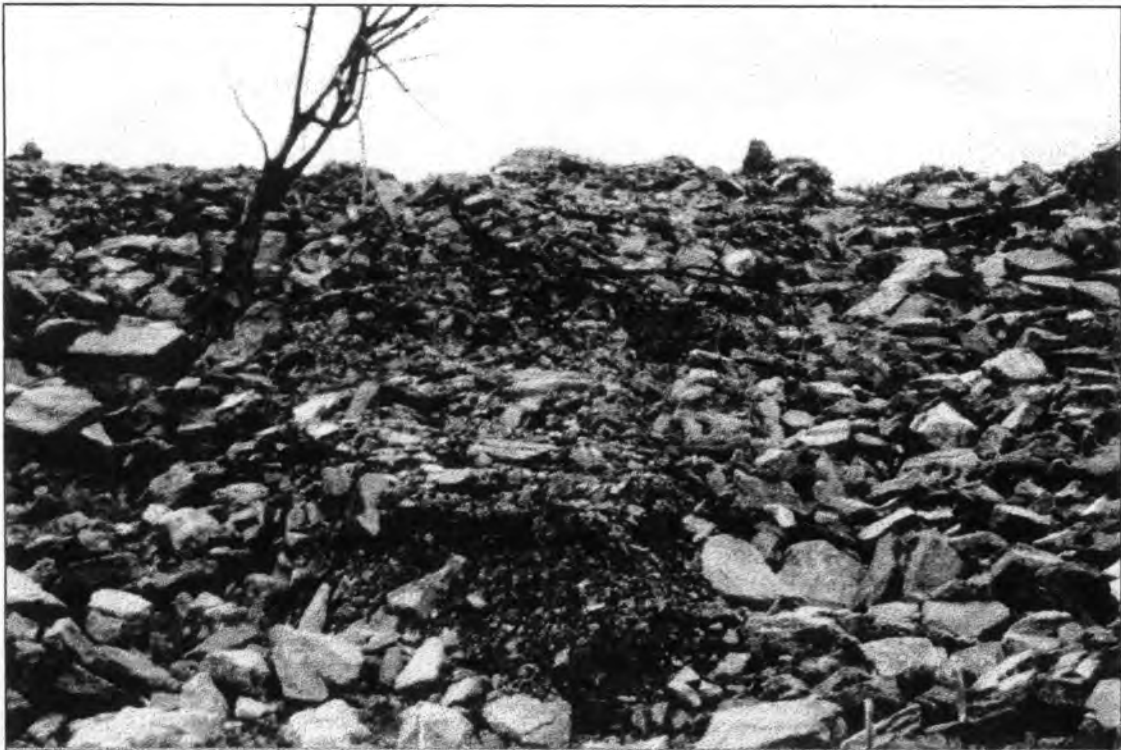
Figure 3.2.10: The two main tributaries were separated between Row A to Row D, with thalwegs crossing below Row D as pictured here. Another tributary developed to the right of this photo, which crossed again below Row E to Row F in consequent events.

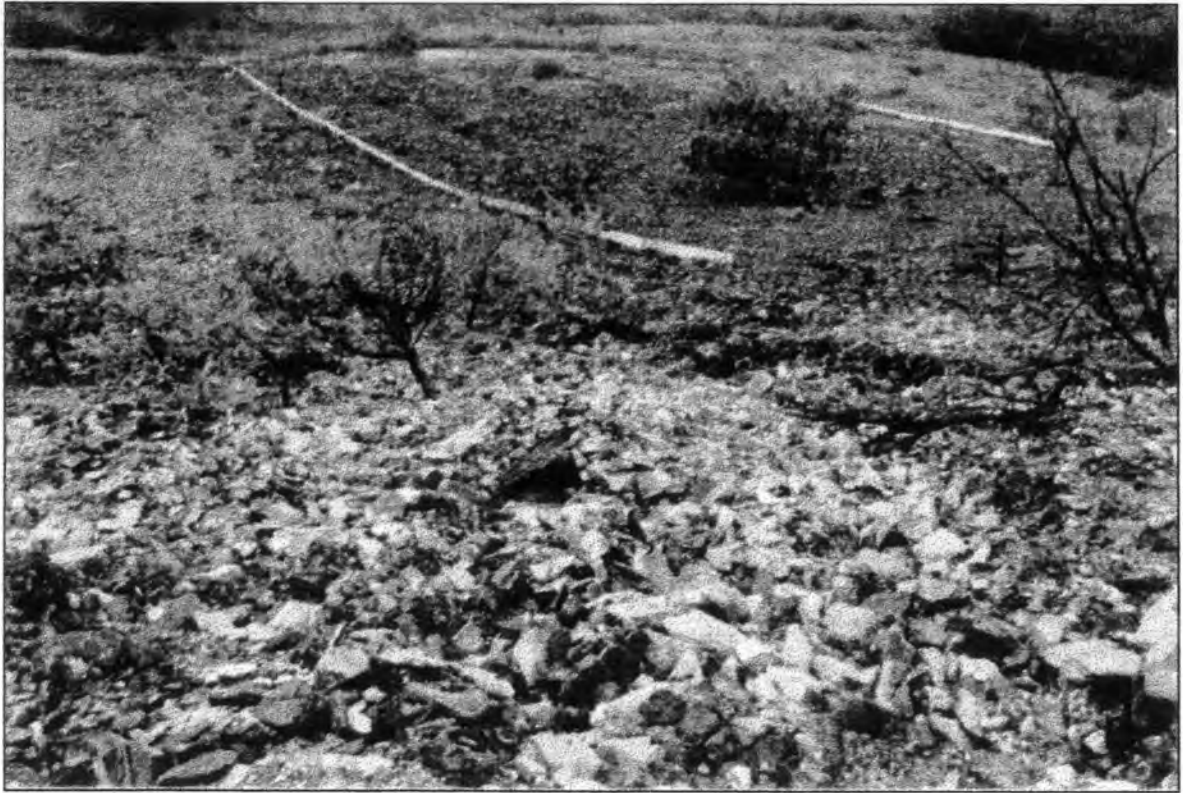
Figure 3.2.11: The removal of fine material was more widespread below Row D, as seen by the painted fluorescent lines across the slope. Both channels combined, and the gully pathway was not easily discernible.

The gully extended to Row H during this event and is illustrated in Figure 3.2.11, and Figure 3.2.12, with the pathway becoming indistinct below Row I with deposited material (over erosion pin row 3) relatively easily erodible. It was noted that this event has a peak discharge of 21L/s, with rainfall continuing for approximately 1.5 hours, eroding the material transported initially.

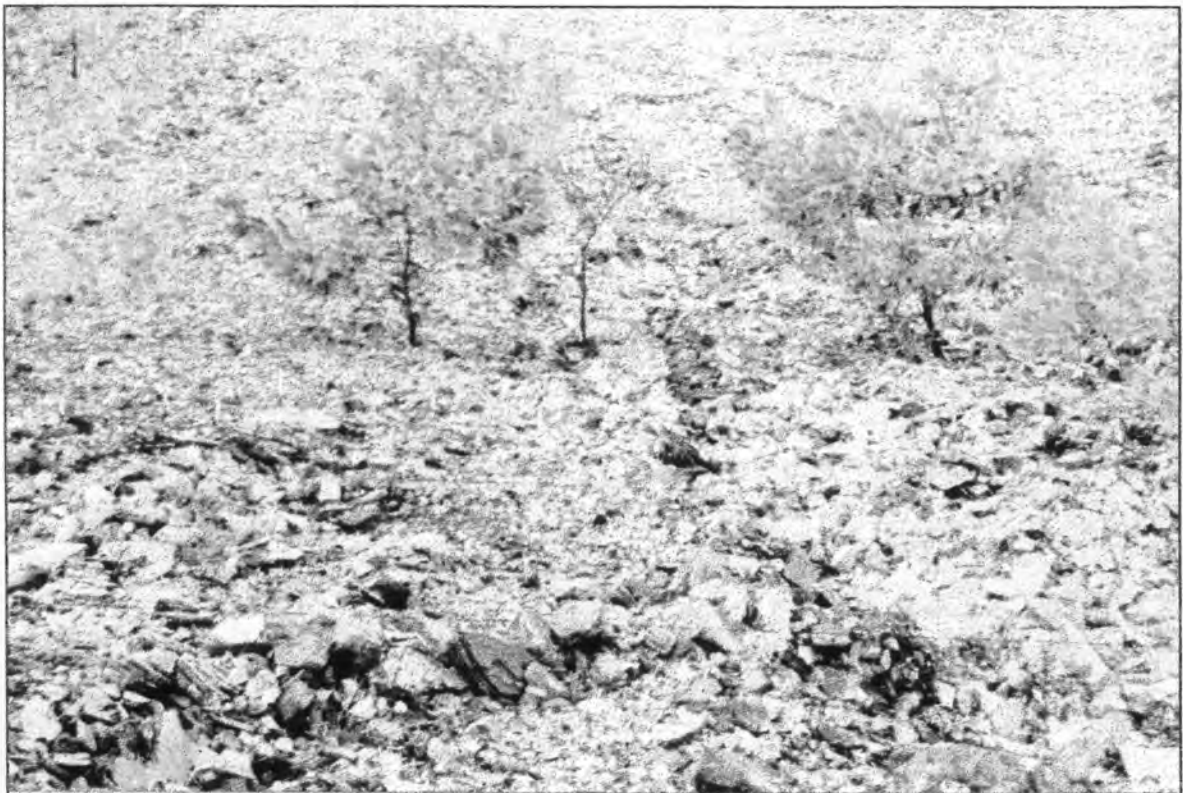
Figure 3.2.12: The left tributary also continued down the hillslope with relatively easily erodible material deposited between Row H and Row I making the pathway adopted distinct in the background of this photo.

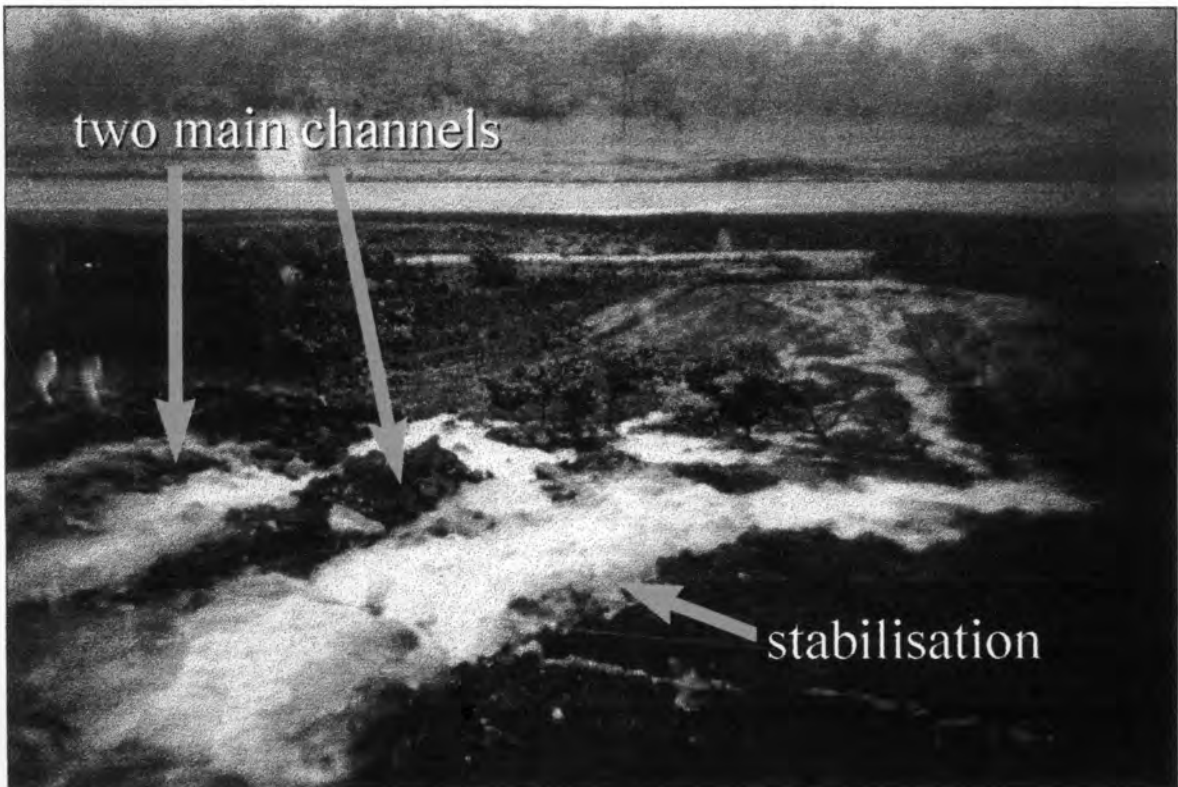
Figure 3.2.14: The pathway of the gully can be delineated by the fluorescent paint markings, indicating regions that were eroded on deposited between each storm event.

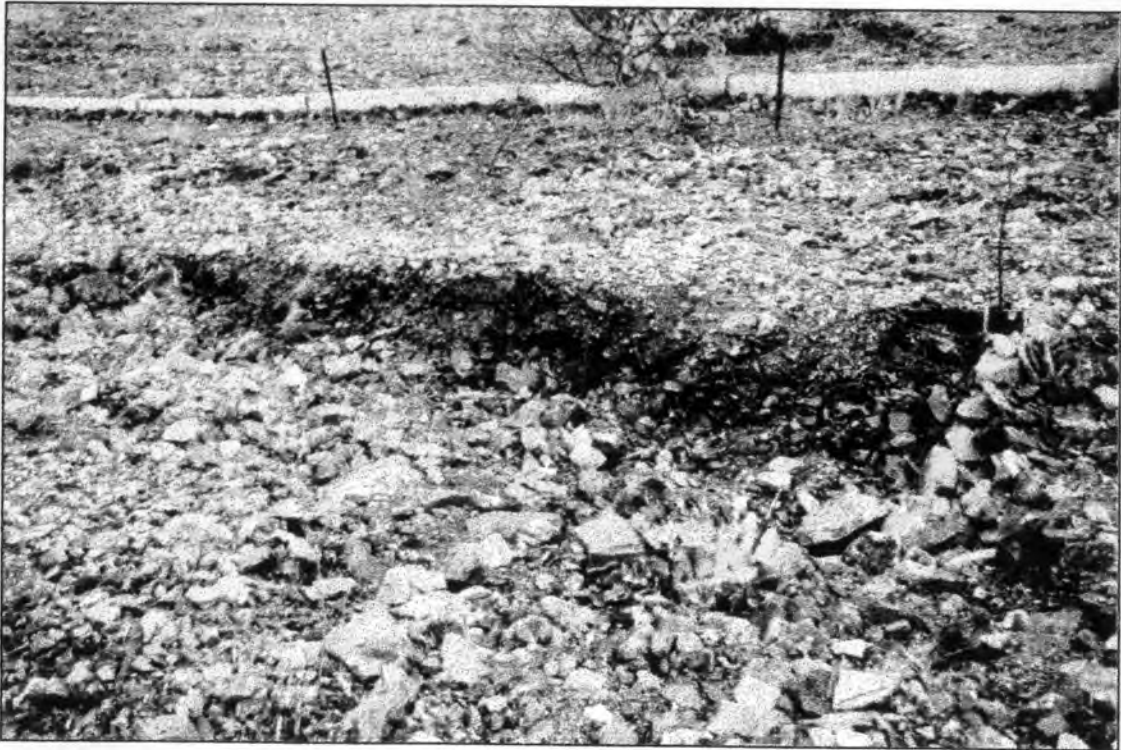
Figure 3.2.16: Excavation of sidewall material slowly increased the width of the gully, with residual layer of fine material about 45cm accumulating at this point.

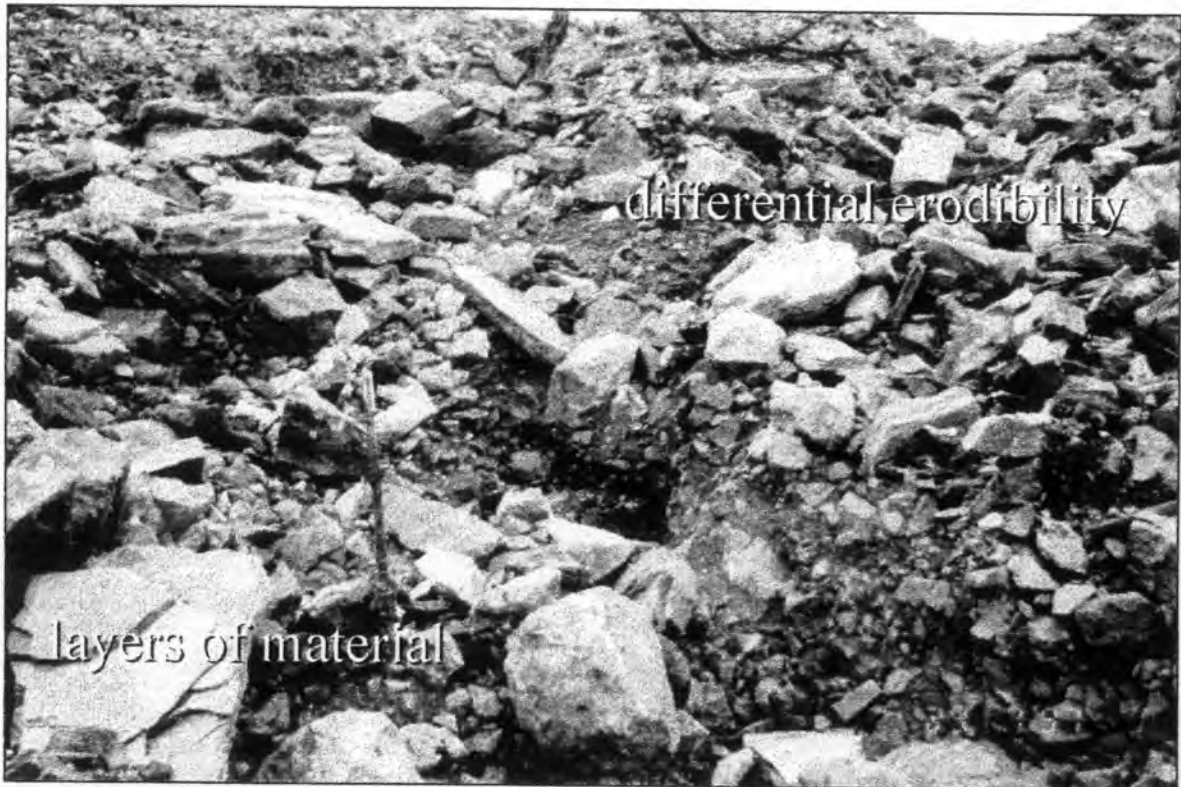
Figure 3.2.17: The depth of erosion reached 60cm in some places, revealing the heavily armoured rock fragment layer. The differential erodibility of these surfaces is considered with the soft earthen material extracted from above the mined ore seen as brown colour. Depth-erodibility relationships for this slope would therefore be complex, once the protective layer is breached.

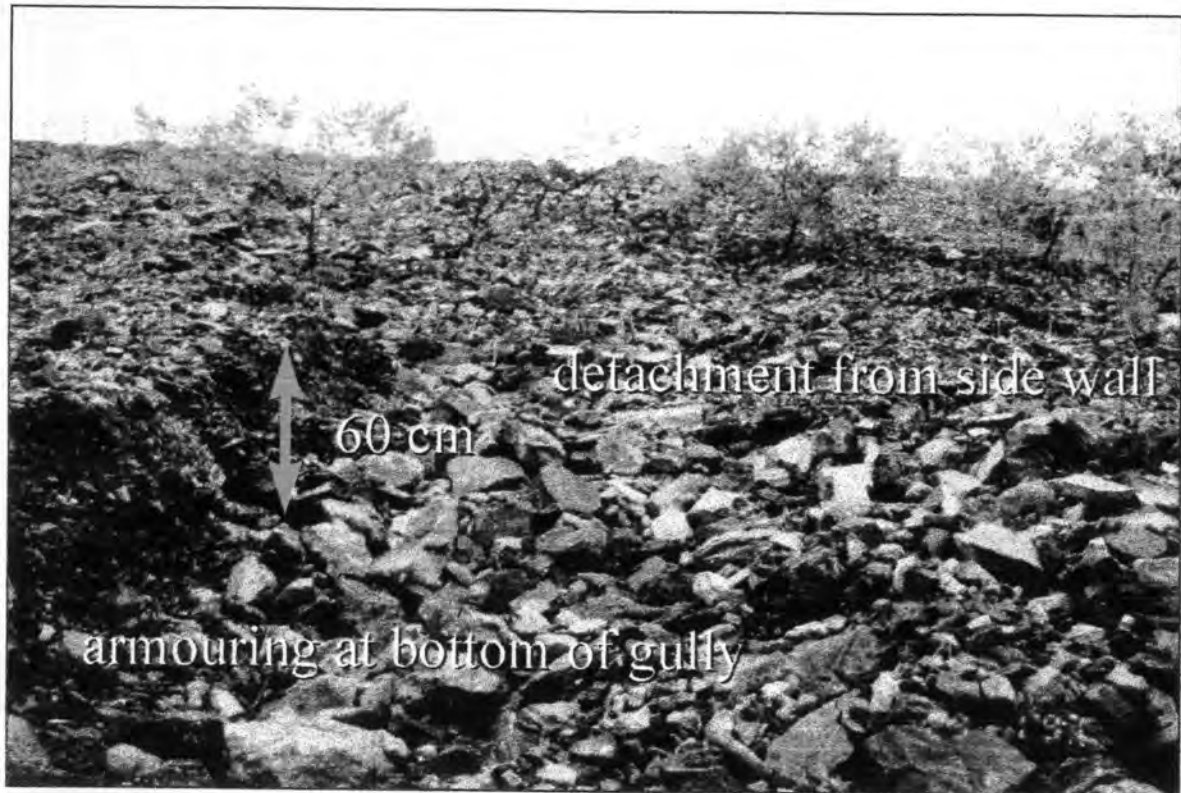
Figure 3.2.18: The excavation of material from Row H to Row I, reaches a depth of 60cm with large rock fragments armouring further incised.

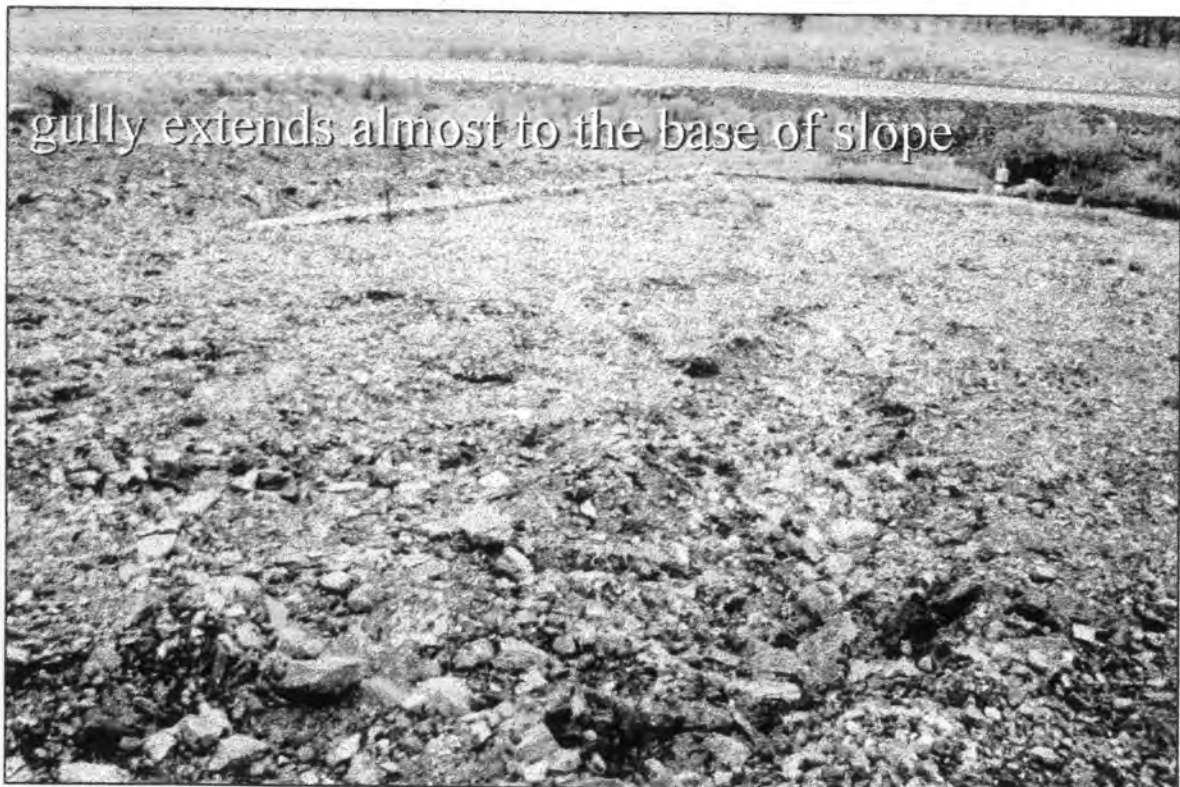
Figure 3.2.19: The gully extends to Row I with depth of 20cm to 30cm, whilst almost reaching the concrete apron of the flume pictured in background.
