CHAPTER 2 : RESEARCH METHODOLOGY

2.1 OVERVIEW

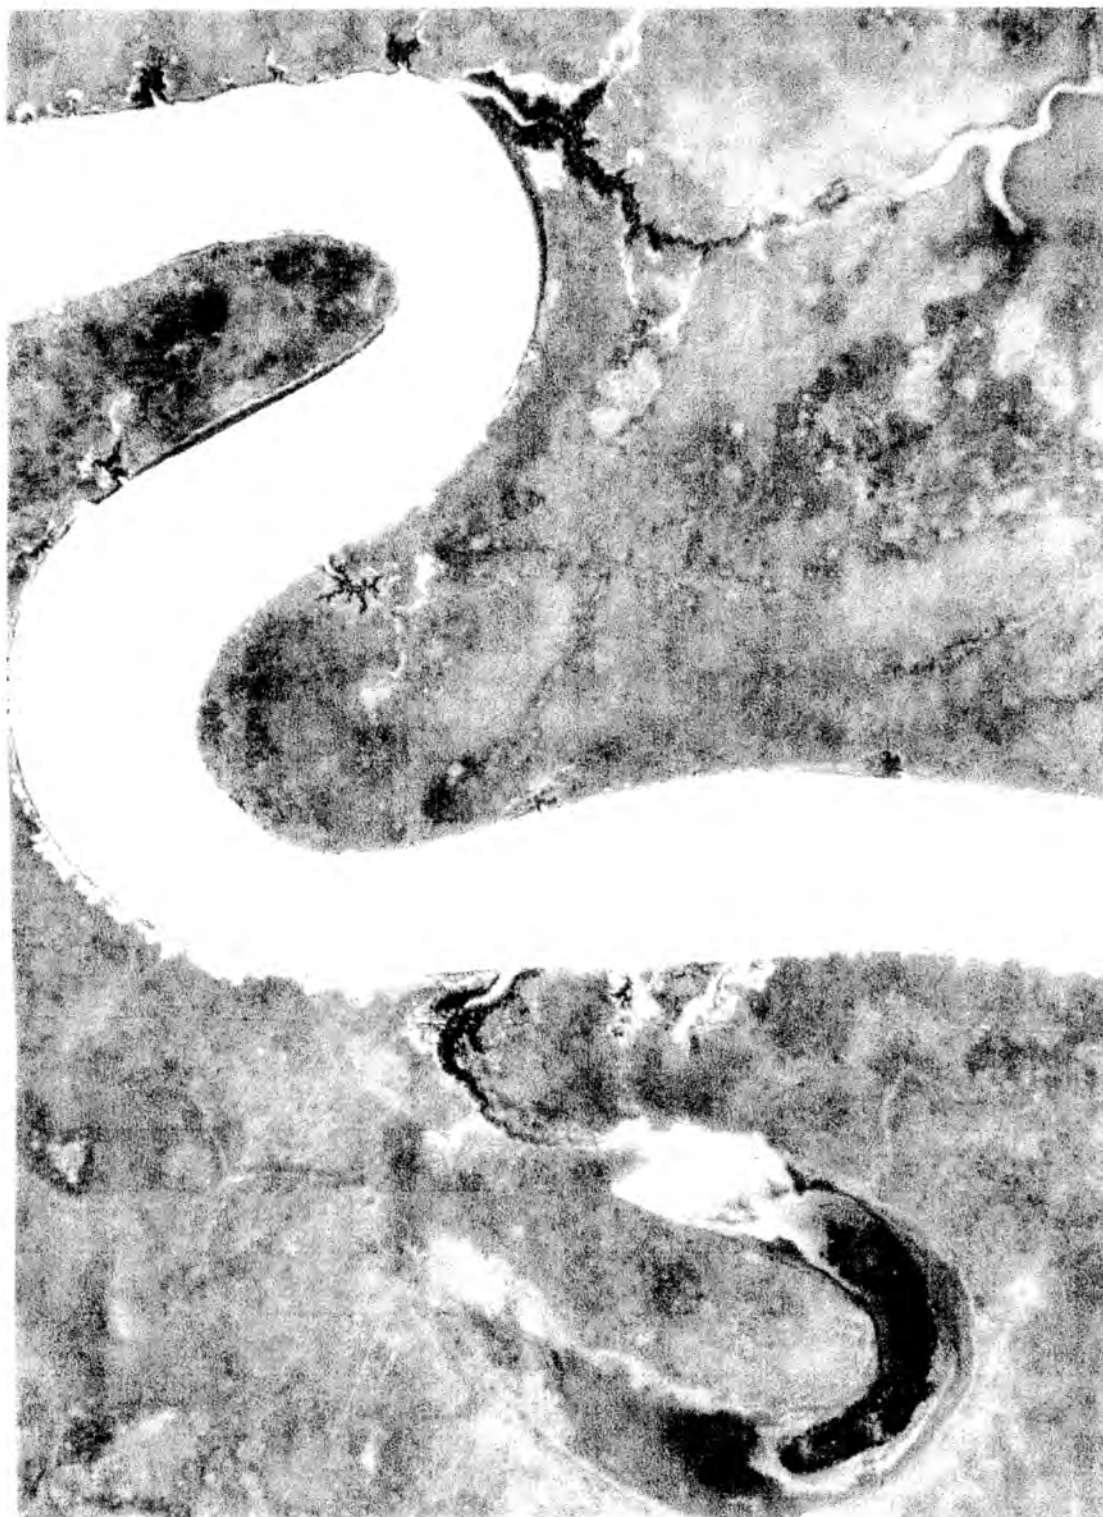
PLATE 2.2a: Aerial photograph of Munmarlary, South Alligator River, 1950.

Photographic evidence of tidal creek extension and mangrove colonisation on the South Alligator River. Scale, 1:25,000.

Munmarlary was selected as a site for the tidal processes operating on the sinuous segments of the river. Examination of aerial photographs for the years 1950 to 1991 revealed evidence of extensive growth of tidal creeks and mangrove encroachment within the confines of a palaeochannel swamp on the western flank of the river (Plate 2.2). Alternate to this trend, on the eastern side there was little evidence of tidal-creek extension (Plate 2.2). Increased mangrove colonisation along already existing creek lines is evidence of an increased saltwater influence. Accessibility to the creek extensions evident within the palaeochannel formation west of the river was limited and unpractical given the time restraints of the fieldwork. Field mapping of the present site morphology was conducted upon the tidal creek to the east of the river. Aerial photographs taken in 1950 and 1991 indicate the creek has remained stable, although mangroves have colonised it since 1950.

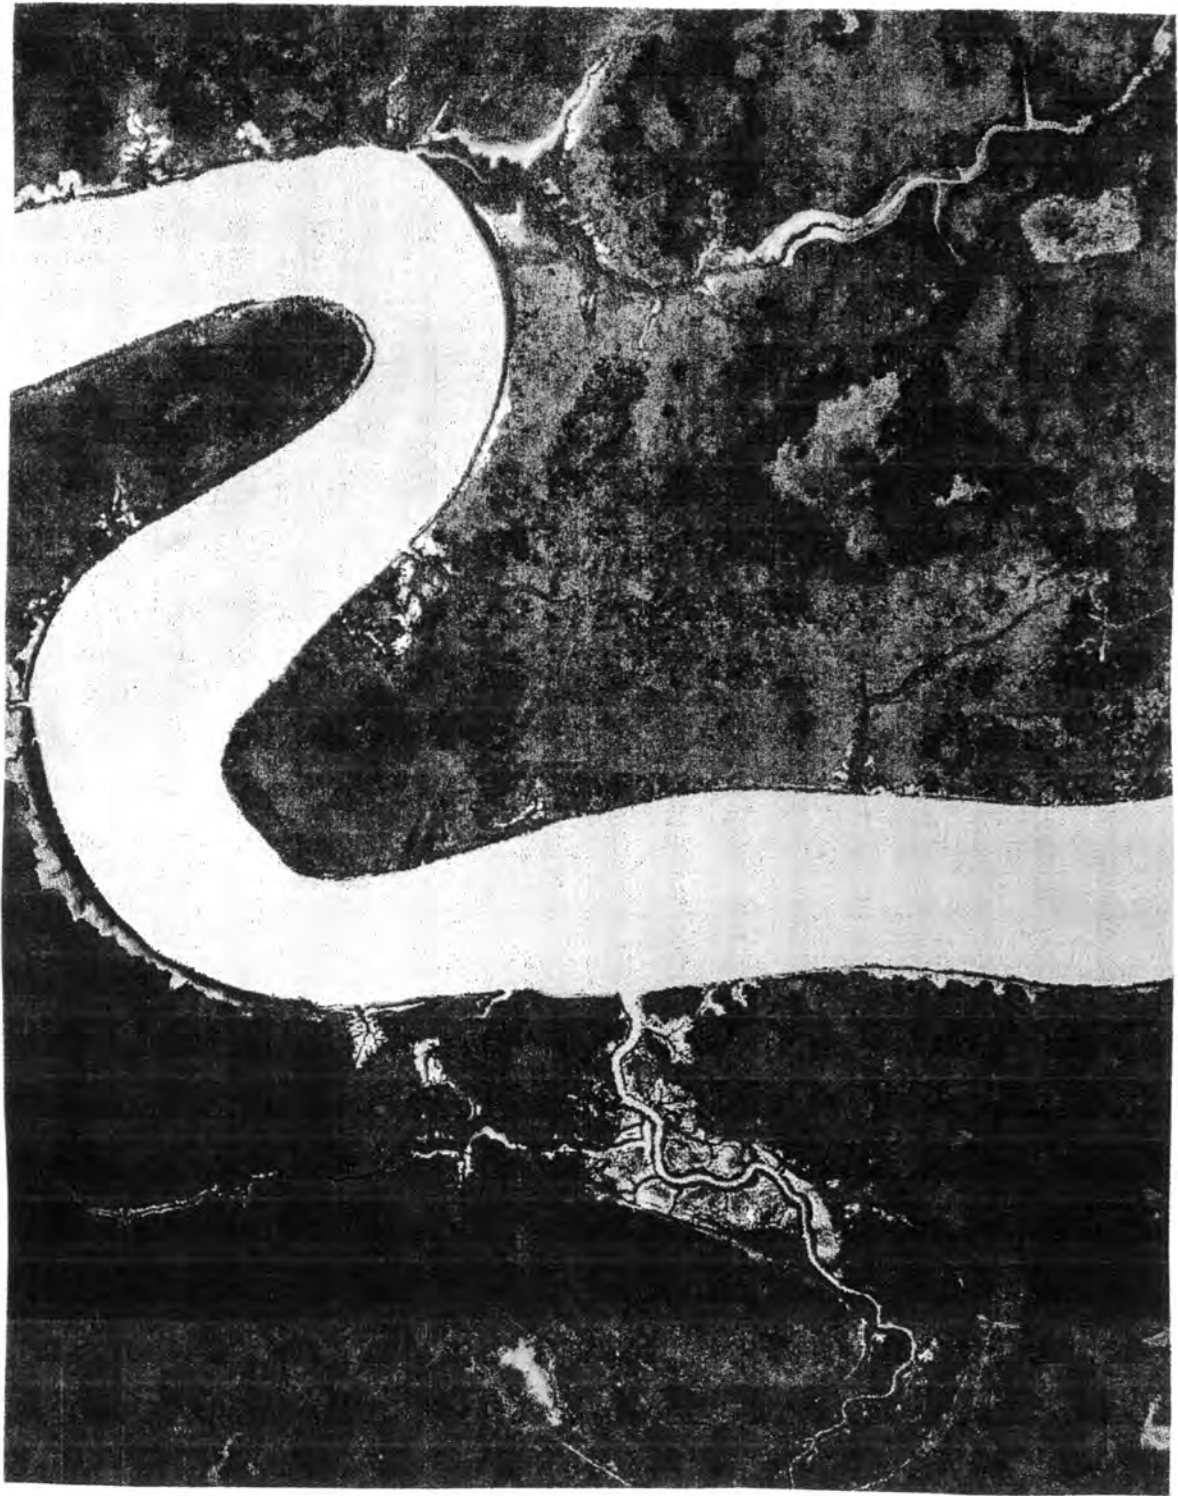
PLATE 2.2b: Aerial photograph of Munmarlary, South Alligator River, 1991.

Photographic evidence of tidal creek extension and mangrove colonisation on the South Alligator River. Scale, 1:25,000.

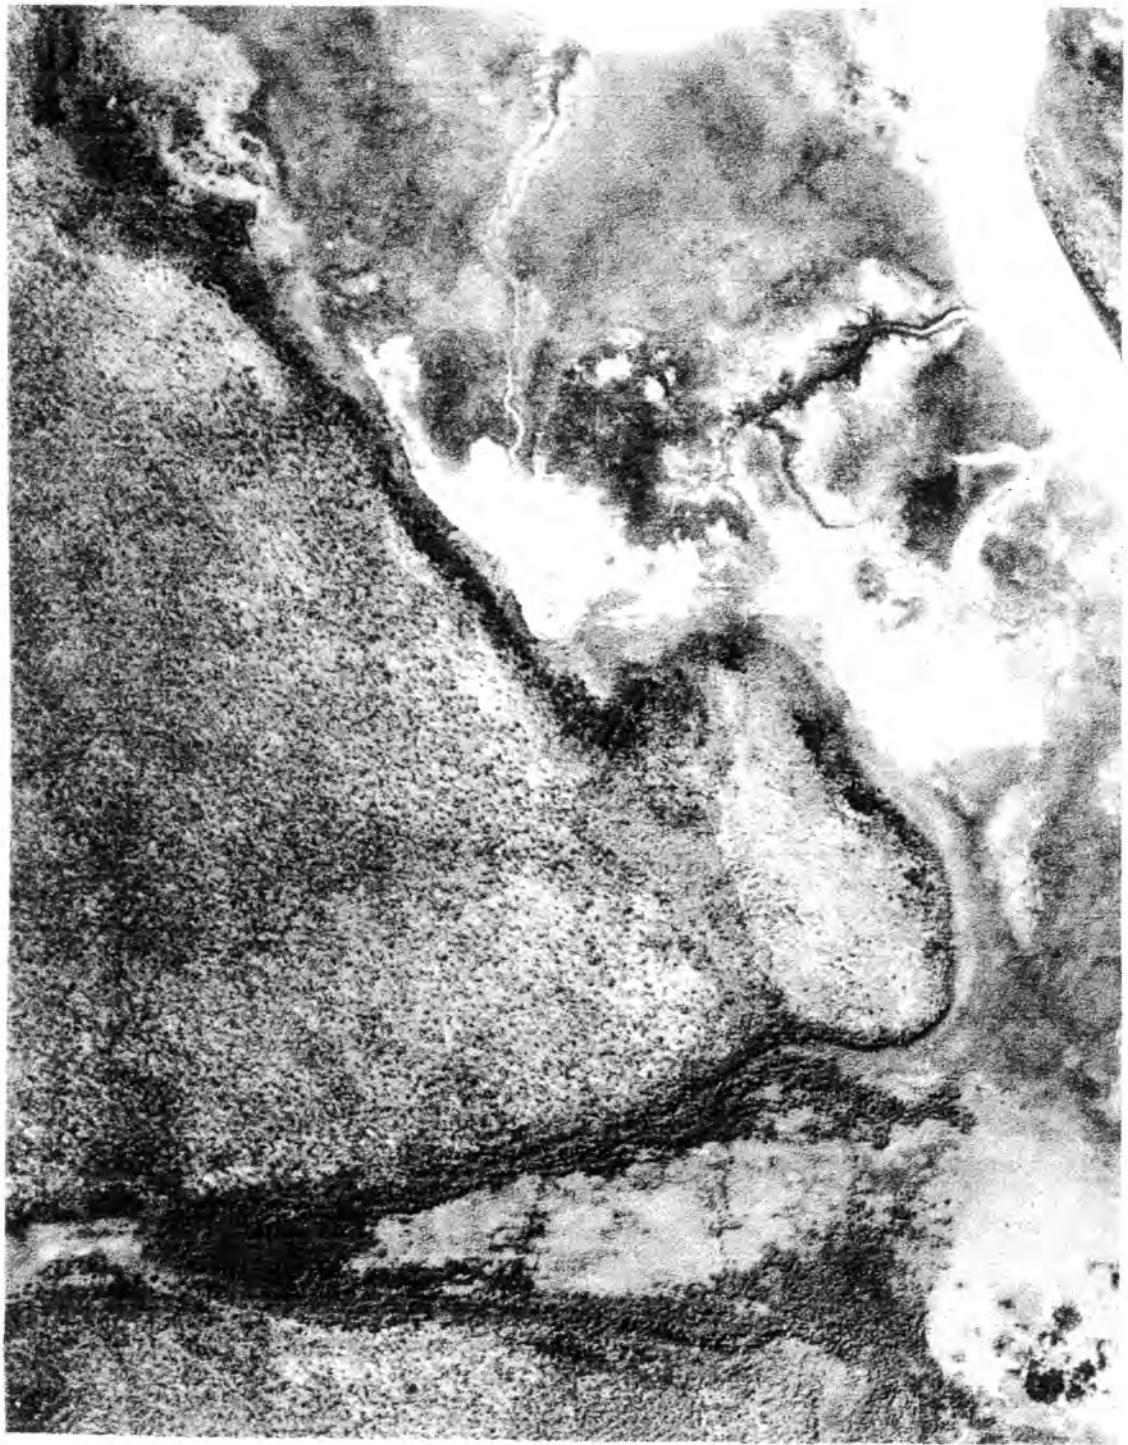
PLATE 2.3a: Aerial photograph of Kapalga, South Alligator River, 1950.

Photographic evidence of tidal creek extension and mangrove colonisation on the South Alligator River. Scale, 1:25,000.

Kapalga is located on the cusped bends of the South Alligator River, approximately 40 km upstream from the river mouth (Figure 2.1). Flood tidal flow is approximately equal to the seasonal freshwater flood discharge within the cusped segment of the river (Chappell and Woodroffe, 1985). Kapalga was selected as a site for the hydrological processes dominating the mechanism of saltwater intrusion on the cusped section of the river. Examination of aerial photographs for the years 1950 to 1991 indicate that extensive changes have occurred within the region (Plate 2.3). Analysis of the aerial photographs using a stereoscope indicated the extension of one main tidal creek network into a freshwater swamp, and also indicated evidence of *Melaleuca* dieback. The Kapalga site was the most accessible of the three field sites and subsequently was revisited over a number of days and the area was extensively mapped.

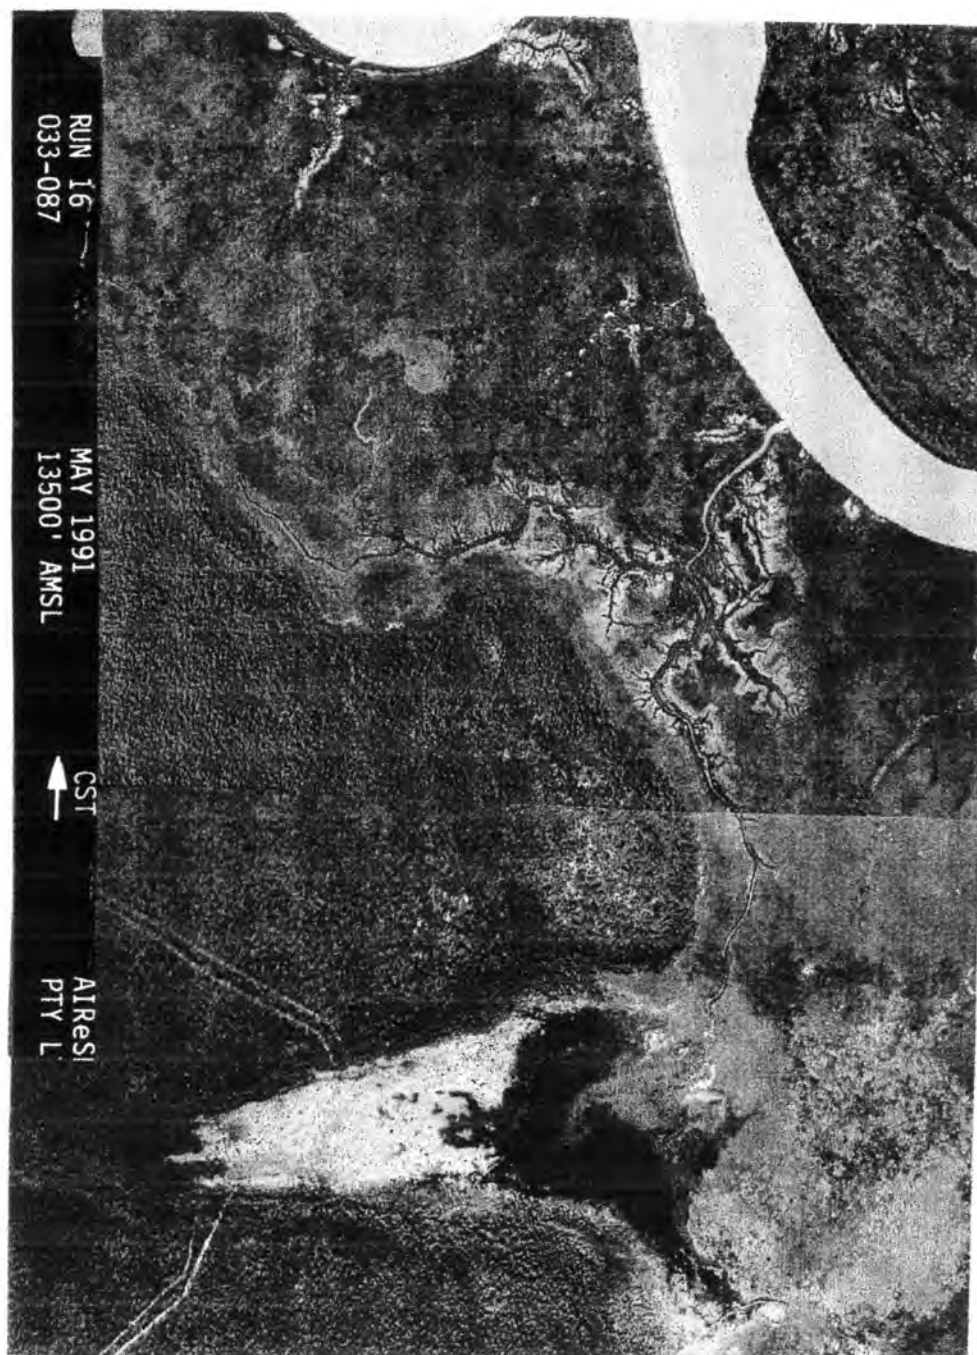
PLATE 2.3b: Aerial photograph of Kapalga, South Alligator River, 1991.

Photographic evidence of tidal creek extension and mangrove colonisation on the South Alligator River. Scale, 1:25,000.

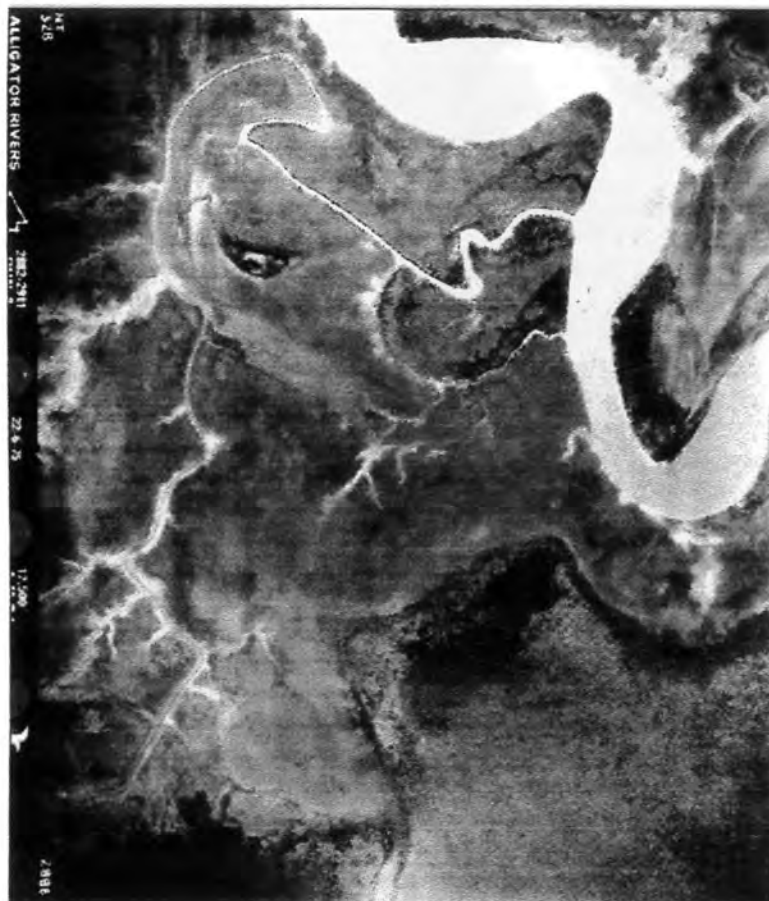
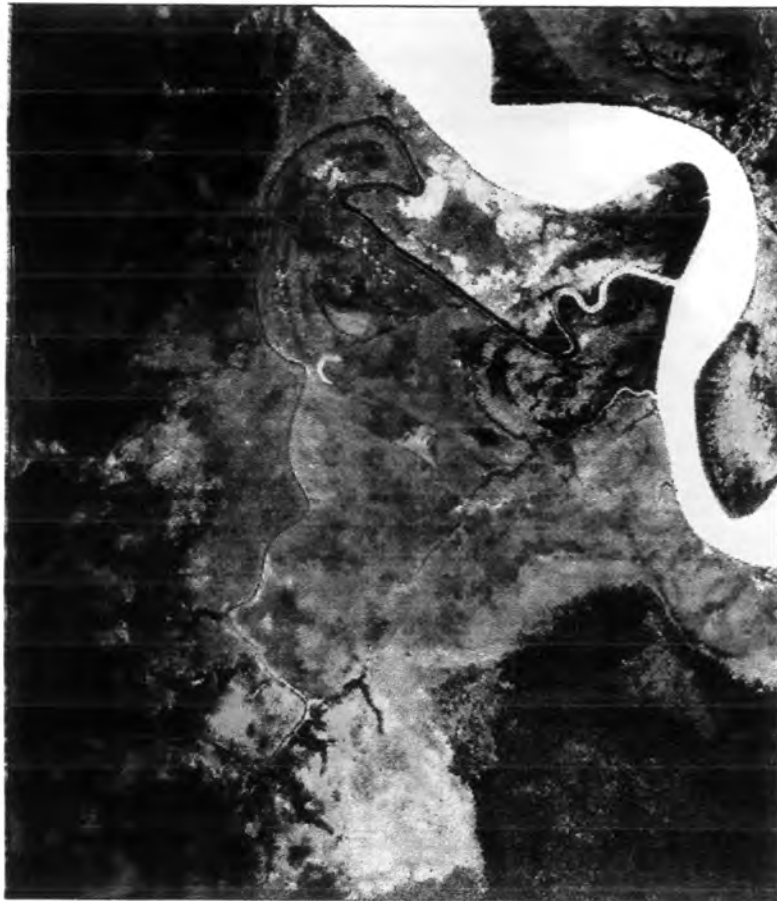
PLATE 2.4 a: Aerial photograph of the Magela Creek joining the East Alligator River, 1975.

Photographic evidence of increased mangrove colonisation of creek lines in the Magela catchment. Scale 1:25,000.

PLATE 2.4 b: Aerial photograph of the Magela Creek joining the East Alligator River, 1991.

The Magela catchment is already exhibiting evidence of environmental change. This change is evident from aerial photographs which indicate the extension of tidal creeks and mangrove colonisation of creeks in the area from 1975 to 1991 (Plate 2.4). The extensive research on the Magela catchment documented to date, in addition to its political significance establishes the area as a suitable site for baseline monitoring. Future research should incorporate a detailed account of the rates and trends of saltwater intrusion within the Magela Creek floodplain.

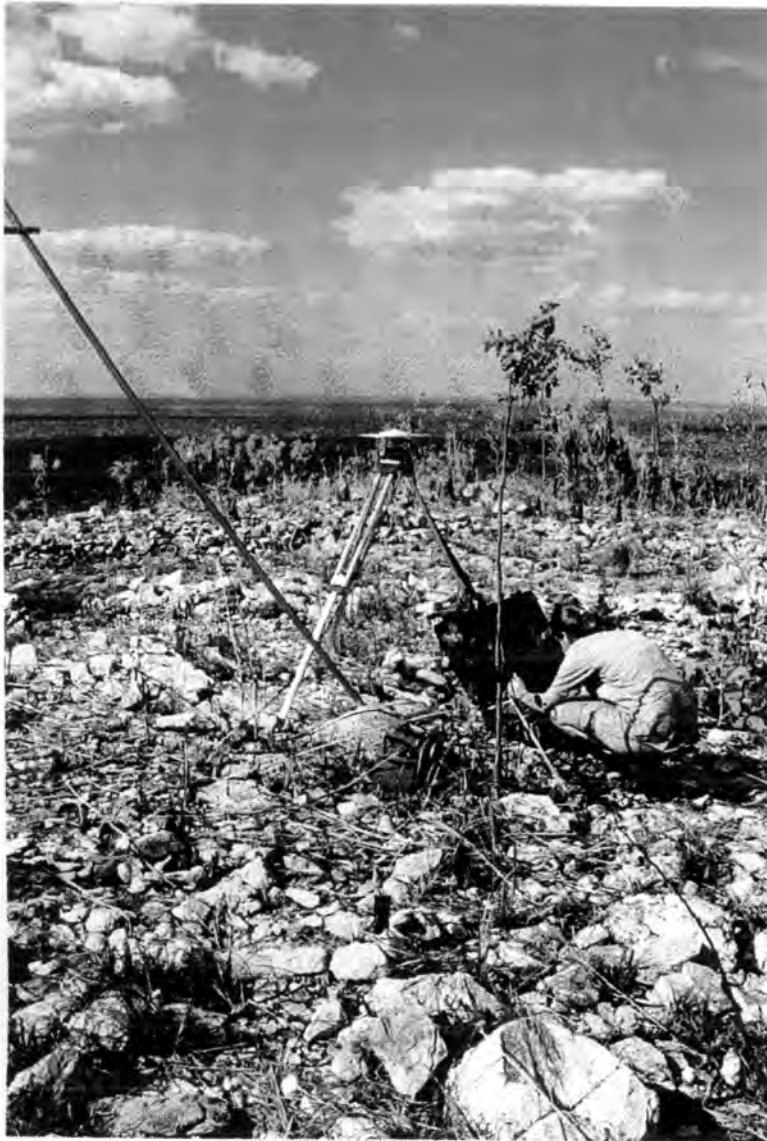
**Plate 2.5: Dual frequency z-12 receiver**

Base station equipment at geodetic site, Kapalga (NTS 018)

It was not possible to position the base station over the station mark at the Kapalga geodetic site (NTS 018), as the beacon would interfere with the signal. As an alternative the z-12 receiver was positioned over one of the marker spikes. Since the distance between the spike and the station mark was known, it was possible to determine the relative height of the spike. There was no known reference bench mark or geodetic site at Point Farewell. Therefore, the dGPS

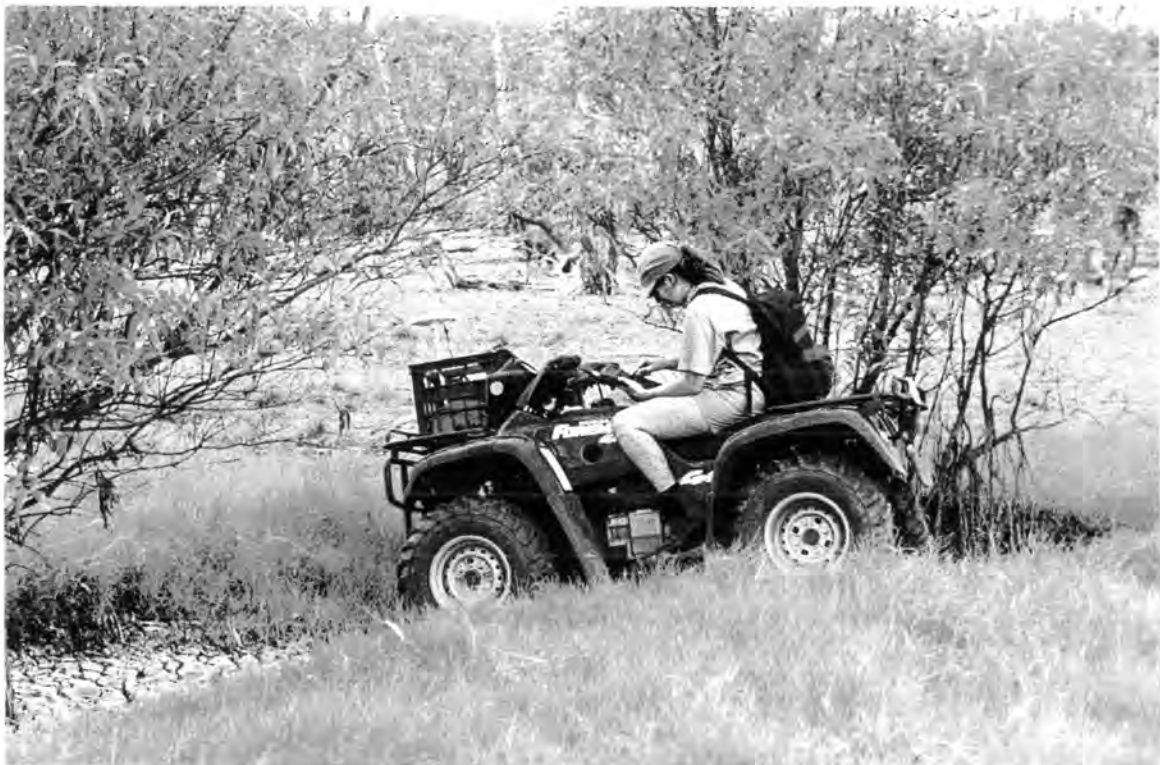
Plate 2.6: Reliance Rover Receiver

The Marine IV antenna of the Reliance rover receiver mounted on quad bike, operated by a hand-held control.

Features of each site were mapped using the Reliance rover of the dGPS. The rover had a portable Marine IV antenna which could be mounted on vehicle, boat, pole, or carried on back (Plate 2.6). The outskirts of the intruding creek at the Kapalga site were mapped using the rover receiver mounted on a boat (Plate 2.7). Tidal creeks were mapped during a spring high tide of seven metres. This enabled travelling as far upstream as possible without getting stranded as the tide went out. Features of each site that were mapped included the mangrove boundary flanking tidal creeks as an indicator of the extent of saline influence, areas of salt flats, patches of dead *Melaleuca*, boundaries of *Melaleuca* forest, tidal channels (Plate 2.8), single mangroves, areas of dead mangroves, and areas of mangrove seedlings. Five second logging intervals were set for line and area features, and 20 seconds for point features.

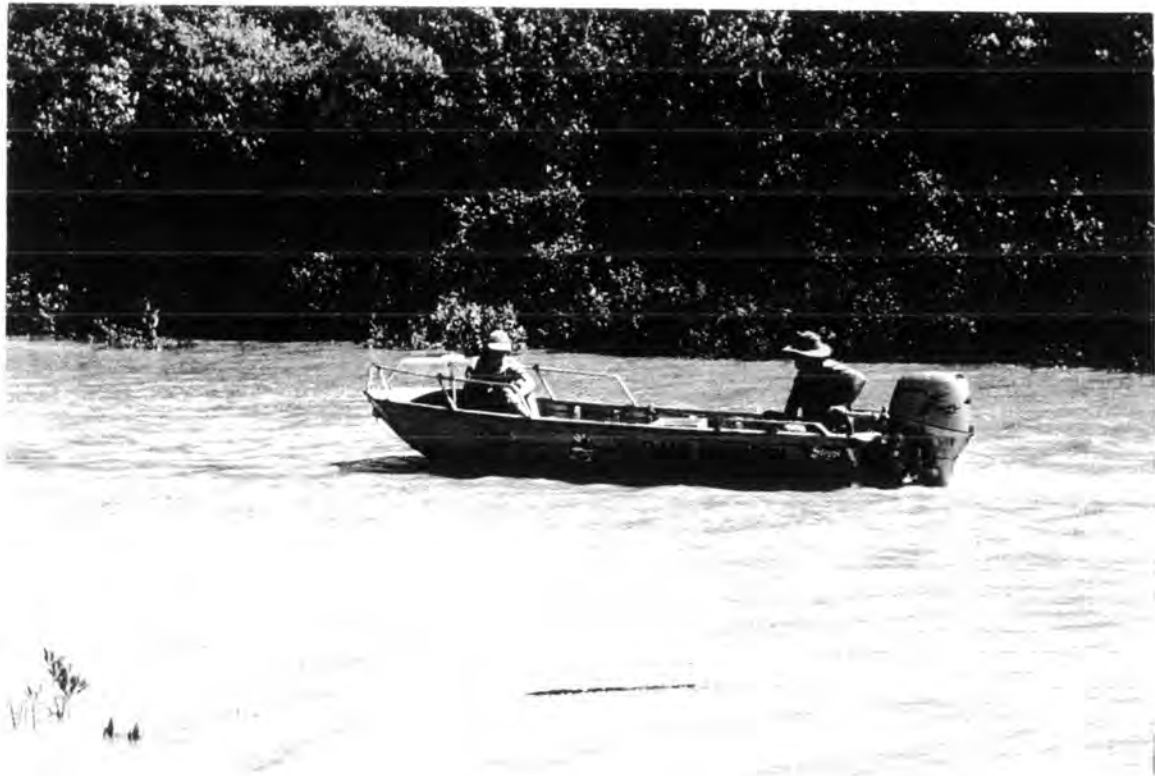
Plate 2.7: Mapping the outskirts of a tidal creek on boat, Kapalga

Outskirts of tidal creeks mapped by the Reliance rover receiver mounted on boat at spring high tide (seven metres).

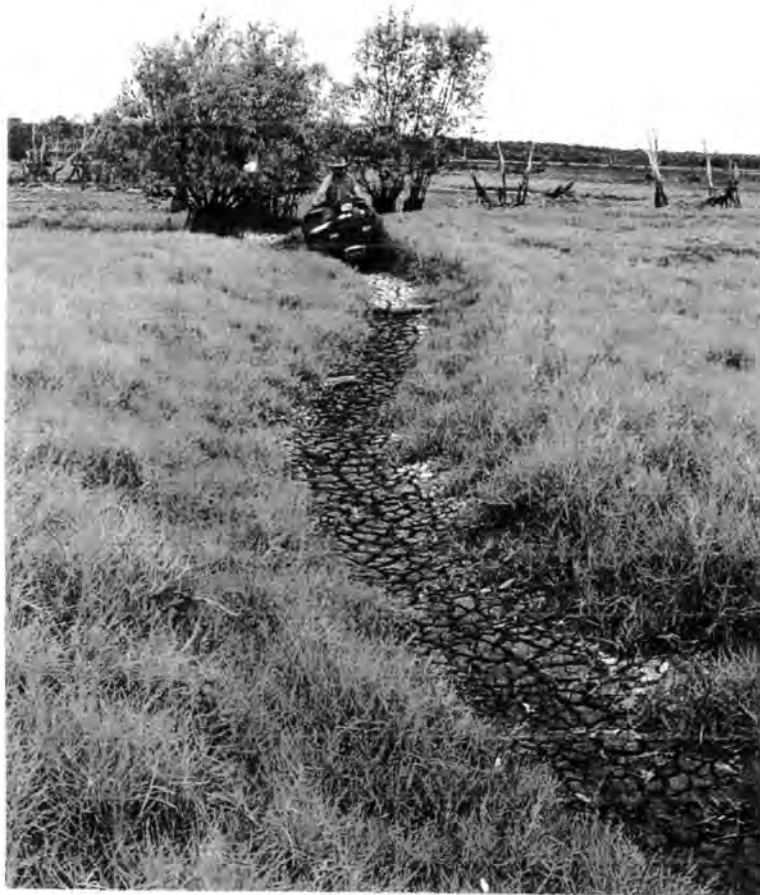
Plate 2.8: Mapping tidal creeks on quad bike, Kapalga

Tidal creeks mapped by the Reliance rover receiver mounted on quad bike. Tidal creeks were mapped at low tide.
