**Diagnosis of a fish kill in Georgetown Billabong
near Ranger Uranium Mine
on 11 October 2001**

**Robert Pidgeon, Frederick Bouckaert
& James Boyden**

Ecosystem Protection Section
Environmental Research Institute of the Supervising Scientist
GPO Box 461
Darwin NT 0801

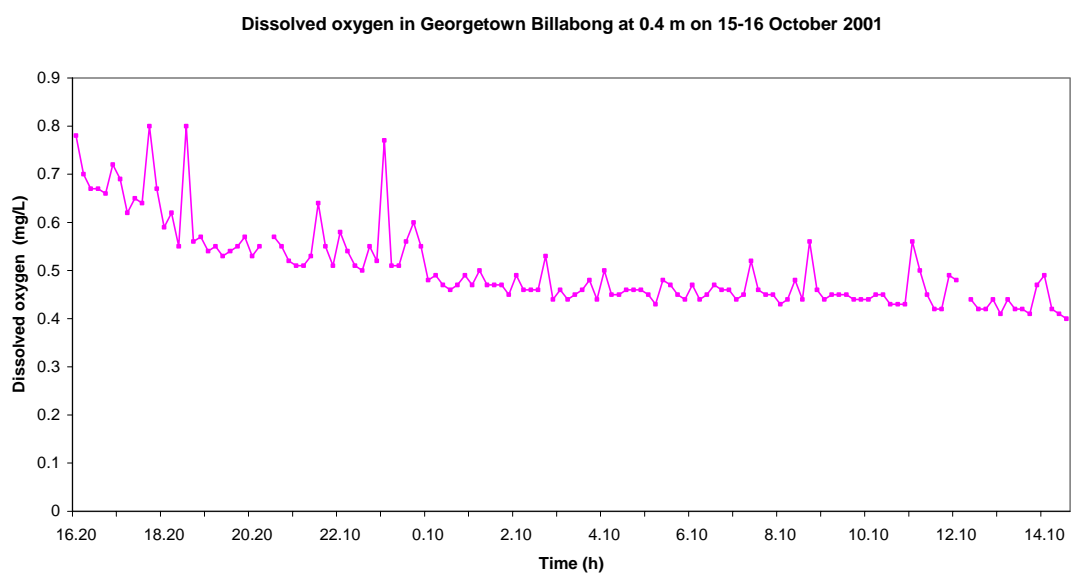
Figure 3 Diurnal pattern of dissolved oxygen at 0.4 m deep in Georgetown Billabong on 15–16 October 2001

The results from the logger placed at a depth of 40 cm on 15–16 October showed that in the deeper water layer the dissolved oxygen levels remained very low (less than 0.8 mg/L) throughout the 22 hour measurement period (1600 h to 1430 h) (figure 3). There was also a decline through the evening from around 0.8 mg/L at sunset to around 0.4 mg/L around midnight. From sunrise until midday when the logger was removed there was no increase in dissolved oxygen at this depth so that for a large part of the day there was very little oxygen available in the deeper water of the billabong.
