Radiological anomalous
area on the Nabarlek
minesite – visual
interpretation of
temporal aerial
photography

K Pfitzner

March 2004

Registry File SG2003/0107

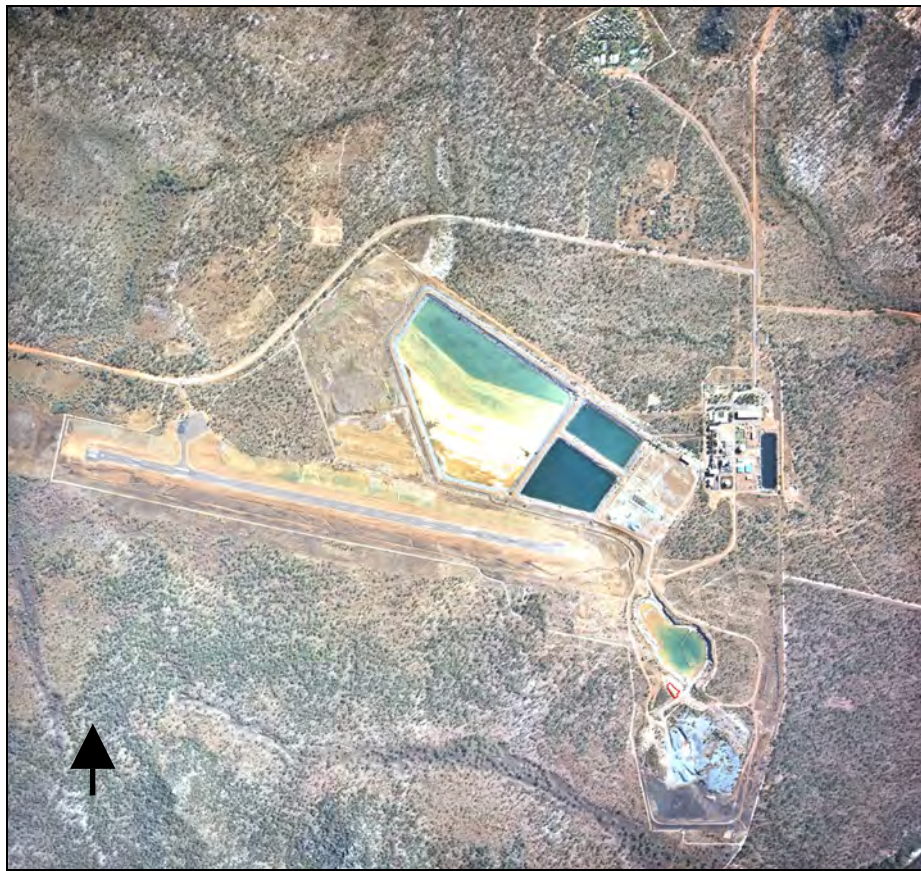
Figure 1 1989 aerial photograph with the bare area (red), obtained from the Quickbird data overlaid (area is to the south west of the pit)

3 Results

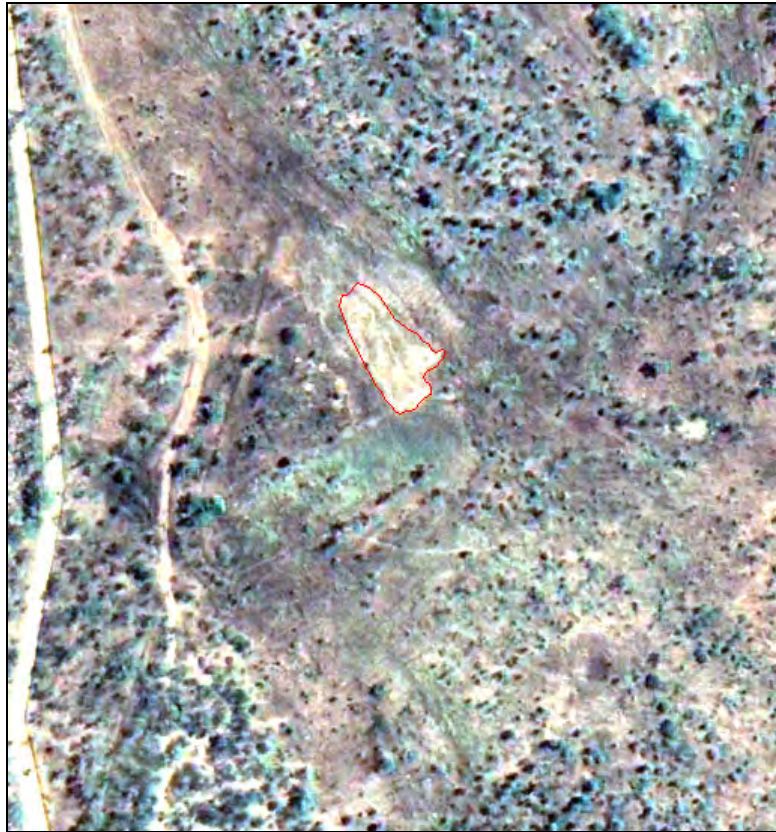
Figure 2 Extent of the area (red), as interpreted from the Quickbird data

The current extent of the radiological anomalous area was visualised from the Quickbird imagery as a bare sediment area devoid of vegetation (Figure 2). Whether this area encompasses the real area of *radiological* extent during and post mining operations is unknown, but the results described below suggest that the bare area during mining operations was at times greater than the extent on the rehabilitated surface. The area digitised corresponded to changes in landform over the sequence of aerial photographs and therefore suggests that the general area was a result of mining operations. The area digitised from the Quickbird data corresponds very well with the spatial location of bare sediment in the 1999 aerial photograph (Figure 6), suggesting that the area lacked vegetation at the time of rehabilitation.

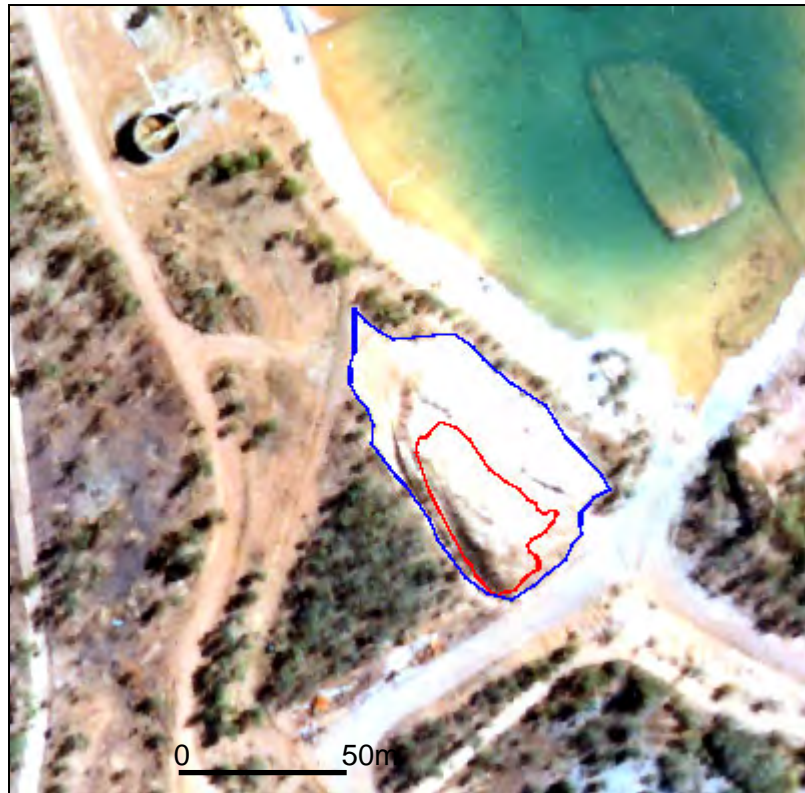
Figure 4 Digitised area (in red from Quickbird data) overlaid on a subset of the 1989 aerial photograph. The extent of the bare area as seen in the 1989 aerial photograph is highlighted in blue.

Figure 4 illustrates the 1989 aerial photograph with the area identified from the Quickbird data overlaid. The area corresponds to bare sediment, the boundary of which is greater in the aerial photograph (3323.4 m^2) compared to the Quickbird (1055.3 m^2) area. By contrast to the 1984 interpretation, the area appears to be higher in elevation than the immediate surrounds, visualised as a pile of material. No longer could a linear feature, interpreted as a road (Figure 8c) be seen dissecting the area, but roads intersected the boundary of the area.
