Ranger Trial Landform:  
Hydrology – Rainfall &  
runoff data for Erosion  
Plot 2: 2009 - 2014

M Saynor, J Boyden and  
W Erskine

April 2016

Project number – RES-2009-011

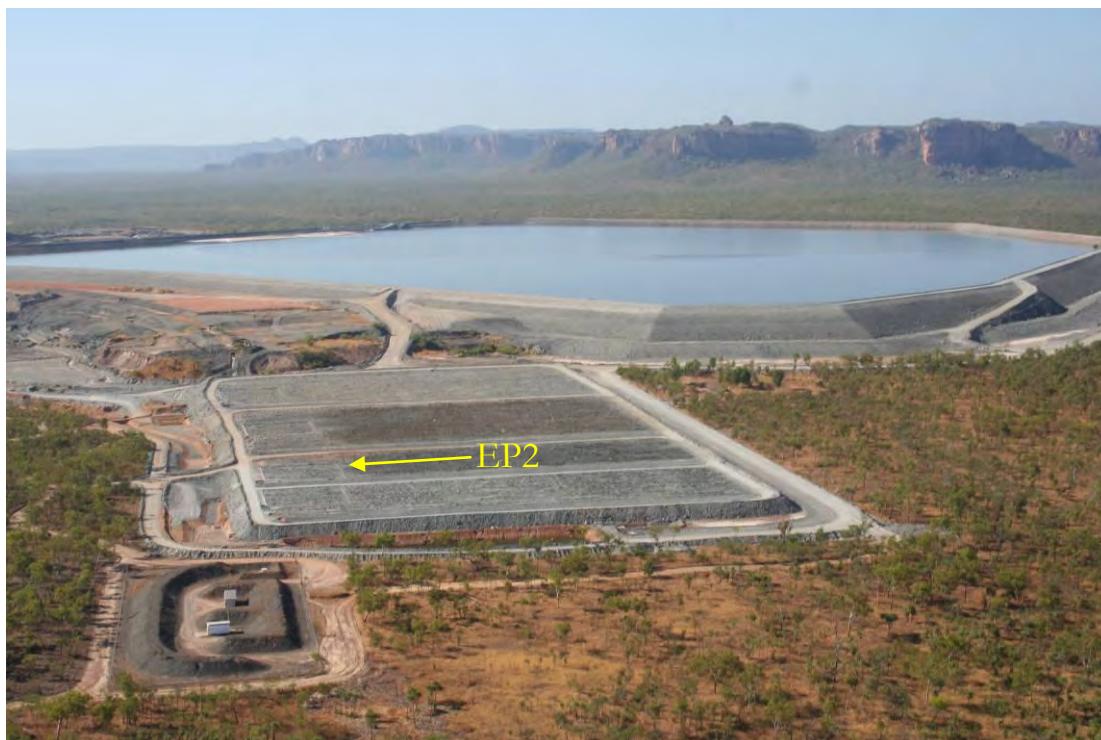
**Figure 2** Aerial view of the completed trial landform located next to the Ranger mine Tailings Storage Facility (taken 28 August 2009)

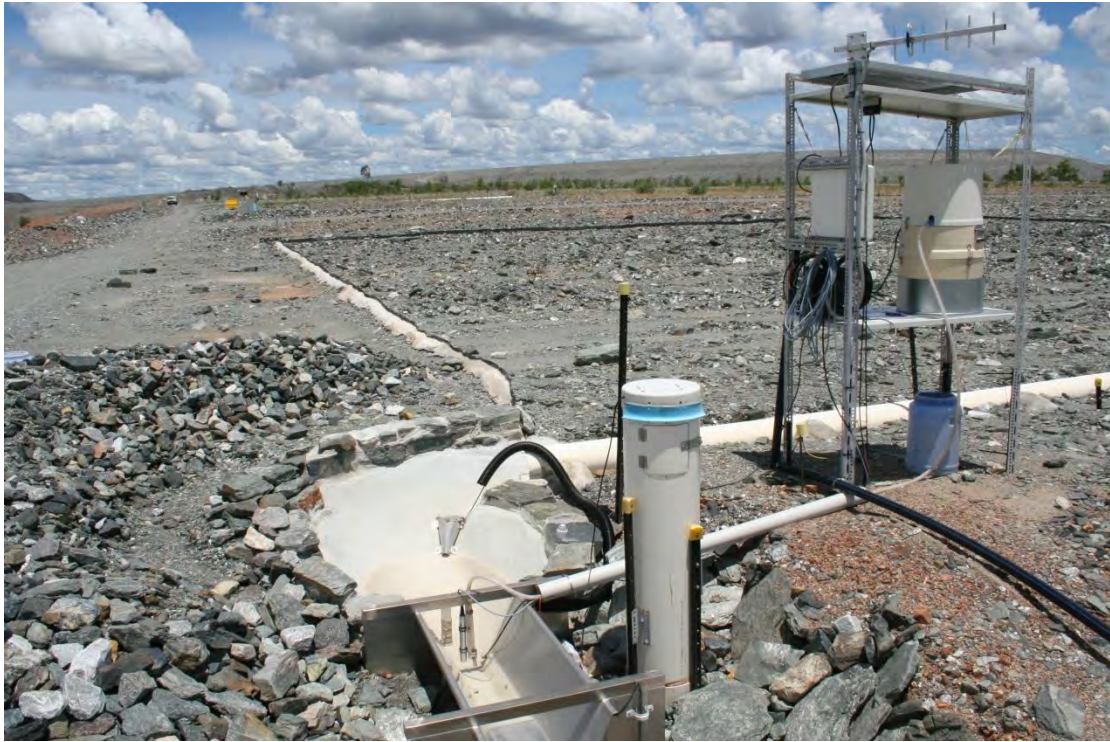
**Figure 3** Across EP2, showing the upstream stilling-basin, part of the flume and the shelter for the data logger (2 February 2010).

Stage height of water leaving the plot is measured by two sensors, a shaft encoder (primary sensor) in a stilling well with the intake in the stilling basin and a pressure transducer (secondary sensor) with the intake in the upstream section of the flume. The shaft encoder is the primary sensor because they are highly accurate (with a float on the water surface in the stilling well) and have good temperature stability. Stage height data in both height recorders is measured at 10 second intervals with a vertical precision of 1 mm. New data points are recorded only when the change in water level is greater than 1 mm.

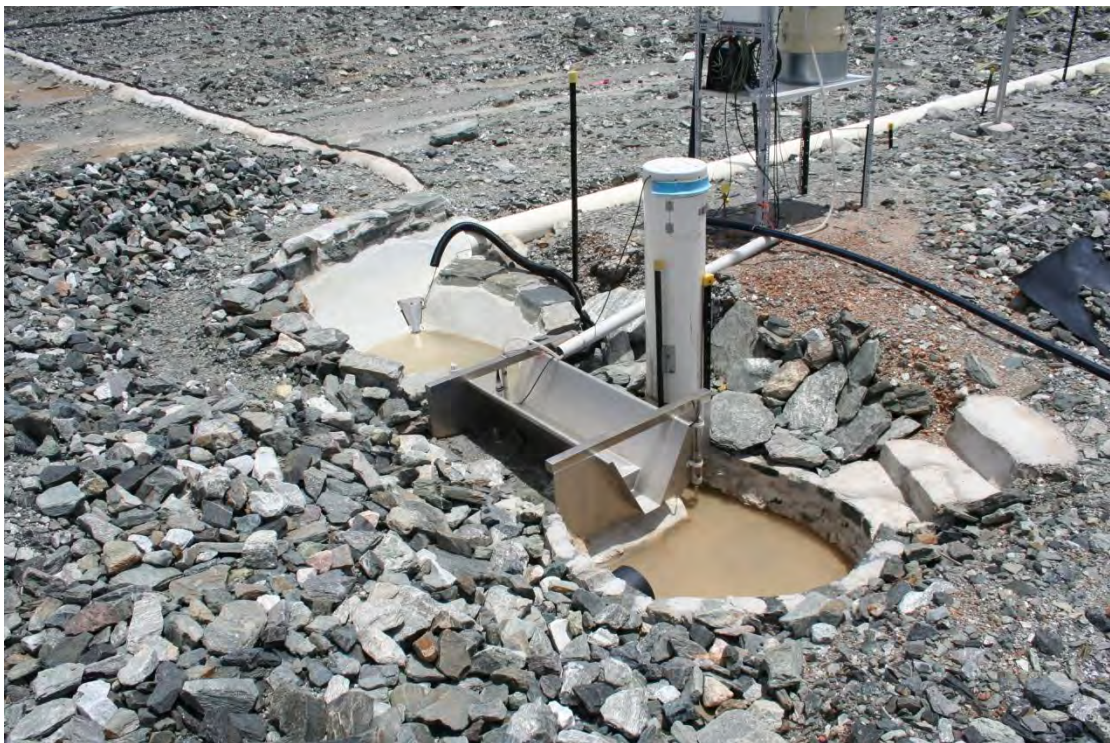
**Figure 4** Flume, upstream stilling-basin and downstream draining-basin of EP2 (2 February 2010).

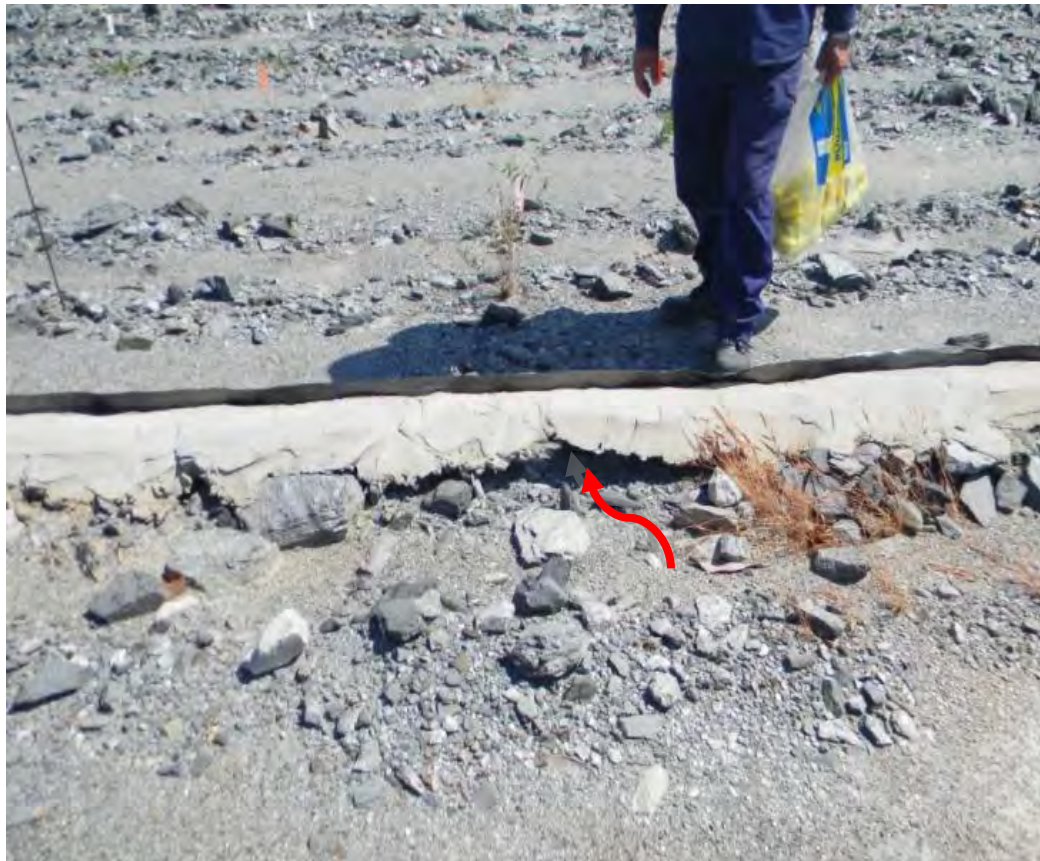
**Figure 5** Piping failure under the top boundary of EP2 indicated by arrow.

At the end of the 2010-2011 water year a large breach was noticed in the boundary along the upslope edge of EP2 (Figure 5). This breach is believed to have occurred during the very large event on 22 February 2011 (Figure 6). This breach was fixed during the 2011 dry season using a concrete truck and a team of staff. The impact of this breach could be identified in the stage trace by a second peak appearing well after the rainfall had finished. The second peak was not present on stage traces on erosion plot 1 (EP1) for the same event. A comparison of the EP2 and EP1 stage traces should be used to apply corrections to the EP2 stage traces affected by the breach.

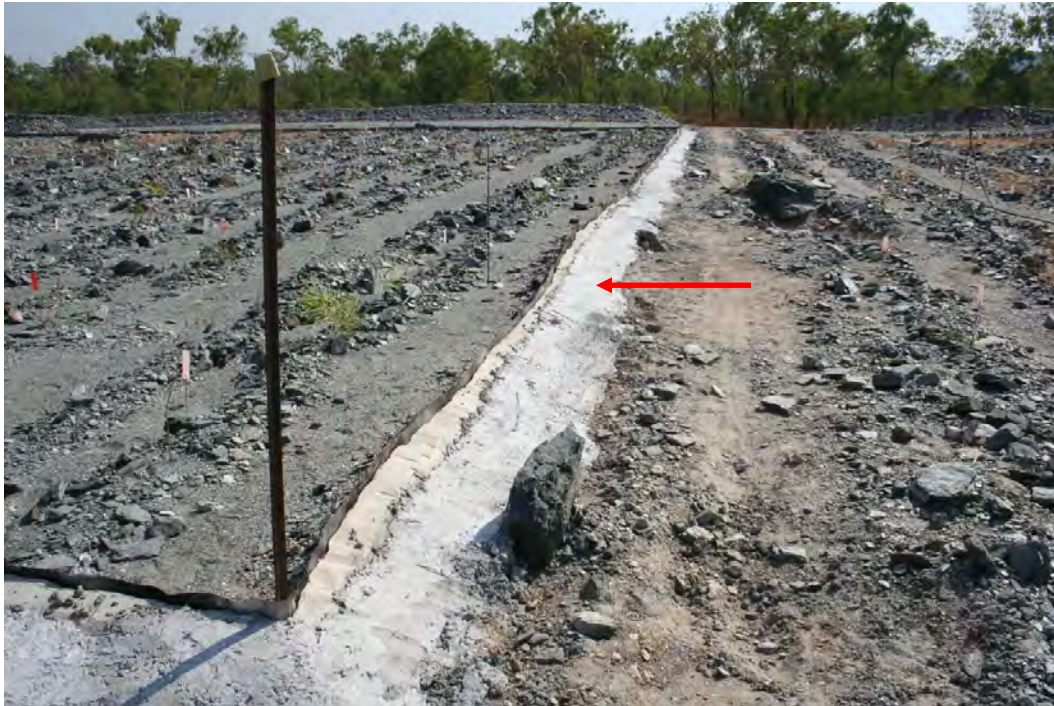
**Figure 6** Concrete along the top boundary of EP2 to seal the breach and reinforce the boundary. The red arrow shows where the breach occurred.

Event stage traces continued to be compared for EP1 and EP2 for the early 2011–2012 water year, after repairs to the EP2 boundary had been completed. It was determined that the repair of the top boundary during 2011 had stopped additional (offsite) surface flow onto EP2, as the shapes of the stage traces from both plots were very similar.

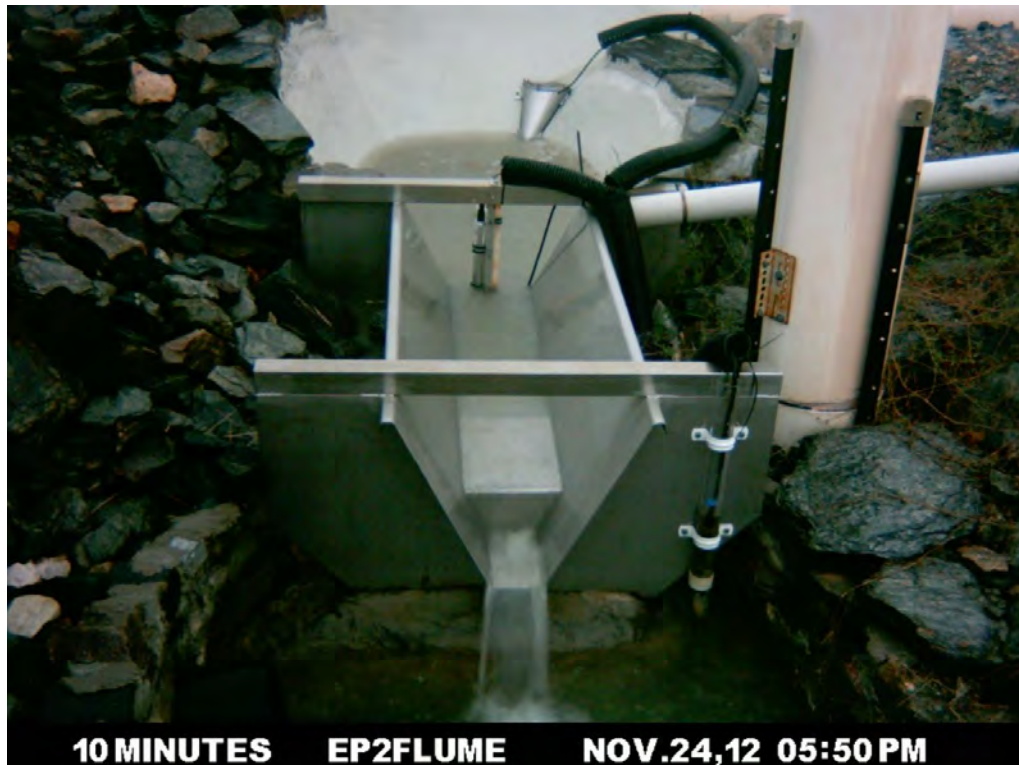
**Figure 7** Flow through TLF2 flume at 5:50pm, uniform steady flow.

Figure 7 taken at 5:50 pm shows steady flow through the flume and also a settled water level in the upstream stilling basin. Figure 8 taken at 6:00 pm shows water deflecting off the stainless steel cage that houses the EC probe. The water can be seen rising up the side of the stilling basin, however, the flow through the flume looks to be uniform. By 6:10 pm (Figure 9) most of the water is being deflected off the side of the stainless steel cage and rising high up the right side of

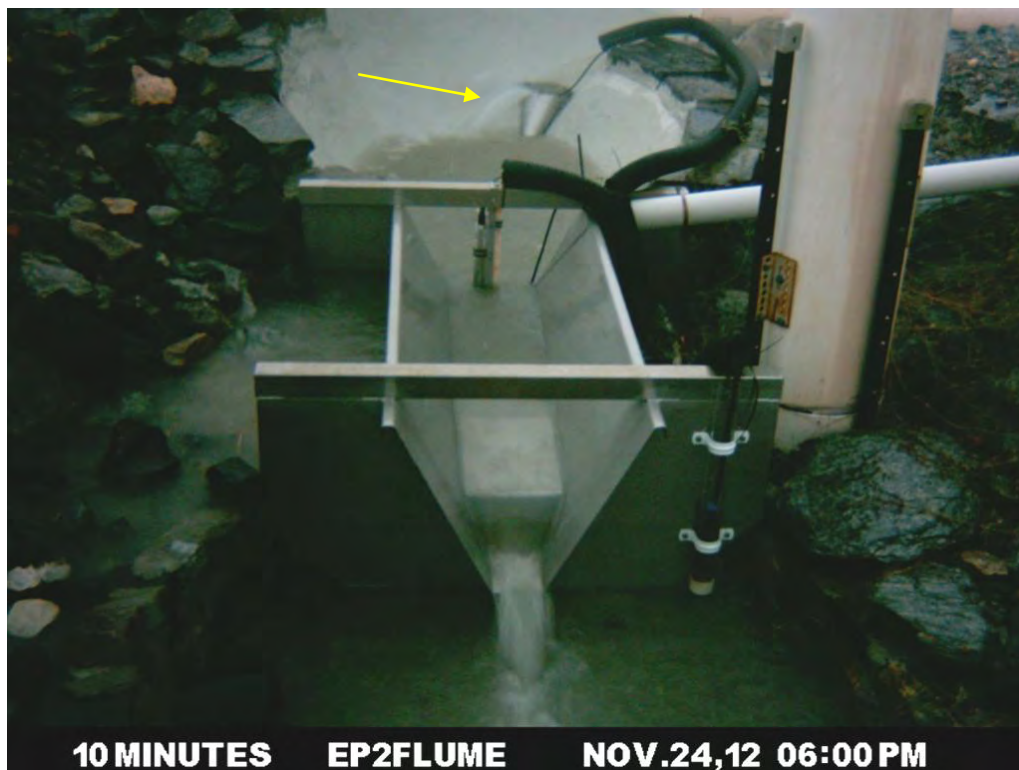
**Figure 8** Flow through TLF2 flume at 6:00 pm, flow is starting to be deflected by the stainless cage, indicated by the yellow arrow.

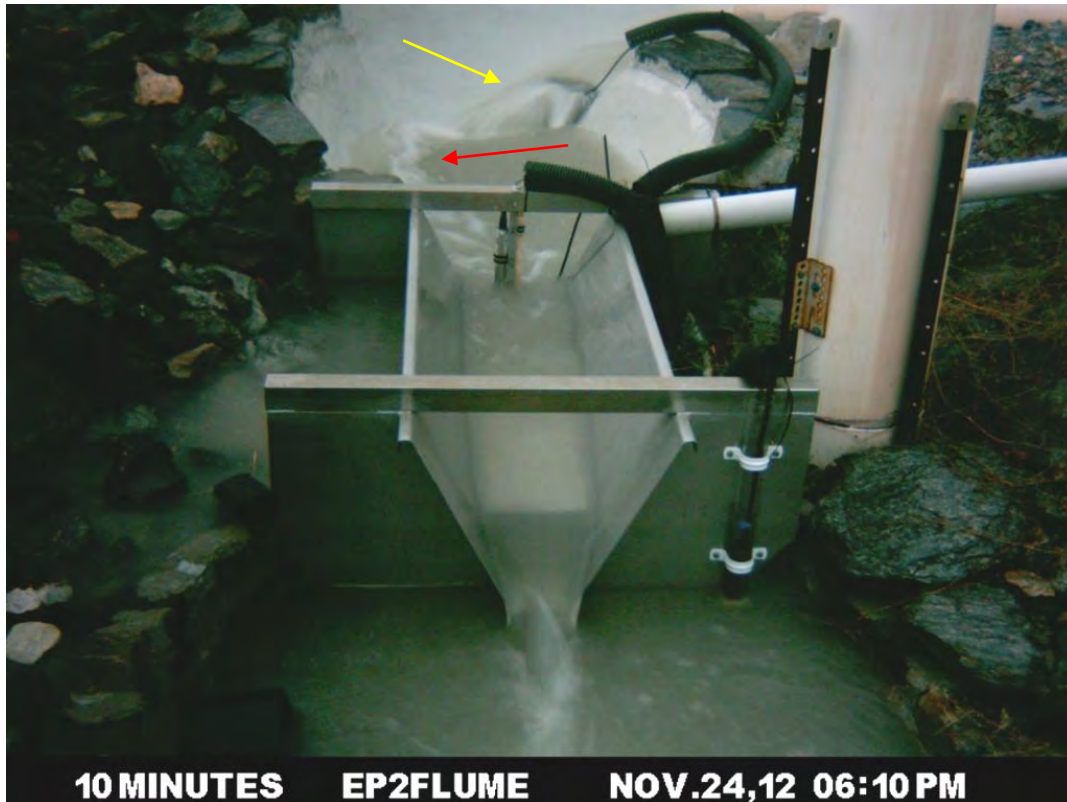
**Figure 9** Flow through TLF2 flume at 6:10 pm, flow is being affected. The flow can be seen deflecting off the cage (yellow arrow) and can be seen rising up around the outside of the basin (red arrow).

the stilling basin. The water looks to be turbulent as it enters the flume, which is not a uniform height through the flume. At 6:20 pm (Figure 10) less water is deflecting off the stainless cage and the water through the flume has become more uniform.

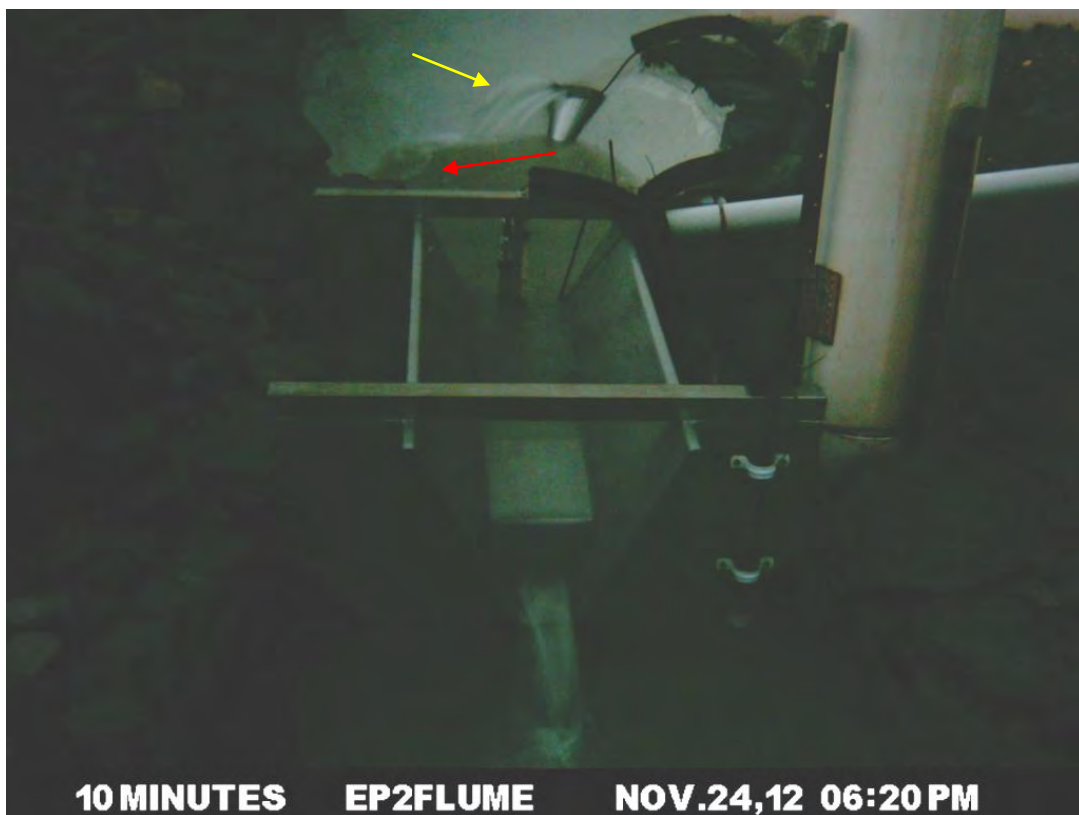
**Figure 10** Flow through TLF2 flume at 6:20 pm, Getting much darker and the water is still deflecting off the cage (yellow arrow) but is not rising up as high on the outside of the basin (red arrow).

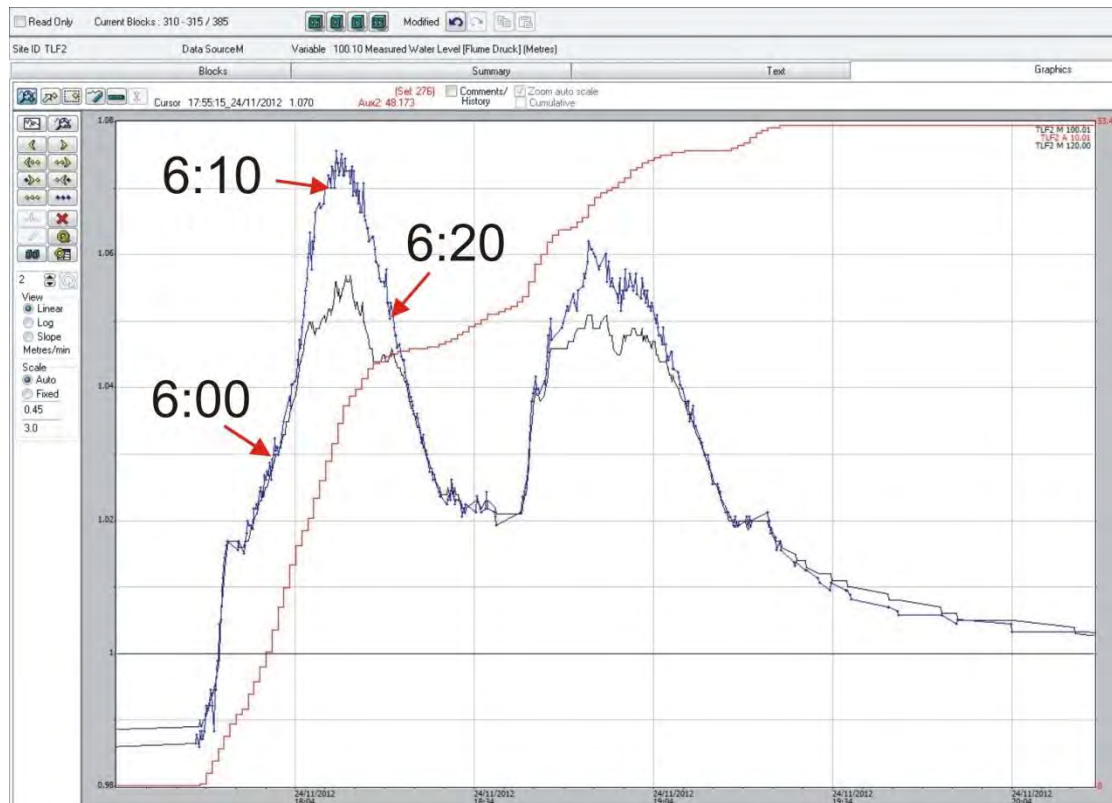
**Figure 11** Example of the difference in water level between the stage trace and pressure transducer at higher runoff flows. The blue line (higher peaks) is the EP2 pressure transducer and black line is the shaft encoder. The red line is the cumulative rainfall for the event.

On EP2 water levels through the flume are disrupted at high flows by both the smaller size of the upstream stilling basin and the location of the stainless steel cage. Inspection of many events indicated that this problem appeared to occur only when water depths were greater than 1.045 m as recorded by the shaft encoder).

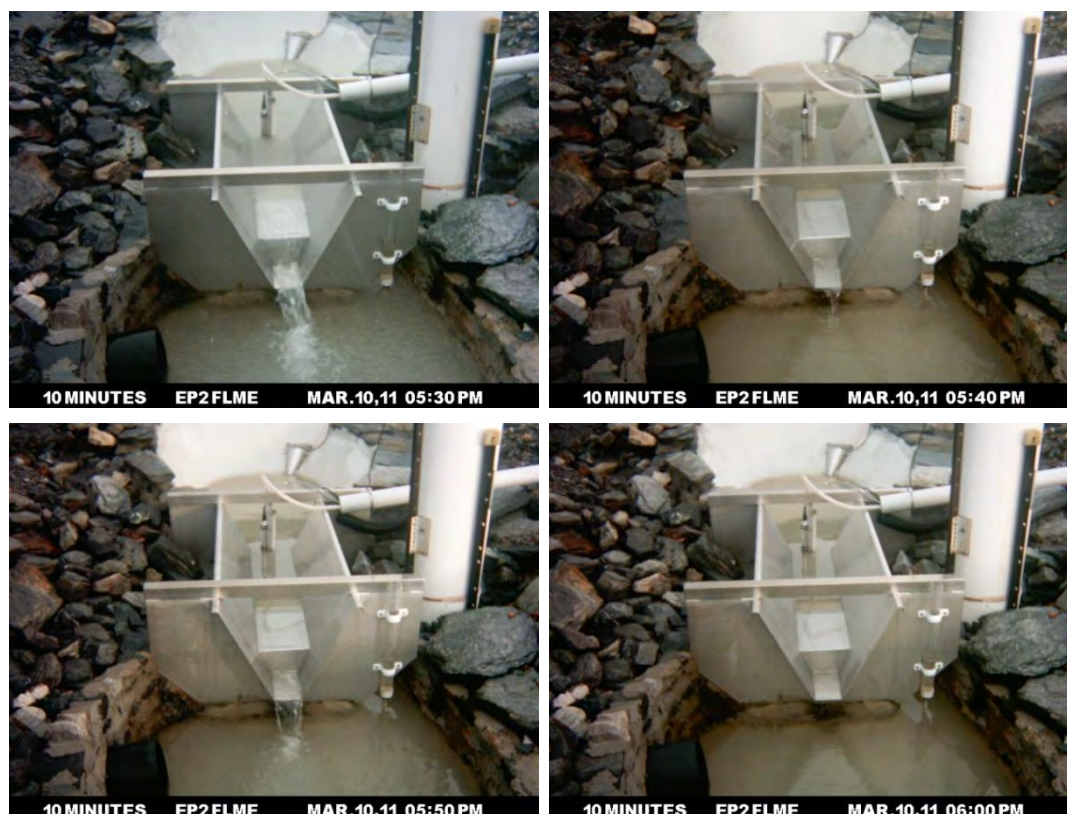
**Figure 17** Runoff from EP2 for the event 10 March 2011.

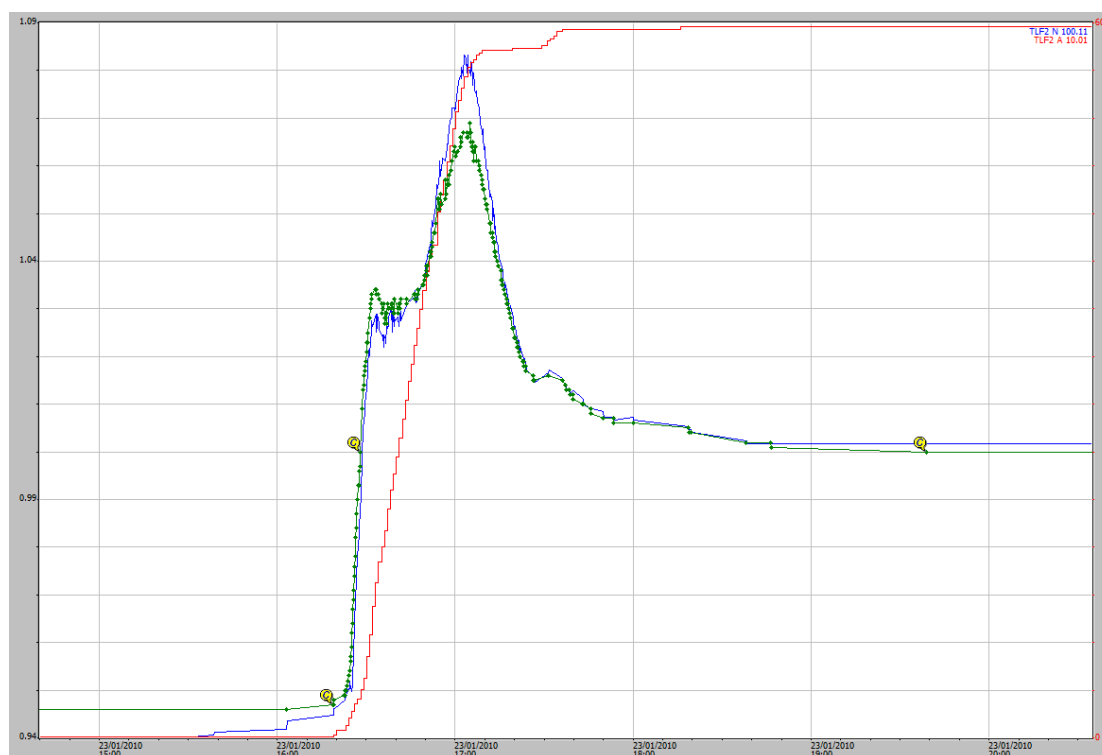
**Figure 18** Event 1 – 23 January 2010, the pressure transducer (blue) aligned with the shaft encoder (green). Cumulative rain is shown in red. Stage height (m) is shown on the left y axis and rainfall (mm) is shown on the right y axis.

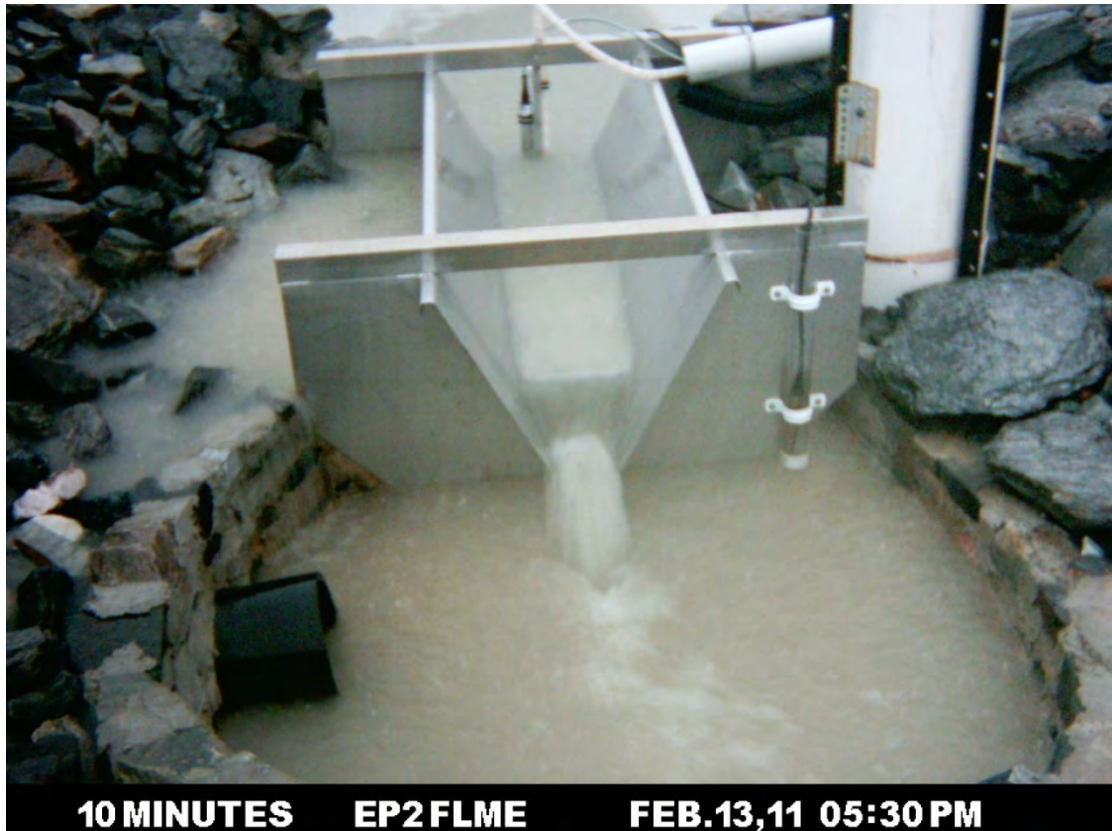
Figure 20 Water through EP2 flume at 5:30 pm on 13 February 2011.

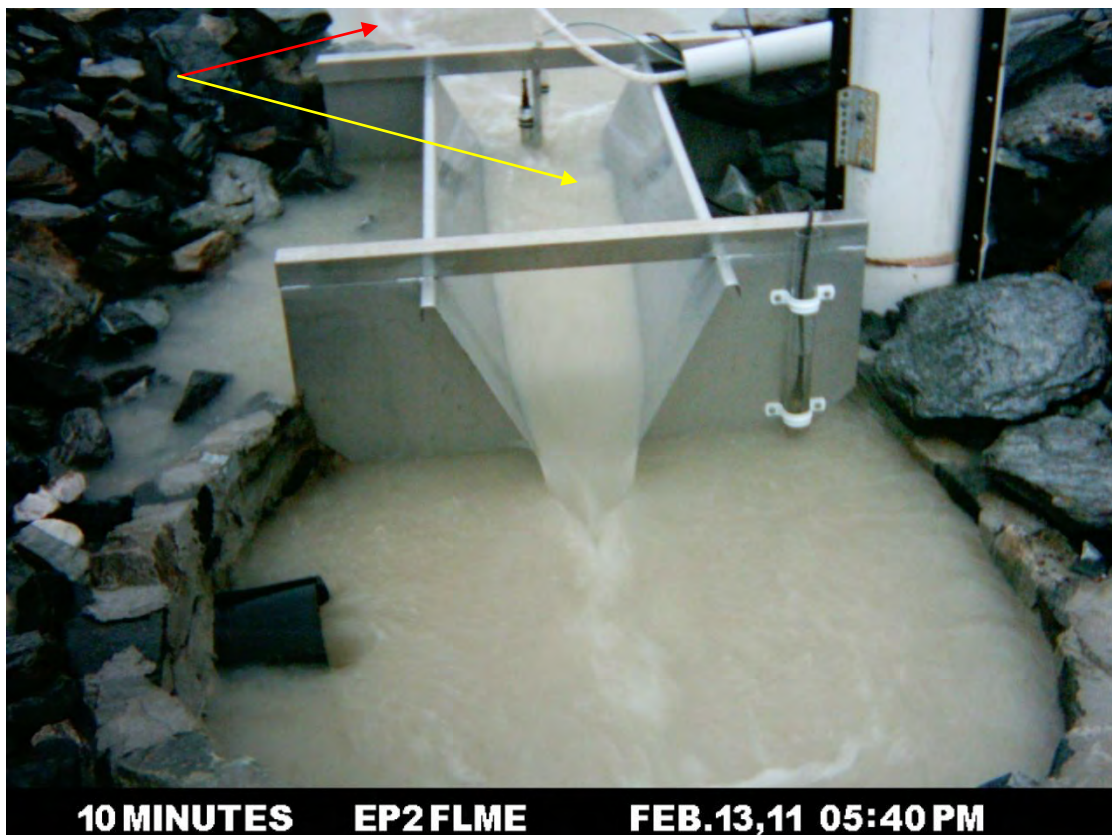
Figure 21 Water through EP2 flume at 5:40 pm on 13 February 2011. Although a poor field of view the disturbance in the upstream stilling basin can just be seen at the top of the image (red arrow) and the uneven flow through the flume is shown by the yellow arrow.

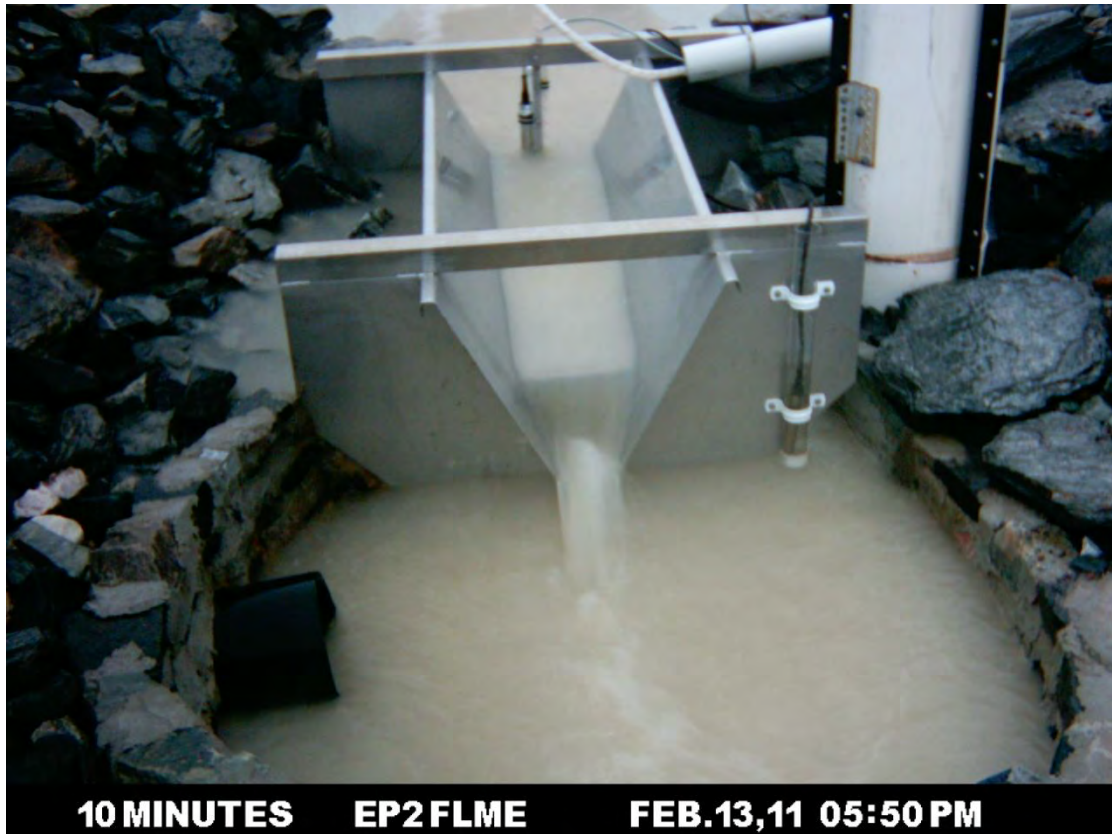
**10 MINUTES    EP2 FLME    FEB.13,11 05:50 PM**

Figure 22 Water through EP2 flume at 5:50 pm on 13 February 2011.

Event 6 shows a difference between the shaft encoder and the pressure transducer with the pressure transducer 15mm higher than the shaft encoder. Photos in figures 20 to 23 show flow through the flume at 10 minute intervals. The image at 5:40 pm (Figure 21) shows the initial disturbance in the upstream stilling basin. The pressure transducer trace was used to correct the higher part of the shaft encoder stage trace after aligning it to the same datum as the 1<sup>o</sup> shaft-encoder.

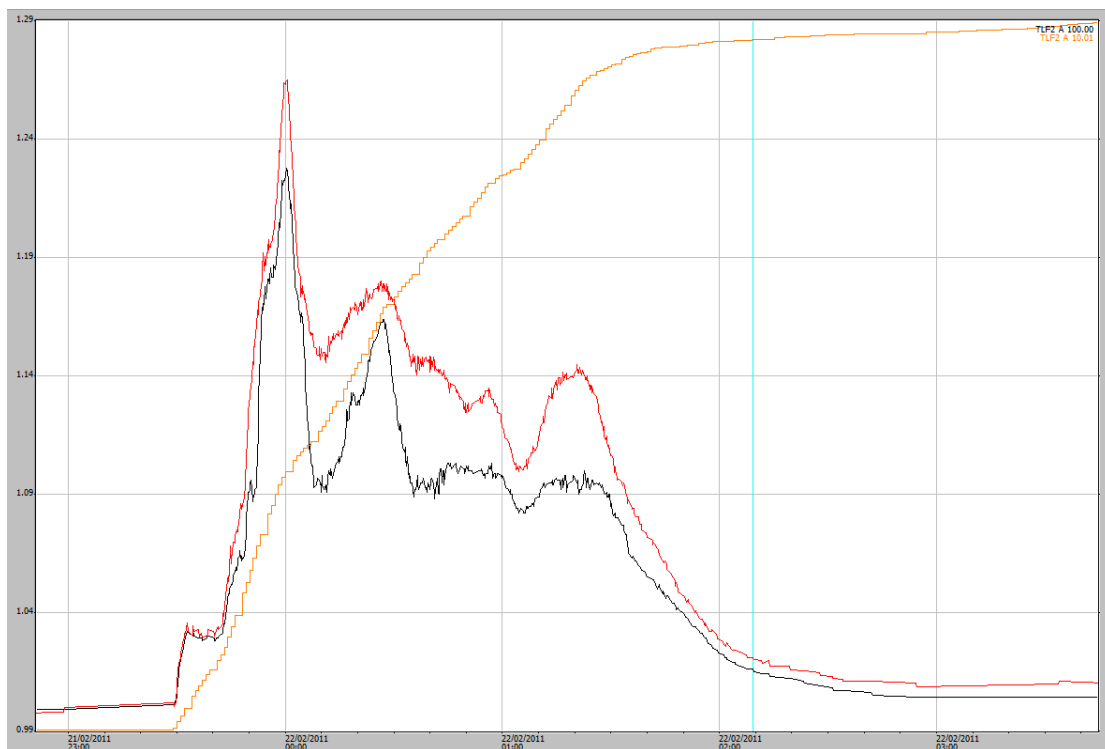
**Figure 24** Event 8 hydrograph. The black is the shaft encoder and the red is the pressure transducer. 0.789m has been added to the pressure transducer. The start of the event has been aligned to the same datum. Orange is the cumulative rainfall. Stage height (m) is shown on the left-y axis.

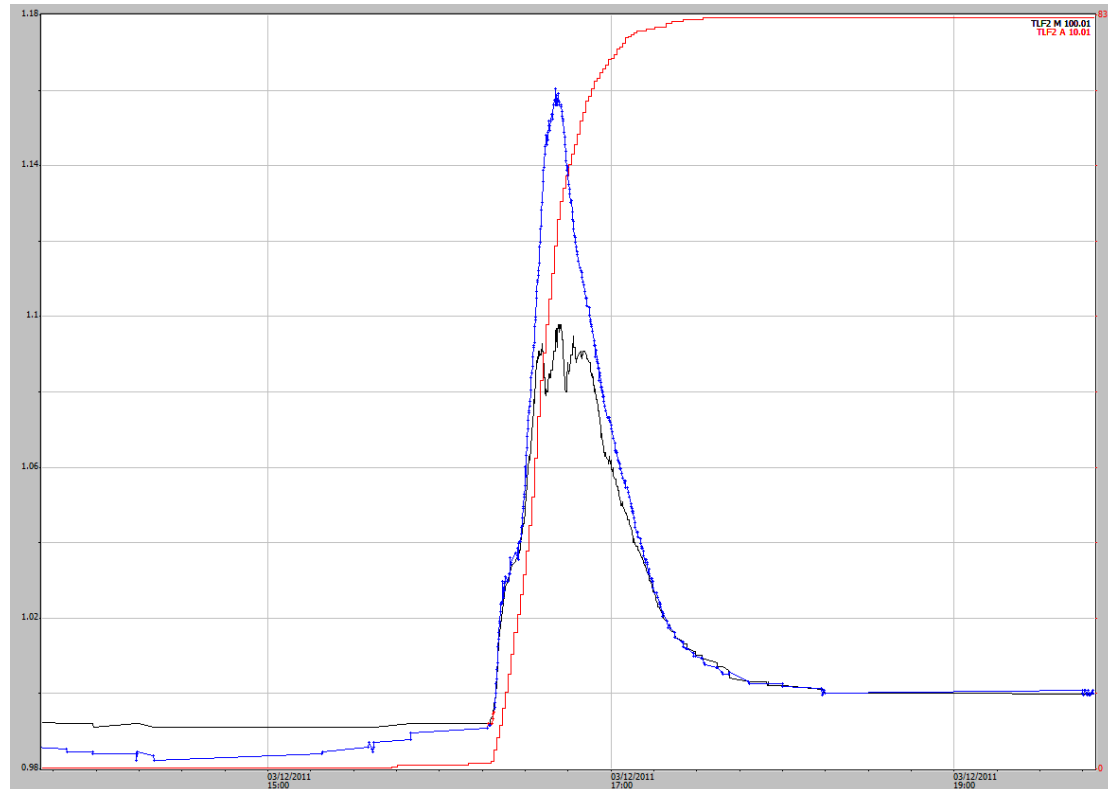
**Figure 25** Event 11, the black is the shaft encoder and the blue is the pressure transducer. The pressure transducer trace has been raised by 0.807m to align it to the same datum as measured by the shaft encoder. Cumulative rainfall is indicated in mm by the red line. Stage height (m) is shown on the left y-axis and rainfall (mm) is shown on the right y-axis.

The 2011–2012 water year had 6 events (10 – 15) when the shaft encoder stage trace was greater than 1.040 m. The largest, Event 11, occurred on 3 December 2011 and is shown in Figure 25. Rain started at 4:18 pm and continued for 50 minutes during which 82 mm of rain fell. Other events are shown in Appendix 3. Note that from the 18<sup>th</sup> of December 2011 the pressure transducer stopped recording meaningful data and was not replaced until May 2012.

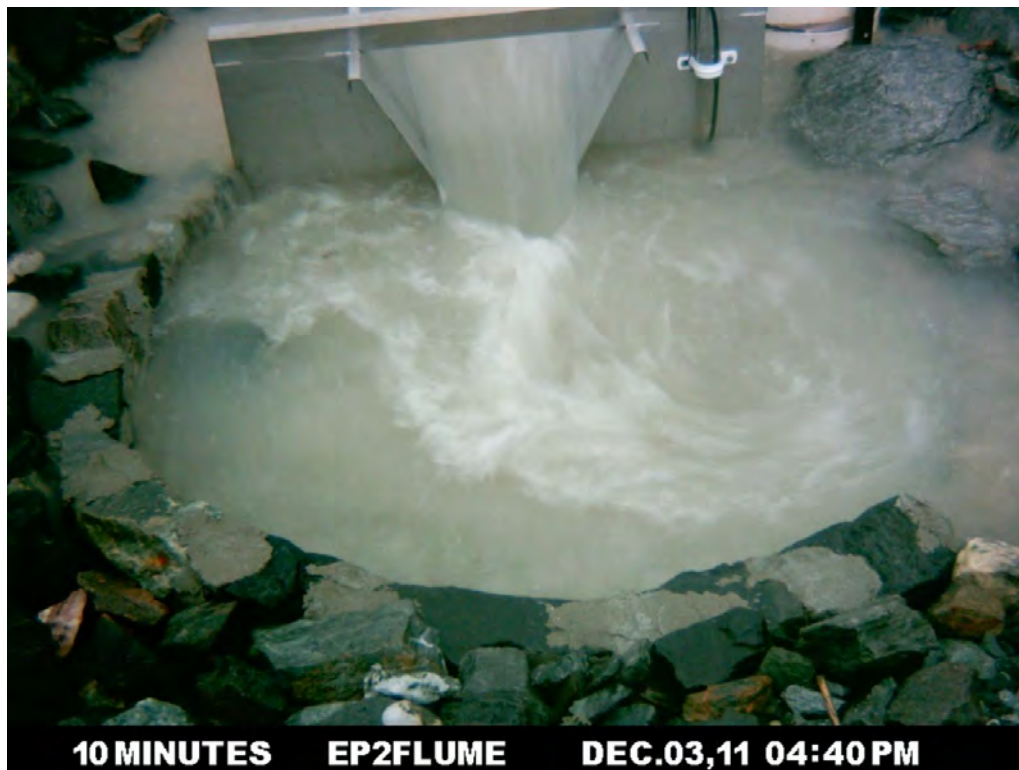
**Figure 26** Flow through the flume on EP2 at 4:40 pm (time of the highest flow). The upstream basin cannot be seen in the image.

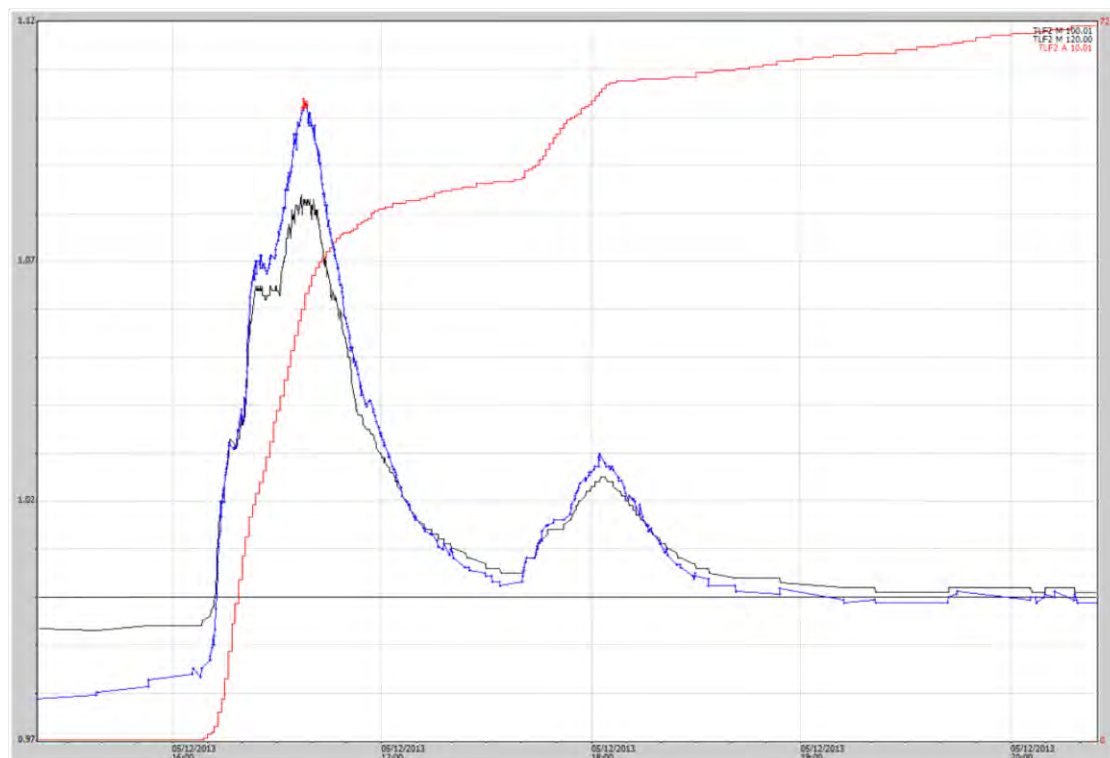
**Figure 28** Event 30, the black is the shaft-encoder and the blue (higher peak) is the pressure transducer. Stage height (m) is shown on the left y-axis and rainfall (mm) is shown on the right y-axis.

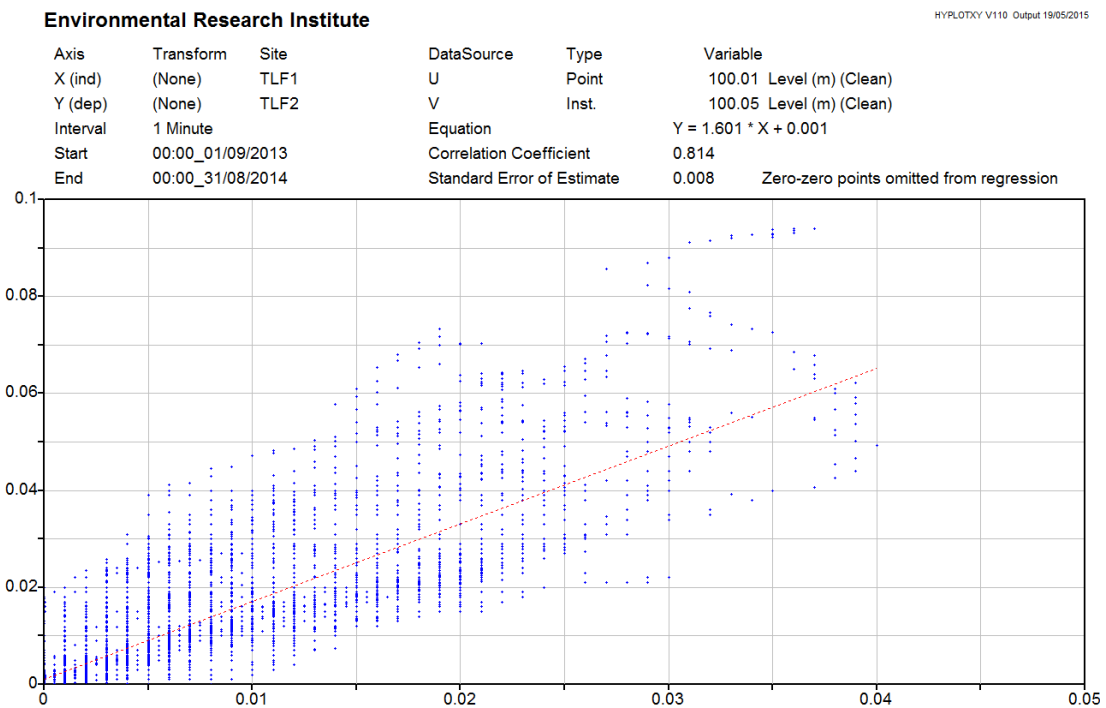
**Figure 29** Output from Hydstra HYPLOTXY for common data on EP1 and EP1 during the 2013–2014 water year. TLF1 is EP1 and TLF2 is EP2.

$Y_{TLF2} = 1.6 * X_{TLF1} + 0.001$  (where  $TLF2 = EP2$  and  $TLF1 = EP1$ ) and a correlation coefficient of 0.814. This regression equation was used to infill the missing data for the 7 day period.

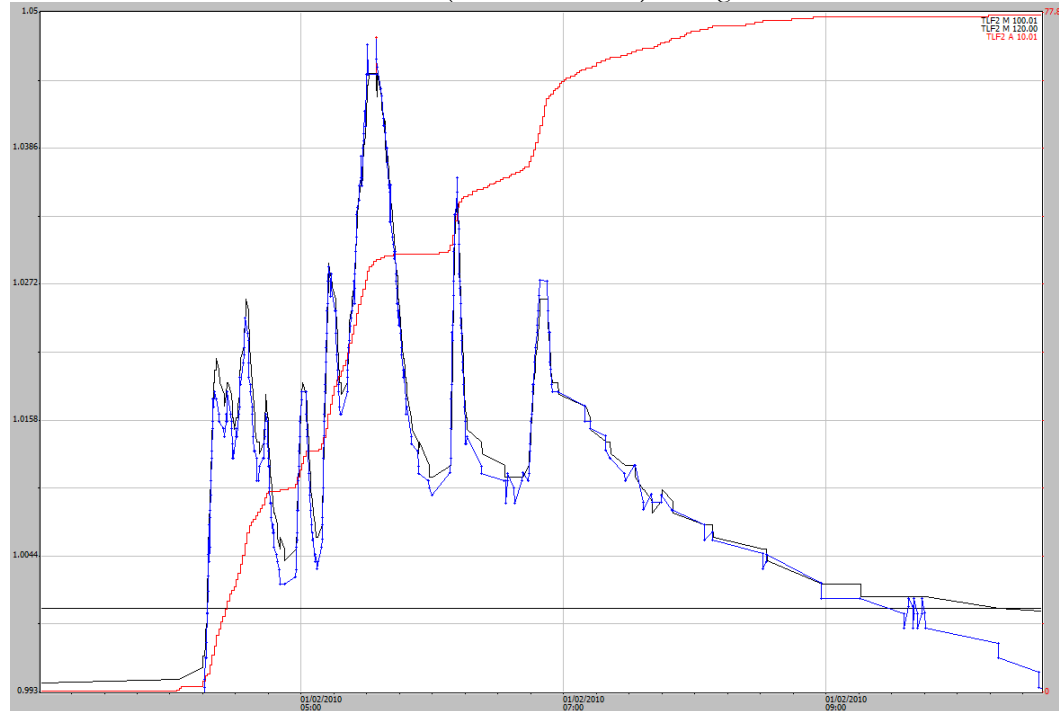
**Figure A3-1** Event 2 hydrograph on 1 February 2010 both the pressure transducer (blue) and the shaft-encoder (black) stage traces are very similar. 0.895m has been added to the pressure transducer.

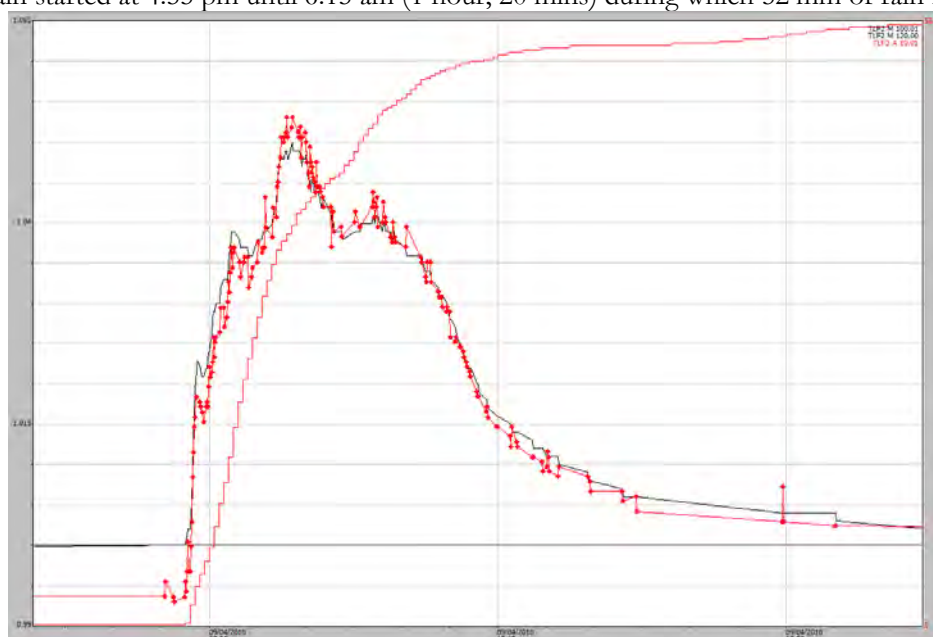
**Figure A3-2** Event 3 hydrograph on 9 April 2010 both the pressure transducer (red) and the shaft-encoder (black) stage traces are very similar. 0.894m has been added to the pressure transducer.

The main peak on the pressure transducer is slightly higher than the shaft encoder. In this case the pressure transducer data should be substituted for to the shaft-encoder data.

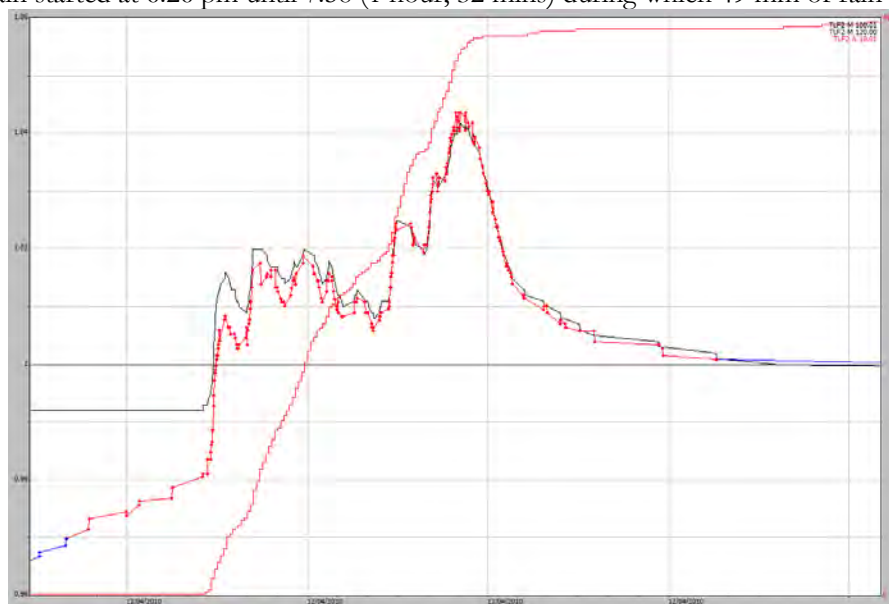
**Figure A3-3** Event 4 hydrograph on 9 April 2010 both the pressure transducer (red) and the shaft-encoder (black) stage traces are very similar. 0.895m has been added to the pressure transducer.

The main peak on the pressure transducer is slightly higher than the shaft encoder. The main peak should have the pressure transducer data smoothed and added to the shaft-encoder data.

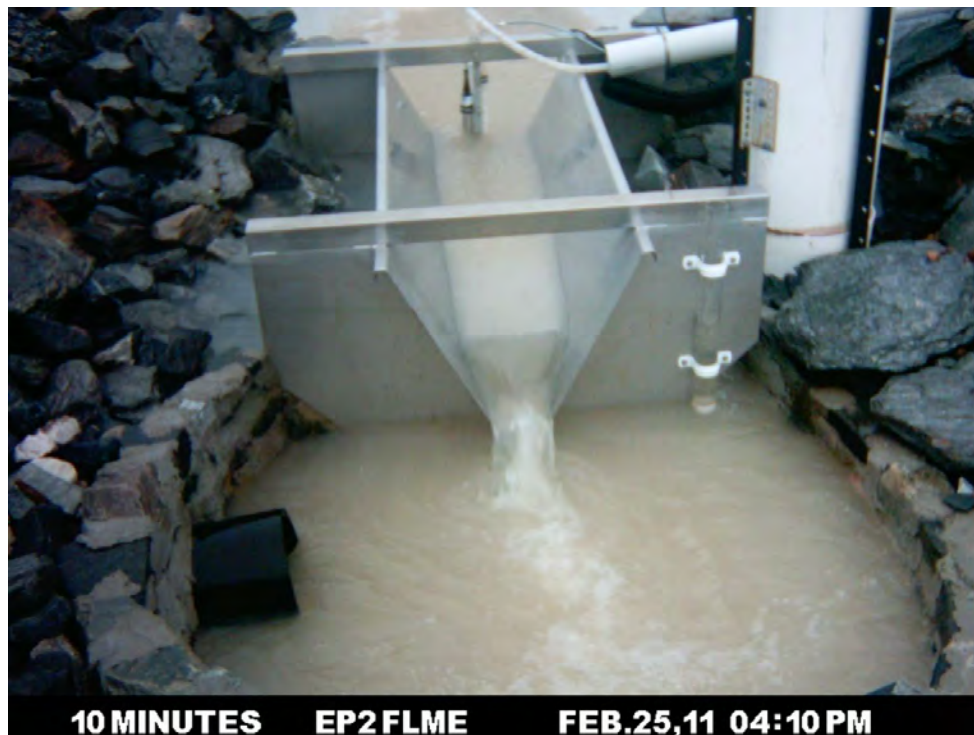
**Figure A3-7** Image of the event 9 on 25 February 2011, however it is difficult to see what is going on in the upstream stilling basin.

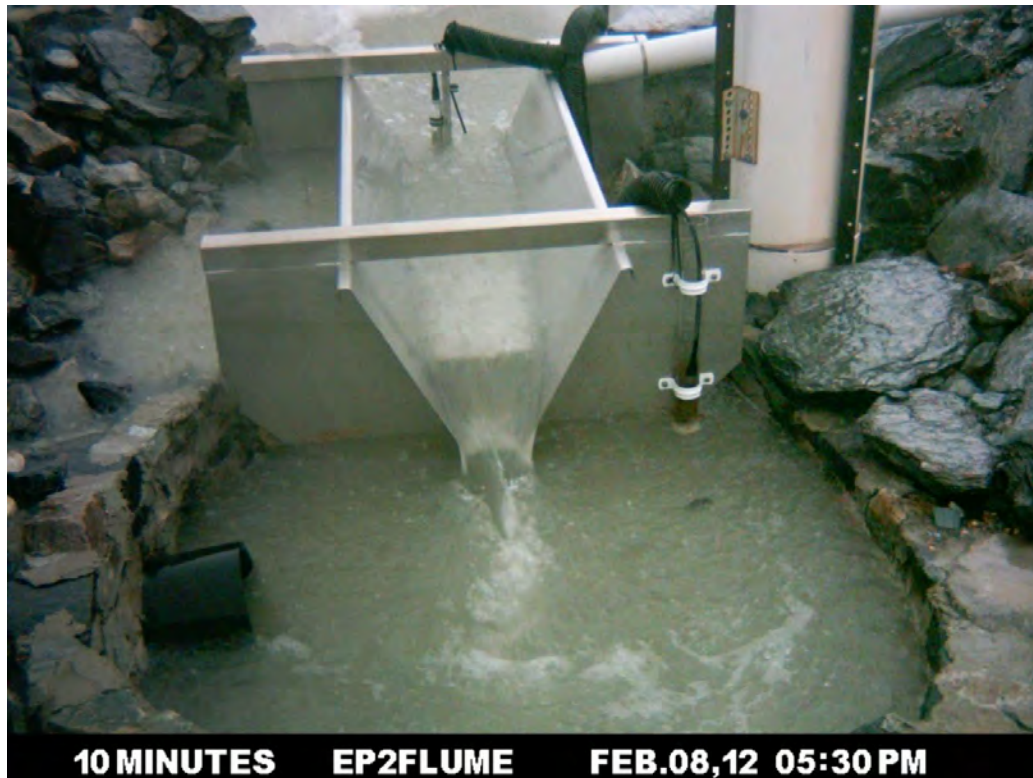
**Figure A3-11** Event 13 on 8 February 2012 at 5:30 pm. Some disturbance can be seen in the upstream stilling basin at this time.
