Ranger Trial Landform:  
Hydrology – Rainfall &  
runoff data for Erosion  
Plot 2: 2009 - 2014

M Saynor, J Boyden and  
W Erskine

April 2016

Project number – RES-2009-011

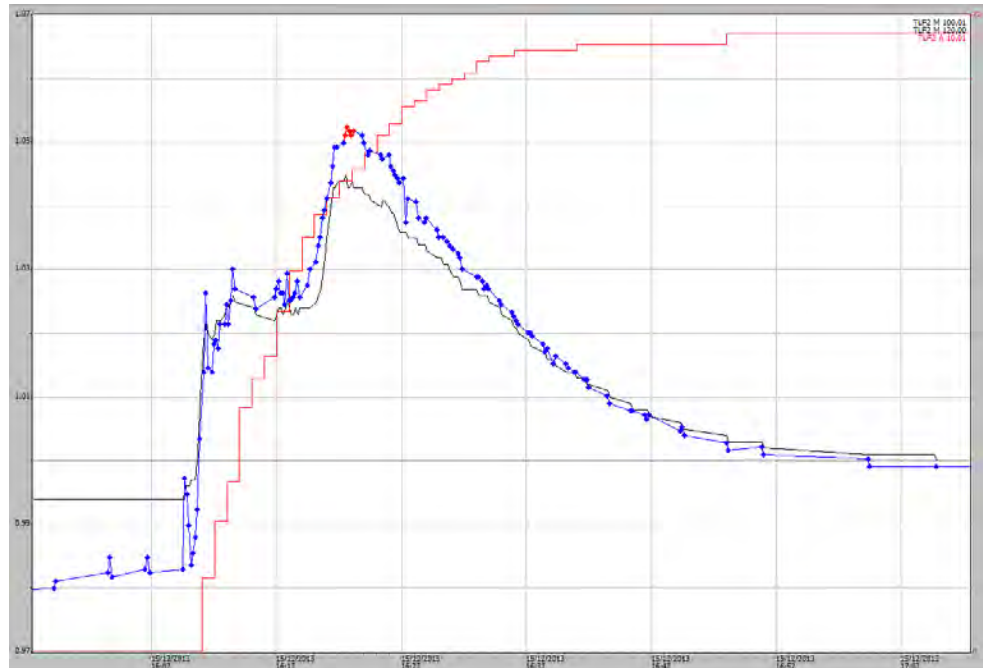
**Figure A3- 24** Event 31 hydrograph from 15 December 2013. Blue is the pressure transducer and black is the shaft-encoder.

The shaft encoder should have the higher values from the pressure transducer added.

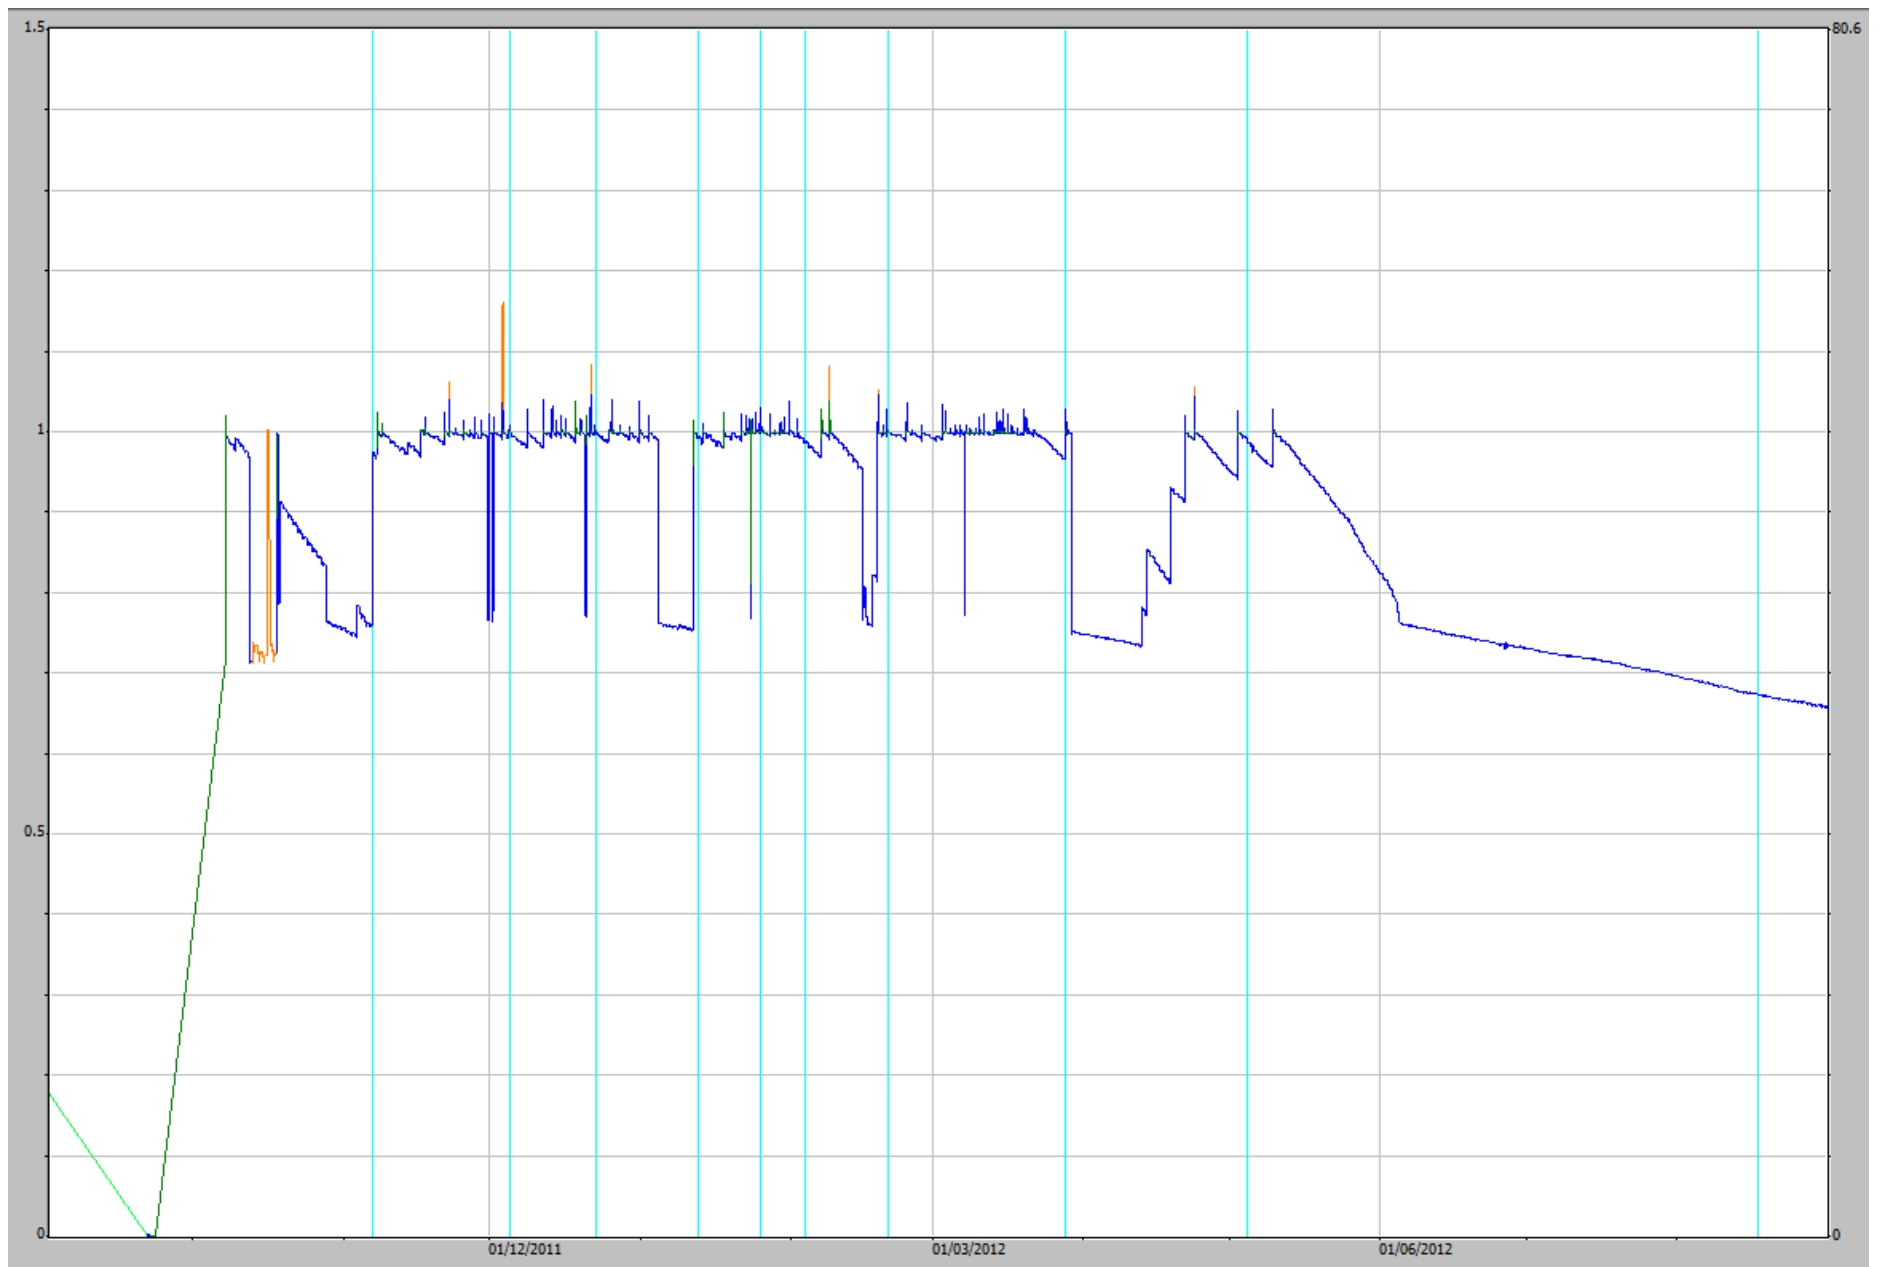
**Figure A4-3** Stage trace for the 2011–2012 water year. The different colours represent different quality codes and the low points are where the basins have been drained to collect the bedload.
