646

Ranger Trial Landform:
Hydrology – Rainfall &
runoff data for Erosion
Plot 1: 2009-2015

August 2016

Project number – RES-2009-011

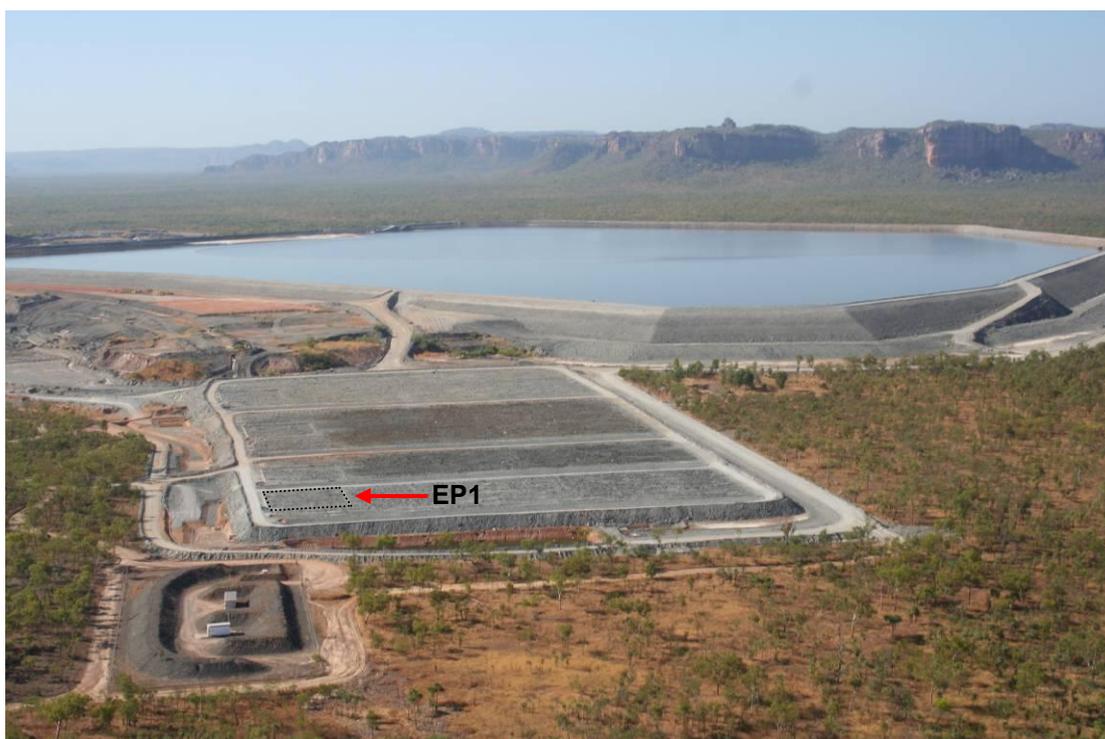
Figure 2. Aerial view of the completed Trial Landform located next to the Ranger mine Tailings Storage Facility. Erosion Plot 1 (EP1) is indicated by red arrow and black dotted outline.

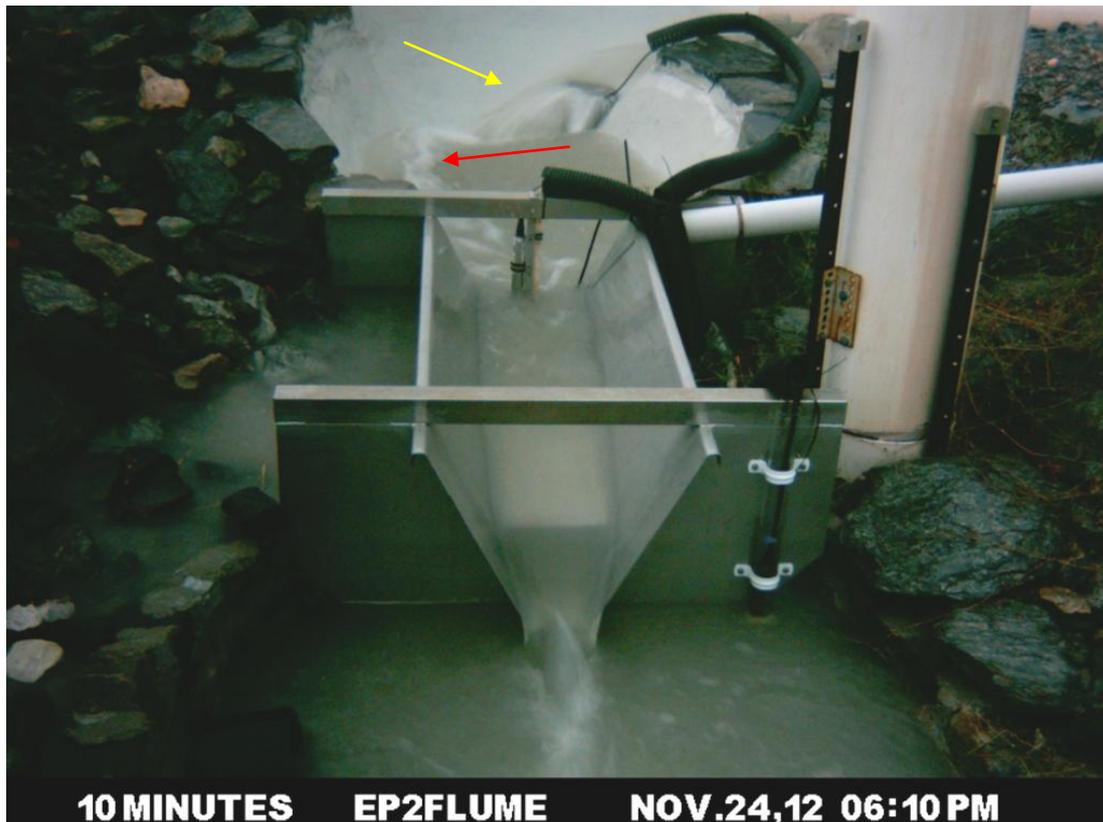
Figure 5 Example of water-level disturbance in the upstream stilling basin at EP2 during the peak of a high-flow event. The flow can be seen deflecting off the cage (yellow arrow) and can be seen rising up around the outside of the basin (red arrow).

Water-level measurements in stilling basins of some plots (e.g. EP2) have been found to be disrupted during high-flow events (Figure 5). This potential issue, which has required some manual correction at EP2 to stage trace flow peaks, was investigated for EP1. This was done by comparing the consistency of the EP1 shaft encoder and pressure transducer stage traces for the larger runoff events. The same higher flow events that were known to cause a problem at EP2 (Saynor et al. 2015) were also investigated at EP1.

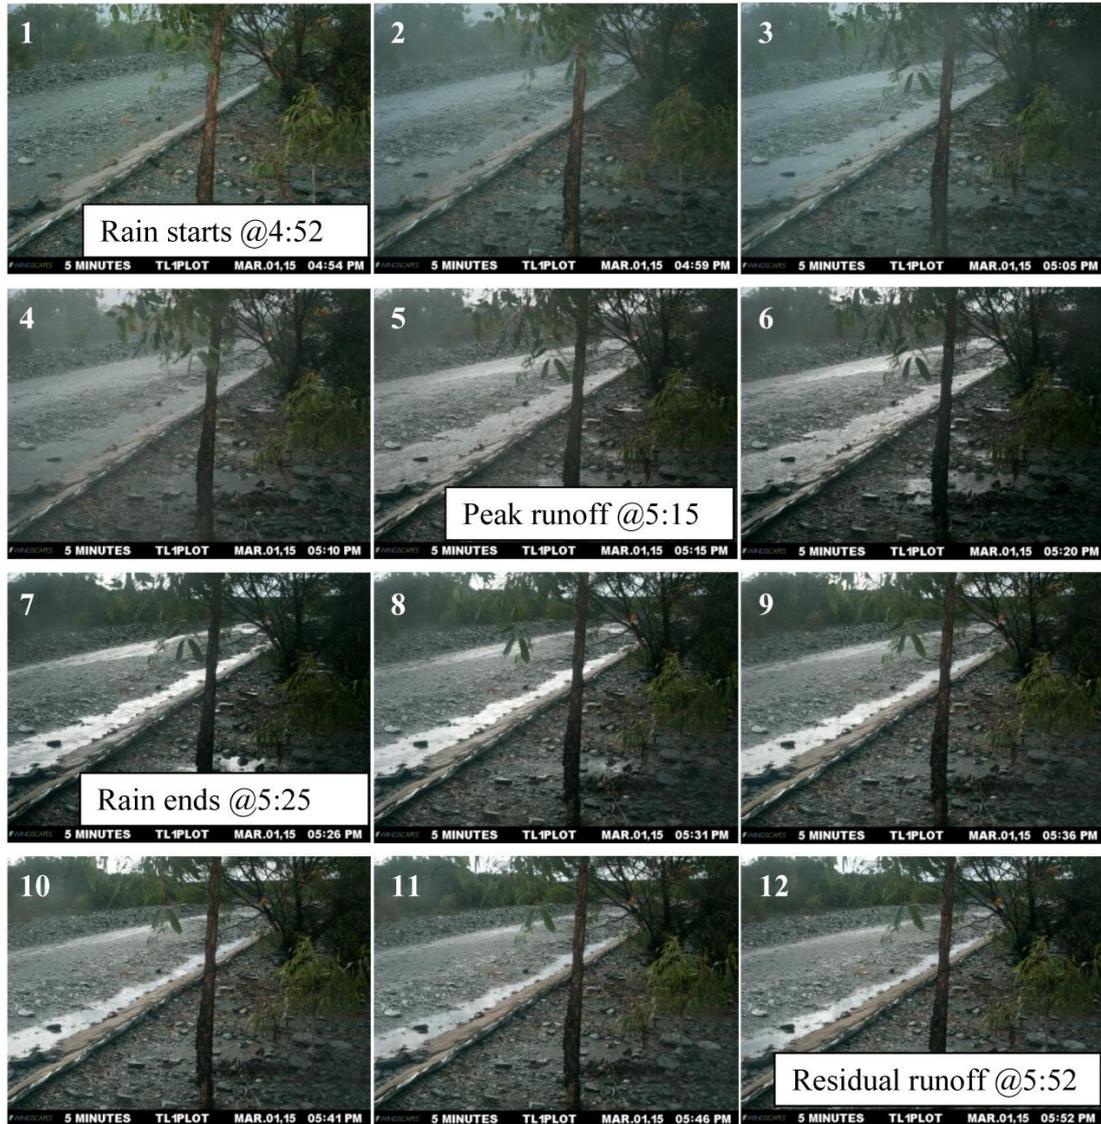
Figure 16 Five-minute interval photo sequence (1 to 12) showing flow along the roadside drain (to left of EP1) during a 22 mm rain event on 1-03-2015. Rain start and stop times are taken from the EP1 raingauge record illustrated in Figure 17.

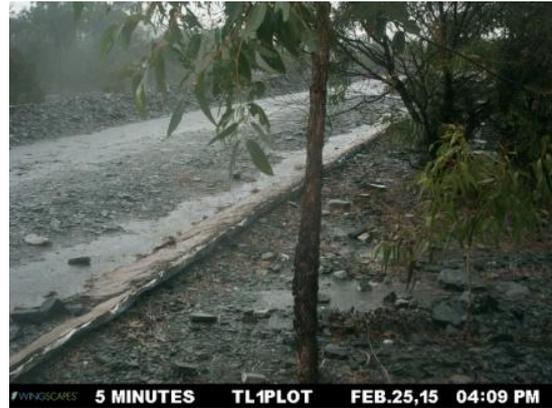
Figure A2-1 EP1 stage trace for a 5.6mm rain event from 4:06 to 4:07 pm on the 25-02-2015 and photo of the adjacent roadside drain showing peak runoff at 4:09 pm with no plot boundary overflow.

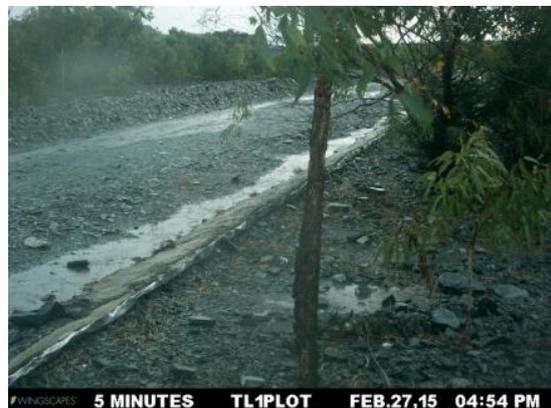
Figure A2-2 EP1 stage trace for a 5.9 mm rain event from 4:40 to 4:56 pm on the 27-02-2015 and photo of the adjacent roadside drain showing peak runoff at 4:54 pm with no plot boundary overflow.

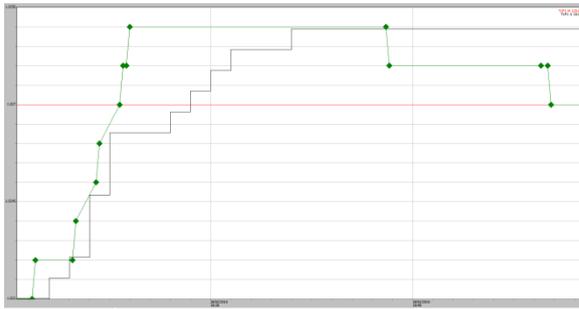
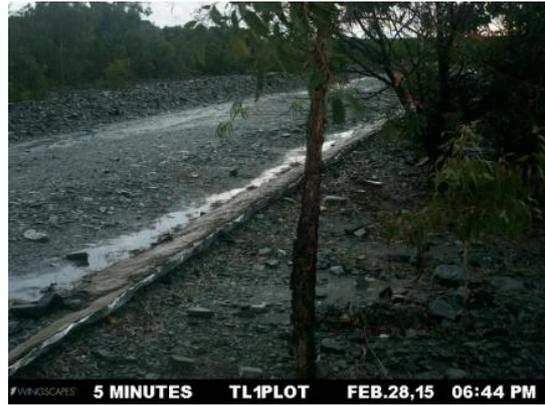
Figure A2-3 EP1 stage trace for a 2.6 mm rain event from 6:13 to 6:46 pm on the 28-02-2015 and photo of the adjacent roadside drain showing peak runoff at 6:44 pm with no plot boundary overflow.

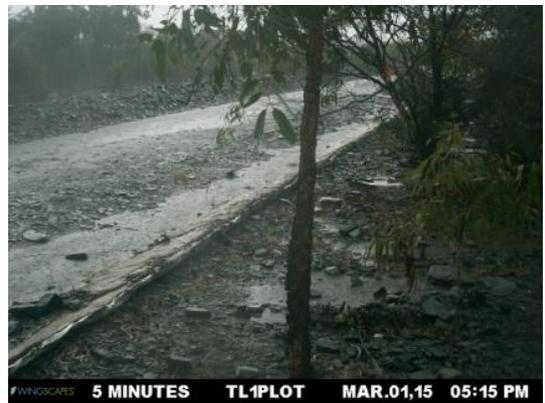
Figure A2-4 EP1 stage trace for a 22 mm rain event from 4:51 to 5:25 pm on the 01-03-2015 and photo of the adjacent roadside drain showing peak runoff at 5:15 pm with no plot boundary overflow. These events are also illustrated in Figures 16 and 17 of the results as the largest rainfall runoff event captured by camera.

Photos of roadside drainage were captured for six daytime rainfall events from the 25 February to 14 March, 2015. The largest of these events was 22 mm and the photos show flow along the road drain but no boundary overflow at peak flow (Figure 16, photo 5). Similarly, the EP1 runoff stage trace for this event showed no indication of boundary overflow (Figure 17). Events with ≥ 30 mm of rain (and where the stage trace indicated overflow) usually occurred at night and could not be captured by the camera were not represented in the photo data.

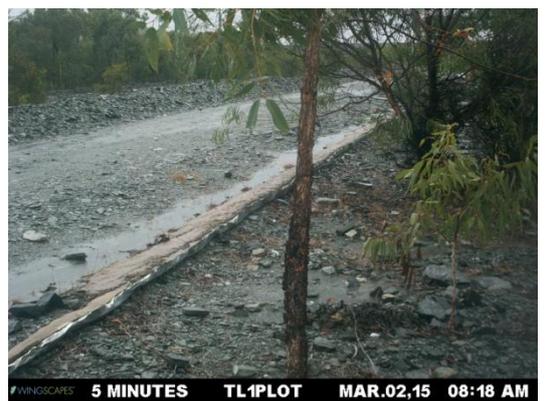
Figure A2-5 EP1 stage trace for a 2.6 mm rain event from 6:20 to 9:51 am on the 02-03-2015 and photo of the adjacent roadside drain showing peak runoff at 8:18 am with no plot boundary overflow.

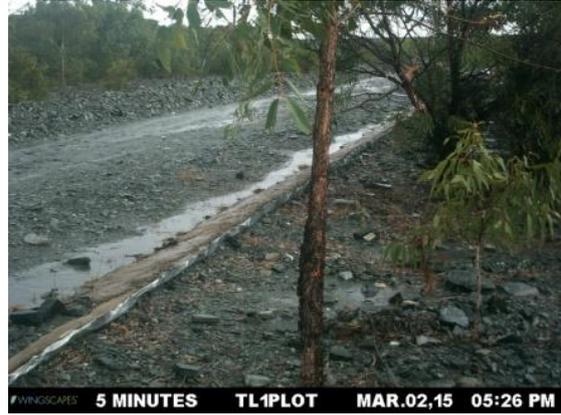
Figure A2-6 EP1 stage trace for a 1.6 mm rain event from 5:22 to 5:26 PM on the 02-03-2015 and photo of the adjacent roadside drain showing peak runoff at 5:26 PM with no plot boundary overflow.

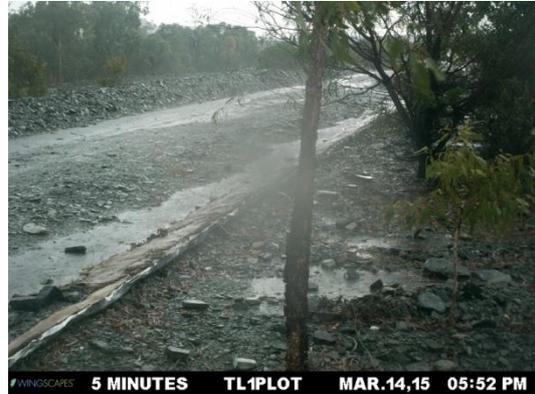
Figure A2-7 EP1 stage trace for a 1.6 mm rain event from 5:22 to 5:26 PM on the 14-03-2015 and photo of the adjacent roadside drain showing peak runoff at 5:26 PM with no plot boundary overflow.
