Lower Macquarie Catchment Temporary Water Monitoring 2017

Commonwealth of Australia, Department of Environment and Energy
and NSW Office of Environment and Heritage

This report was prepared by the Water Catchment and Protection Unit of WaterNSW to describe the installation of a temporary river gauging station and to provide the hydrological data recorded during an environmental flow delivery to the Barwon River from the Macquarie River during May to July 2017.

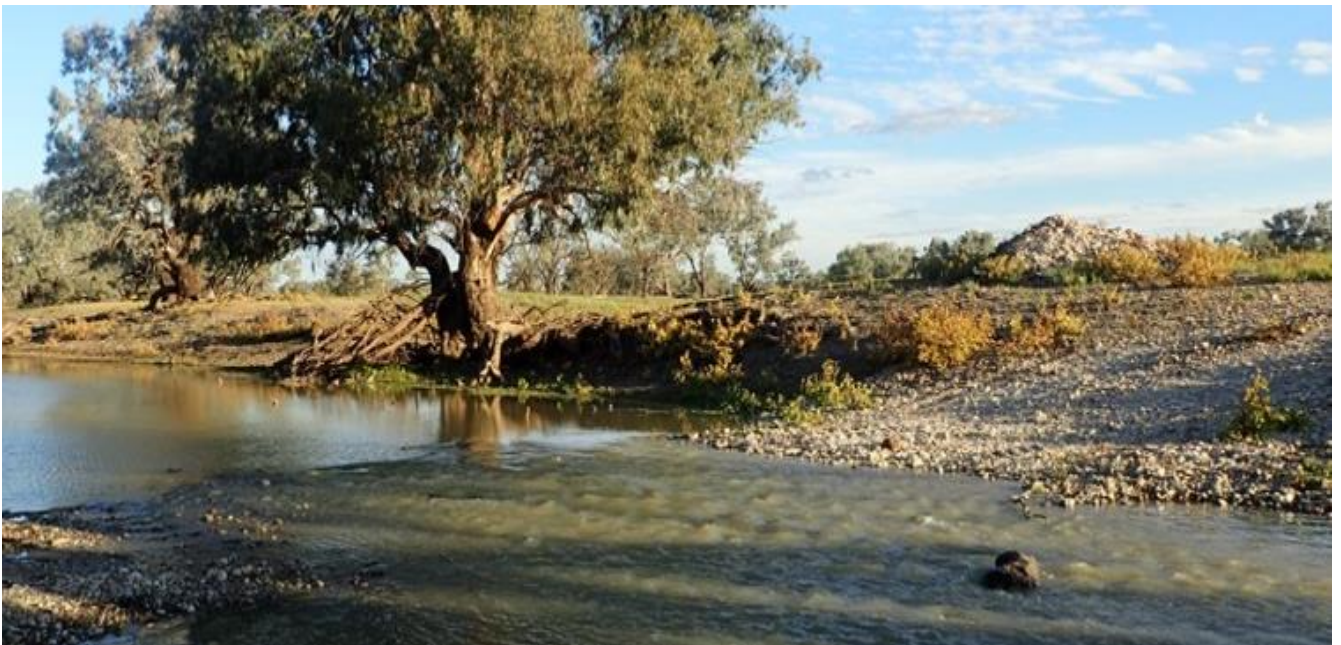
Figure 3: Gravel causeway at site 421907

The site was considered suitable due to the relatively stable controlling feature (gravel causeway) and upstream gauge pool. Site conditions would also allow for reliable gaugings at a range of flows. (Installed site reference 421907 Macquarie River @ Brewon Bridge).

- Site 421907 was considered the most suitable location for a temporary site installation and reliable gaugings at a range of levels.
- Site characteristics are a broad gravel causeway in a shallow U shaped channel forming a broad shallow gauge pool.

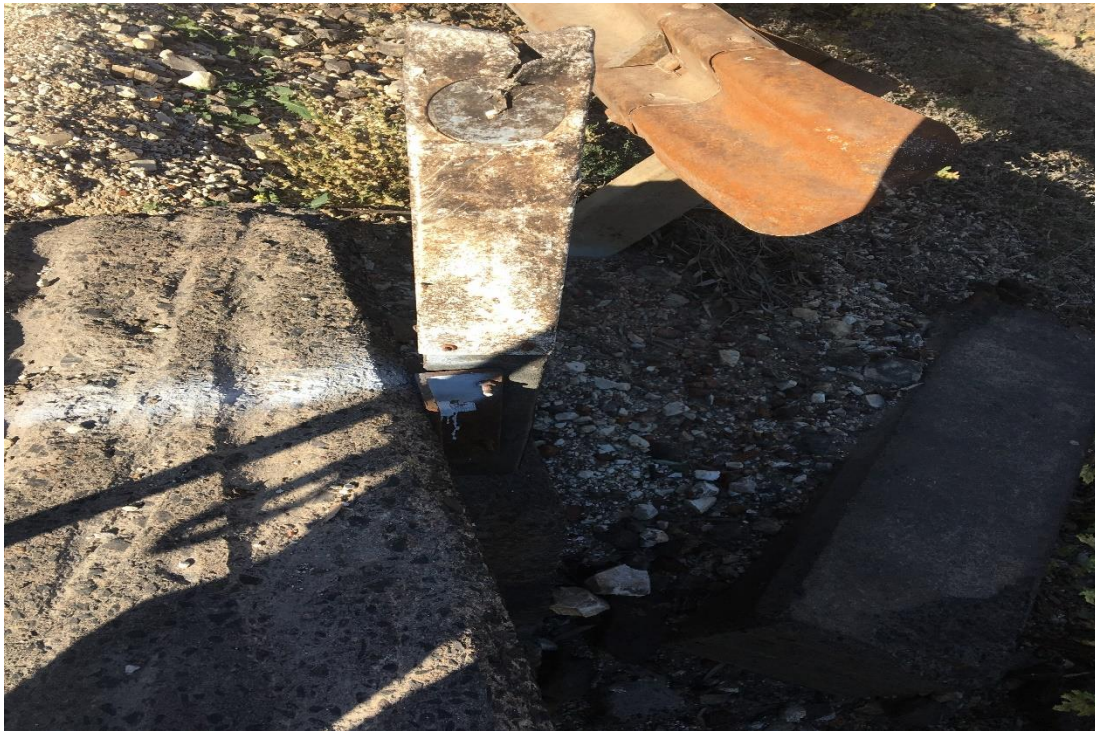
Figure 4: Benchmark on Brewon Bridge

A benchmark was created on the Brewon Bridge and given an assumed datum value of 10.000m. The benchmark is a bolt painted white, right bank, upstream side of Brewon Bridge (Figure 4).

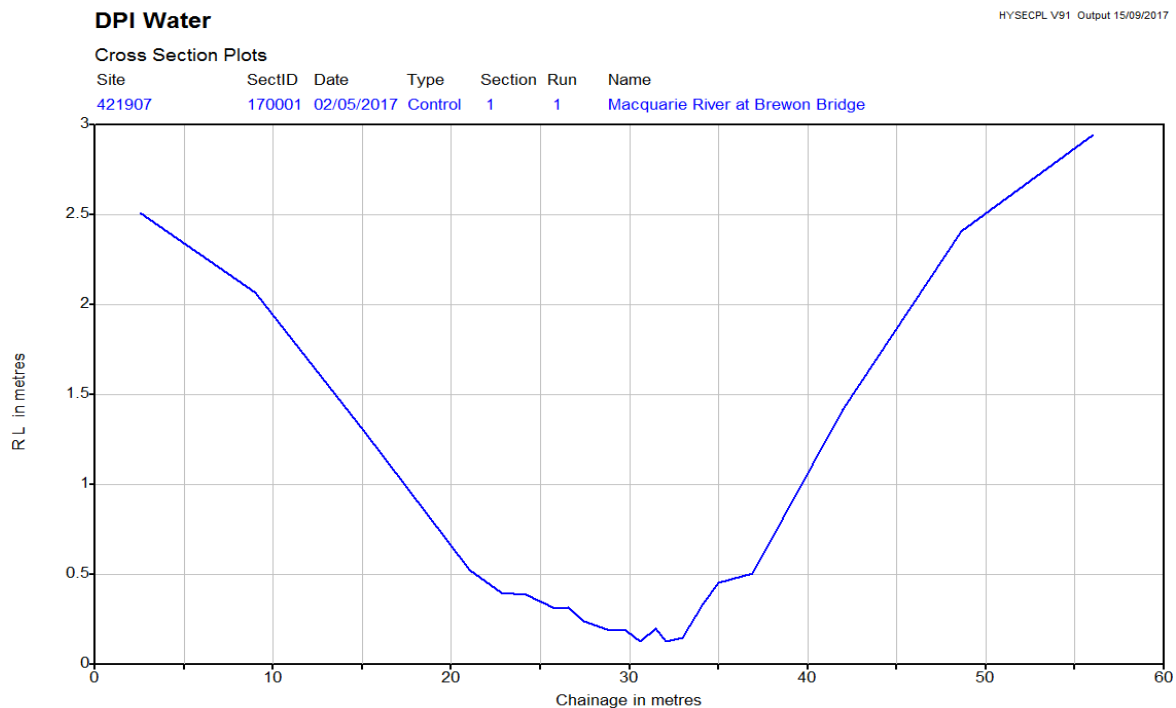
Plot 1: Cross section

A cross section (Plot 1) was carried out on the upstream side of the gravel causeway (the control) to define the channel shape, cross sectional area and cease to flow height, which will be used to develop the stage discharge relationship (rating table).

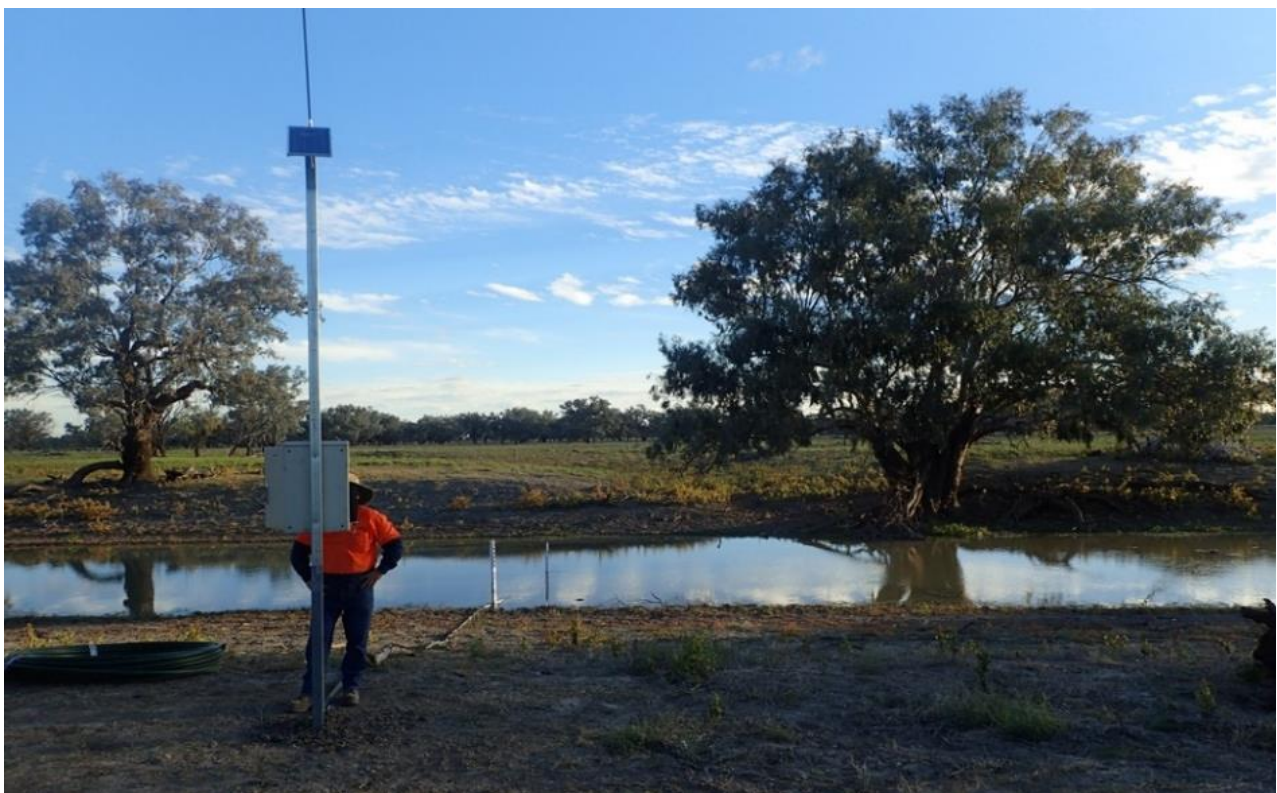
Figure 5: Instrument Shelter and Staff Gauges, Gauging Station 421907

Staff gauges were installed from 0 – 2m in the gauge pool upstream of the gravel causeway. Gauge zero was set at 6.777m (ass. Datum) and the cease to flow value was measured at 6.902m (ass. Datum) which equals 0.125m staff gauge level. Instrument shelter and orifice line were installed in line with staff gauges. (Figure 5)

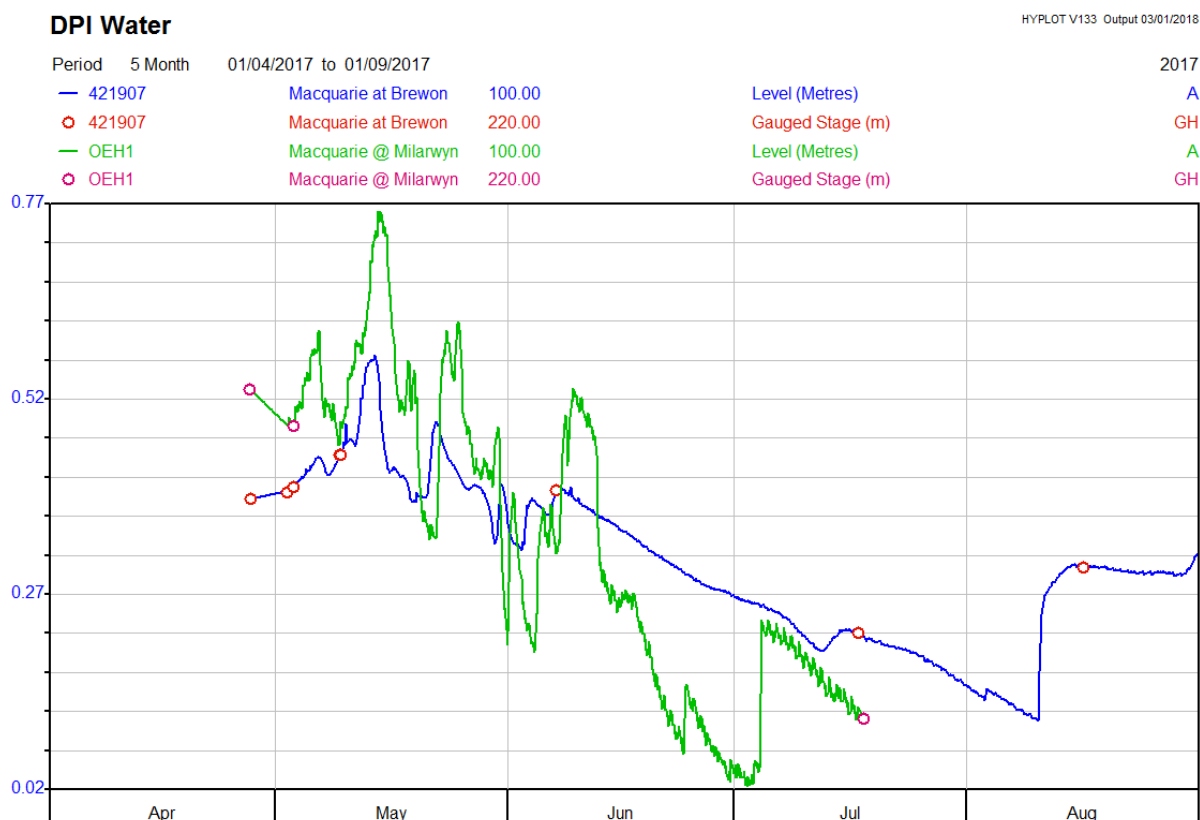
Plot 2: Level and Gauging plot for gauging stations 421907 and OEH1

Level data for sites 421907 and OEH1 (Plot 2) indicate that there was pumping activity during May and some pumping which affected the level at OEH1 in June as the environmental flow receded. It is not possible to determine the location of this pumping.

Temporary loggers and a staff gauges were also installed at gauging stations OEH 1 and OEH 2 to record level data during the environmental flow period (Figure 2 and Table 1). Level data for gauging station OEH 1 is presented in the Plot 2. The logger at OEH 2 could not be located at the end of the flow period. The reason for the removal or loss of these items is unknown.

A number of gaugings were performed at 421907 when the gauging station was established in May 2017. Further gaugings were undertaken in June, July and August to assist in the development of the discharge rating. Gaugings were also performed at site OEH 1 at the beginning and end of the project period. Plot 2 shows the distribution of gaugings against the level trace throughout the flow period for gauging stations 421907 and OEH1.

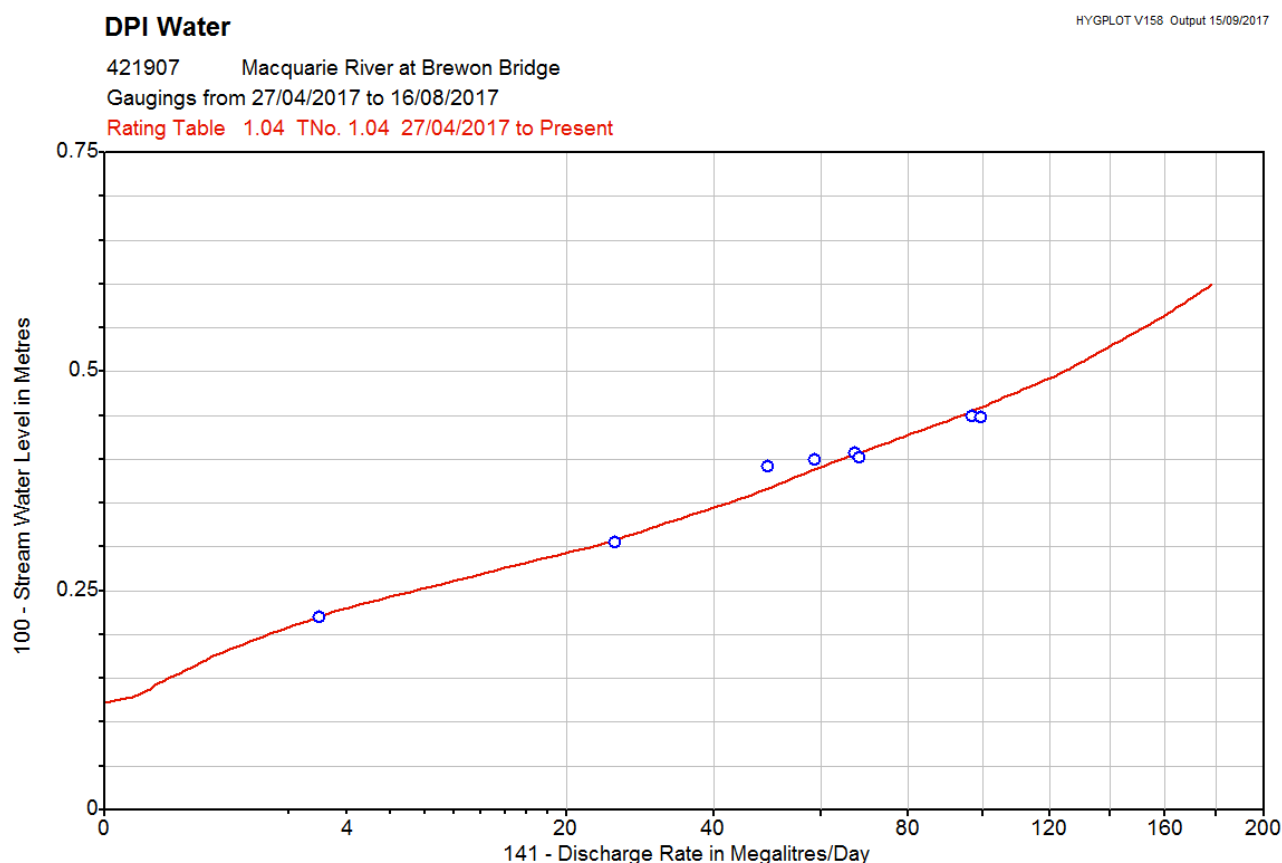
Plot 3: 421907 Discharge rating curve with gaugings plotted

Table 3: Discharge Rating table 1.04 Gauge Height v Discharge Rate (ML/d)

This rating table relates only to the gauge pool at 421907 and it is not possible to estimate depths in the Macquarie River upstream or downstream of this point based on this rating table alone.

A rating table RT1.00 was created on 11/5/17 using the results of a number of gaugings already conducted and the measured CTF value of 0.125m. A Theoretical rating point was created at 0.500m using the non-standard section control formulae $Q=CdH^2$ for a parabolic shaped section control. This was based on the Cd (coefficient of discharge) calculated from previous gauging's.

Rating RT1.01 was created on 21/6/17 using a straight-line log extension to 0.600m, which was above the highest level recorded during the flow event.

RT1.02 was created on 21/6/17 from an additional gauging on 7/6/17 and adjustments made above 100ML/d through a peak correlation method with upstream sites 421135 and 421012 during the same event.

RT1.03 was created on 25/7/17 after a low flow gauging on 17/7/17. This resulted in adjustments below 60ML/d.

RT1.04 was created on 21/8/17 after a gauging on 16/8/17. This resulted in adjustments to the rating table up to 100ML/d

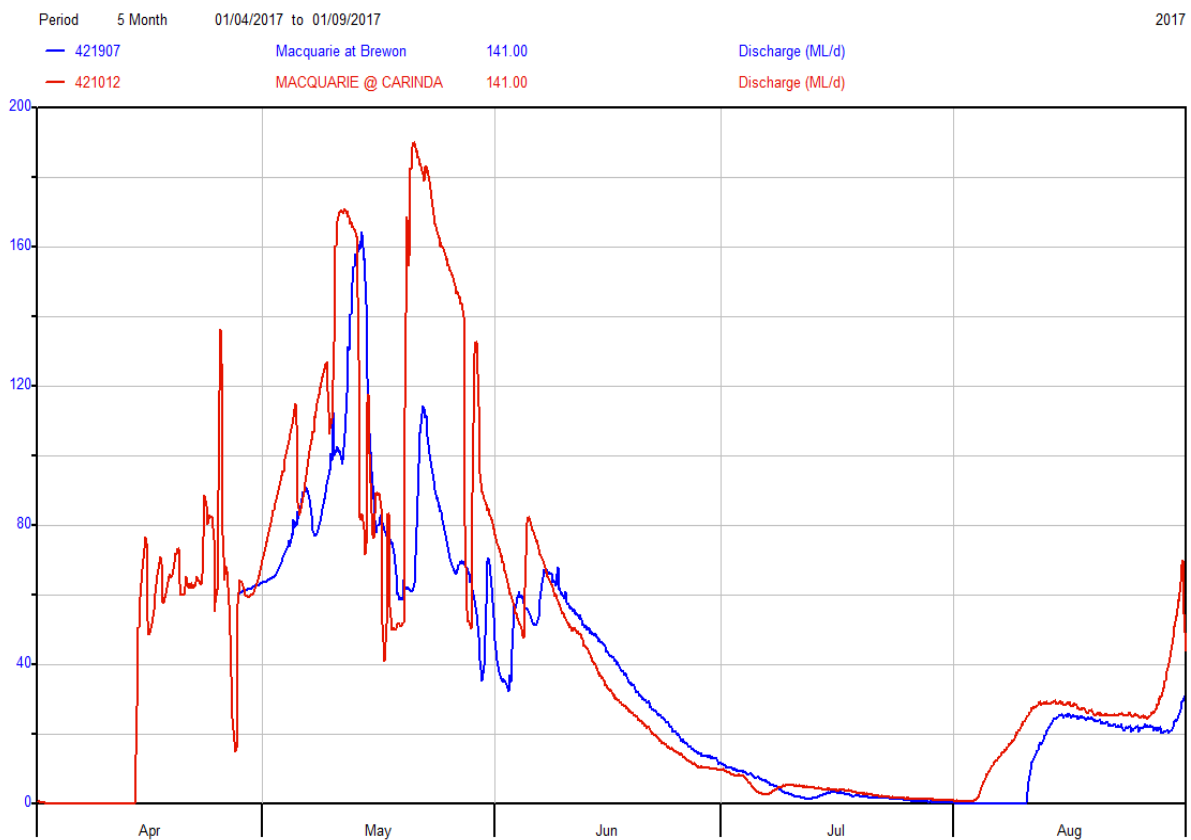
Plot 4: Discharge traces for stations 421907 Macquarie River @ Brewon Bridge and the upstream station 421012 Macquarie River @ Carinda.

The discharge data for sites 421012 Macquarie River @ Carinda and 421907 Macquarie River @ Brewon Bridge (Plot 4) indicates that there was pumping activity upstream of 421907, affecting flows at the monitoring point during May. Significant differences in discharge rates of up to 70ML/d were recorded between sites 421012 and 421907 during this time. It is not possible to determine the effect this has had on water depth throughout this section of the Macquarie River.

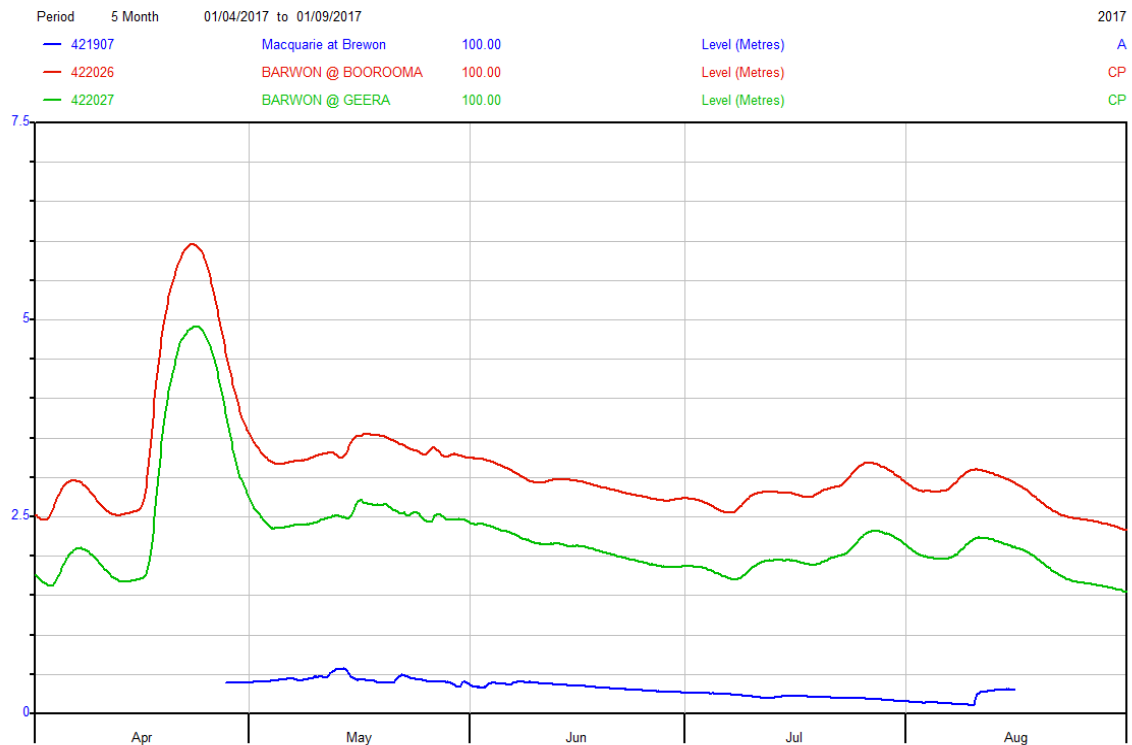
Plot 5: Level traces for stations 421907 on the Macquarie River and stations 422026 and 422027 on the Barwon River

The discharge plots for sites 422026 Barwon River @ Boorooma and 422027 Barwon River @ Geera (Plot 5 and 6) show there is an increase in flow downstream of the Macquarie River confluence at site 422027 during May and into June. This would indicate that the environmental flow in the Macquarie River reached the Barwon River in May during the recession of a significant flow event in the Barwon River during April. There doesn't appear to be any backwater effects evident on any of the level data recorded on the Macquarie River sites during the environmental flow in May.

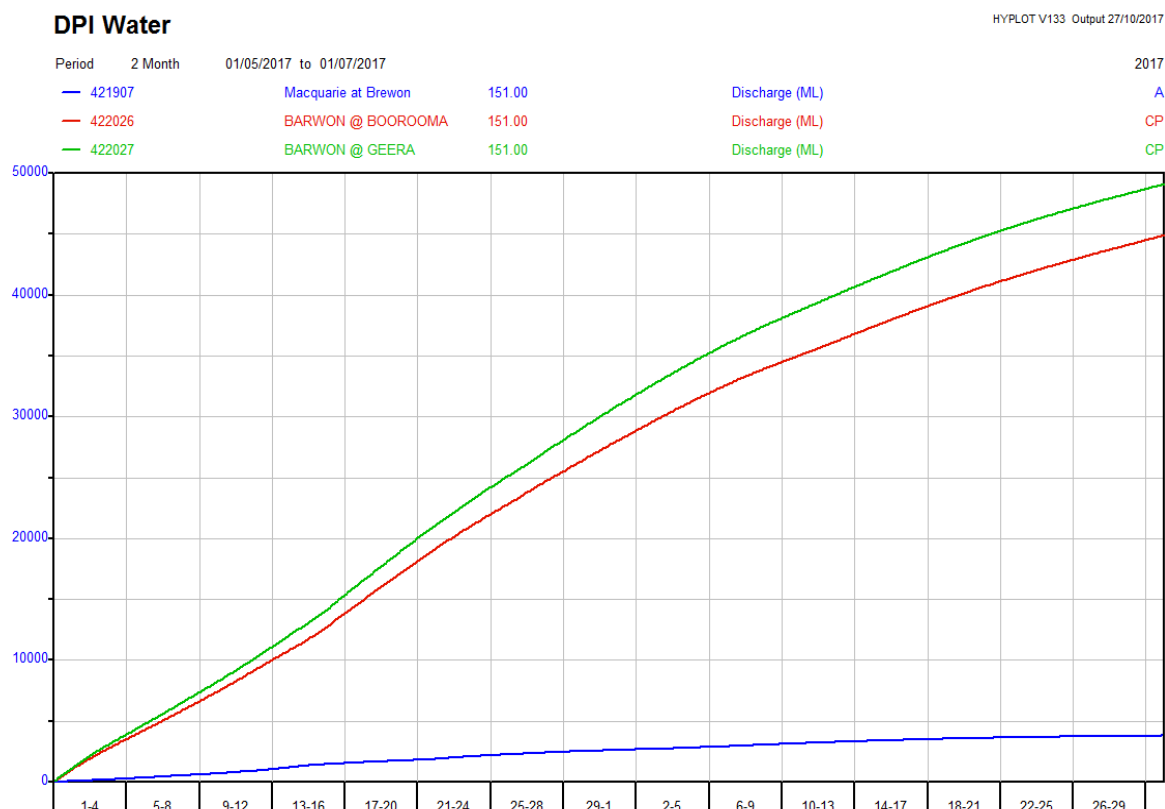
Plot 7: Cumulative Discharge for stations 421907 on the Macquarie River and stations 422026 and 422027 on the Barwon River

The cumulative discharge totals for site 421907 (Plot 7) indicates there was an approximate total of 4000ML of environmental water flowing in the lower Macquarie River during May and June. This correlates reasonably well with the cumulative discharge totals for site 422026 and 422027 which indicate approximately 45000ML and 49000ML at these sites on the Barwon River, respectively.

It should be noted that care should be taken when using this data as the approximate total of 4000ML from the Macquarie River is within the range of potential measurement error for the sites on the Barwon River. There may be other factors such as natural system losses, pumping activity on the Barwon and instrument accuracy tolerances which are not accounted for in this evaluation.

- The environmental flow from the Macquarie River was evident as approximately 4000ML inflow to the Barwon River during May and June, as per the aims of the monitoring project.
