Maximising Water Delivery for Regent Parrot Outcomes

Water for the Environment Program

Document Title: Maximising Water Delivery for Regent Parrots

Date: March 2021

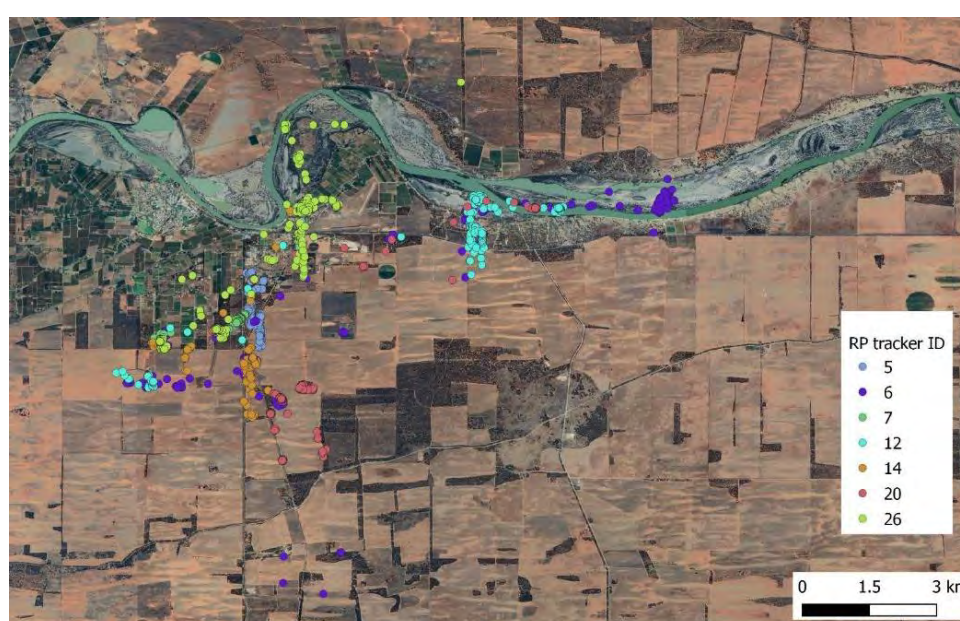
Figure 2.4: The GPS locations of all data loggers recorded during the study into the landscape use by Regent Parrots in the breeding season 2016 (Ireland 2020).

Study 1 - A study in the Waikerie area of South Australia placed GPS data loggers on eight Regent Parrots (five females and three males) aged between one+ and two+ years. The purpose of this study was to identify habitat gaps. The study was conducted for a three week period in 2016 and greatly enhanced the understanding of how Regent Parrots utilise the landscape during the breeding season. Ten land cover types were identified using South Australian GIS Land Cover Layer. The most frequently used habitat types were Mallee (45%), followed by dryland agriculture (19%), Eucalypt floodplain woodland (13%), Floodplain Chenopod Shrubland (9%) and orchards / vineyards (6%). Ireland (2020) identified that Woody Native Vegetation and Orchards / Vineyards are being used in a greater proportion than what is available in the landscape. Regent Parrots are using non-woody Native Vegetation slightly less than is available in the landscape and using dryland agriculture much less than is available to them (Ireland 2020). The GPS locations of all data loggers recorded during the study are presented in Figure 2.4.

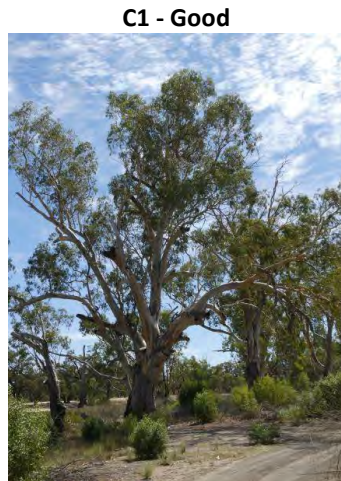
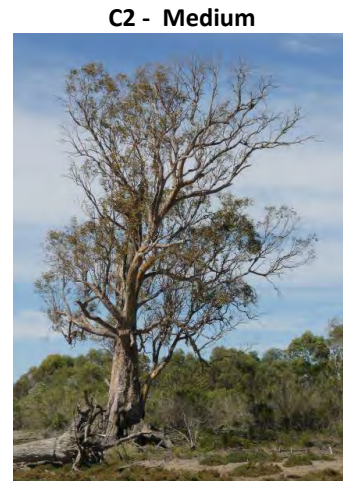
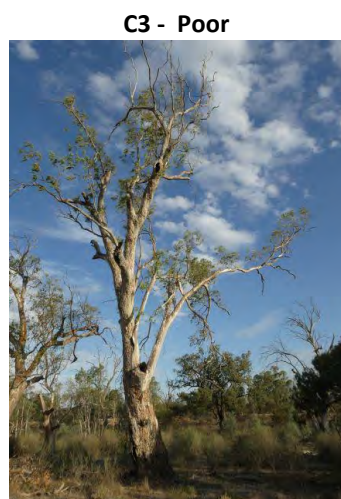
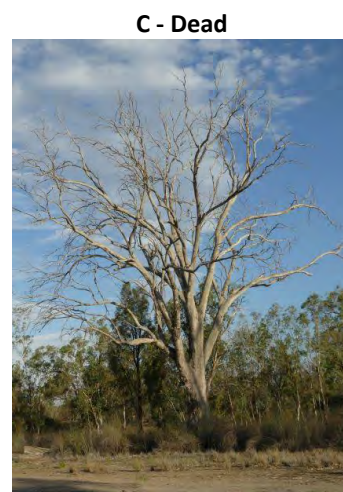
Figure 3.1: River Red Gum Canopy Condition Class. Top left: C1 Good %75 canopy cover, Top right: C2 Medium %75-40% canopy cover, Bottom left: C2 Poor <40% canopy cover, Bottom right: C4 Dead 0% canopy cover.

Canopy condition broadly means how stressed a tree is, without assigning the probable cause. In practice, almost all recent reports of River Red Gum condition have been in the context of acute water stress due to lack of flooding and compounded by falling water tables, saline groundwater, high temperatures and below average rainfall (Roberts and Marston 2011). Examples of each canopy condition class are shown below in Table 3-1 and Figure 3.1.

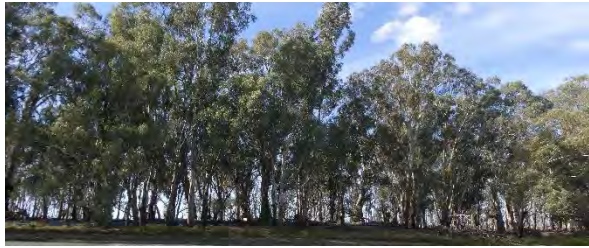
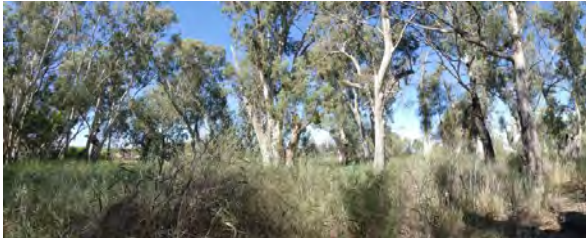
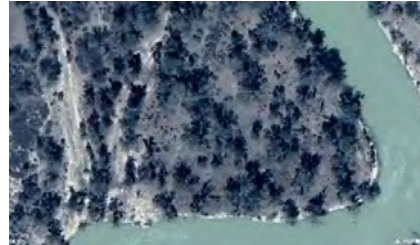
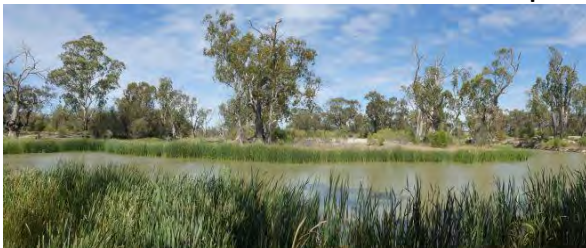
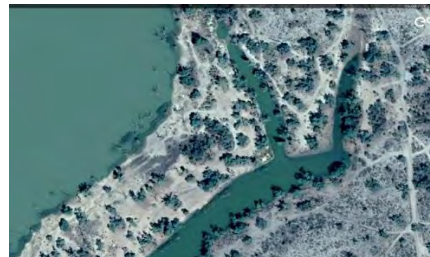
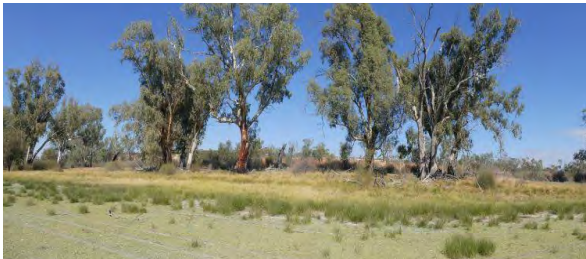
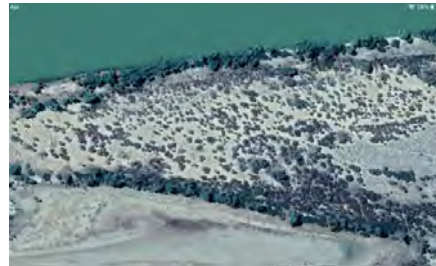
Density Class	Description
D1 – Forest	Forest consists of high numbers of trees with canopies touching to open canopy.
D2 – Open Woodland	Open Woodland consists of areas with fewer and more scattered trees than Closed Woodland.
D3 – Sparse Woodland	Sparse Woodland consist of areas with isolated trees.
D4 – Linear Woodland	Linear Woodland consist of a line of trees along the main river channel, creeks or the edge of a permanent or temporary wetland.

Figure 3.2: Examples of River Red Gum density class with photograph and aerial imagery.

River Red Gum are the dominant tree species in frequently flooded floodplain forest and/or woodland. They are co-dominant in less frequently flooded areas such as higher parts of floodplains and along creek lines in semi-arid areas. Vegetation types with River Red Gum as the dominant or characteristic species show considerable diversity in structure and floristic diversity (Roberts and Marston, 2011). Examples of each density class are shown below in Table 3-2 and Figure 3.2

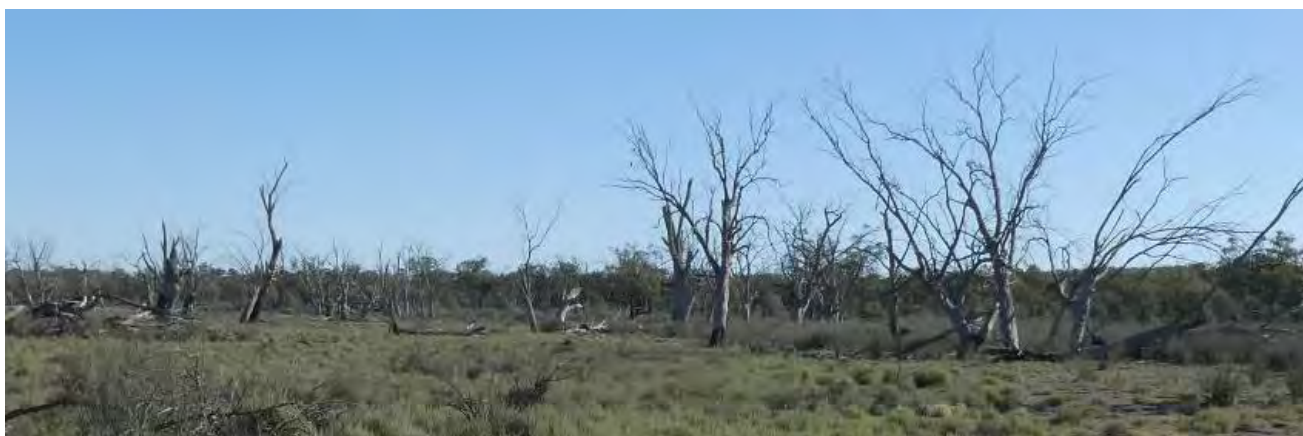
Figure 3.6: During the 2003 whole of river Regent Parrot nest survey, six nests were found in the north east corner of Taylor Flat. At the time of the survey the above trees were alive. (Photo M. Harper 2020).

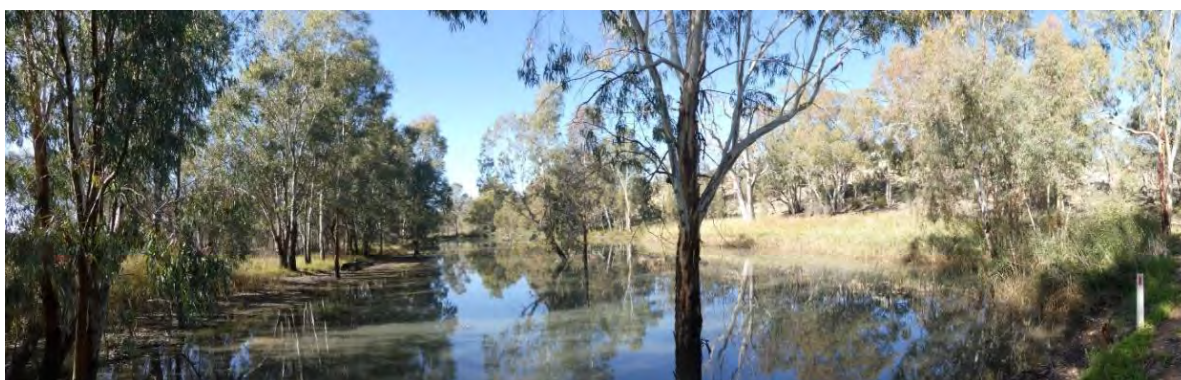
Figure 3.7: Draw down phase of water for the environment site East Morgan. Photo M. Harper.

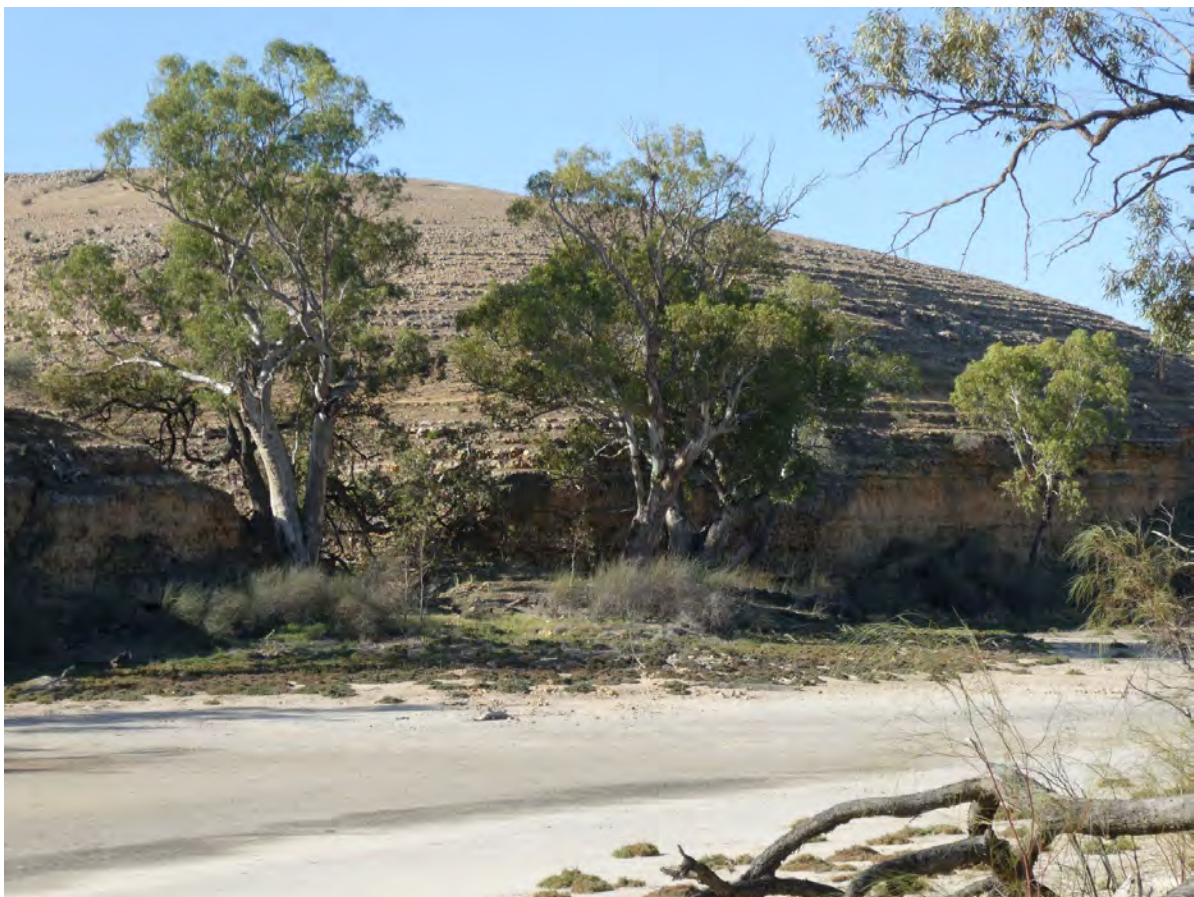
Figure 3.9: Fine line between salinized soils and healthy River Red Gums Yarra Creek. Photo M Harper.

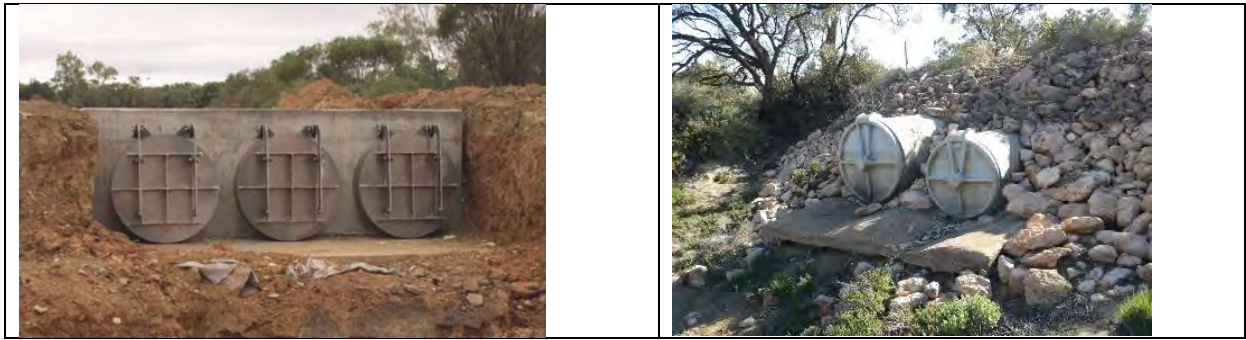
Figure 4.5: Sample of metal and fibreglass hinged flap gates (Photos: B Rampano and M Harper).

The greater the weight of the gate the more energy (head pressure) required to open it and keep it open. This could be a limitation during small to medium natural flood events.

Lighter or more buoyant construction materials can be used to increase the opening aperture of gates within systems operating under small hydraulic pressure. Adequate clearance is required for the gate to swing. Fibreglass gates with neoprene seal are a suitable design for River Murray environmental watering sites.

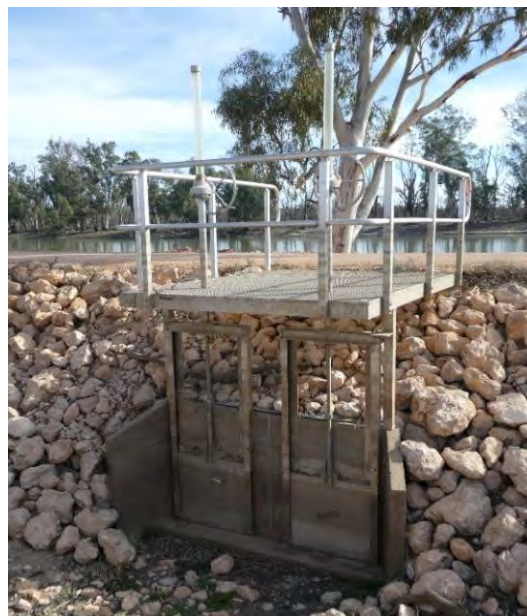
Figure 4.6: Penstock Vertical Winch (Photos: M Harper).

- Can be expensive.
- Friction can develop in the tracks whilst opening or closing gates.
- Vertical winching mechanisms may result in the gate jamming open during outflow.
This can be overcome by use of a worm drive mechanism.
- Vertical space required above culvert for actuation system.

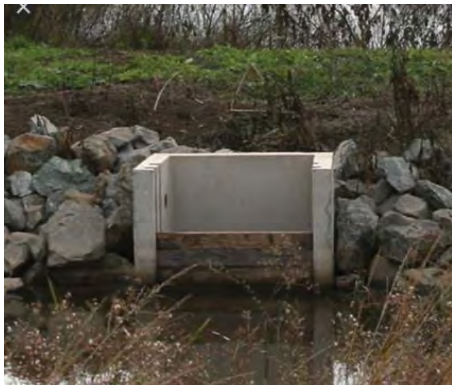
Figure 4.7: Wooden stop logs fitted to a drop board culvert (Photo: M Harper).

- Can result in some leakage but depends on design.
- Boards may be difficult to remove under significant head pressure
- Manually operated.
- Depending on design can be easily tampered with or vandalised which can result in the unauthorised lowering of the operational invert.
- May require additional OH&S infrastructure for safe working access.
- Fish passage is only possible when water level becomes high enough to overtop the stop logs / drop boards or when the boards have been removed. During all other events, a barrier to passage exists.

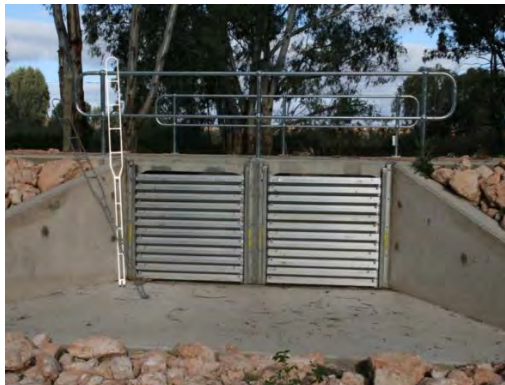
Figure 4.8: Segmented stop boards fitted to a box culvert road access structure (Photo: M Harper).

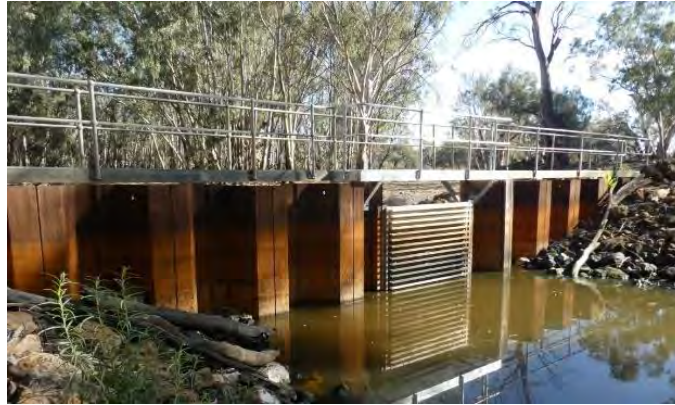
Figure 4.9: Metal Sheet Piling structure fitted with segmented Stop boards. (Photo: M Harper).

- Not adjustable without modification of original installation.
- Depending on the material used to construct the sheet piling often results in some leakage.

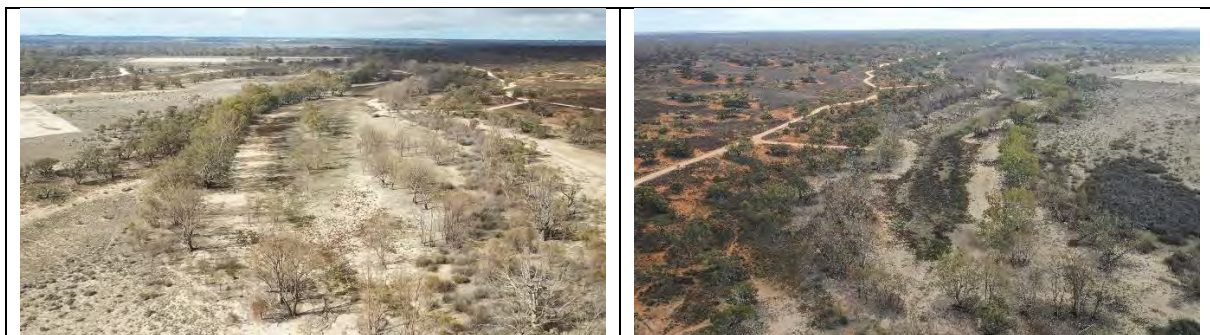
Figure 4.10: Photographs taken by a drone over a stressed wetland site. All tree Canopy Condition Classes can be identified as well as the health variation within a patch of Lignum (left photo). (Photos: M Fauser).

Drones have great potential to be a useful tool to monitor the health of floodplain vegetation especially woody vegetation with the use of limited resources (Figure 6.8). By establishing way points, a drone flight is repeatable, thus enabling long-term monitoring of precise locations. Real time aerial views of the site provides a quick overview of a site's vegetation health condition and can guide a person to a site at risk to conduct an on-ground site inspection.

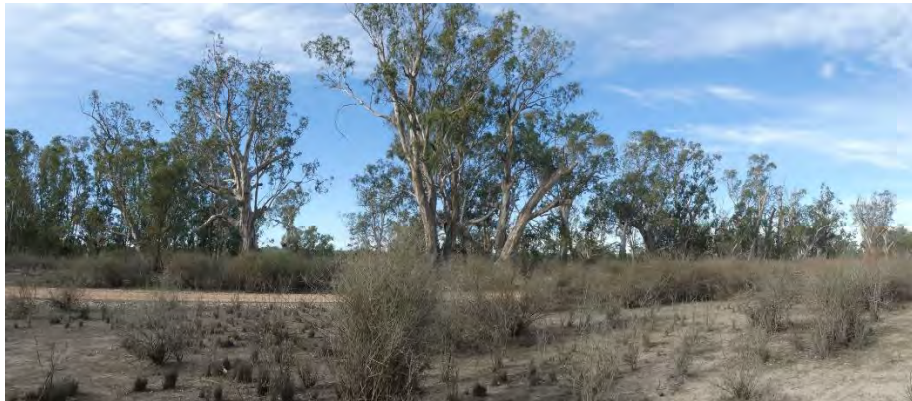
Yatko Lagoon (Sugar Shack Creek Down Stream)

Geomorphic Category - Main Channel Edge

Regent Parrot Nesting Quality River Red Gum River Red Gum Density - Linear and Open Woodland River Red Gum Health Rating – Stressed (Level 3)	Understory Dominant Species and Health Healthy Lignum, desiccated Tussock Grass
--	---

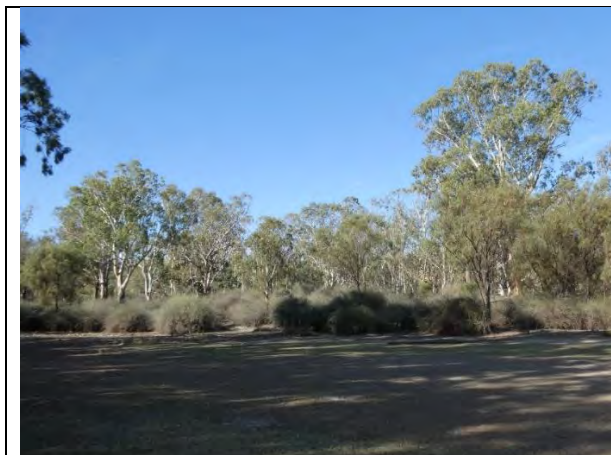
Yatko Creek (Sugar Shack Creek Upstream)

Geomorphic Category – Distribution Channel Edge and Main Channel Edge

Regent Parrot Nesting Quality River Red Gum River Red Gum Density - Linear Woodland River Red Gum Health Rating - Healthy (Level 5)	Understory Dominant Species and Health Healthy Lignum, River Red Gum saplings. Cooba, adult and saplings. Spiny Sedge, Leafless Cherry.
--	---

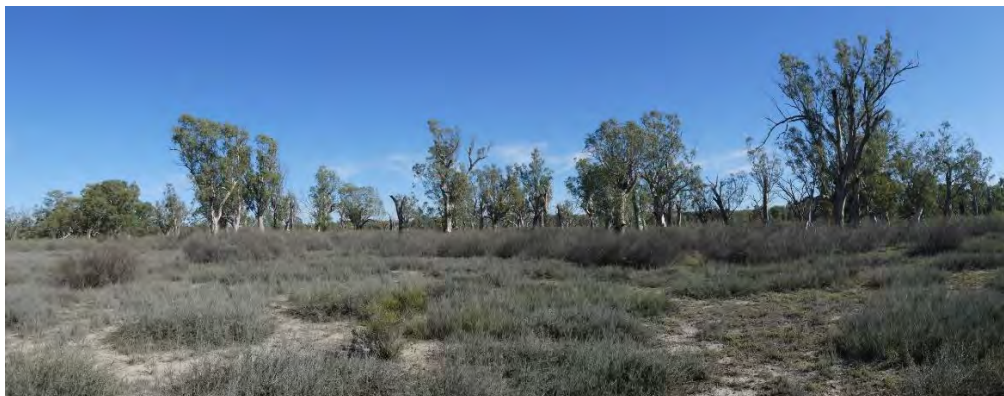
Yarramundi

Geomorphic Category – Interconnecting Depositional Basin Edge

Regent Parrot Nesting Quality River Red Gum
 River Red Gum Density – Sparse Woodland
 River Red Gum Health Rating - Healthy (Level 4)

Understory Dominant Species and Health
 Healthy dense Lignum, River Red Gum sapling,
 Saltbush spp., Creeping Saltbush, Pale Poverty
 Bush, Spiny Sedge, Grey Germander.

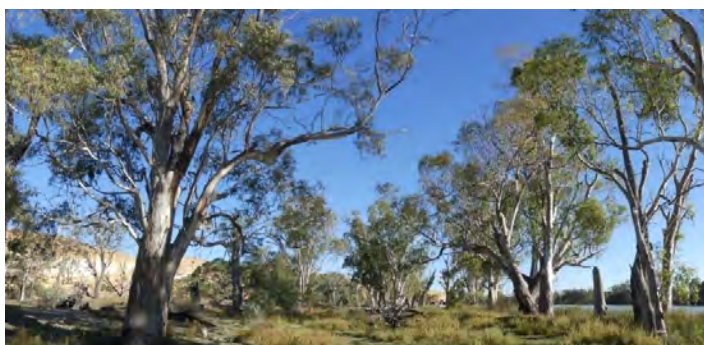
McBean Pound North

Geomorphic Category – Main Channel Edge

Regent Parrot Nesting Quality River Red Gum
 River Red Gum Density – Linear Woodland
 River Red Gum Health Rating - Healthy (Level 4)

Understory Dominant Species and Health
 Healthy River Red Gum seedlings and poles
 /Smooth Heliotrope/Blue Rod/Spiny
 Sedge/Stinkwort/Star Thistle/odd
 Lignum/Yanga Bush

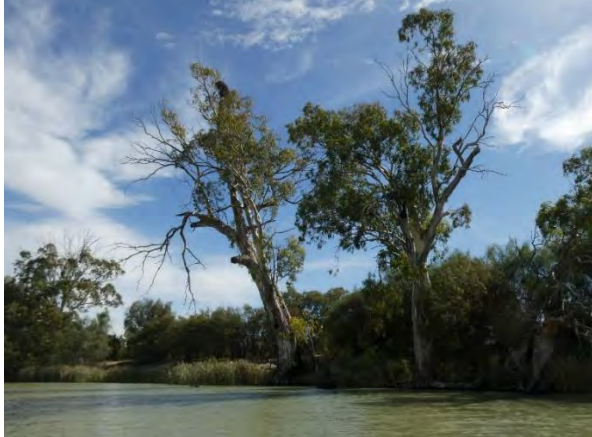
Wombat Hollow (Murbpook)

Geomorphic Category – Main Channel Edge

<p>Regent Parrot Nesting Quality River Red Gum River Red Gum Density – Sparse Linear River Red Gum Health Rating - Healthy (Level 4)</p> <p>Understory Dominant Species and Health Healthy Cooba/Prickly Bottlebrush /Western Boobialla/Floodplain Saltbush/Smooth Heliotrope/Ruby Saltbush/Yanga Bush</p>
---	---

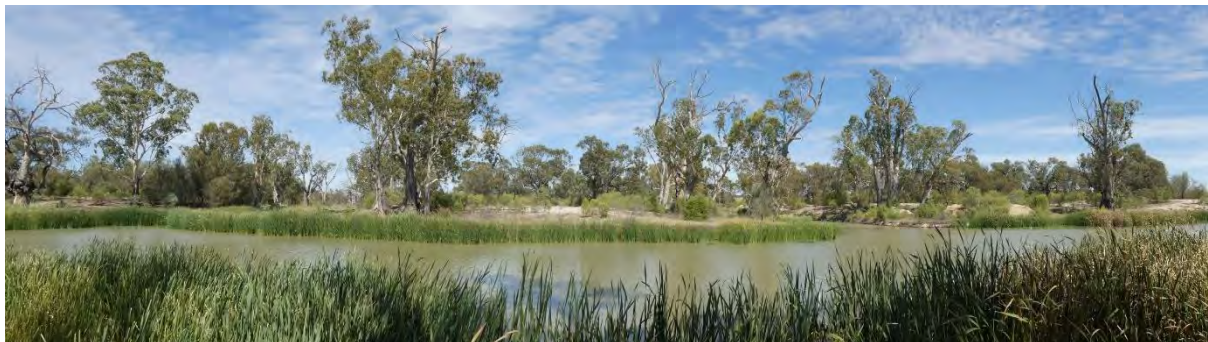
Murbko Flat

Geomorphic Category – Distribution Channel Edge

<p>Regent Parrot Nesting Quality River Red Gum River Red Gum Density – Sparse Woodland River Red Gum Health Rating - Stressed (Level 3)</p>	<p>Understory Dominant Species and Health Healthy Cooba/Western Boobialla/Lignum /River Red Gum seedlings /Spiny Sedge/Black Box seedlings/ Stinkwort/Smooth Heliotrope /Creeping Saltbush</p>
--	--

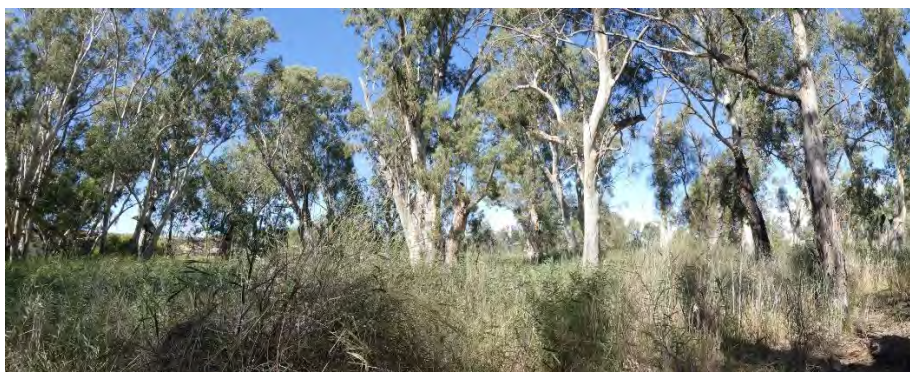
Pelican Point

Geomorphic Category – Main Channel Edge

Regent Parrot Nesting Quality River Red Gum River Red Gum Density – Forest River Red Gum Health Rating - Healthy (Level 4)	Understory Dominant Species and Health Healthy Phragmites/Lignum/Spiny Sedge/Smooth Heliotrope
---	---

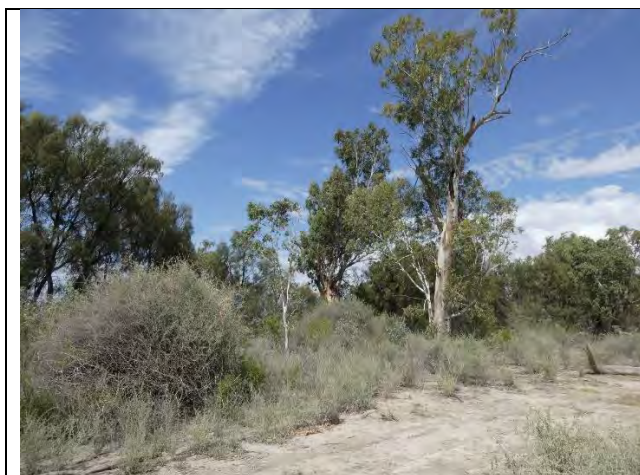
Scott Creek Lagoon (Brenda Park)

Geomorphic Category – Deflation Basin Edge

Regent Parrot Nesting Quality River Red Gum River Red Gum Density – Sparse Linear Woodland River Red Gum Health Rating - Healthy (Level 5) Understory Dominant Species and Health Healthy Cooba, Lignum, Creeping Saltbush, Pale-Poverty Bush, Western Boobialla, Red Gum seedlings, Nitre Bush.
--

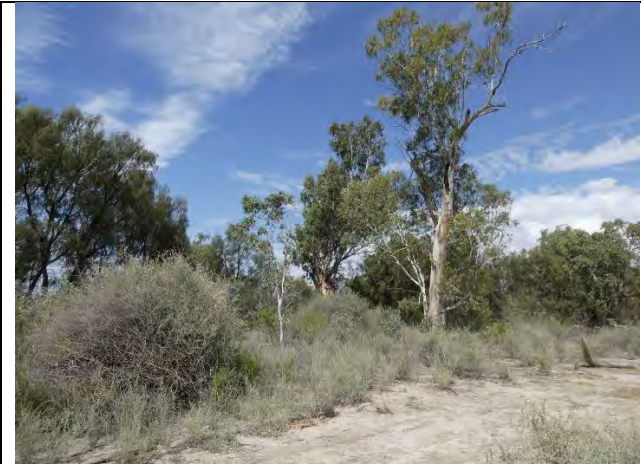
Mulyoulpko (Brenda Park)

Geomorphic Category – Deflation Basin Edge

<p>Regent Parrot Nesting Quality River Red Gum River Red Gum Density – Sparse Linear Woodland River Red Gum Health Rating - Healthy (Level 4)</p> <p>Understory Dominant Species and Health Healthy Cooba, Lignum, Red Gum saplings, Yanga Bush, Ruby Saltbush, Lagoon Saltbush</p>
---	--

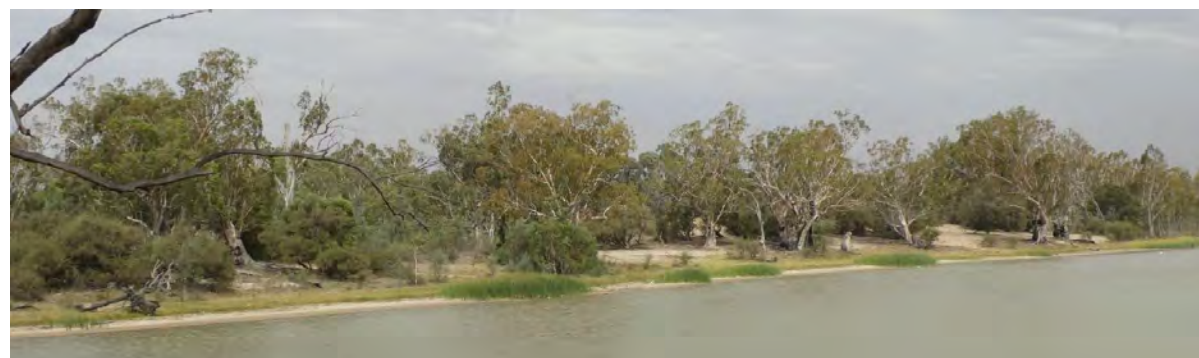
Morgan South Lagoon

Geomorphic Category – Deflation Basin Edge

<p>Regent Parrot Nesting Quality River Red Gum River Red Gum Density – Open Woodland River Red Gum Health Rating - Healthy (Level 4)</p>	<p>Understory Dominant Species and Health Healthy River Red Gum seedlings and poles, Cooba adults and seedlings, Spiny Sedge, Purple Burr-daisy, Blue Rod, Smooth Heliotrope</p>
---	--

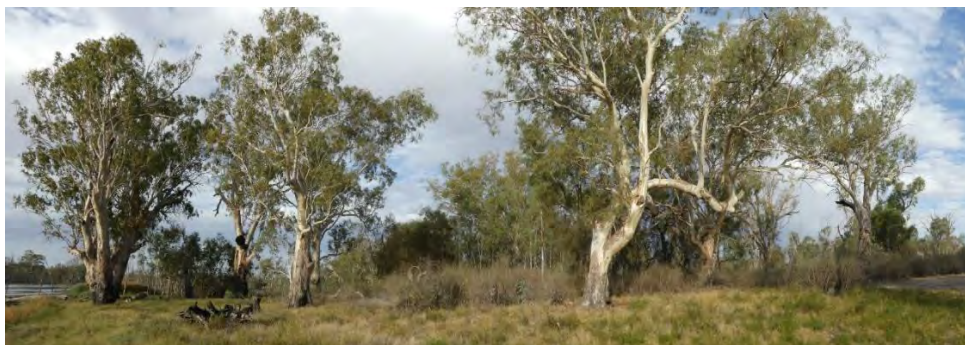
Morgan Lagoon Flood-out

Geomorphic Category – Deflation Basin Edge

Regent Parrot Nesting Quality River Red Gum River Red Gum Density – Open Woodland River Red Gum Health Rating- Stressed (Level 3)	Understory Dominant Species and Health Healthy River Red Gum seedlings and poles, Cooba adults and seedlings, Spiny Sedge, Native Liquorice, Purple Burr-daisy, Blue Rod, Smooth Heliotrope
--	---

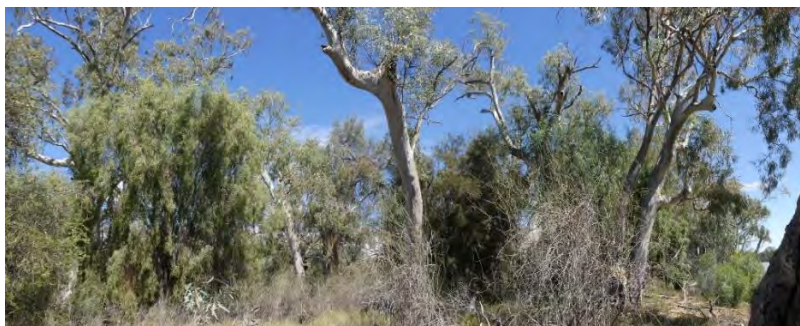
Morgan North East)

Geomorphic Category – Main Channel Edge

Regent Parrot Nesting Quality River Red Gum River Red Gum Density – Linear Woodland River Red Gum Health Rating-Healthy (Level 4)	Understory Dominant Species and Health Heathy Lignum/Prickly Bottle Brush/Spiny Sedge/Ruby Saltbush/Cooba and saplings/River Red Gum saplings/Western Boobialla/Purple Burr-daisy/Native Willow
--	---

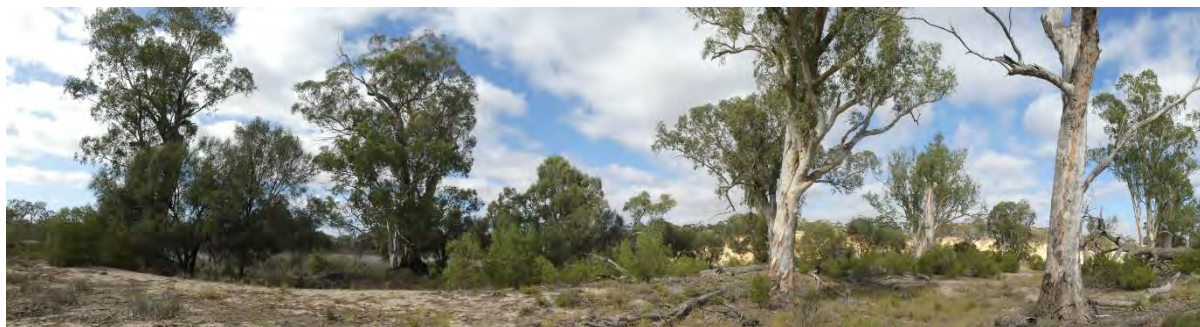
H Boord Reserve Bend

Geomorphic Category –Chute Channel and Main Channel Edge

Regent Parrot Nesting Quality River Red Gum	Understory Dominant Species and Health
River Red Gum Density – Sparely Linear Woodland River Red Gum Health Rating - Healthy (Level 4)	Heathy Spiny Sedge, Lignum, Native Liquorice, Creeping Saltbush, Smooth Heliotrope, Rat's-Tail Couch

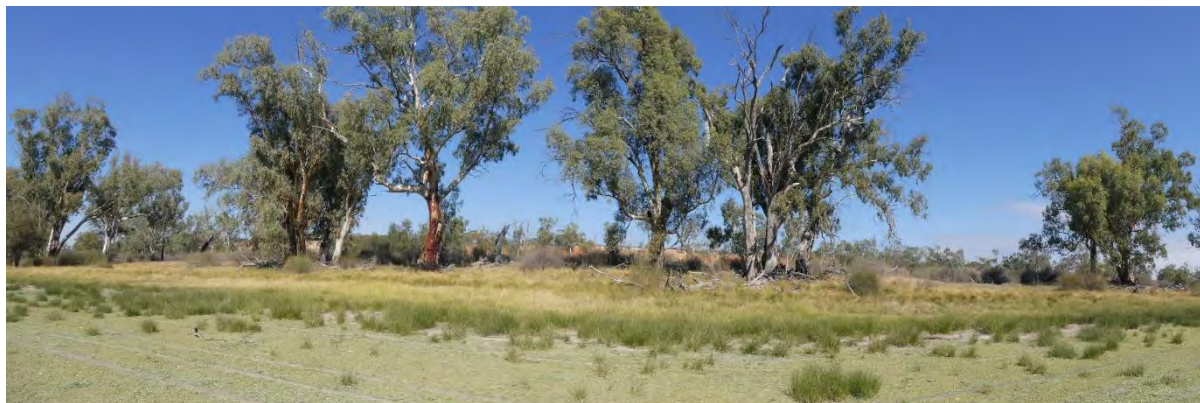
Nikalapko Lagoon

Geomorphic Category – Deflation Basin Edge

Regent Parrot Nesting Quality River Red Gum	Understory Dominant Species and Health
River Red Gum Density – Linear Woodland River Red Gum Health Rating - Healthy (Level 5)	Heathy Spiny Sedge, Lignum, Native Liquorice, Creeping Saltbush, Smooth Heliotrope, Rat's-Tail Couch

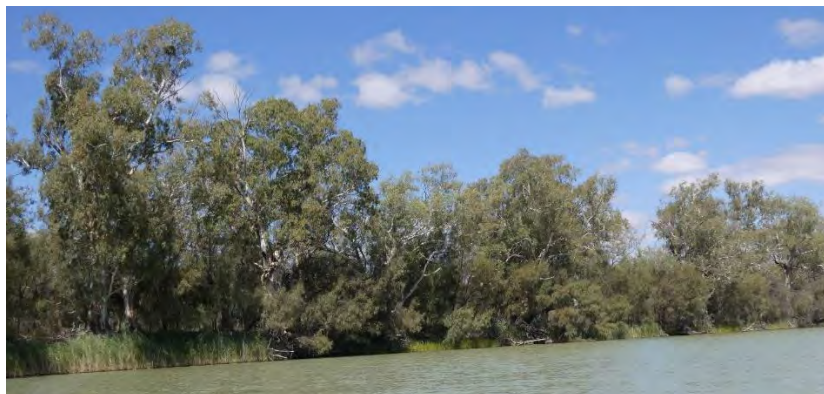
Molo Flat

Geomorphic Category – Flood-out and Main Channel Edge

Regent Parrot Nesting Quality River Red Gum River Red Gum Density – Linear Woodland River Red Gum Health Rating - Healthy (Level 5)	Understory Dominant Species and Health Healthy Cooba, Lignum, Red Gum Saplings, Common Sneezeweed, Hairy Carpet-weed, Lesser Joyweed
--	--

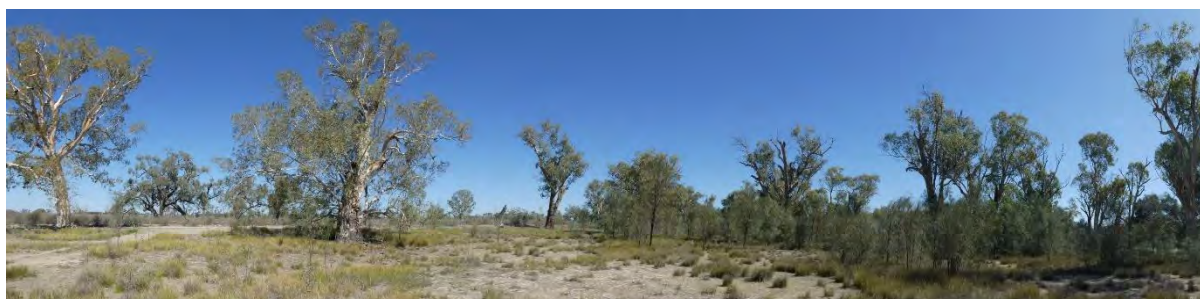
Taylor Flat West

Geomorphic Category –Distribution Channel Delta

Regent Parrot Nesting Quality River Red Gum River Red Gum Density – Sparse Woodland River Red Gum Health Rating-Healthy (Level 4)	Understory Dominant Species and Health Healthy Cooba (adults and saplings), River Red Gum seedlings, Lignum, Spiny Sedge, Rat's-Tail Couch, Native Liquorice, Lippia, Purple Burr-daisy, River Blue Bell, Swamp Daisy, Grey Germander, Blue Rod, Star Thistle, California Burr
--	---

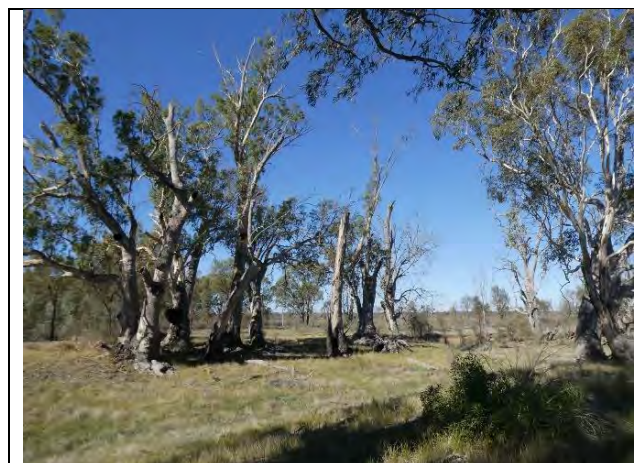
Taylor Flat Outlet Creek

Geomorphic Category – Distribution Channel

Regent Parrot Nesting Quality River Red Gum

River Red Gum Density –Open Woodland

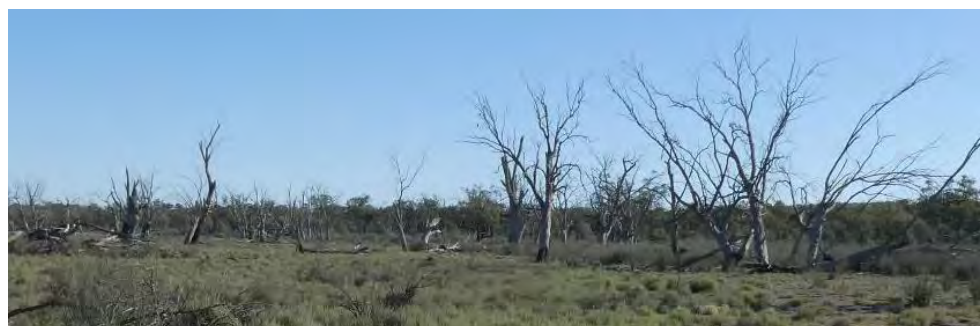
Taylor Flat

Geomorphic Category –Deflation Basin

Regent Parrot Nesting Quality River Red Gum

River Red Gum Density – Open Woodland
River Red Gum Health Rating–Degraded (Level 0)

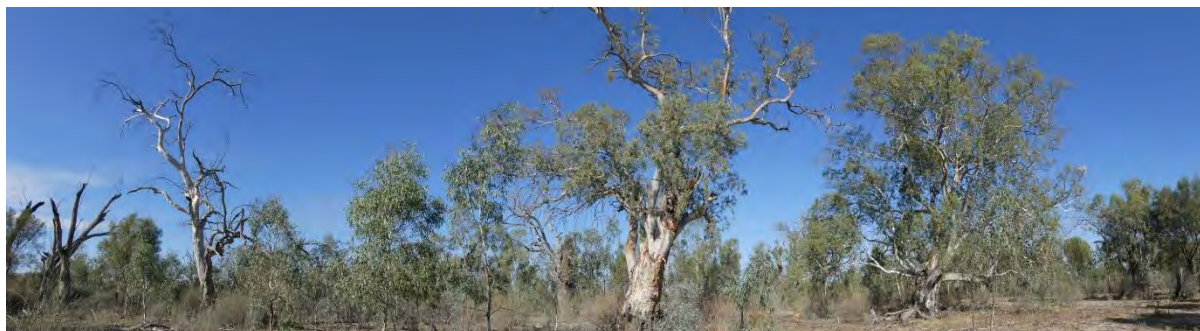
Markaranka Flat

Geomorphic Category – Flood-out

Regent Parrot Nesting Quality River Red Gum River Red Gum Density – Open Woodland River Red Gum Health Rating– Stressed (Level 3)	Understory Dominant Species and Health Healthy River Red Gum saplings and poles, Cooba adults and saplings, Lignum, Spiny Sedge, Smooth Heliotrope, Native Liquorice, Creeping Saltbush, Lagoon Saltbush, Bladder Saltbush
--	--

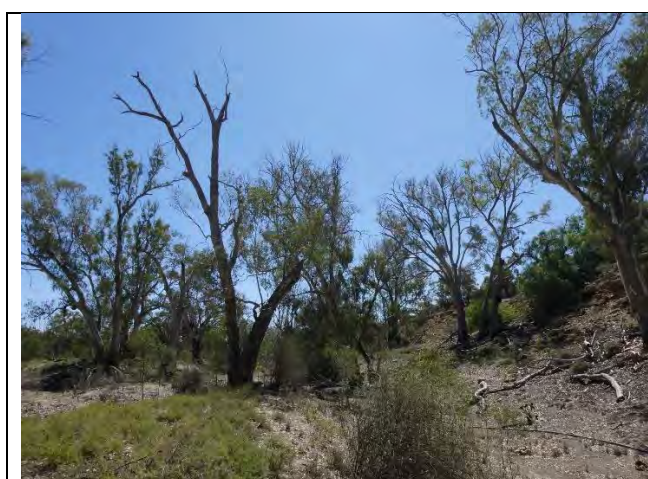
Markaranka Flat Channel

Geomorphic Category – Chute Channel

Regent Parrot Nesting Quality River Red Gum River Red Gum Density –Open Woodland River Red Gum Health Rating- Stressed (Level 3)	Understory Dominant Species and Health River Red Gum saplings, Lignum, Blue Rod, Spiny Sedge, Cooba adult saplings, Ruby Saltbush, Lagoon Saltbush, Yanga Bush
---	--

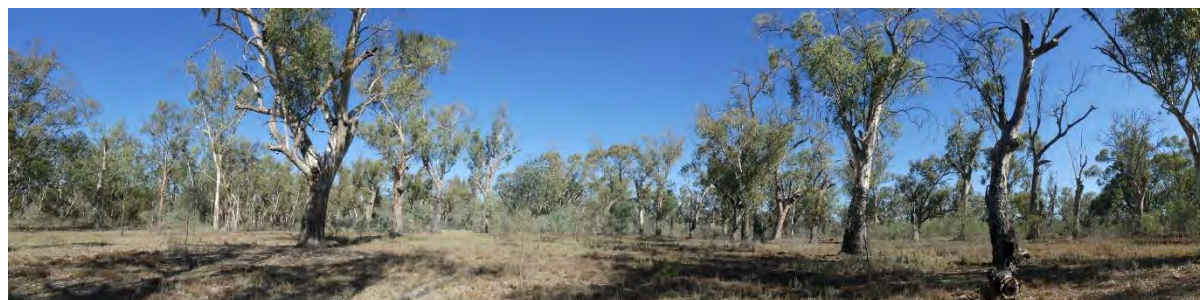
Hogwash Council Area

Geomorphic Category – Flood-out

<p>Regent Parrot Nesting Quality River Red Gum River Red Gum Density – Open Woodland River Red Gum Health Rating–Healthy (Level 4)</p>	<p>Understory Dominant Species and Health Healthy River Red Gum saplings, Lignum, odd Cooba, Lagoon Saltbush, Creeping Saltbush, Spiny Sedge, Grey Germander, Native Liquorice, Lippia, Tussock Grass, Smooth Heliotrope, Rat’s-Tail Couch</p>
---	--

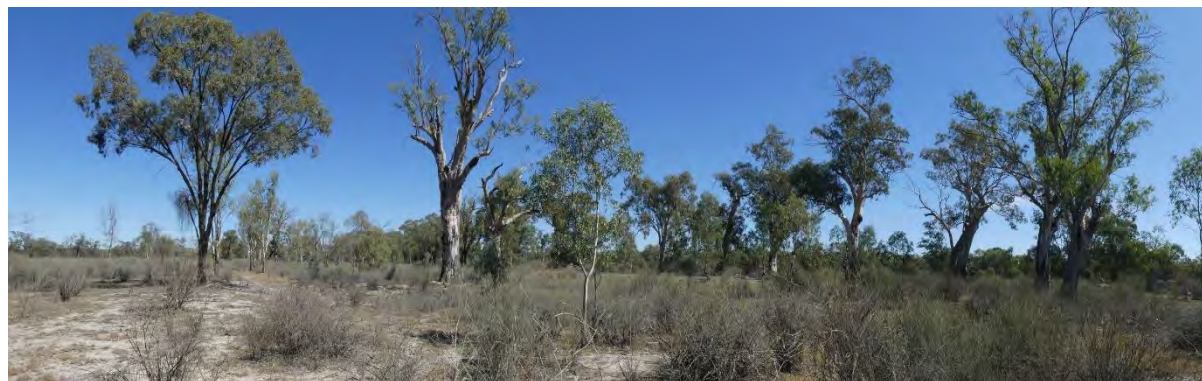
Markaranka River Flood-out

Geomorphic Category – Flood-out

<p>Regent Parrot Nesting Quality River Red Gum River Red Gum Density – Open Woodland River Red Gum Health Rating– Stressed (Level 3)</p>	<p>Understory Dominant Species and Health Healthy River Red Gum saplings and poles, Black Box adults and saplings, odd Cooba, Lignum, Creeping Saltbush, Lagoon Saltbush, Ruby Saltbush, Native Liquorice (inland depression is dominated by Lignum with odd River Red Gum, Black Box and Cooba)</p>
---	--

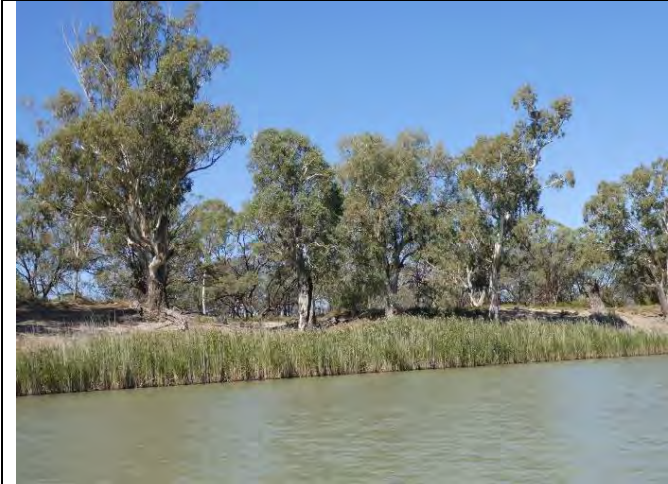
Markaranka Lagoon Main River Channel

Geomorphic Category – Main Channel Edge

<p>Regent Parrot Nesting Quality River Red Gum River Red Gum Density – Linear Woodland River Red Gum Health Rating-Healthy (Level 4)</p> <p>Understory Dominant Species and Health Healthy Lignum, Cooba, Ruby Saltbush, Lagoon Saltbush, Yanga Bush, Spiny Sedge</p>
---	--

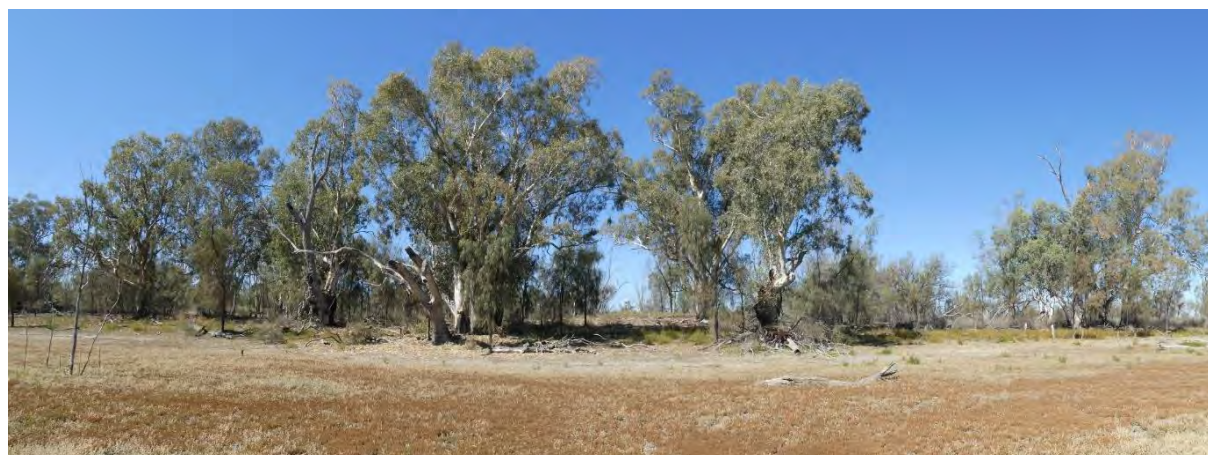
Markaranka Lagoon

Geomorphic Category – Distribution Channel Edge

<p>Regent Parrot Nesting Quality River Red Gum River Red Gum Density – Linear Woodland River Red Gum Health Rating-Healthy (Level 5)</p>	<p>Understory Dominant Species and Health Healthy odd Lignum, Cooba, Lagoon, Spiny Sedge, Native Liquorice, Rat's-Tail Couch</p>
---	--

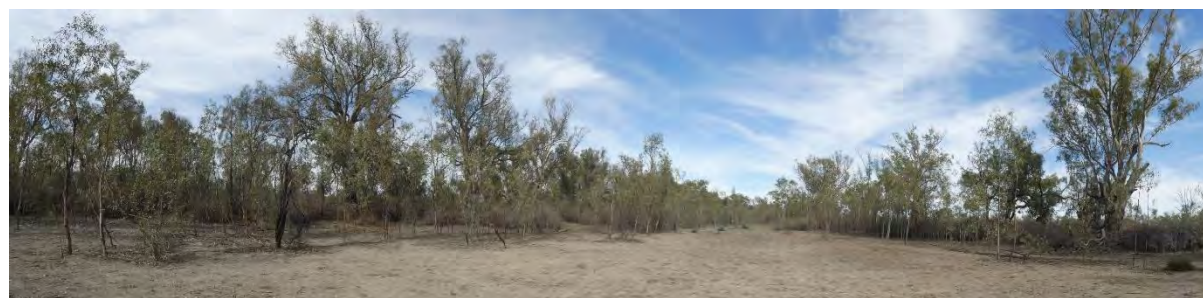
Little Schiller Lagoon

Geomorphic Category – Interconnecting Depositional Basins Edge

<p>Regent Parrot Nesting Quality River Red Gum River Red Gum Density – Linear Woodland River Red Gum Health Rating– Stressed (Level 3)</p>	<p>Understory Dominant Species and Health Healthy River Red Gum adults and saplings, odd Black Box, Cooba adults and saplings, Lignum, Spiny Sedge, Lagoon Saltbush</p>
---	---

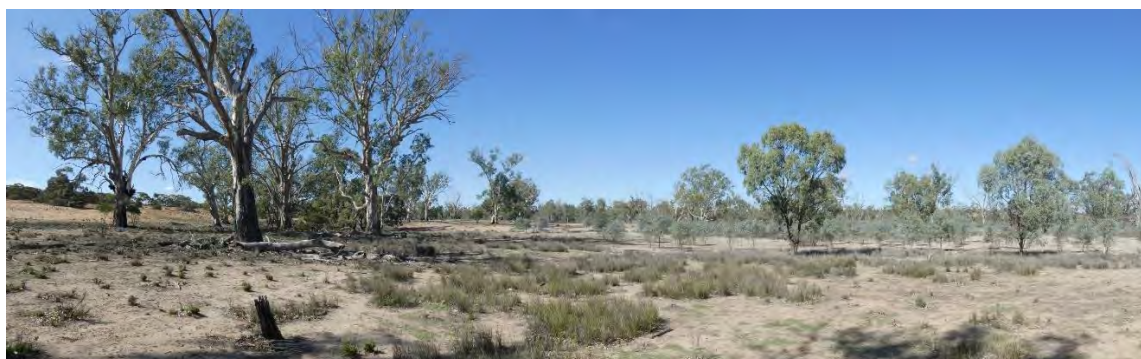
Island Reach

Geomorphic Category – Distribution Channel and Main Channel Edge

Regent Parrot Nesting Quality River Red Gum River Red Gum Density – Linear and Sparse Woodland River Red Gum Health Rating– Stressed (Level 3) Main Channel (Level 4)	Understory Dominant Species and Health Healthy River Red Gum and Black Box saplings, Spiny Sedge, Rat's-Tail Couch, Lippia, Ruby Saltbush, odd Lignum, Tussock Grass
---	--

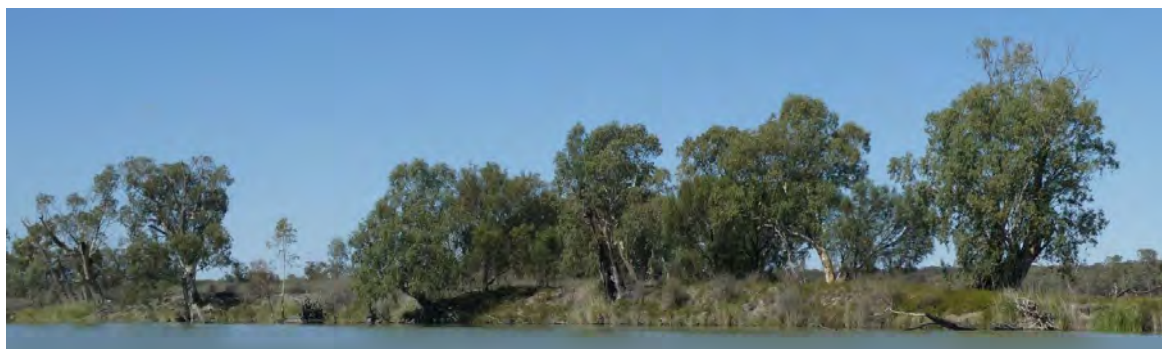
Yarra Point

Geomorphic Category – Distribution Channel and Main Channel Edge

Regent Parrot Nesting Quality River Red Gum River Red Gum Density – Linear and Sparse Woodland River Red Gum Health Rating–Healthy (Level 4)	Understory Dominant Species and Health Healthy River Red Gum Saplings, Lignum, Cooba, odd adult poles, saplings, Native Liquorice
---	---

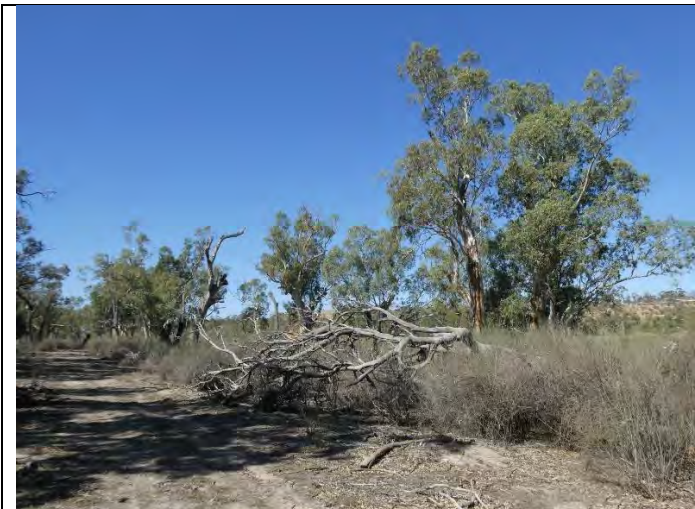
Yarra View

Geomorphic Category – Main Channel Edge

<p>Regent Parrot Nesting Quality River Red Gum River Red Gum Density – Linear Woodland River Red Gum Health Rating-Healthy (Level 4)</p> <p>Understory Dominant Species and Health Healthy Lignum dominant, River Red Gum and Cooba saplings, Creeping Saltbush, Ruby Saltbush, Lagoon Saltbush, Pale Poverty Bush, Spiny Sedge, Blue Rod</p>
---	--

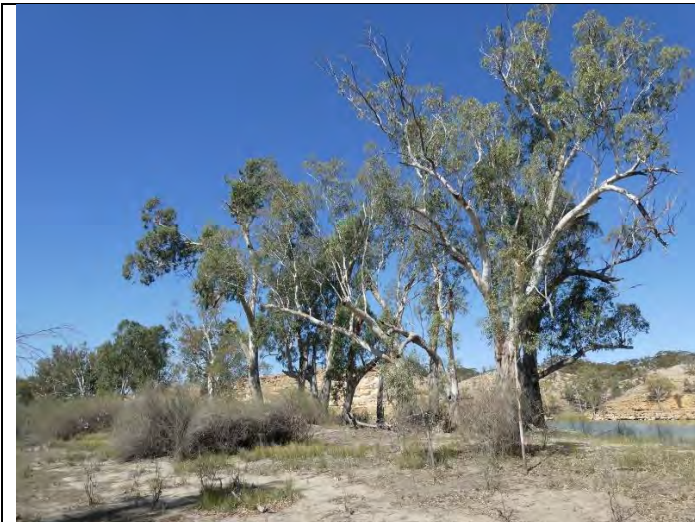
Yarra Reach

Geomorphic Category – Main Channel Edge

<p>Regent Parrot Nesting Quality River Red Gum River Red Gum Density – Linear Woodland River Red Gum Health Rating-Healthy (Level 4)</p> <p>Understory Dominant Species and Health Healthy, Lignum, River Red Gum sapling, Spiny Sedge, Ruby Saltbush, Creeping Saltbush, Blue Rod, Native Liquorice, Pale Poverty Bush, Purple Burr-daisy</p>
---	---

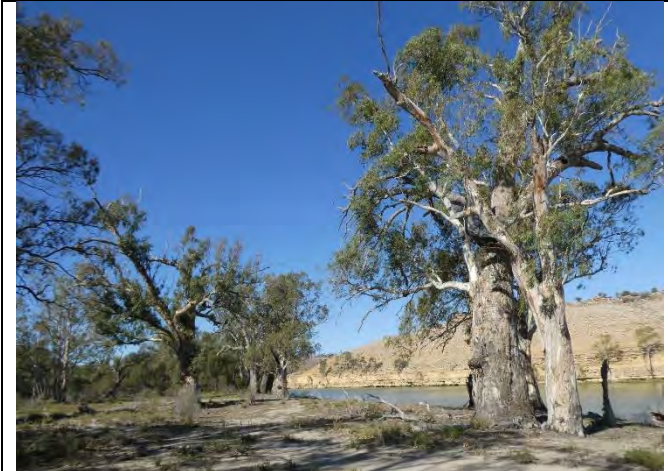
East Good Hope

Geomorphic Category – Main Channel Edge

<p>Regent Parrot Nesting Quality River Red Gum River Red Gum Density – Linear Woodland River Red Gum Health Rating-Healthy (Level 4)</p> <p>Understory Dominant Species and Health Healthy Odd lignum, Cooba adult and saplings, Spiny Sedge, Ruby Saltbush, Purple Burr-daisy</p>
---	--

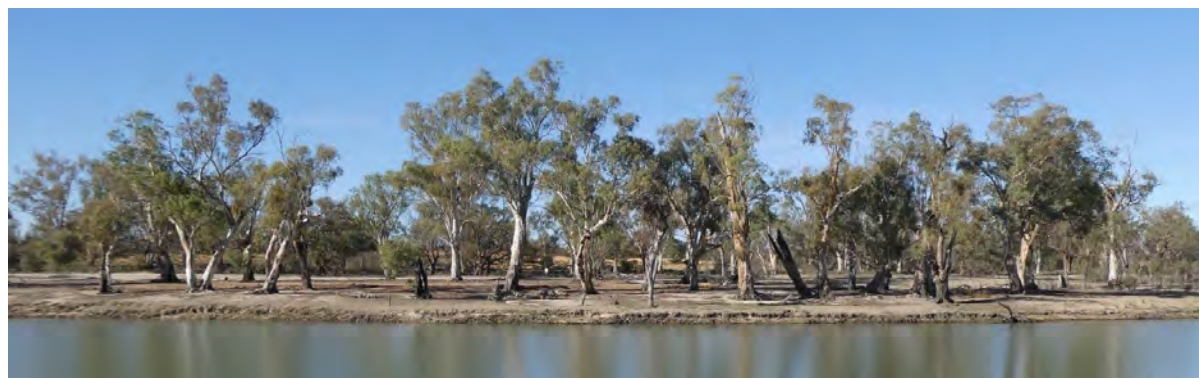
Banrock Creek

Geomorphic Category – Distribution Channel and Main Channel Edge

<p>Regent Parrot Nesting Quality River Red Gum River Red Gum Density – Linear Woodland River Red Gum Health Rating–Healthy (Level 4)</p>	<p>Understory Dominant Species and Health Healthy River Red Gum saplings, odd adult Cooba, Lignum outer edge, Smooth Heliotrope, Native Liquorice, Rat's-Tail Couch, Grey Germander</p>
---	--

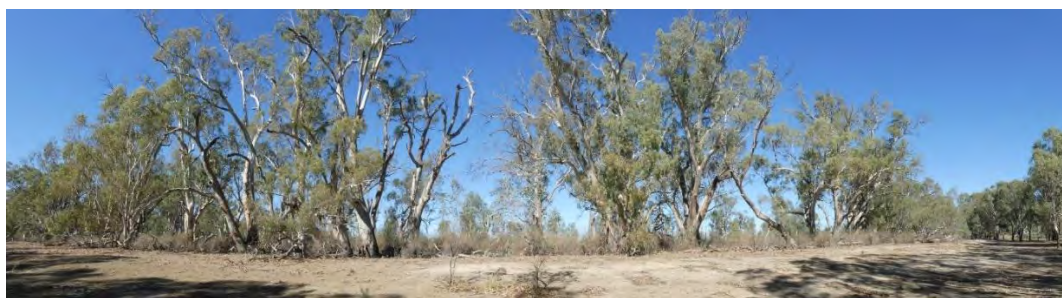
Heron Bend

Geomorphic Category – Bar Platform

Regent Parrot Nesting Quality River Red Gum River Red Gum Density – Open Forest and Woodland River Red Gum Health Rating– Stressed (Level 3)	Understory Dominant Species and Health Healthy River Red Gum saplings, Lignum. Lagoon floor - Smooth Heliotrope, Lagoon Saltbush, Creeping Saltbush, Pale Poverty Bush
--	--
