Maximising Water Delivery for Regent Parrot Outcomes

Water for the Environment Program

Document Title: Maximising Water Delivery for Regent Parrots

Date: March 2021

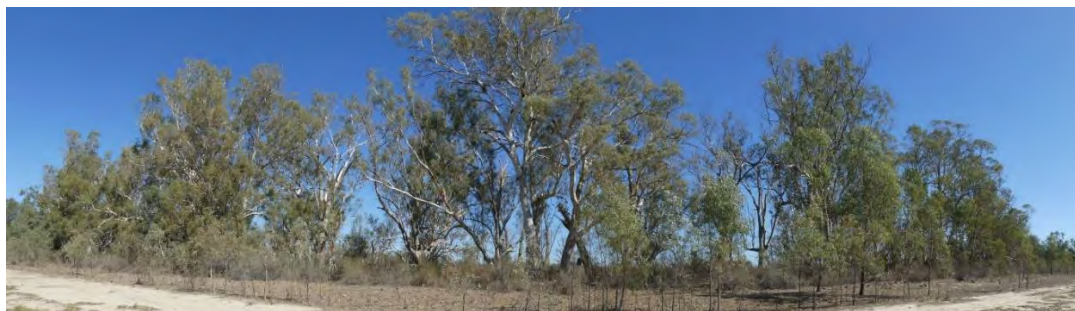
Banrock Bend

Geomorphic Category – Bar Platform

Regent Parrot Nesting Quality River Red Gum River Red Gum Density – Open Forest and Woodland River Red Gum Health Rating– Stressed (Level 3)	Understory Dominant Species and Health Healthy dominated by Lignum. River Red Gum and saplings, Cooba adults and saplings, Smooth Heliotrope, Creeping Saltbush, Pale Poverty Bush
---	--

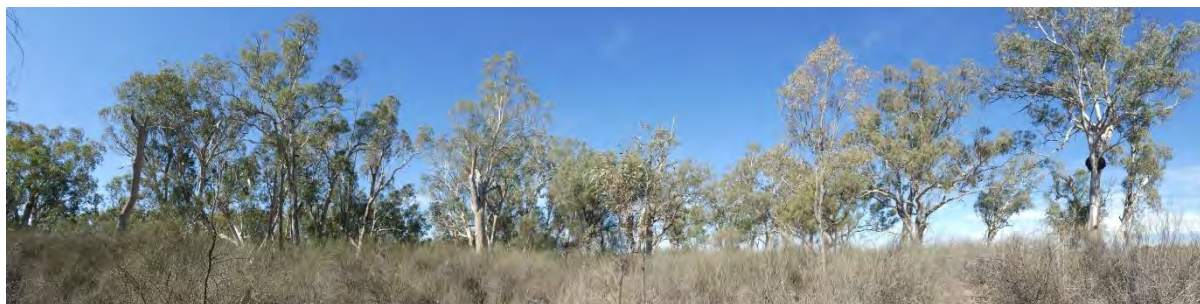
Ball Island

Geomorphic Category – Main Channel Edge and Island

Regent Parrot Nesting Quality River Red Gum River Red Gum Density – Open Woodland River Red Gum Health Rating– Stressed (Level 3)	Understory Dominant Species and Health Healthy Lignum, Spiny Sedge, Blue Rod, Smooth Heliotrope, Creeping Boobialla, Smooth Heliotrope, Pale Poverty Bush
--	---

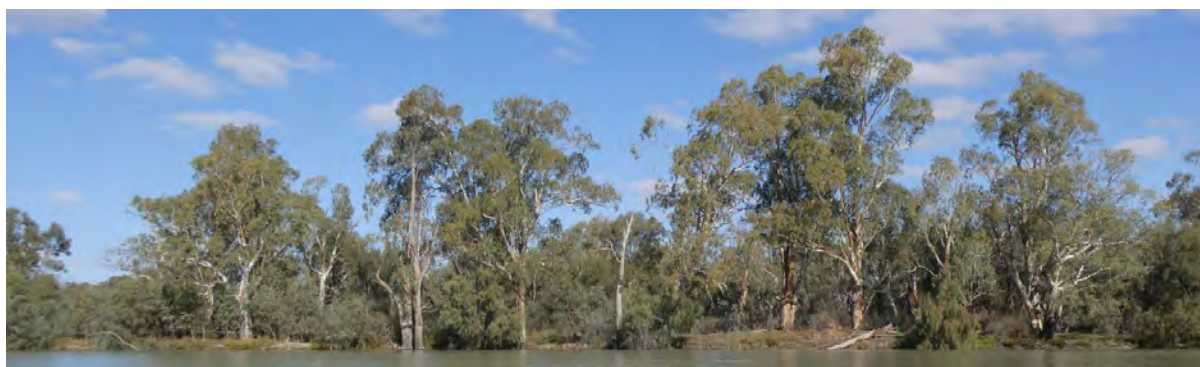
North Pyap

Geomorphic Category – Main Channel Edge

Regent Parrot Nesting Quality River Red Gum River Red Gum Density – Linear Woodland River Red Gum Health Rating–Healthy (Level 4)	Understory Dominant Species and Health Healthy Lignum, River Red Gum sapling, Blue Rod, Creeping Boobialla, Native Liquorice, Creeping Saltbush, odd Smooth Heliotrope plant
--	---

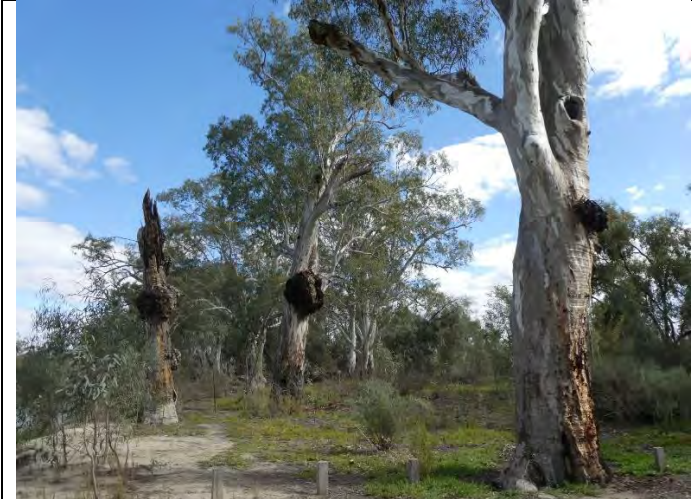
Katarapko Creek Campsite 47)

Geomorphic Category – Main Channel Edge

<p>Regent Parrot Nesting Quality River Red Gum River Red Gum Density – Open Woodland River Red Gum Health Rating–Healthy (Level 5)</p> <p>Understory Dominant Species and Health Healthy Patches River Red Gum saplings. Patches of Nitre Bush adults and seedlings. Odd Lignum. Creeping Boobialla, Blue Rod.</p>
---	---

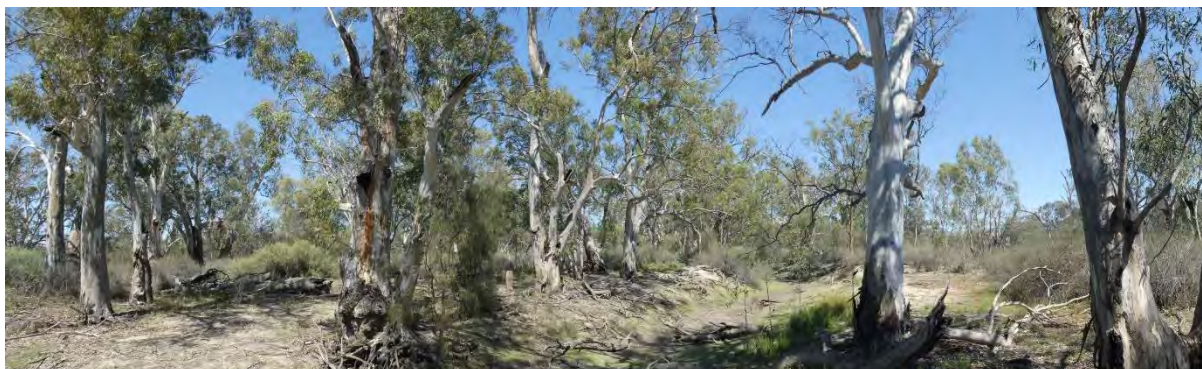
Katarapko Creek North South

Geomorphic Category – Distribution Channel Edge

<p>Regent Parrot Nesting Quality River Red Gum River Red Gum Density – Open Woodland River Red Gum Health Rating–Healthy (Level 4)</p>	<p>Understory Dominant Species and Health Healthy Odd River Red Gum sapling, Cooba adults and saplings. Tall Groundsel. Lignum and patches Nitre Bush. Ruby Saltbush. Spreading Emu Bush. Atriplex spp.</p>
---	---

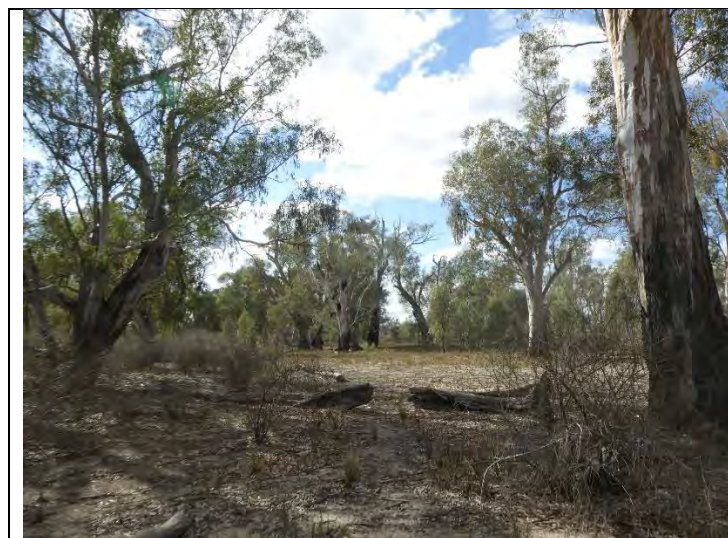
Katarapko Creek Campsite 45

Geomorphic Category – Main Channel Edge and Flood-out

Regent Parrot Nesting Quality River Red Gum

River Red Gum Density – Open Woodland

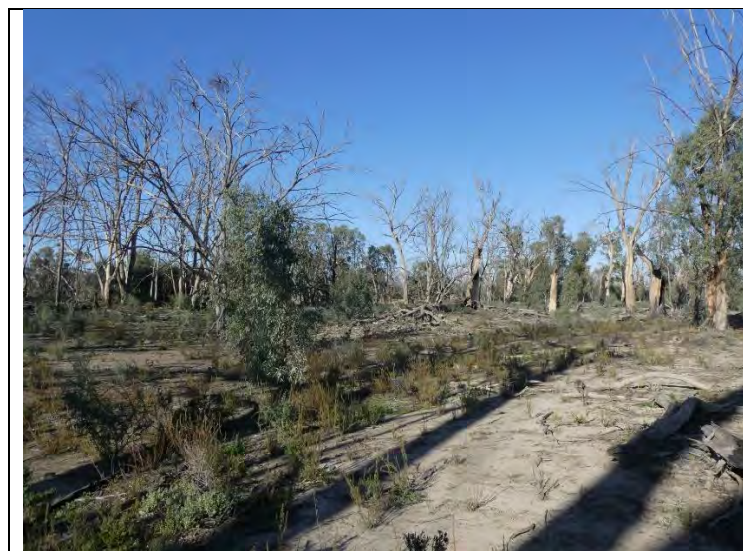
Katarapko Creek Campsite closed (previously campsite 25)

Geomorphic Category – Flood-out

Regent Parrot Nesting Quality River Red Gum

River Red Gum Density – Open Woodland

River Red Gum Health Rating–Degraded (Level 0)

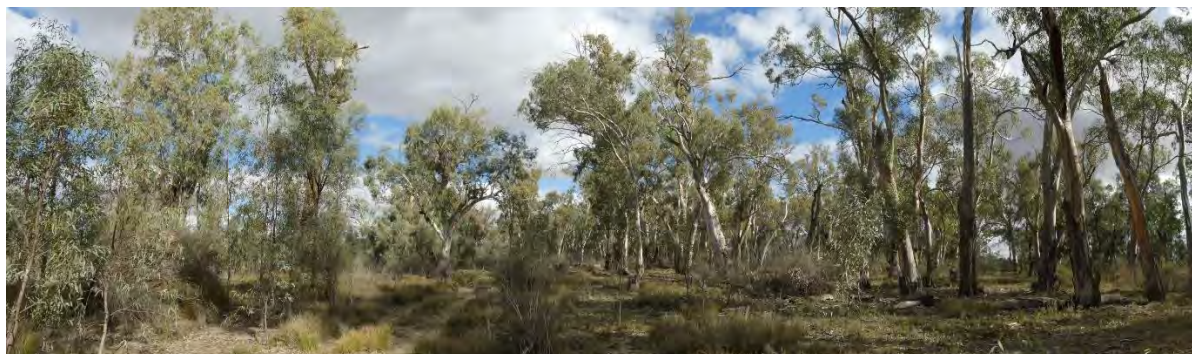
Westbrook Bend

Geomorphic Category – Flood-out

Regent Parrot Nesting Quality River Red Gum River Red Gum Density – Open Woodland River Red Gum Health Rating– Stressed (Level 3)	Understory Dominant Species and Health Healthy Lignum patches, odd Spreading Emu Bush, Cooba adults and saplings, River Red Gum saplings, Creeping Saltbush, desiccated Tussock Grass, Smooth Heliotrope, Lagoon Saltbush, Atriplex spp. Creeping Saltbush
--	--

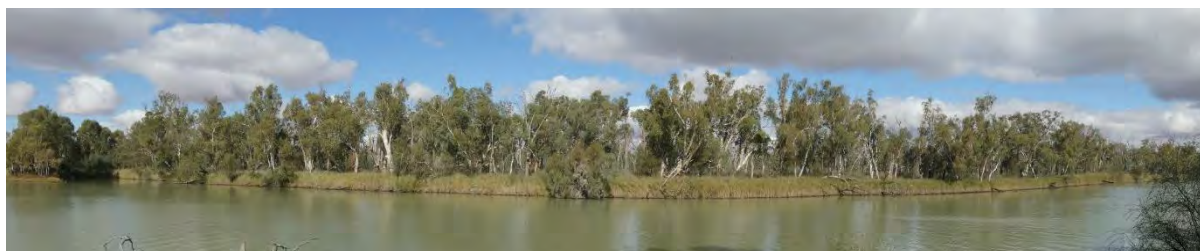
Rilli Island

Geomorphic Category – Main Channel Edge and Island

Regent Parrot Nesting Quality River Red Gum River Red Gum Density – Open Woodland River Red Gum Health Rating–Healthy –(Level 4) Centre of Island Stressed (Level 2)	Understory Dominant Species and Health Healthy Lignum, Phragmites, River Red Gum poles and saplings. Cooba adults and saplings
--	--

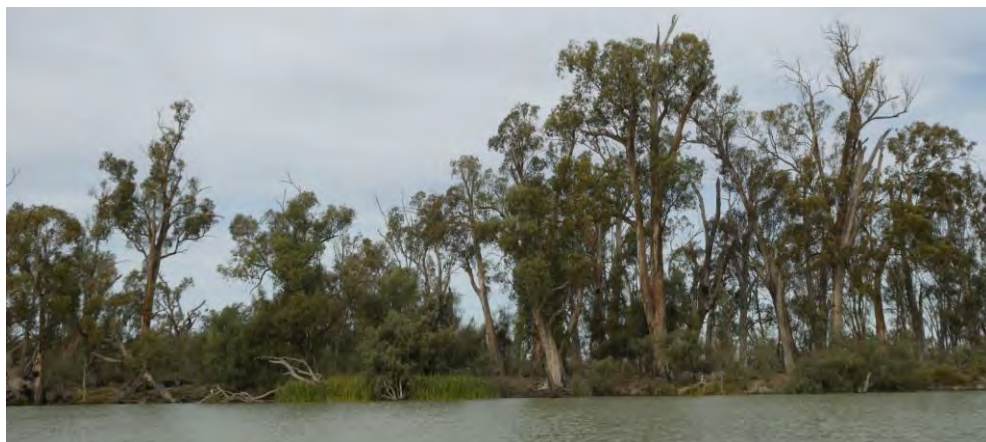
Coongalena

Geomorphic Category – Main Channel Edge

Regent Parrot Nesting Quality River Red Gum	Understory Dominant Species and Health
River Red Gum Density – Linear Woodland	Healthy River Red Gum saplings, Blue Rod,
River Red Gum Health Rating– Stressed (Level 3)	Bushy Groundsel, Smooth Heliotrope

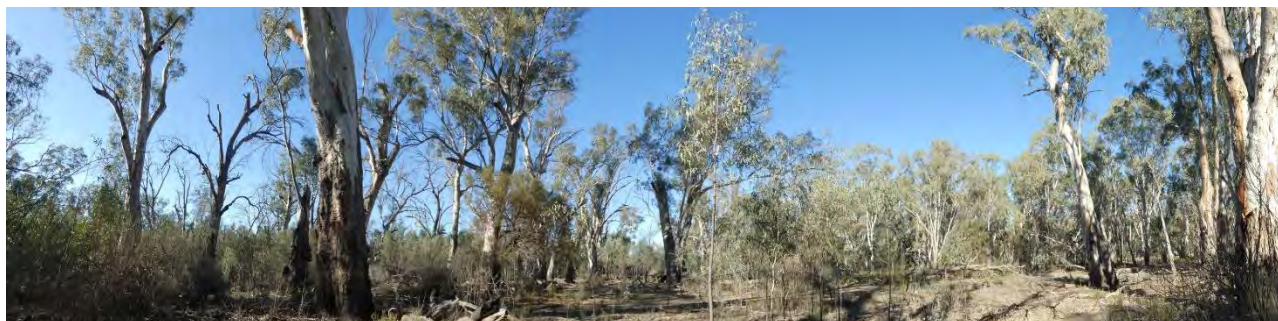
Wielä

Geomorphic Category – Main Channel Edge and Island

Regent Parrot Nesting Quality River Red Gum	Understory Dominant Species and Health
River Red Gum Density – Open Woodland	Healthy Scattered River Red Gum saplings,
River Red Gum Health Rating–Healthy –(Level 4)	Tall Groundsel, Lignum on edges, odd Cooba adult, odd Spreading Emu Bush, odd Nitre Bush, Native Liquorice, Creeping Boobialla

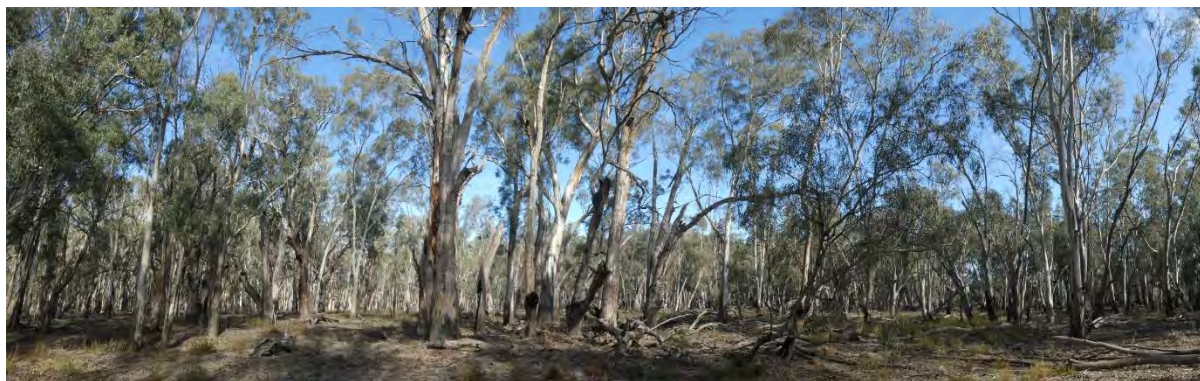
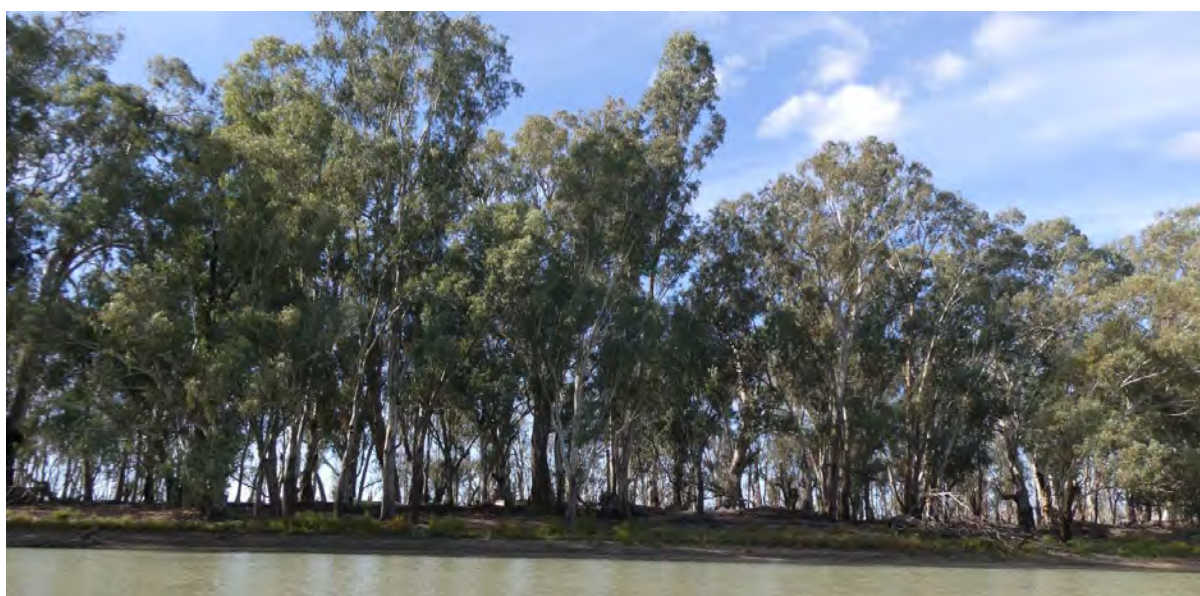
Chowilla Creek Inlet

Geomorphic Category – Main Channel Edge

Downstream Site

Upstream Site

Regent Parrot Nesting Quality River Red Gum River Red Gum Density – Forest River Red Gum Health Rating–Healthy (Level 4)	Understory Dominant Species and Health Healthy Bushy Groundsel, Blue Rod
--	--

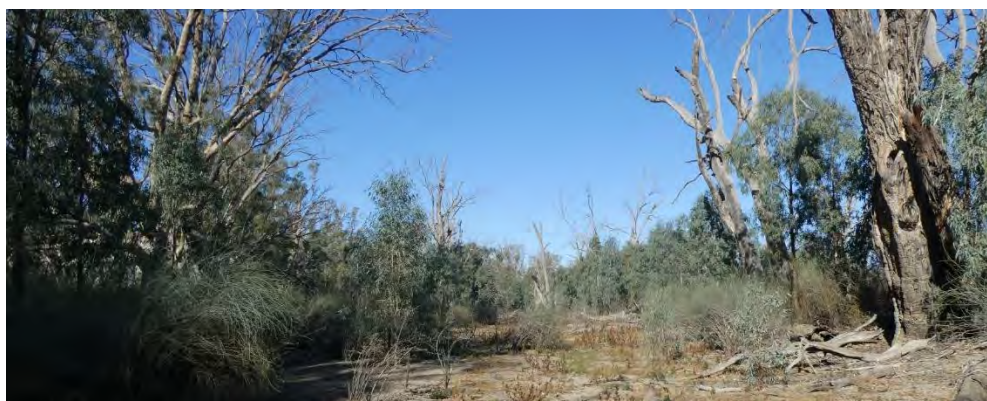
River Red Gum Woodland Stressed (level 3)	Adults and scattered poles and saplings centred on the inside of the sandbar are healthy (level 4) grading to stressed (level 3) further inland. Understory dominated by Lignum and scattered adult Cooba. Existing watering depression sites surrounded by healthy (level 5) poles and sapling with adult trees mostly dead (level1). Western section all adult trees dead with scattered patches of poles and saplings dead to healthy.
Lignum Shrubland Stressed (level 3)	Lignum dominate understory on the inside of the sandbar healthy (level 5 and 4). Existing watering depression sites degraded (level 1). Western section low areas most Lignum dead with sparse healthy shrubs at higher elevations with scattered River Red Gum saplings.
Low Shrubland/Herbland Stressed (level 3)	Existing watering depression sites dominated by scattered patches (areas) of California Burr, Nitre Bush, Common Sneezeweed, Smooth Heliotrope, Common Joyweed and Native Liquorice. Downstream flood-outs and Wetland 616 dominated by Smooth Heliotrope, Lagoon Saltbush and Native Leek with Bladder, Creeping and Ruby Saltbush, Pale Poverty Bush and patches of desiccated Tussock Grass.

Existing watering site Latitude 34.10029 Longitude 140.20766 Direction 100

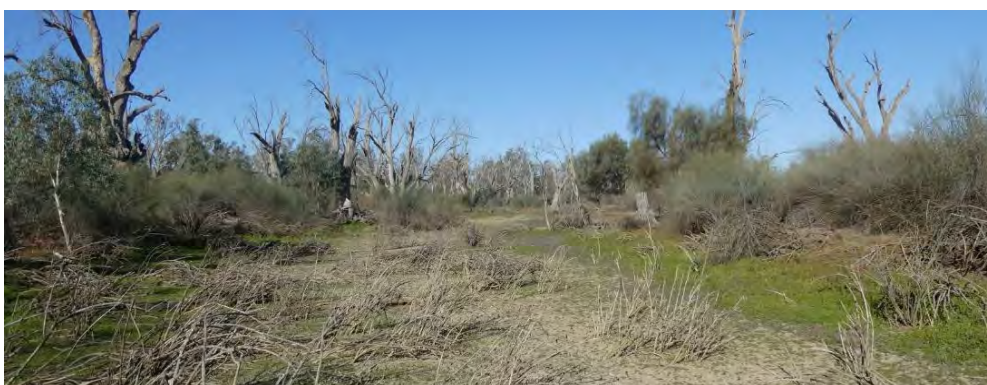
Existing watering site Latitude 34.10050 Longitude 140.20717 Direction 120

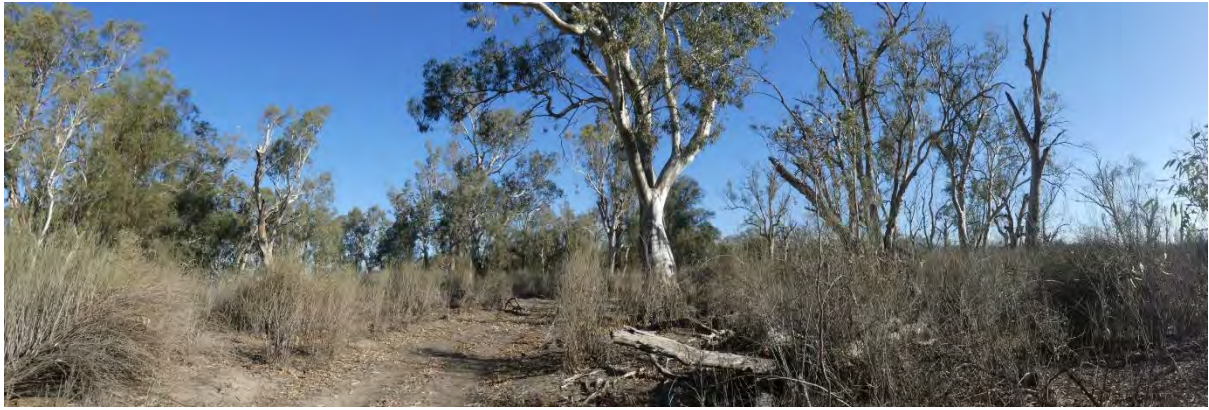
Upstream area inside of the river sandbar Latitude 34.10231 Longitude 140.20927 Direction 220

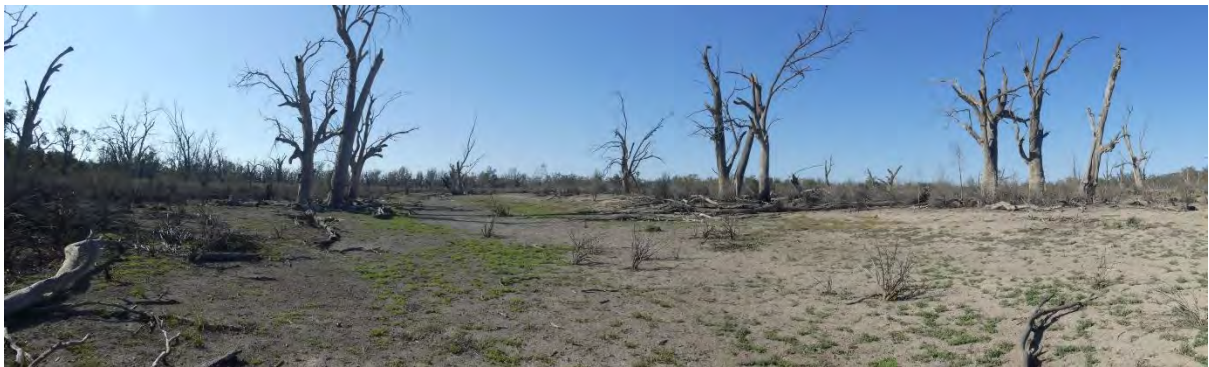
Downstream flood-out Latitude 34.10017 Longitude 140.20595 Direction 130

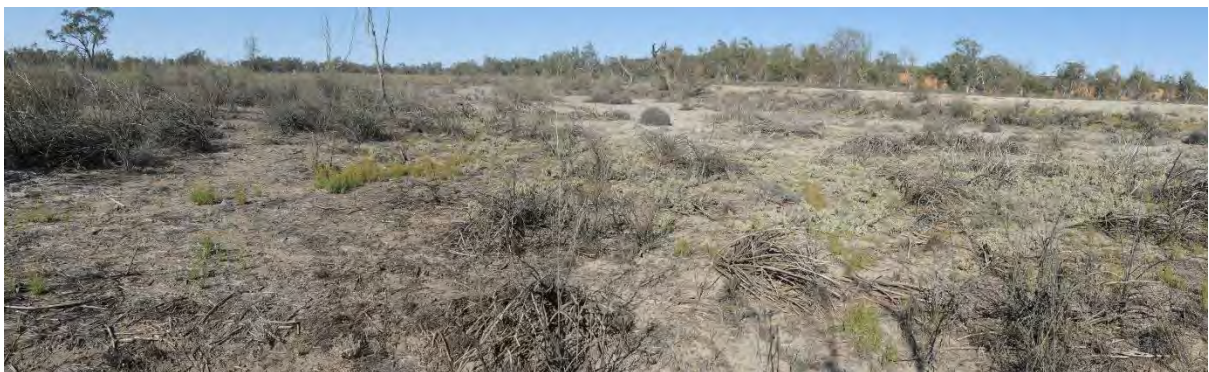
Wetland 616 Latitude 34.10097 Longitude 140.20516 Direction 210

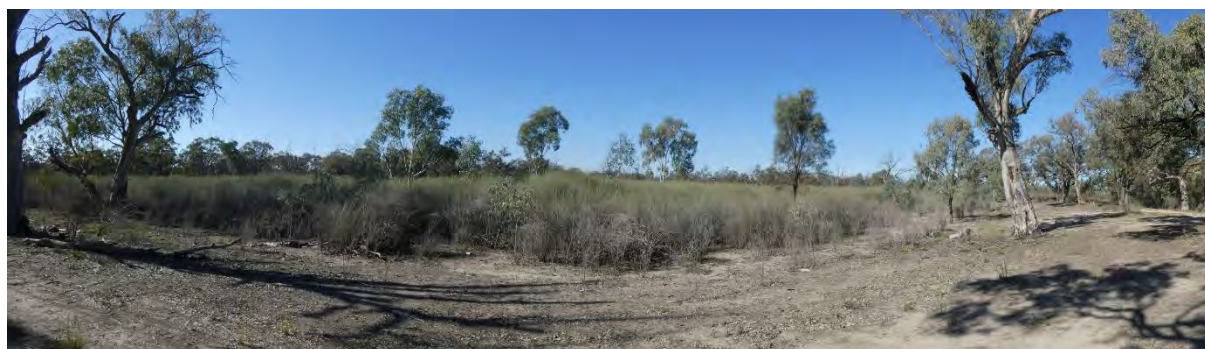
River Red Gum Woodland Stressed (level 3)	River inlet lagoon (existing watering site) adult trees stressed (level 3) poles and saplings healthy (level 5) understory Cooba and Lignum. Most lagoons have scattered long-term dead adult and pole River Red Gum around the edges.
Black Box Woodland Healthy (level 4 and 5)	All Lagoons surrounded by adult and sapling Black Box understory dominated by Lignum and odd Cooba adult and sapling.
Lignum Shrubland Healthy (level 4 and 5)	Lignum dominates the floor of all the lagoons except the inlet lagoon. Patches of Creeping Boobialla and Spiny Sedge plus Common Sneeze Weed, Lesser Joyweed, Blown Grass, Lagoon Saltbush, Smooth Heliotrope and Tussock Grass.

Wetland 903 northern end Latitude 34.23682 Longitude 140.29439 Direction 110

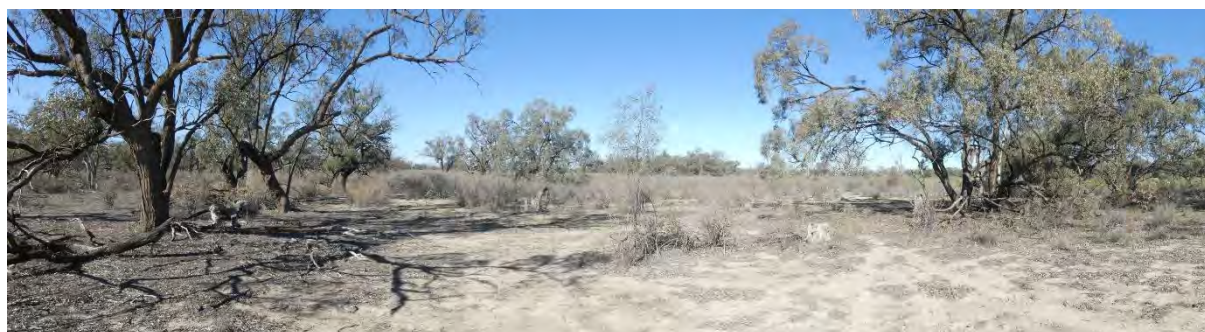
Eastern side of the complex Latitude 34.23695 Longitude 140.29578 Direction 170

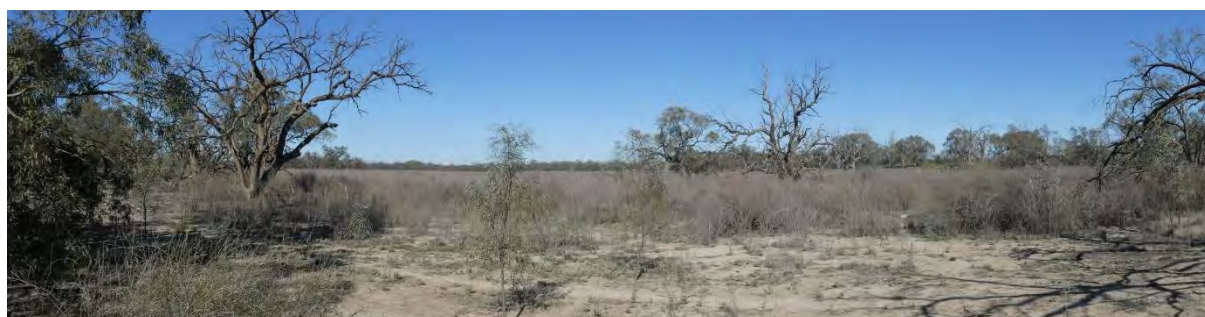
Southern extension of Wetland 909 Latitude 34.23775 Longitude 140.29658 Direction 190

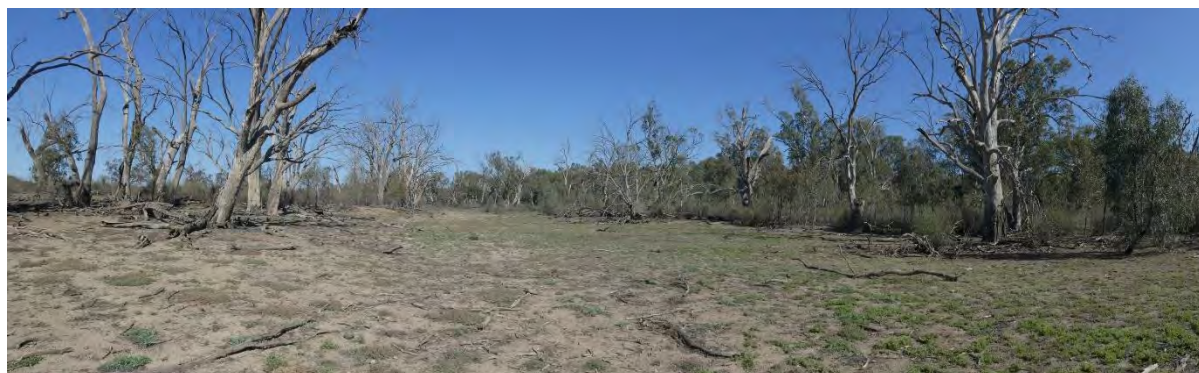
River Red Gum Woodland Stressed (level 3)	Southern side of site adult long-term dead. Sandbar side - adult understory Lignum and River Red Gum saplings.
Low Shrubland/Herbland Stressed (level 3)	Lagoon bed – Dominated by Smooth Heliotrope, Lagoon and Creeping Saltbush with scattered Pale Poverty Bush and a salt scald at the downstream end.

Lagoon bed looking downstream Latitude 34.09429 Longitude 140.19802 Direction 260

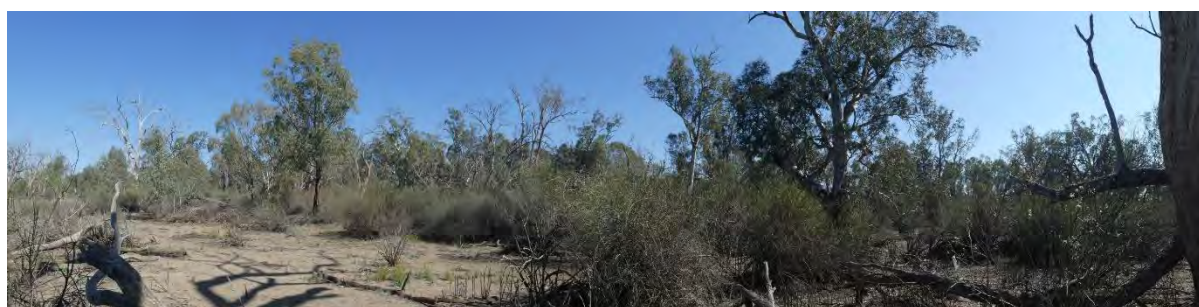
Back edge of river sandbar Latitude 34.09403 Longitude 140.19839 Direction 300

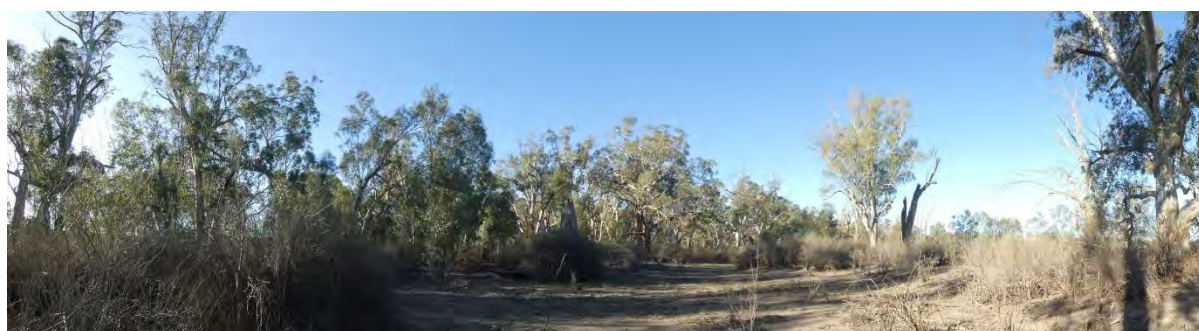
River Red Gum Woodland Stressed (level 3)	Band of adult trees along back of the Sandbar.
Lignum Shrubland Healthy (level 4)	Small patches and scattered bushes throughout the eastern two thirds of the site with scattered young adult River Red Gum.
Low Shrubland/Herbland Stressed (level 3)	Scattered amongst small odd Lignum, Pale Poverty Bush, Creeping Saltbush, and Lagoon Saltbush and desiccated Tussock Grass.

Back edge of river sandbar Latitude 34.09382 Longitude 140.19832.Direction 30

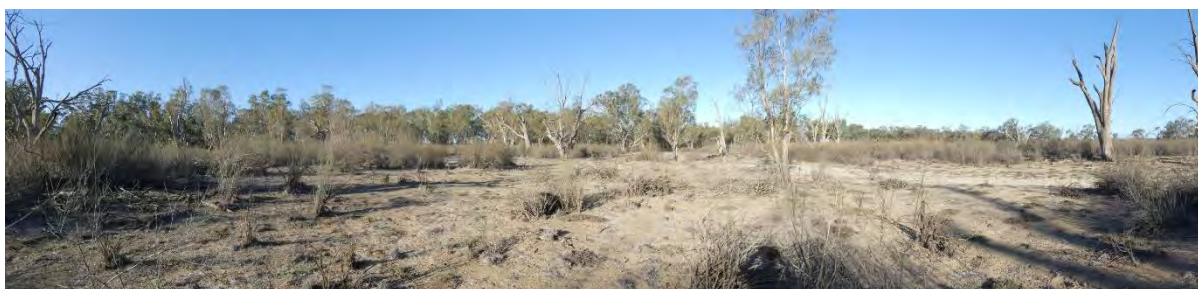
Downstream end Latitude 34.09455 Longitude 140.19927 Direction 90

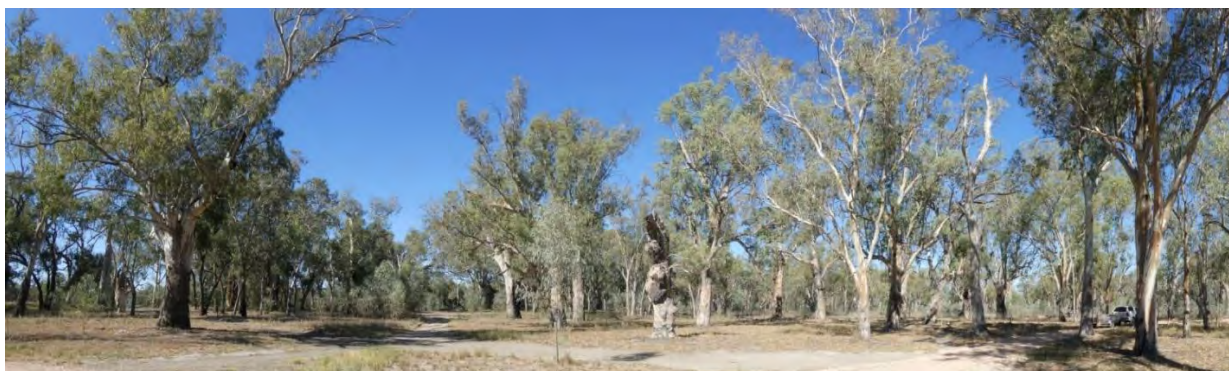
River Red Gum Woodland Healthy (level 4)	River Red Gum adults and saplings, odd Black Box and Cooba, with understory healthy comprising of sparse Lignum, Creeping Saltbush, Spiny Sedge, Lagoon Saltbush, Grey Germander, Lippia, and Native Liquorice
--	--

Mid Murray Council Reserve Latitude 34.03961 Longitude 140.29578 Direction 70

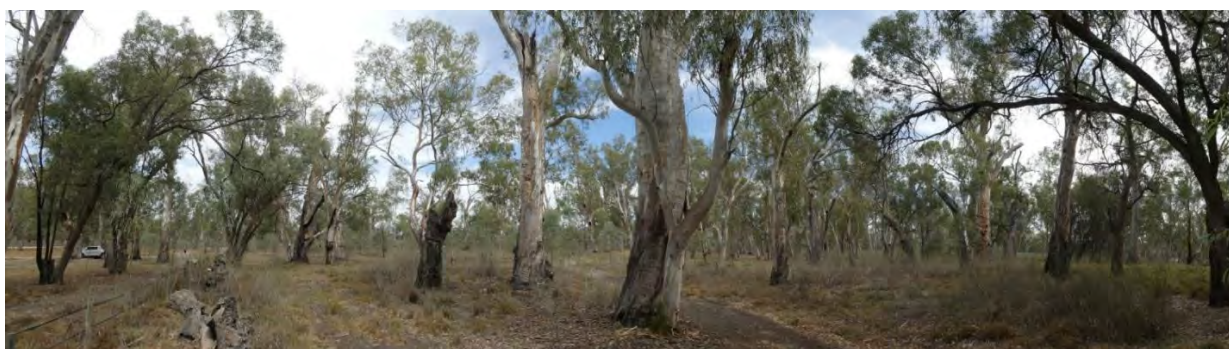
Western section within Hogwash Conservation Park Latitude 34.03919 Longitude 139.51105 Direction 246

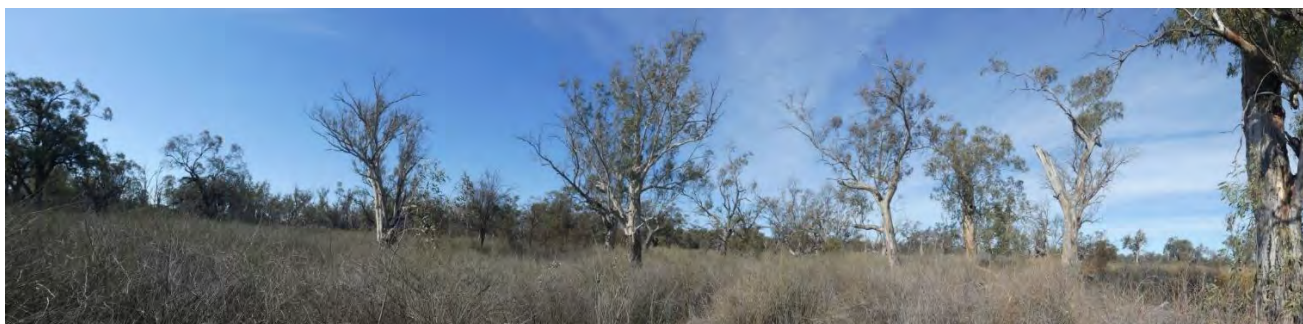
River Red Gum Woodland Stressed (level 3)	Majority patches of adult River Red Gum lining the bank of the western section of Wetland 1259. Odd adult dead River Red Gum and patches of saplings throughout the site. Understory dominated by Lignum with Creeping Saltbush and scattered Cooba
Lignum Shrubland Healthy (level 5)	Lignum dominates the bed of Wetland 1259 and 1258 and depression east of the road.

North eastern area of the site Latitude 34.04023 Longitude 139.50844 Direction 50

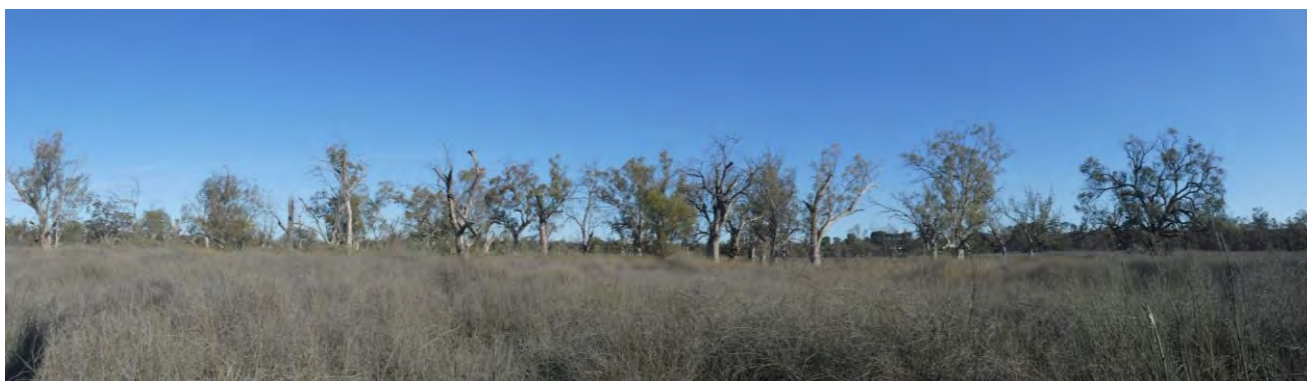
River Red Gum along the Southern shoreline of Wetland 125

Latitude 34.03988 Longitude 139.50744 Direction 150

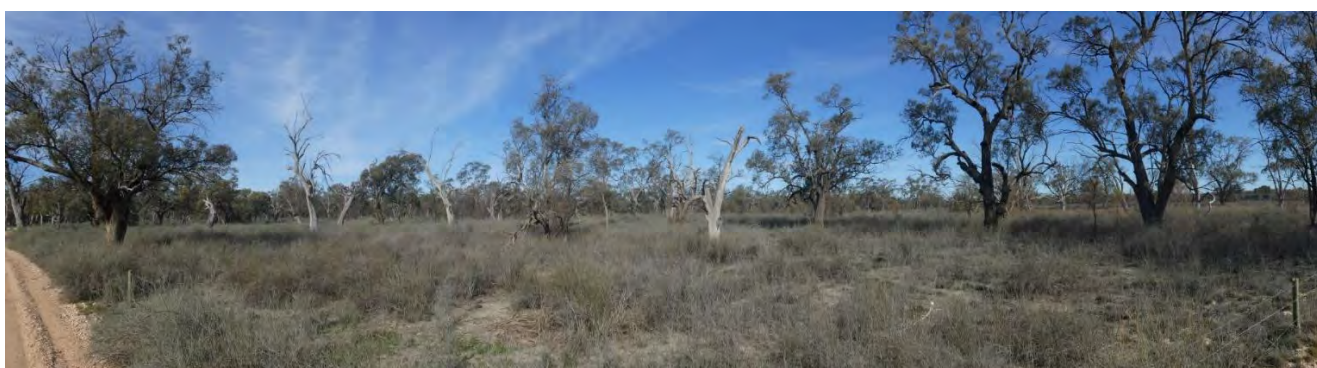
Black Box Woodland Healthy (level 4)	The site was once a mixed woodland but now the majority of River Red Gum are dead with a few still alive (in poor health) on the northern edge of the site. Healthy to poor adult Black Box dominate the site with patches of unhealthy Cooba adults and saplings. Understory dominated by patches of dense and sparse Lignum, Creeping Saltbush. Black Box sapling and seedlings in high density throughout the elevated areas of the site.
Lignum Shrubland Healthy (level 4 and 5)	Lignum dominates the eastern extension of Wetland 1259 and throughout the Black Box Woodland.

Western edge of Central Basin East Latitude 34.04061 Longitude 139.50983 Direction 130

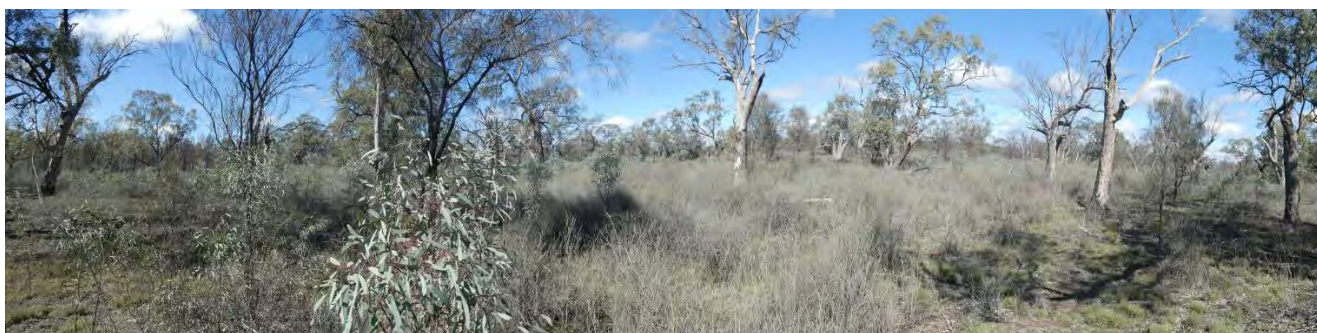
Eastern end of Central Basin East Latitude 34.04071 Longitude 139.57108 Direction 200

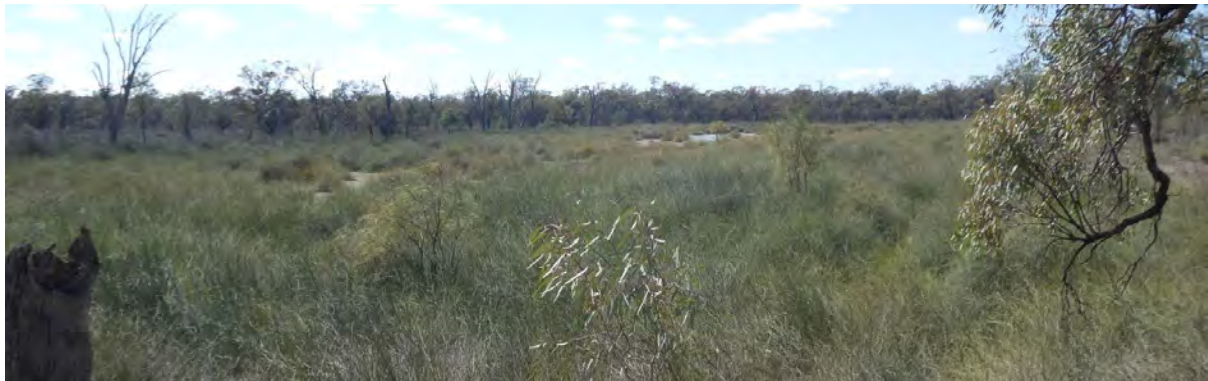
River Red Gum Woodland Degraded (level 1)	Majority of adult River Red Gum dead around edge of Wetlands 1549 and 1550. Patches of healthy young adult trees around the edge of Wetland 1546 with understory dominated by Lignum and Common Spike-rush with patches of Blown Grass and Clover.
Lignum Shrubland Healthy (level 4 and 5)	Wetland 1549 dominated by Lignum with open areas. Wetland 1546 large open areas with dense patches and scattered Lignum.
Low Shrubland/Herbland Stressed (level 3) and possibly Healthy (level 4 or 5)	Wetlands 1546 and 1549 would have Herbland areas but are flooded at time of survey. Wetland 1550 bed dominated by Creeping, Lagoon and Bladder Saltbush with patches of Clover and odd Pale Poverty Bushes.

Wetland 1549 Latitude 34.04185 Longitude 139.50692 Direction 80

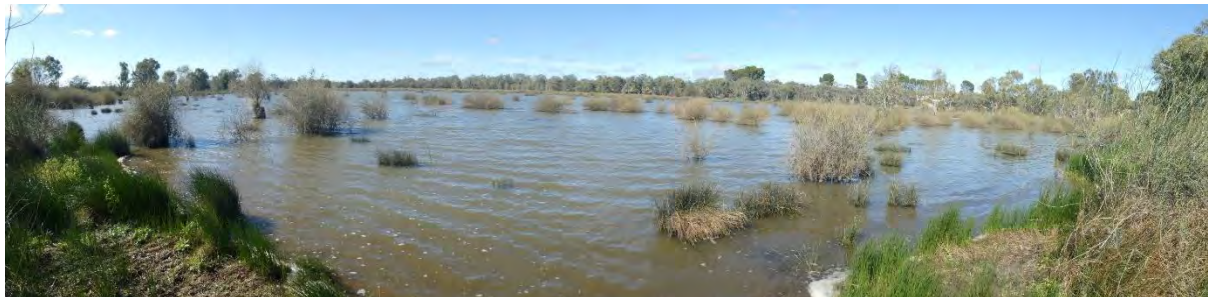
Wetland 1546 Latitude 34.04317 Longitude 139.50695 Direction 160

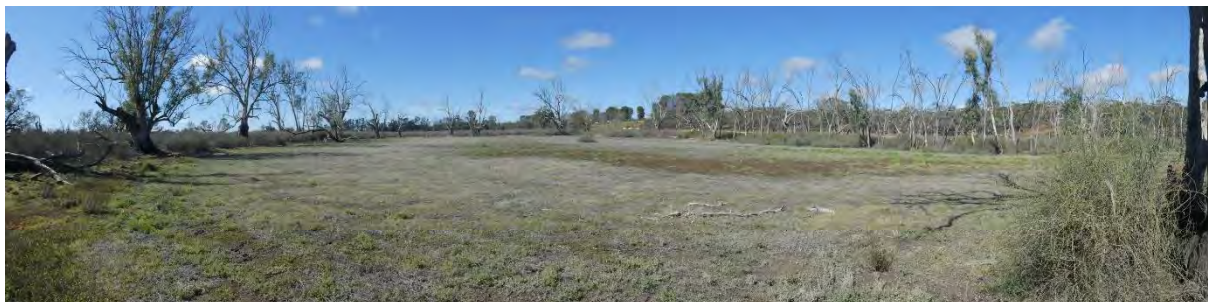
98 Wetland 1550 Latitude 34.04116 Longitude 139.50483 Direction 150

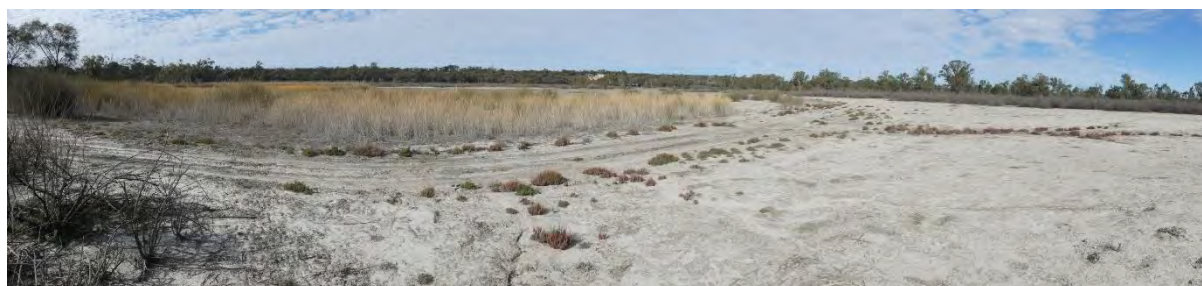
Lignum Shrubland Healthy (Level 4 and 5)	Lignum was scattered throughout the site ranging from large dense patches to scattered bushes on the floor of Wetland 1638 and 1675. Most of the floodplain edge had strips or scattered bushes. The majority of areas were healthy with some patches in Wetland 1638 stressed.
Low Shrubland/Herbland Stressed (level 3)	Ranged from Wetland 1638 dominated by Samphire and bare damp patches of salt crystals and no soil structure. Wetland 1665 small scattered patches of Samphire and Smooth Heliotrope, Ice-plant spp., Creeping Boobialla and Spiny Sedge, Rat's-Tail couch and Phragmites. Wetland 1675 Creeping Saltbush, Creeping Boobialla, Smooth Heliotrope, Spiny Sedge, Clover spp. and Ruby Saltbush. Health ranged between sites from degraded (level 0) to healthy.

Wetland 1665 downstream end Latitude 34.10694 Longitude 140.000882.Direction 150

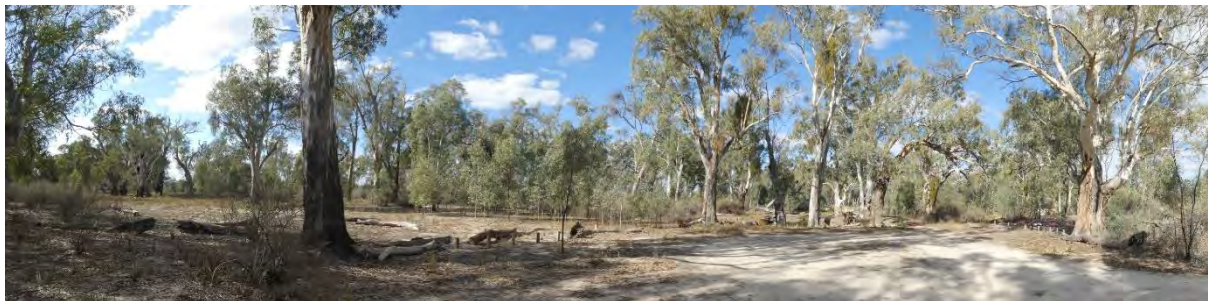
333 Campsite 45 Latitude 34.24620 Longitude 140.32339 Direction 160

River Red Gum Woodland Healthy (level 4)	Majority adult trees understory scattered patches of River Red Gum Saplings and Lignum, with Blue Rod and Creeping Boobialla.
--	---

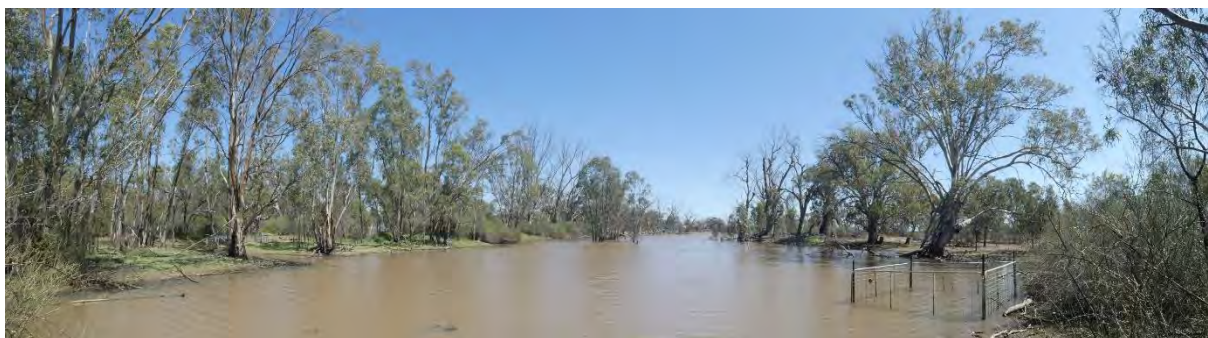
Katarapko Creek North Wetland 1984 Latitude 34.24735 Longitude 140.32122 Direction 250

River Red Gum Woodland Healthy (level 5)	The majority of adult trees around Wetland 1984 are dead with the remainder healthy (level 5) as are the trees along the southern watercourse.
Lignum Shrubland Healthy (level 5)	Healthy dense Lignum around the edge of Wetland 1984

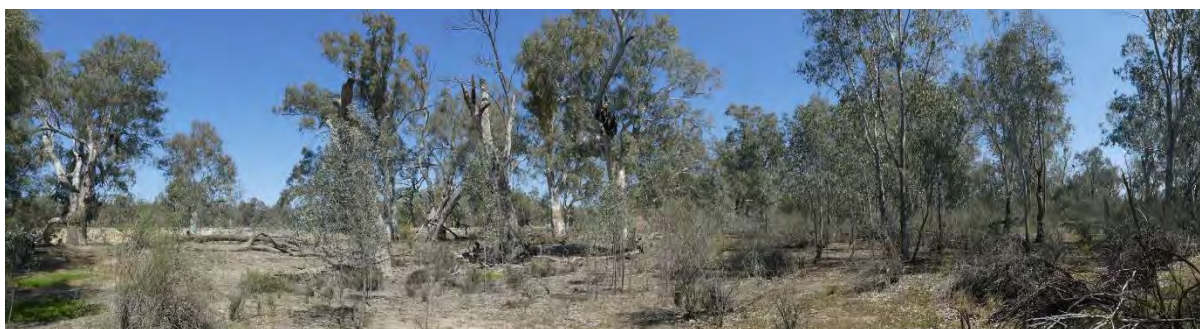
Katarapko Creek East creek edge Latitude 34.24806 Longitude 140.32267 Direction 230

River Red Gum Stressed (level 3)	Adults poor to good health with scattered patches of healthy saplings. Understory Blue Rod, Creeping Boobialla, desiccated Tussock Grass, Spiny Sedge, Nitre Bush seedlings and odd Lignum
Low Shrubland/Herbland Stressed (level 3)	Northern depression dominated by Creeping and Bladder Saltbush and odd Smooth Heliotrope with Lignum, Cooba and Nitre Bush on northern edge.

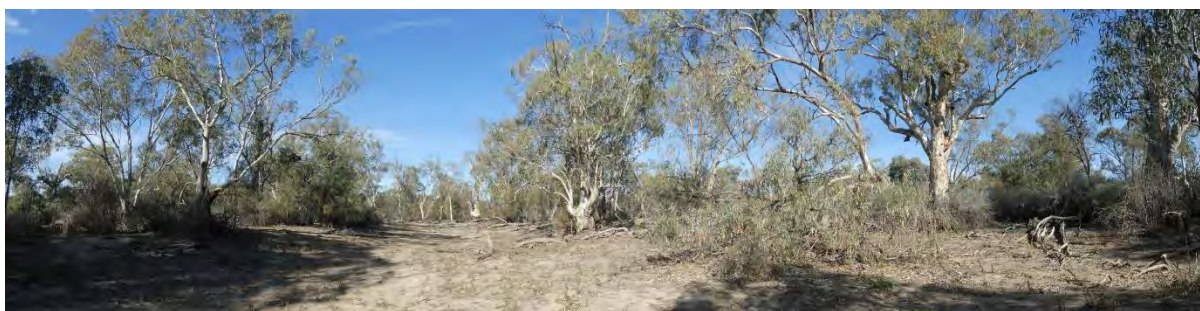
Upstream end of Creek Latitude 34.25065 Longitude 140.31844 Direction 190

River Red Gum Woodland Stressed (level 3)	Both downstream and upstream ends adult River Red Gums healthy (level 4) with patches of sapling. Cooba adults and sapling scattered along the watercourse bank. Moving towards the centre of the watercourse tree health changes from stressed to dead.
Low Shrubland/Herbland Healthy (level 4)	Watercourse floor Creeping Boobialla, Blue Rod, Rat's-Tail Couch and odd Smooth Heliotrope. Healthy (level 4)

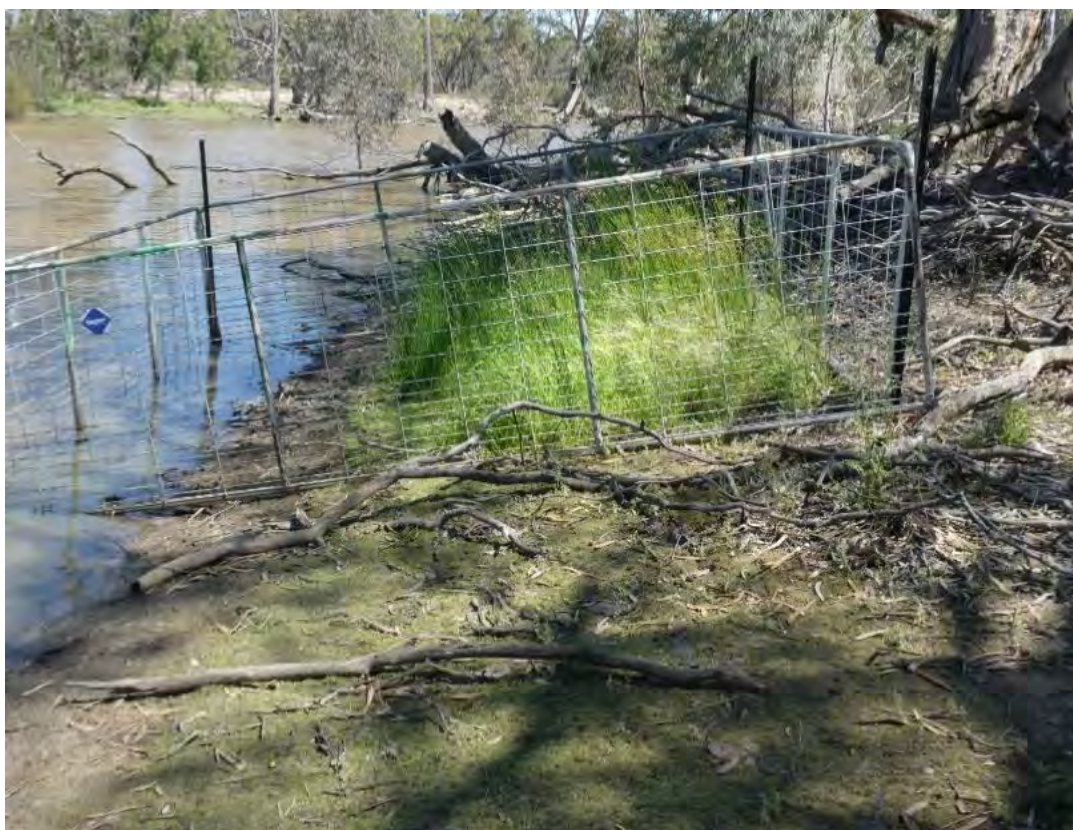
Kangaroo grazing impacts on the edge of Wetland 1984

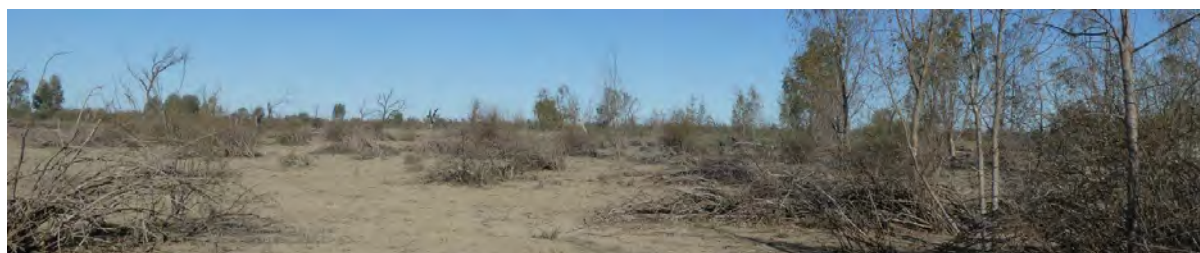
River Red Gum Woodland Stressed (level 3)	In 2007 the majority of adult River Red Gum were dead at the following Wetland sites 1541, 1078, 437 and 149. At Wetland 779 the gums were mostly alive but by 2015 were dead (Harper and Harper 2015). In January 2014 a bush fire spread across the site burning out most of the dead trees. In early 2015 the majority of the Wetlands received pumped Water for the Environment which aided the regeneration of River Red Gum throughout the sites. This recent survey revealed that there are significant number of healthy saplings and poles throughout northern section of the site except Wetland 149 where the young trees range from dead to stressed. The sandy elevated floodplain between the northern and southern sections of the site and along the eastern arms of Wetland 1541 and 1542 have scattered patches and individual healthy (level 4) and stressed (level 3) adult, poles and saplings River Red Gum with Cooba adults and saplings. Understory consists of Ruby Saltbush, Blue Rod, Rat's-Tail Couch, Creeping Boobialla and patches and odd Nitre Bush and Lignum.

Stressed River Red Gum saplings at Wetland 149 Latitude 34.10029 Longitude 140.20766.Direction 100

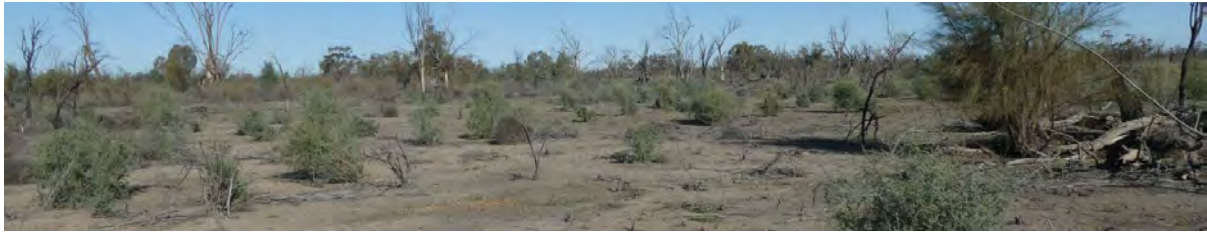
Nitre Bush regrowth within the fire scar between Wetland 779 and the eastern inlet watercourse.
Latitude 34.10029 Longitude 140.20766.Direction 100

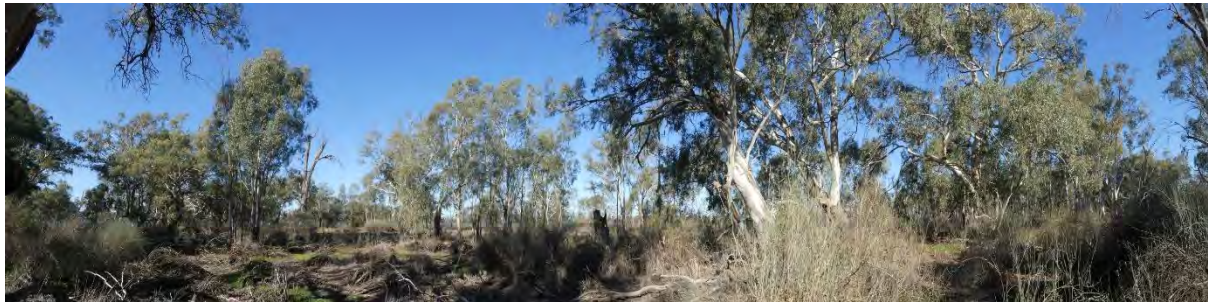
Downstream end Latitude 34.23956 Longitude 140.29183.Direction 200

River Red Gum Woodland Stressed (level 3)	Large healthy (level 4) adult trees with poles and sapling throughout the gutters inside the bend. Understory patches of Lignum, Spiny Sedge, Creeping Boobialla and odd Smooth Heliotrope. Eastern depression scattered with dead River Red Gum with healthy (level 4) adult and sapling River Red Gum and Cooba along the western edge.
Lignum Shrubland healthy (level 5)	Eastern depression dominated by dense Lignum.

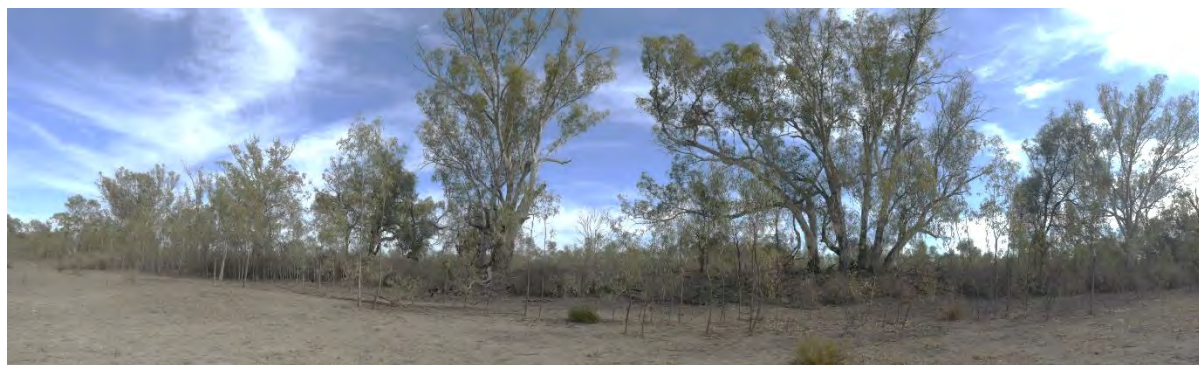
Northern bank of Little Schiller Lagoon Latitude 34.04850 Longitude 139.55551 Direction 312

River Red Gum Woodland Stressed (level 3)	River Red Gum adults and saplings, odd Black Box, Cooba adults and saplings. Understory Lignum and Spiny Sedge, Lagoon Saltbush.
Low Shrubland/Herbland Healthy (level 4)	Lagoon bed dominated by River Red Gum saplings with Spiny Sedge and Lagoon Saltbush.
