Maximising Water Delivery for Regent Parrot Outcomes

Water for the Environment Program

Document Title: Maximising Water Delivery for Regent Parrots

Date: March 2021

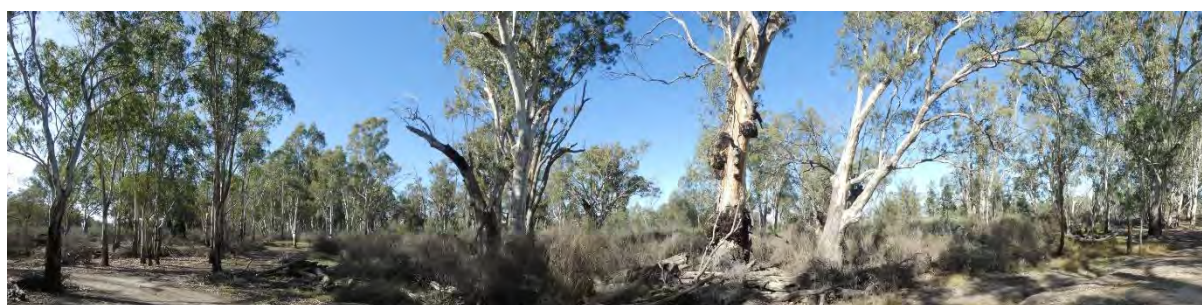
271 Western end of floodplain Latitude 34.22746 Longitude 140.27297 Direction 150

River Red Gum Woodland Stressed (level 3)	Floodplain dominated by adult hollow bearing River Red Gum with patches of saplings. Healthy (level 4). Understory Cooba adult and sapling small patches of Lignum, Spiny Sedge, Blue Rod, and Smooth Heliotrope. Edge of Lagoon River Red Gum predominately dead. Degraded (level 1).
Black Box Woodland Healthy (level 4)	Edge of Lagoon dominated by Black Box and Cooba adult and sapling with Lignum dominated understory.
Low Shrubland/Herbland Stressed (level 2)	Wetland 519 Southern upper edge Smooth Heliotrope, Creeping Saltbush, Ruby Saltbush, Creeping Boobialla and Lagoon Saltbush. Lagoon floor and northern edge dominated by Samphire with patches of bare soil.

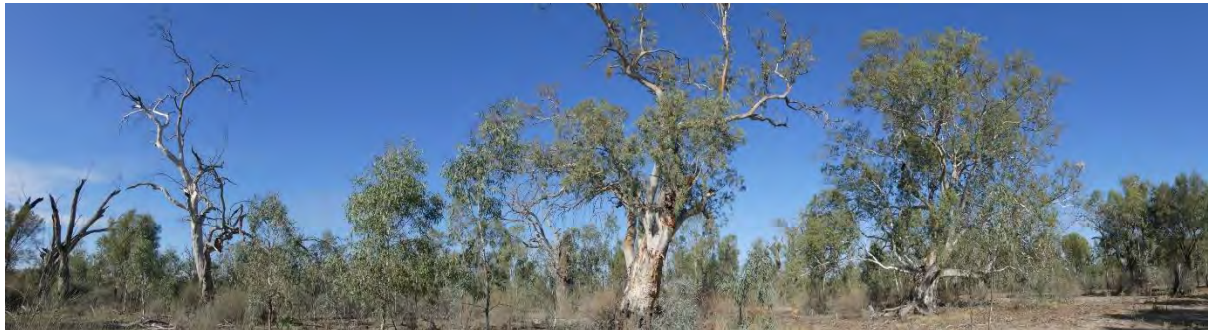
Latitude 34.03282 Longitude 139.51152 Direction 190

River Red Gum Woodland Stressed (level 3)	Stressed adult trees with patches of healthy poles and saplings. Understory Lignum, Spiny Sedge, Smooth Heliotrope, Native Liquorice, Creeping Saltbush, Lagoon Saltbush and Bladder Saltbush.
---	--

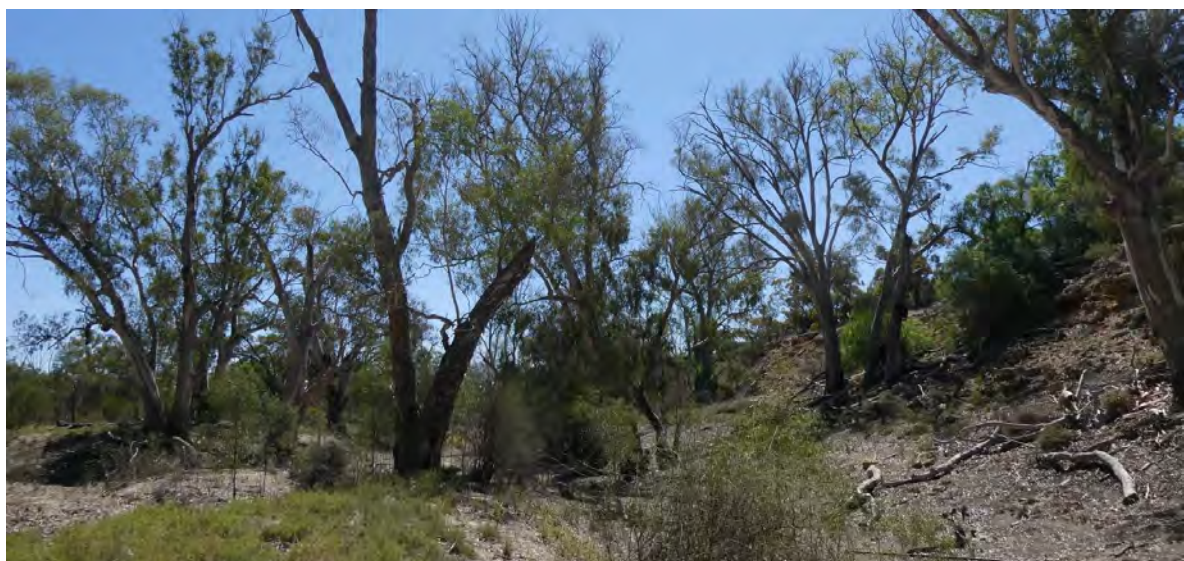
Latitude 34.03889 Longitude 139.51384 Direction 350

River Red Gum Woodland Stressed (level 3)	Healthy and stressed adult trees with patches of healthy saplings. Understory Lignum, Blue Rod, Spiny Sedge, Cooba adults and saplings, Ruby Saltbush, Lagoon Saltbush and Yanga Bush.
---	--

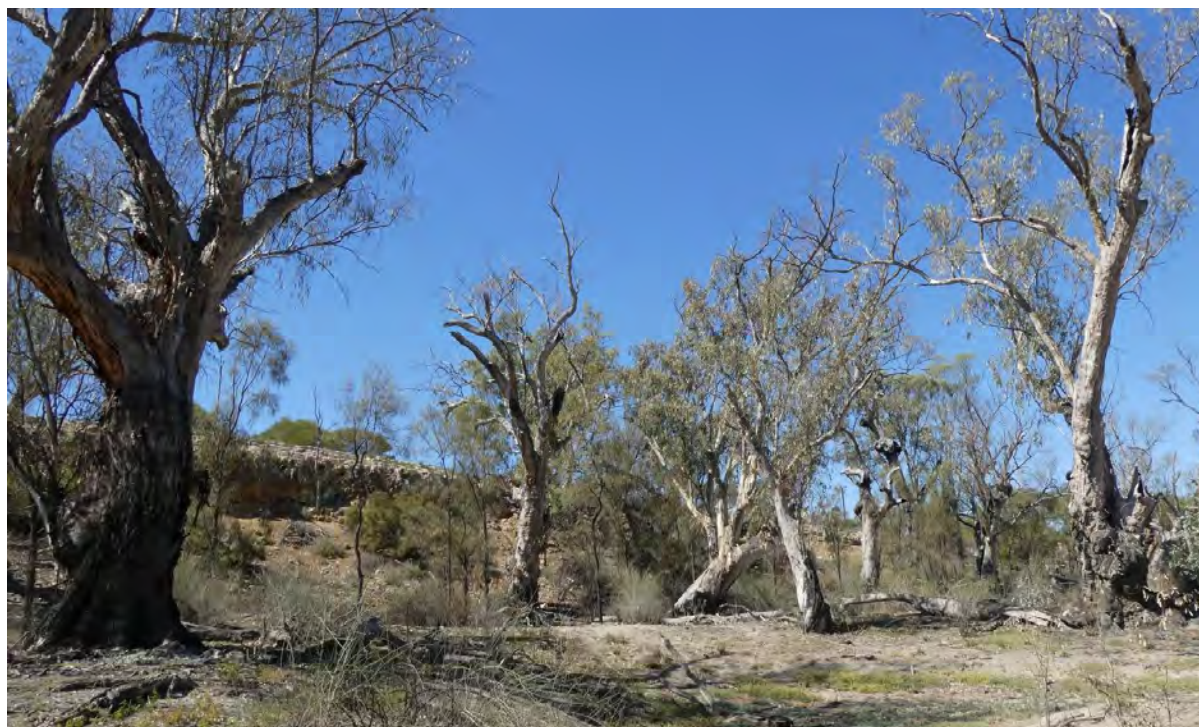
Existing Watering site Latitude 34.04165 Longitude 139.51538 Direction 96

River Red Gum Woodland Stressed (level3)	River Red Gum adults and saplings (poles mostly dead). Understory Cooba adult and saplings, scattered Lignum patches, Creeping Saltbush, Lagoon Saltbush, Ruby Saltbush, Smooth Heliotrope, Blue Rod, Native Liquorice, Bladder Saltbush, Pale Poverty Bush.
--	--

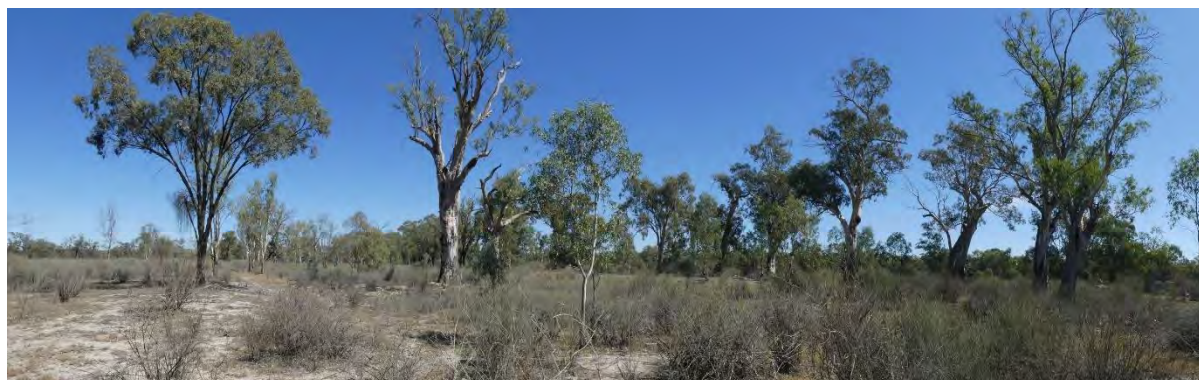
Western section of site Latitude 34.04500 Longitude 139.51416.Direction 240

River Red Gum Woodland Stressed (level3)	River Red Gum adults, poles and saplings. Understory odd Cooba, scattered Lignum, Creeping Saltbush, Lagoon Saltbush, Ruby Saltbush and Native Liquorice.
Black Box Woodland Healthy (level 4)	Scattered adults and saplings across the eastern section of the site with Cooba and dense Lignum understory.
Lignum Shrubland Healthy (level 4 and 5)	Continuous thick Lignum across the eastern section of site with odd Black Box and Cooba.

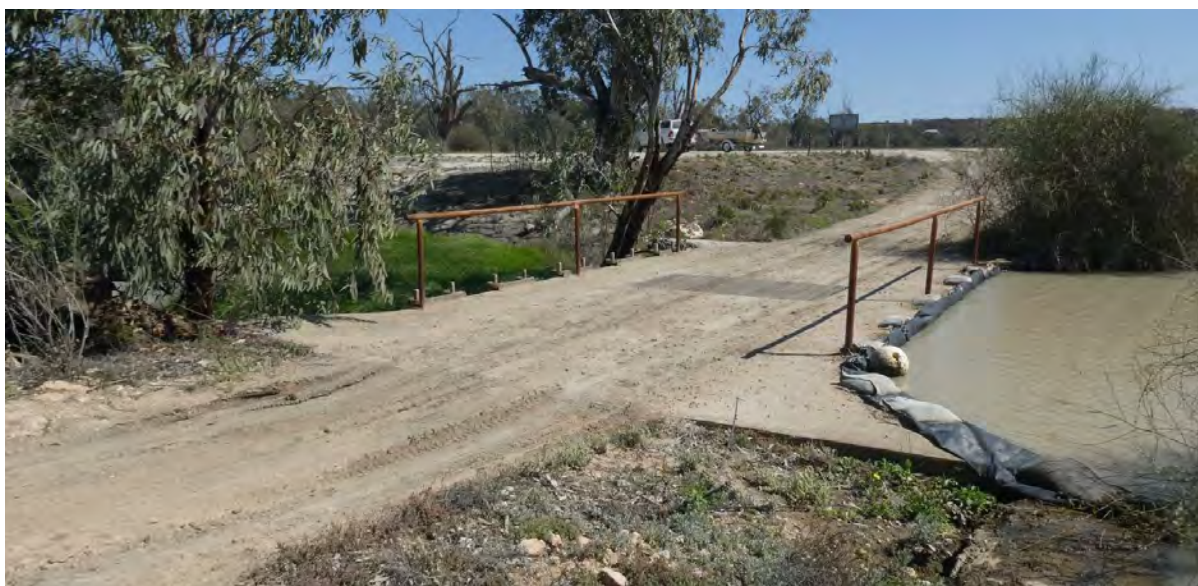
**Overland Corner outlet structure - Note the plastic on the wetland side to hold back pumped water.
(Photo: by M Harper)**

Potential Infrastructure Requirements

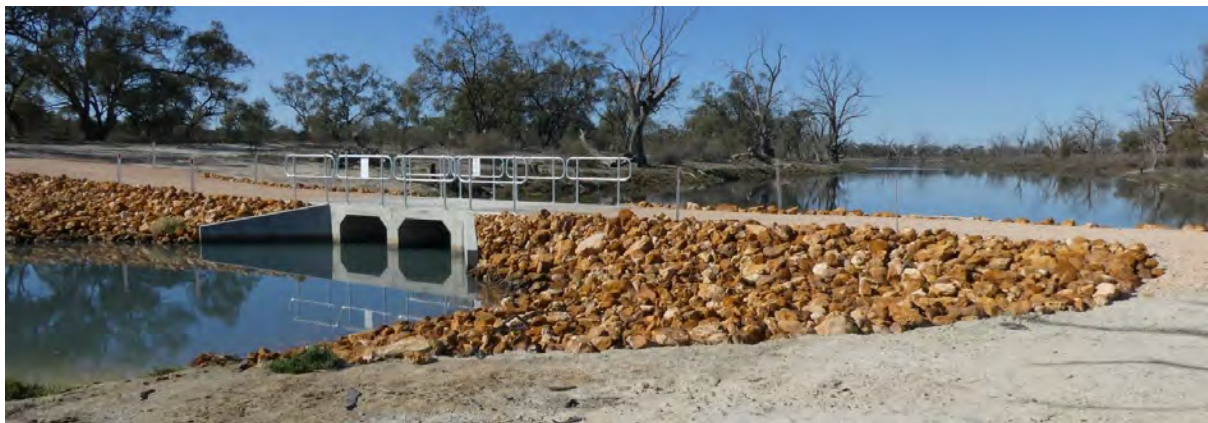
Putjeda Creek downstream Box Culvert

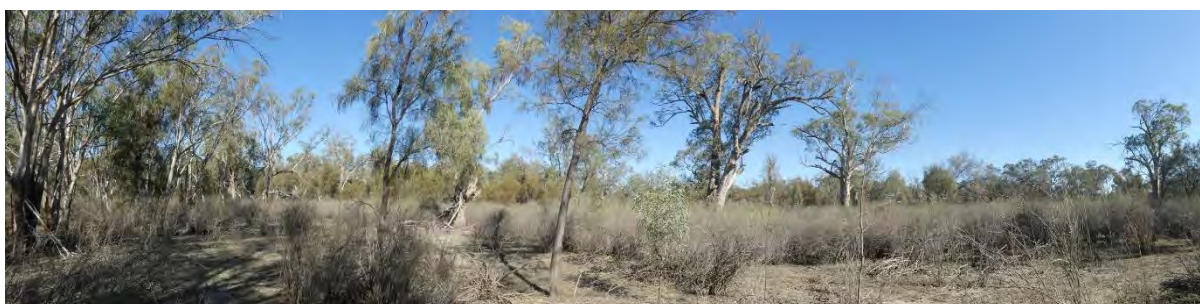
1.5m diameter gum in the centre of the site

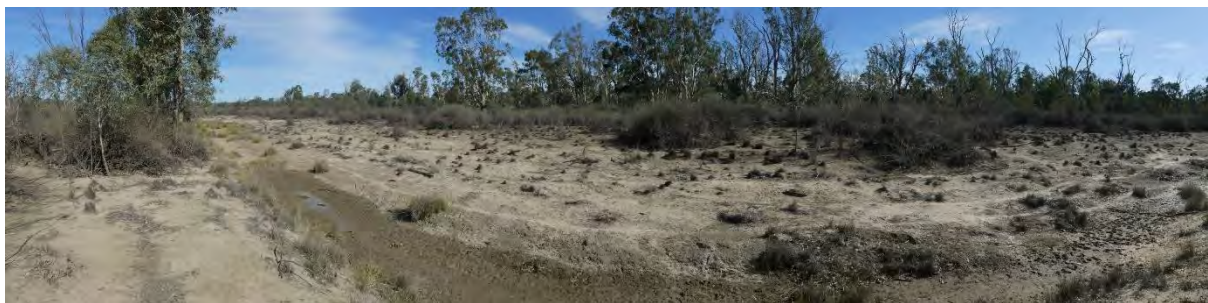
River Red Gum Woodland Stressed (level 3)	Upstream flood-out River Red Gum adults, poles and saplings stressed (level 3). Understory Cooba adults and saplings, Lignum, desiccated Tussock Grass, Spiny Sedge and Rat's-Tail Couch. Lagoon edge River Red Gum adults and saplings patches of long-term dead, majority healthy with areas of stressed trees away from water's edge.
Lignum Shrubland Healthy (level 4 and 5)	Lignum areas both scattered and dense patches along the lagoon edge and throughout the upstream flood-out.
Low Shrubland/Herbland Healthy (level 4)	Wetland 554 bed Spiny Sedge, Rat's-Tail Couch, Patches of Cumbungi and Clover spp. Upstream flood-out Herbland Spiny Sedge, Rat's-Tail Couch and odd Lignum. All heavily grazed by stock and Kangaroos.

Western area of Northern Flood-out Latitude 34.30148 Longitude 139.34532.Direction 240

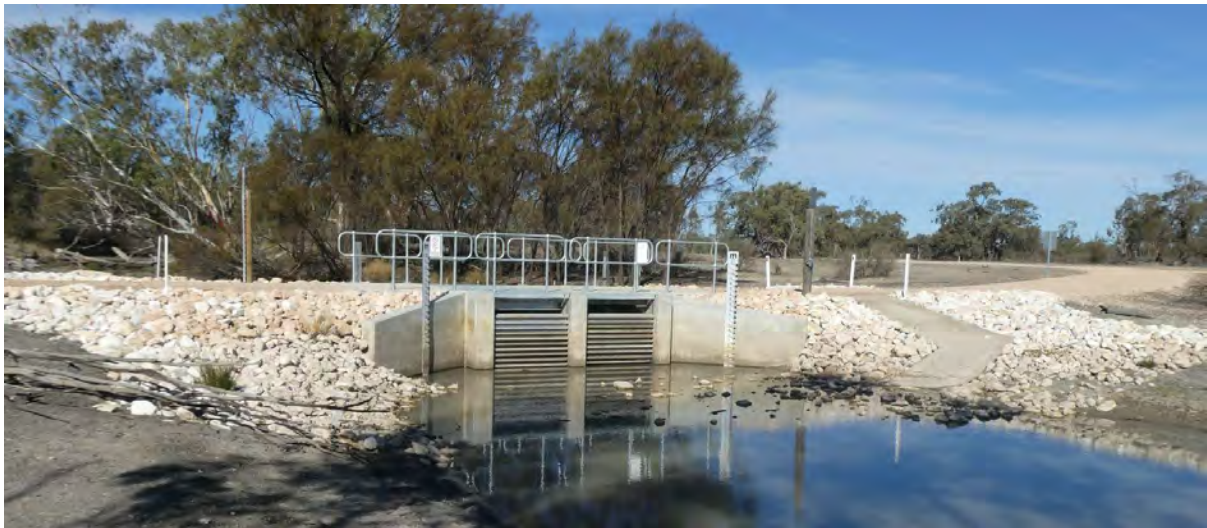
Existing Box Culvert located at Bank 3

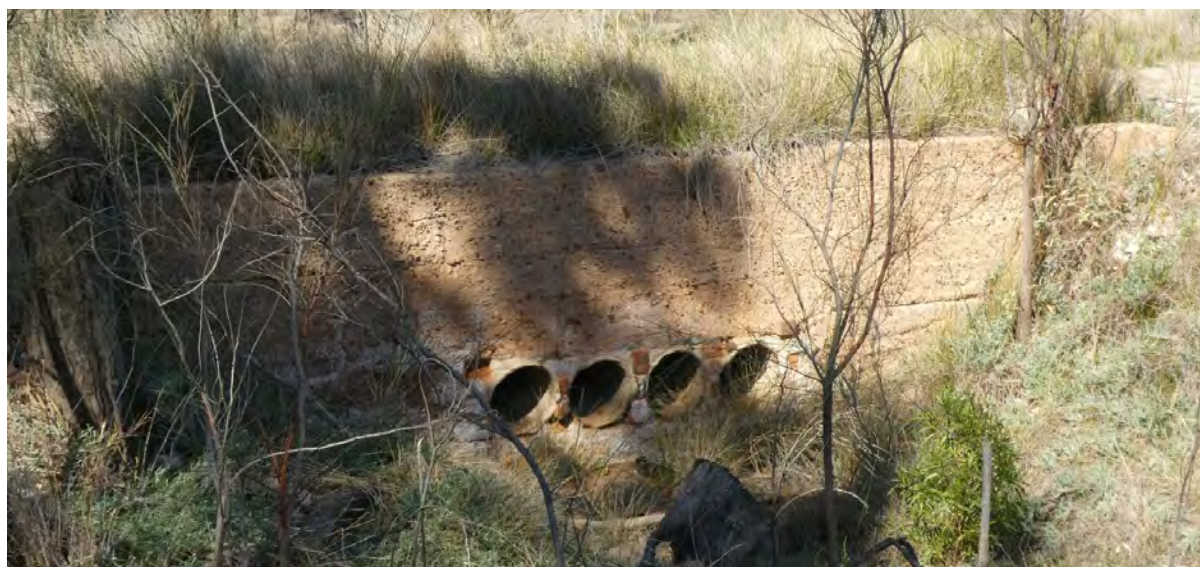
Taylor Flat Outlet Creek road crossing

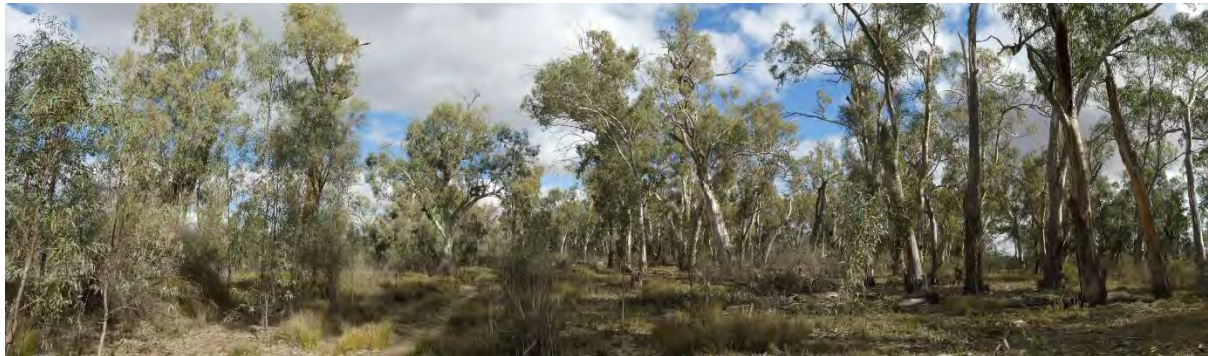
Westbrook Regent Parrot nesting colony site.

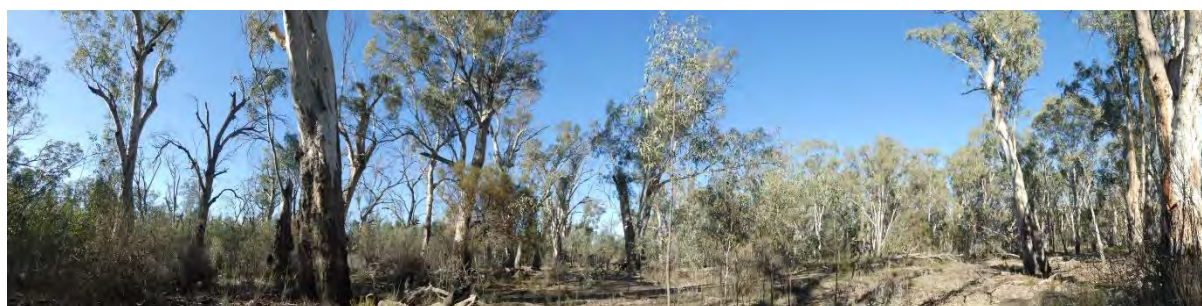
Existing Regent Parrot nesting site Latitude 34.01054 Longitude 140.52194 Direction 136

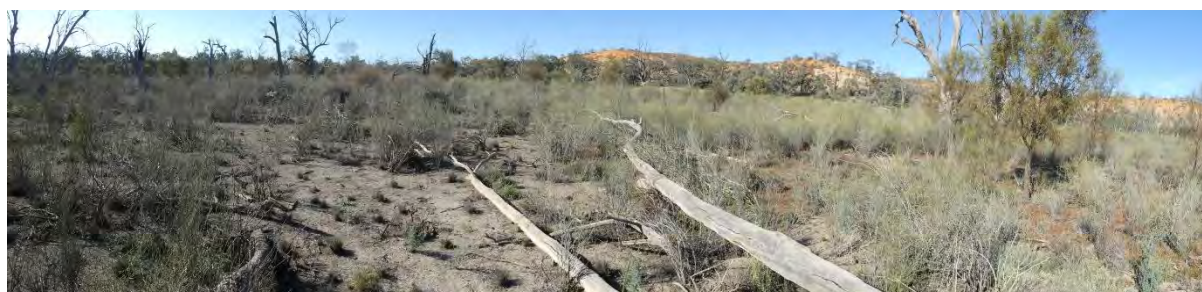
Flood-out east of Wetland W3 Latitude 34.01382 Longitude 140.52274 Direction 120

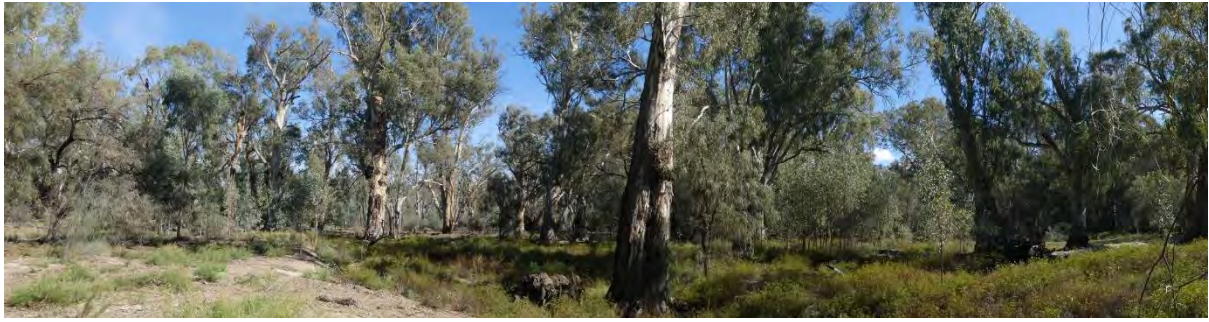
Main inlet flow path from River @ Bank 3 Latitude 34.01045 Longitude 140.52387 Direction 260

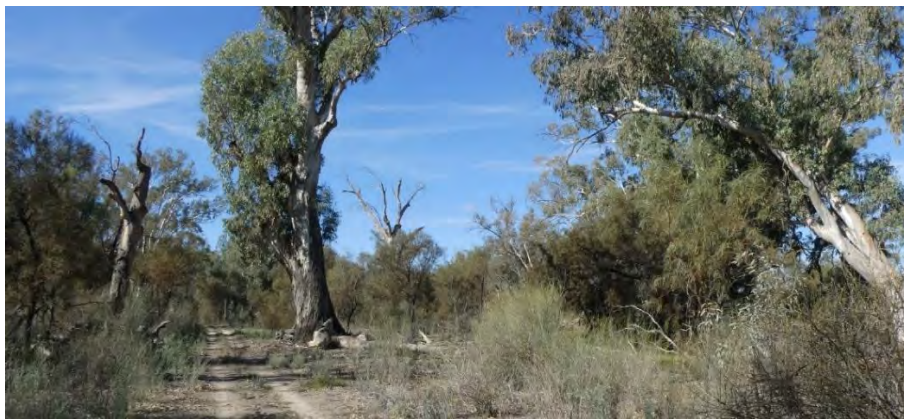
North Western Flood-out of Wetland W1 Latitude 34.01196 Longitude 140.52411 Direction 110

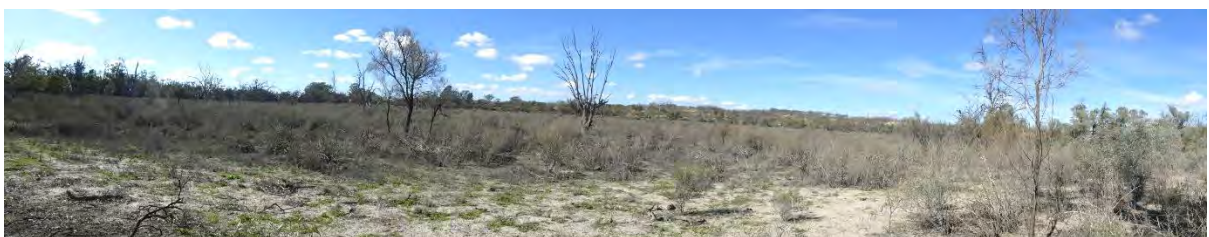
Upstream Lignum Depression Latitude 34.01363 Longitude 140.52881 Direction 94

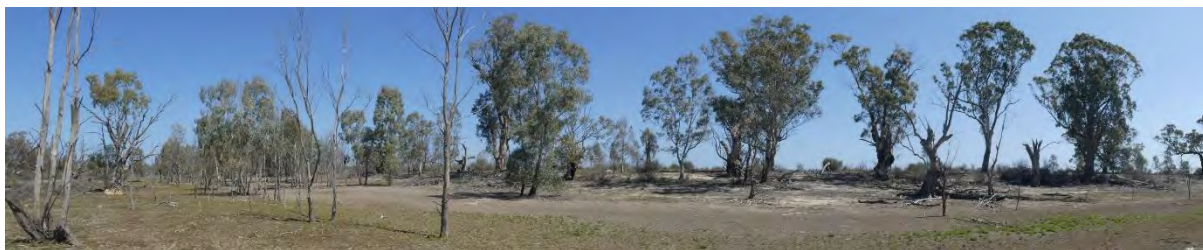
The 2019/20 watering event influenced tree high up the creek bank

Latitude 34.26421 Longitude 140.33364 Direction 270

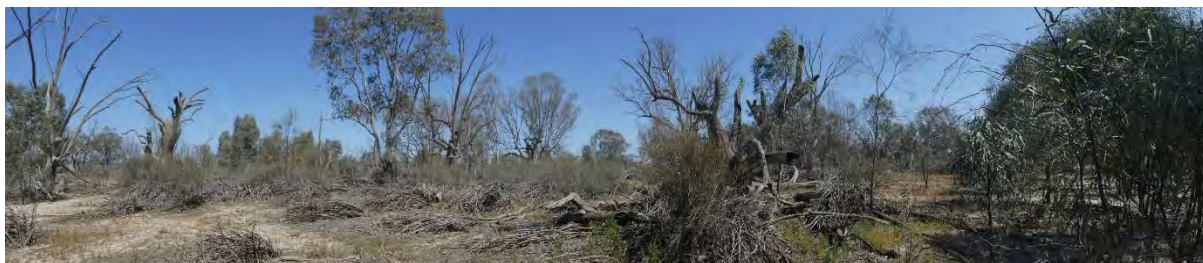
Above the influence of the 2019/20 watering event Latitude 34.26264 Longitude 140.33484 Direction 220

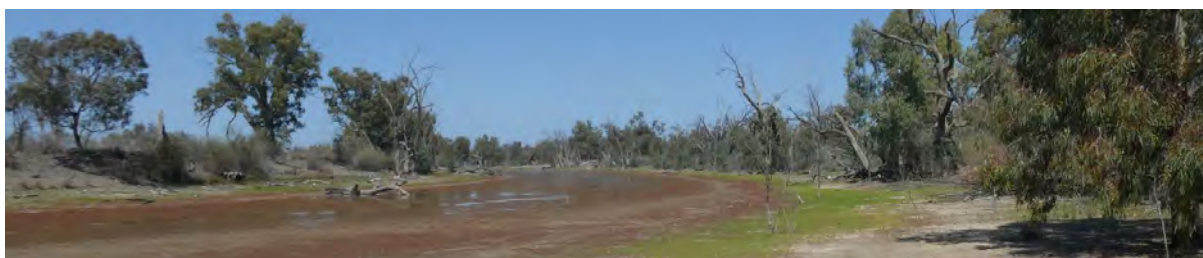
Remnants of the 2019/20 watering event Latitude 34.25998 Longitude 140.33384 Direction 170

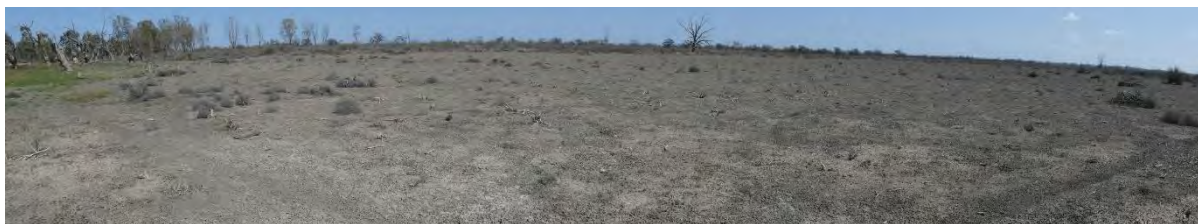
North western flood-out Latitude 34.25760 Longitude 140.33414 Direction 270

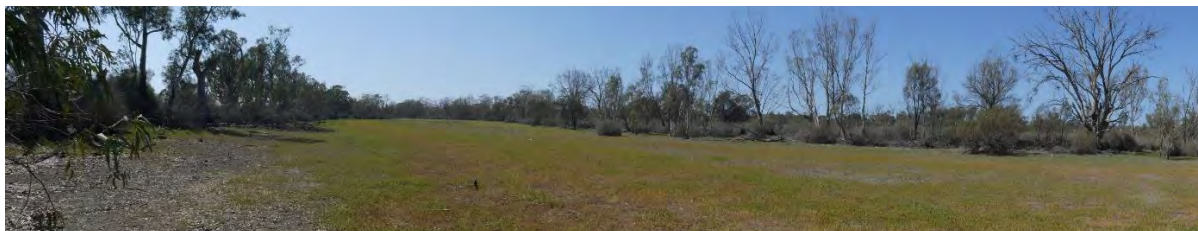
Bed of Central section of lagoon Latitude 34.26717 Longitude 140.33571 Direction 80

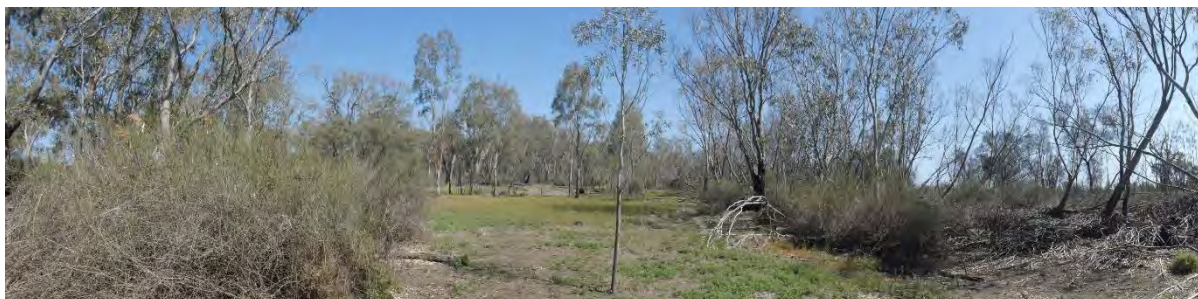
Elevated bed between the two open lagoon areas Latitude 34.26782 Longitude 140.33392 Direction 280

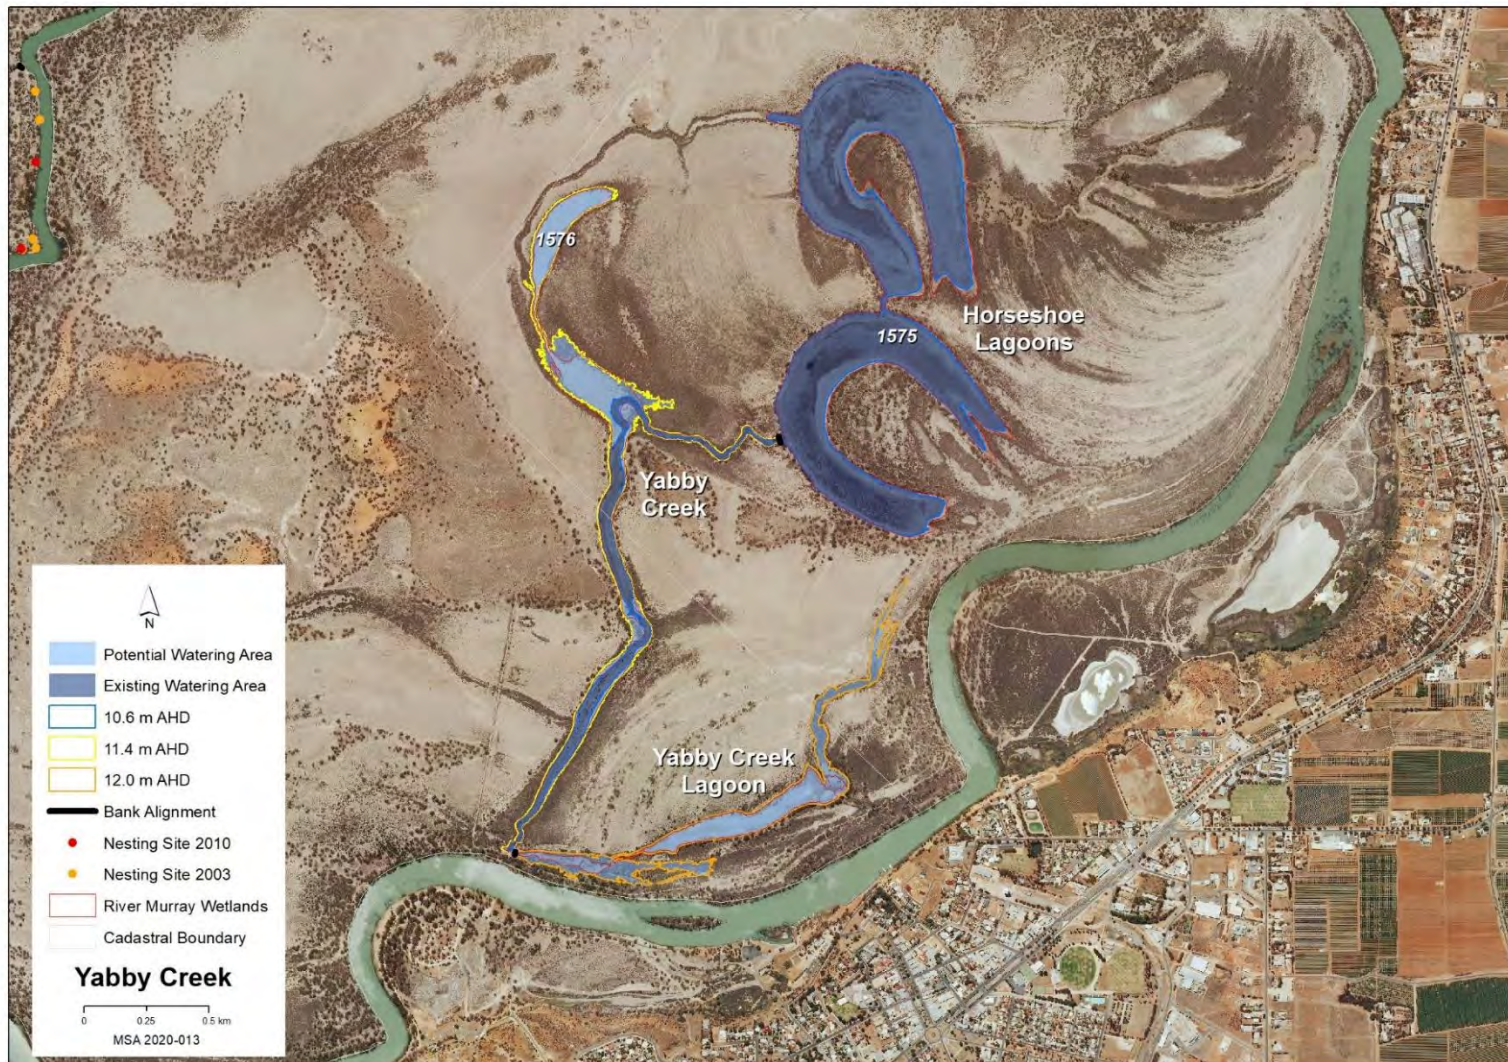
Map identifies the existing and potential watering areas

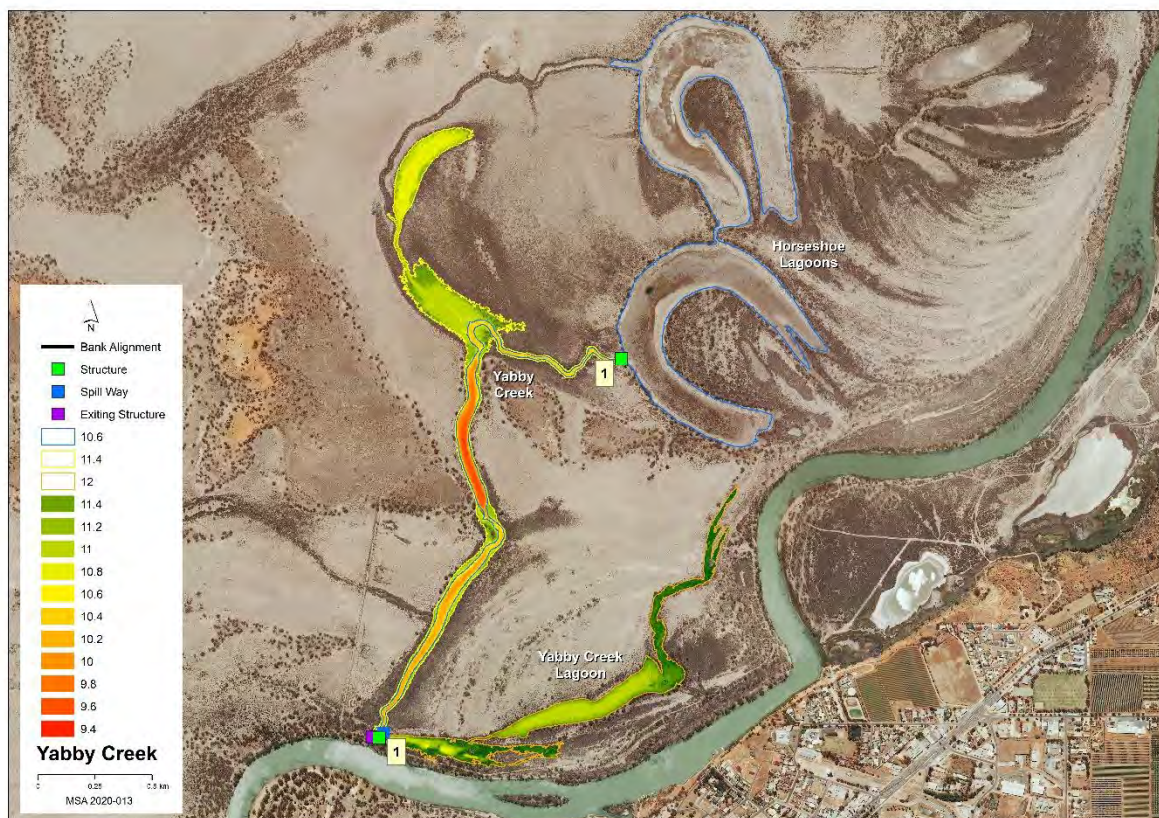
Map features AHD heights across the site and identified infrastructure locations

Bank or Channel Details						
Location	ID	Length (m)	Freeboard (m)	Height with freeboard (m)	Volume (m3)	Regulator equipment and comments
Yabby Creek	Bank 1	26.3	0.50	1.70	254.5	Sheetpile regulator with 3 bays of dropboards
Yabby Creek Lagoon	Bank 1	12.6	0.30	0.90	57.4	600mm concrete pipe with flap valve

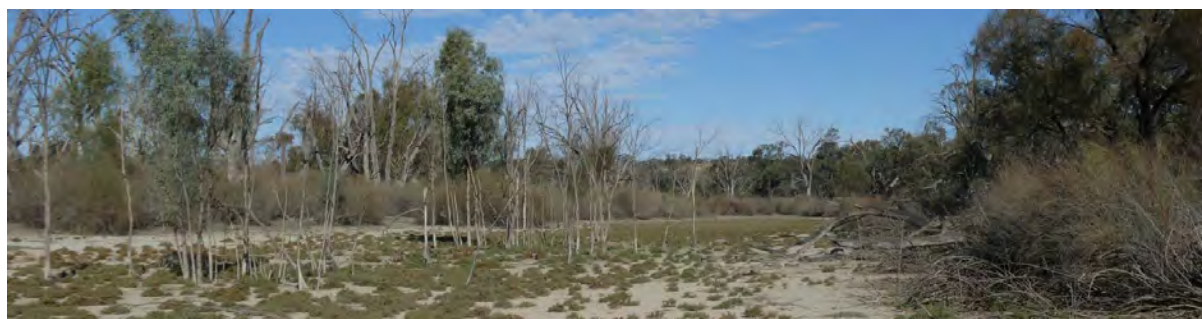
Wetland 306 eastern finger flood-out Latitude 34.09721 Longitude 140.08701 Direction 130

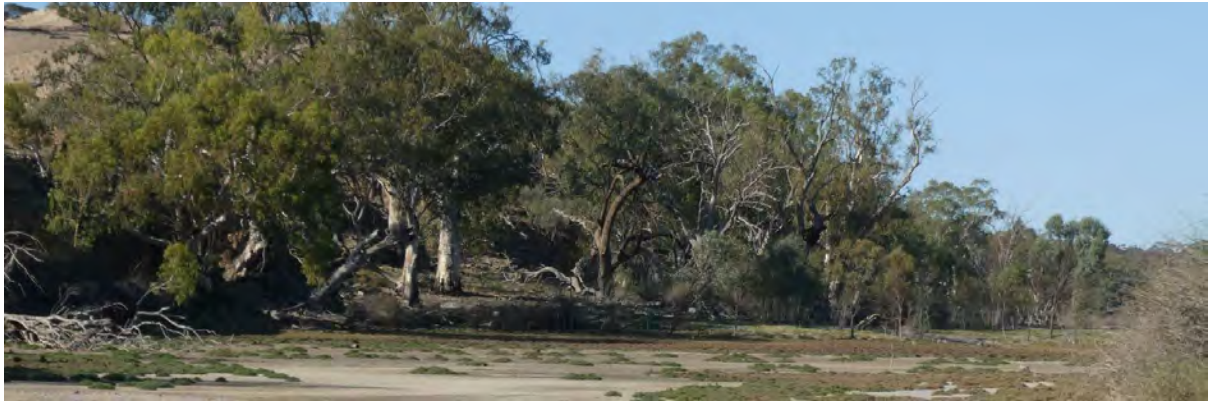
Northern cliff edge of Wetland 306

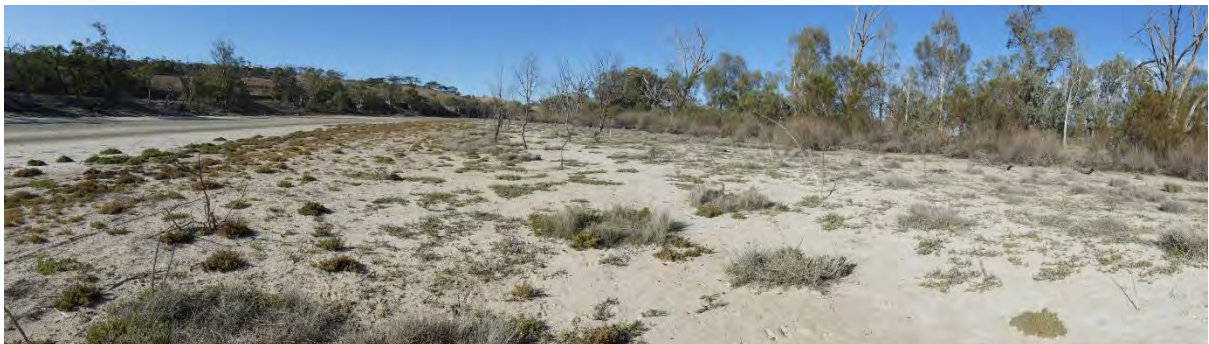
Central section Of Wetland 306 Latitude 34.09871 Longitude 140.08300 Direction 40

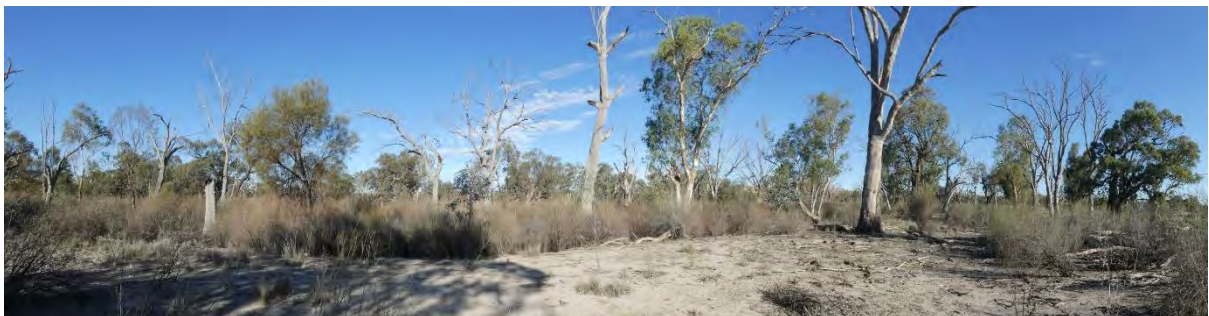
One of the four parallel floodplain features Latitude 34.09947 Longitude 140.08291 Direction 124

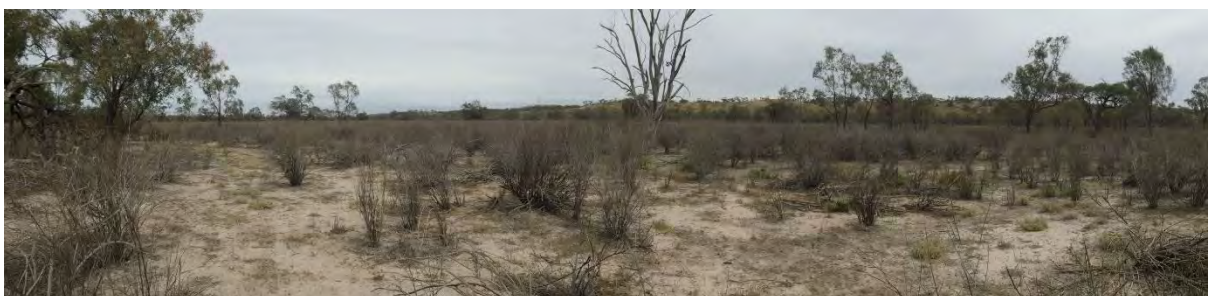
Wetland 559 Latitude 34.10260 Longitude 140.07927 Direction 300

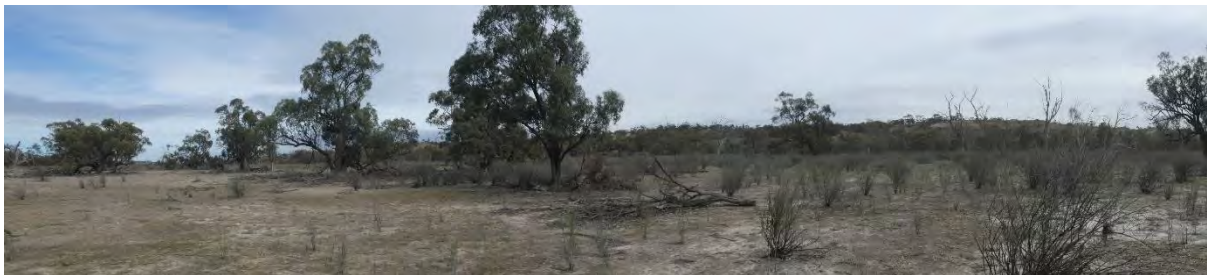
Flood-out between Wetland 419 and 421 Latitude 34.10340 Longitude 140.07410 Direction 250

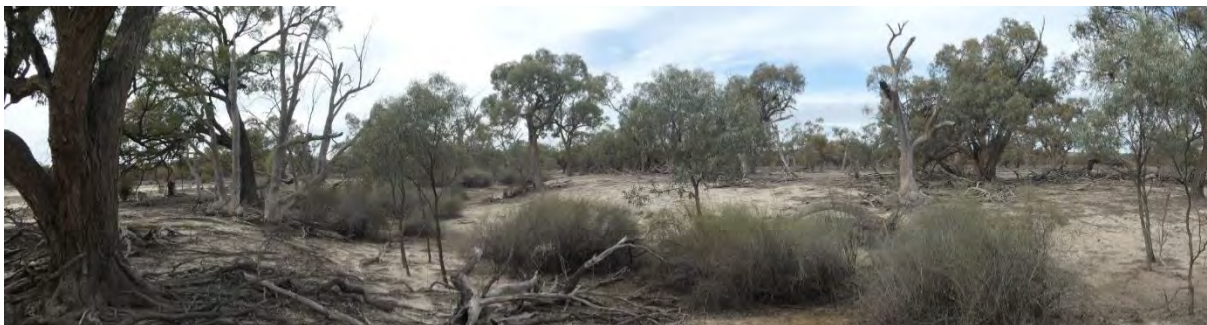
Wetland 421 (outlet watercourse) Latitude 34.10356 Longitude 140.07497 Direction 150
