Report onto the Warrego River flow into the Darling: April - June 2019

Prepared for the Commonwealth Environmental Water Office as part of ongoing monitoring

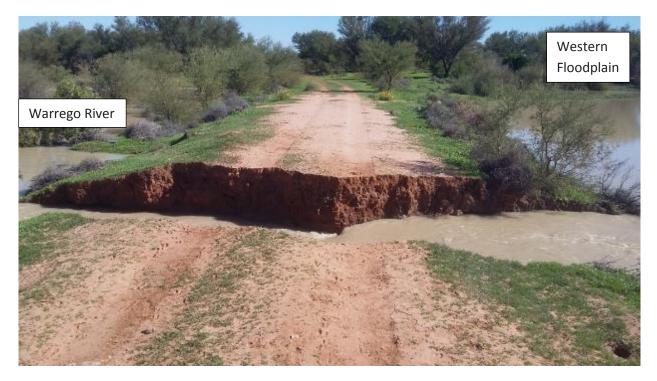
Figure E7: Breach in the eastern embankment between the Western Floodplain (right) and Warrego River (left)

Some water returned to the Warrego River and flowed back into the Darling through a breach in the embankment between the Western Floodplain and Warrego River (Figure E7) near Booka Dam. The flow through Toorale was also impeded initially by the passing capacity of pipes in Peebles Dam and water backed up and flowed into Ross Billabong on the eastern side of the Warrego. Most of this water subsequently drained back into Peebles Dam where it then passed to the Darling River. These floodplain flows would have reduced the peak of the flow in the Warrego River and into the Darling but likely extended the duration of the flow.

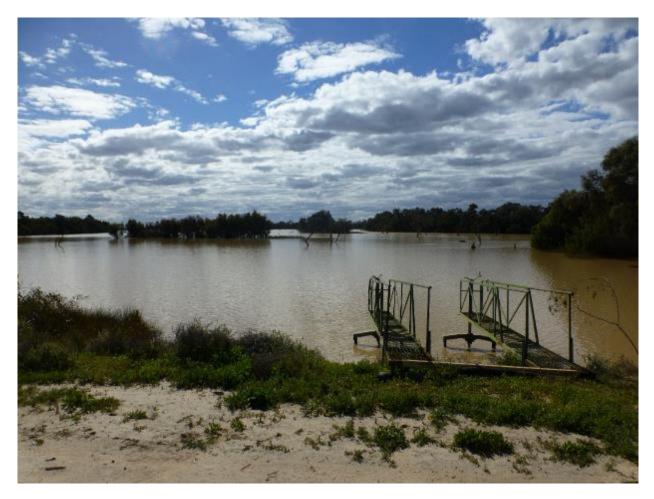
Figure 4: Regulating gates on Boera Dam

Currently, the gates at Boera have a limited capacity to allow large flows through to the Warrego River. Even with the gates open, once Boera Dam is full (capacity 1.5 GL), any flows greater than around 600 ML/d, raise the level of the dam and flow onto the Western Floodplain or through the Eastern Bywash and into the Warrego River below the dam. During the April-June flow event, the gates at Boera Dam were open for the equivalent of 40 days, or 77% of the flow duration. The gates were fully opened as water moved into Boera Dam on the 22 April 2019 and remained open until Boera Dam fell back below the Western Floodplain connection level. One gate was then closed on the 28th May, before both gates were closed on the 1 June 2019. One gate was then partially opened over the period $6 - 14^{th}$ June 2019 to allow water to flow down the lower Warrego River and maintain Boera Dam at around 2m on the gauge.

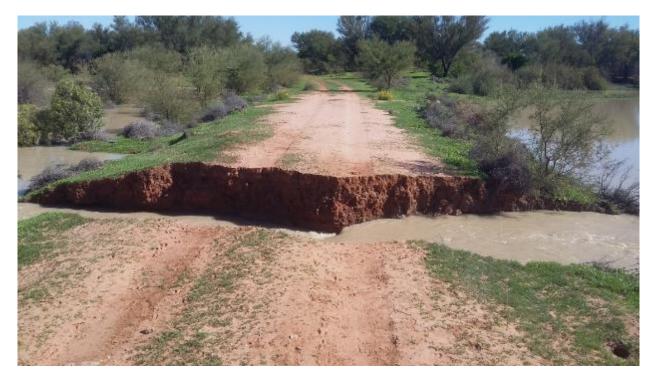
Figure 5: Breach in the eastern embankment between the Western Floodplain (right) and Warrego River (left)

When inflows exceed outflows through Boera Dam or the regulating gates are shut, water is diverted either onto the Western Floodplain, or around the dam wall via the Eastern Bywash and back into the Warrego River. Generally, water on the Western Floodplain is kept from re-entering the Warrego River by an embankment. However, during the April-June flow event in 2019, this embankment was breached (seemingly, shortly before 15 April), allowing water from the floodplain to re-enter the Warrego River

upstream of Booka Dam (Figure 5). Without this breech, much more water would have remained on the Western Floodplain during the event.

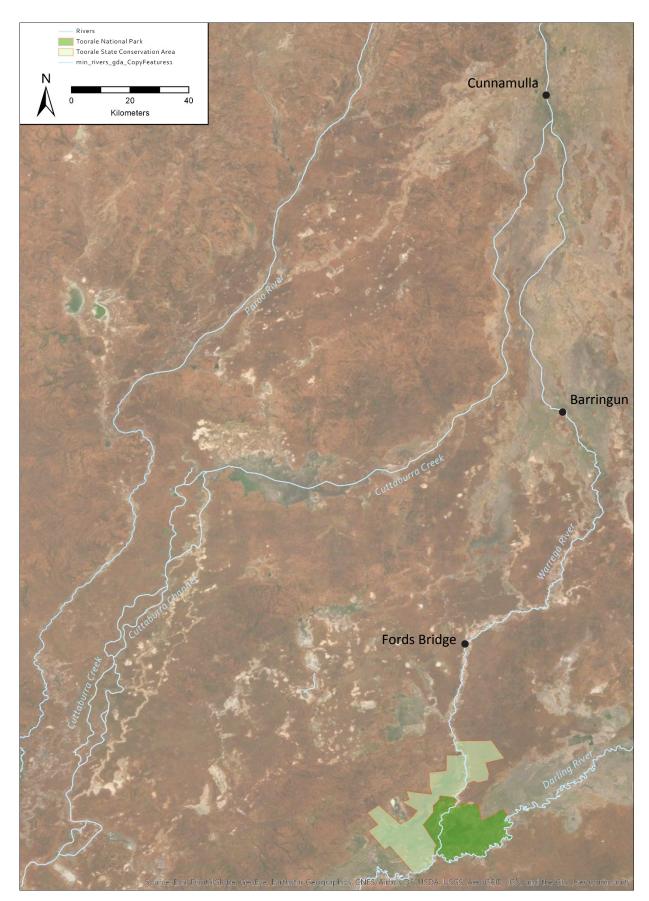
Figure 6: Upper Warrego and Paroo River catchments. Green polygons represent the Toorale National Park and State Conservation area
