# Ruins

A guide to conservation and management

**Australian Government**  
**Australian Heritage Council**

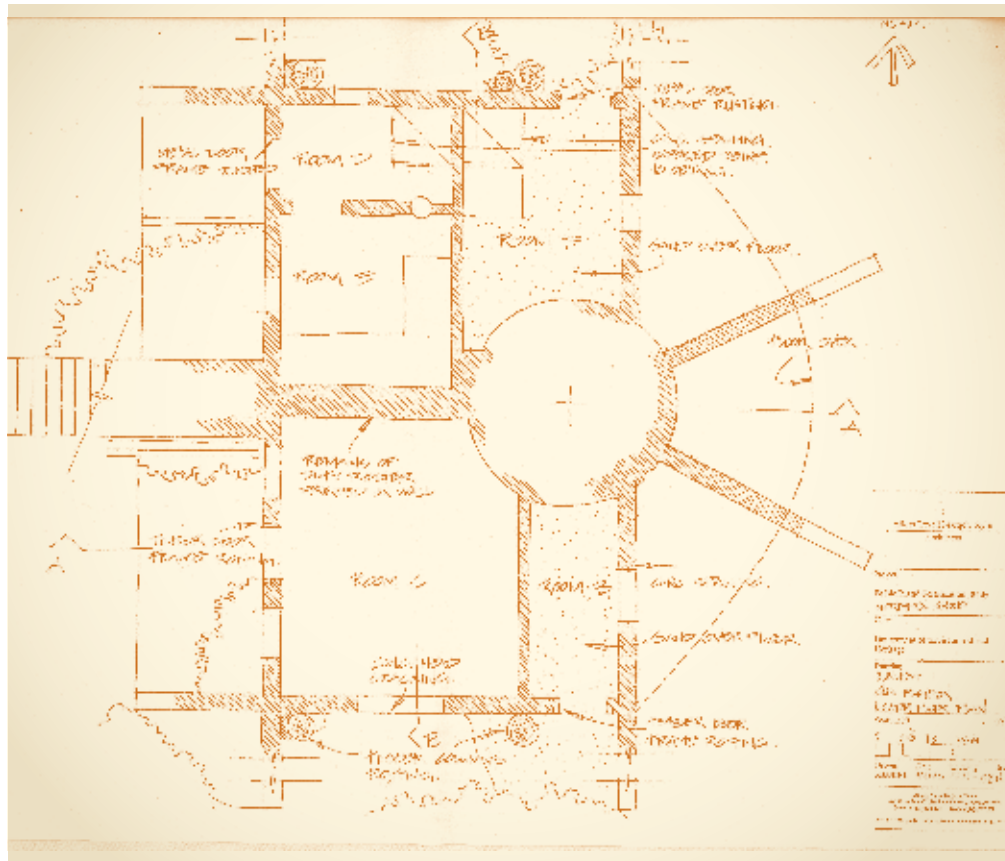
**Photo:** An example of historic documentation necessary for the management of a heritage ruin (Department of Environment and Heritage (Qld)).

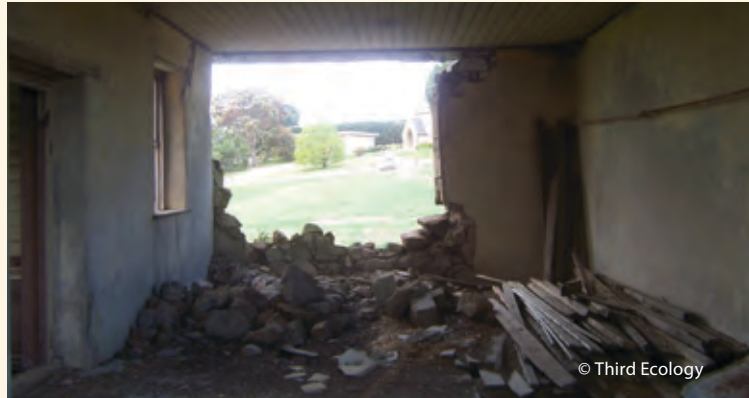
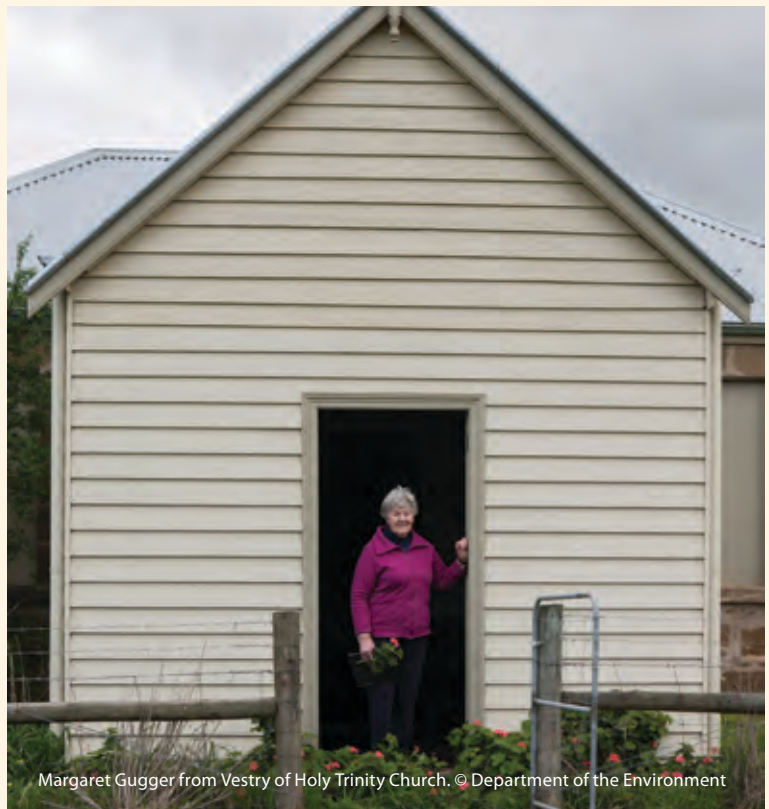
It is not known when the building ceased serving as a school, or was no longer occupied. But in 1994, the school building was in a ruinous and unstable condition. It had been identified in a regional heritage study in 1986 and its significance recognised. But by then the building was standing empty, used only by sheep for shelter. Parts of the walls had collapsed, yet the roof remained, protecting some of the interior spaces.

Based on significance and cost, a decision was made to reconstruct the original stone section of the building (using stone from the collapsed sections) and the timber porch, and to record and then demolish the later 1889 timber teacher's residence, demonstrating two distinct management approaches—reconstruction and removal—in combination. The stone footings of the teacher's residence were retained, and the chimney was repaired and retained. The windows of the school building were secured and sheeted over to prevent vandalism.

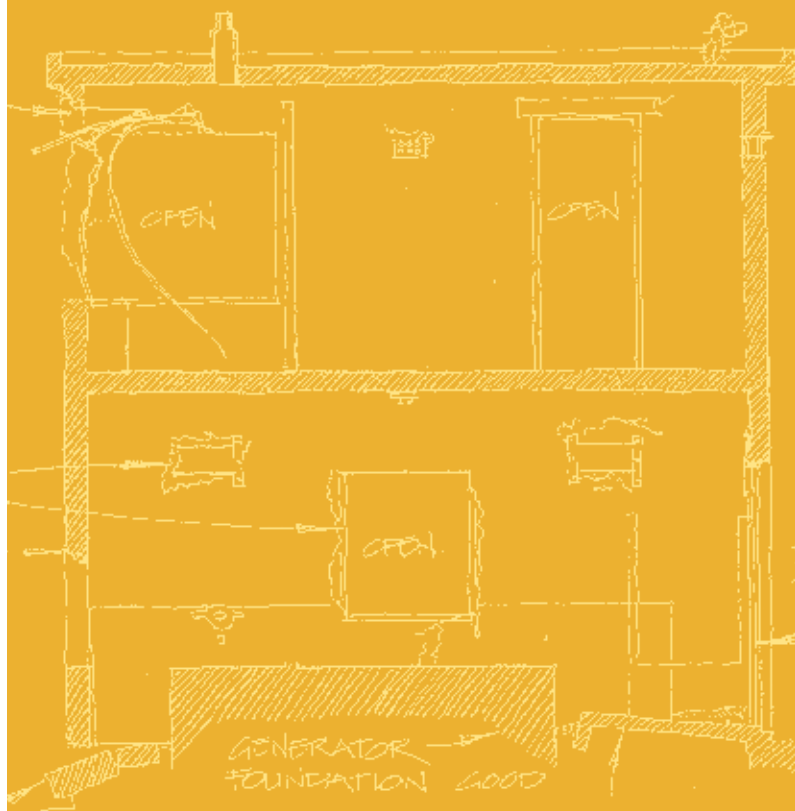
DOOR FRAME  
RUSTED.

GENERATOR  
FOUNDATION GOOD

REMAINS  
COLUMNS  
DO NOT  
RUST,  
NO  
CRACKS

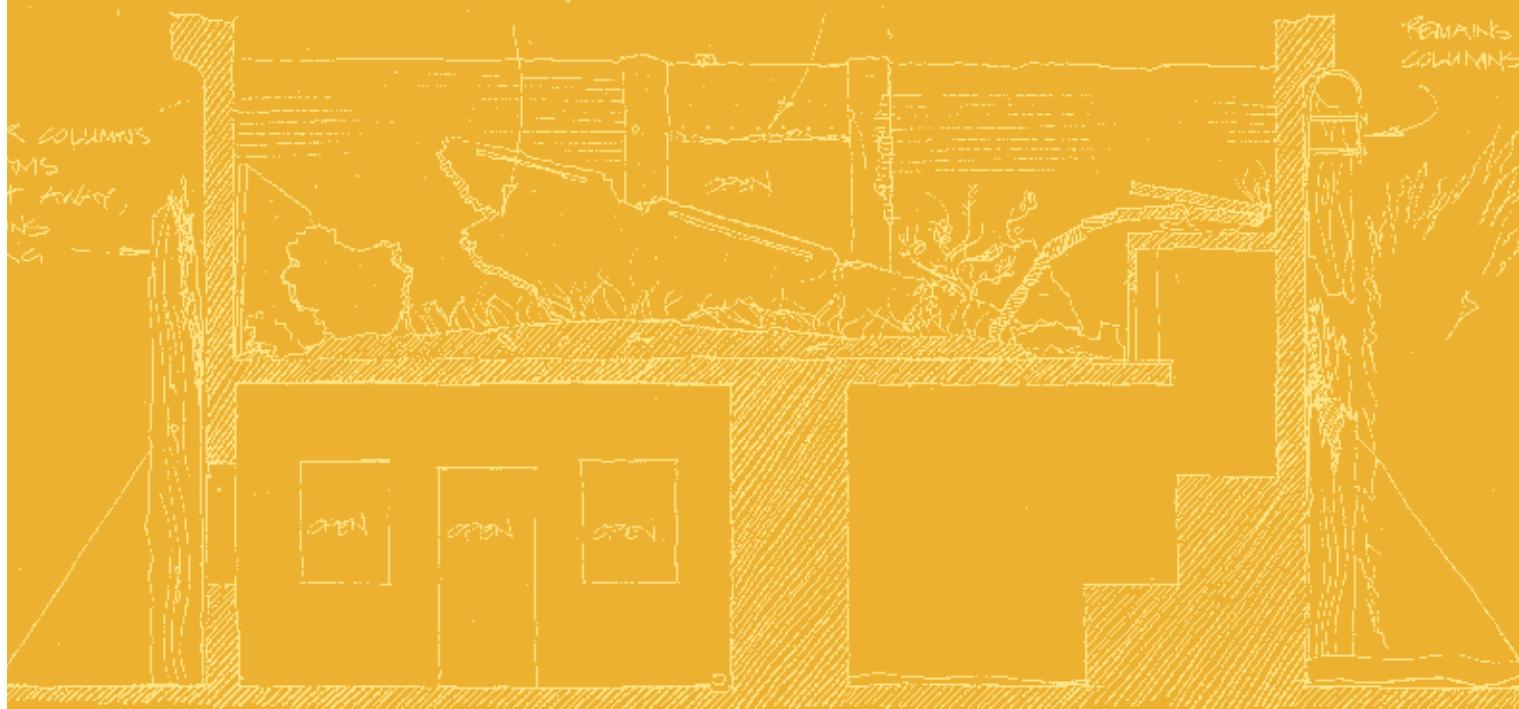
DOOR & FOUNDATION  
GOOD.

CONC. FLOOR SEVERELY  
CRACKED & LIFTING.

CONC. SPALLING,  
EXPOSED REIN.

REMAINS  
COLUMNS
