A view through time

The freshwater basin today

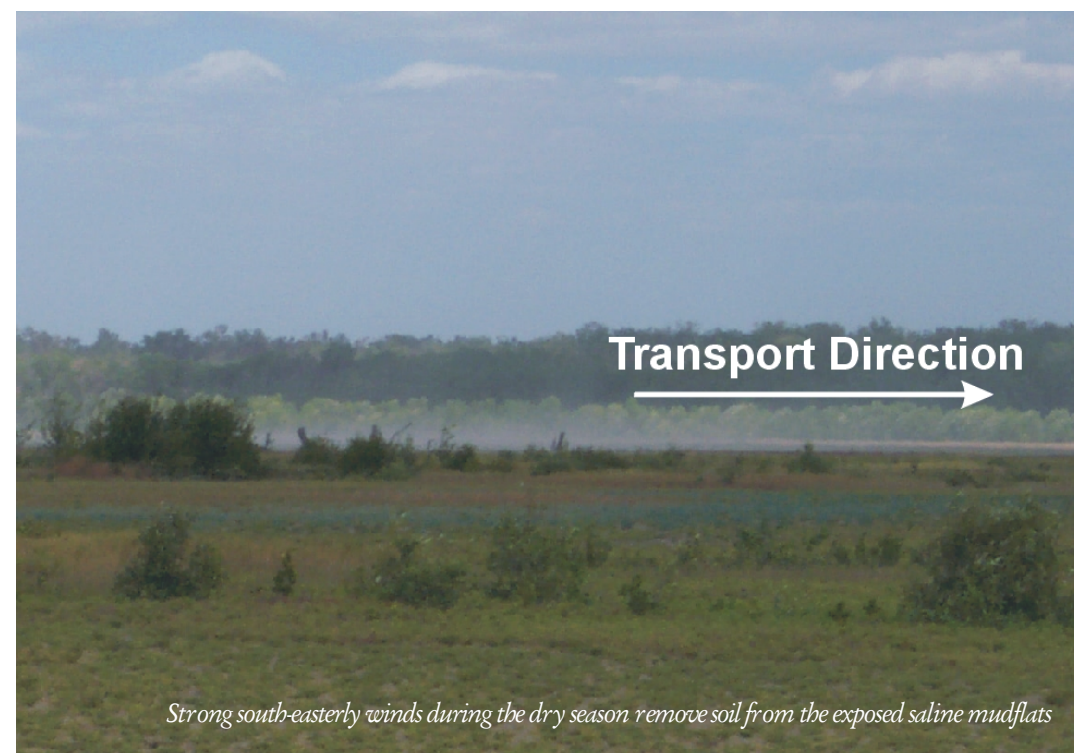
Left: During the dry season the unvegetated saline mudflat cracks deeply and the soil/sediment is removed by strong winds

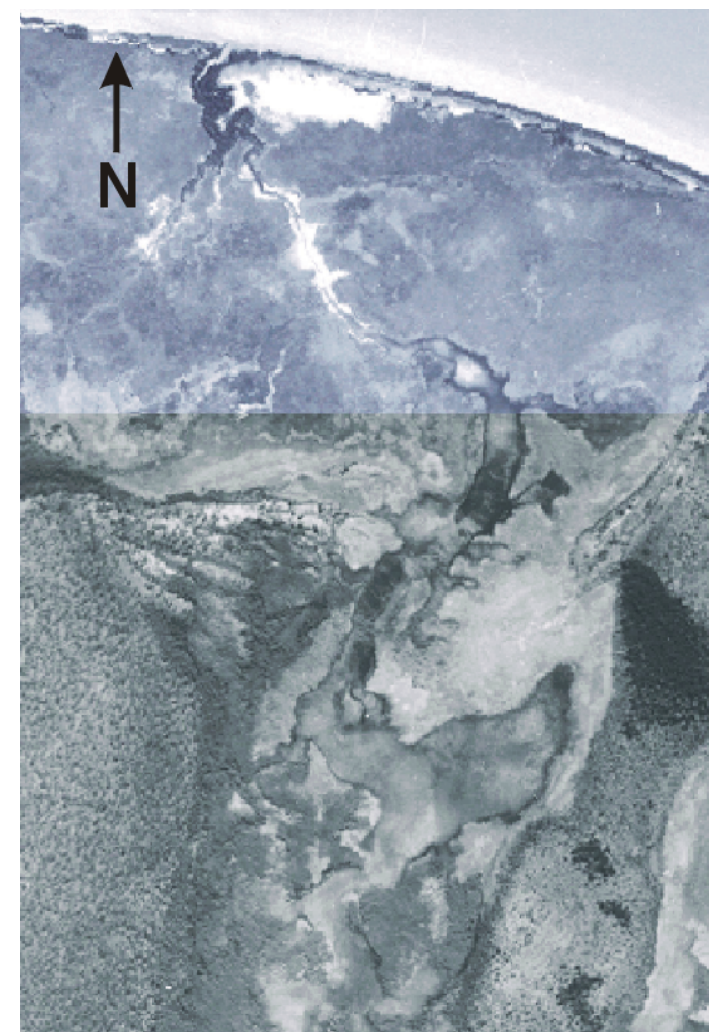
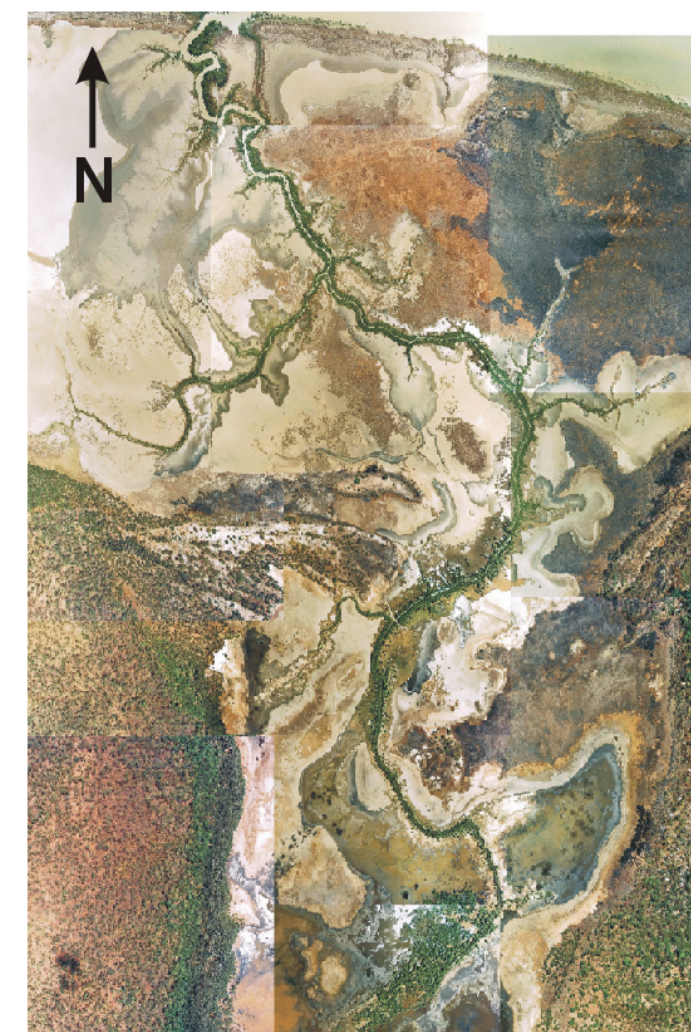
Below: Study area at Point Farewell. The left image shows the extent of the tidal creek in 1950 and the right image shows the tidal creek in 1997. By 1997 the tidal creek had penetrated 4km inland from its opening at the estuarine funnel of the East Alligator River.

By 1997, bare saline mudflats on this part of the coastal plain had increased almost 10 times, more than half the paperbark forest had been lost, and the tidal creek had extended 4 km inland.
