# Supervising Scientist

### SALTWATER INTRUSION – A NATURAL PROCESS

#### Point Farewell - a case study in Kakadu

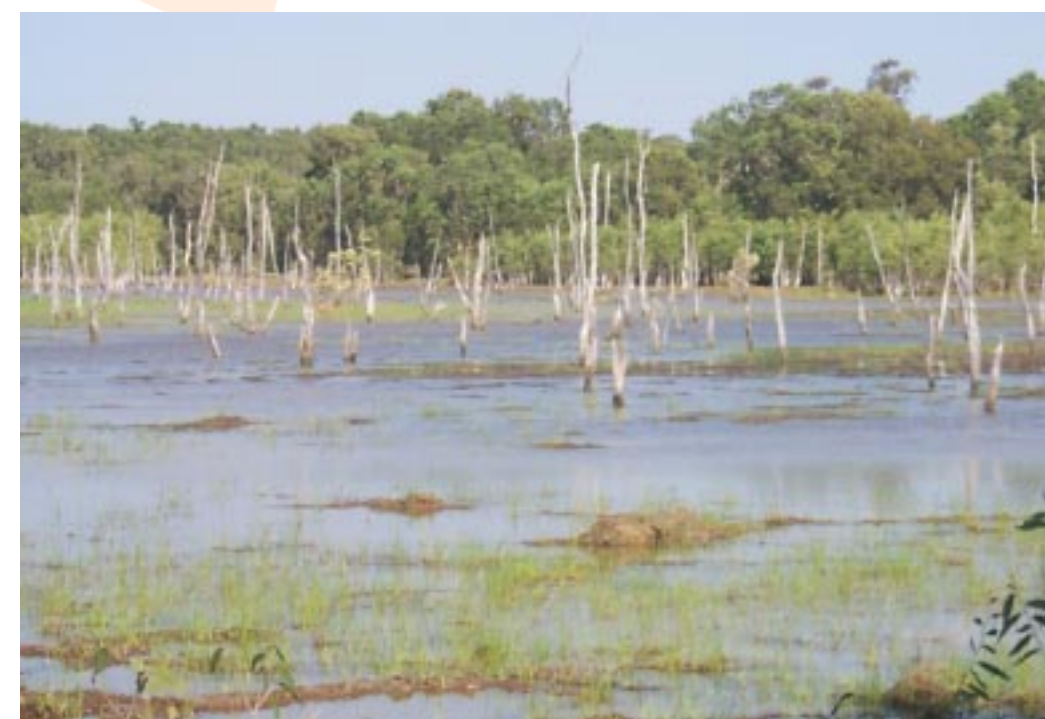
*Dead stands of paperbark trees (Melaleuca) often indicate saltwater intrusion*

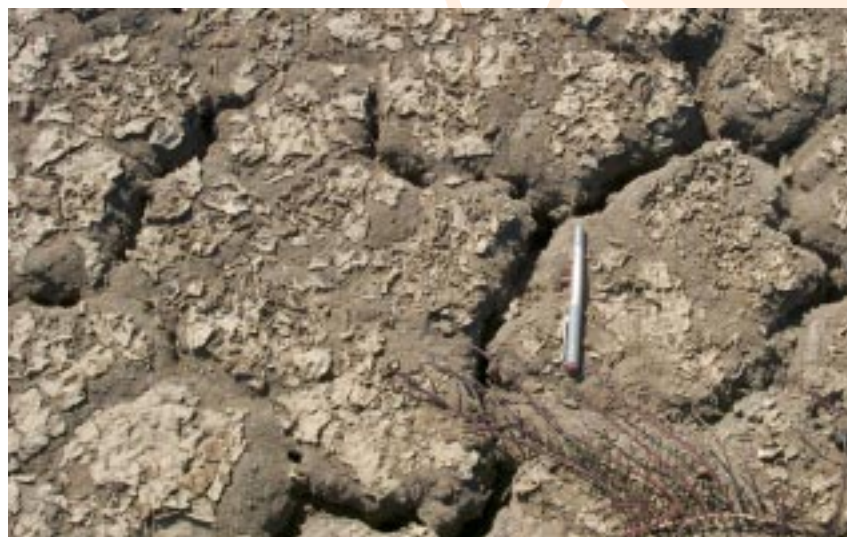
*Left: During the dry season the unvegetated saline mudflat cracks deeply and the soil/sediment is removed by strong winds*

occupy a large portion of the coastal plain. The mudflats dry during the dry season and are eroded by the wind as dust storms sweep the coastal plain. Loss of soil from wind transport may increase the depth of the basin, letting in even more salt water.

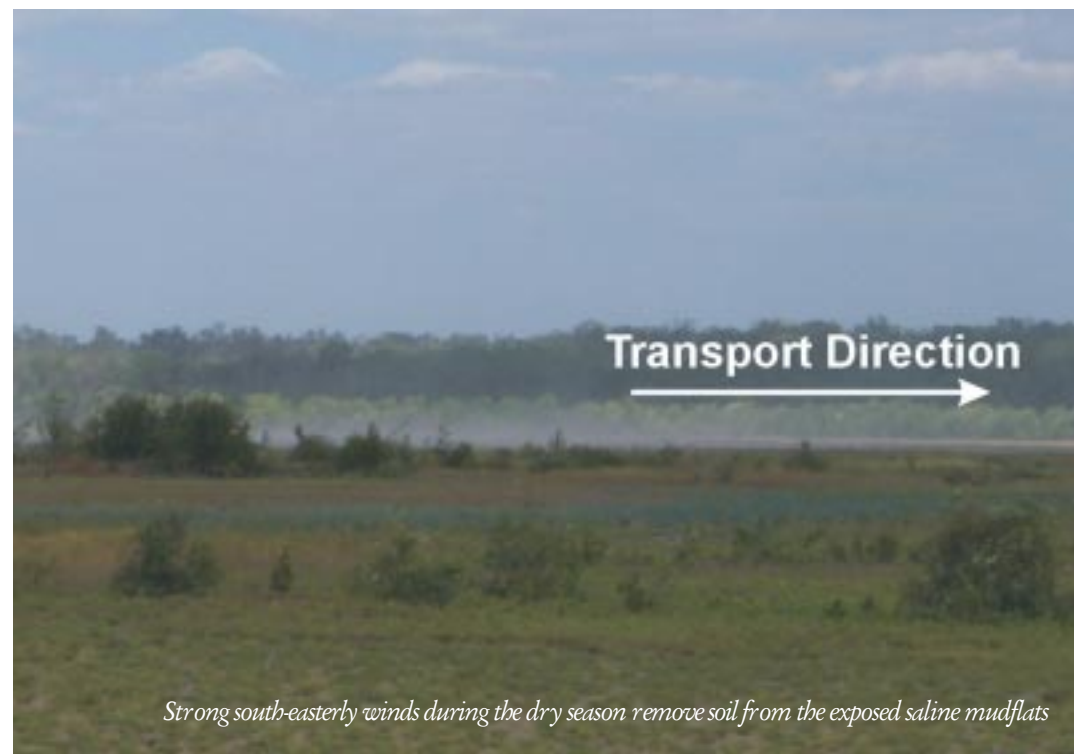
*Strong south-easterly winds during the dry season remove soil from the exposed saline mudflats*

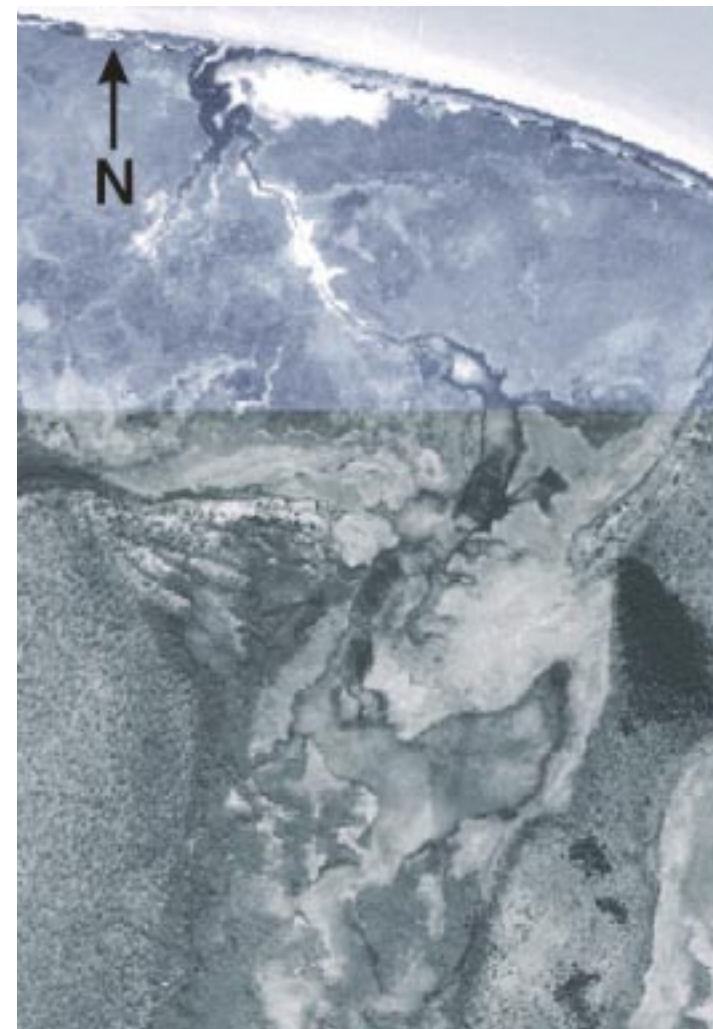
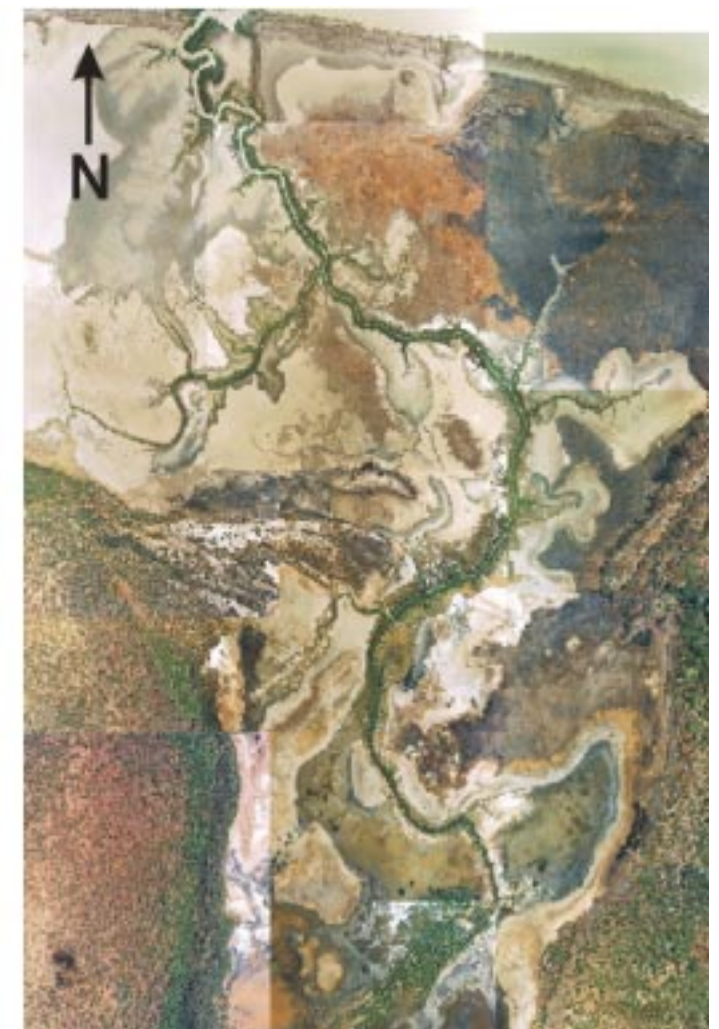
*Below: Study area at Point Farewell. The left image shows the extent of the tidal creek in 1950 and the right image shows the tidal creek in 1997. By 1997 the tidal creek had penetrated 4km inland from its opening at the estuarine funnel of the East Alligator River.*

In 1950, the area was almost free of saltwater intrusion. The freshwater basin, a string of billabongs vegetated with forests of paperbark trees, was protected from the incoming saltwater tide by old beach ridges, vegetation, and a build-up of alluvium deposited by the freshwater stream during the wet season. Sedges and grasses covered the coastal plain, and the salty tidal creek extended just 1 km inland.

By 1997, bare saline mudflats on this part of the coastal plain had increased almost 10 times, more than half the paperbark forest had been lost, and the tidal creek had extended 4 km inland.
