**The rehabilitation  
of Nabarlek**

**Uranium Mine**

Proceedings of Workshop,

18–19 April 2000

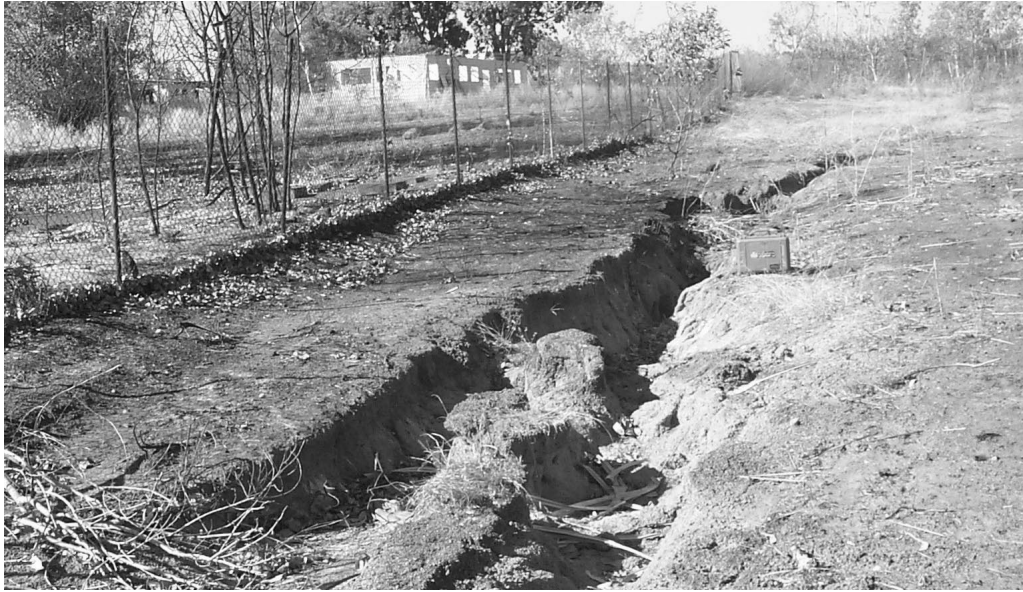
**Plate 1** Gully in the road at Site 1

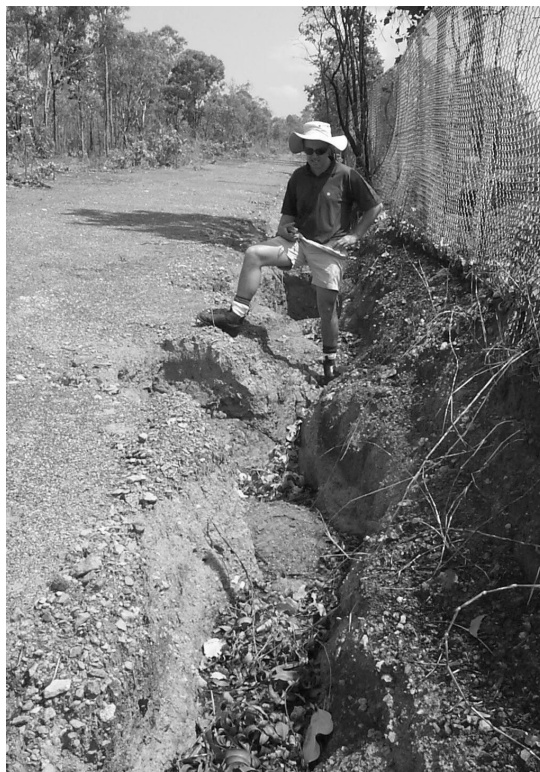
**Plate 2** Gully in road at Site 4

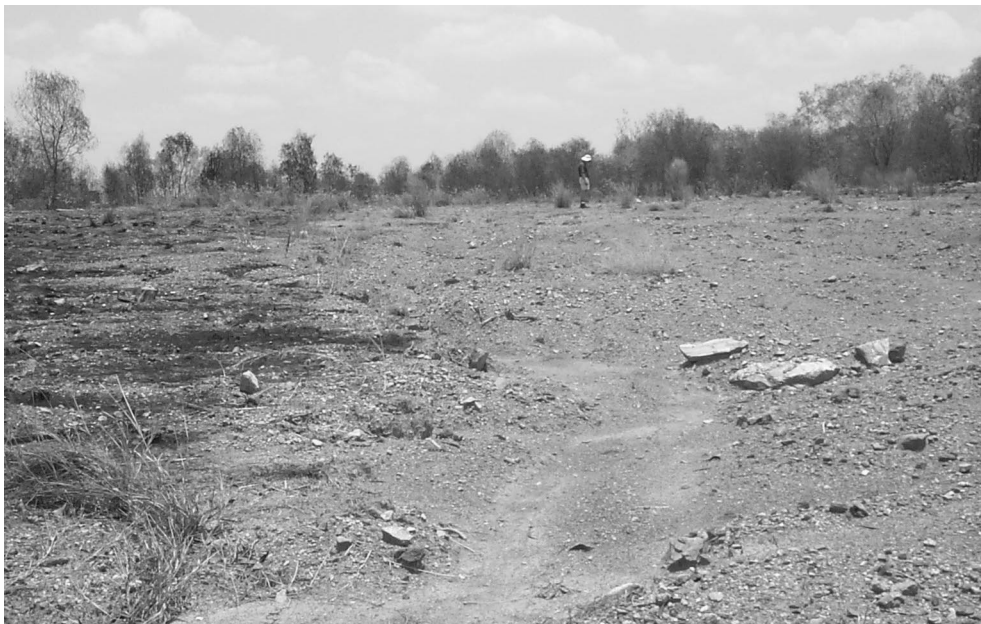
**Plate 4** Rills/gullies near the pit at Site 8

**Site 8:** At the western end of the pit transect at the north west of the WRD, ‘badlands’ are developing (plate 4). There is sparse vegetation and four rills/gullies are developing across this unvegetated area. The spoil material in this area has a different appearance (structure, texture, colour) to the rest of the waste rock. The badlands are surrounded by a ripped and revegetated perimeter.

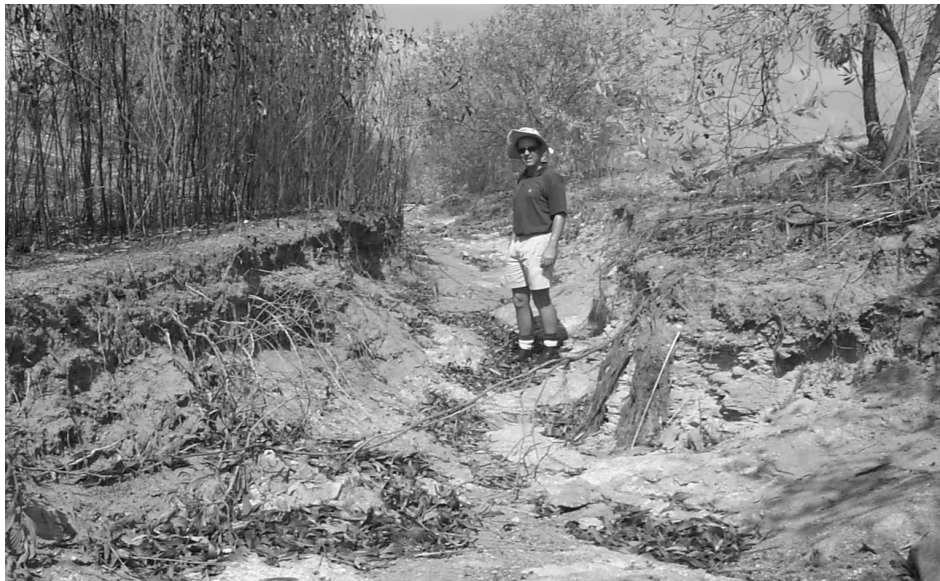
**Plate 5** Incision in the base of the constructed earth drain parallel to the airstrip (Site 10)

**Site 10:** An earth drain runs parallel and to the south of the airstrip draining toward the east to the pond at the north of the pit. Severe incision has occurred in the base of this drain (Plate 5). In places this gully is  $>2$  m wide and  $>1$  m deep.

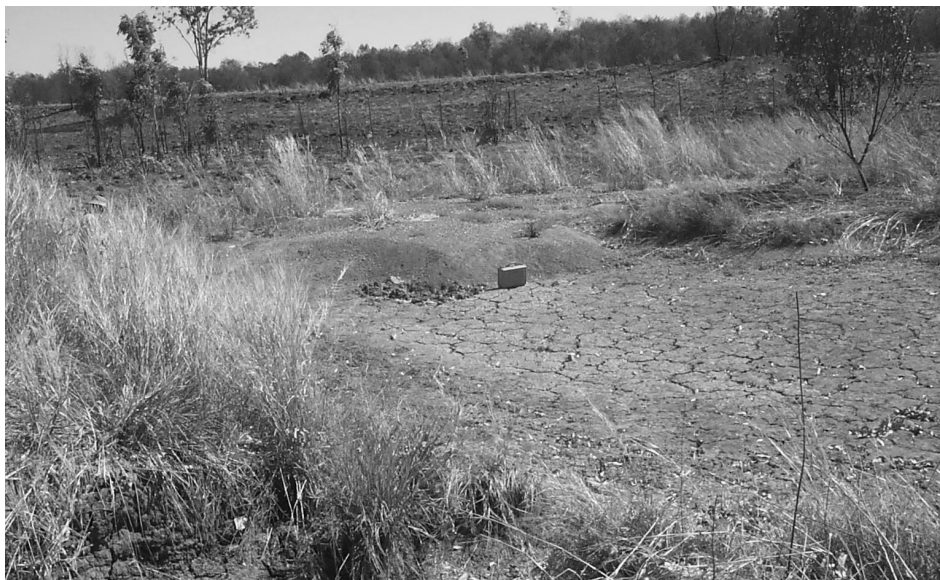
**Plate 6** This is the sedimentation pond outside the south east corner of the boundary fence (Site 14). The breach is seen in the foreground. The bund wall at the southern end of the WRD can be seen at the top of the plate.

**Site 14:** There is a sedimentation pond (Plate 6) outside the south east corner of the boundary fence that receives discharge from the drainage system discussed in Site 3 and Site 5 above. Classic deltaic sedimentation is occurring each wet season in this pond. Coarse gravelly sand and fine mud is being deposited. There is a breach in the south east bund wall of the pond that is approximately 2 m wide by 1.5 m deep and fine sediment has discharged from the pond on to the unsealed road running east-west outside the southern boundary fence next to the WRD. Sediment discharges through the bund breach on to this road where deposition and rilling has occurred. The rill continues for a distance of approximately 50 m in a westerly direction along the road and then crosses the road into woodland where it discharges into a drainage depression leading to Cooper Creek West Branch.

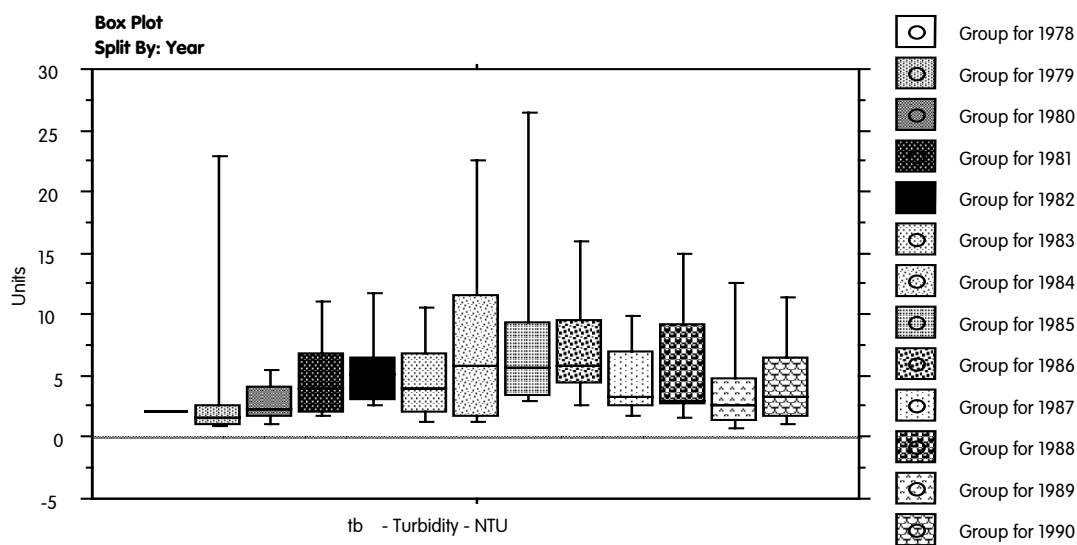
**Figure 15** Box Plot of turbidity (NTU) at GS8210024
