Bank erosion in the
Ngarradj catchment:
Results of erosion pin
measurements between
1998 and 2001

MJ Saynor, WD Erskine
& KG Evans

MJ Saynor, WD Erskine & KG Evans 2003. *Bank erosion in the Ngarradj catchment: Results of erosion pin measurements between 1998 and 2001*. Supervising Scientist Report 176, Supervising Scientist, Darwin NT.

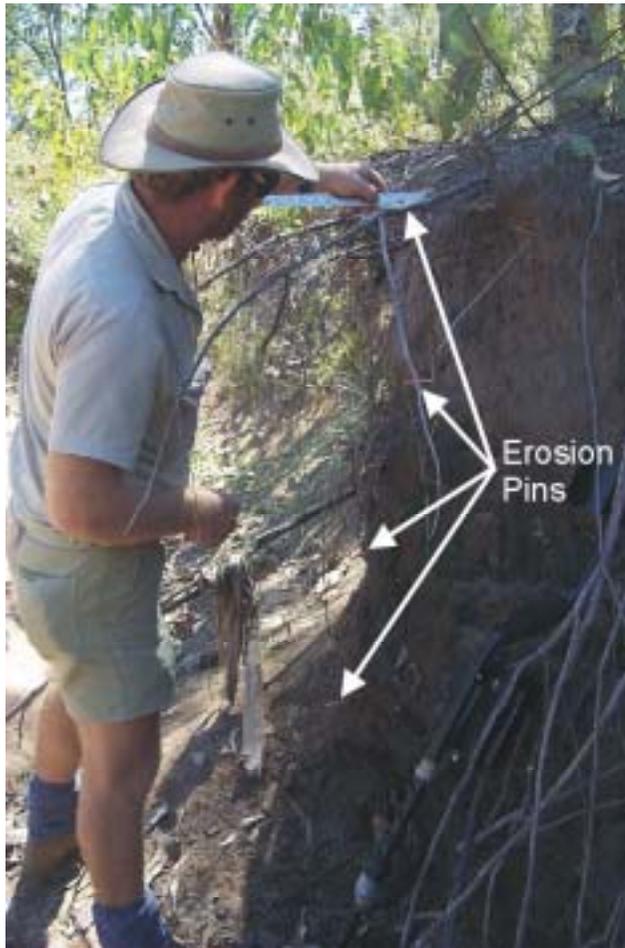
Figure 2 Measurement of erosion pins on Tributary Central at cross section TC6B during the dry season. Metal detector is resting against the bank. Vertical bank profile on the outside of a meander loop.

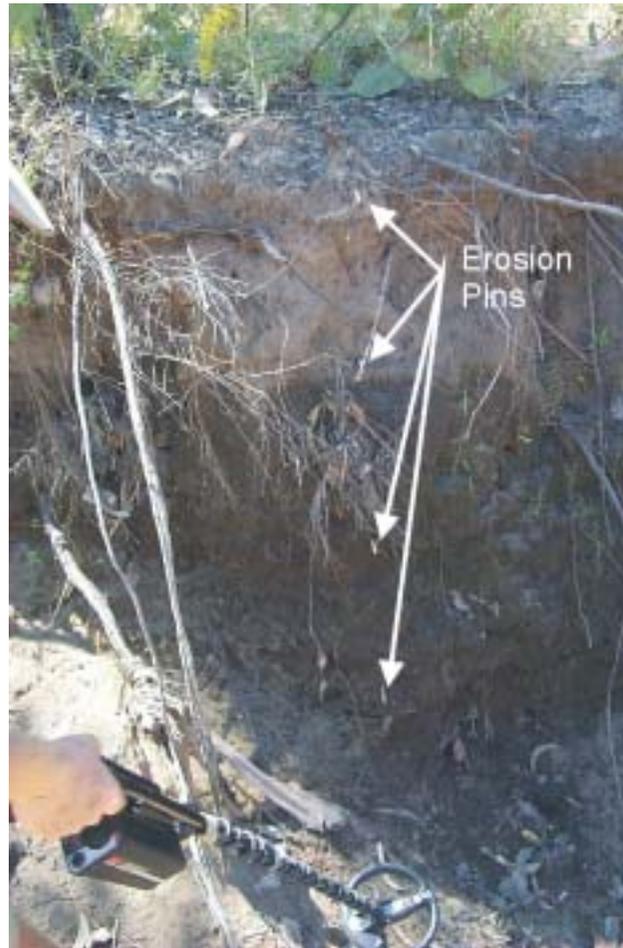
Figure 3 Metal detector used to relocate buried pins. Tributary Central cross section TC6B during the dry season when the water table is at least 0.5 m below the river bed. Bank profile is vertical. Compare with wet season conditions in fig 4.

Figures 3 and 4 compare the same bank profile between wet and dry seasons. Bank sediments are at least episodically saturated because bankfull discharge occurred at least once during each wet season (Moliere et al 2002). During the dry season, all channels ceased flowing and the water table dropped to at least 0.6 m below the river bed (Saynor et al 2002b). These extreme soil moisture conditions occurred every year and should be conducive to bank erosion because of severe desiccation where there is no riparian vegetation.

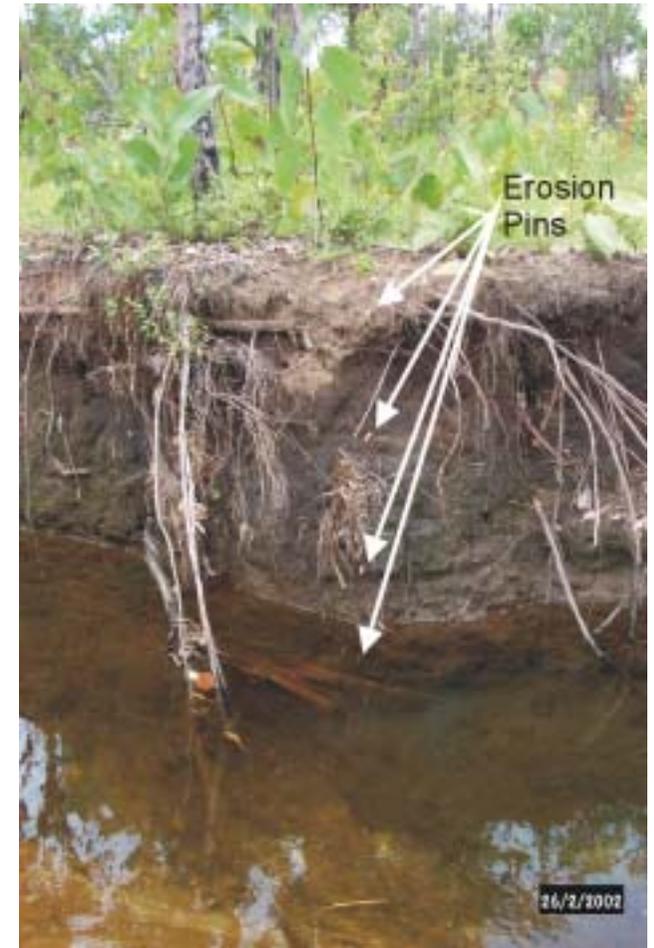
Figure 4 Same bank as in fig 3 during wet season baseflows

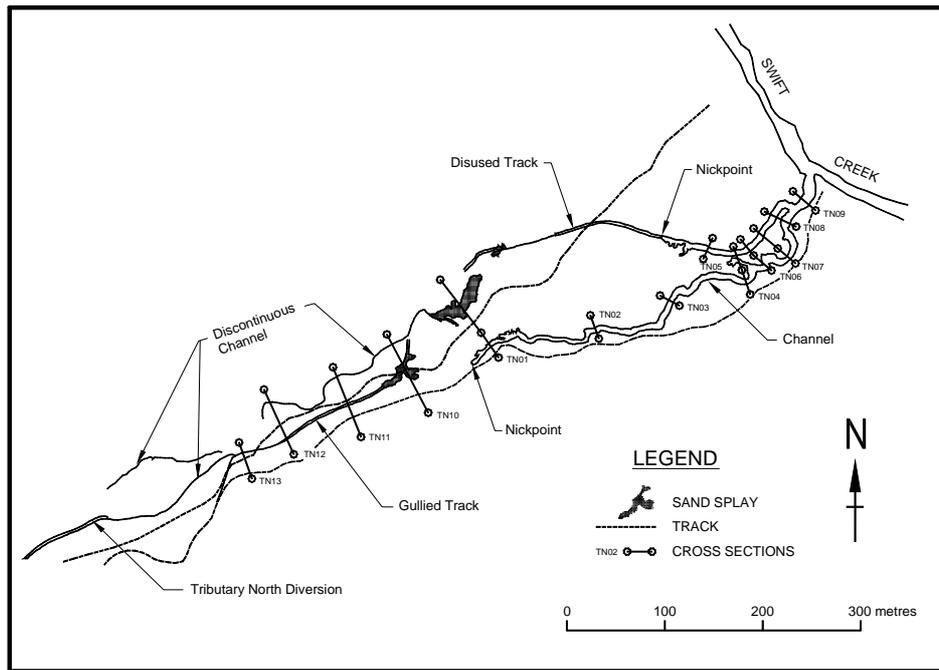
Figure 6 Location of the permanently marked cross sections on Tributary North

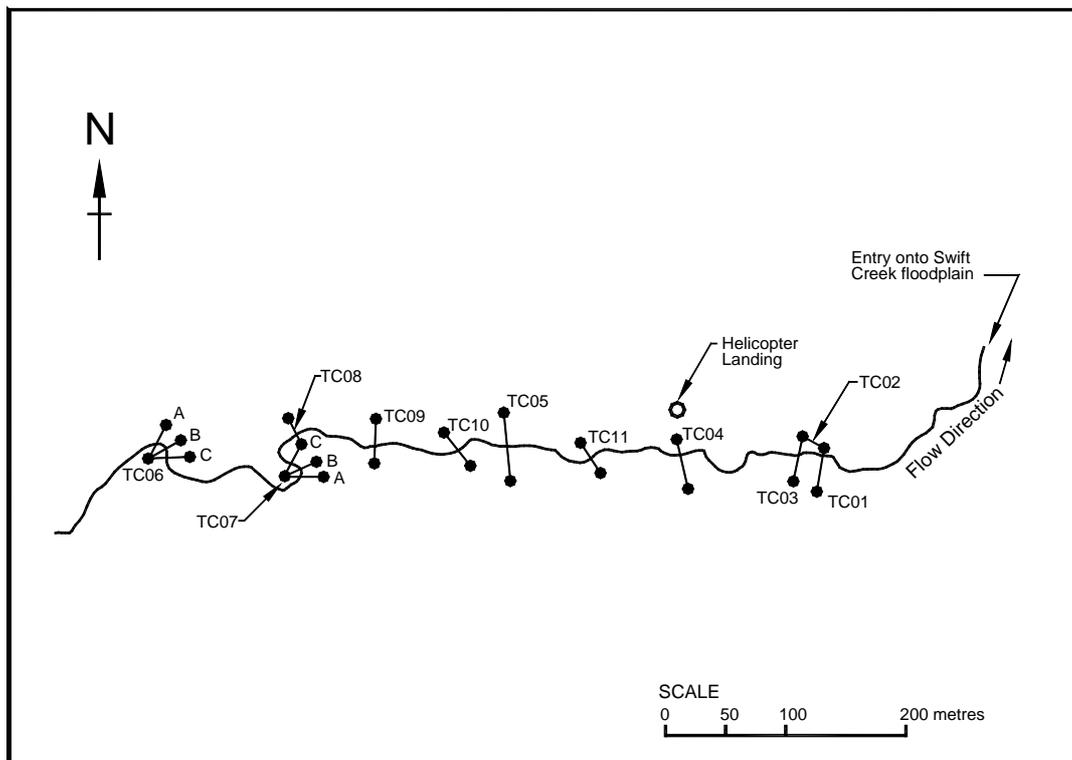
Figure 7 Location of the permanently marked cross sections on Tributary Central

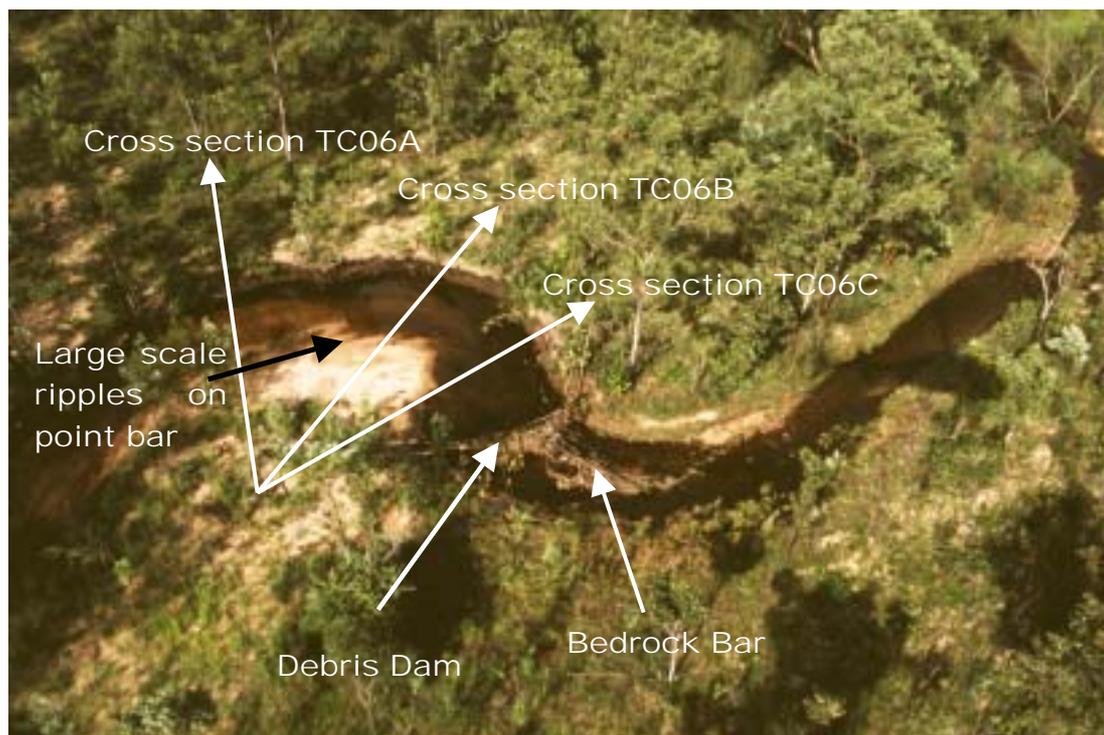
Figure 8 Cross sections TC06A, B and C on a loop of Tributary Central, showing a large sandy point bar opposite the erosion pin sites and a debris dam downstream of the sites at the head of a bedrock bar

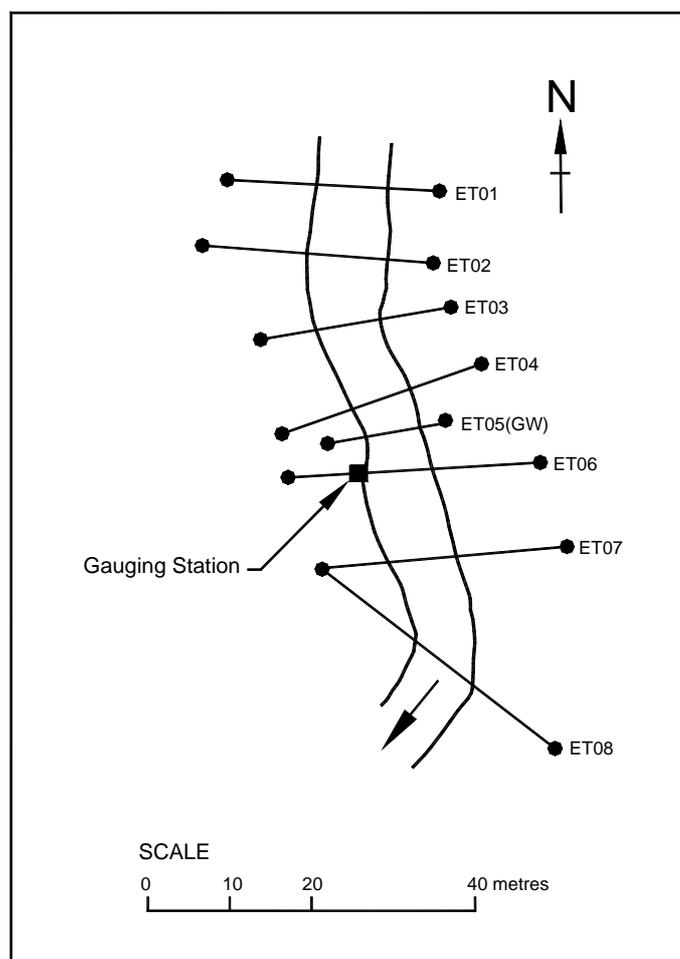
Figure 9 Location of the cross sections on East Tributary at the *eriss* gauging station

Erosion pins are located on four of the cross sections, ET01, ET04, ET07 and ET08 (fig 9). The results of the erosion pin measurements are shown in table 8.

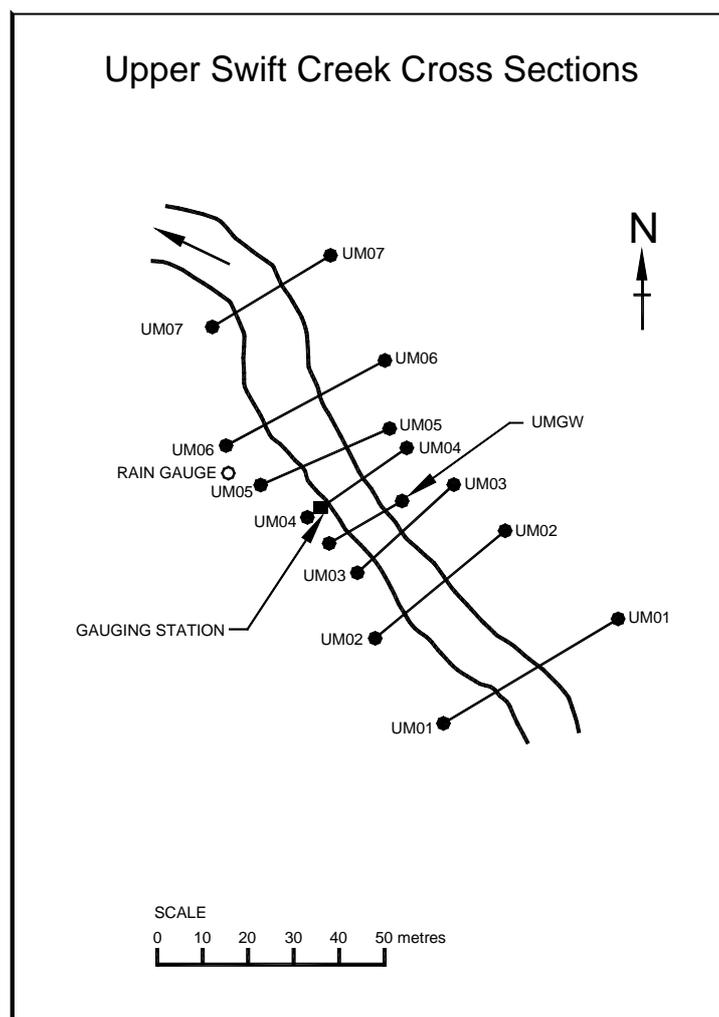
Figure 10 Location of the cross sections at the upper Swift Creek gauge

Erosion pins are located on three cross sections, UM02, UM05 and UM07 (fig 10). The results are shown in table 9. Pins at cross section UM07 were not measured on 1 December 2000, hence values for 9 July 2001 have been compared with those for 1 August 2000 (table 9).

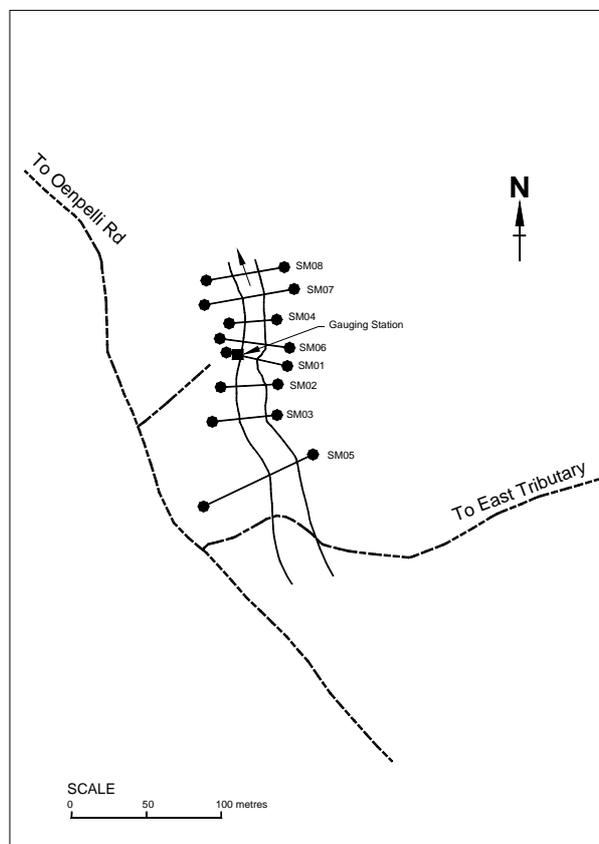
Figure 11 Location of cross sections at the lower Swift Creek gauge

Erosion pins are located on three cross sections, SM05, SM02 and SM08 (fig 11). The results are shown in table 10.

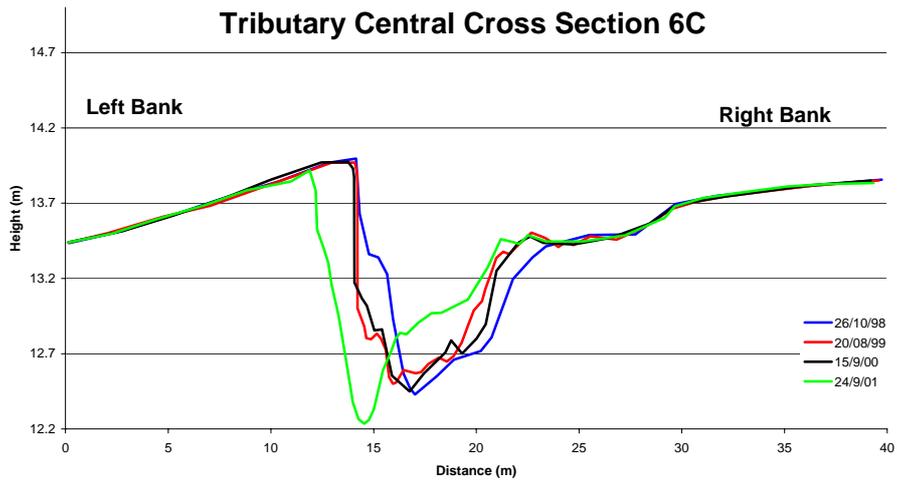
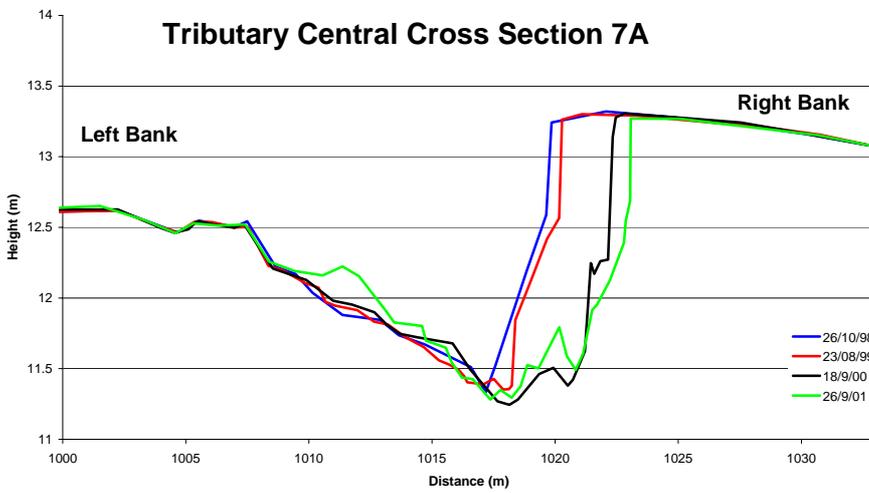
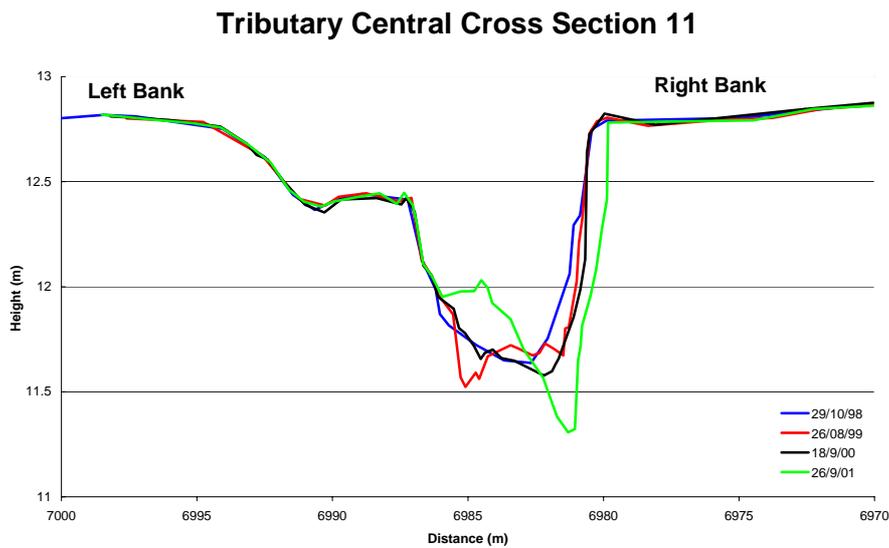
Figure 12 Recent lateral migration of three bends on Tributary Central. See fig 7 for the location of the sections and Saynor et al (2002a) for further details.

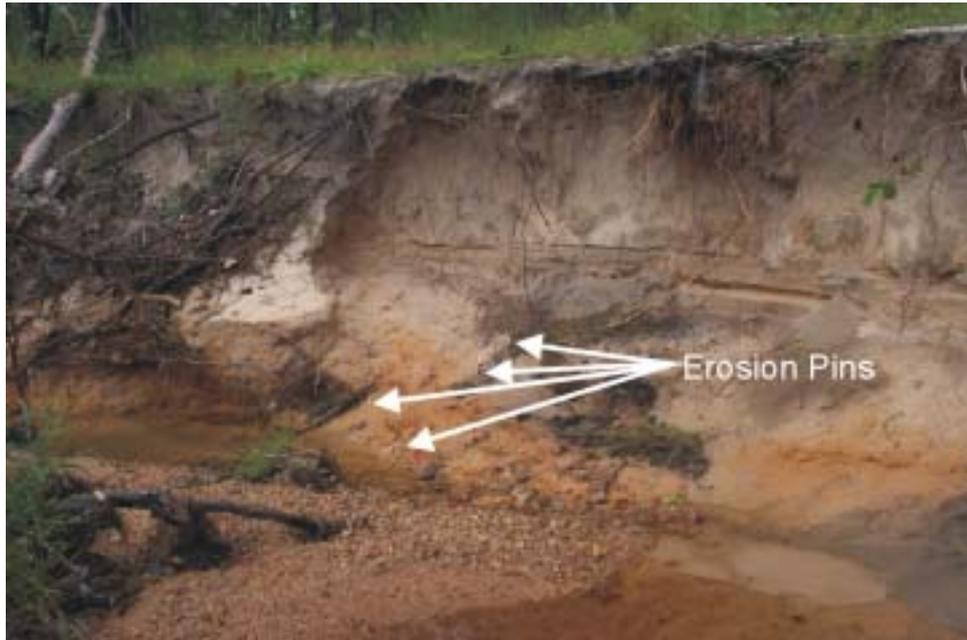
Figure 13 Completely eroded pins on cross section TC07A on 27 February 2002. See fig 7 for the location of the cross section.

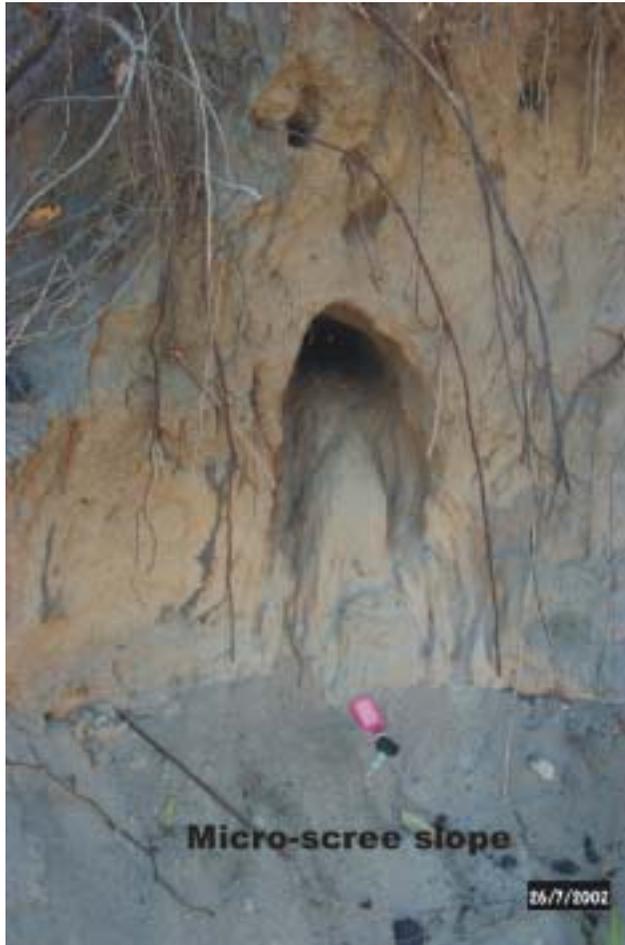
Figure 14 Bank burrow on Tributary Central near cross section TC07A which has resulted in the localised loss of sand from the face of the bank during the dry season. Note sandy micro-scee slope at base of bank which has formed by the accumulation of sand dislodged from immediately above.

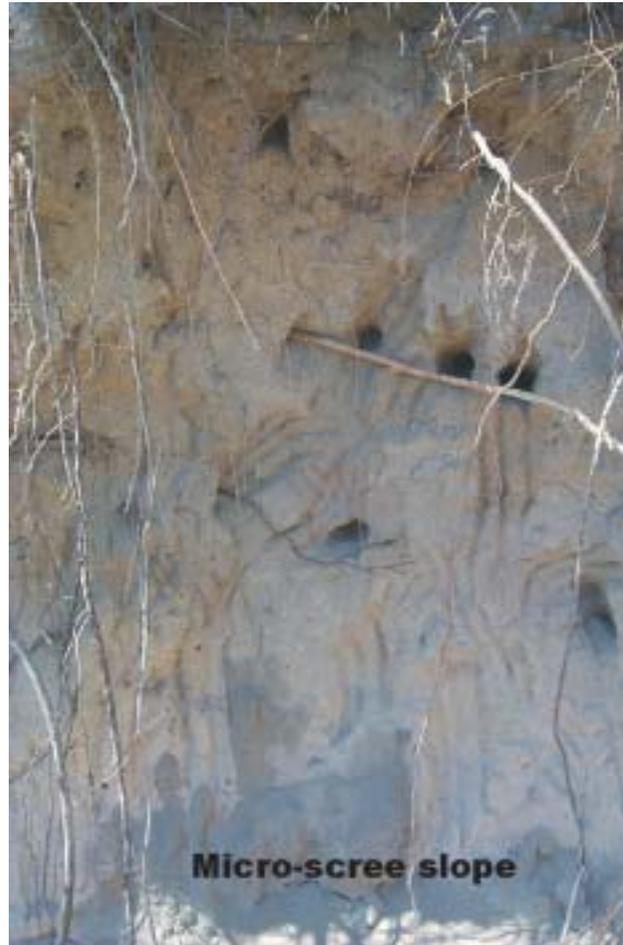
Figure 15 Faunal scratch marks on the right bank of Tributary Central near cross section TC07A which have removed sediment from the bank face during the dry season. Note sandy micro-scee slope at base of bank which has formed by the accumulation of sand dislodged from the bank above by scratching and desiccation.

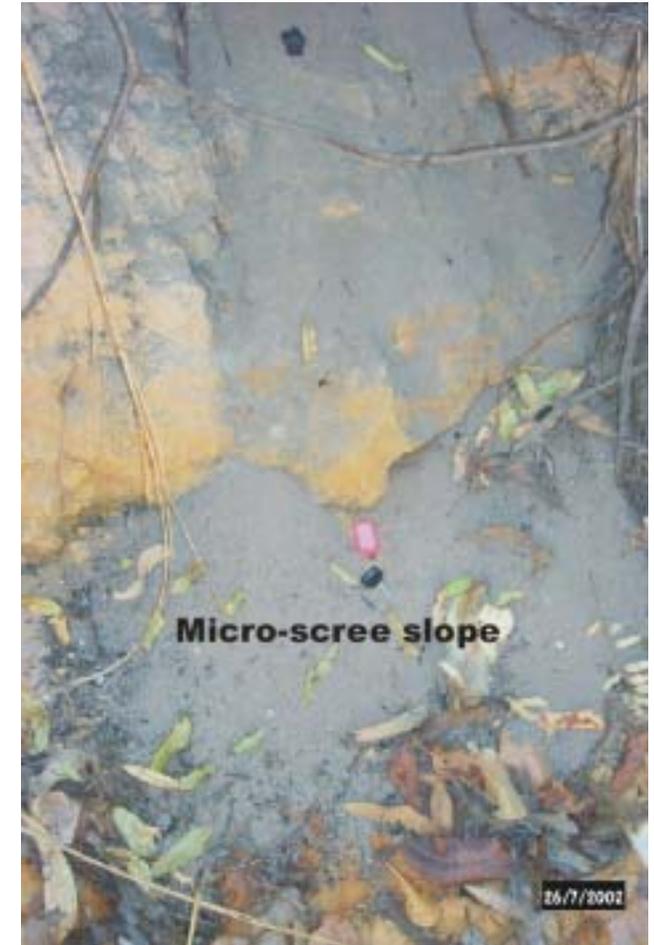
Figure 16 Sandy micro-scee slope formed by the dry flow of sand down the right bank of Tributary Central near cross section TC07A

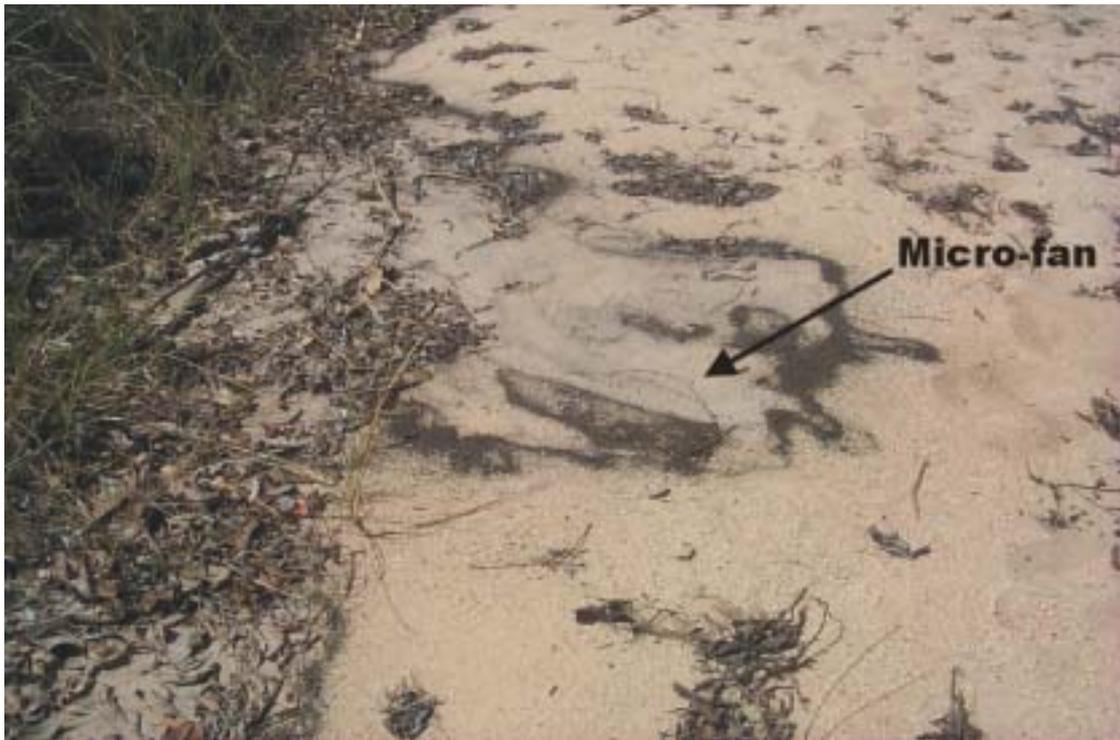
Figure 17 Micro-fan deposited at the base of the river bank at the **eriss** Swift Creek gauge by infiltration of Hortonian overland flow into the sand. The fan is the fill zone of a small-scale scour-transport-fill sequence.

Bank deposition was also caused by conveyance losses involving the complete infiltration of overland flow moving down gently sloping river banks. Intense convective rain storms during the build up to the wet season often generated Hortonian overland flow (rainfall intensity greater than soil infiltration rate) on the floodplain and river banks which was exacerbated by strongly hydrophobic (water repellent) surface soils, especially following dry season fires in 1998 and 1999. Overland flow which passed over sandy channel banks, caused local erosion of the upper banks and deposition on the lower banks. These corresponded to small-scale scour-transport-fill (STF) sequences, up to 5 m long, which are similar to, but smaller, than those described by Pickup (1985, 1988) and Saynor et al (1994). Figures 17 and 18 show such STF sequences on the river banks at the Swift Creek gauge in December 2001. STF processes can cause erosion at pins in the upper scour zone and can result in deposition over pins in the lower fill zone, where infiltration into dry, deep sand can totally absorb the Hortonian overland flow (figs 17 & 18).

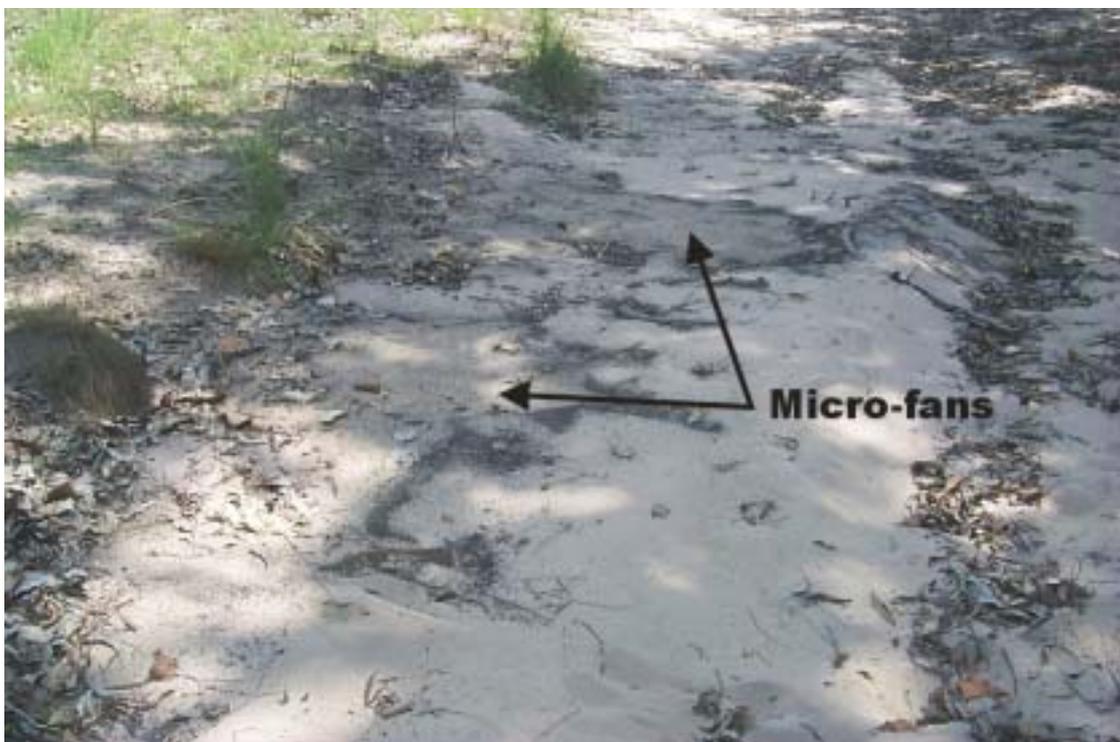
Figure 18 Two micro-fans deposited at the base of the river bank at the **eriss** Swift Creek gauge by infiltration of Hortonian overland flow into the sand. The fans are the fill zones of small-scale scour-transport-fill sequences.
