Investigation of the  
potable water  
contamination incident  
at Ranger mine  
March 2004

Supervising Scientist

Supervising Scientist 2004. *Investigation of the potable water contamination incident at Ranger mine March 2004*. Supervising Scientist Report 184, Supervising Scientist, Darwin NT.

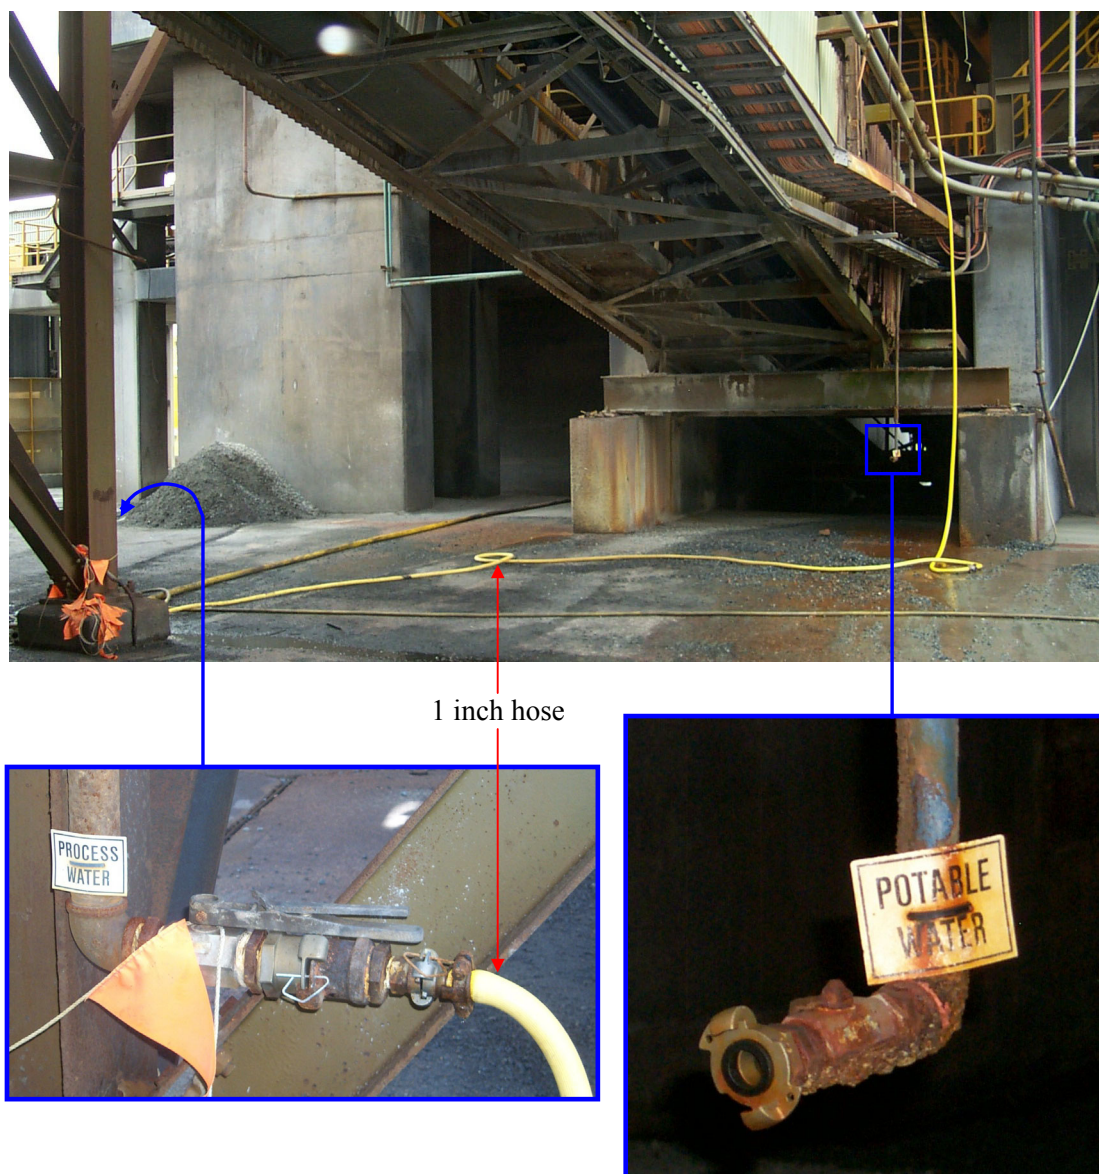
There is an inconsistency in the statements of the operators. It is clear that the 1 inch hose was connected between the potable water hosepoint on the ground level and the FOB scrubber on the second level. It is also clear that both valves were open at 9.38 pm on 23 March 2004 allowing contamination of the potable water system with process water and that Night Shift Operator A opened the valve at the FOB scrubber. However, it has not been possible to determine conclusively who opened the valve on the potable water hose point on the ground level and precisely when this occurred.

**Figure 5** Ground Level Outside Fine Ore Bins – Insets: Potable Water Hose Point through which process water entered the potable water system and the Process Water Hose Point to which the FOB scrubber was intended to be connected.

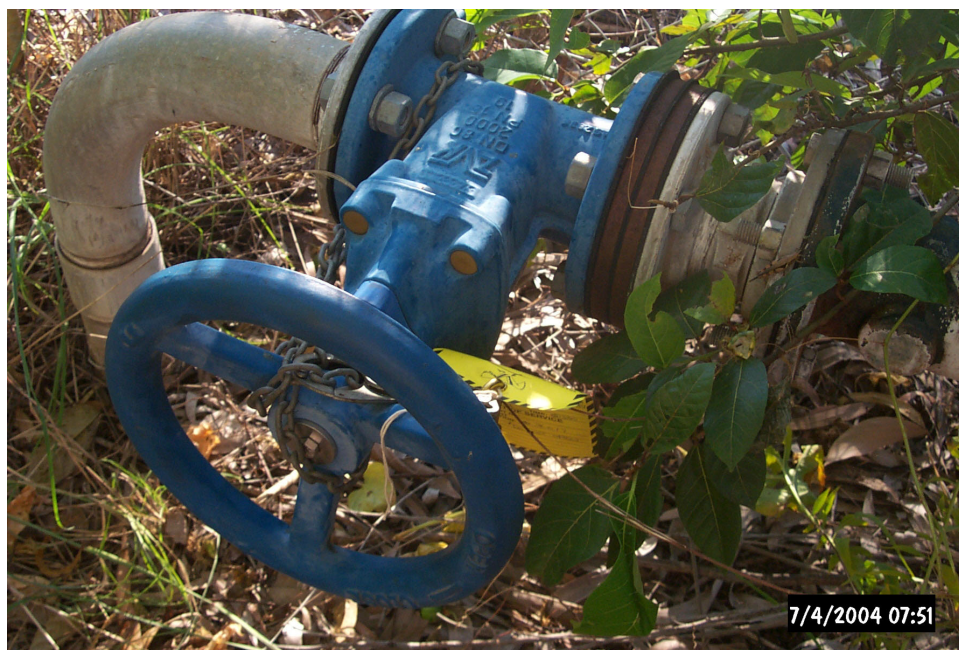
from all taps. He investigated and found that the main isolation valve (see figure 7) at the front gate was open. As no communication had been received from ERA regarding a change in the status of the potable water, he closed the valve and opened the taps in the men's toilet. An e-mail message was sent to staff directing them not to use the water.

**Figure 7** Jabiru Field Station main isolation valve

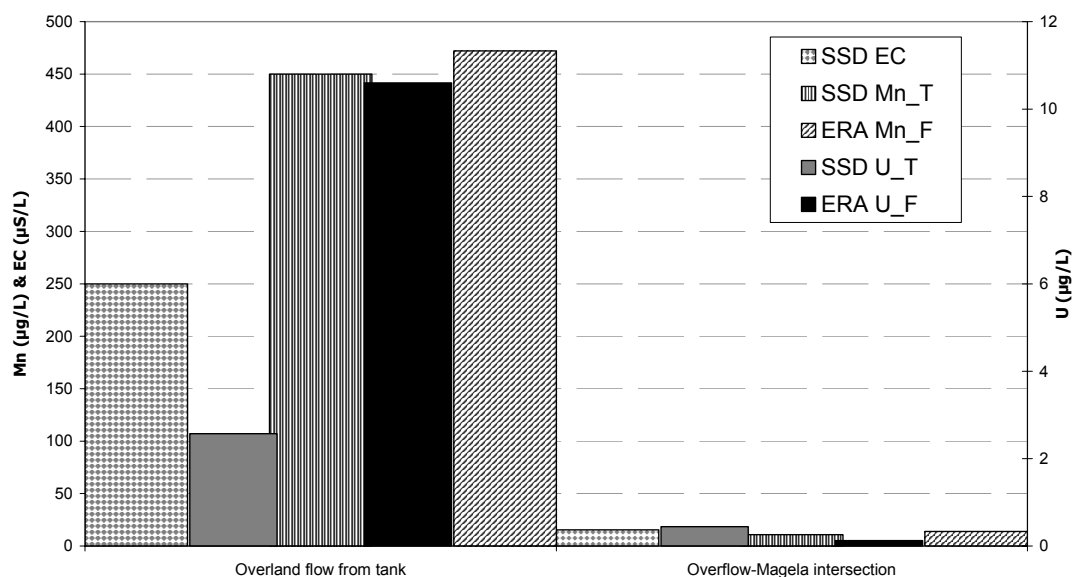
Dilution from heavy rains and standing water, as well as chemical/physical processes, decreased the concentration of contaminants in the overflow water on its passage to the creek. The change in EC measurements and manganese and uranium concentrations between the tank and the edge of Magela Creek is shown in figure 8.

**Figure 8** Concentration changes of key process water indicators between the Jabiru East tank and Magela Creek on 26<sup>th</sup> March (SSD and ERA data)

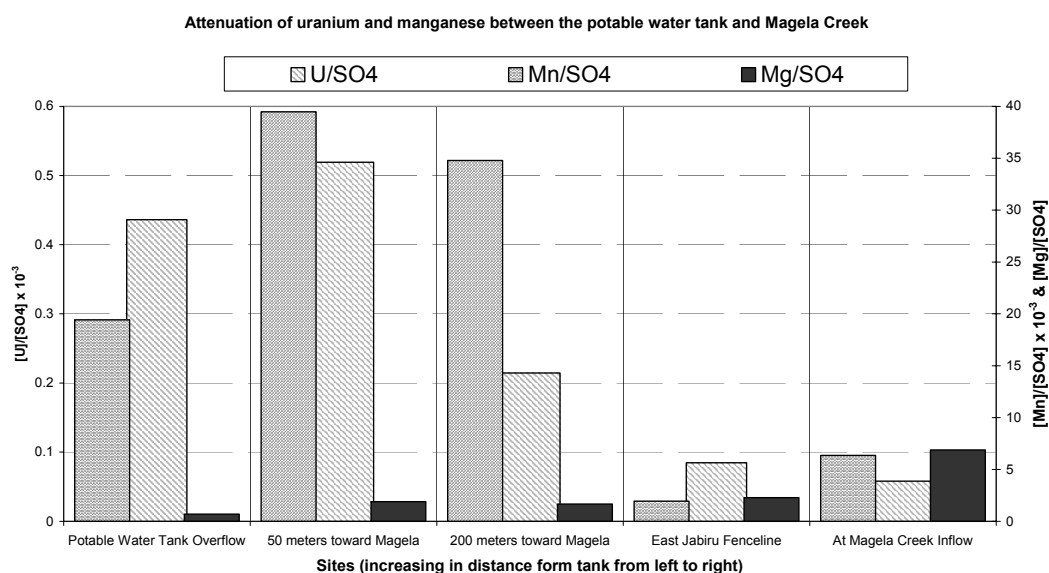
It was concluded in section 3.4.2 that the water quality in the Jabiru East tank on 24 March 2004 when the tank was overflowing to Magela Creek can not be reliably determined from the measurements taken on that date. For example, the uranium concentration on 25 March, the day after the incident, was about 460 ppb but the concentration could have been greater on 24 March. For this reason it has been necessary to model a worst case scenario for concentrations in the tank during the period of overflow.

**Figure 9** Changes in metal to sulfate ratios indicating the attenuation of metals along a transect between the Jabiru East tank and Magela Creek (ERA data)

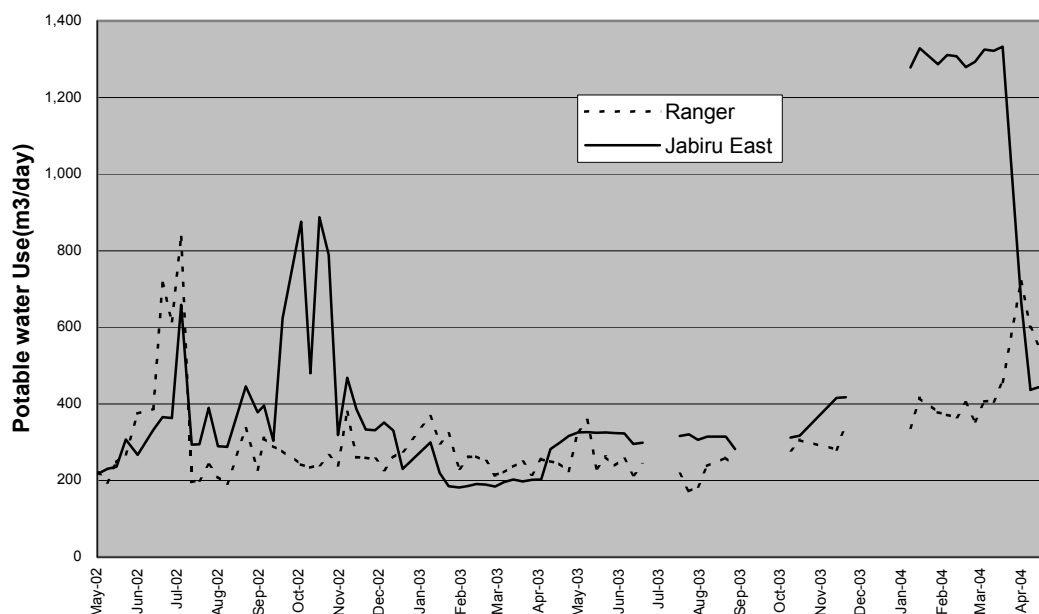
Based on the volumes used on site, and an estimation of flow into the Jabiru East tank once the system was turned back on, the supply to Jabiru East has been estimated to have been closer to 18 L/s. Apart from a small amount used for irrigation at the Jabiru Field Station, the remainder would have entered the Jabiru East tank and would have subsequently discharged via the overflow pipe at the same rate. The figure of 18 L/s is higher than historical data indicates but it has been adopted for the purposes of modelling to ensure conservatism. Given the extra pressure added to the potable system due to the connection of the process line during the incident, it is likely that the true leak rate on the night of the incident lies somewhere between 12 L/s and 18 L/s.

**Figure 10** Historical potable water usage on site (Ranger) and Jabiru East (data collected by ERA and provided by DBIRD)

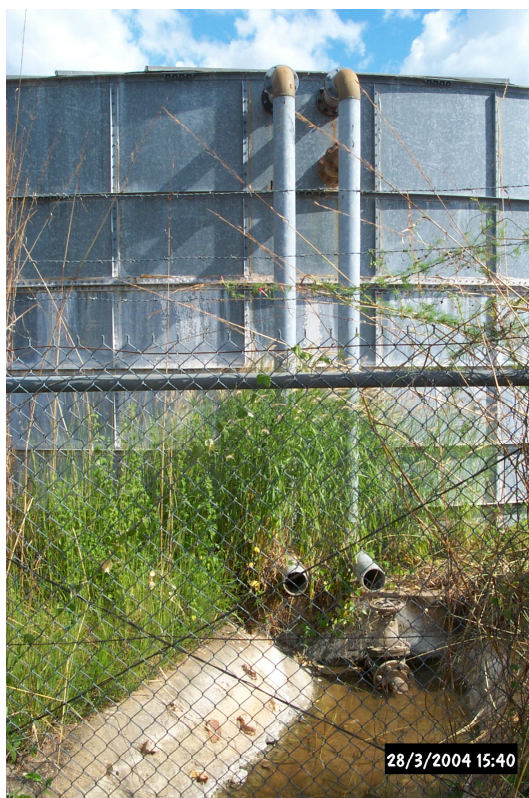
**Figure 11** Jabiru East Potable Water Tank – overflow pipes and concrete drain

The volume of the supply line to Jabiru East is approximately 135 m<sup>3</sup>. At a rate of 18 L/s, water from site during the incident would have reached the Jabiru East tanks in 2 hours.

Water discharging from the tanks is assumed to have travelled down a path and entered Magela Creek just downstream of Coonjimba billabong. Inspections of this path following the incident have shown the presence of wetland vegetation suggesting that the leak from the tank has probably occurred for some time. The presence of this wetland vegetation would have aided the attenuation of contamination discharged from the tank. Measurements reported in the previous section indicated that about 80 - 90% of the metals would have been attenuated along this path.

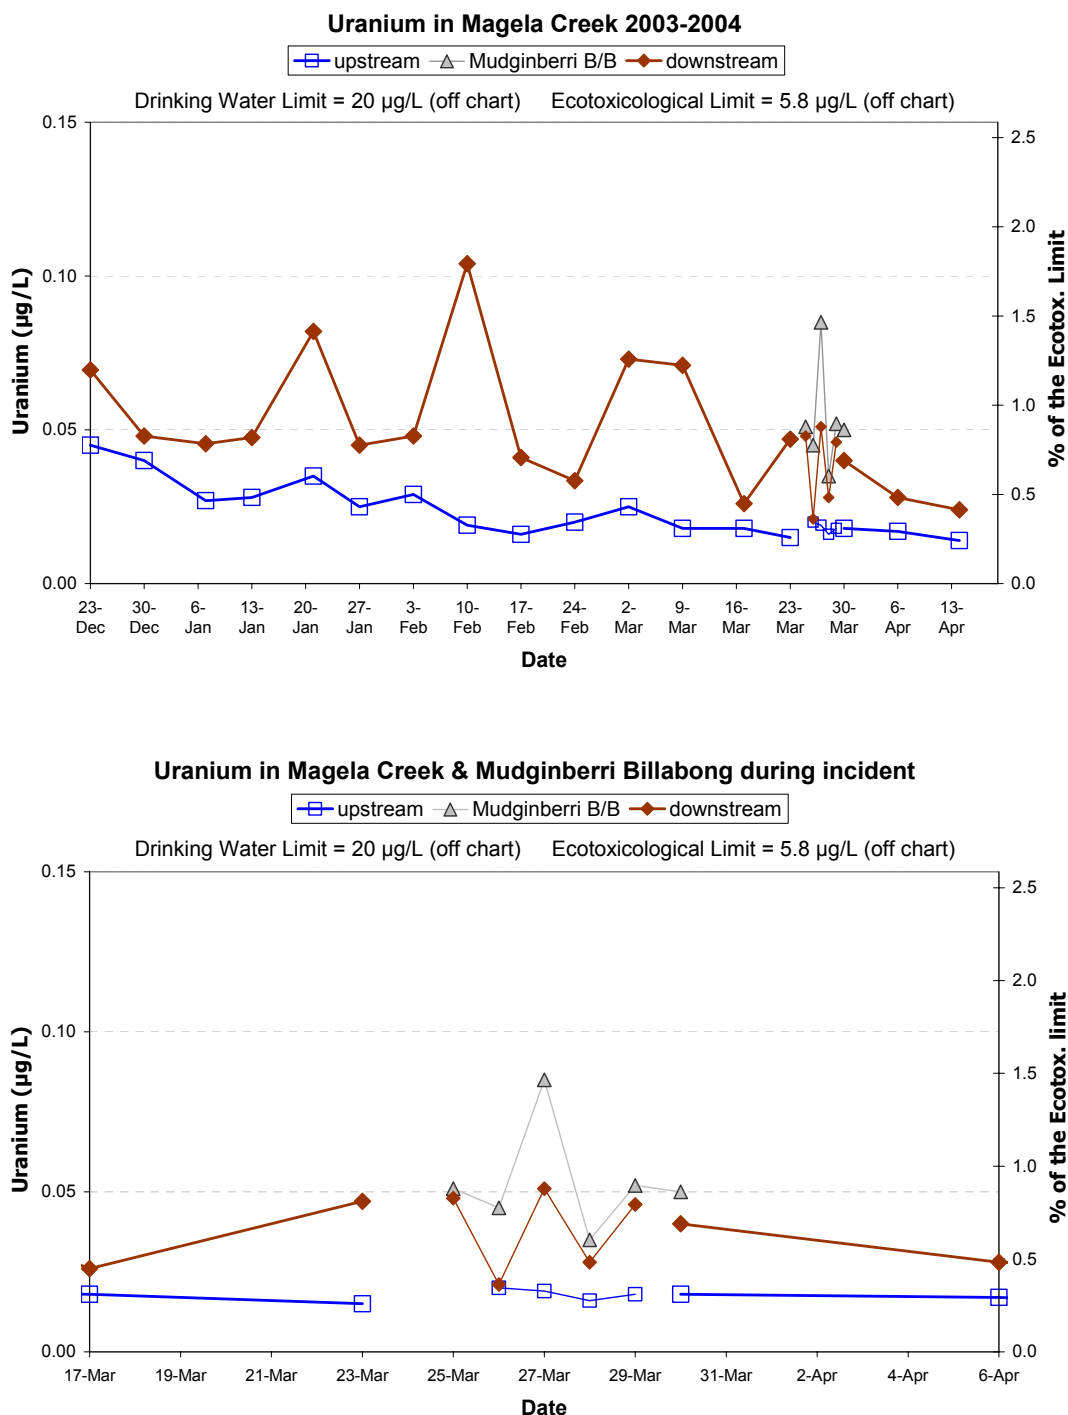
only the daily data and that from two weeks either side of the incident are shown. The data show that uranium concentrations at the downstream sites during the period of the incident were typical of such concentrations throughout the wet season and that no detectable change occurred during the period of the incident. The maximum concentration of uranium at the downstream compliance point during the incident was lower than the uranium compliance limit by about a factor of one hundred.

**Figure 13** Time series charts of uranium concentrations at the routine monitoring sites on Magela Creek and at Mudginberri Billabong. The upper chart shows data for the 2003–04 wet season, the lower chart shows the period of the incident expanded.

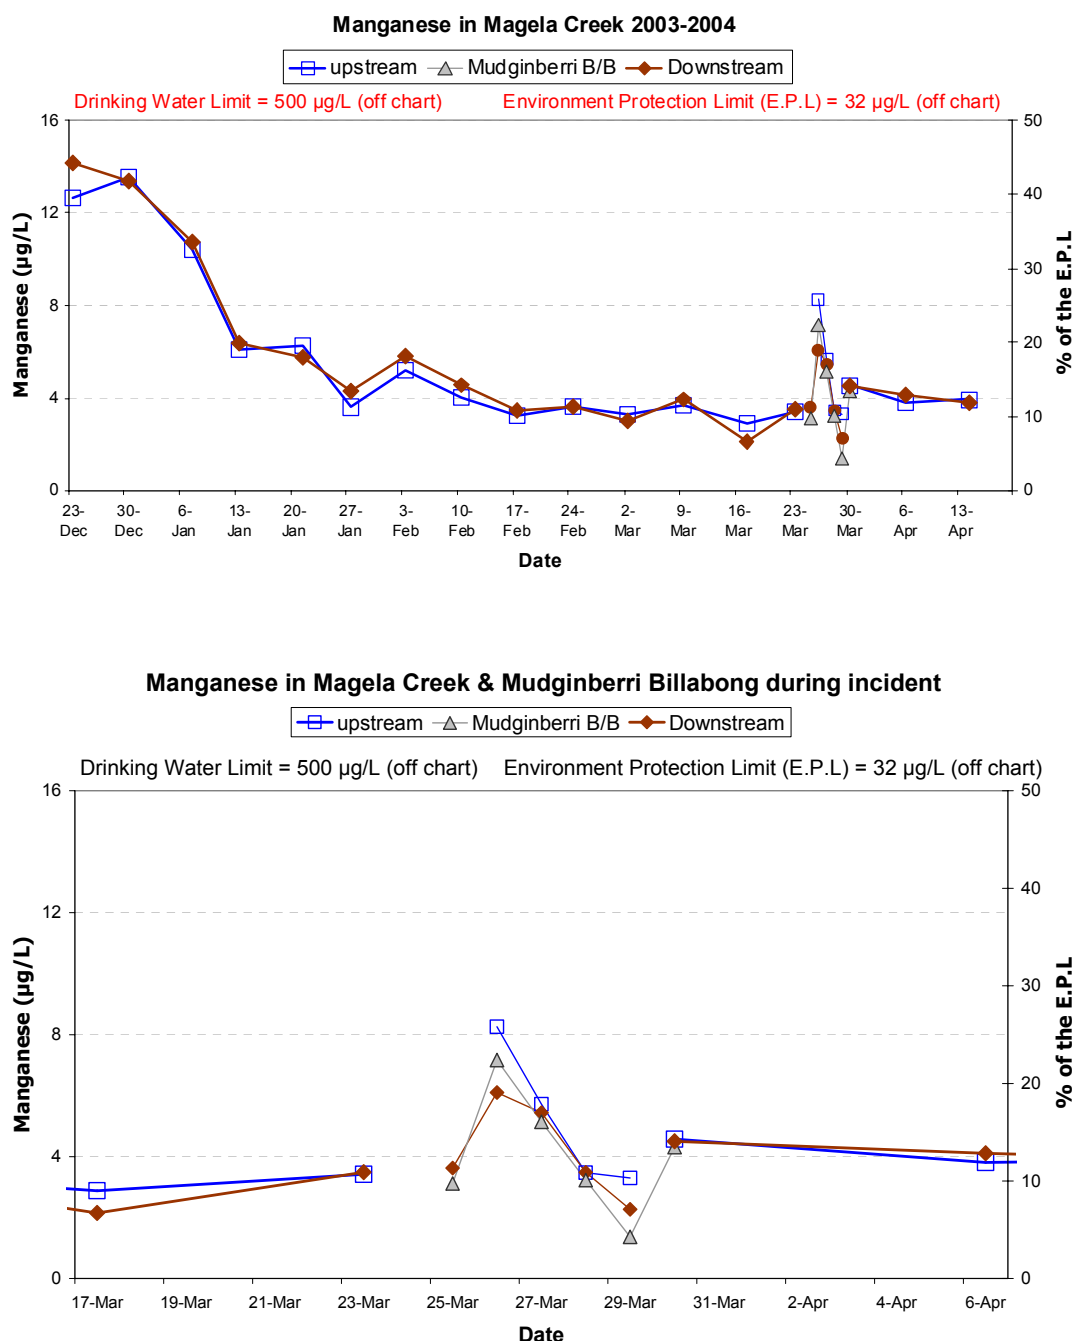
The corresponding data for manganese, a major constituent of process water, are shown in figure 14. On first inspection, it seems that a small increase in manganese concentration occurred at both the downstream compliance point and at Mudginberri Billabong during the period of the incident. However, the same small increase (about 4  $\mu\text{g/L}$ ) was observed at the upstream site and the increase was probably a natural occurrence. In any case, these concentrations are significantly below the manganese compliance limit of 32  $\mu\text{g/L}$  and also lower than the concentrations observed typically each year in the early stages of the wet season (see upper chart in figure 14).

**Figure 14** Time series charts of manganese concentrations at the routine monitoring sites on Magela Creek and at Mudginberri Billabong. The upper chart shows data for the 2003–04 wet season, the lower chart shows the period of the incident expanded.

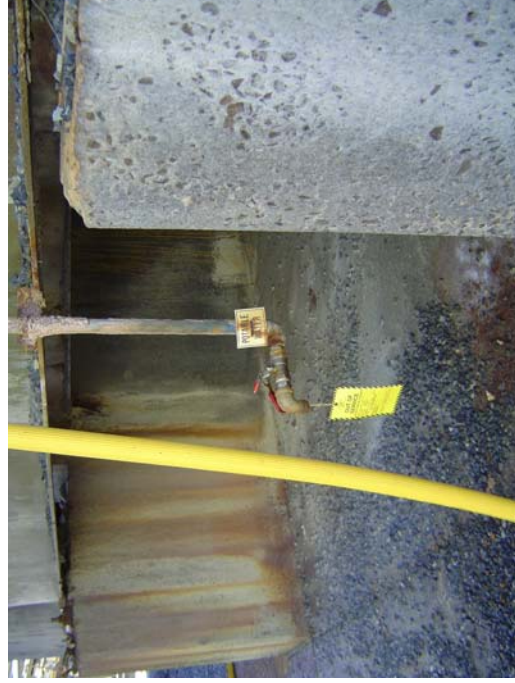
1" hose hanging from scrubber manifold  
**Photograph 5**

The location of the potable water supply valve (X) at ground level (photo 1 in Plates) is some 5 metres from an additional process water connection. Inspection of the site on March 26<sup>th</sup> showed a 25mm hose fixed to the supply side of the scrubbers about 5 metres directly overhead and hanging into the area near the potable water offtake valve (X) (photos 1, 5 in Plates; Figure 4). A 50mm hose also lay on the ground. The accepted practice at the time, when there was insufficient process water flow to the scrubber (two instances were logged during March 2004), was to change over to pond water by connecting the 50mm hose to a pond water line inside the nearby mill building, or a process water offtake about 20 metres away, then connect the smaller 25 mm hose to the larger 50mm hose. The process water connection located about 5 metres from the potable water valve (X) is not used often because it has not had a suitable coupling attached. Photograph 2 in Plates shows this connection with a 25mm coupling attached. This was attached after the incident. On the evening of March 23<sup>rd</sup>, in order to provide additional process water, the operator would have had to find such a coupling before being able to connect the 25mm or 50mm line to it.

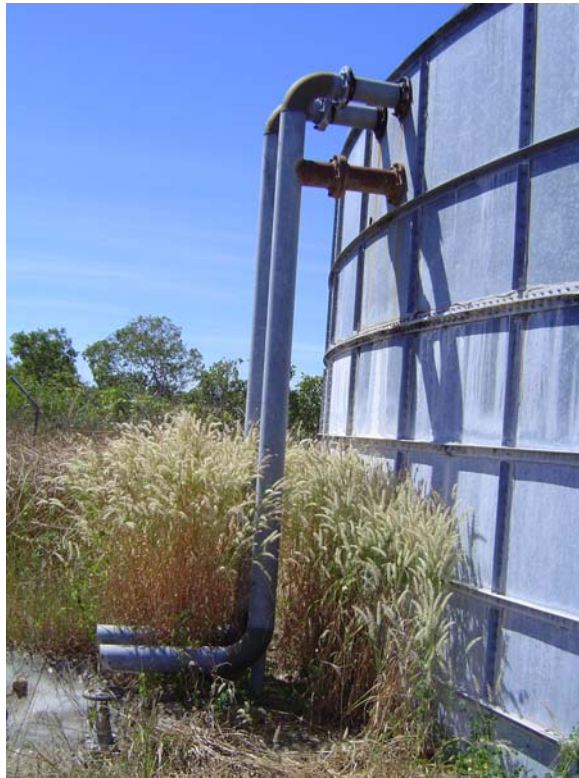
Booster Pumps – Faulty Valve shown on right  
**Photograph 8**

The low flow alarm had initiated towards the end of the day shift and continued into night shift. An operator hoped he could increase the flow by switching on the second pump but was unable to start the pump because the diaphragm valve on the supply side could not be opened. This valve had been difficult to open in the past and the pump had therefore not been used recently (photo 8). It is not clear why the operator felt that bringing the second pump into service would improve the flow to the scrubbers, as the pumps are not designed to operate in parallel and would have only had a small impact on flow. This was not normal practice and there are no procedures for this. None of the operators on other shifts had ever tried this as a solution to a low flow problem.

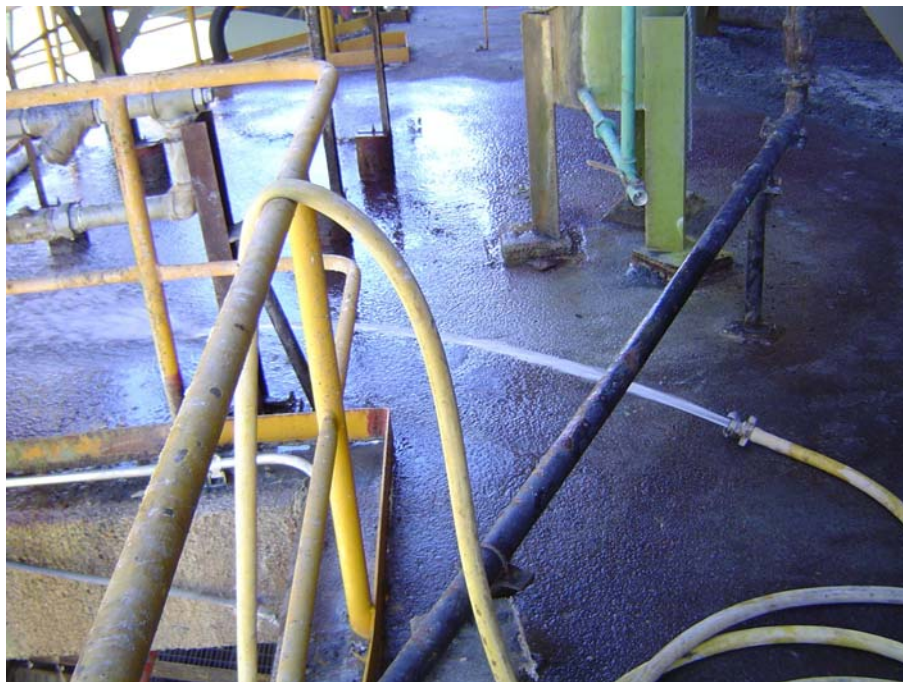
1" flattened hose when discharging  
**Photograph 10**

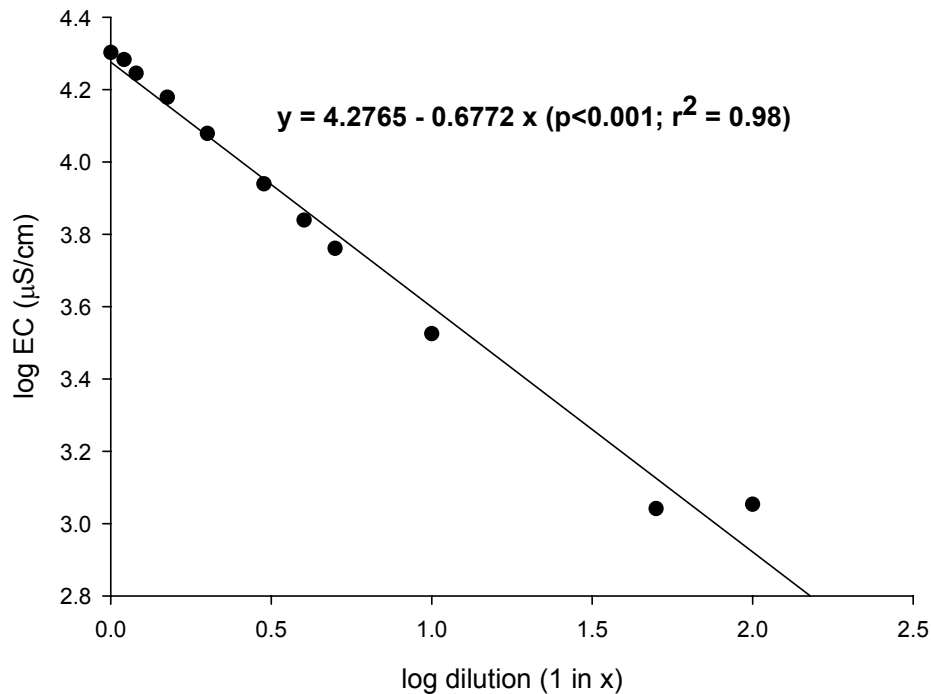
**Figure 4-5:** The effect on EC of diluting process water with potable water

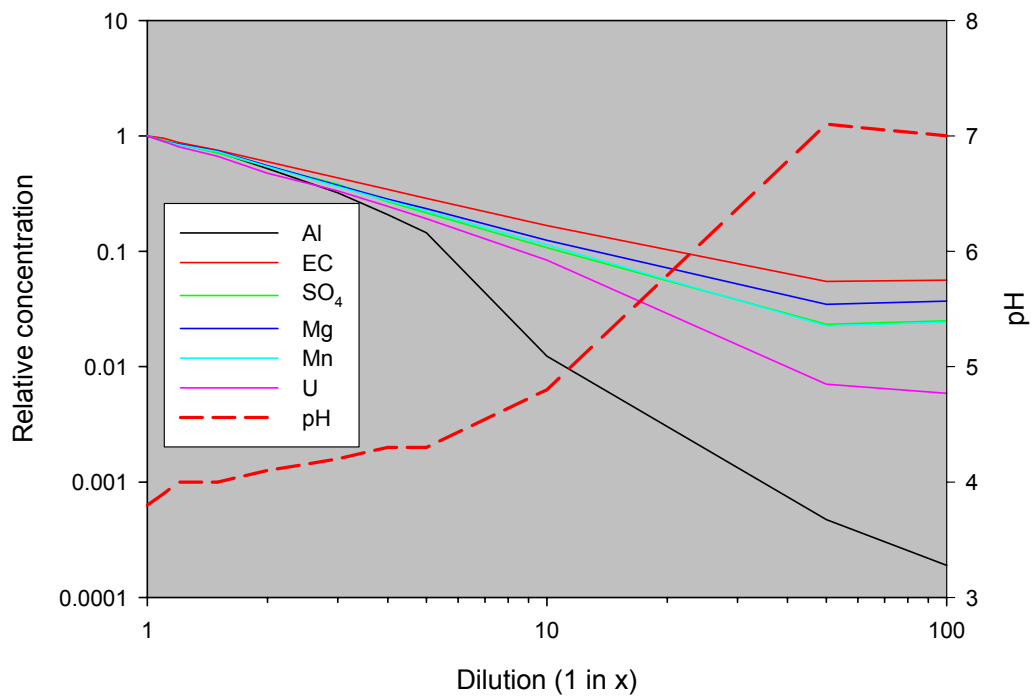
**Figure 5-1:** The effects of diluting process water with Brockman Bore water on the relative change in pH and EC, and Mg, SO<sub>4</sub>, Al, Mn and U in solution

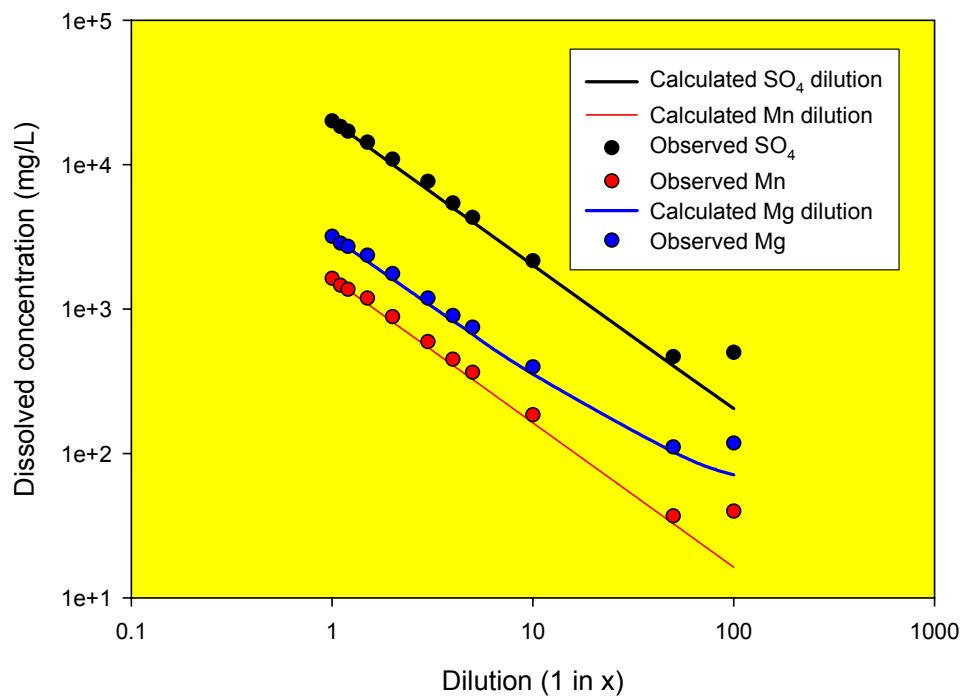
**Figure 5-2:** Calculated dilution for Mg, SO<sub>4</sub> and Mn assuming conservative behaviour following mixing compared to observed concentrations

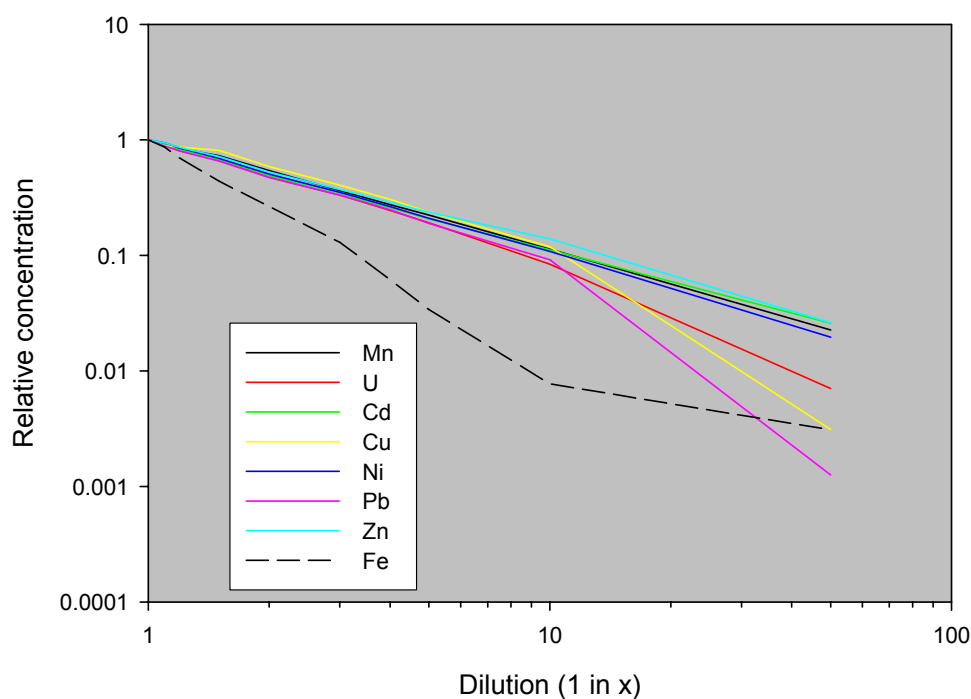
**Figure 5-3:** The effects of diluting process water with Brockman Bore water on the relative change in Mn, U, Cd, Cu, Ni, Pb, Zn and Fe in solution

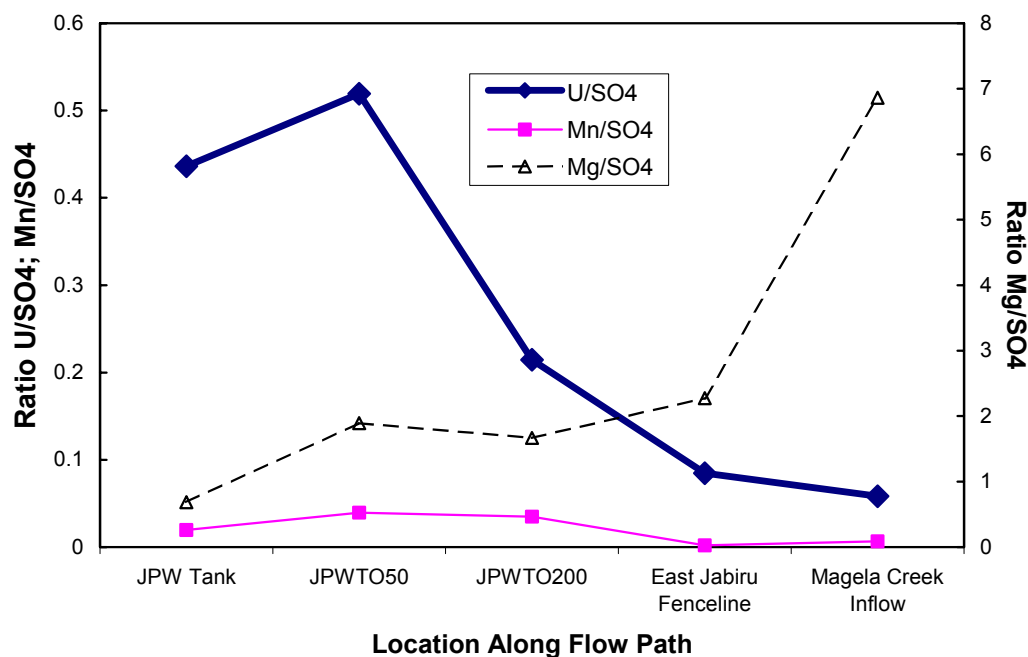
**Figure 3-1:** Ratios of indicator cations to sulfate showing attenuation for U and Mn, and inputs of Mg-rich water.

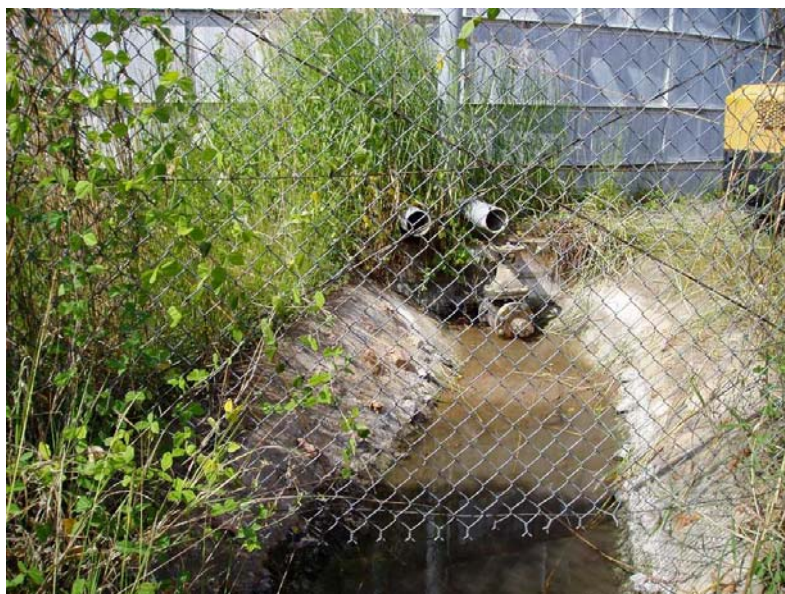
Plate 5-1: Sample site 1, overflow pipe outlet at base of storage tank

Samples were numbered consecutively, from 1 to 27, in the order in which they were collected. The first sample (1) was collected in the drain invert directly below the spigot outlet from the water holding tanks (Plate 5.1).

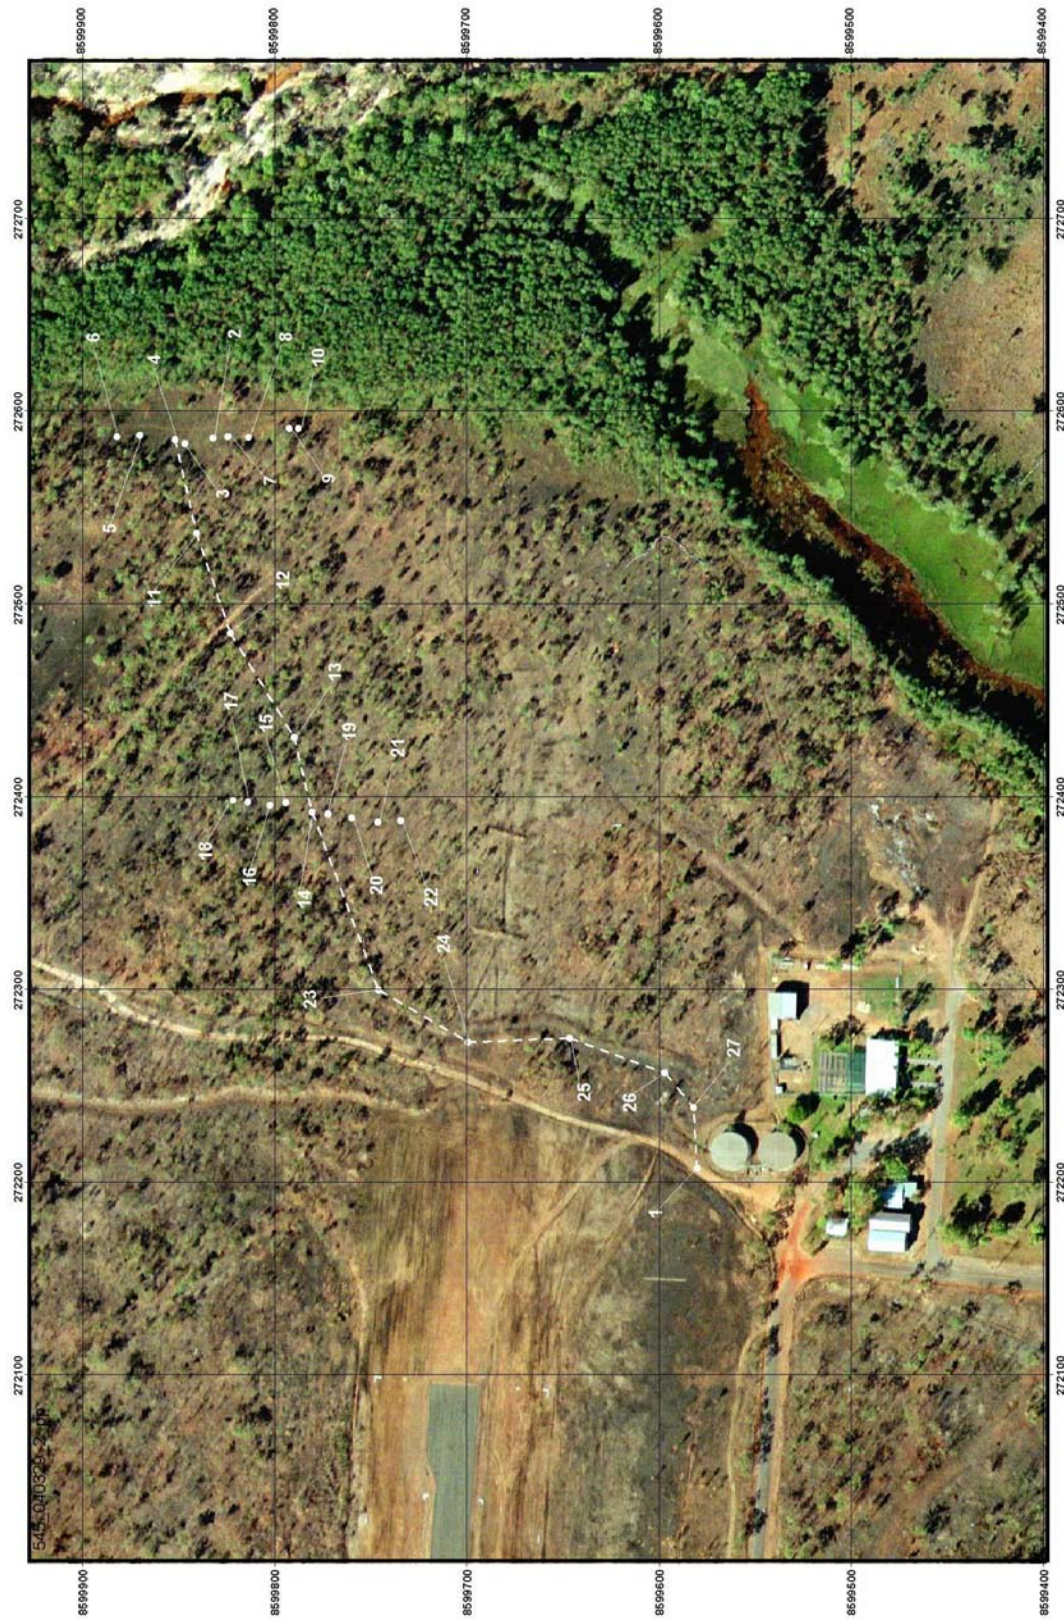
Figure 5-1: Locations of soil sampling sites (refer Table 5.1)

Twenty seven samples of the surface 1 to 2 cm of soil (over an approximate 30cm x 30cm area for each sample) were collected using a shovel. The GPS co-ordinates of the sampling locations are given in Table 5.1, and the locations are marked on Figure 5.1.

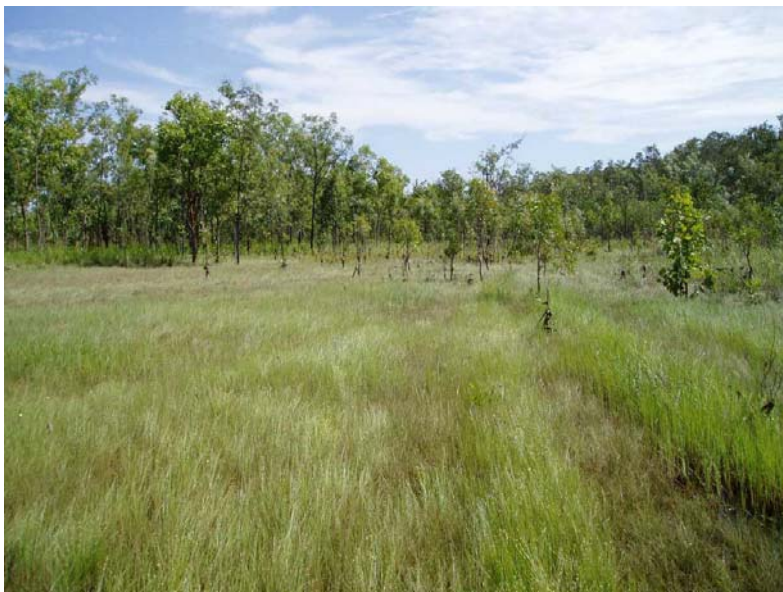
**Plate 5-2:** Sample site 2, overflow channel

The second sample site (2) was located at the end of the flow path to the receiving water body, ie, in the overflow channel adjacent to Coonjimba Creek (Plate 5.2).

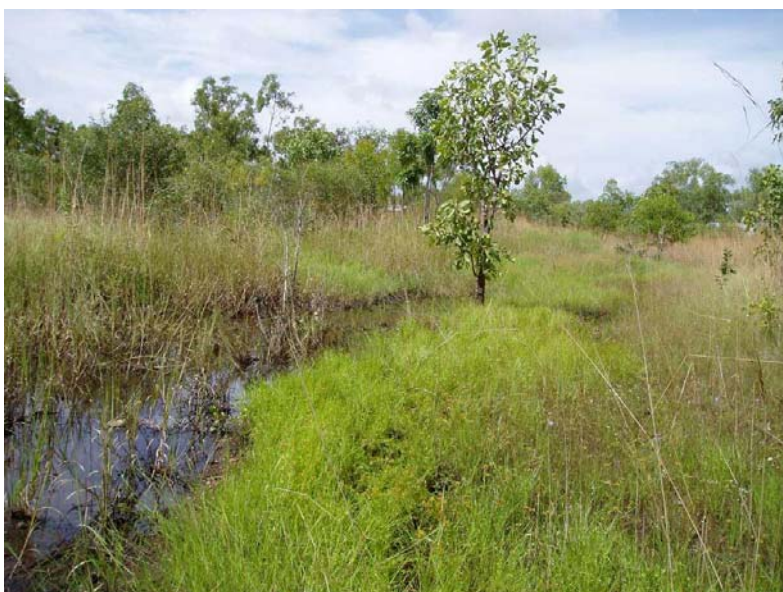
**Plate 5-3:** Wetland vegetation along the drain invert

Wetland vegetation has established along the formed invert of the drain (Plate 5.3). This indicates that it carries prolonged flow through the dry season. The drain receives flow from the water storage tank overflow (wet and dry seasons) and runoff (wet season) from the airstrip.

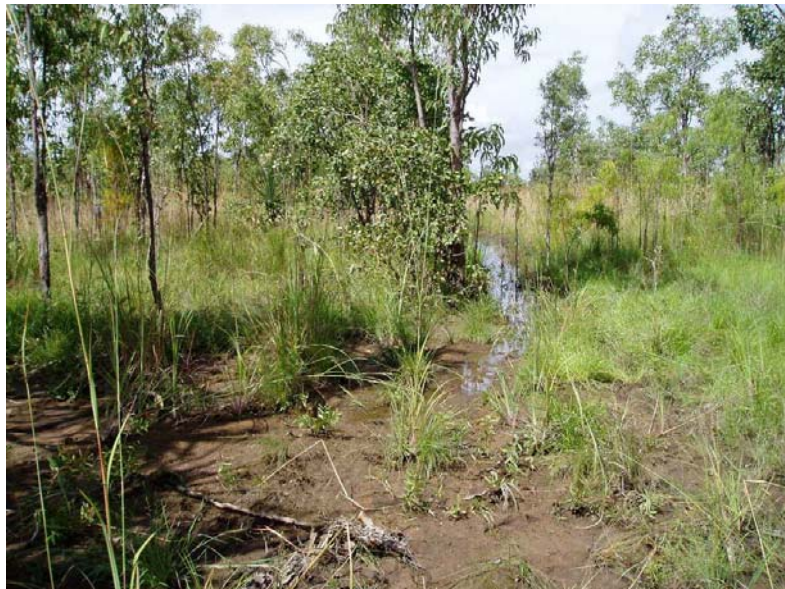
**Plate 5-4:** End of drain channel and start of overland flow

The invert of the drain ended and overland flow began at site 23 (Plate 5.4). Samples collected in the flow line above site 23 corresponded with 50 m mark above the end of the drain invert (site 24), the bottom corner of the airstrip (site 25), a track crossing the drain which carries airstrip runoff (site 26) and a gauging structure in the drain invert (site 27).

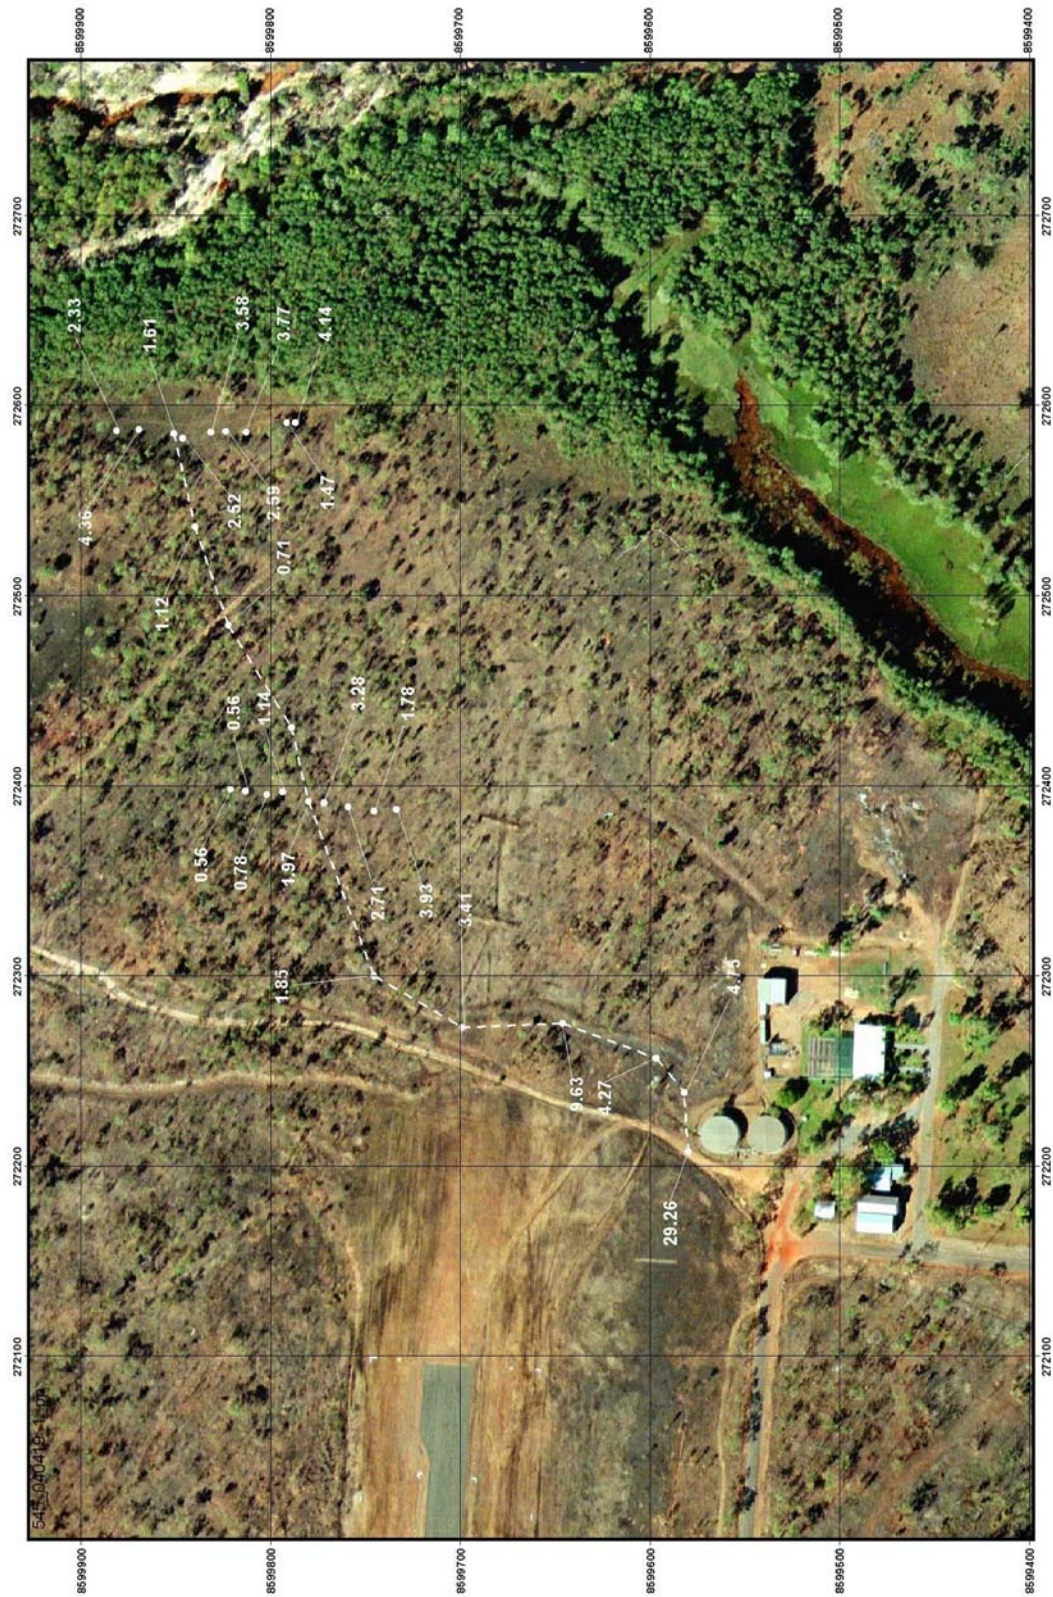
Figure 5-2: Concentrations of U in surface 0-2 cm of soil (mg/kg dry weight)

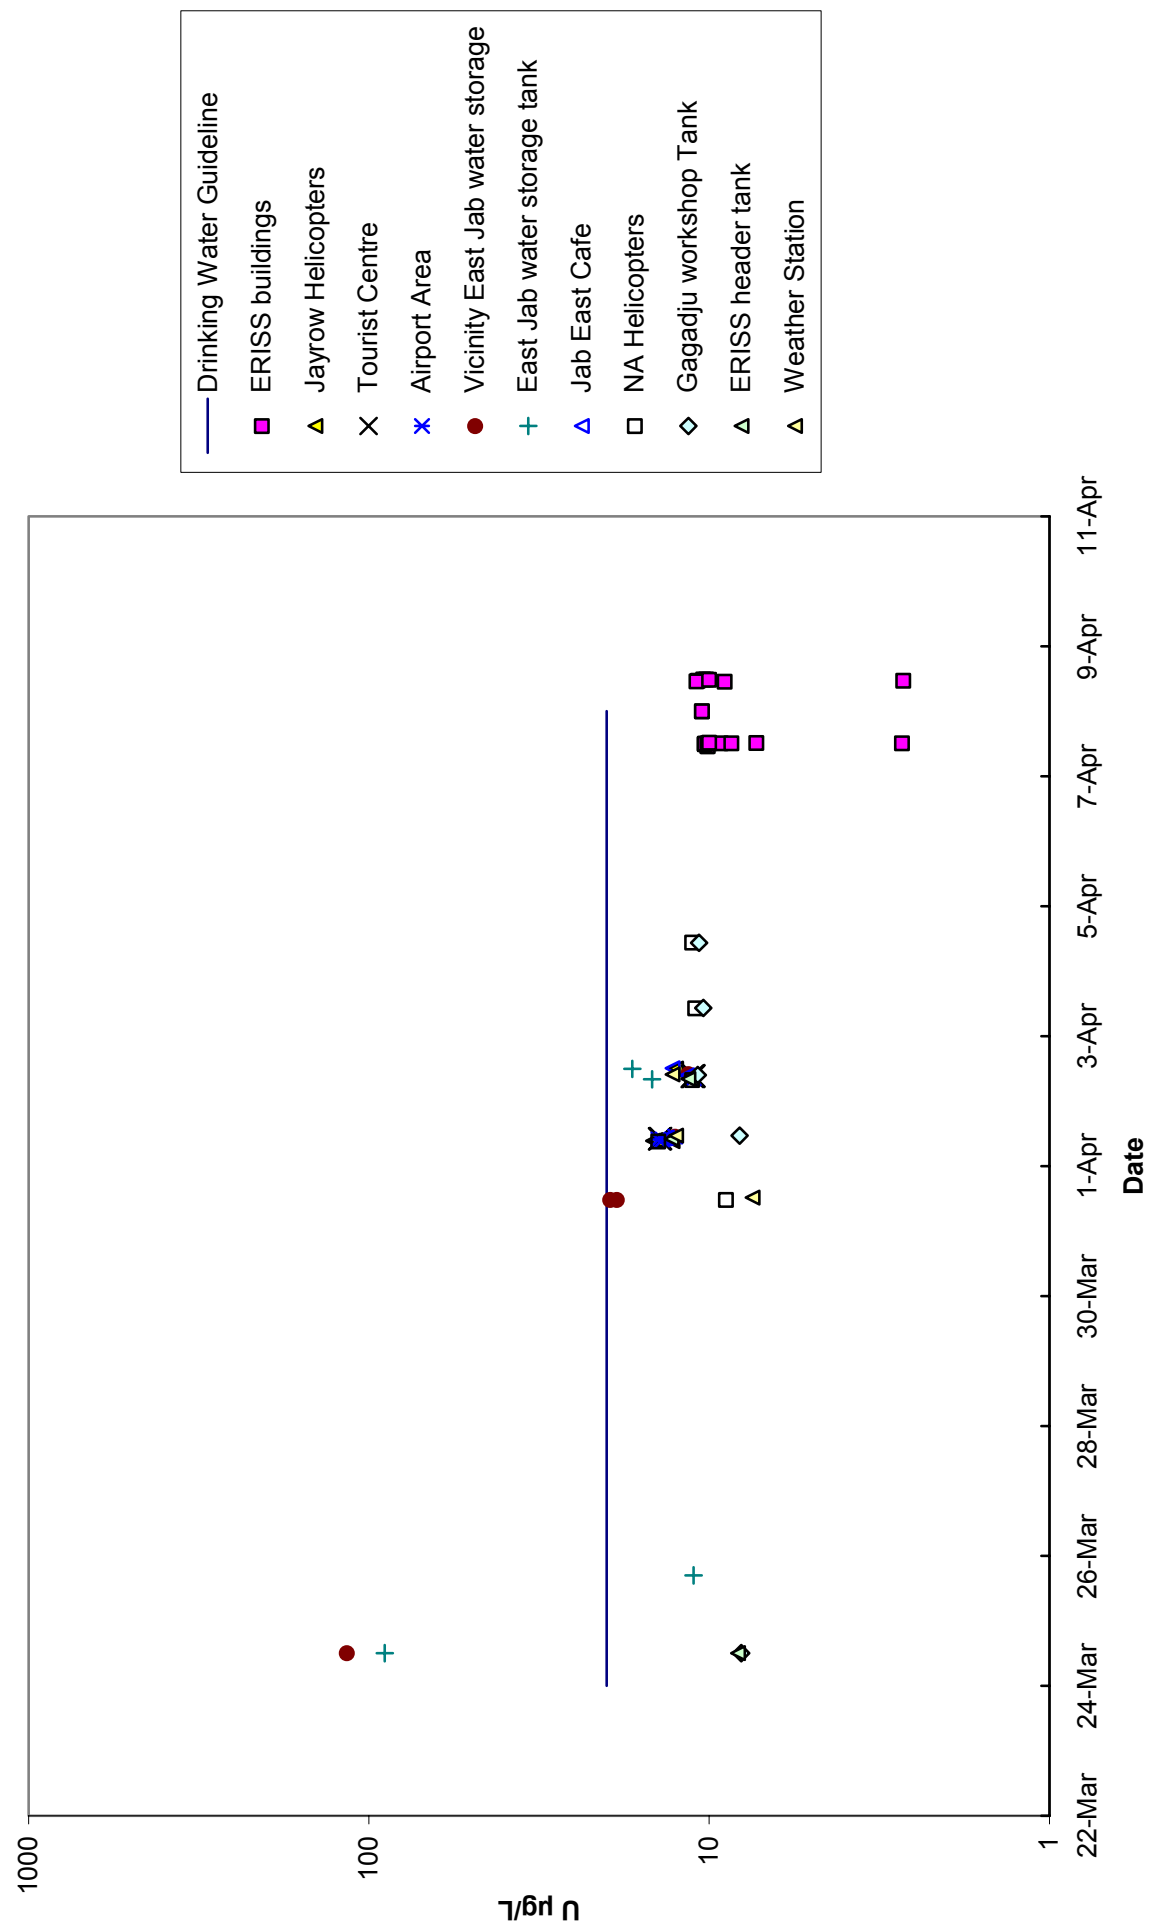
Figure 2: Time series data for Jabiru East showing recovery of reticulation system
