Interim Report: Investigation
into the environmental impacts
of the leach tank failure at
Ranger uranium mine,
December 2013

Supervising Scientist 2014. *Interim Report: Investigation into the environmental impacts of the leach tank failure at Ranger uranium mine, December 2013*. Supervising Scientist Report 206, Supervising Scientist, Darwin NT.

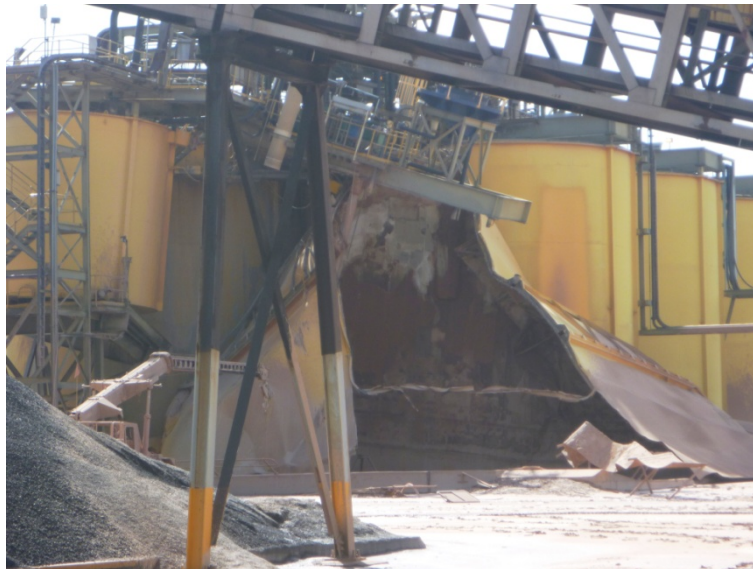
Figure 2.1 Collapsed Leach Tank 1.

At approximately 00:10 on Saturday 7 December 2013 operators in the processing area at Ranger observed slurry under pressure being released from the wall of Leach Tank 1 through a hole approximately 2 metres above the base of the tank. ERA staff attempted to contain the leaking material in the concrete bunded area of the leach tanks. All personnel were evacuated from the area at approximately 00:40 following the identification of a second leak. At 00:54 Leach Tank 1 catastrophically failed, releasing approximately 1400 m³ of slurry into the surrounding processing area (Figure 2.1).

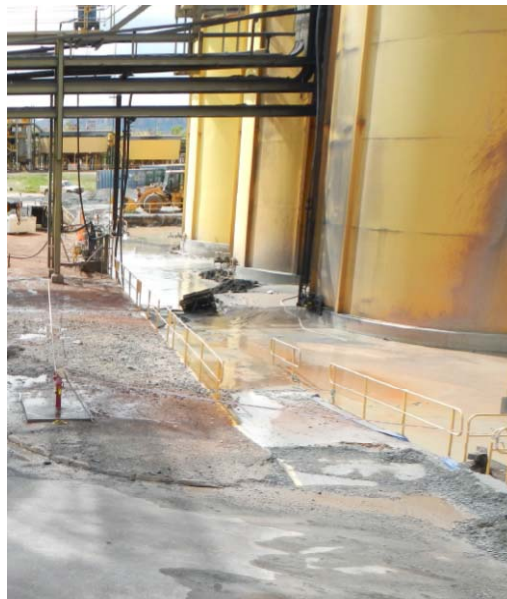
Figure 2.4 Leach tank bund following the failure of Leach Tank 1.

An assessment of the level of slurry in the leach tank bund immediately after the incident suggests that the bund was approximately half filled (Figure 2.4). The leach tank bund capacity is 1666 m³ (ERA data) and therefore it is estimated approximately 700-800 m³ of slurry was retained in the bund with the remaining 600-700 m³ spilling outside the bund.

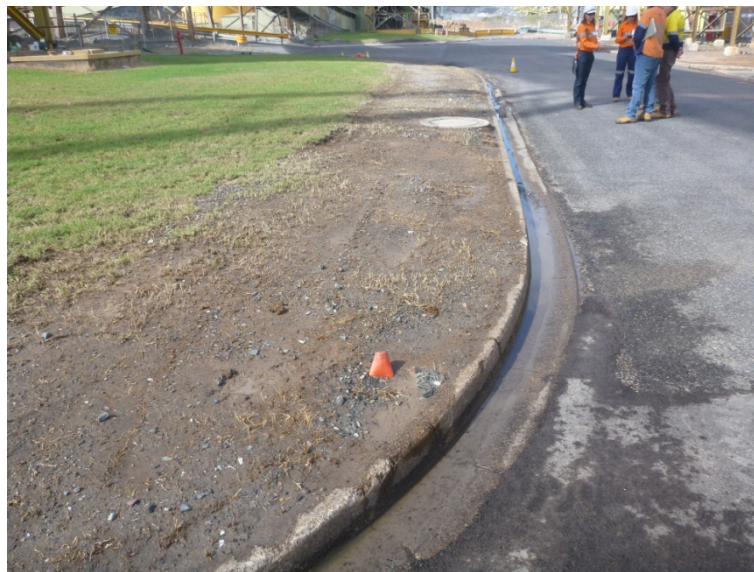
Figure 2.5 Scraped verge following cleanup.

With the exception of the exclusion zone established around the failed tank, the major cleanup activities were completed within 4 days and were inspected by stakeholders on 12 December 2013.

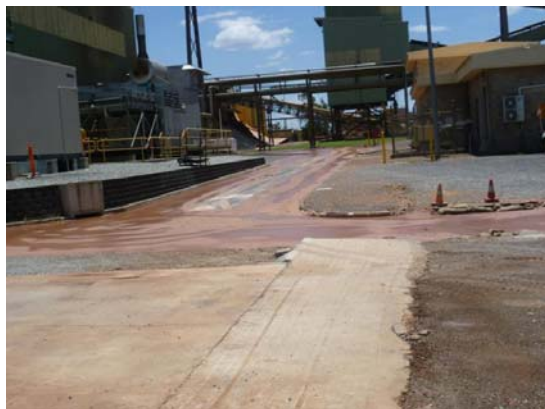
Figure 3.1 Looking south east at the failed tank from the end of the slurry flow.

Representatives from SSD Jabiru Field Station (JFS), Northern Land Council (NLC) and Gundjeihmi Aboriginal Corporation (GAC) inspected various areas of the site around the failed leach tank and observed that slurry from the leach tank had filled low lying areas such as roads and drains and flowed in a north westerly direction for approximately 200m (Figure 3.1 and Figure 3.2).

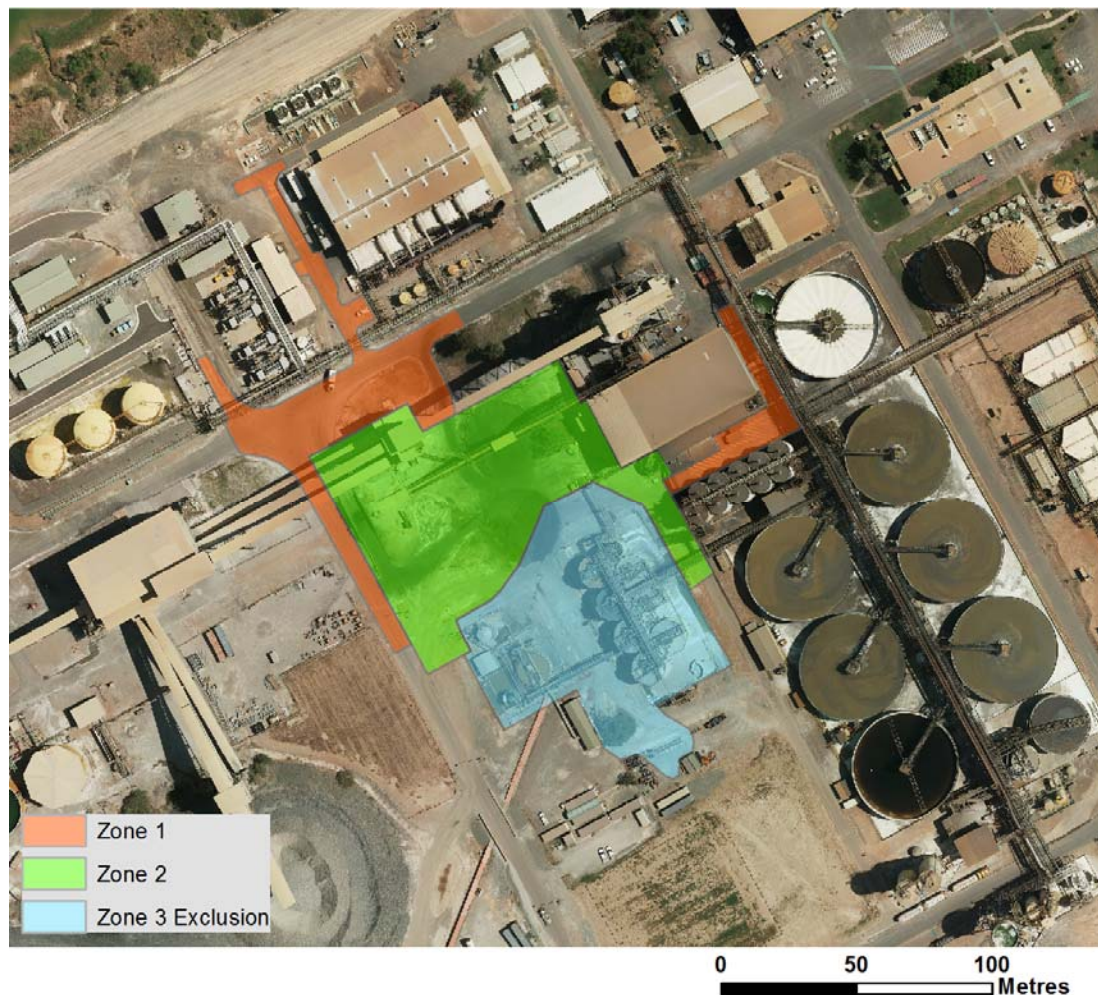
Figure 3.5 Classification of impact zones for wash down purposes.

As part of the cleanup operations, the impact area from the slurry was broadly separated into three main zones as identified during the routine periodic inspection (Section 3.1.3). These three zones are shown below in Figure 3.5. The purpose of this zoned approach was to facilitate a return to the pond water system of those areas impacted by the slurry once a specific area had been sufficiently cleaned. An assessment of runoff water quality was used to verify the area was suitable to be reincorporated into the pond water system.

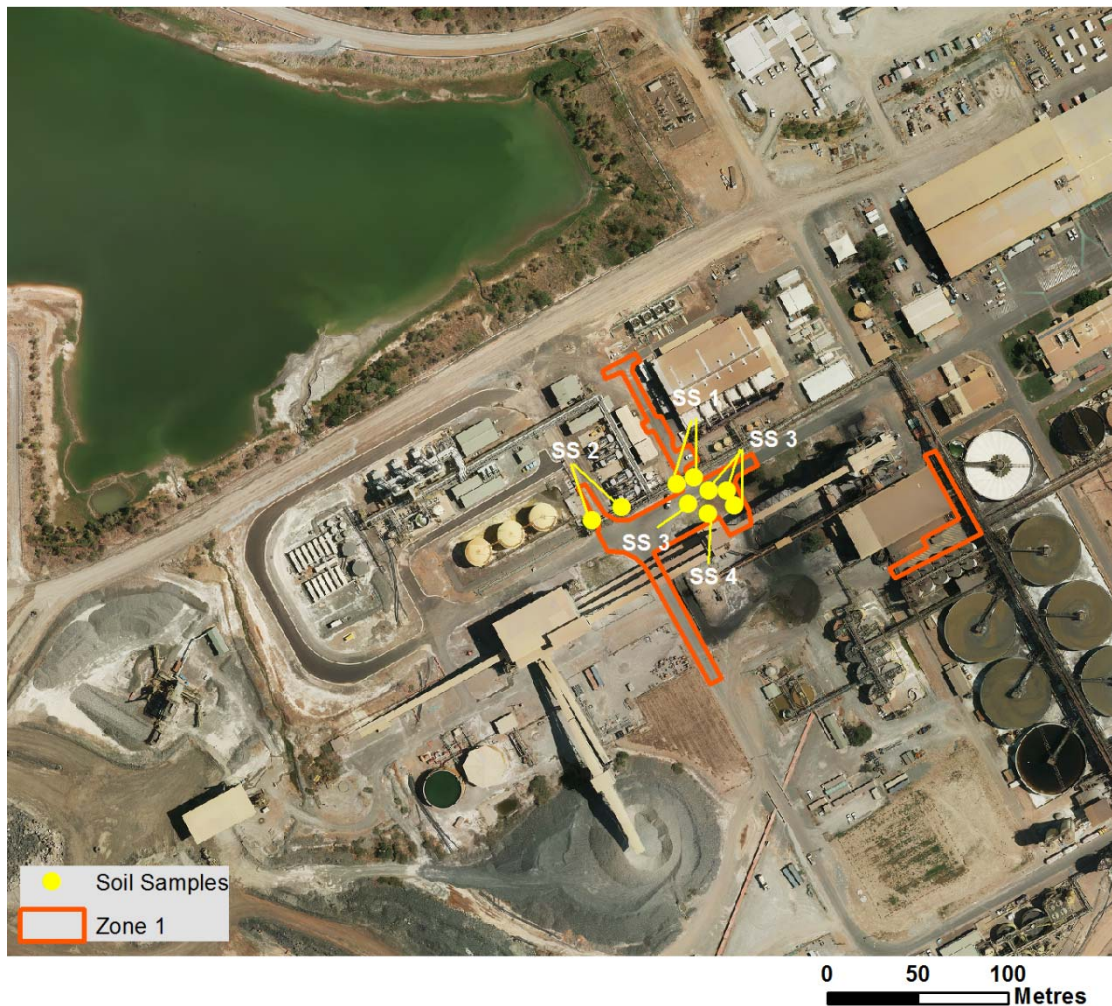
Figure 3.6 Sample locations for soil scrapes.

The soils were assessed for their potential to release slurry-related elements into rainwater runoff by performing a 1:20 water leach (AS4439.2) followed by ICP-MS and OES analysis on the leachate. The results are reported in section 4.1.4.

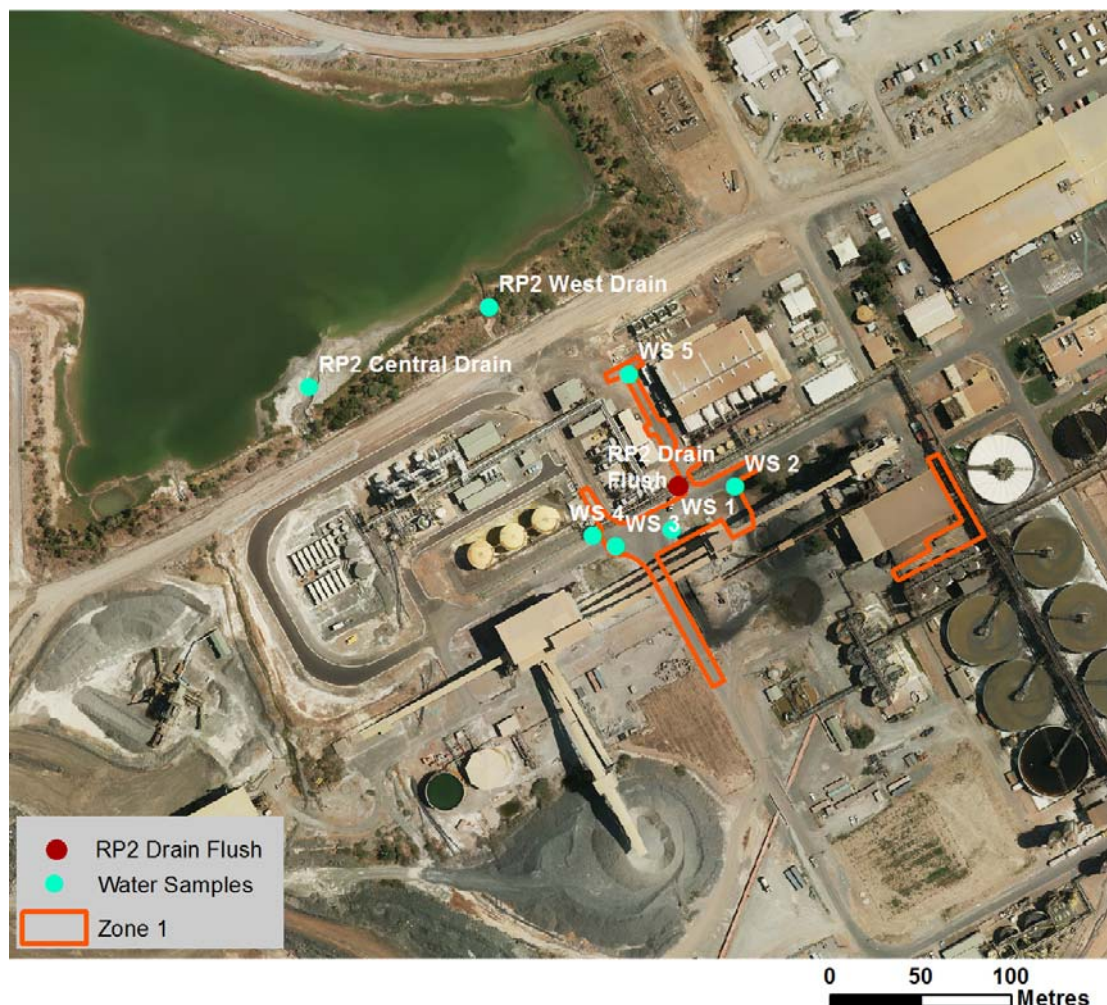
Figure 3.7 Sample locations for Zone 1 clearance.

A water cart of approximately 8,000 L was utilised to spray RP2 water onto road verges and the road in areas that had been exposed to the spilled slurry. Water samples were then taken where the resulting water ponded in the stormwater drains as shown in Figure 3.7.

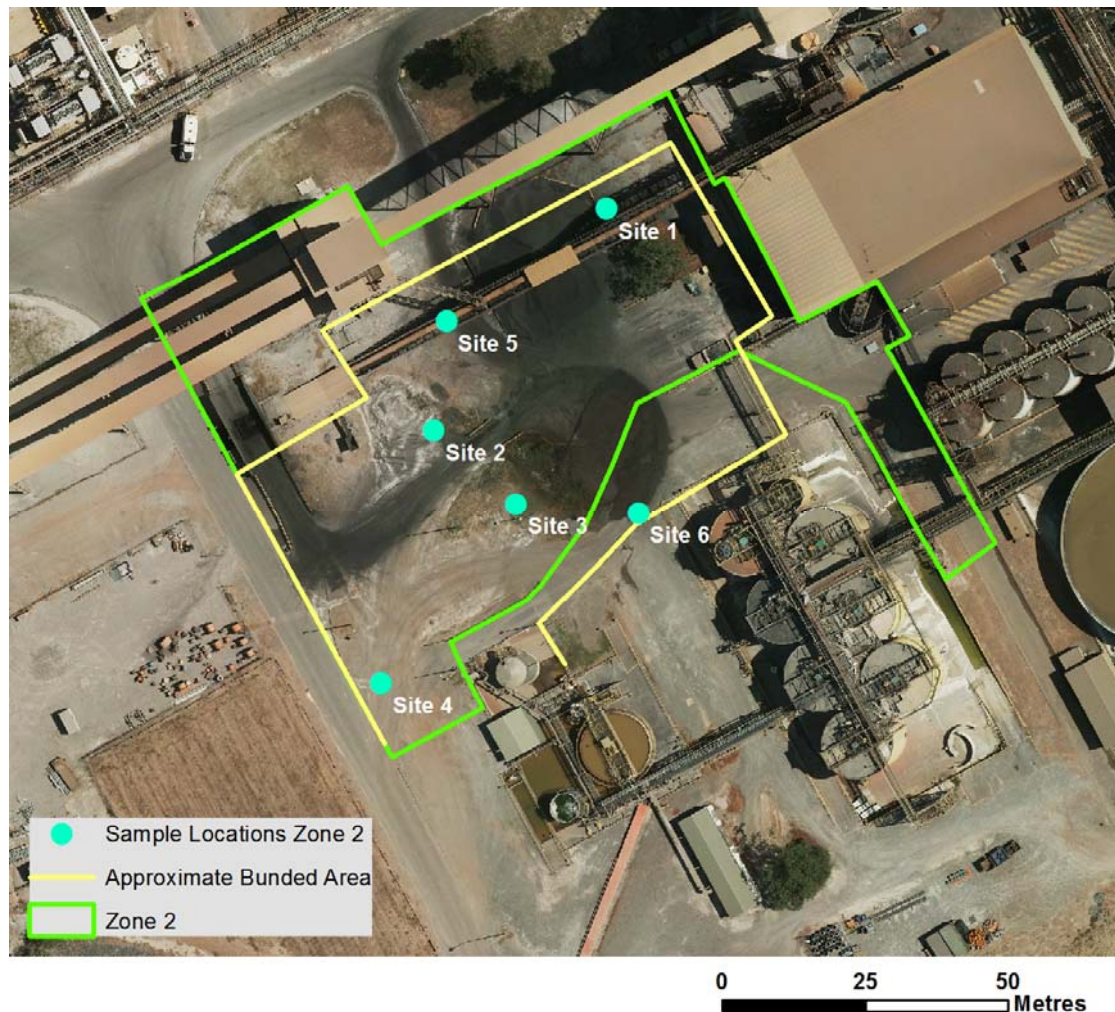
Figure 3.8 Sample locations for Zone 2.

Six pools of water were sampled within Zone 2 (See Figure 3.8). A duplicate was taken at Site 2 and a laboratory blank on return to the SSD field station. At each sampling site SSD, collected water samples for analysis of filtered and total metals, general parameters (electrical conductivity and pH) and ^{226}Ra . Results of this water sampling are detailed in Section 4.1.1.2.

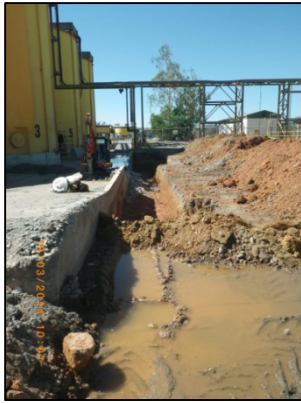
Figure 3.9 Excavated area within Zone 3.

Two locations within Zone 3 had been excavated, associated with repair of the concrete bund wall around the failed tank (See Figure 3.9 and Figure 3.10). Both of these areas would drain into the tank bund area and thereby report to the process water circuit.

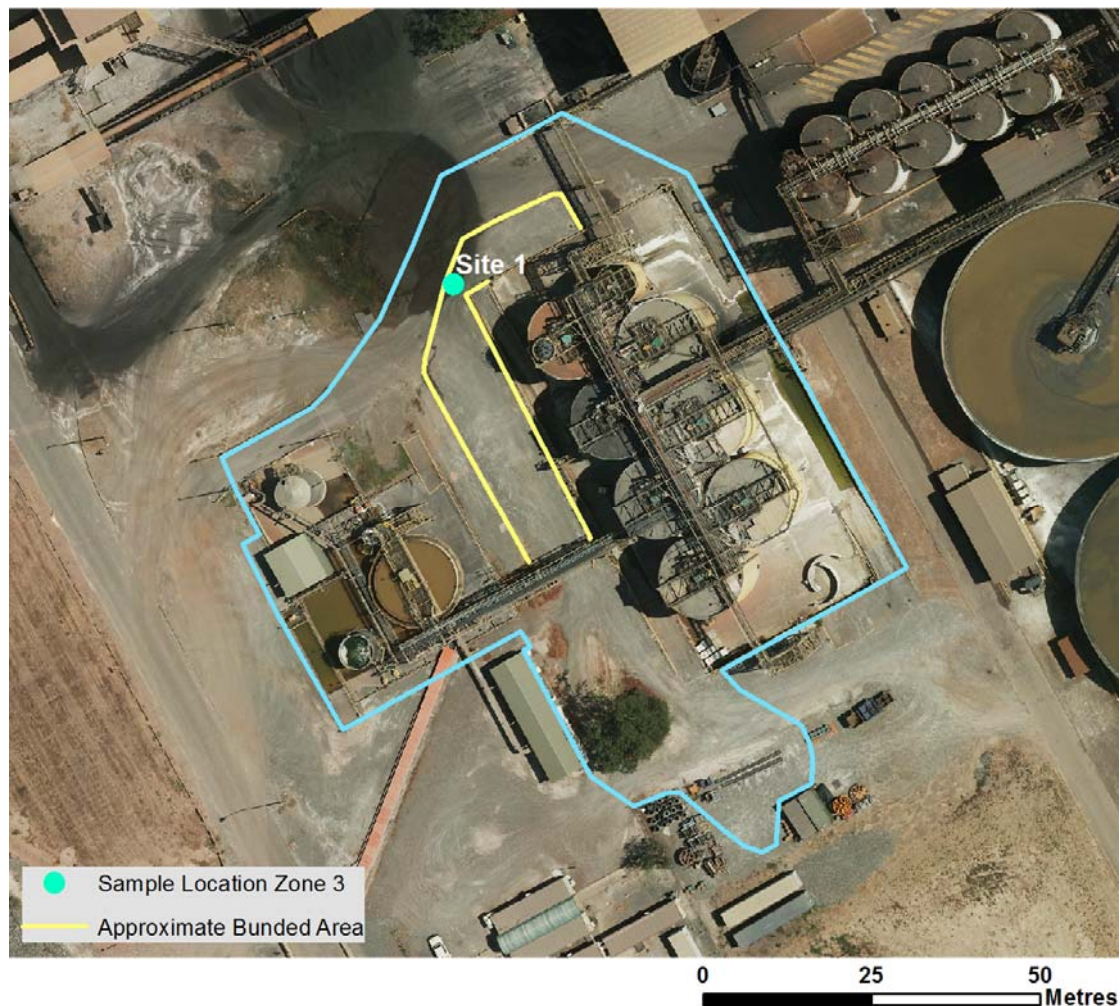
Figure 3.11 Sample location for Zone 3.

One pool of water was sampled within Zone 3 (See Figure 3.11). SSD collected water samples for analysis of filterable and total metals and filterable ^{226}Ra . A field blank for total metals was also taken. Results of this water sampling are detailed in Section 4.1.1.2.

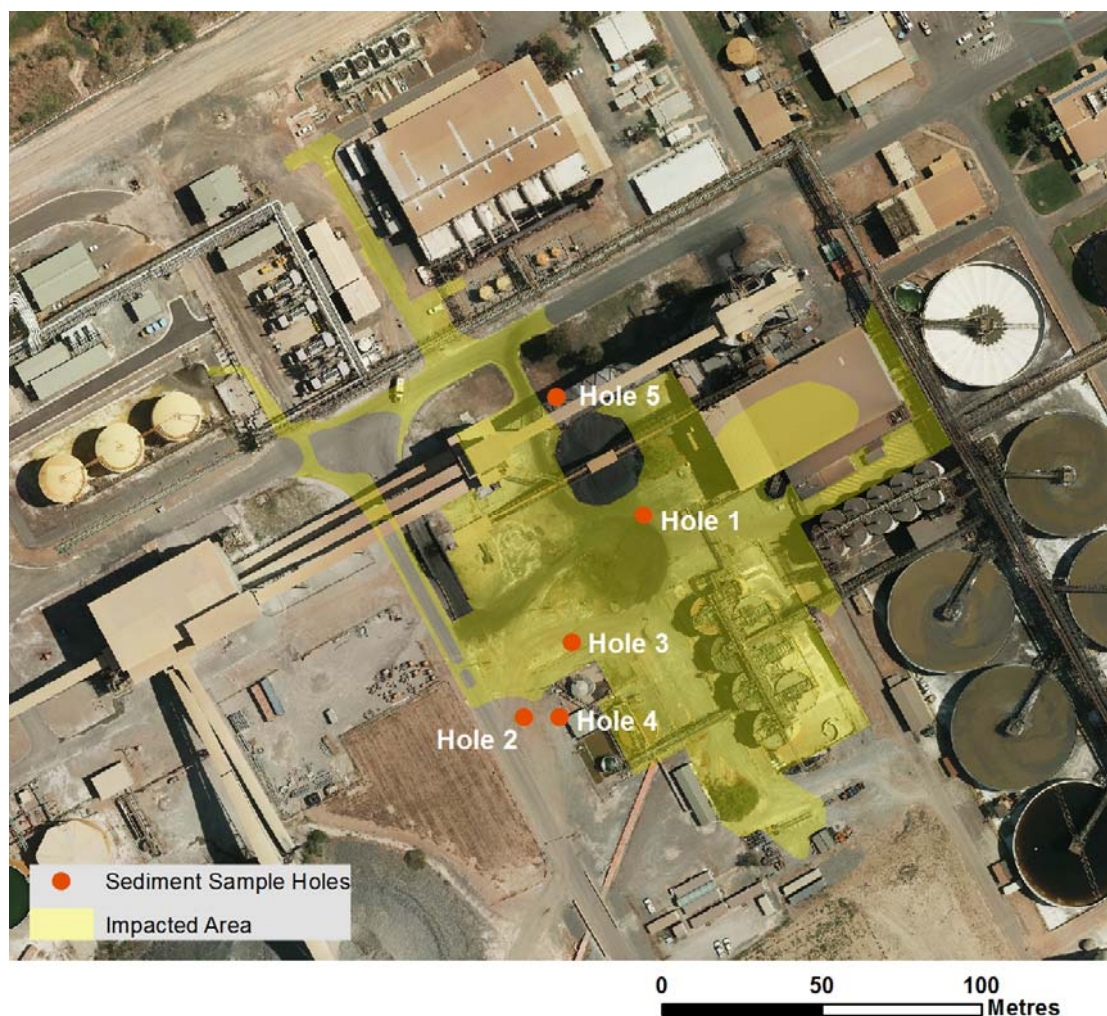
Figure 3.13: Location of soil profiles.

Soil profiles for each of the five holes were described. In these descriptions, their compositions, including the percentage abundance of different grains such as sand, clay or gravel, were included. Approximate grain size distributions were estimated. This information is essential to classify the material. It is especially useful to determine the porosity and permeability of the material in order to estimate the likelihood of infiltration. The results of this soil profiling work are presented in Section 4.2.1.

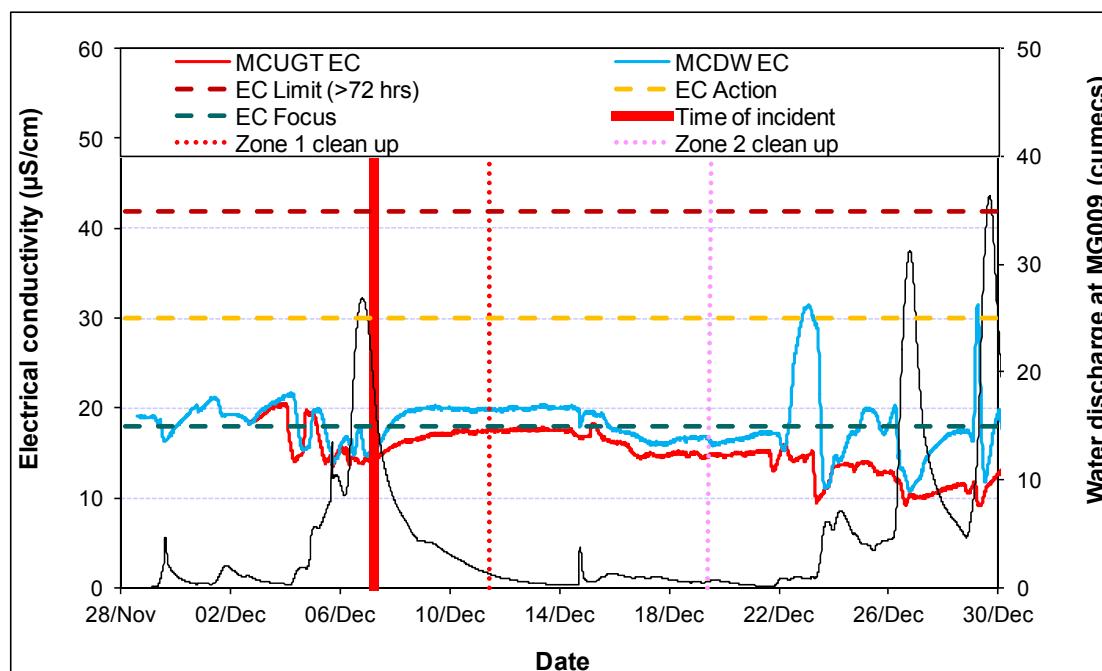
The leach tank failure occurred on the recessional tail of a peak in Magela Creek water level related to a 69 mm rainfall event recorded on 6 December 2013. During the 15 day period following the incident there were no significant flow events in Magela Creek and the EC at the upstream (MCUGT) and downstream (MCDW) sites stabilised at approximately 18 $\mu\text{S}/\text{cm}$ and 20 $\mu\text{S}/\text{cm}$, respectively (Figure 4.9).

Figure 4.9 SSD continuous EC data for Magela Creek from 28 November 2013–27 December 2013.

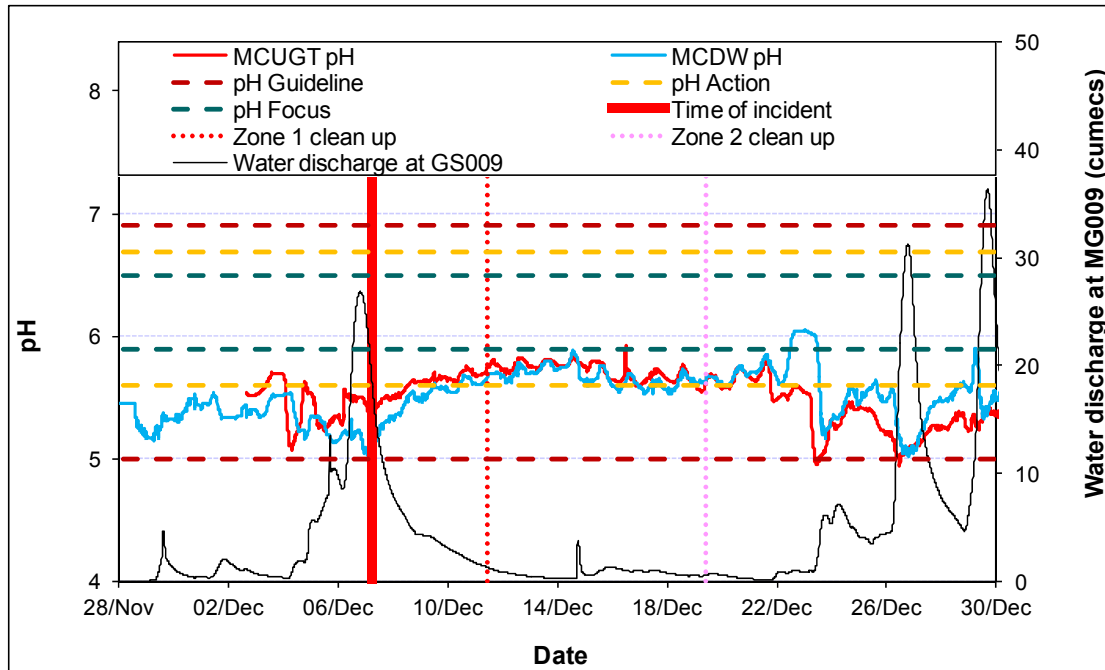
The upstream and downstream pH also stabilised at approximately 5.75 (Figure 4.10). The coincident behaviour and the similar values measured at the upstream and the downstream sites for both pH and EC indicates that there was no effect from the leach tank failure on Magela Creek physico-chemistry during this period. This is unsurprising as there was no rainfall during this period and, hence, no transport mechanism enabling export of contaminants from the mine site to Magela Creek.

Figure 4.10 SSD continuous pH data for Magela Creek from 28 November 2013–30 December 2013. The pH trigger values are provided for information only as these trigger values were determined statistically from historical weekly grab sampling data, and only apply to water quality measured in grab samples.

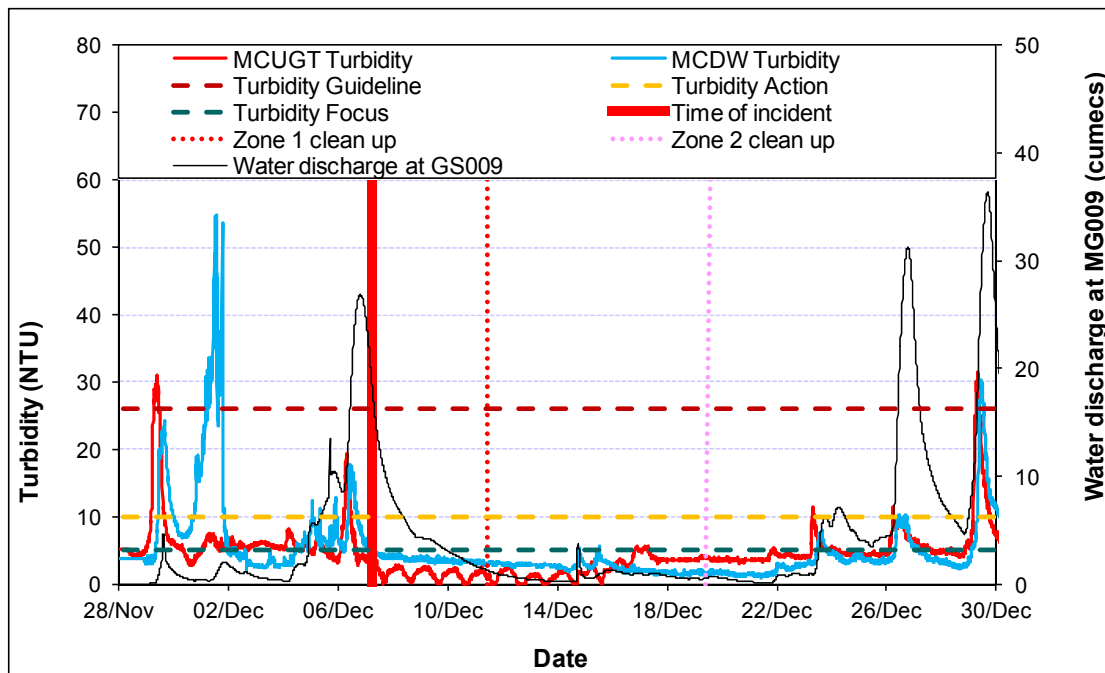
Figure 4.11 SSD continuous turbidity data for Magela Creek from 28 November 2013–30 December 2013. The turbidity trigger values are provided for information only as these trigger values were determined statistically from historical weekly grab sampling data, and only apply to water quality measured in grab samples.

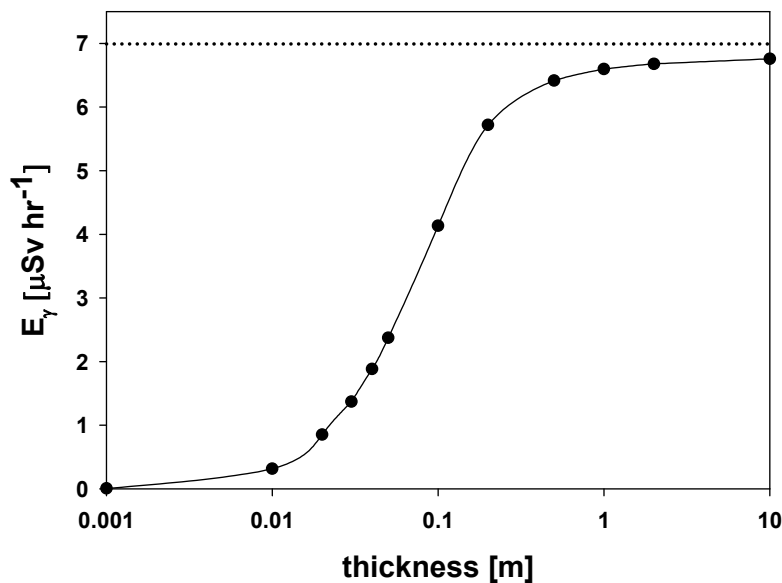
Figure 4.30 Effective gamma dose rates for various thicknesses of dried material with an activity concentration of ²³⁸U in equilibrium with its decay products of 21.6 Bq·g⁻¹

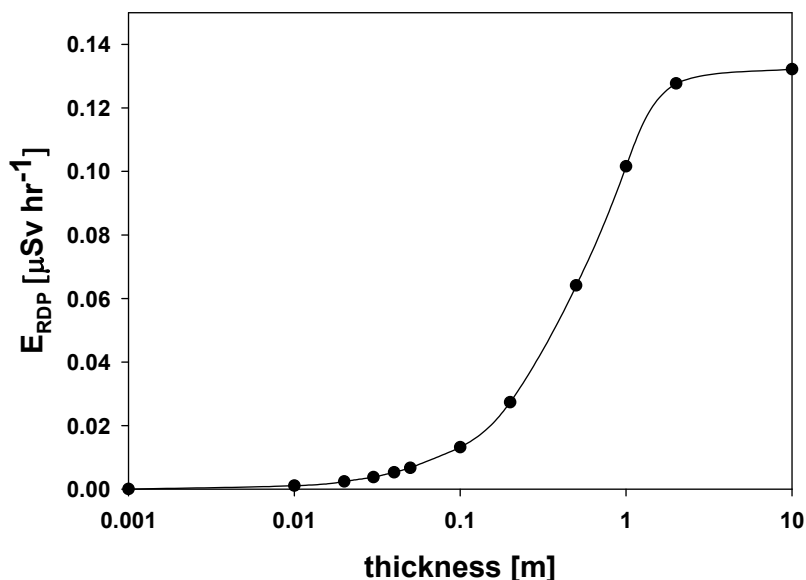
Figure 4.31 Dose rate from the inhalation of radon decay products for various thicknesses of dried material with an activity concentration of ^{238}U of $21.6 \text{ Bq}\cdot\text{g}^{-1}$ in radioactive equilibrium with its decay products. Dose rates were modelled using the ResRad computer code and assuming a worker is standing on top of the spilled material and assuming a low wind speed of $< 1 \text{ m}\cdot\text{s}^{-1}$ and atmospheric stability class A.

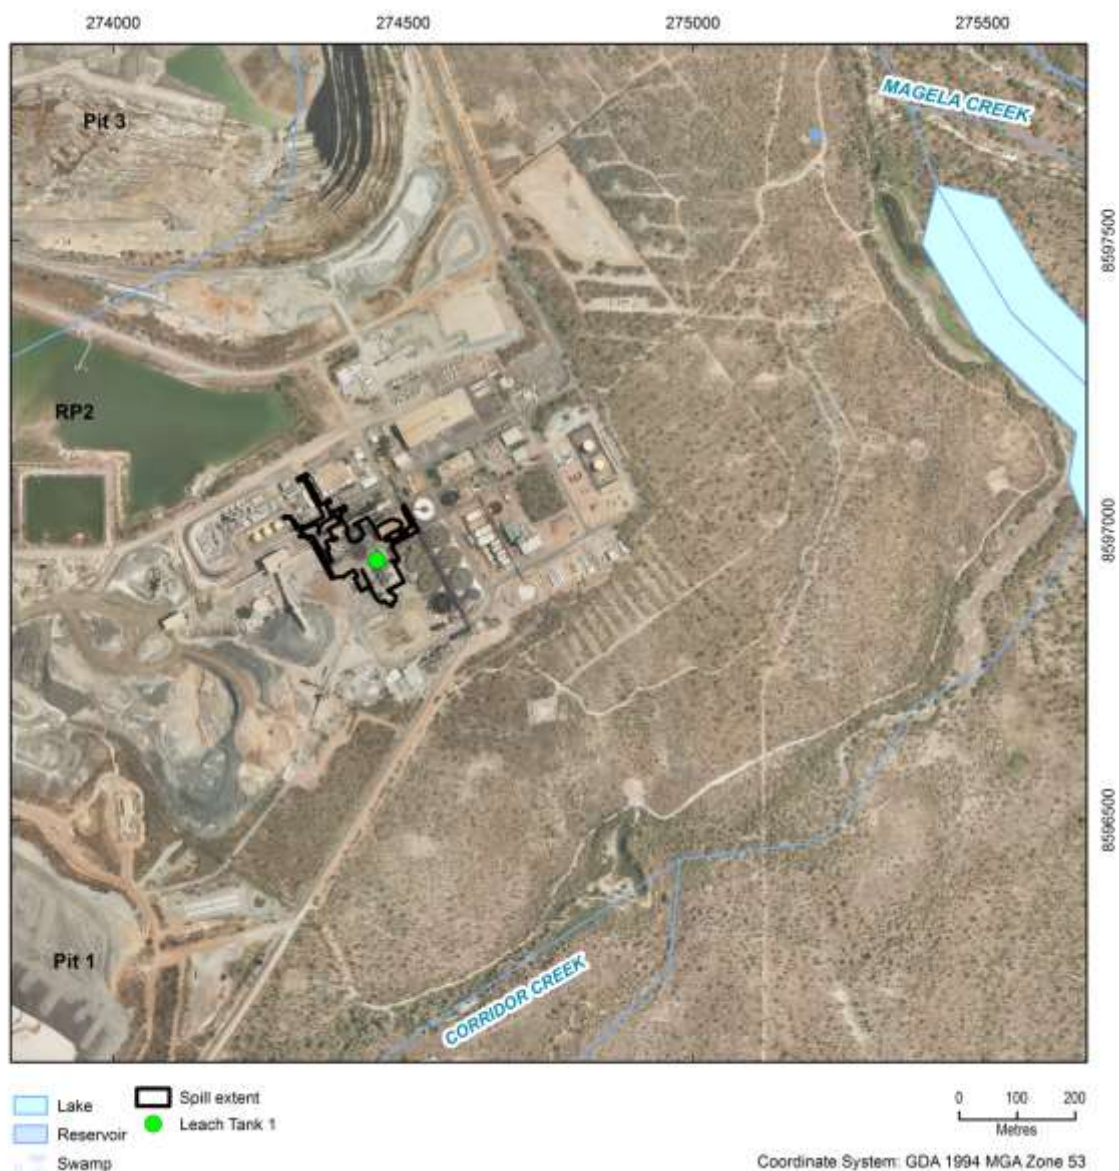
Figure 7. Leach Tank 1 location and mapped spill extent at the surface (spill extent data provided by ERA to SSD³)

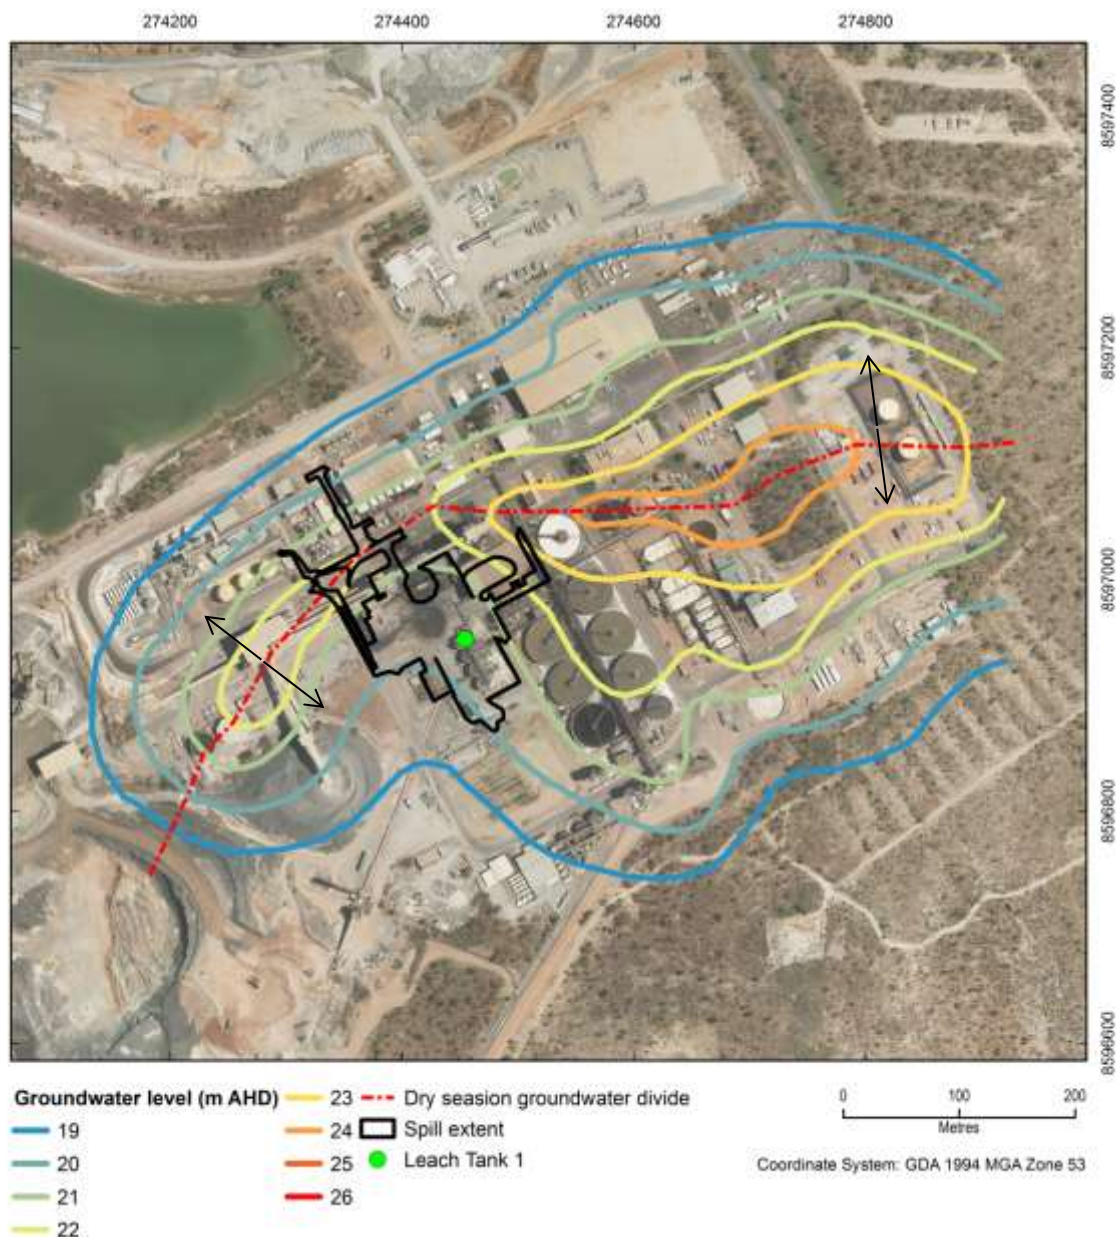
Figure 12. Dry season water table elevation map showing a groundwater flow divide immediately to the north of Leach Tank 1 (from Alarcon Leon et al., 2007a). Black arrows indicate general groundwater flow direction

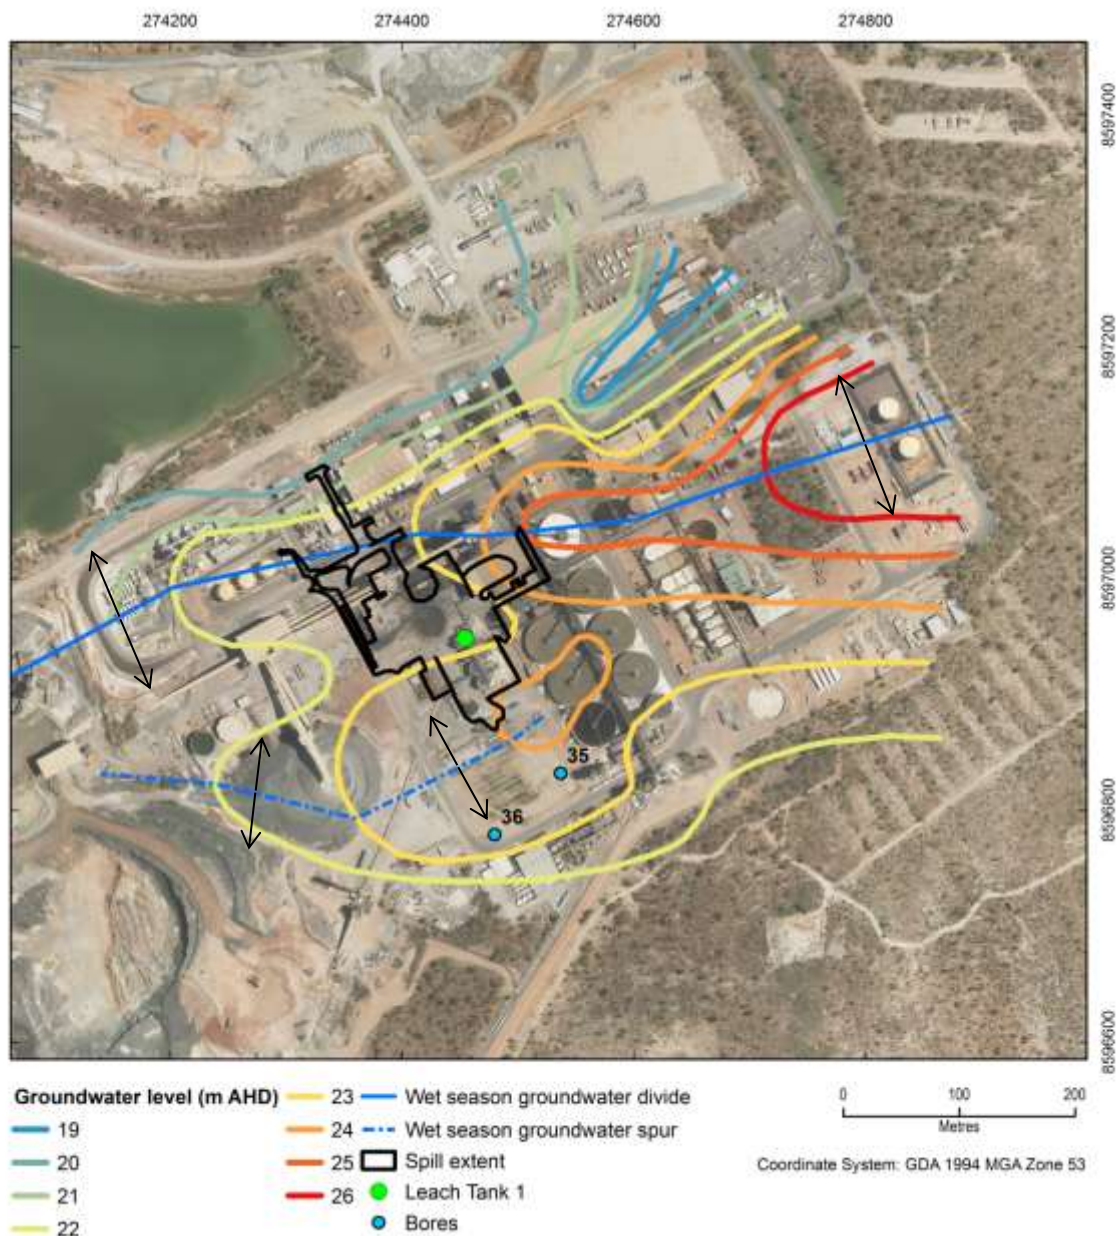
Figure 13. Wet season water table elevation map showing a groundwater flow divide immediately to the north of Leach Tank 1, and a flow valley directly underneath the tank caused by the divide bifurcating (from Alarcon Leon et al., 2007a). Black arrows indicate general groundwater flow directions

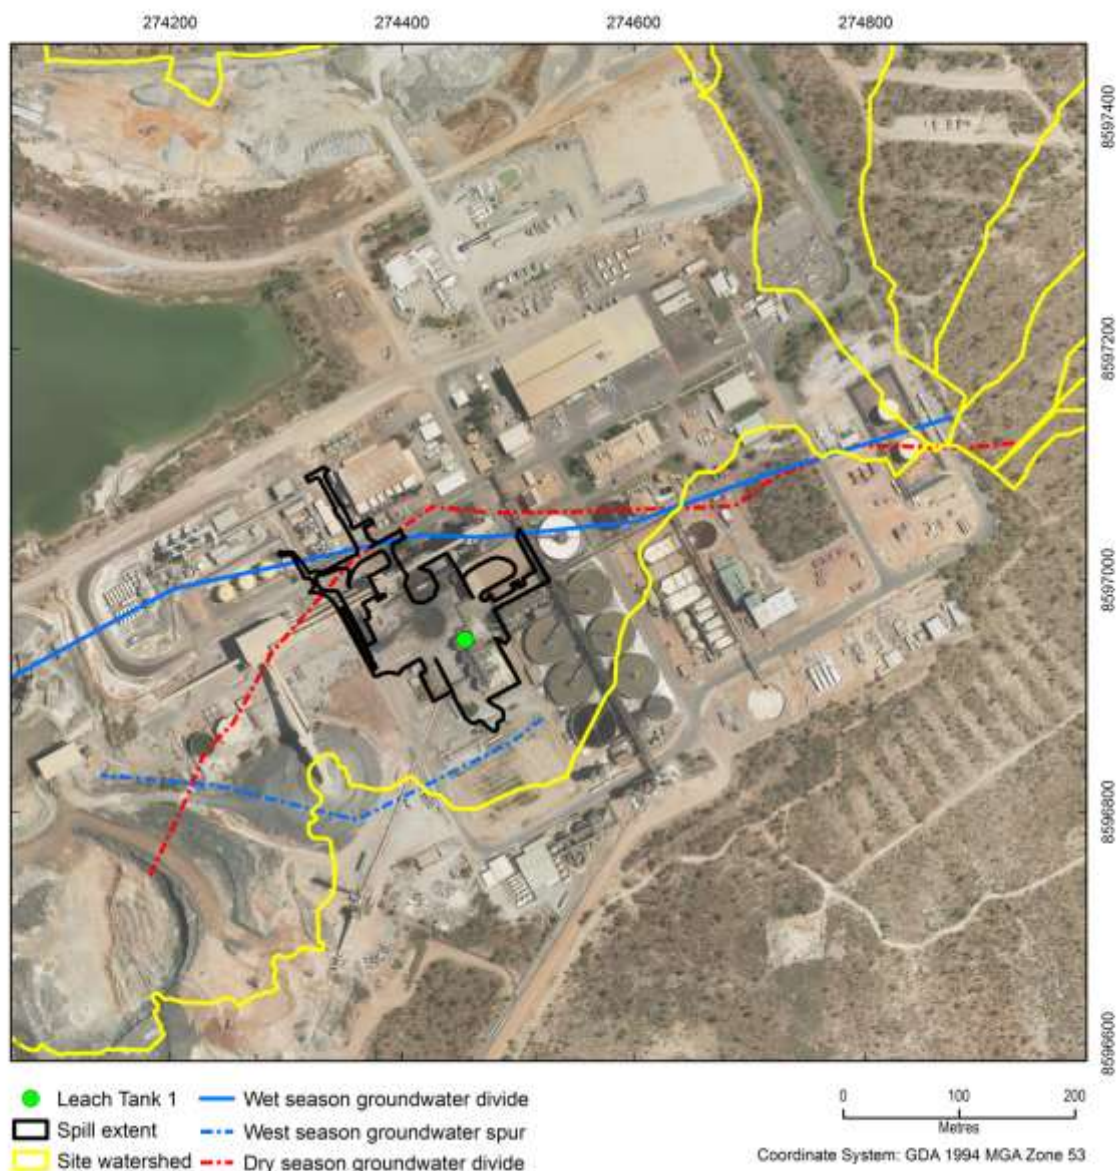
Figure 14. Site watershed (data provided by SSD) compared to wet and dry season groundwater divides (Alarcon Leon et al., 2007a). Note that the location of the surface watershed implies that all surface flow from the plant area exposed to spill material will flow to RP2, while the groundwater divides sit directly under the spill-affected area

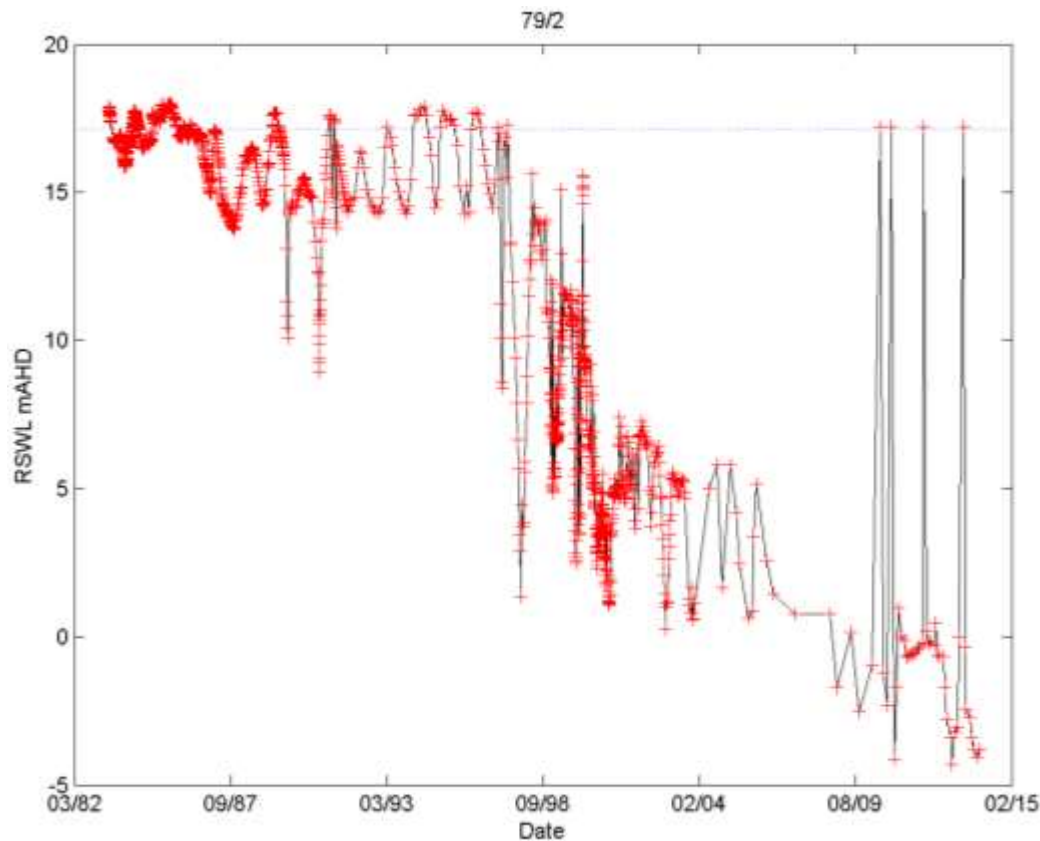
Figure 21. Reduced Stand Water-level (RSWL) records for bore 79/2 (black line). The red crosses are individual measurements. Note the high density of measurements during the wet season of 1982-1987 and 1998-2000 relative to the number of records post 2005. Spikes in the data appear anomalous with no reason found in the metadata accompanying the 79/2 water-level data. The blue dotted line plots the available top of casing data for the bore 79/2. The decline in water-levels from September 1998 is likely associated with dewatering

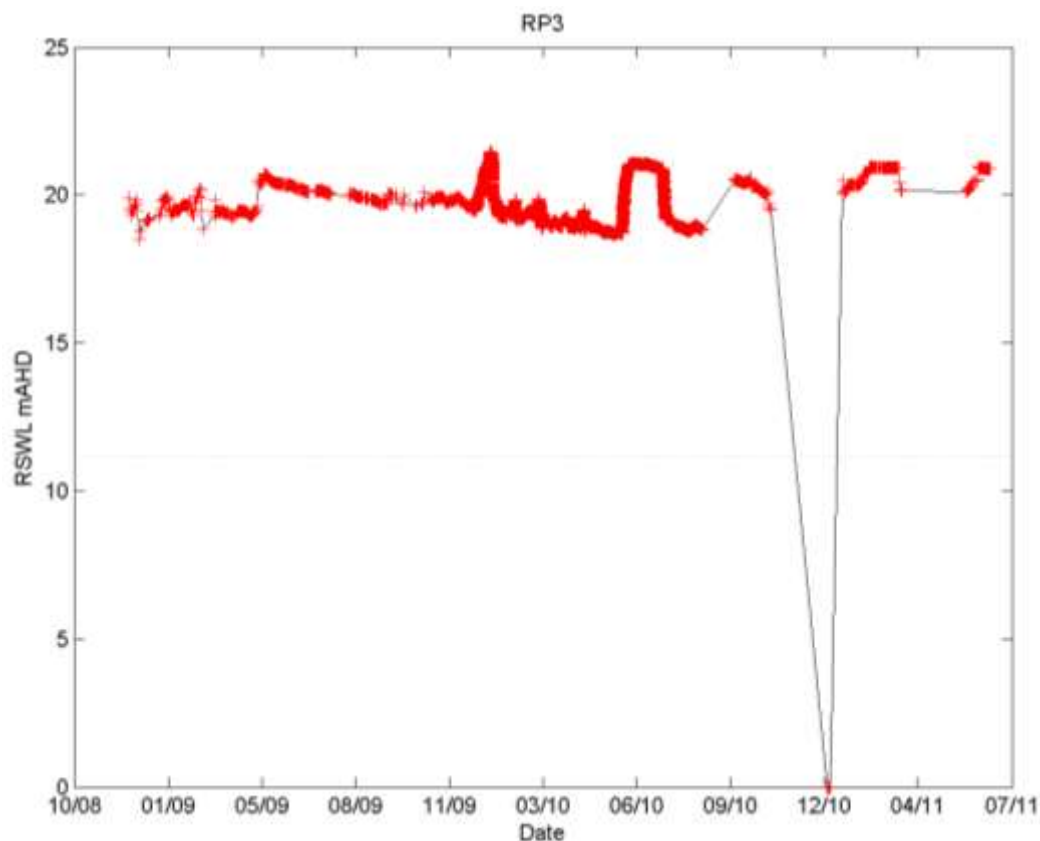
Figure 22: Reduced Stand Water-level (RSWL) records for bore RP3 (black line). The red crosses are individual measurements. Note the high density of measurements during the wet season of September 2009 and September 2010 relative to the number of records post 2010. Spikes in the data around December 2010 appear anomalous with no reason found in the metadata accompanying the RP3 water-level data. The apparent lack of seasonal variation may be due to a buffering provided by Retention Pond 2, and other on-site water management practises
