Investigation into the
environmental impacts of the
leach tank failure at Ranger
uranium mine, December 2013

Supervising Scientist

Supervising Scientist 2014. *Final Report: Investigation into the environmental impacts of the leach tank failure at Ranger uranium mine, December 2013*. Supervising Scientist Report 207, Supervising Scientist, Darwin NT.

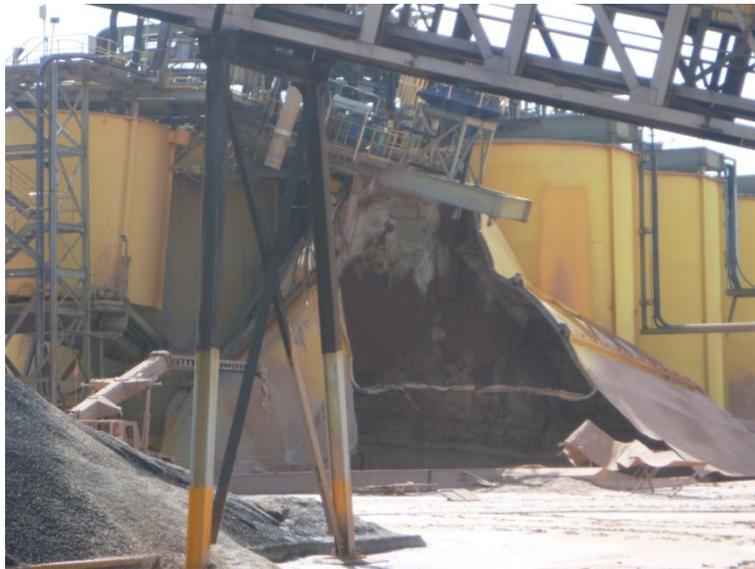
Figure 2.1 Collapsed Leach Tank 1.

At approximately 00.10 am on Saturday 7 December 2013 operators in the processing area at Ranger observed slurry under pressure being released from the wall of Leach Tank 1 through a hole approximately 2 m above the base of the tank. ERA staff attempted to contain the leaking material in the concrete bunded area of the leach tanks. All personnel were evacuated from the area at approximately 00.40 am following the identification of a second leak. At 00.54 am Leach Tank 1 catastrophically failed, releasing approximately 1 400 m³ of slurry into the surrounding processing area (Figure 2.1).

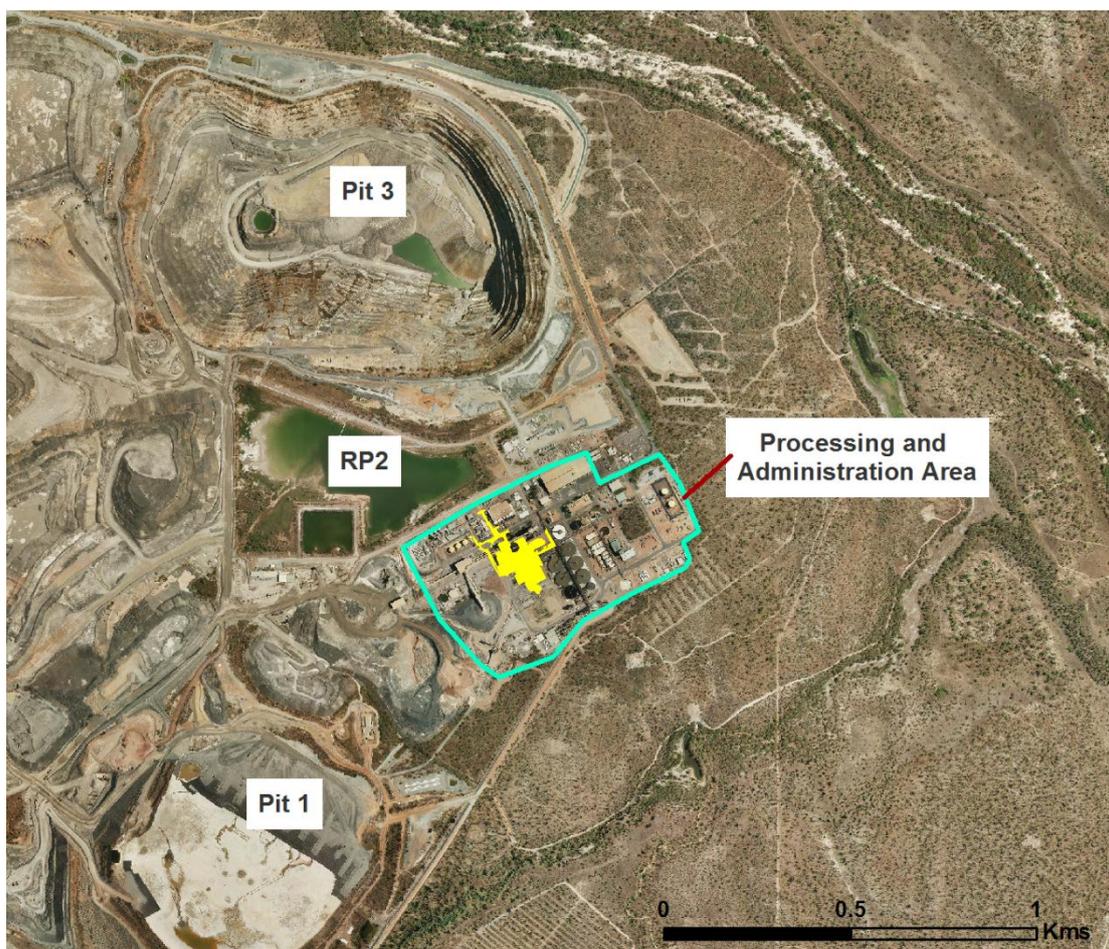
Figure 2.2 Ranger minesite showing spatial extent of the slurry spill.

Leach Tank 1 failed towards the north-west with the slurry being expelled in that general direction. The slurry was primarily dispersed between the leach tanks and RP2 and remained within the processing area and adjacent service roads (Figure 2.3). It was identified that an unknown quantity of the slurry entered the storm water drainage system and thereby reported

Spatial extent of slurry spill

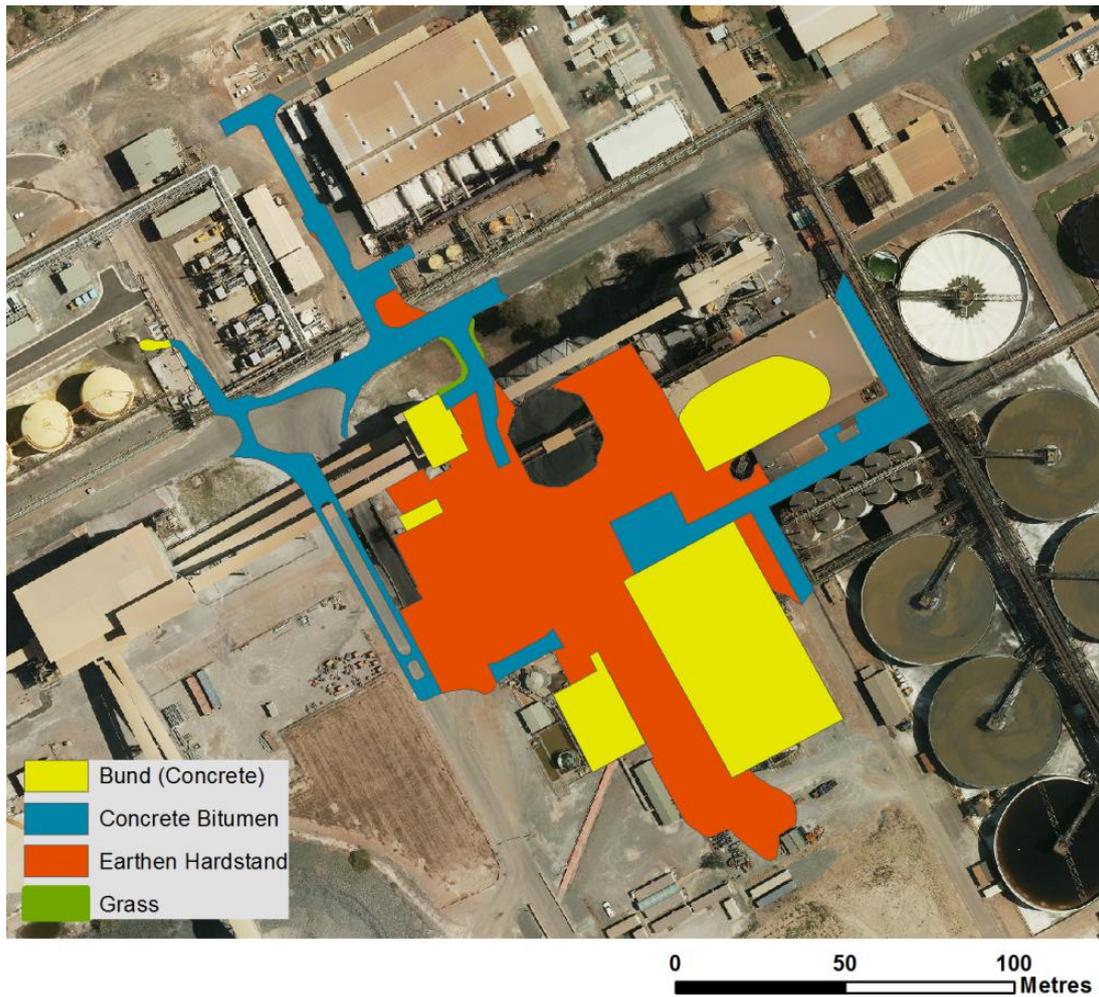
Figure 2.3 Slurry spill area by groundcover type. ERA data.

The area impacted by the spill comprised four main groundcover types, namely concrete bunded areas, earthen hardstand, grass and bitumen/concrete (including roadways). A breakdown of the area impacted for each surface type is shown in Table 2.3. The extent of the spill, broken down by groundcover type, is shown in Figure 2.3.

Surface type	Area m ²	% of total
Bitumen/concrete	3 570	24.2
Bund (Concrete)	4 220	28.6
Grass	30	0.18
Earthen Hardstand	6 930	47.0
Total	14 750	100

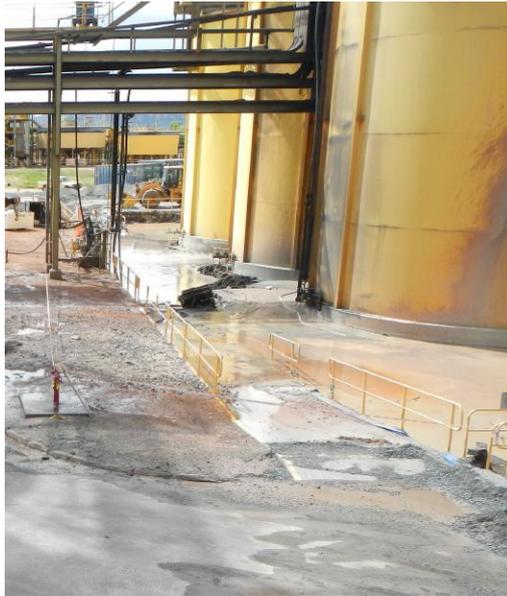
Figure 2.4 Leach tank bund following the failure of Leach Tank 1.

An assessment of the level of slurry in the leach tank bund immediately after the incident suggests that the bund was approximately half filled (Figure 2.4). The leach tank bund capacity is 1 666 m³ (ERA data). It is estimated approximately 700–800 m³ of slurry was retained in the bund with the remaining 600–700 m³ spilling outside the bund. Whilst there was sufficient capacity to contain the entire volume of the leach tank within the bund, by its nature bunding is designed to contain minor spills and leaks and not catastrophic failure.

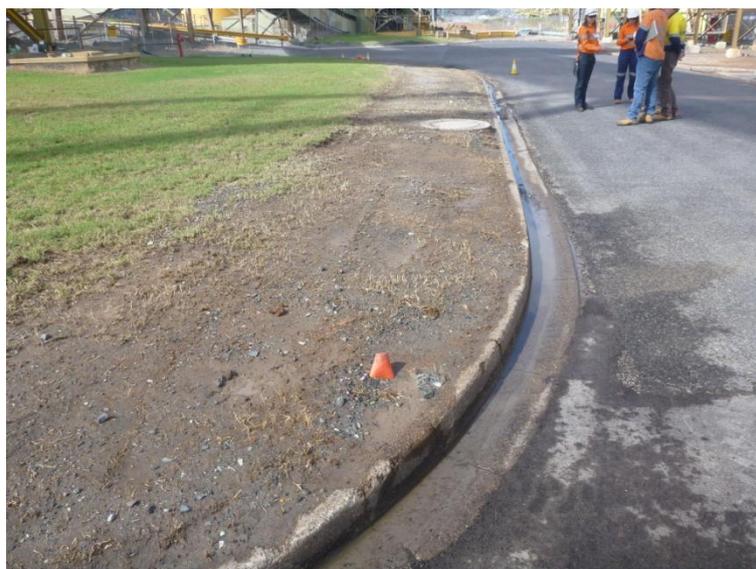
Figure 2.5 Scraped grass verge following cleanup. Grass cover adjacent to the road verge was removed during clean up.

Blue metal/cracker dust was then spread over the slurry to absorb any liquid and then scraped up by bobcat (Figure 2.5) for removal and final disposal in Pit 1.

With the exception of the exclusion zone established around the failed tank, the major cleanup activities were completed within four days and were inspected by SSD, DME, NLC and GAC during the Routine Periodic Inspection on 12 December 2013.

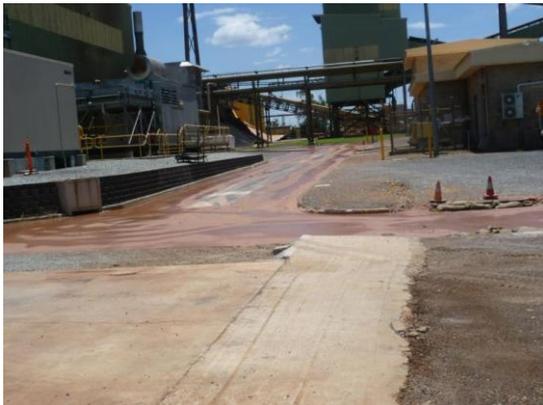
Figure 3.1 Looking south east at the failed tank from the end of the slurry flow.

Representatives from SSD Jabiru Field Station (JFS), Northern Land Council (NLC) and Gundjeihmi Aboriginal Corporation (GAC) inspected various areas of the site around the failed leach tank. It was observed that slurry from the leach tank had filled low lying areas such as roads and drains and flowed in a north westerly direction for approximately 200 m (Figure 3.1 and Figure 3.2).

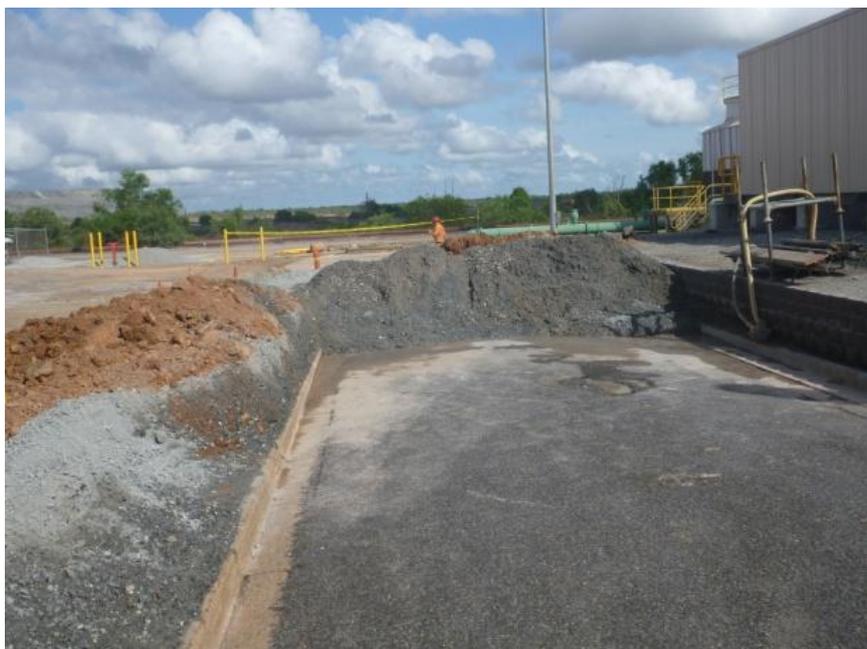
Figure 3.3 Containment bunding between RP2 and leach tanks.

A walk through was conducted of the immediate area of impact. Primary and secondary containment bunding had been established (Figure 3.3) to broadly separate the slurry impact area into three main zones, Zone 3—the immediate vicinity of tank; Zone 2—adjacent hardstand and impacted crushing circuit, and Zone 1—a wider impacted zone including roads and grass areas (Figure 3.4). All drains inspected were blocked with plastic sheets and sandbags to restrict any further movement of material into the drainage system (Figure 3.5). Surface cleanup had occurred including removal of slurry from main roads and topsoil removal from grassed areas adjacent to these roads.

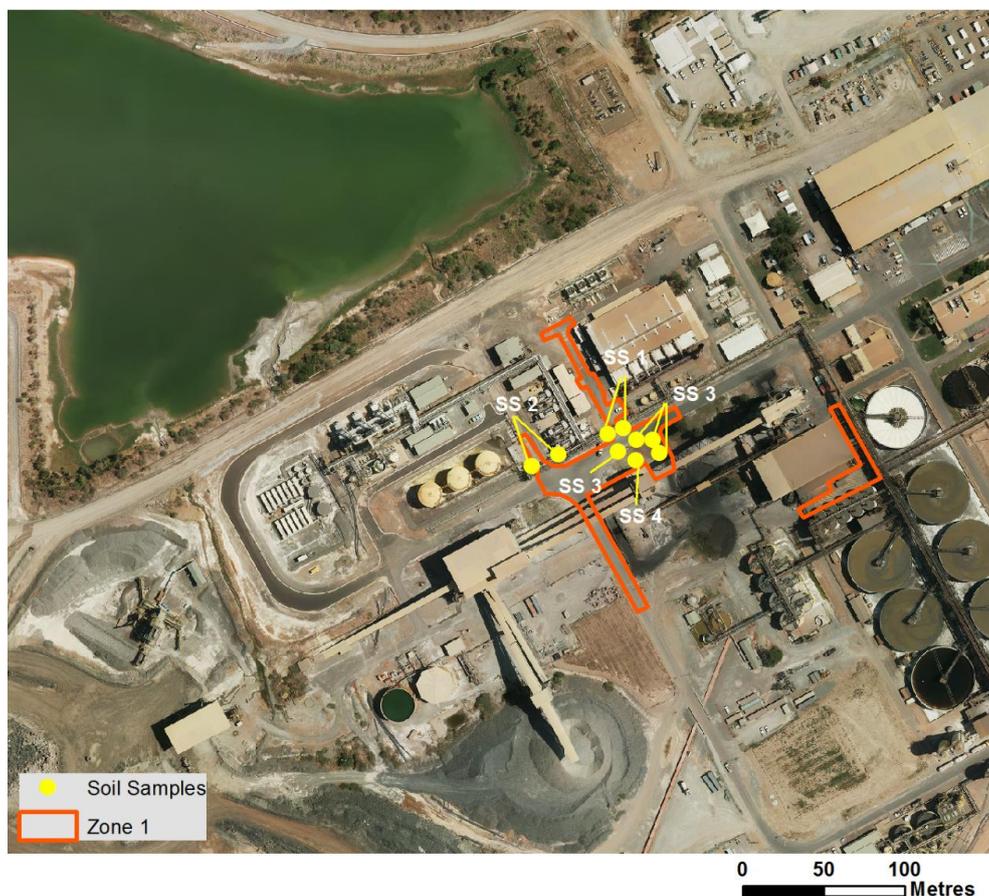
Figure 3.6 Sample locations for soil scrapes.

Composite soil scrape samples were collected from the road verges in front of the acid plant and under the crushing transfer tower (Figure 3.6). At each of these locations, samples were collected in areas that had been exposed to the slurry (SS1 and SS3), and corresponding control samples were collected in areas where it was indicated by ERA that the slurry had not reached (SS2 and SS4). The samples were collected at each site using a plastic trowel to scrape approximately the top five centimetres of soil from three randomly selected locations (composited) within a 0.5 m² area. General methods for soil sampling are outlined in Saynor et al. (2001).

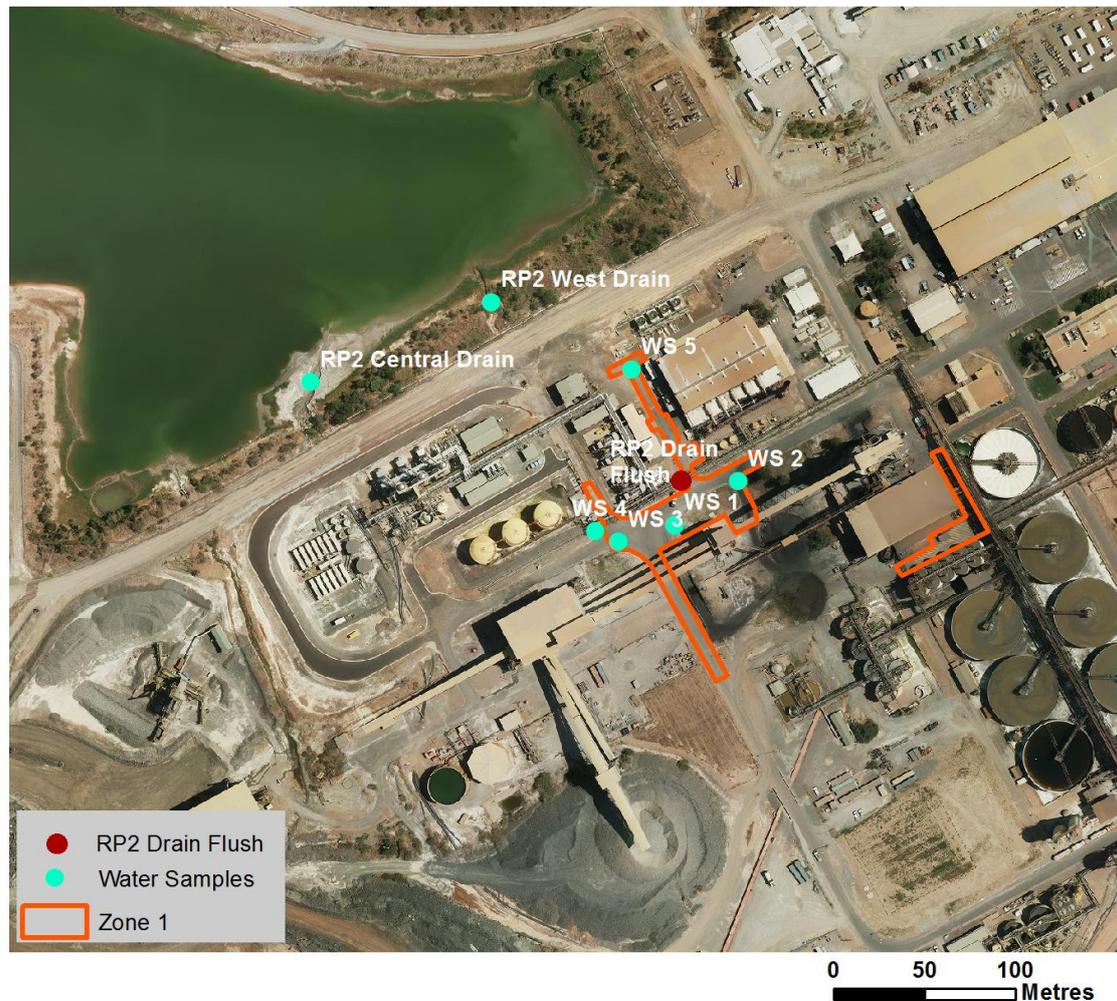
Figure 3.7 Sample locations for Zone 1 clearance.

A water cart of approximately 8 000 L was utilised to spray RP2 water onto road verges and the road in areas that had been exposed to the spilled slurry. Water samples were then taken where the resulting water ponded in the stormwater drains as shown in Figure 3.7.

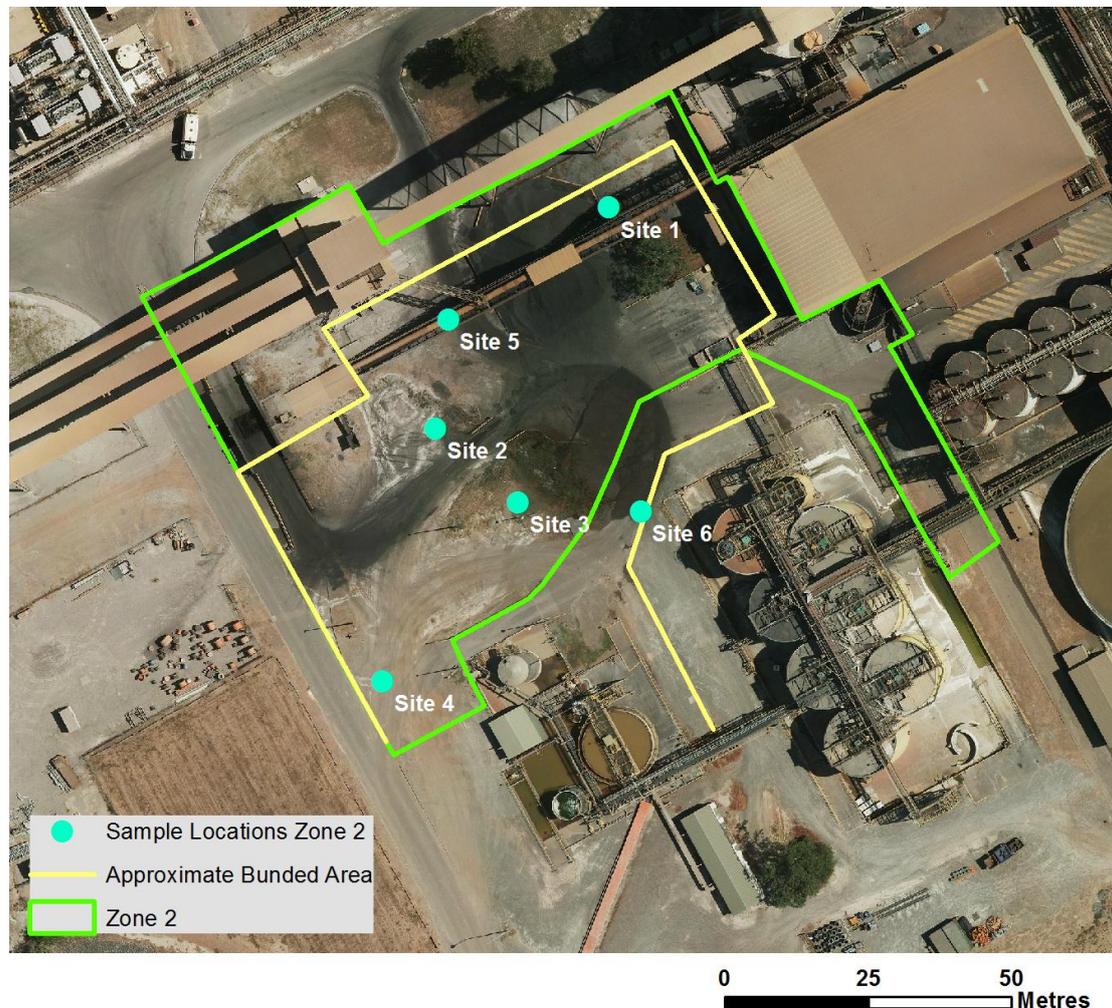
Figure 3.8 Sample locations for Zone 2 clearance.

Six pools of water were sampled within Zone 2 (Figure 3.8). At each sampling site SSD, collected water samples for analysis of filtered and total metals and ²²⁶Ra. Results of this water sampling are detailed in Section 4.1.2.2.

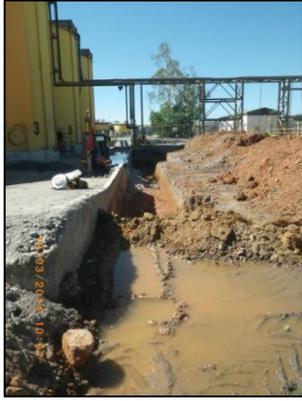
Figure 3.9 Excavated area within Zone 3

Two locations within Zone 3 had been excavated, associated with repair of the concrete bund wall around the failed tank (Figures 3.9–3.10). Both of these areas would drain into the tank bund area and thereby report to the process water circuit.

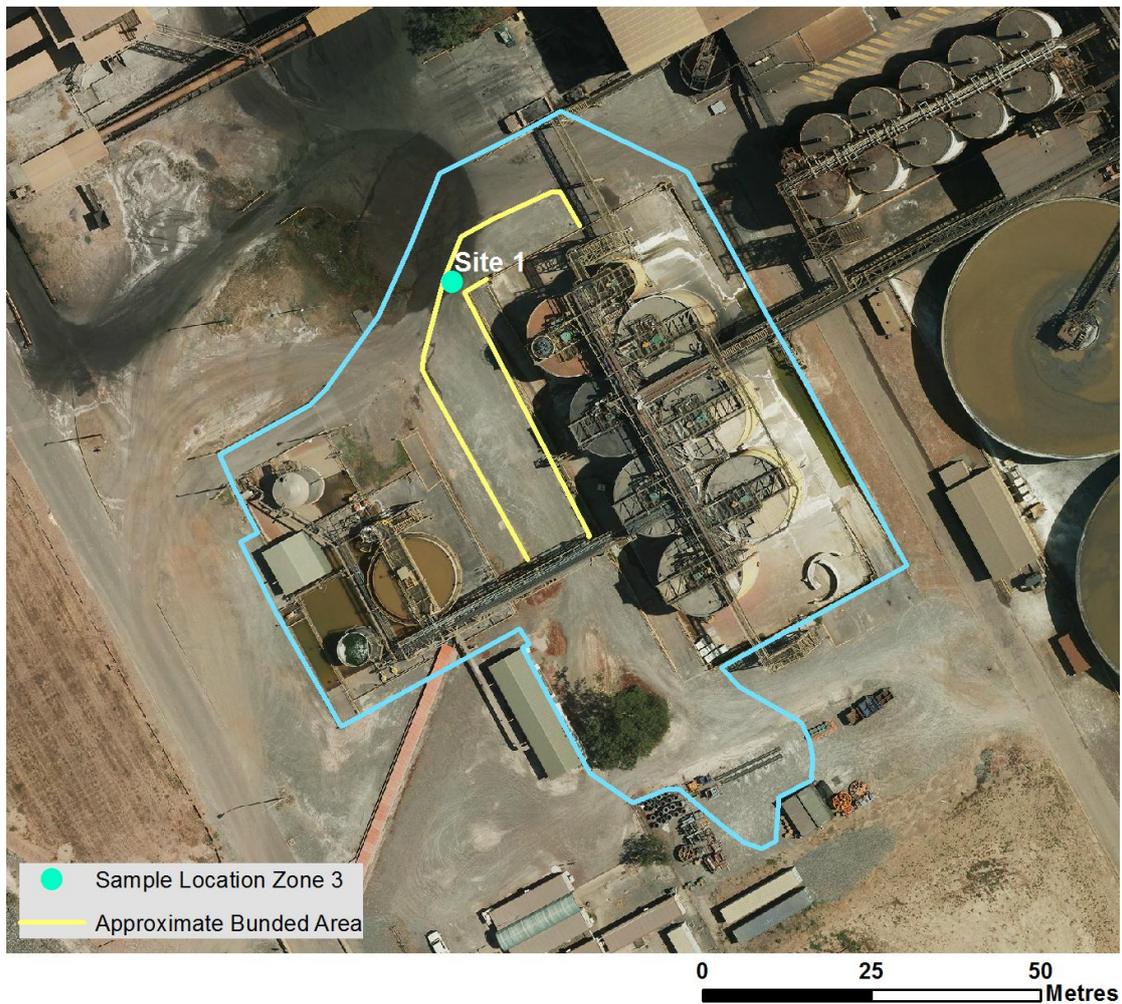
Figure 3.11 Sample location for Zone 3 clearance.

One pool of water was sampled within Zone 3 (Figure 3.11). SSD collected water samples for analysis of filterable and total metals and filterable ^{226}Ra . Results of this water sampling are detailed in Section 4.1.2.2.

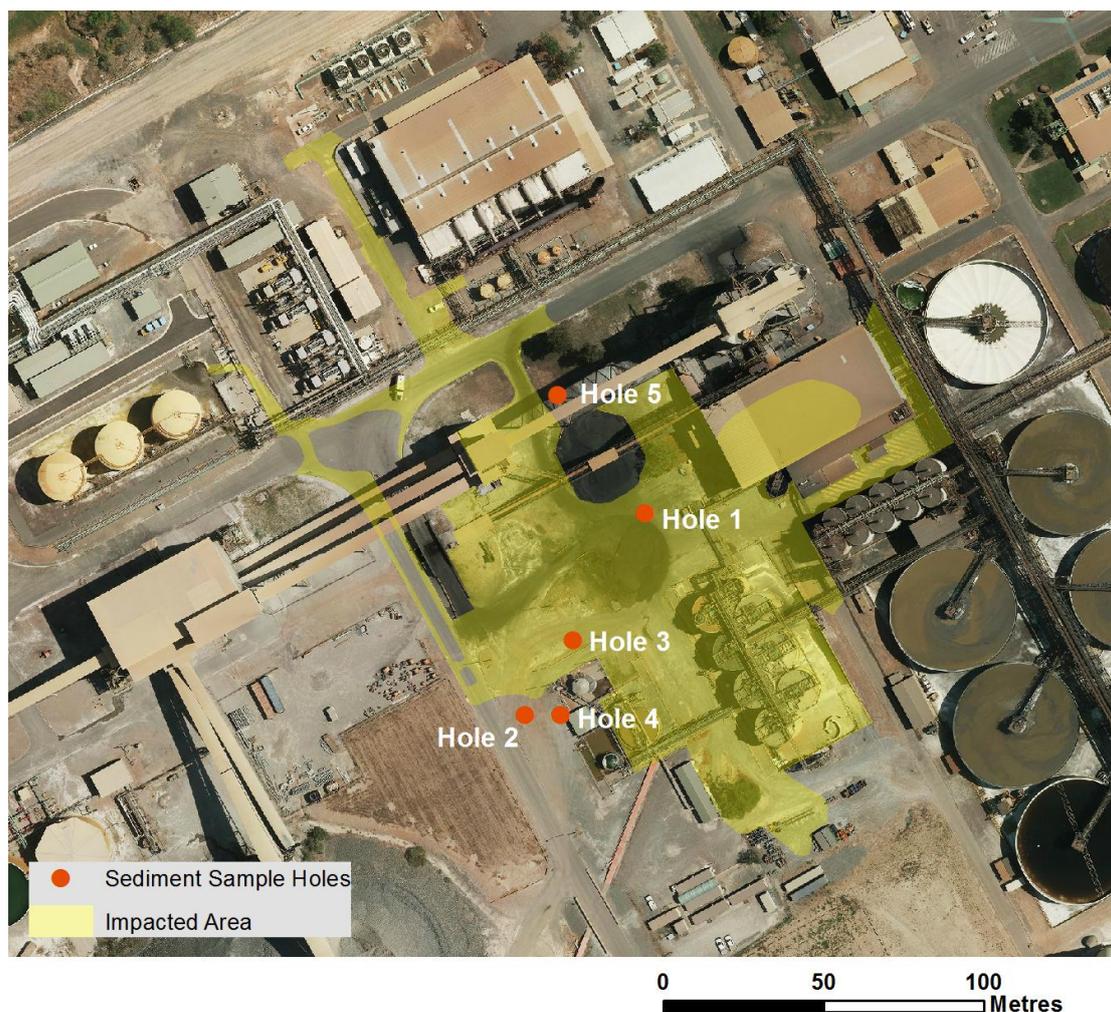
Figure 3.13 Location of soil profiles

Soil profiles for each of the five holes were described. In these descriptions, their compositions, including the percentage abundance of different grains such as sand, clay or gravel, were included. Approximate grain size distributions were estimated. This information is essential to classify the material. It is especially useful to determine the porosity and permeability of the material in order to estimate the likelihood of infiltration. The results of this soil profiling work are presented in Section 4.2.1.1.

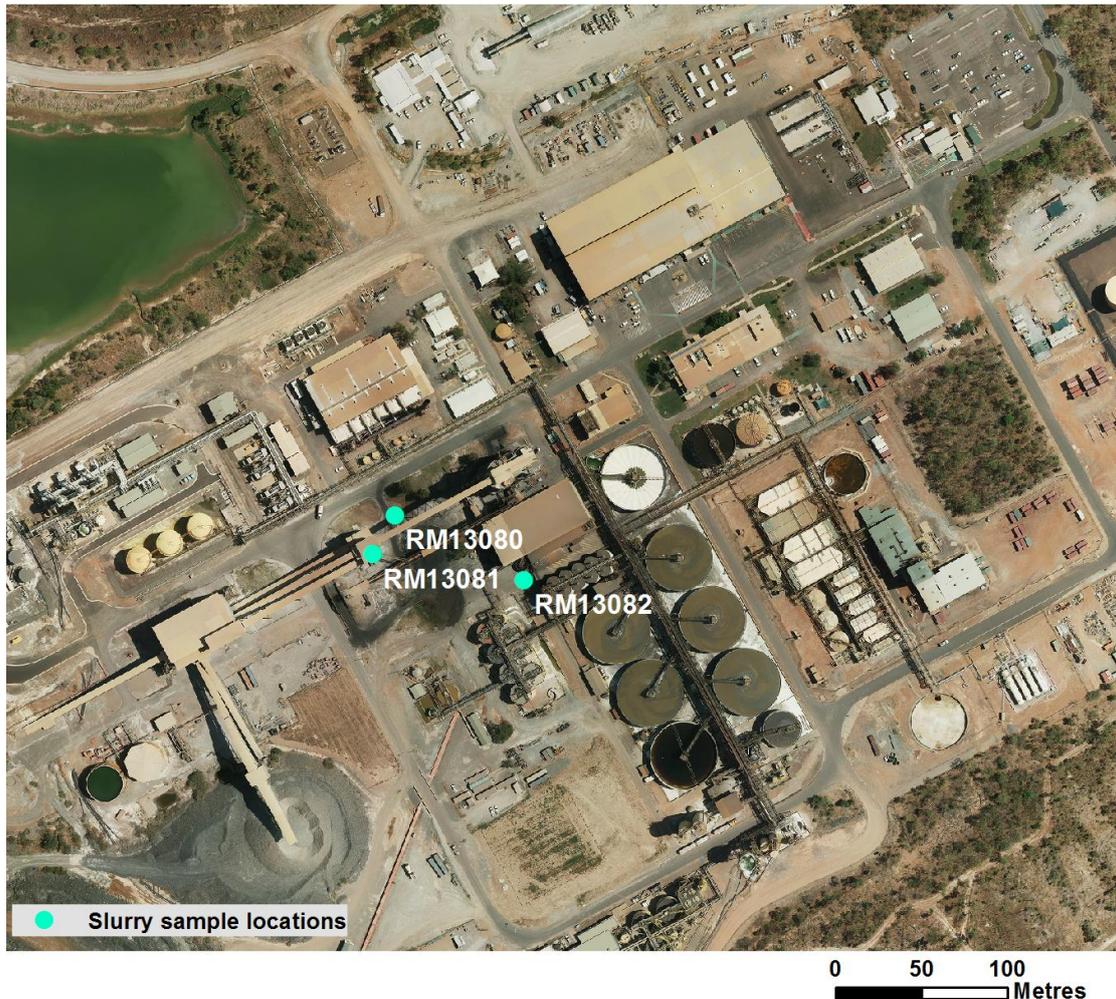
Figure 3.16 Location of the samples collected by ERA in the morning of 7 December 2013.

Samples of the slurry have been collected by ERA after the spill and were sent to SSD for radioanalysis. Table 2.4 shows the sample details. Figure 3.16 shows the locations from which the slurry samples were collected.

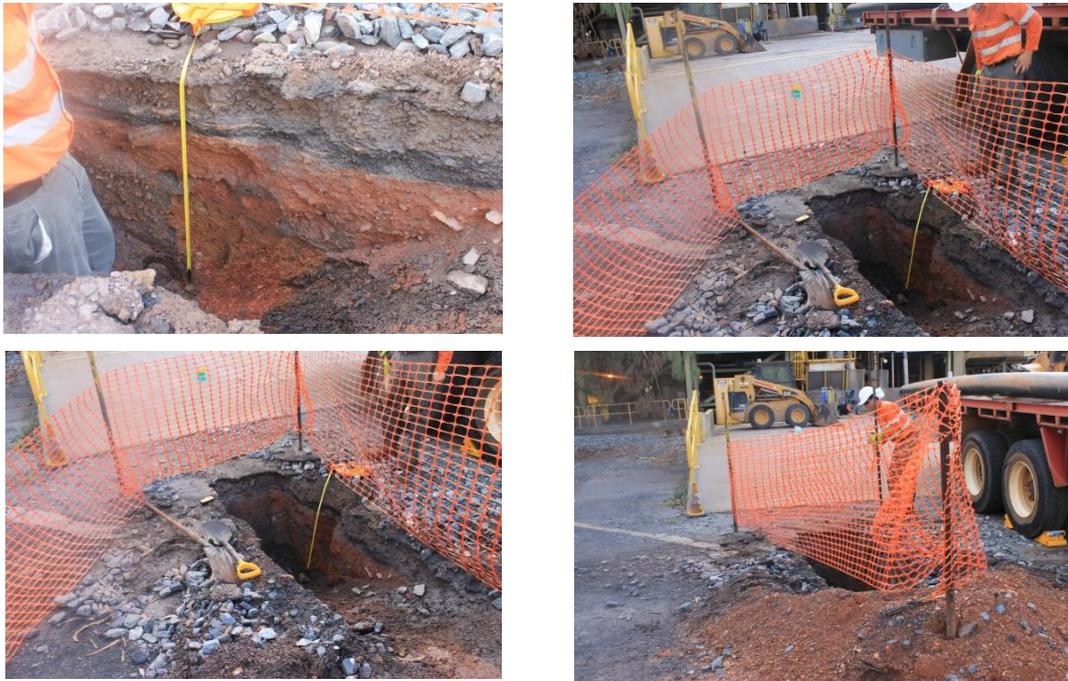
Figure 4.18 Sediment sampling Hole 1.

the surface, underlain by a grey/black coarse grained horizon at approximately 0.1–0.5 m in the middle of the profiles, underlain by yellows, browns and deeper reds in the lowermost horizons. In Hole 1, the grey/black coarse grained horizon intersects the surface and does not have an uppermost brown horizon as the other holes do. The abundance of red soils and the presence of ferruginised nodules indicate a high concentration of iron. Figures 4.18–4.22 show the soil profiles for each hole, with the exception of Hole 2 which was excavated by auger.

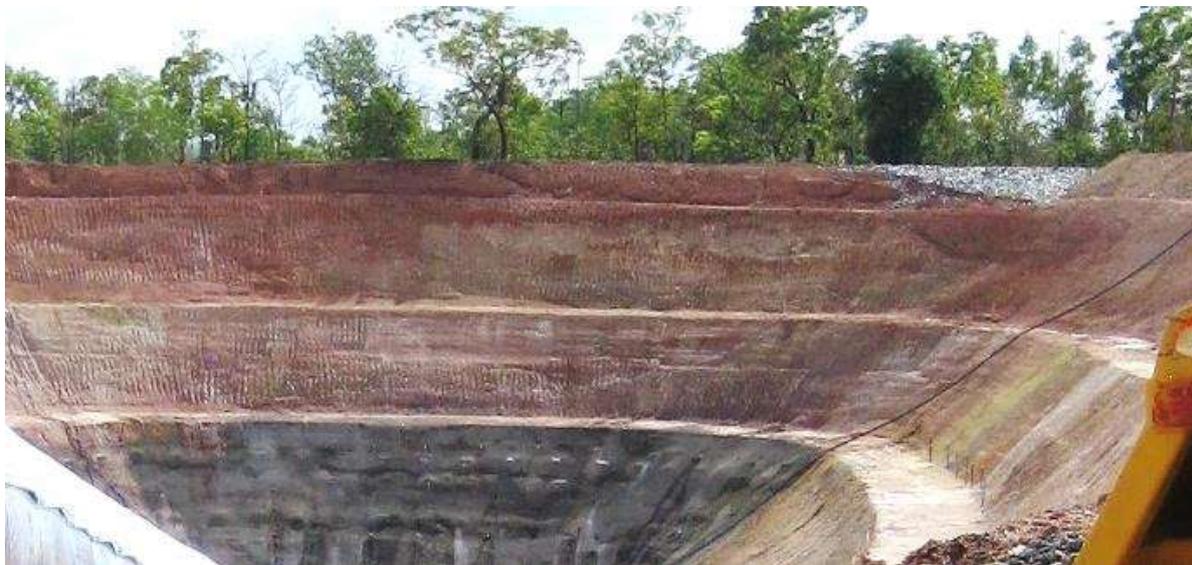
At the Ranger mine site, regolith consists of both residual and alluvial material. Weathering materials include clays and ferruginous oxides. The idealised weathered profile at Ranger is characterised by an upper highly weathered sand-dominated topsoil, a thin calcrete or ferricrete, clayey sand or sandy clay, clay weathered remnant materials and saprolitic bedrock to the base. Regolith thickness varies, and reaches up to 70 m depth (Golder Associates Pty Ltd., 2011). The thickness, distribution and character of regolith materials play an important part in the hydrogeology of the site. Figure 5 is an

example of the heterogeneous nature of regolith, and is located to the north of the spill site, adjacent to Pit 3.

Figure 5. Exposed weathering profile at Ranger. This photograph shows the Ranger 3 Deeps Exploration Drive Portal boxcut, taken October 2012. Note the variable development of iron oxides (red material) in the top part of the profile, which indicates a heavy influence of rock fabric and structure in regolith development. Photograph taken by Martin Smith, GA

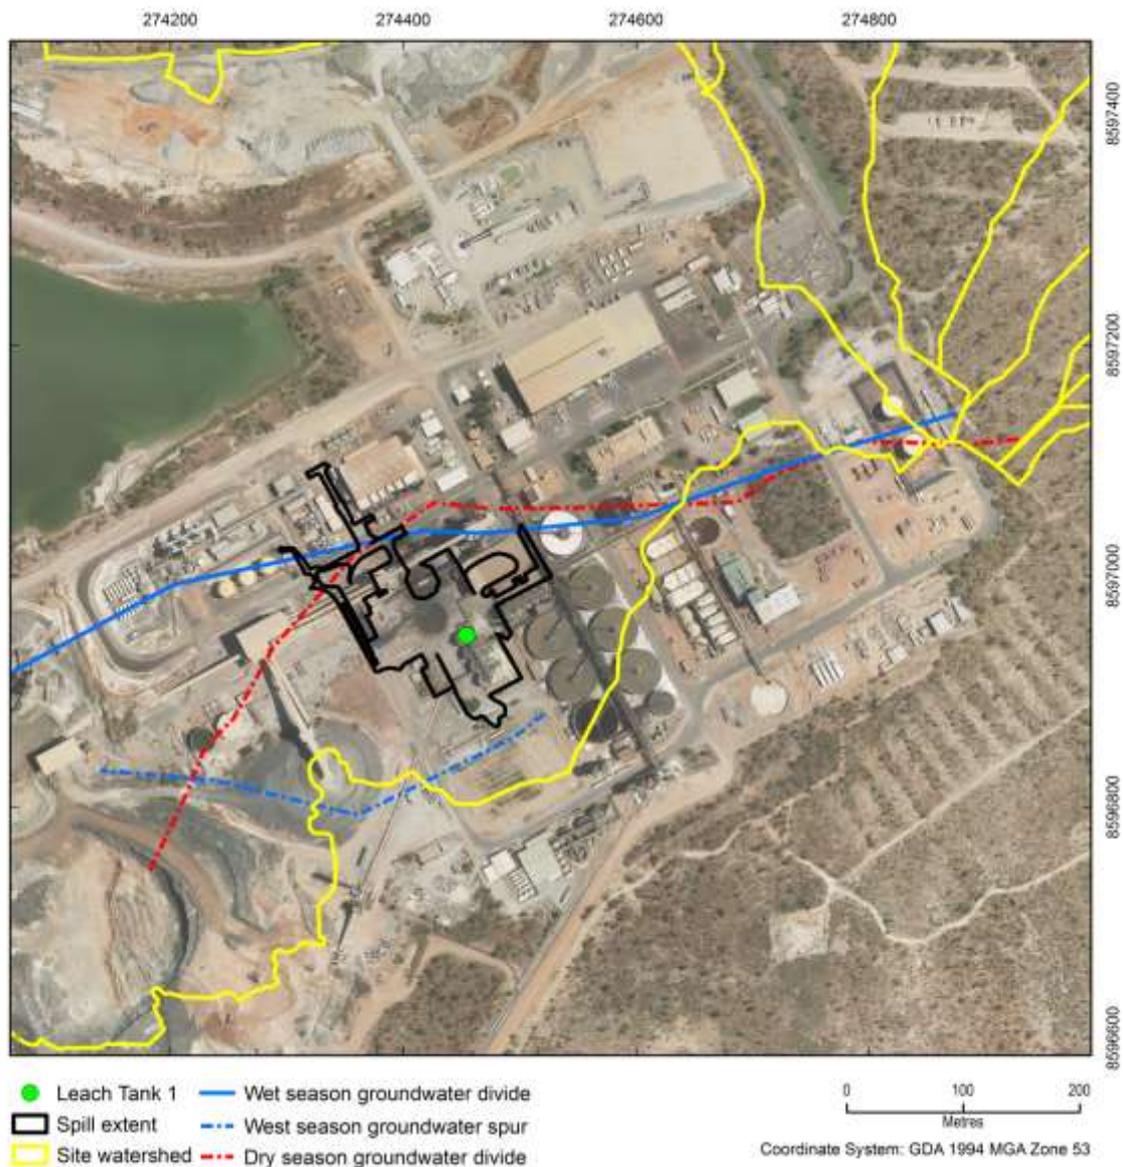
The local groundwater flow divide is different to the surface watershed, as shown in Figure 14. This groundwater divide is also described in Energy Resources of Australia Ltd (2013a) noting that the plant sits astride the divide. The dry season groundwater divide sits to the north of Leach Tank 1, with water levels between 18 and 25 m AHD (~2 to 12 m below ground). The divide in the wet season shows a spur to the south. Groundwater flow changes across the area underlying the spill extent, moving towards RP2 and Pit 3 to the north of the divide and towards Corridor Creek (south to south-southeast) to the south of the divide. Flow in the wet season may be channelled to the west and west-southwest, but the southerly flow direction is still persistent. The wet season water table is between 18 and 27 m AHD (~2 to 10 m below ground).

Figure 14. Site watershed (data provided by SSD) compared to wet and dry season groundwater divides (Alarcon Leon et al., 2007a). Note that the location of the surface watershed implies that all surface flow from the plant area exposed to spill material will flow to RP2, while the groundwater divides sit directly under the spill-affected area

The 1 second DEM (Figure 15) highlights the low topographic relief across the plant site, with ore and waste rock stockpiles having greater elevation. It can be seen that groundwater flow broadly follows topography, however the surface watersheds and local groundwater divides are not always co-located as inferred by Alarcon Leon et al. (2007a) is the case under the plant area (Figure 14).

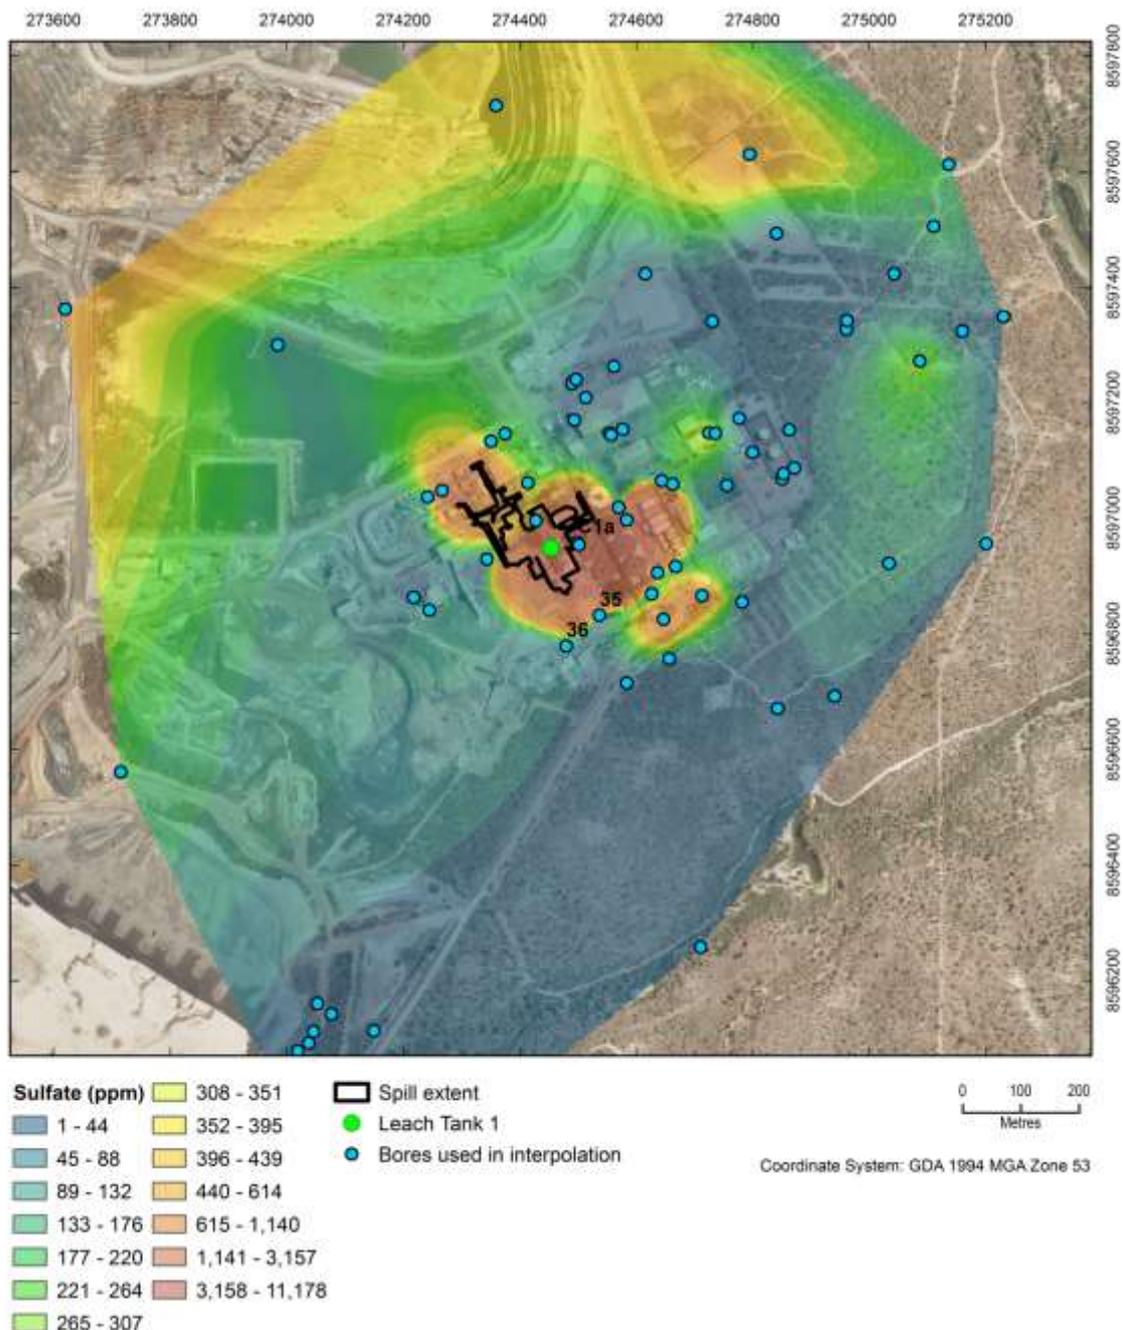
Figure 23. Natural neighbour interpolated surface of average SO_4 concentrations in groundwater between 2006 and 2013. Labelled bores are used for more detailed analysis

Only two post-spill hydrogeochemical samples were taken by ERA in the Corridor Creek catchment immediately following the spill, at bores 35 and 36 (as shown in Figure 23 in Appendix A). They are in the plant area but from existing contaminant maps are probably outside the pre-spill plume extents. These bores were sampled by ERA six days after the 7 December 2013 Leach Tank 1 spill. Following recommendations by GA, on 14 February 2014, SSD requested ERA commence a groundwater monitoring program in the spill area. ERA obtained the first samples related to this request on 2 April 2014. Samples were then collected weekly for 5 weeks prior to reducing to monthly. Sample data was provided to SSD and GA for analysis. The 6 week timeframe for the commencement of monitoring reduces the ability of the program to definitively determine pre-spill groundwater characteristics as, while it is unlikely, it is possible that by April 2014 contamination from the spill could have already impacted on the bores in question. As such, while it is likely that data from these bores do represent background groundwater conditions for the plant area, this cannot be stated with absolute certainty. This delay and resultant introduction of uncertainty into the assessment of background conditions highlighted the importance of timeliness in ERA's response to requests for investigative actions.
