River Reaches, Historical
Channel Changes and
Recommended Methods to
Improve Macquarie Perch
Habitat on Hughes Creek,
Victoria

Wayne D Erskine

Erskine WD 2016. *River Reaches, Historical Channel Changes and Recommended Methods to Improve Macquarie Perch Habitat on Hughes Creek, Victoria*, May 2016. Supervising Scientist Report 208, Supervising Scientist, Darwin NT.

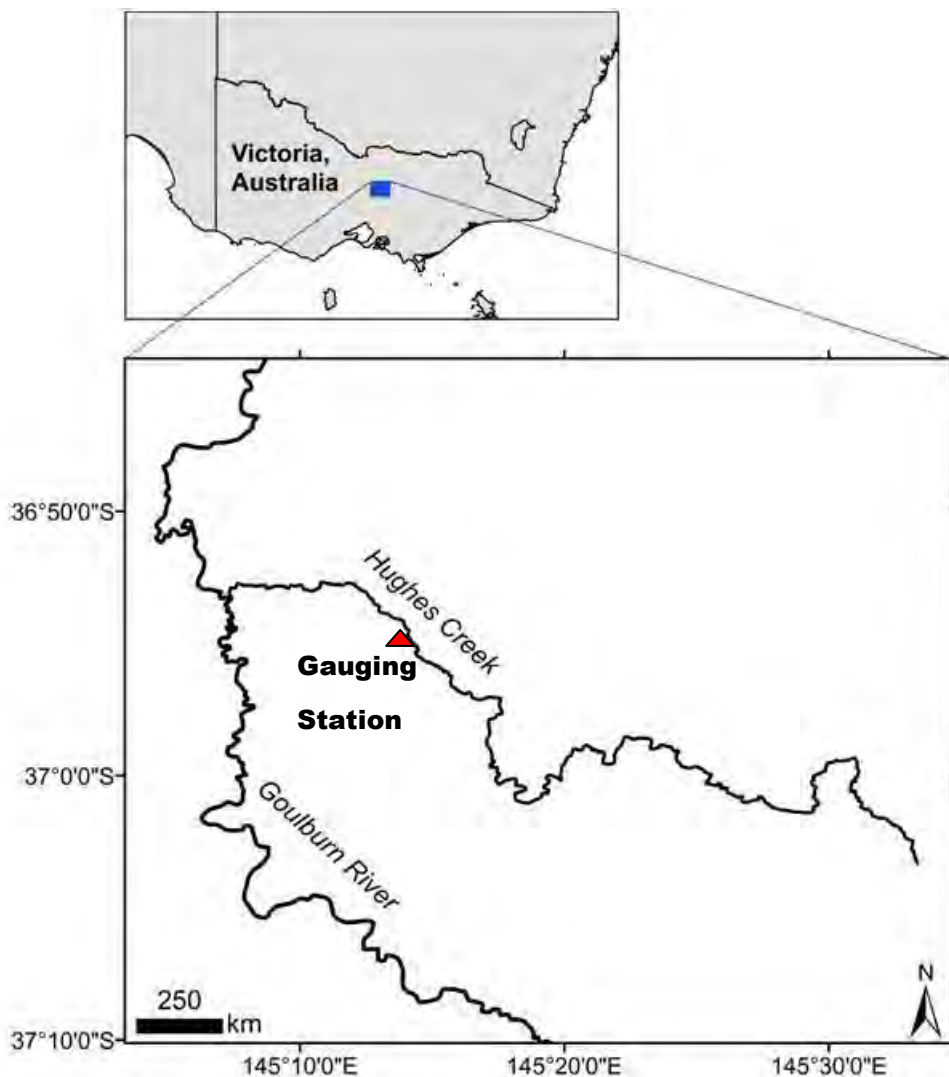
Figure 1 Hughes Creek, a tributary of the Goulburn River in central Victoria.

The continued presence of the Perchichthyid Macquarie perch (*Macquaria australasica* Cuvier) in Hughes Creek upstream of Avenel (Figure 1), especially after the millennium drought of the 1990–2000s, is a significant management issue for the Goulburn Broken Catchment Management Authority (CMA). Macquarie perch is an endangered species and has persisted in Hughes Creek (Cadwallader 1981, Trueman & Luker 1992, Trueman 2012) despite the formation of a sand slug after European settlement (Erskine 1993a). However, the Hughes Creek population seems to be in decline possibly because of recent new deposits of sand (Kearns et al. 2012). Translocated specimens of Macquarie perch have also been introduced to the remnant native population in Hughes Creek from the Goulburn River (Cadwallader 1981) as in the nearby Seven and Faithfull Creeks further to the north (Cadwallader 1979, 1981).

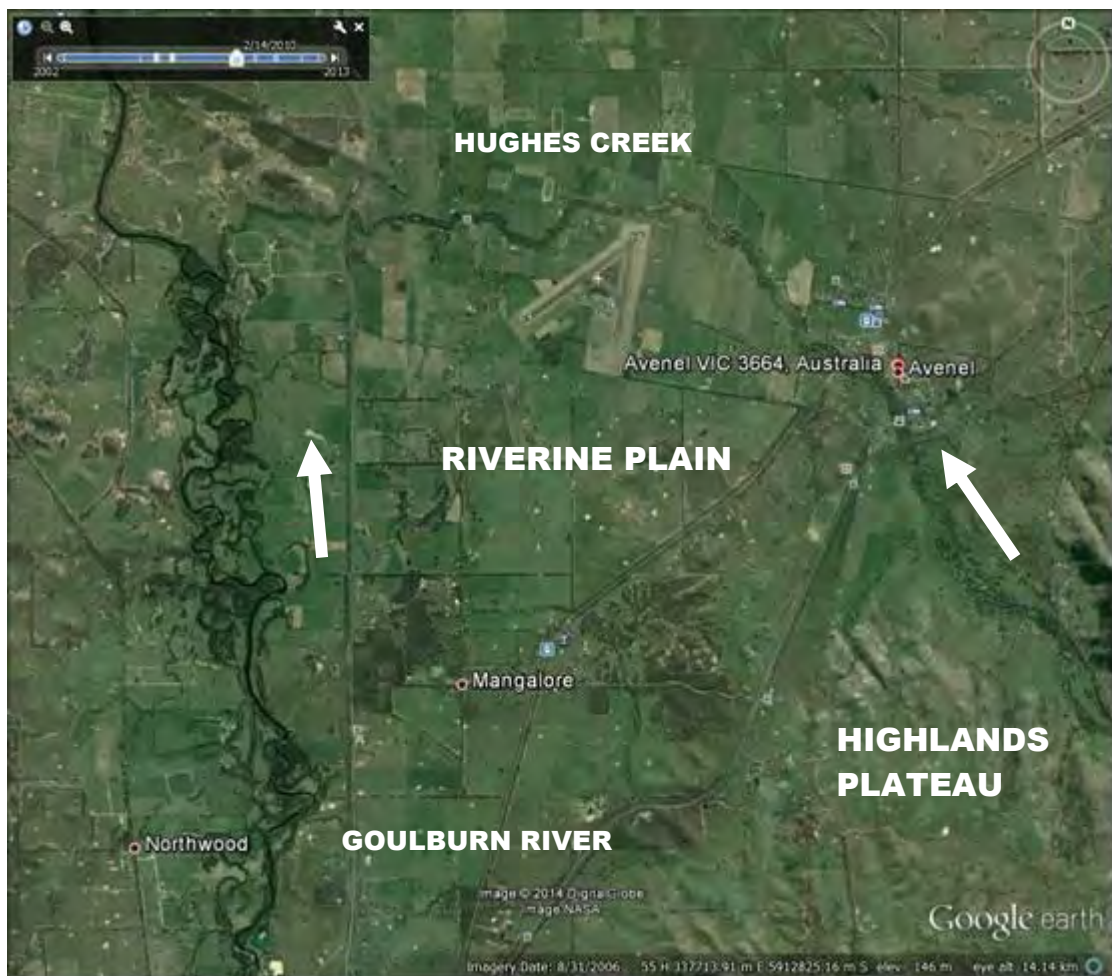
Figure 2 Riverine Plain on lower Hughes Creek.

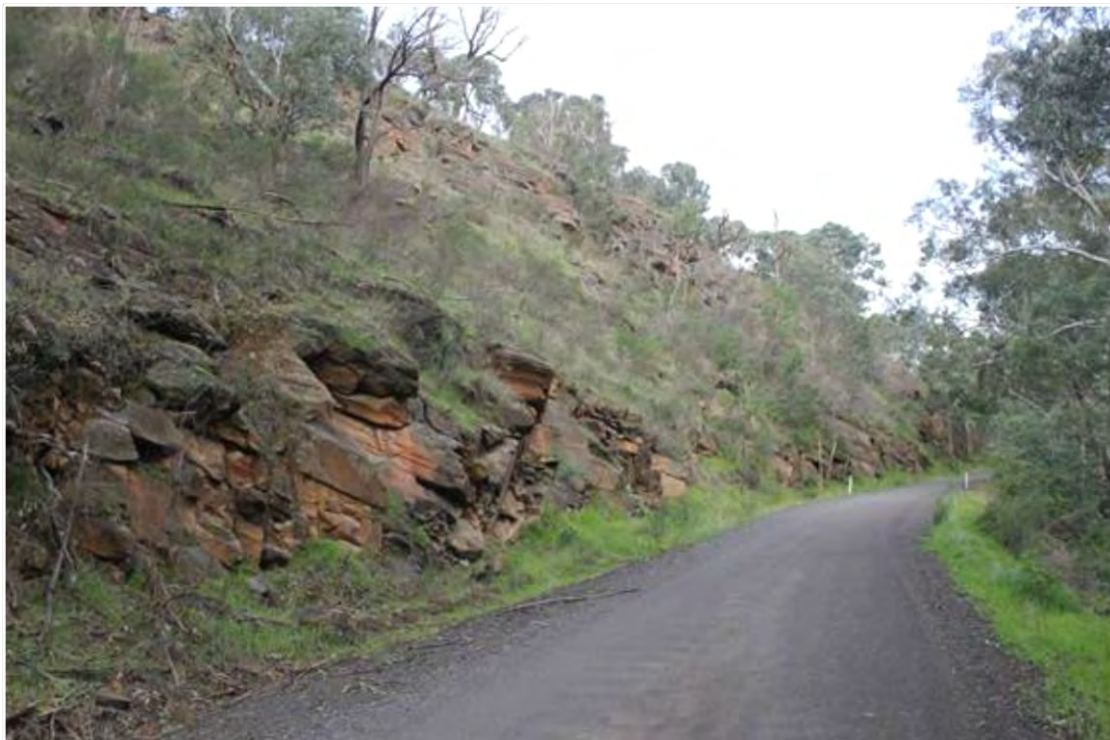
Figure 3 Metamorphic aureole surrounding the Strathbogie pluton on Hughes Creek Road near the Bucklands Creek junction with Hughes Creek.

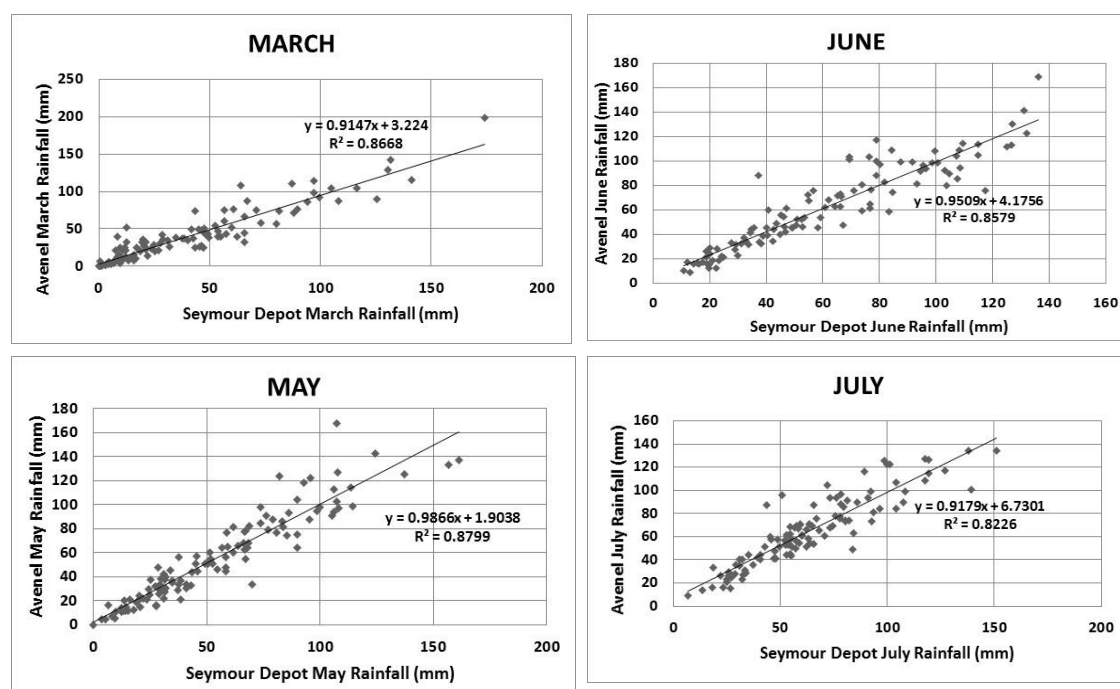
Figure 4 Examples of the regressions used to infill missing monthly rainfall at Avenel PO from Seymour Depot.

The Bureau of Meteorology's rainfall data base was interrogated for long-term rainfall stations located within or near the Hughes Creek catchment. Avenel PO (Station No. 88002) had the longest record (1900–2014) for any station located within the catchment. Missing monthly values were estimated by regression with the neighbouring Seymour Depot station (No. 88053). A complete record was produced for Avenel PO for 1900–2013. All regressions were highly significant ($p < 0.01$) and selected examples are included in Figure 4.

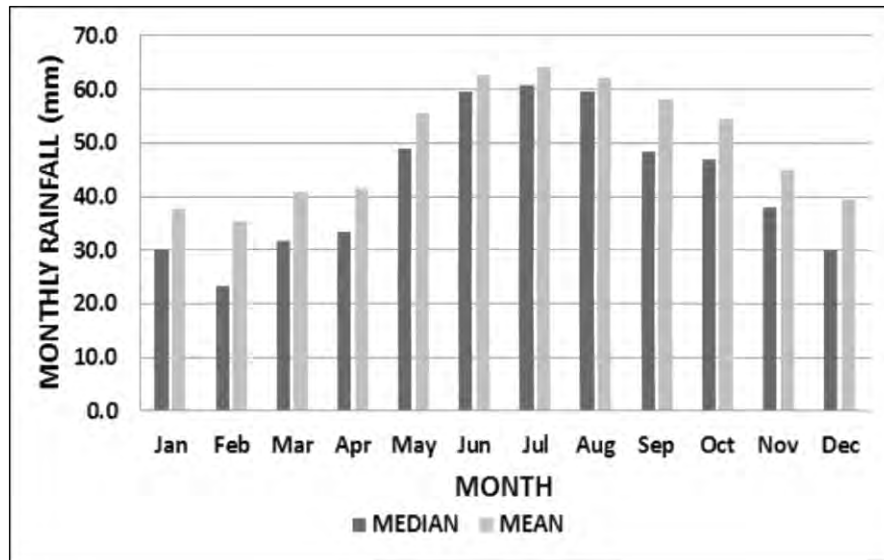
Figure 5 Distribution of median and mean monthly rainfall at Avenel PO for 1900–2013.

For 1900–2013, inclusive mean and median monthly rainfall were lowest in February when mean monthly rainfall was 35.3 ± 3.7 mm (SE) and median monthly rainfall was 23.3 mm. Monthly rainfall then progressively increased until July when it peaked at a mean of 64.2 ± 2.8 mm (SE) and a median of 60.8 mm. Monthly rainfall then progressively declined until February. This seasonal Mediterranean rainfall trend is shown in Figure 5. Clearly there is a winter rainfall peak and a late summer minima in rainfall. Temperature varies inversely with rainfall.

For 1976–2013, inclusive mean and median monthly runoff were lowest in February when mean monthly runoff was 991 ± 204 ML and median monthly runoff was 579 ML (Figure 9). Monthly runoff then progressively increased until August when it peaked at a mean of 14223 ± 1752 ML and a median of 13371 ML. Monthly rainfall then progressively declined until February. This seasonal Mediterranean runoff trend is shown in Figure 9. Clearly there is a winter runoff peak which occurs a month later than the rainfall peak and a late summer minima (February) in both rainfall and runoff (Figures 5 and 9).

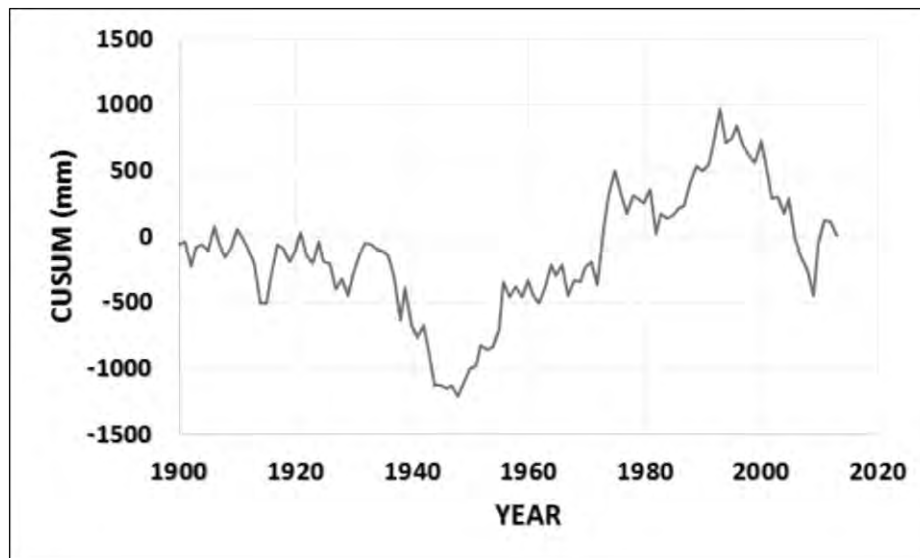
Figure 6 CUSUM plot of annual rainfall at Avenel PO for 1900–2013.

Furthermore, the rainfall and runoff trends are slightly different (compare Figures 6 and 8) with the 1976–1982 dry period missing and the Millenium drought starting later and continuing longer for the stramflow record. Nevertheless, the Mann Whitney test showed that median annual runoff decreased significantly between 1977–1996 and 1997–2013 (91262 v 37444 ML).

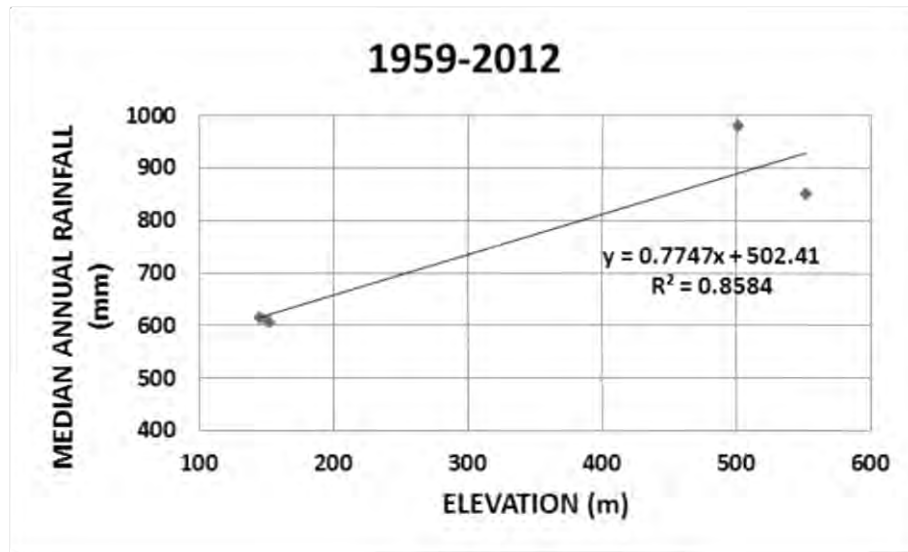
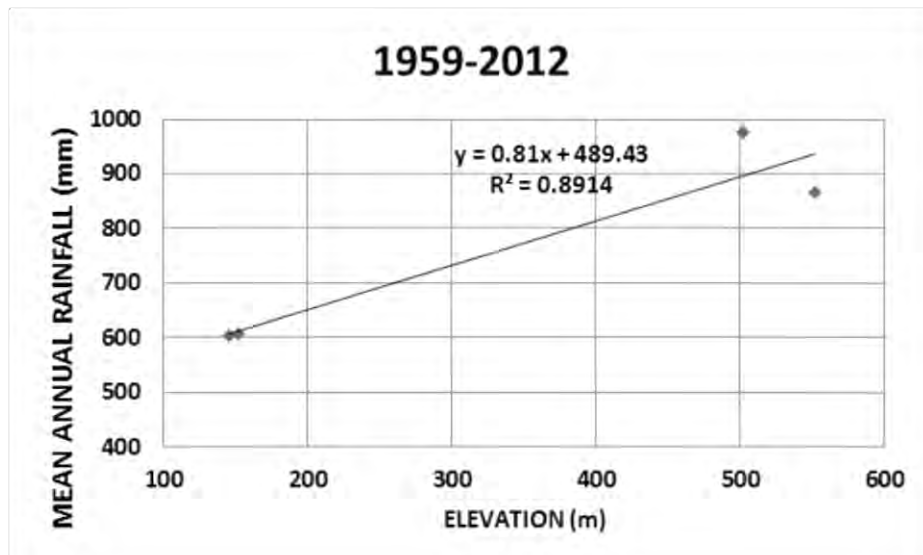
Figure 7 Variations in median (top) and mean annual rainfall for 1959–2012 (bottom) for four stations (Avenel PO, Seymour Depot, Terip Terip and Strathbogie) located in and near the Hughes Creek catchment.

Median annual rainfall increases by 77.5 mm for each 100 m increase in elevation through the Hughes Creek catchment and mean annual rainfall increases by 81 mm for each 100 m increase in elevation. For the common period of record, 1959–2012, median annual rainfall increased from 607.9 mm at Avenel to 851.7 mm at Terip Terip and mean annual rainfall increased from 606 mm to 865.9 mm. The seasonal distribution of monthly rainfall is similar at Terip Terip to that outlined above for Avenel PO, except that August is the month of maximum rainfall.

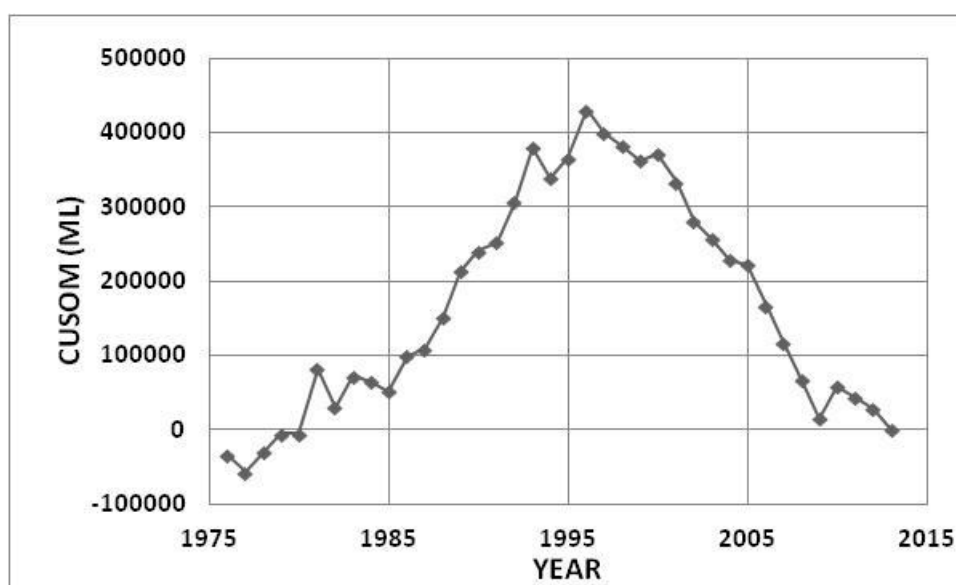
Figure 8 CUSUM plot of annual runoff at Hughes Creek at Tarcombe Road (No. 405228) for 1976–2013.

for Hughes Creek, the neighbouring gauge, Home Creek at Yarck (No. 405274; area 187 km²), was investigated and mean annual runoff for essentially the same time period was 119.4 mm. Therefore, the station record for Hughes Creek is most likely correct and Peel et al.'s (2000) estimate of mean annual runoff is an overestimate because of a short period of record that excludes most of the Millenium drought. A CUSUM plot of annual runoff for the period 1976–2013 is shown in Figure 8. Intervention analysis again shows that although there are two distinct maxima/minima ($i_1 = 1977$; $i_2 = 1996$) the year 2010 marked an upwards change in CUSUM during a long-term downward trend (Figure 8).

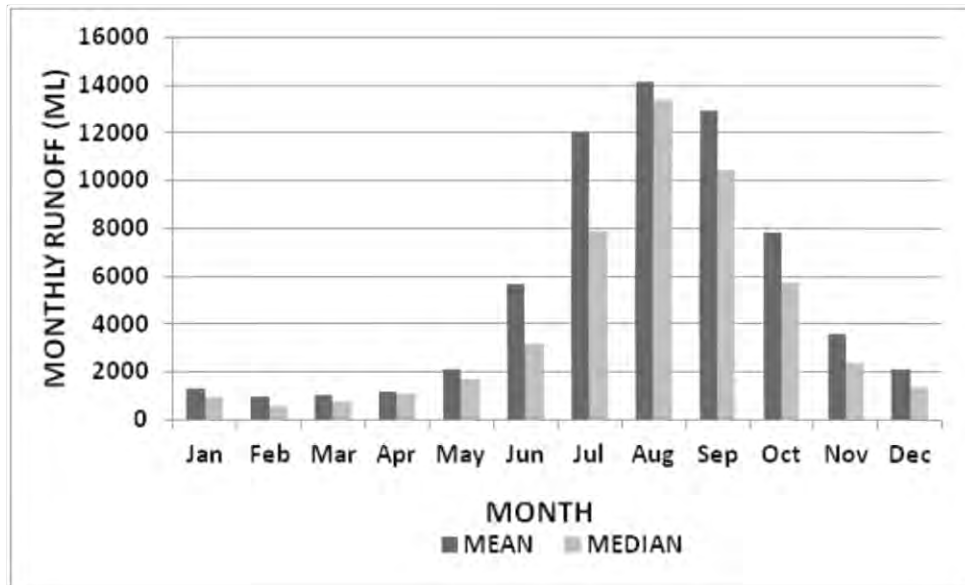
Figure 9 Distribution of median and mean monthly runoff at Hughes Creek at Tarcombe Road (No. 405228) for 1976–2013.

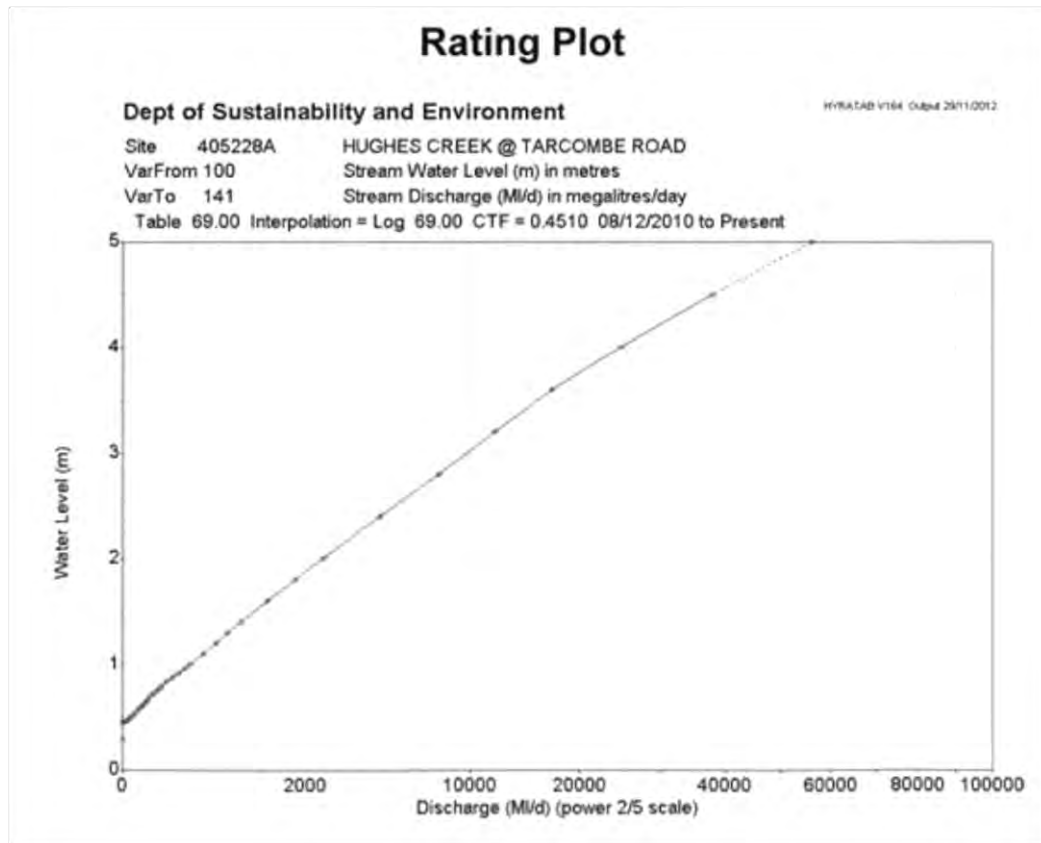
Figure 10 Rating curve at Hughes Creek at Tarcombe Road (No. 405228) downloaded from <http://203.12.195.133/dseflood/basin%2005%20goulburn/4.5228%20-%20tarcombe> on 27 June 2014.

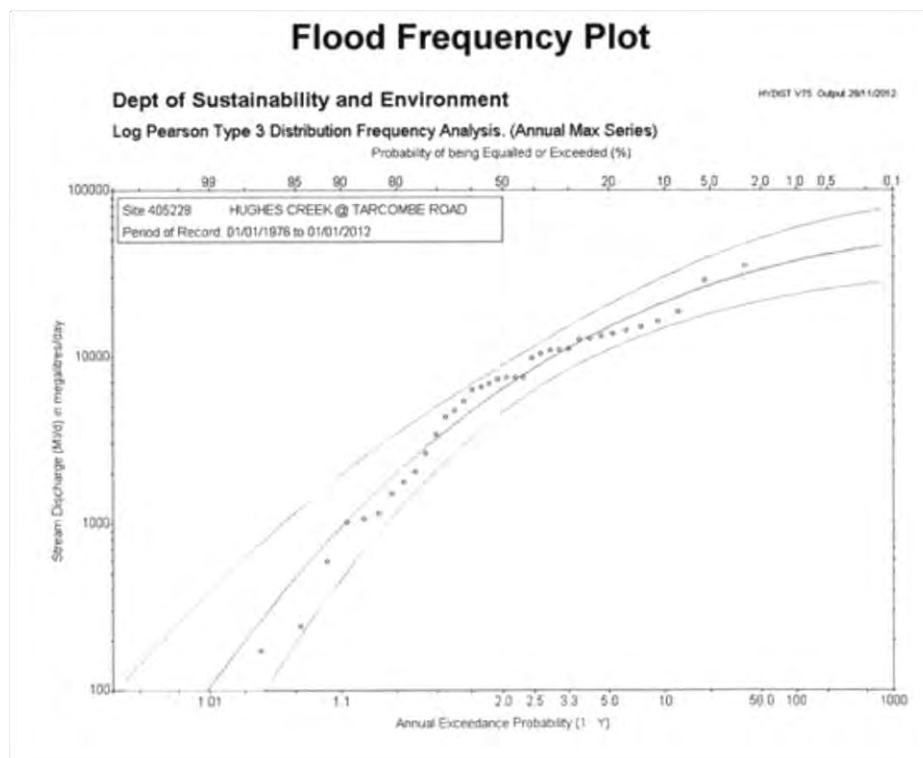
Figure 11 Log Pearson Type III flood frequency curve at Hughes Creek at Tarcombe Road (No. 405228) downloaded from <http://203.12.195.133/dseflood/basin%2005%20goulburn/4.5228%20-%20tarcombe> on 27 June 2014.

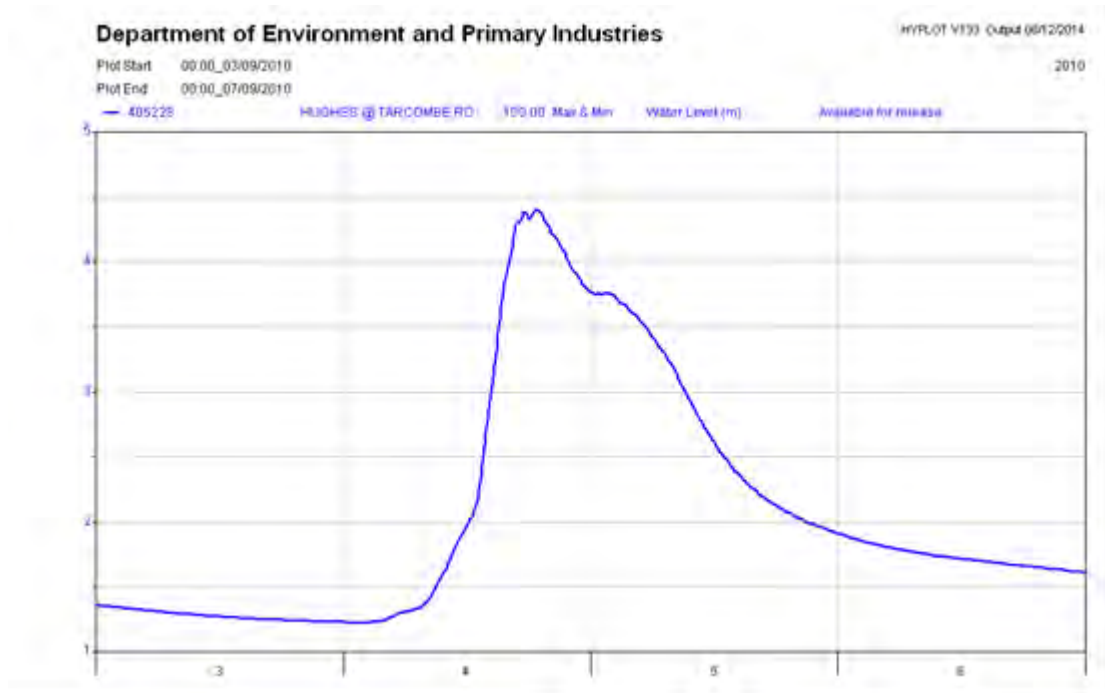
Figure 12 Stage hydrograph for the 4-6 September 2010 flood at Hughes Creek at Tarcombe Road (No. 405228) downloaded from data.water.vic.gov.au/monitoring.htm on 8 December 2014.

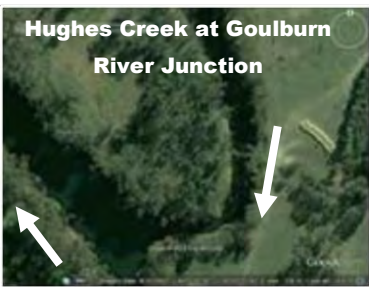
Reach Name	River Length (km)	River Bed Slope (m/km)	Geomorphic Characteristics	Photos
Goulburn Backwater Reach (Reach 1)	0–1.1	Essentially 0	Well vegetated, low sinuosity, backwater-affected channel with many pools and a reasonable load of large wood. Probably warmer water than in Goulburn River and lower flow velocities, except when Hughes Creek is in flood. Refuge from a cold Goulburn River. Mud deposition is usual in backwater reaches (Pickup 1984; Pickup & Marshall 2009). Gullyng of high right bank at junction with Goulburn River.

<p>Hughes Creek at Goulburn River Junction</p>
Avenel Recovering Sand Slug Reach (Reach 2)	1.1–21.9	1.04 to 2.67	Narrow, low slope, low sinuosity, sand-bed stream, usually flanked by continuous Phragmites stands with a narrow floodplain vegetated by <i>Eucalyptus camaldulensis</i> . Short sections of island anabranching present. Significant recent recovery has occurred from the main period of sand aggradation and channel widening when the sand slug first formed. Channel contraction increases flow velocity which transports greater sand fluxes and increases the rate of channel recovery. Phragmites is essential for protecting banks from erosion. Sand size is likely to be increasing in response to reduced upstream supply. Many small sand extraction sites have been active since 2000 and were important for creating pools.

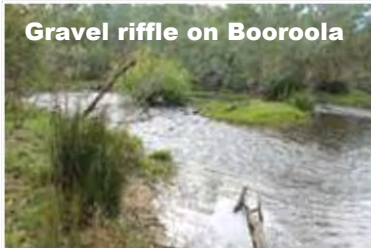
<p>Gravel riffle on Booroola</p>

Reach Name	River Length (km)	River Bed Slope (m/km)	Geomorphic Characteristics	Photos
Booroola Granite (Bedrock) Confined Reach (Reach 3)	21.9–29.8	2.35 to 3.33	<p>Strathbogie Granite laterally confines the low sinuosity channel and significantly restricts lateral migration. Sand is present in large amounts but only in patches with gravel riffles and deep pools dominant in many discontinuous areas.</p> <p>Alternating sections of sand-bed flanked by sandy side bars and gravel bed, pool-riffle channel are present. High level sand bars flank gravel bed, pool-riffle sections. Gravel-bed sections are protected by dense riparian vegetation but sand-bed sections tend to be relatively free of riparian vegetation. Gauging station 405228 (Hughes Creek at Tarcombe Road) located in this reach as well as timber groynes. Continuous riparian fencing and continuous riparian revegetation worthwhile in many sections, as shown by adjacent photos.</p>

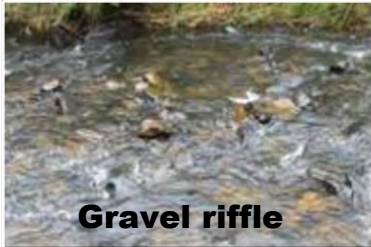
Kulaba Hornfels (Bedrock)- Confined Reach (Reach 4)	29.8–40.3	3.64 to 15.8	<p>Low sinuosity channel is more closely laterally confined by highly resistant hornfels (metamorphic rocks) of the metamorphic aureole into which Strathbogie Granite was intruded than immediately downstream and upstream. Pools and gravel riffles are more common than adjoining reaches. Spatially disjunct floodplains are less common than adjoining reaches. Sand was recently transported into this reach by the 2010 flood. Riparian vegetation is in good condition.</p>

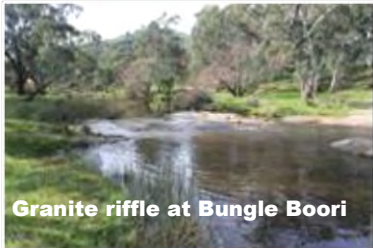
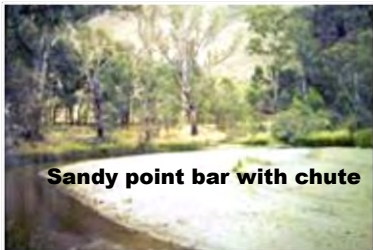
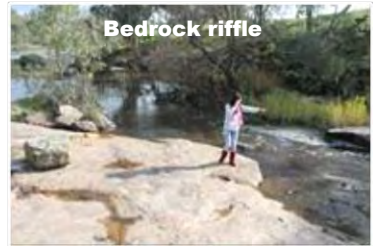
Reach Name	River Length (km)	River Bed Slope (m/km)	Geomorphic Characteristics	Photos
Bungle Boori Granite (Bedrock)- Confined Reach (Reach 5)	40.3–55.6	1.82 to 3.08	Granite often exposed in bed and banks and alternates with sand aggraded sections. Granite frequently exposed in bed immediately upstream and downstream of Bungle Boori where slope increases significantly. Sand bars common in sand aggraded sections. Limited pool development because of oversupply of sand, especially by the 2010 flood. Spatial distribution of sand indicates that tributaries of this reach have been but are no longer a significant source of sand. Short sections of anabranching present. Riparian vegetation is discontinuous. Limited sand extraction has occurred in the downstream part of this reach. Small amounts of extraction will not damage channel and floodplain.

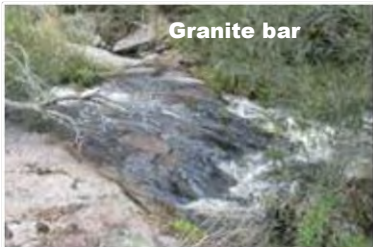
The Peak Granite Gorge (Reach 6)	55.6–61.1	13 .3 to 40.0	Steep granite gorge where Hughes Creek completes its fall from the top of the Strathbogie Ranges/Highlands plateau into the Hughes Creek valley. Bedrock bars, boulder steps and step pools, cascades, rapids and long pools present. Some sand deposition and emergent macrophytes present in flatter sections.

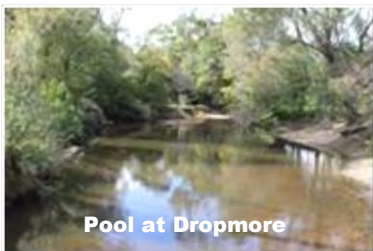
Dropmore Granite (Bedrock)- Confined Reach (Reach 7)	61.1–64.8	3.91 to 40.0	Short section of flatter, low sinuosity, sandy, vegetated channel confined by granite. Bedrock often exposed in bed and banks. Sand benches occasionally present. Emergent macrophytes present in flatter sections.

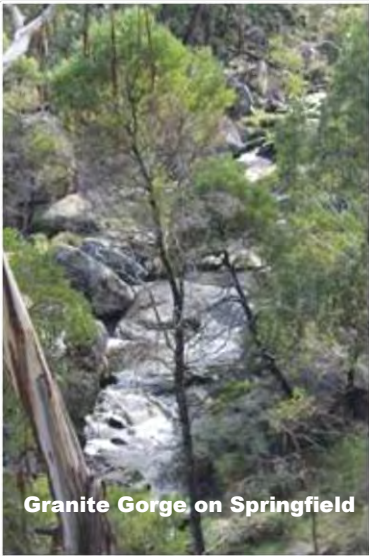
Reach Name	River Length (km)	River Bed Slope (m/km)	Geomorphic Characteristics	Photos
Springfield Granite Gorge (Reach 8)	64.8–68.5	40.0 to 100	Very steep, deep, straight, granite gorge with boulder and bedrock bed. Channel units include bedrock and boulder steps, step pools, cascades and pools. Riparian vegetation is in good condition despite high stream energy. Emergent macrophytes common in flatter sections. Major natural barrier to fish passage. No alien fish species should be introduced upstream of this gorge because of potential impact on the fish biodiversity of chain of ponds and percolines.

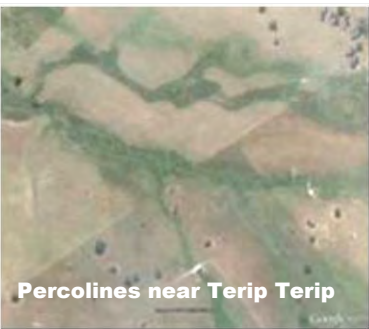
Terip Terip Percolines Reach (Reach 10)	72.1–74.3	2.86 to 5.00	Well vegetated, swampy, unchannelled valley floor, except where shallow drains have been excavated. Very rare chain of ponds present but fewer and smaller than downstream. Drainage works could cause large-scale gully development.

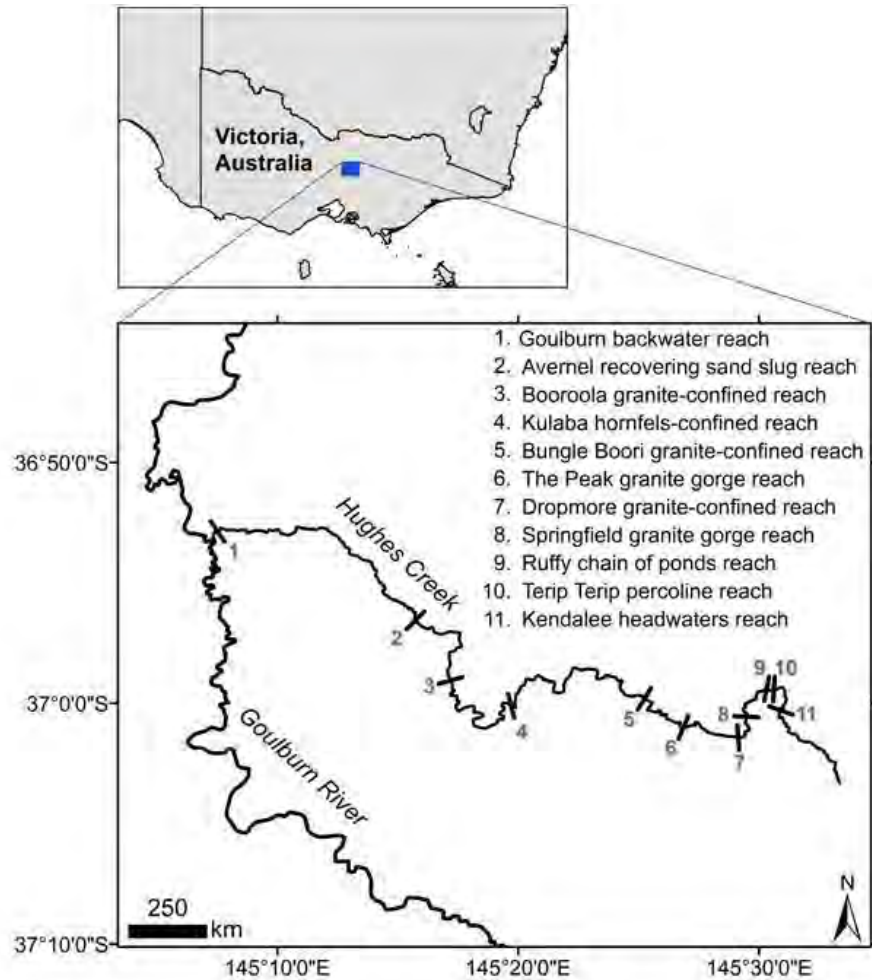
Figure 13 Location of the river reaches described in Table 2 in the Hughes Creek catchment.

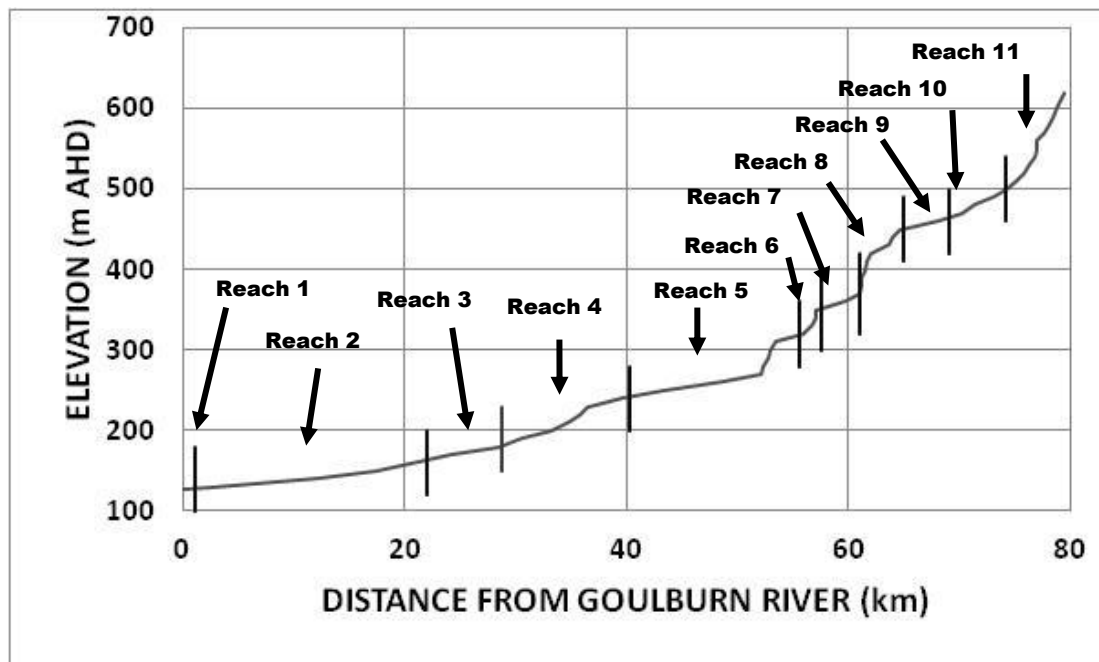
Figure 14 Long profile of Hughes Creek showing location of river reaches. See Table 2 for details of river reaches.

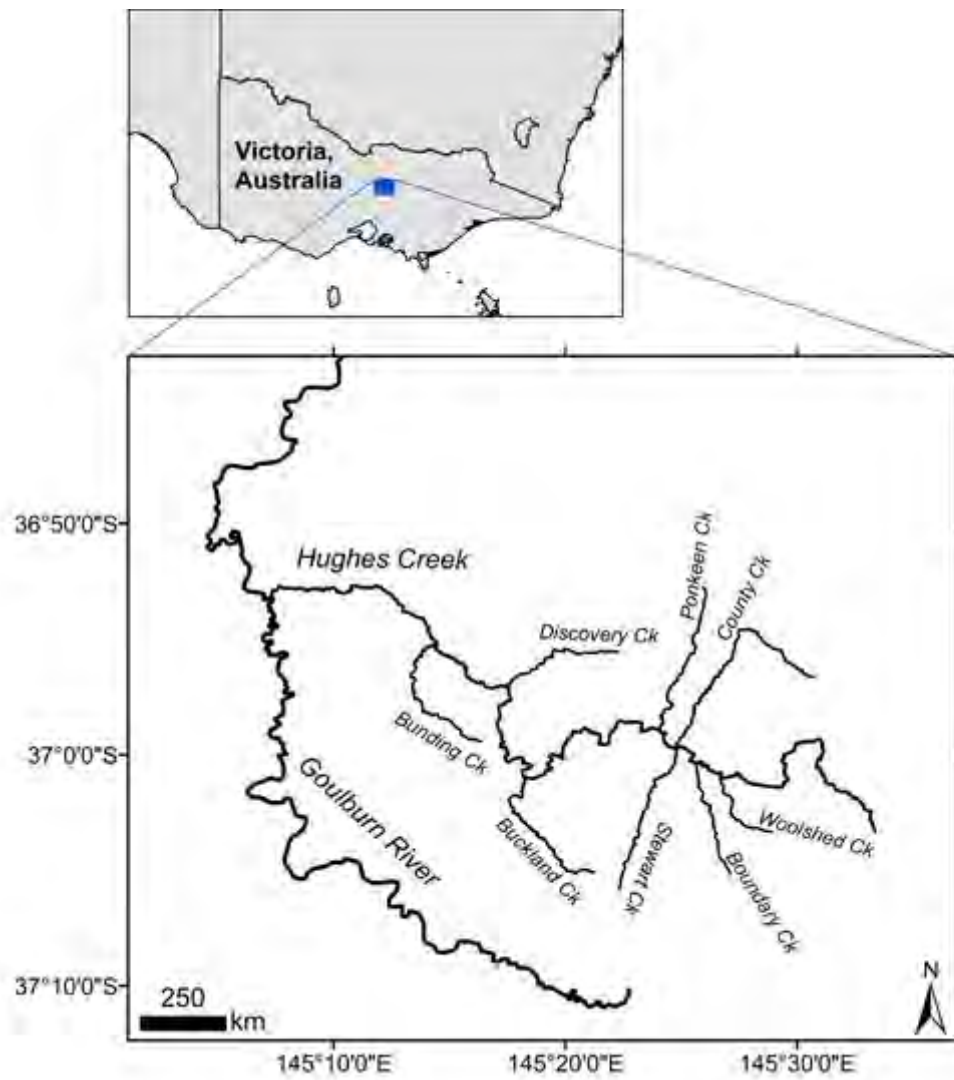
Figure 15 The location of the eight tributaries of Hughes Creek investigated for this report.

The Goulburn-Broken Catchment Management Authority requested that the tributaries of Hughes Creek also be classified and discussed. River reach mapping is not intended to cover small tributaries because they are too small to be seen in detail on vertical aerial photography. Therefore, river reaches are only formally defined here where the tributary channel is clearly visible on Google Earth Pro for most of its length. Where the channel is not clearly visible, general comments only on downstream changes in channel morphology and current channel condition are presented. Again Ian Drummond and Associates (1984) and the author's 'Field Notes No. 26' from 1991 and 1992, 'Field Notes No. 27' from 1994 and 1995, and 'Field Notes No. 159' from 2008 to 2014 were consulted before completing this work. The location of the eight tributaries discussed below is shown in Figure 15.

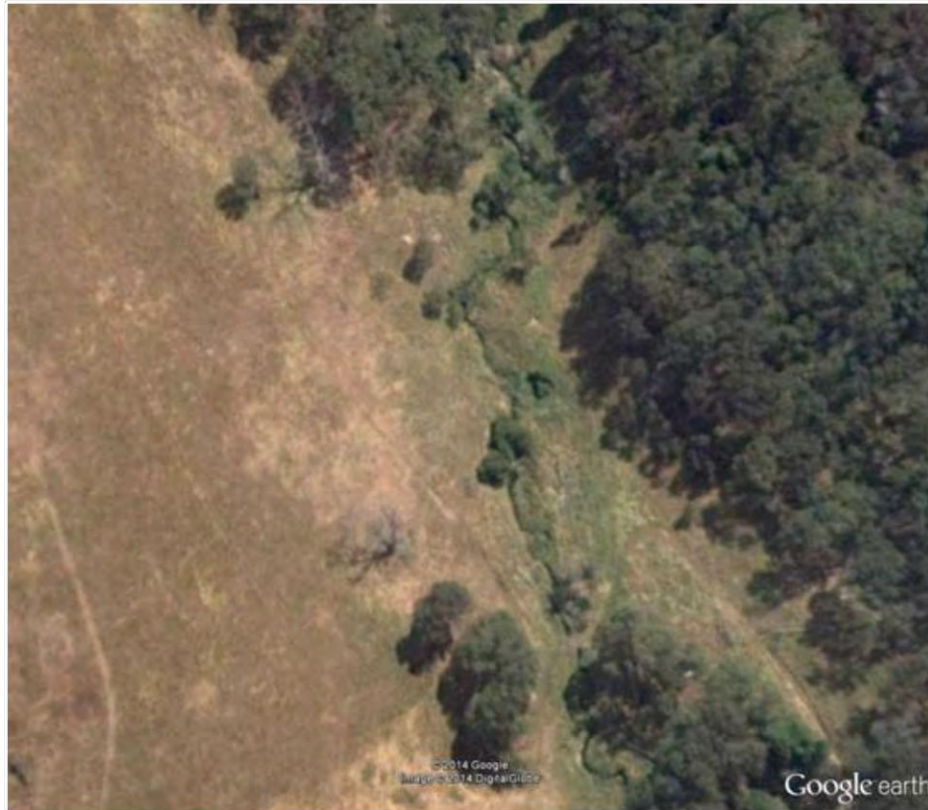
Figure 16 A recovering section of formerly incised channel on Woolshed Creek in 2012.

Woolshed Creek is a left bank tributary of Hughes Creek in Reach 6 at Dropmore (Figure 15). Its riparian zone is well vegetated by remnant forest along most of its length and granite vertically constrains and laterally confines the channel in many locations. No significant historical information on the condition of the channel was found on the early Dropmore Parish map. Where the channel can be seen on the 2012 air photos, the channel is recovering from historical incision (Figure 16). Woolshed Creek is currently stable and is not a contemporary sand source.

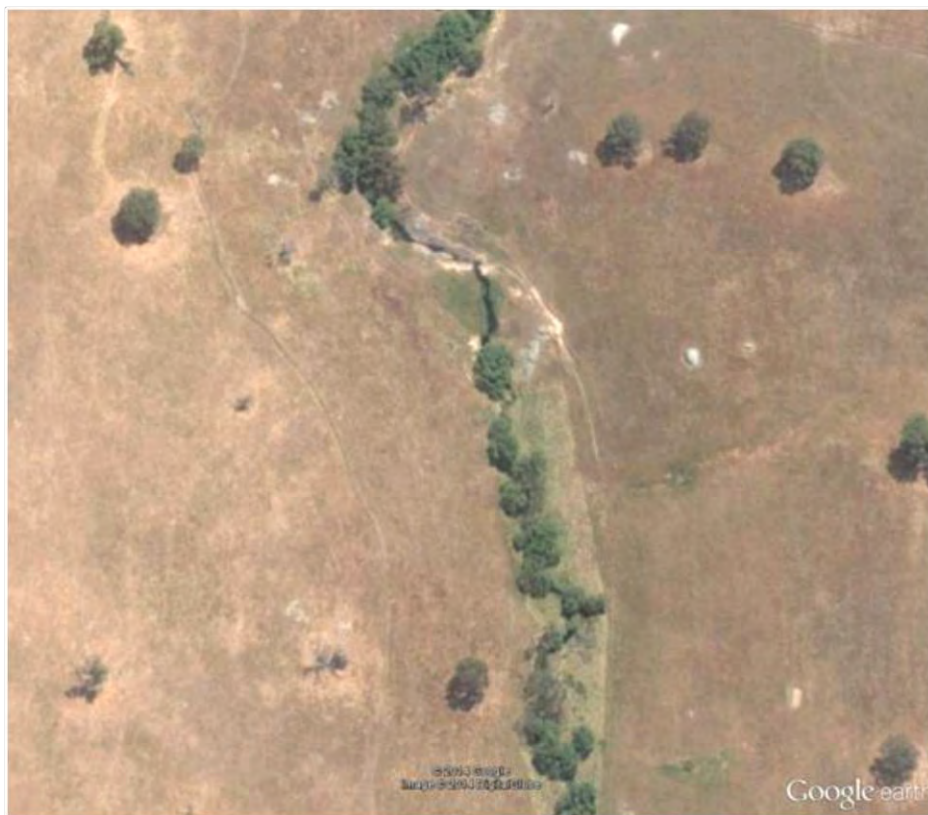
Figure 17 A recovering section of formerly incised channel on Boundary Creek in 2012.

Boundary Creek is a left bank tributary of Hughes Creek in Reach 6 downstream of Dropmore (Figure 15). It is similar to Woolshed Creek (Figure 17), discussed above. No significant historical information on the condition of the channel was also found on the early Dropmore Parish map. Boundary Creek is currently stable and is not a contemporary sand source.

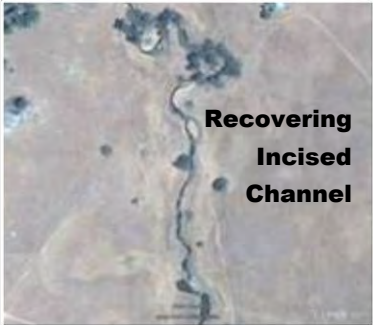
Reach Name	River Length (km)	River Bed Slope (m/km)	Geomorphic Characteristics	Photos
Stewart Recovering Incised Channel Reach (Reach 1)	0–2.75	5.26	Well vegetated, low sinuosity, formerly incised channel that has progressed a long way along a recovery trajectory. In-channel bars are still present. Sections of the riparian zone have been planted. Well developed pools are common. Many tributaries have not been extensively rejuvenated.

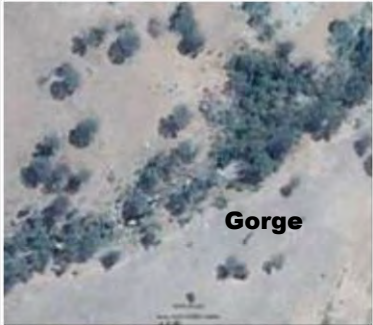
Mt Helen Granite Gorge (Reach 2)	2.75–3.75	45.5 to 133	Short reach of well vegetated, bedrock-ensconced channel which is continuously tree-lined. It is difficult to see the channel although pools are present.

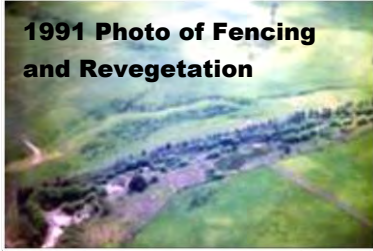
Kobyboyn Recovering Incised Channel Reach (Reach 3)	3.75–10.55	4.06 to 8.03	Well vegetated, low sinuosity, formerly incised channel that has progressed a long way along a recovery trajectory. Sections of the riparian zone have been fenced and planted. Well developed pools are common and bars are being colonised.

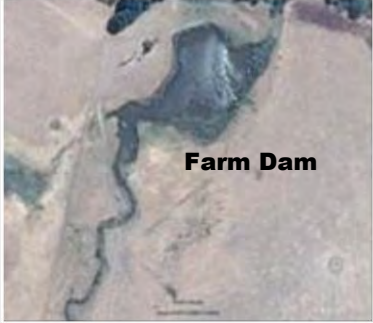
Habbies Howe Dammed Reach (Reach 4)	10.55–11.23	Essentially 0 because of backwater	Farm dam with emergent macrophytes and occasional trees. This is a major sediment trap.

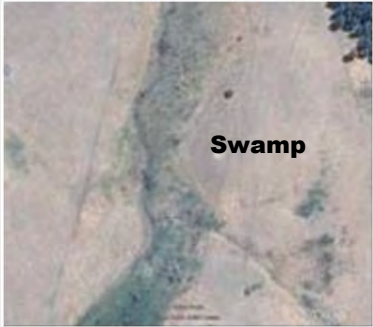
Reach Name	River Length (km)	River Bed Slope (m/km)	Geomorphic Characteristics	Photos
Highlands Swamp Reach (Reach 5)	11.23–12.03	17.9	Broad swamp with occasional ponds. Discontinuous well vegetated small capacity channel present in patches.

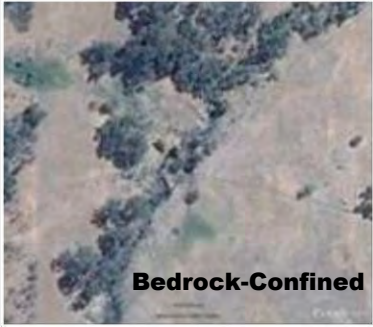
Rockcliff Bedrock-Confining Reach (Reach 6)	12.03–12.69	14.6 to 16.4	Short reach of well vegetated sinuous bedrock-confining channel containing small pools with large wood.

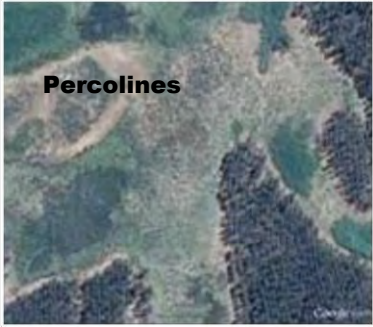
Hillcrest Percoline Reach (Reach 7)	12.03–14.73	29.4 to 37.0	Broad well vegetated swampy valley floor with occasional depressions. Occasional ponds present in downstream area. Extensive recent catchment reforestation with <i>Eucalyptus</i> plantations.

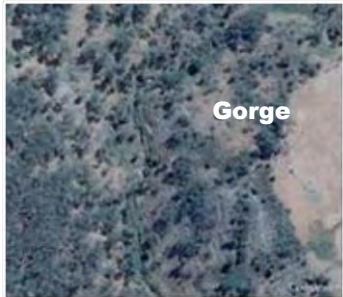
Pool
Mt Monica Granite Gorge (Reach 2)	11.0–12.2	27.0 to 100	Short reach of steep, well vegetated, granite-ensconced channel or gorge which is continuously tree-lined. Pools present.

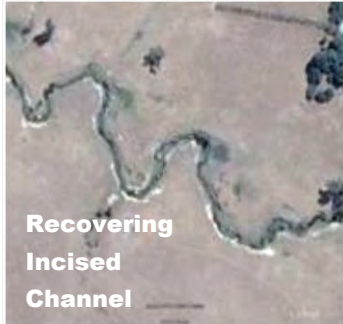
Gorge
Kurrajong Recovering Incised Channel Reach (Reach 3)	12.2–16.2	10.3 to 33.9	Well vegetated, slightly sinuous, formerly incised channel that has progressed a moderate way along a recovery trajectory. It appears that the banks of the former incised channel are subject to dryland salinity (appear white on the air photos) but they have not been inspected in the field. Sections of the riparian zone are very well vegetated and have been planted. Well developed pools are common. Chain of ponds are reforming in the bed of the recovering incised channel. Large granite outcrop is located at 13.5 km. Channel less clearly defined immediately downstream of this outcrop.

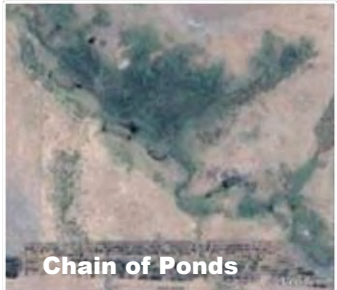
Innisfail Chain of Ponds Reach (Reach 4)	16.2–19.2	12.0	Swampy valley floor with a discontinuous well vegetated small capacity channel with chain of ponds alternating with disconnected chain of ponds.

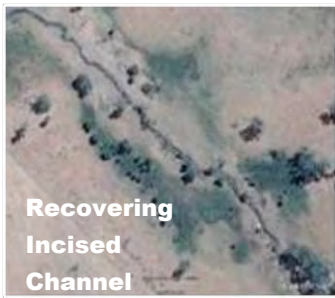
Reach Name	River Length (km)	River Bed Slope (m/km)	Geomorphic Characteristics	Photos
Strathearn Recovering Incised Channel Reach (Reach 5)	19.2–19.5	17.9	Short section of straight (previously ditched?) recovering incised channel from post-European channel erosion. May extend further upstream into remnant forest but channel cannot be seen. Channel boundary well grassed but no river restoration works carried out to date.

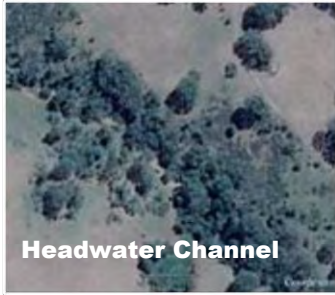
Headwater Channel

Recovering Incised Channel
Willowmavin Headwaters Reach (Reach 6)	19.5–21.2	19.4 to 37.0	Steep reach located in remnant forest downstream of a large farm dam.

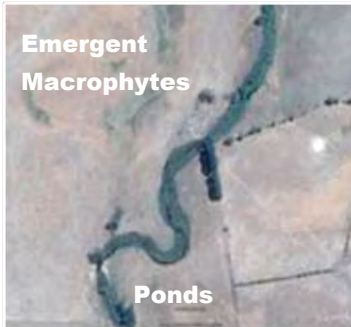
Reach Name	River Length (km)	River Bed Slope (m/km)	Geomorphic Characteristics	Photos
Ponkeen Recovering Incised Channel Reach (Reach 1)	0–9.6	4.66 to 10.0	Often well vegetated, slightly sinuous, formerly incised channel that has progressed a long way along a recovery trajectory. Sections of the riparian zone have been planted and fenced. Well developed pools are common. Chain of ponds reforming where there are emergent macrophytes on the valley floor.

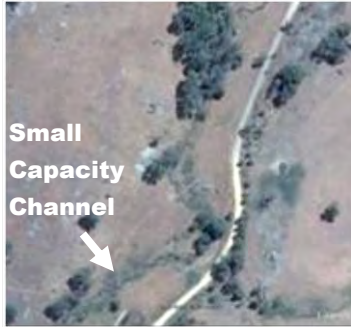
Reach Name	River Length (km)	River Bed Slope (m/km)	Geomorphic Characteristics	Photos
Karep Chain of Ponds Reach (Reach 3)	10.7–12.0	11.4 to 18.7	Well vegetated narrow valley floor with sections of small capacity channel containing chains of ponds and disconnected chains of ponds.

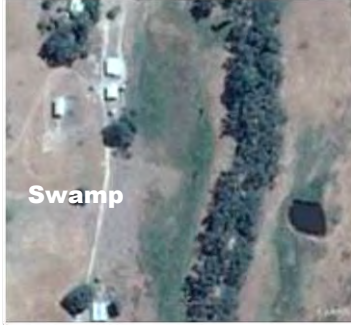
Ardroy Percolines Reach (Reach 4)	12.0–15.7	15.7 to 66.7	Swampy valley floor and percolines with scattered farm dams at 14.0 km, 14.8 km and 15.6 km.

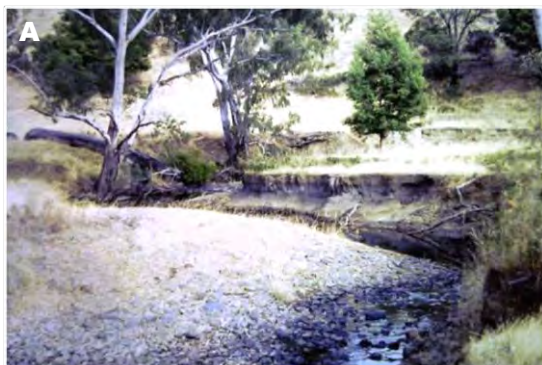
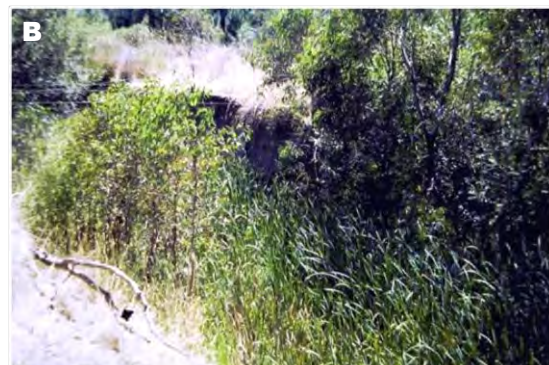
Figure 18(A) Middle section of Buckland Creek where it was a gravel bed stream flanked by an inset floodplain covered by thin post-settlement alluvium on 25 February 1992; (B) Buckland Creek where the bed was covered with rhizomatous emergent macrophytes on 25 February 1992. The macrophytes indicate that Buckland Creek is not a significant contributor of bedload to Hughes Creek.

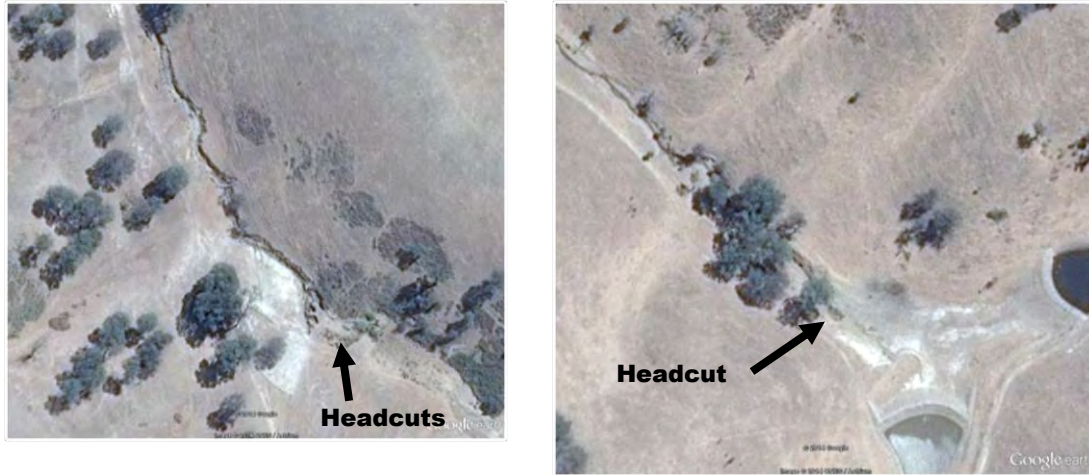
Figure 19 Discontinuous gullies on a right bank tributary of Buckland Creek showing headcuts in 2013.
