River Reaches, Historical
Channel Changes and
Recommended Methods to
Improve Macquarie Perch
Habitat on Hughes Creek,
Victoria

Wayne D Erskine

Erskine WD 2016. *River Reaches, Historical Channel Changes and Recommended Methods to Improve Macquarie Perch Habitat on Hughes Creek, Victoria*, May 2016. Supervising Scientist Report 208, Supervising Scientist, Darwin NT.

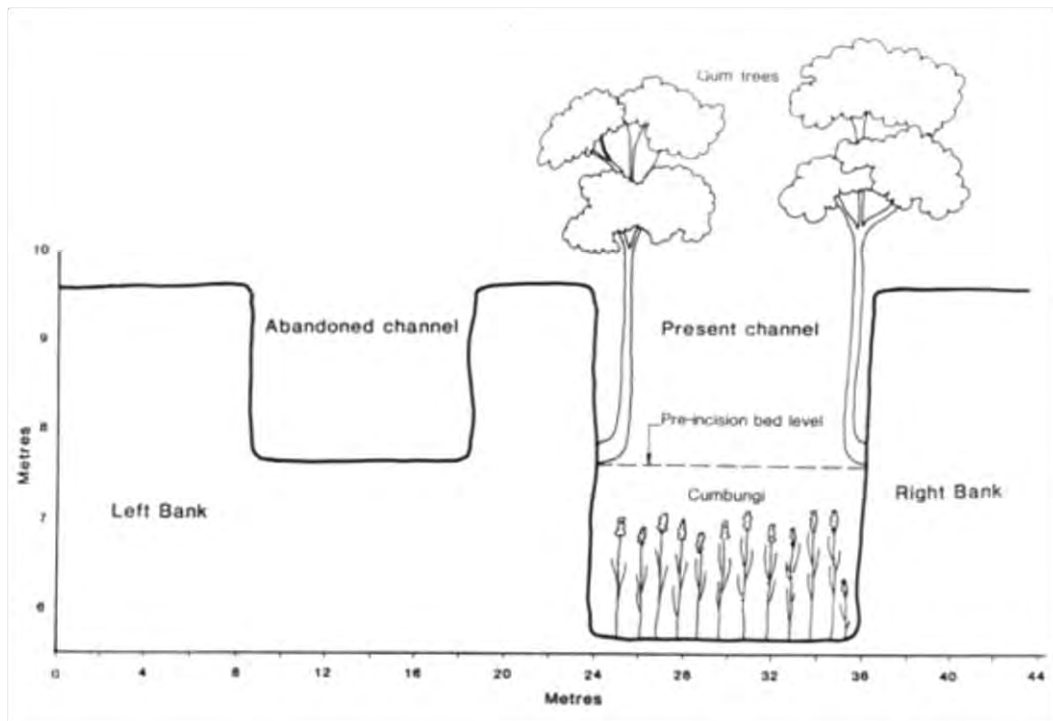
Figure 20 Difference between current incised Buckland Creek and its pre-European unincised channel (abandoned channel) on the middle reaches of Buckland Creek (from Erskine 1993a: Figure 11.2).

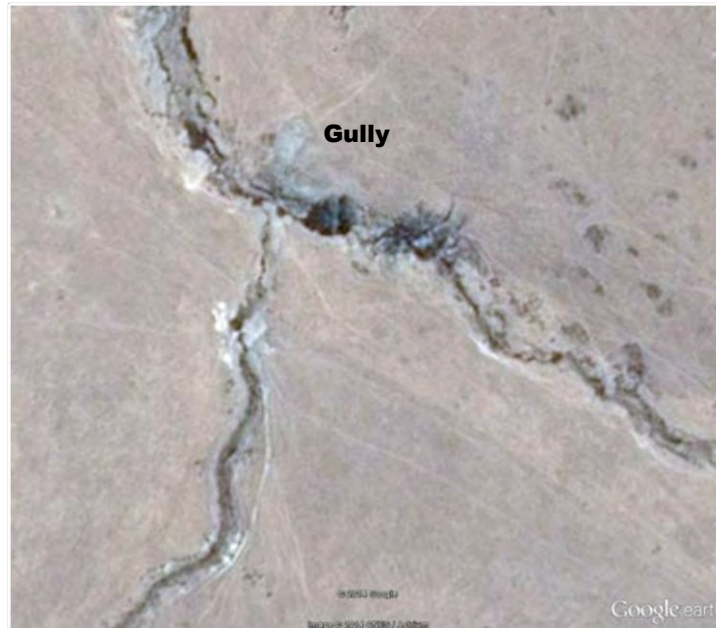
Figure 21 Gullying in upper Buckland Creek catchment in 2014.

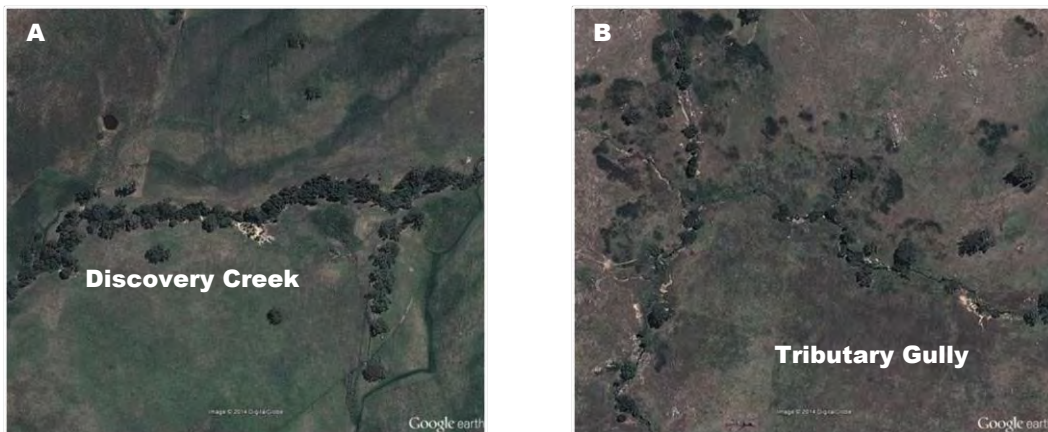
Figure 22 (A) Well treed channel of Discovery Creek upstream of Tarcombe Road in 2011;
(B) Tributary gullying in upper Discovery Creek catchment in 2011.

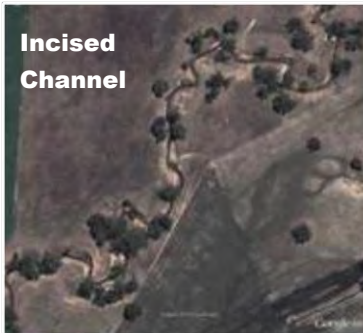
Reach Name	River Length (km)	River Bed Slope (m/km)	Geomorphic Characteristics	Photos
Avenel Incised Channel Reach (Reach 1)	0–3.6	6.83 to 25.6	Poorly vegetated, meandering, active sand-bed channel, that has incised since European settlement. Outer bank on beds is eroding. There is a small floodout where the channel debouches onto the floodplain of Hughes Creek. The channel discharges into an anabranch of Hughes Creek. Connected to the next incised reach upstream by a steep bedrock-confined reach.

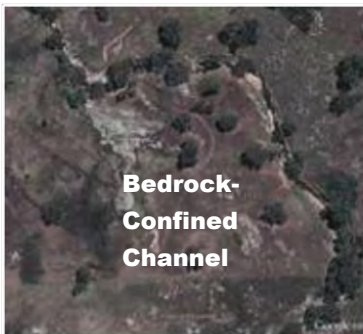
<p>Incised Channel</p>
Mittagong Bedrock-Confined Reach. (Reach 2)	3.6–6.3	21.5 to 58.8	Short reach of granite-confined channel with granite pavement, boulders and pools interspersed with sand-bed sections.

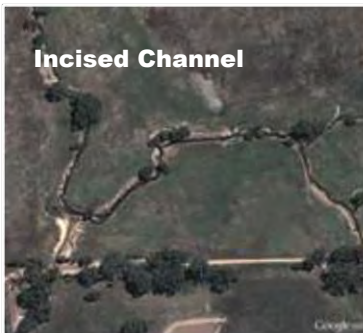
<p>Incised Channel</p>

<p>Bedrock-Confined Channel</p>
Mt Alexina Incised Channel Reach (Reach 3)	6.3–13.3	12.0 to 22.7	Poorly vegetated, incised channel that is actively eroding and has rejuvenated tributaries. Most of the main channel length has now been eroded.

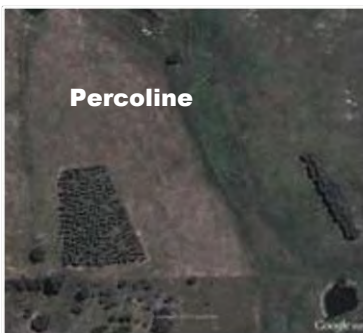
<p>Percoline</p>

One Tree Hill Percoline Reach (Reach 4)	13.3–14.0	>31.5	Short length of swampy valley floor with percolines and a farm dam at 13.8 km.

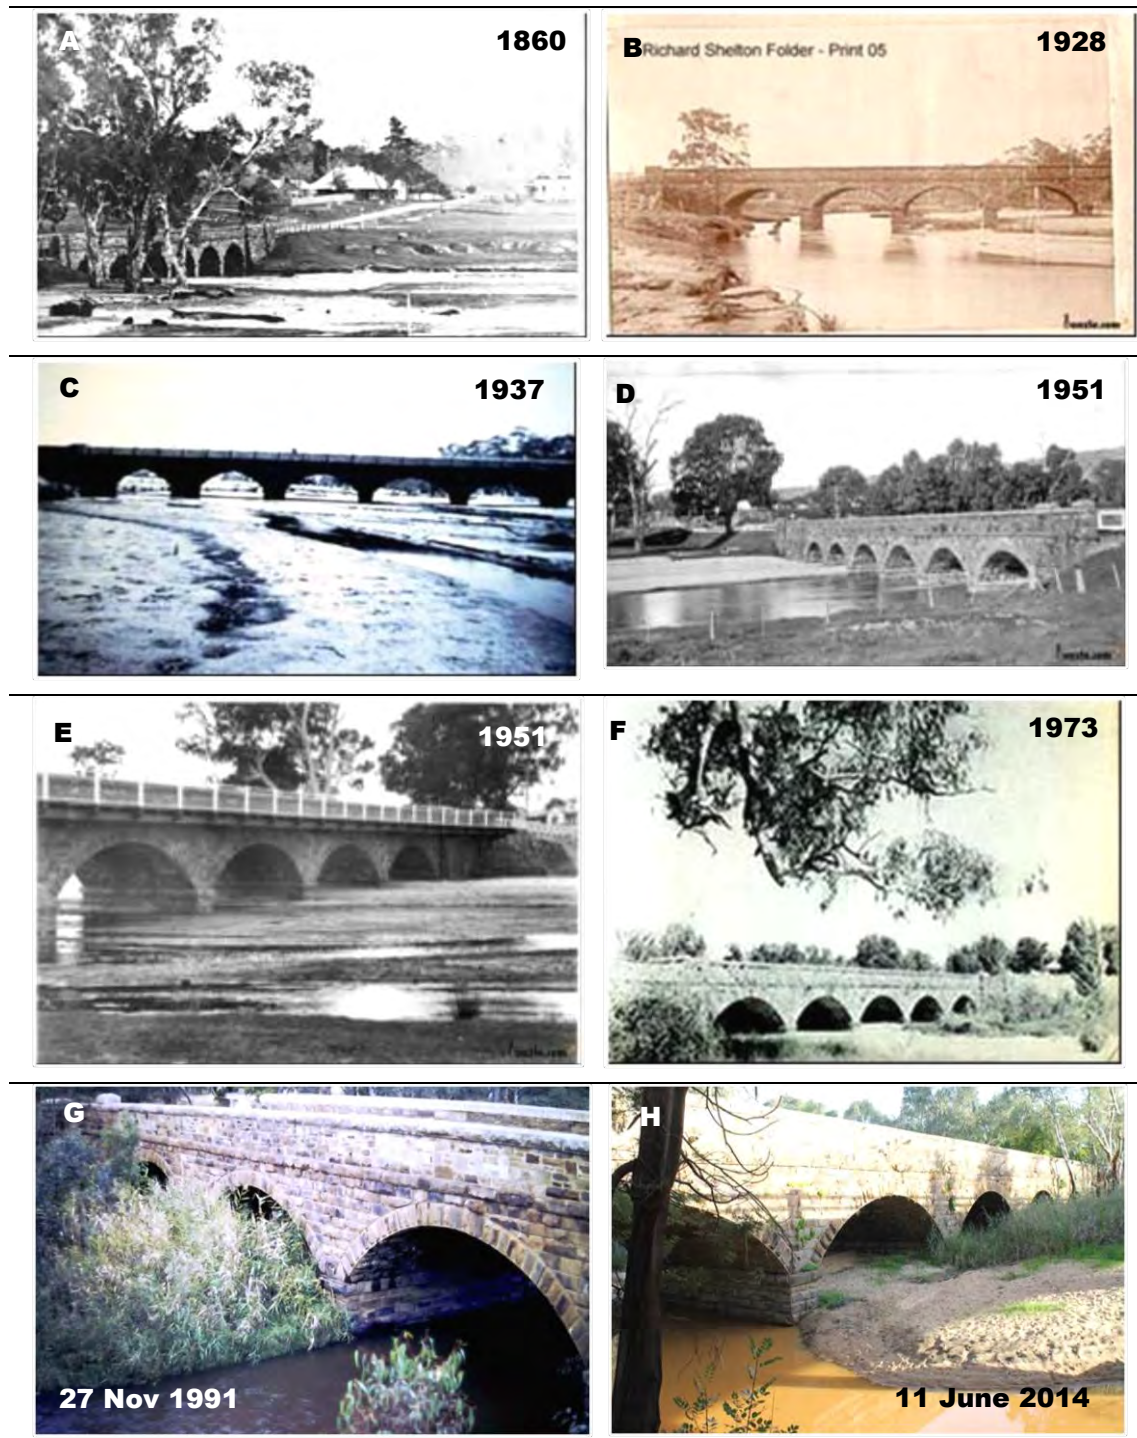
Figure 23 Historical photographs of the stone arch bridge over Hughes Creek on the former Hume Highway at Avenel. Dates specified where known. (A) sourced from <http://www.bonze.com/c/a?a=pic&fn=ud1hre92&s=3> on 5 Sep 2014 and dated as 1860; (B) sourced from internet, 1928; (C) sourced from the former State Rivers and Water Supply Commission's collection, 1937; (D) sourced from Burgoyne (1955), 1951; (E) sourced from internet, 1951; (F) sourced from Field (1973: p. 69), probably 1973 ;(G) sourced from Wayne Erskine's collection, 27 November 1991; and (H) sourced from Wayne Erskine's collection, 11 June 2014.

Figure 23A. This must be incorrect because the stone arch bridge was not completed until 1859/1860. A search of the internet found Figure 23A at <http://www.bonzle.com/c/a?a=pic&fn=ud1hre92&s=3> on 5 September 2014 with a date for the photo of 1860. Furthermore, the quality of the photo was much better than that in Martindale (1958) and a pool was present under the bridge on the left bank where the channel occupied two arches. Martindale (1958: 165) noted that a shallow ford on Hughes Creek at Avenel was formerly deeper than it was in 1958. He goes on to say that "...much silting up having gone on within living memory." The complete quote is contained in Erskine (1993a, p. 189). Living memory could be anywhere between 10 and 60 years. So the timing of sand slug development was likely to be in the twentieth century. This was supported by the residents of Avenel that the author interviewed for this project (Mr P Lewis, Mr J Newton).

The photos in Figure 23 indicate that the sand slug had formed by 1928 when the channel flowed through all six arches. By 1973, Hughes Creek had started to contract and vegetation had colonized the higher parts of the former bed (Figure 23F). The rate of contraction accelerated after 1973 (Figure 23G & H). While attempting to find the correct dates for the photos in Figure 23, the State Library of Victoria collection was found and the four extra photos in Figure 24 were located. Figure 24 confirms the conclusions made on the basis of Figure 23.

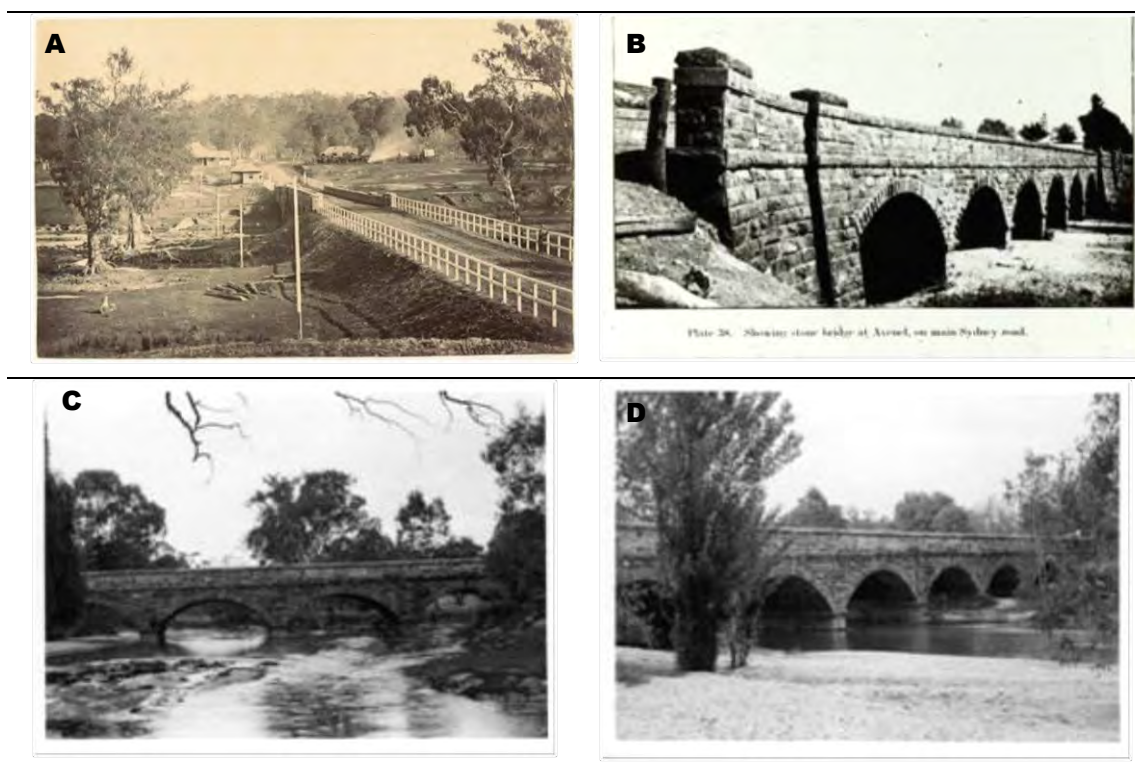
Figure 24 Historical photographs of the stone arch bridge over Hughes Creek on the former Hume Highway at Avenel. Dates specified where known. (A) sourced from State Library of Victoria, 1859; (B) sourced from State Library of Victoria image H40636/31, dated between about 1915 and 1925; (C) sourced from State Library of Victoria image H90 100/474, dated 18 October 1968; and (D) sourced from State Library of Victoria image H90 100/475, dated 9 November 1986. (C) and (D) taken by photographer John T. Collins.

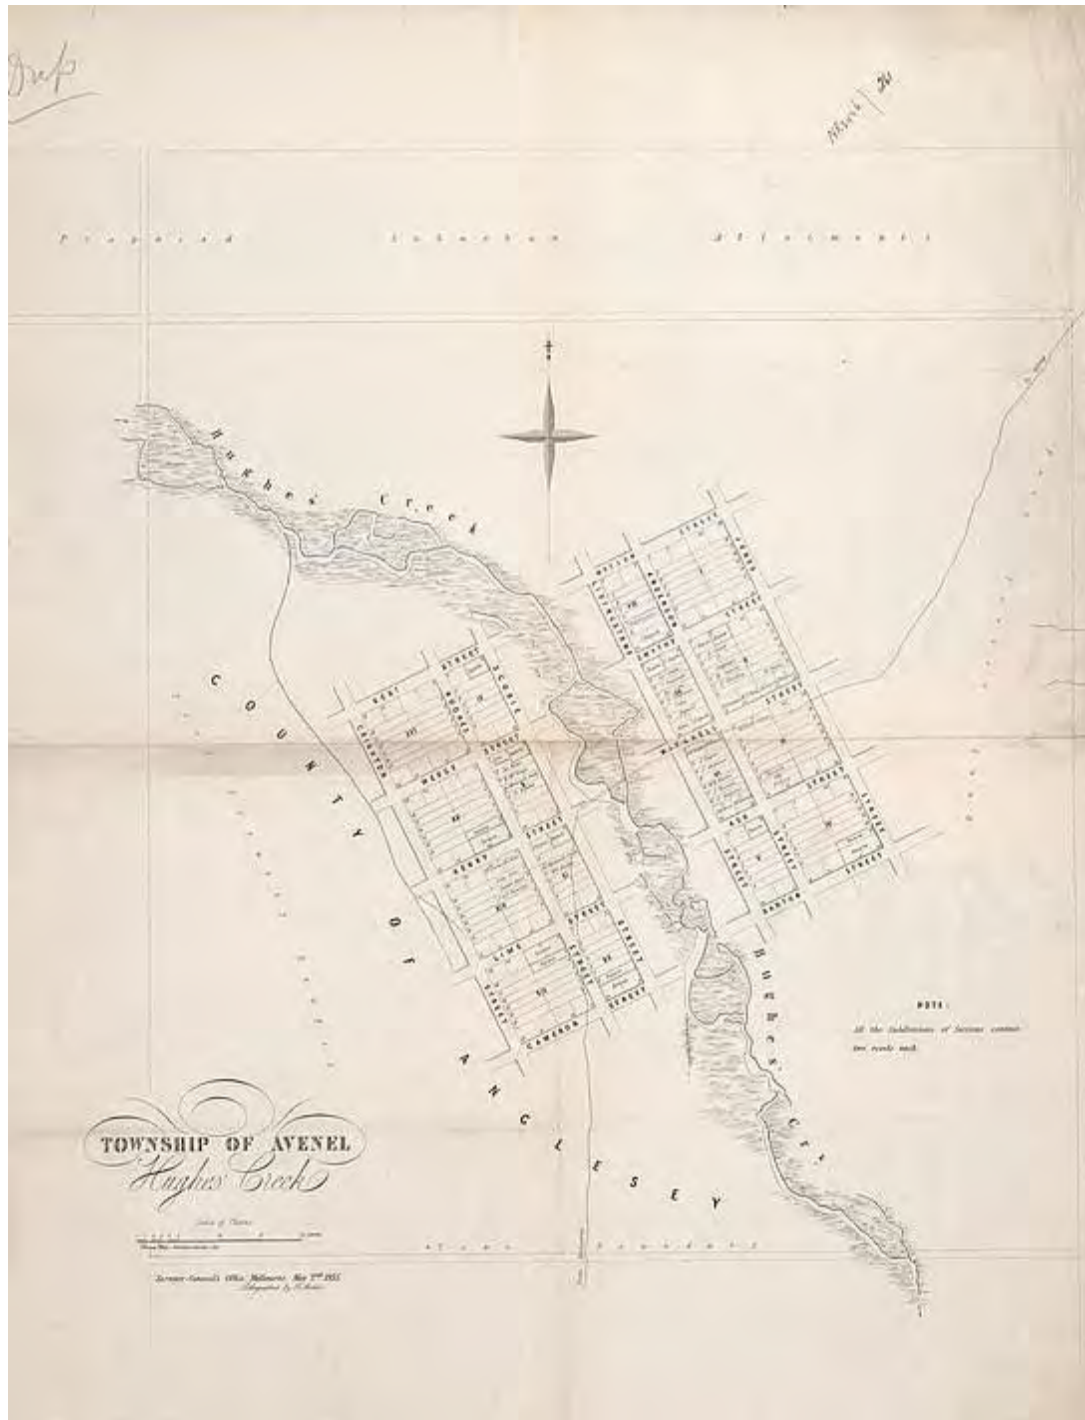
Figure 25 The Township of Avenel map of the 1800s showing anabranching channel.

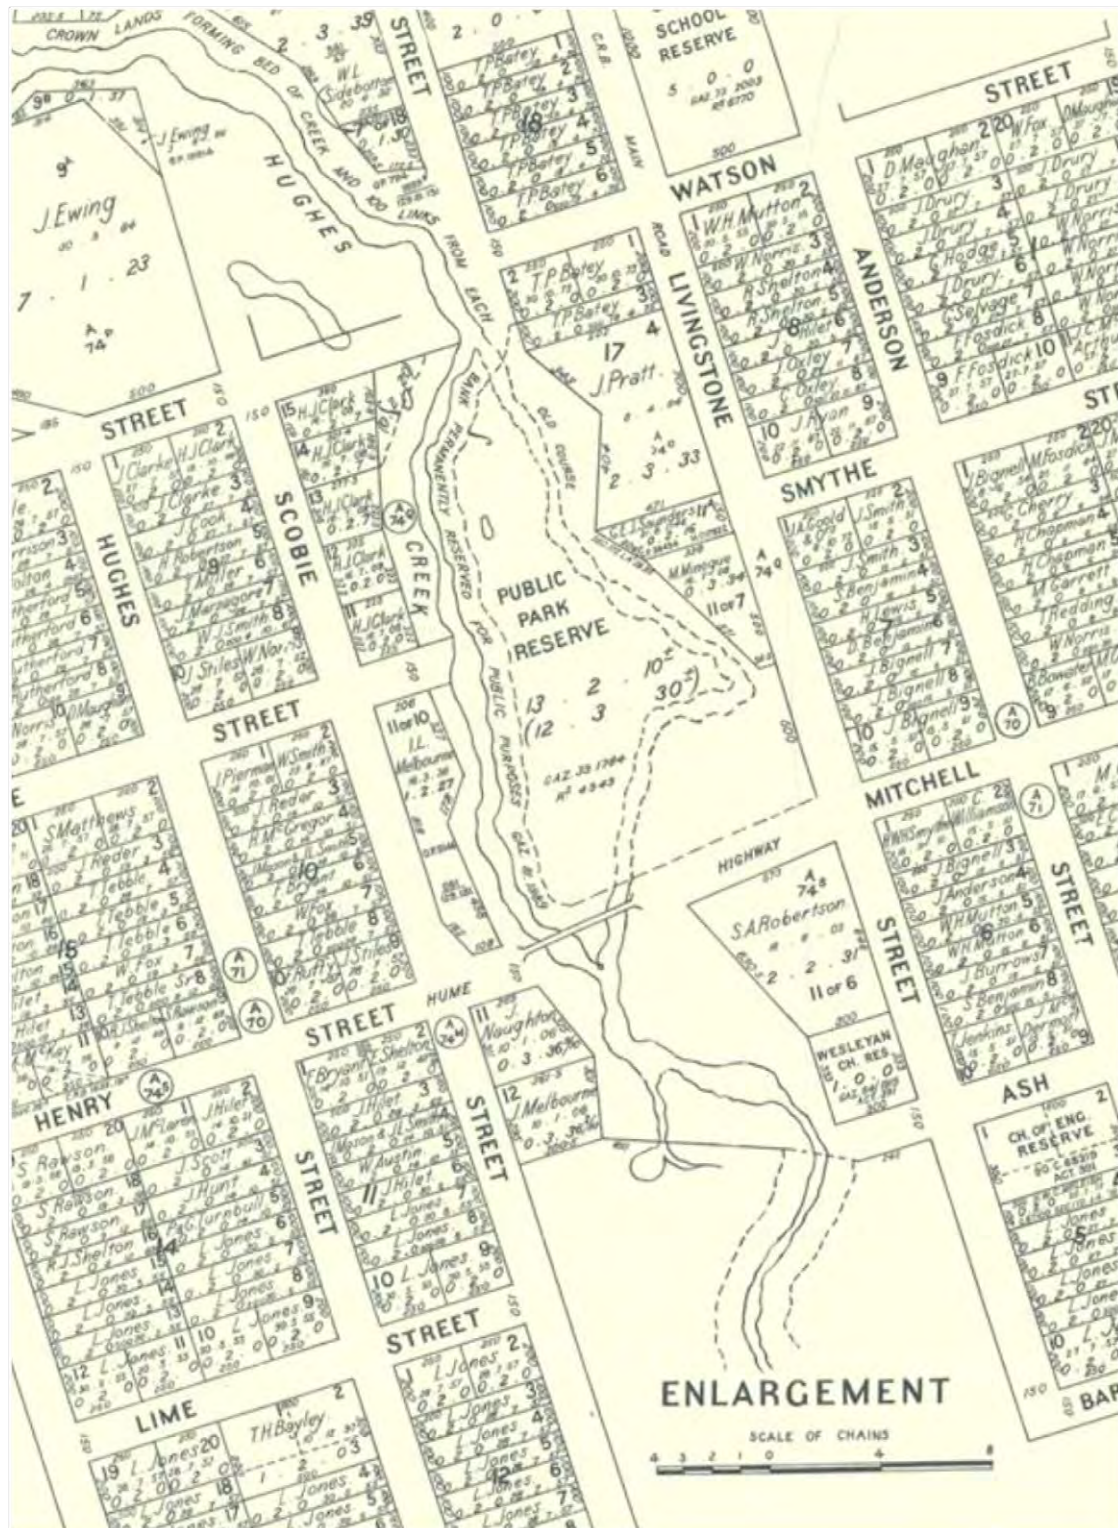
Figure 26 Excerpt of the Township of Avenel map showing that Hughes Creek did not occupy all of the Hume Highway bridge span when the town was surveyed and that an avulsion had occurred with the “old course” shown on the right bank side of the channel downstream of the Hume Highway.

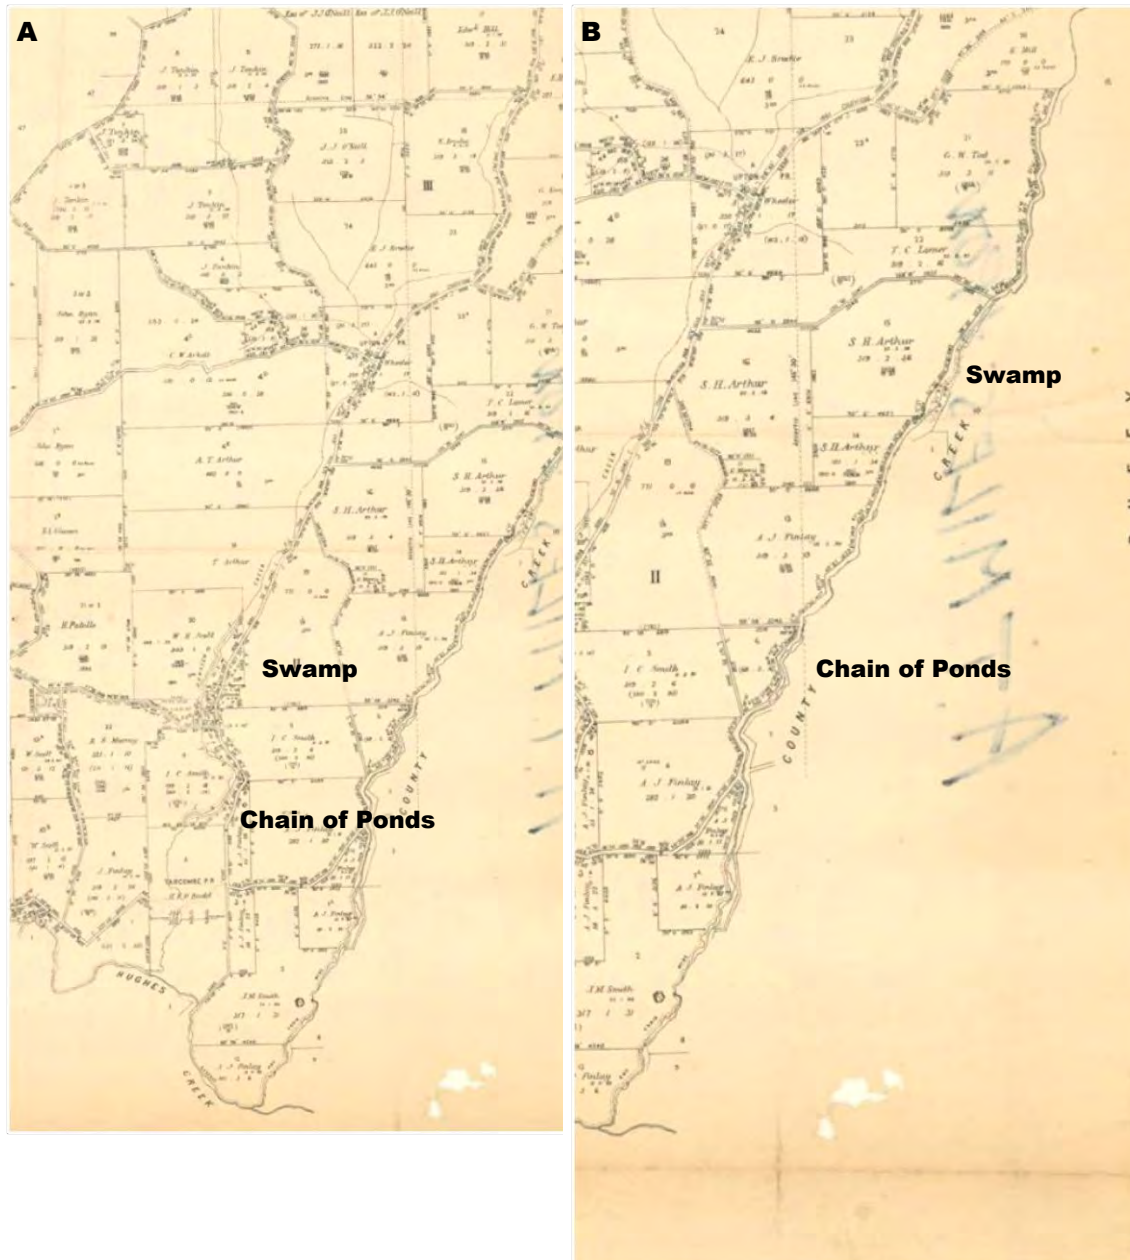
Figure 27 (A) Ponkeen Creek showing chain of ponds and swamps on the Parish of Tarcombe map; (B) County Creek showing chain of ponds and swamps on the Parish of Tarcombe map. Ponds and swamps have been destroyed by post-settlement channel incision. Size of Parish map is too small to permit further enlargement.

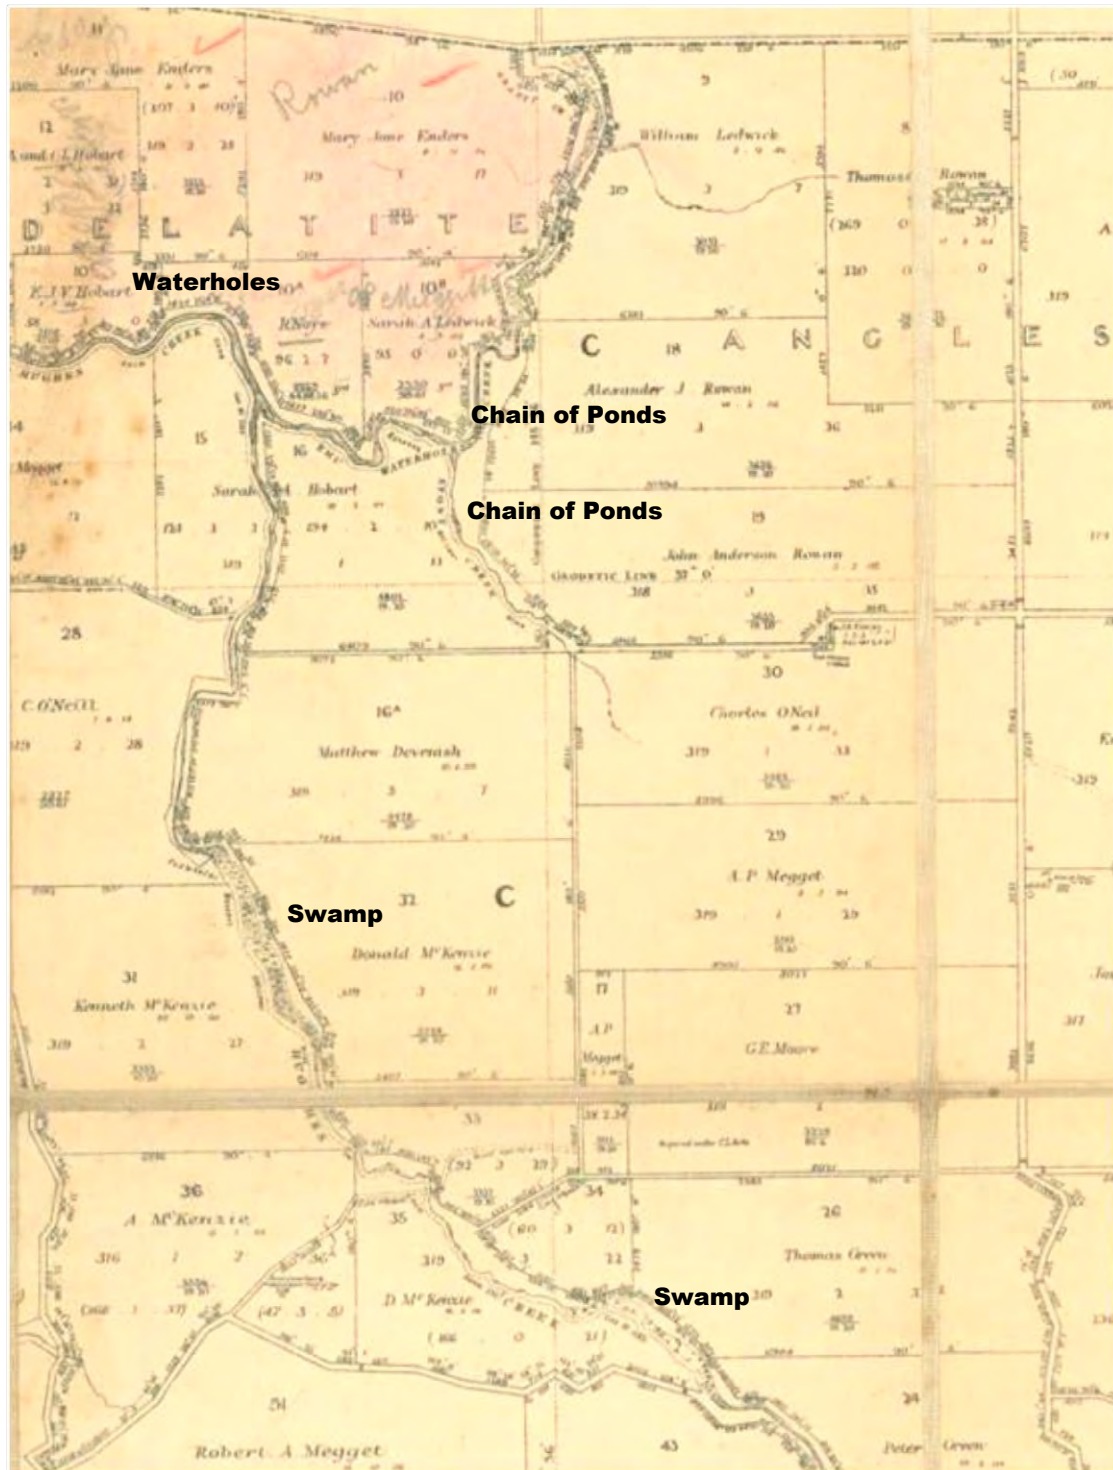
Figure 28 Hughes Creek, Emu Waterholes Creek and Stony Creek showing chain of ponds (continuous channel and isolated waterholes) and percolines (swamps) on the Parish of Dropmore map. The area covered includes the Ruffy Chain of Ponds Reach, Terip Terip Percolines Reach and Kendalee Headwaters Reach from Section 3.2 and Figure 13.

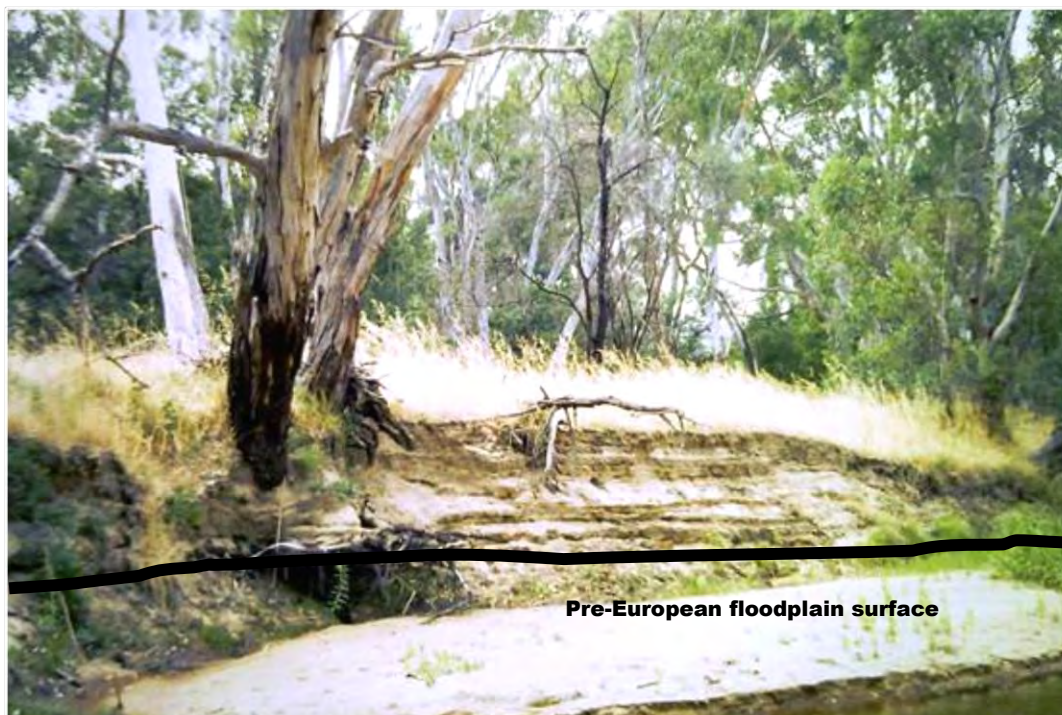
Figure 29 Pre-European settlement floodplain surface on Hughes Creek at Avenel. The floodplain facies of the sand slug comprises 1 m of interstratified medium, coarse and very coarse sand sediments which bury and have killed *Eucalyptus camaldulensis* trees and contain buried fence posts. Pre-European floodplain sediments are dark coloured massive homogeneous medium sandy mud.

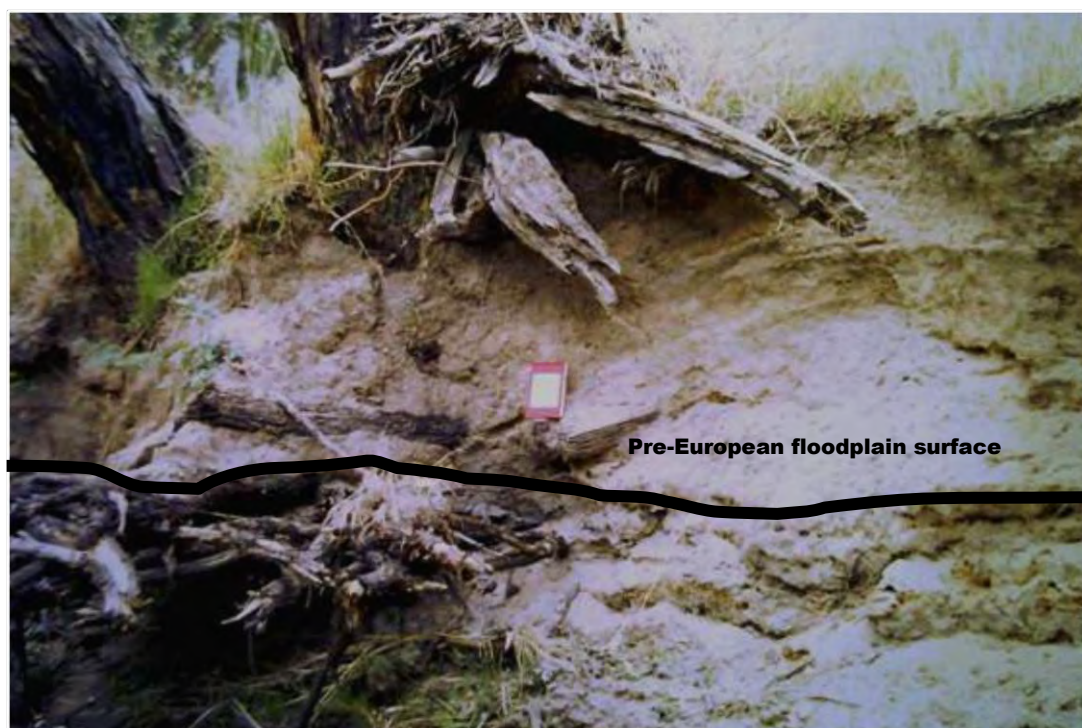
Figure 30 A close up of the pre-European floodplain surface at Avenel.

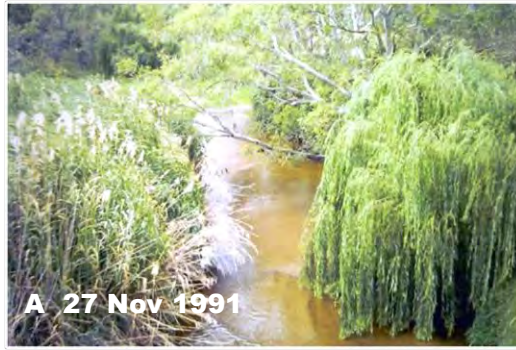
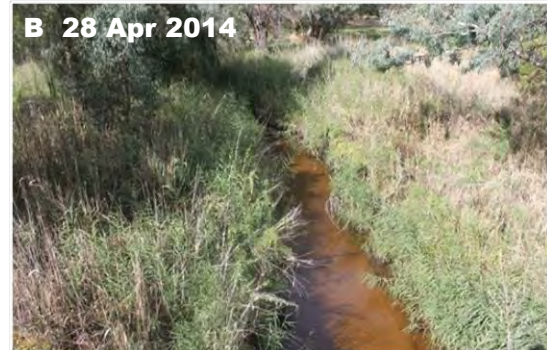
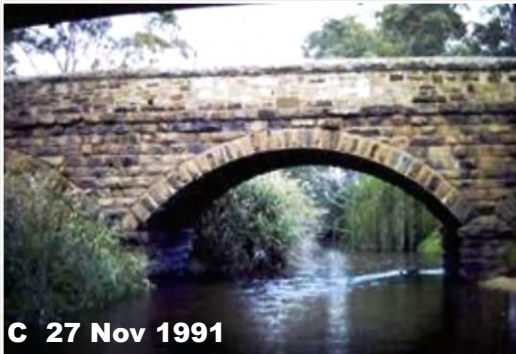
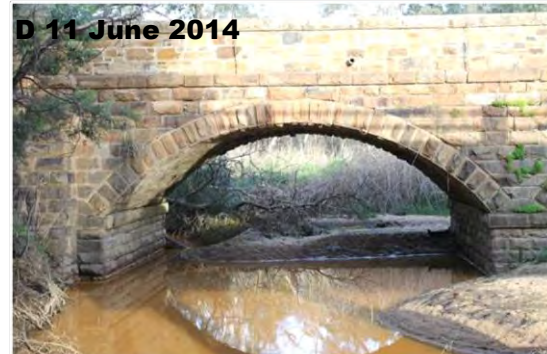
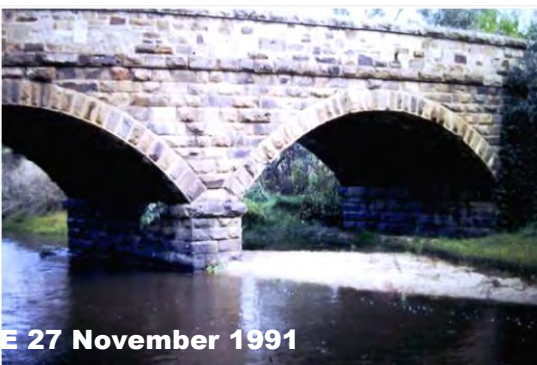
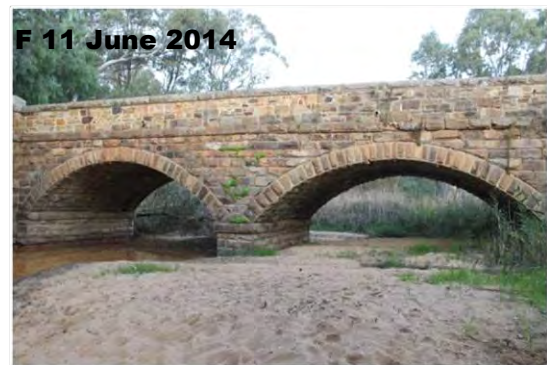
Figure 31 Hughes Creek at the old Hume Highway bridges at Avenel showing partial recovery of the sand slug since at least 1991. (A) and (B) Immediately upstream of Avenel stone bridge showing minor channel contraction between 1991 and 2014. (C), (D), (E) and (F) Avenel stone arch bridge showing the low flow channel and flood channel. (G) and (H) scour below the pile cap on the old Hume Highway bridge. Note that discharge is different between the two dates.

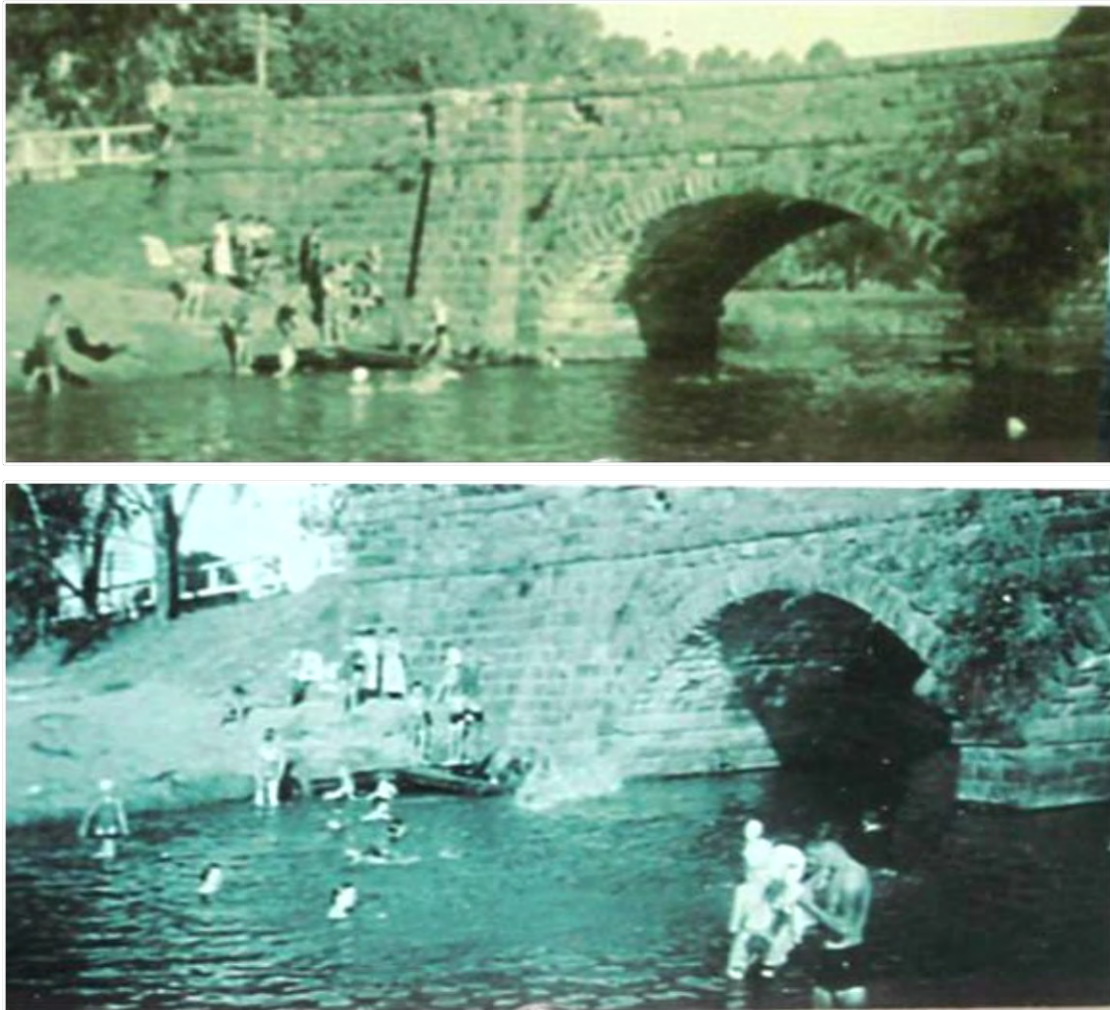
Figure 32 Hughes Creek at the Avenel stone bridge on the original Hume Highway. Photos taken between 1955 and 1961.

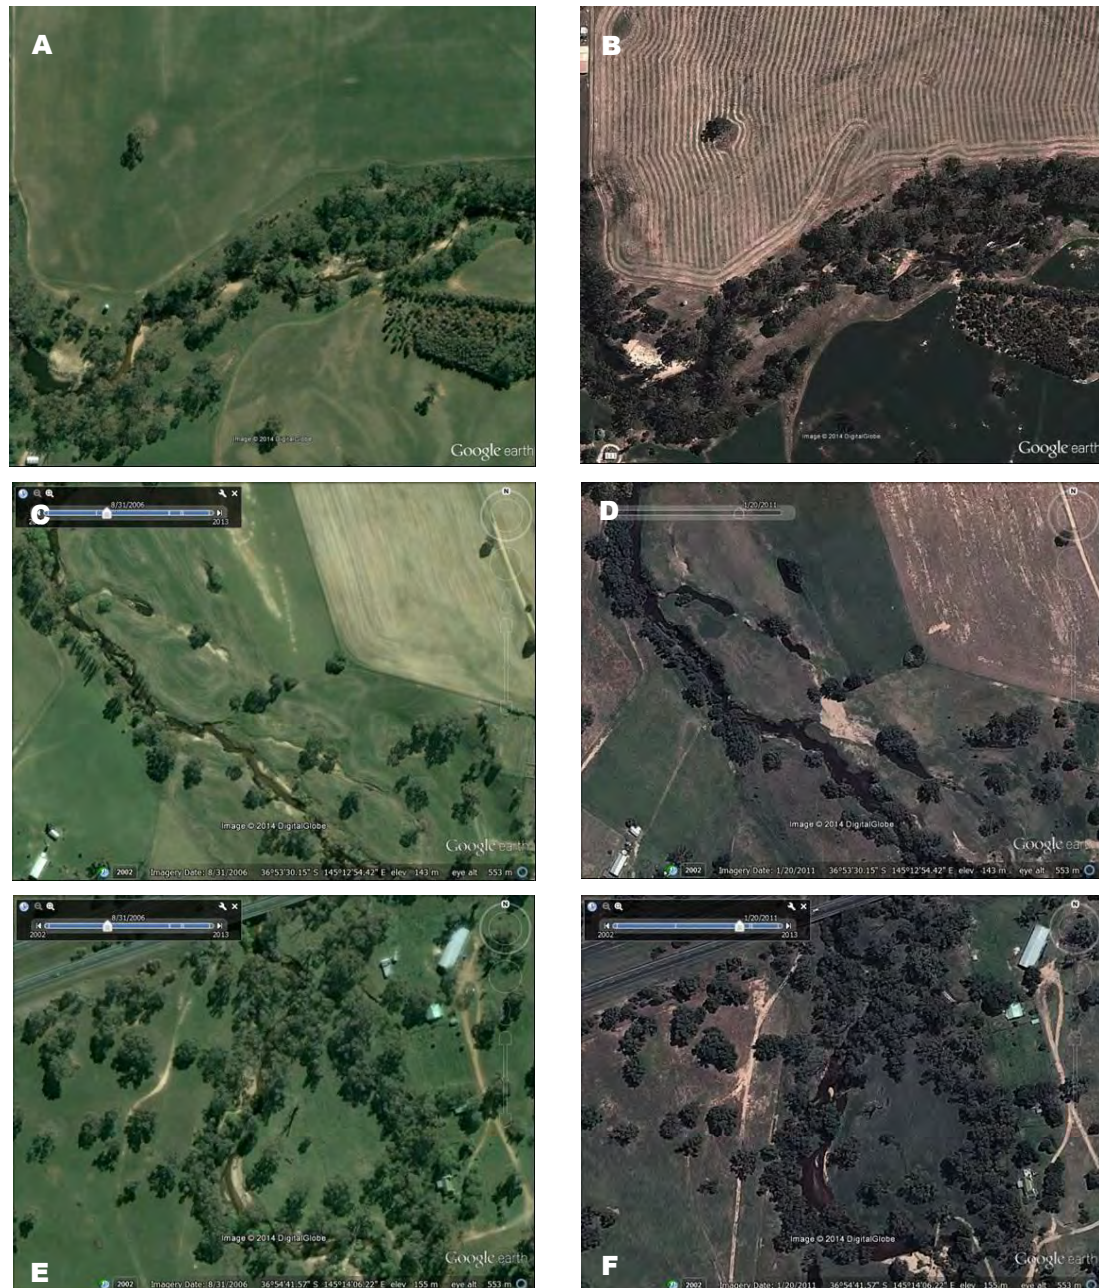
Figure 33 Channel changes produced by the September 2010 flood in Reach 2 of Hughes Creek. Photos on left taken on 31 August 2006 and photos on right, 20 January 2011. (A) and (B) upstream of Goulburn Valley Highway; (C) and (D) at Avenel; and (E) and (F) upstream of Hume Freeway.

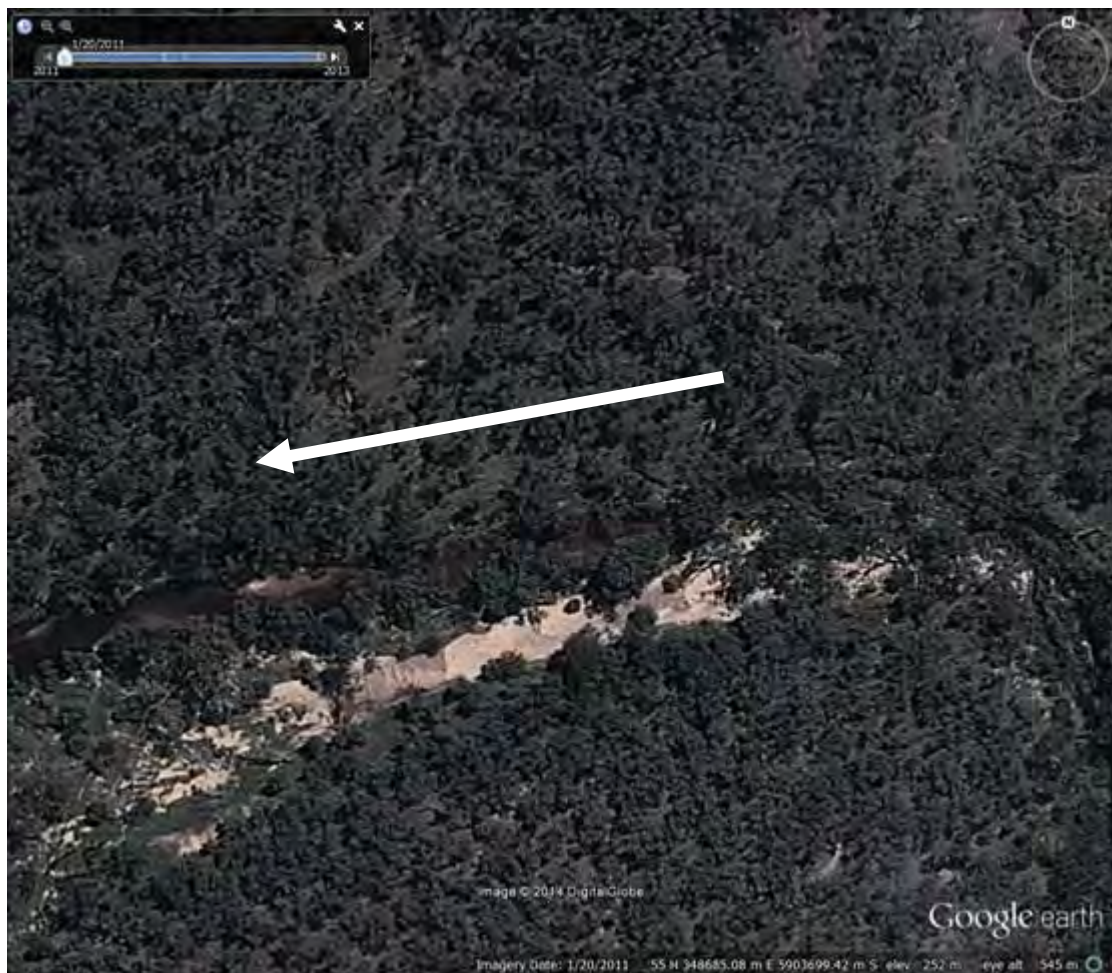
Figure 34 Anabranch infilled with sand by the September 2010 flood in Reach 4 of Hughes Creek.

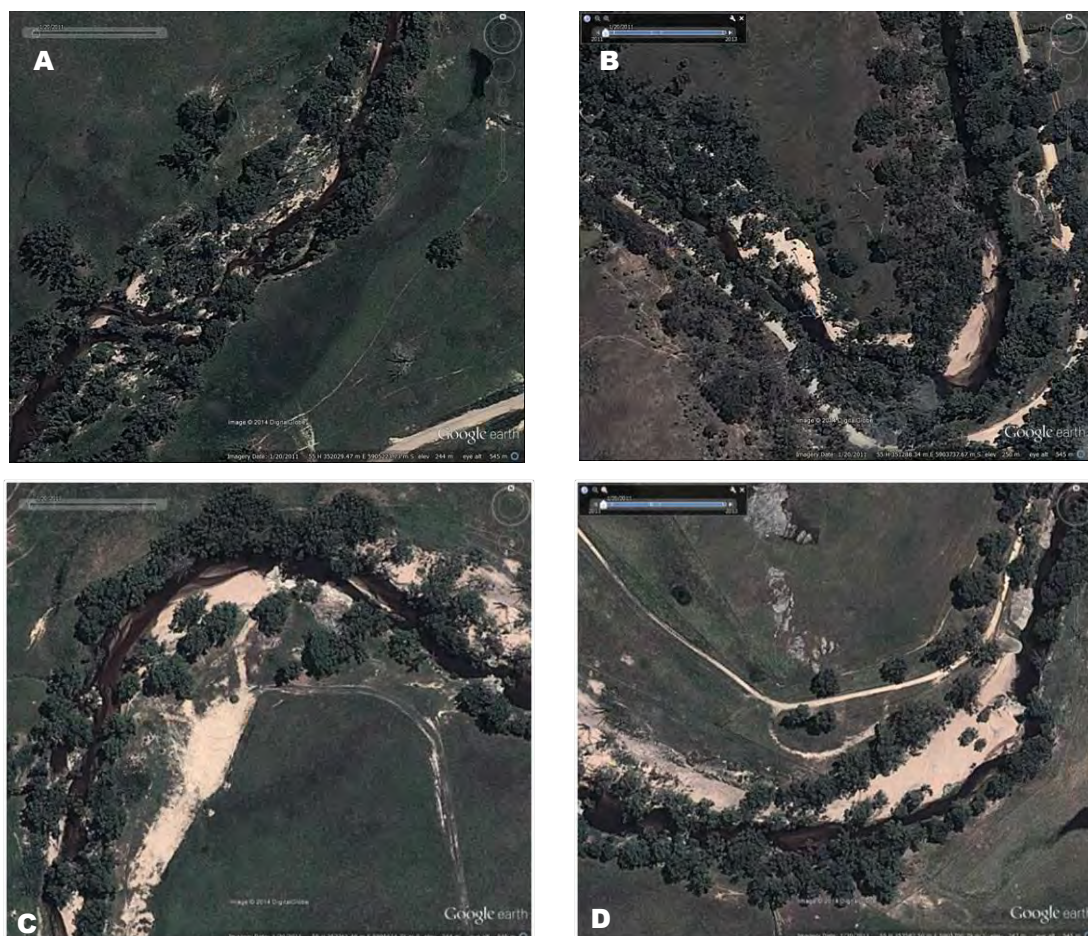
Figure 35 Various parts of Hughes Creek in Reach 5 on 20 January 2011. The sand was derived from reworking of channel sand storages within the reach by the September 2010 flood.

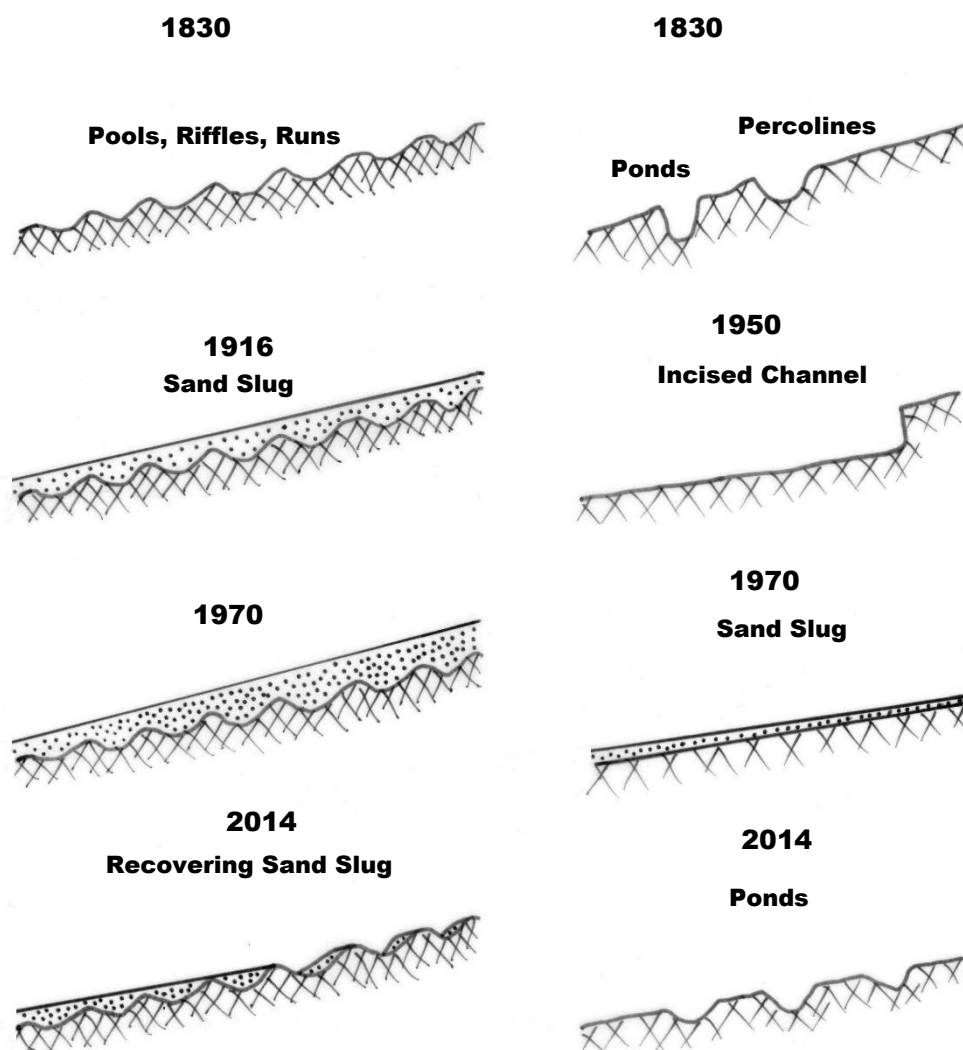
Figure 36 Evolution of Hughes Creek in Reaches 2, 3, 4 and 5 and tributaries, except Buckland and Bunding creeks, since European settlement

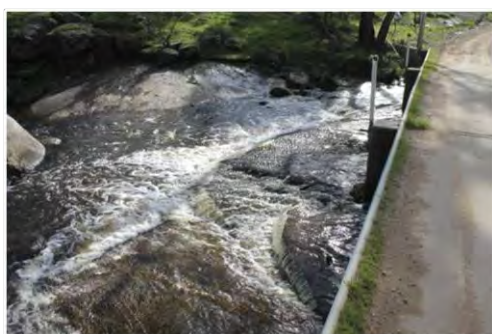
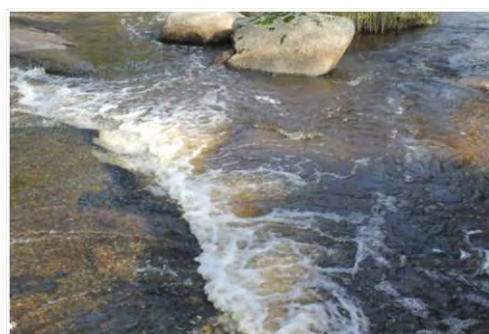
Figure 41 Low bedrock steps at Bungle Boori on Ponkeen Creek Road.

Historically, Macquarie perch used to extend upstream on Hughes Creek to “Tarcombe” (Trueman & Luker 1992, Trueman 2012). This could mean either Bungle Boori or Tarcombe homestead. In the author’s opinion, Macquarie perch should be able to pass the low bedrock steps at Bungle Boori during floods (Figure 41) but would not be able to pass the higher, steeper more turbulent bedrock steps of The Peak Granite Gorge downstream of Dropmore (Figure 42). Furthermore, The Peak Granite Gorge is upstream of the confluence with Ponkeen, County and Stewart creeks. Therefore, discharge and hence flow depths are likely to be much less than at Bungle Boori. Trueman & Luker (1992) and Trueman (2012) concluded that Springfield Granite Gorge was a natural barrier to the passage of all native fish species. While climbing species like some of the morphotypes of *Galaxias olidus* would be able to climb the high energy bedforms (Raadik 2011), it is not known if these morphotypes inhabit Hughes Creek.

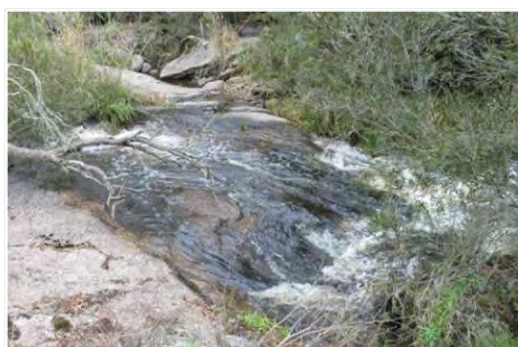
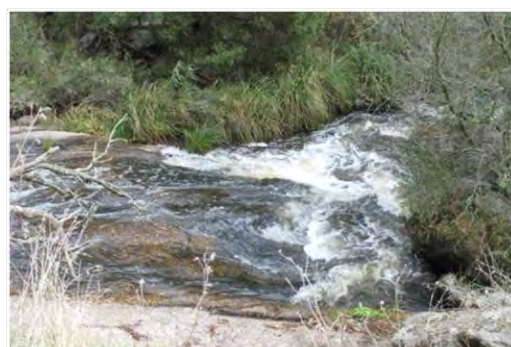
Figure 42 The lowest bedrock steps at the downstream end of The Peak Granite Gorge. There are steeper, shallower and more turbulent steps further upstream.

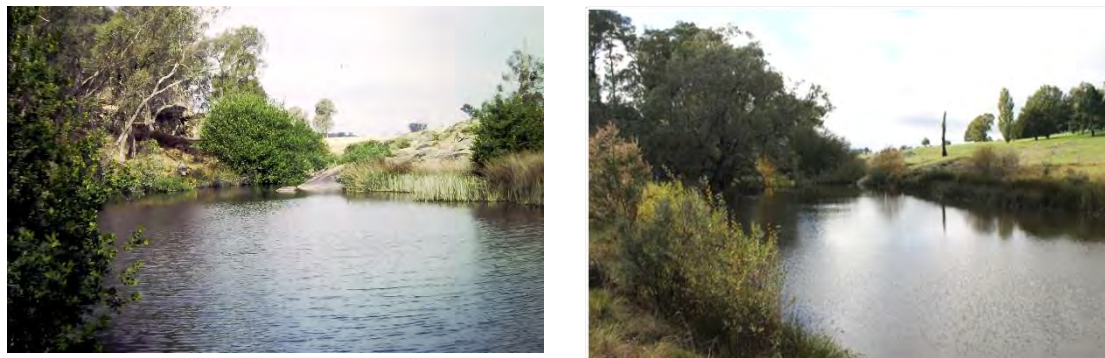
Figure 43 Left: Boathole in February 1995; Right: Boathole on 30 April 2014. This 'hole' corresponds to what have been called 'natural ponds' or 'chain of ponds'.
