River Reaches, Historical
Channel Changes and
Recommended Methods to
Improve Macquarie Perch
Habitat on Hughes Creek,
Victoria

Wayne D Erskine

Erskine WD 2016. *River Reaches, Historical Channel Changes and Recommended Methods to Improve Macquarie Perch Habitat on Hughes Creek, Victoria*, May 2016. Supervising Scientist Report 208, Supervising Scientist, Darwin NT.

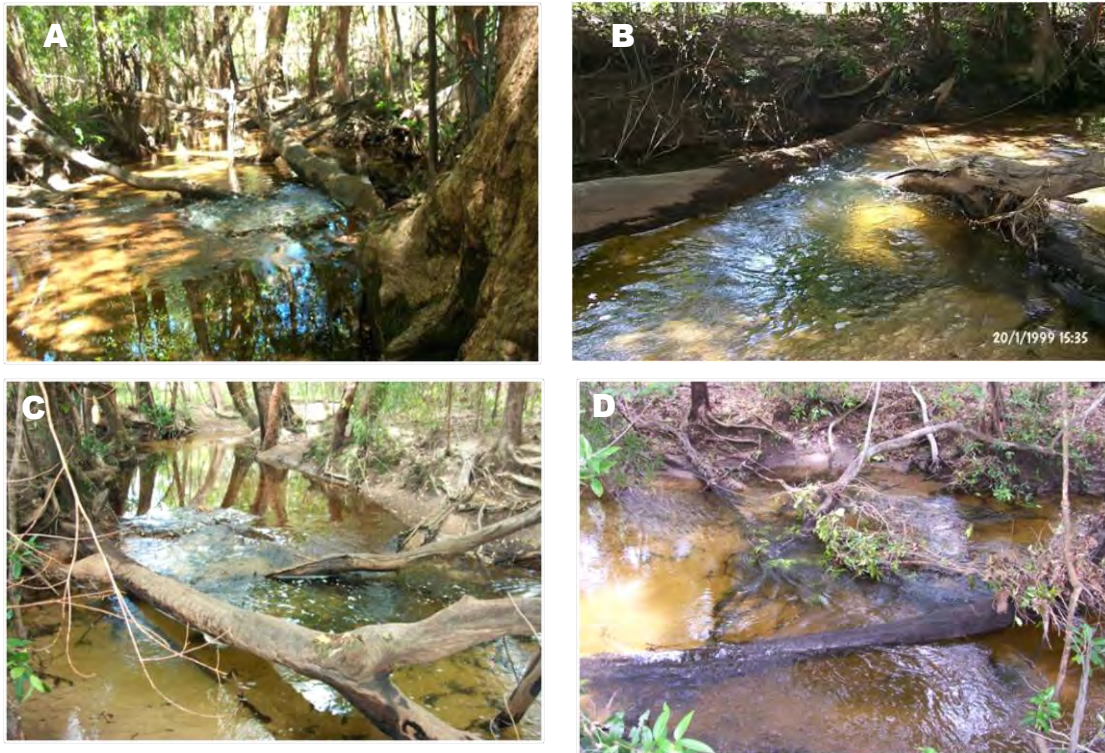
Figure 43 Local scour associated with the interaction of variously oriented pieces of large wood increasing pool complexity in an *Allosyncarpia ternata*-dominated riparian forest at Jabiluka, NT that was investigated by Erskine et al. (2012). (A) Longitudinal scour pool, (B) Complex log step and longitudinal scour pool, (C) Complex transverse and log step scour pool, (D) Log step scour pool with overhanging vegetation. See Webb & Erskine (2006) and Erskine et al. (2012) for further details. These creeks are only slightly smaller than Hughes Creek and the size of individual pieces of *Allosyncarpia ternata* is similar to that for *Eucalyptus camaldulensis*.

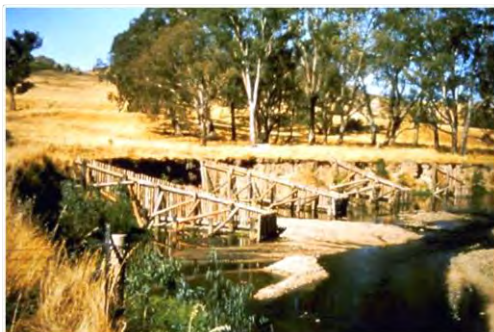
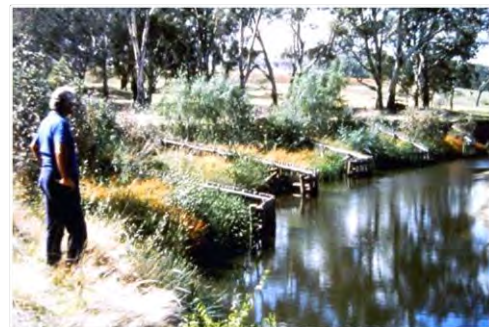
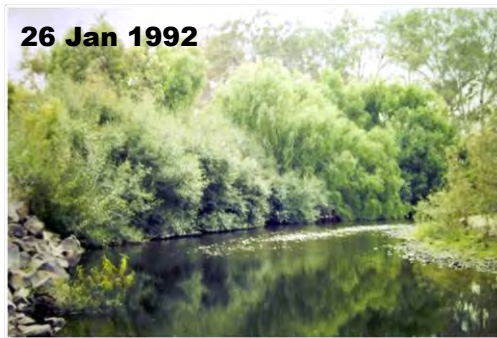
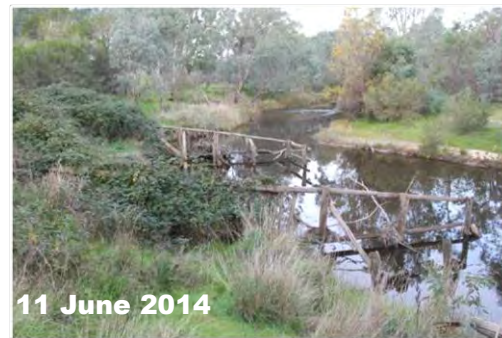
Figure 44 Timber needle groynes and their impact on pool development in Hughes Creek next to the Tarcombe Road at “Ganoora”. Note deterioration in timber walings over time. The photos at the top were taken from Standing Committee on Rivers and Catchments, Victoria (1990) and the cover of Standing Committee on Rivers and Catchments, Victoria (1991) and the bottom photos were obtained from Wayne Erskine’s library.

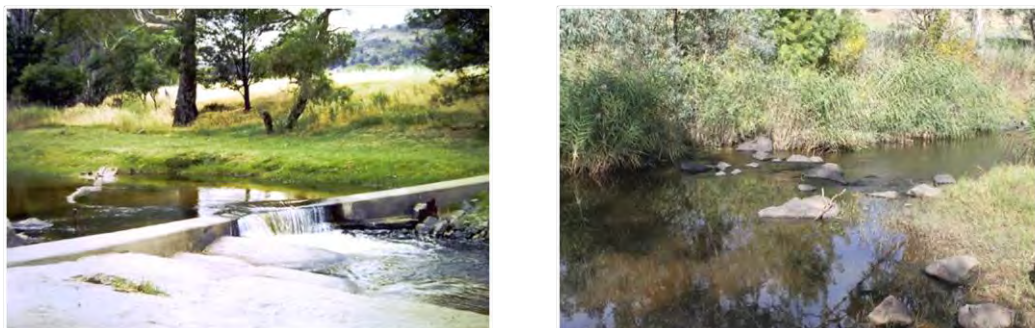
Figure 43 Left photo. Concrete weir at Hughes Creek at Tarcombe Road (No. 405228) gauging station on 27 November 1991 when the weir acted as a physical barrier to fish movement under low streamflows. Right photo. New rock ramp fishway which drowns out the original concrete weir under low streamflows on 28 April 2014.

Pest species management should prevent the establishment and dispersion of alien fish species (including *Misgurnus anguillicaudatus* and *Rutilus rutilus* which have not been reported from Hughes Creek yet). Fish exclusion devices have been used on Hughes Creek in the past where the gauging weir at Tarcombe Road gauge was previously a physical barrier before being drowned out by a downstream rock ramp fishway (Figure 43). There is essentially unimpeded fish movement from the Goulburn River to Bungle Boori now. The effectiveness of increasing flow velocities to impede fish movement by Carp and Redfin perch has been investigated (Knight 2010). While Carp young-of-year possess similar maximum sustained and burst swimming speeds to native fish, redfin perch do not (Knight 2010). Water velocities of 0.5 m/s over at least a distance of 2 m would form a complete barrier to redfin perch (Knight 2010). Investigations and modifications of the Tarcombe Road rock ramp fishway should be carried out to assess the feasibility and cost of modifying the fishway to prevent the passage of Redfin perch but still permit the passage of native fish species.

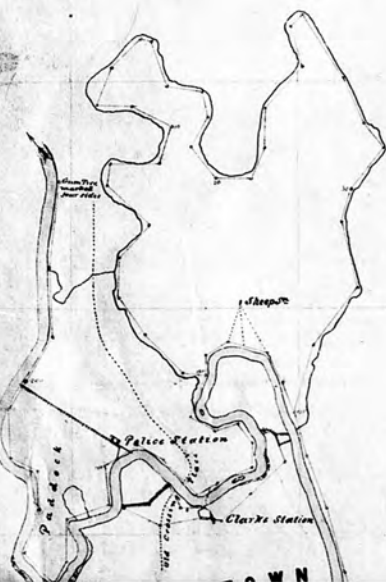
**Appendix 2 'Survey of the River Goulburn from
the New to the Old Crossing Place with a
Tributary Hughes's Creek on the East Side of it.
Sheet No. 2. Surveyor W Pickering, State Library
of Victoria Goulburn, Ovens Etc 15. 27
December 1841.'**

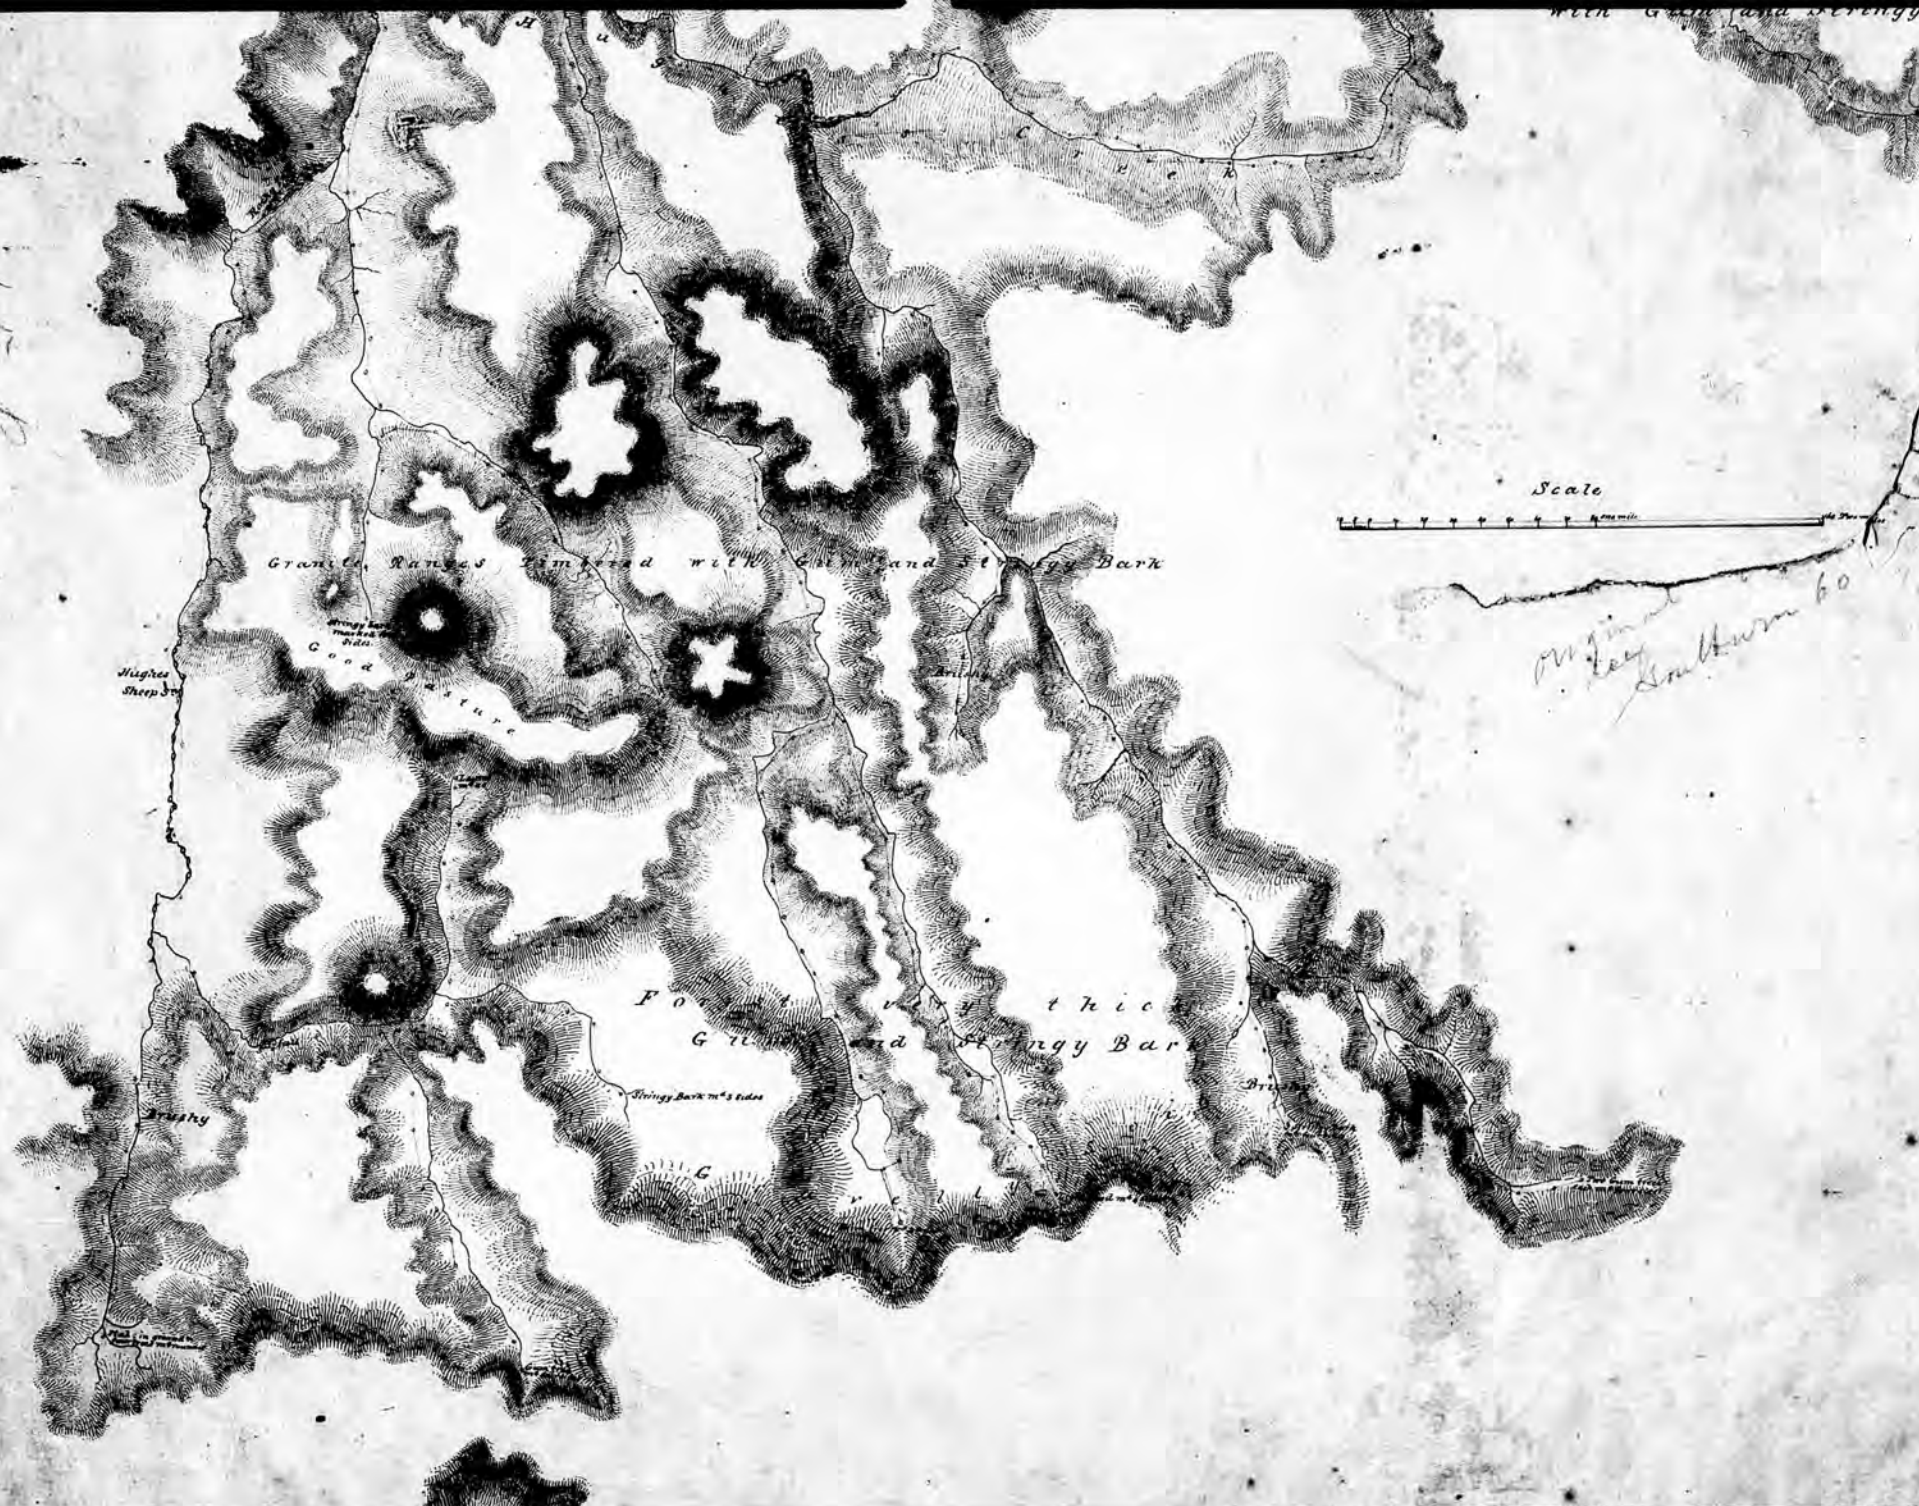
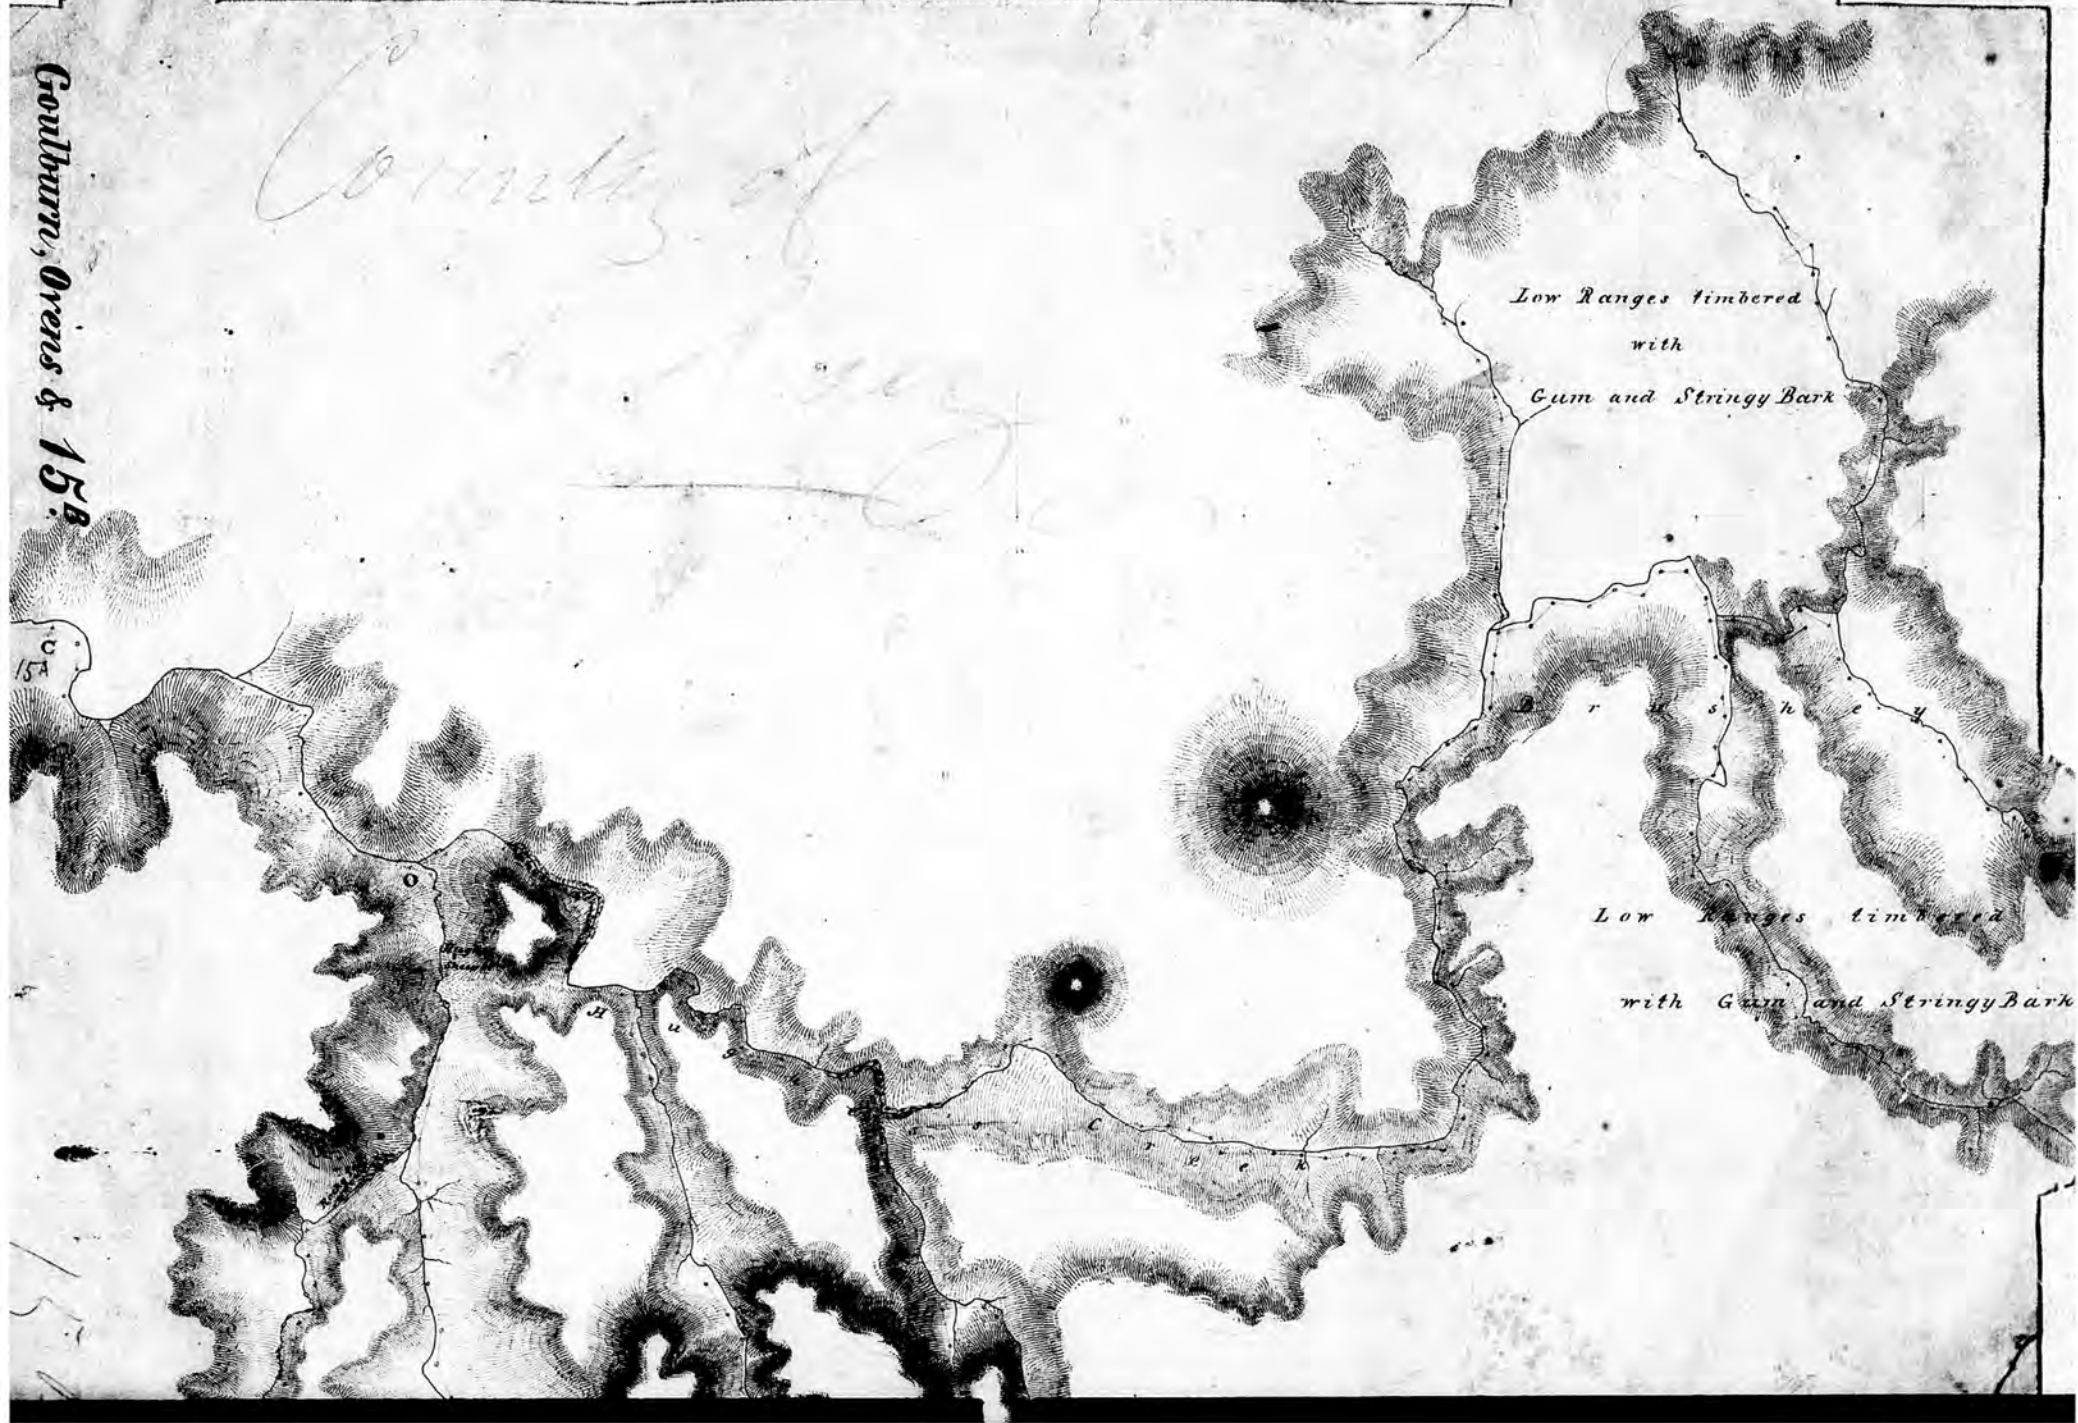
**Appendix 3 'Survey of the River Goulburn from
the New to the Old Crossing Place with a
Tributary Hughes's Creek on the East Side of it.
Sheet No. 3. Surveyor W Pickering, State Library
of Victoria Goulburn, Ovens Etc 15A. 27
December 1841.'**

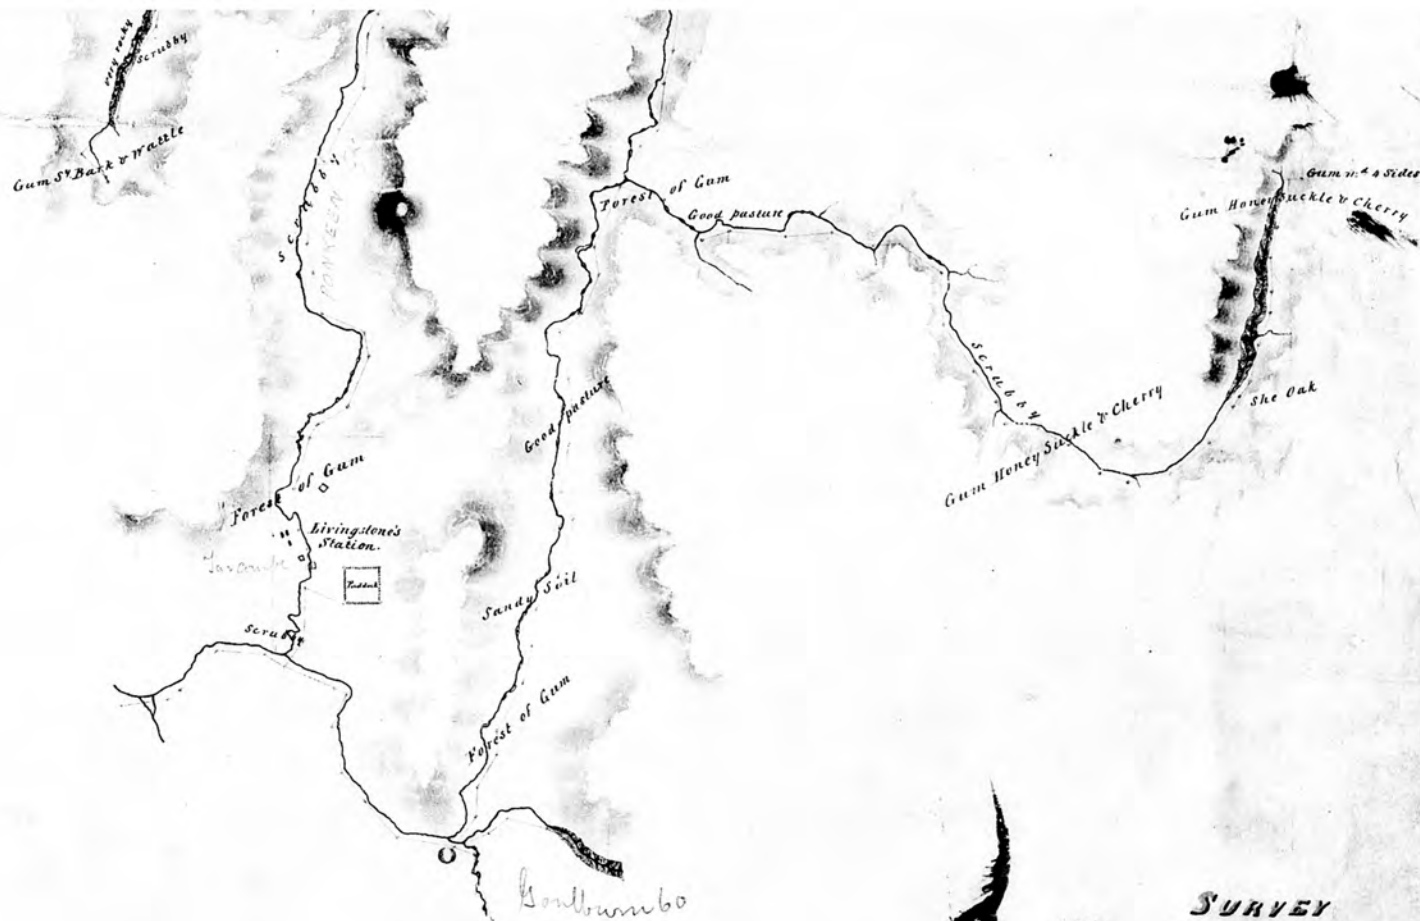
**Appendix 4 'Survey of the River Goulburn from
the New to the Old Crossing Place with a
Tributary Hughes's Creek on the East Side of it.
Sheet No. 4. Surveyor W Pickering, State Library
of Victoria Goulburn, Ovens Etc 15B. 27
December 1841.'**

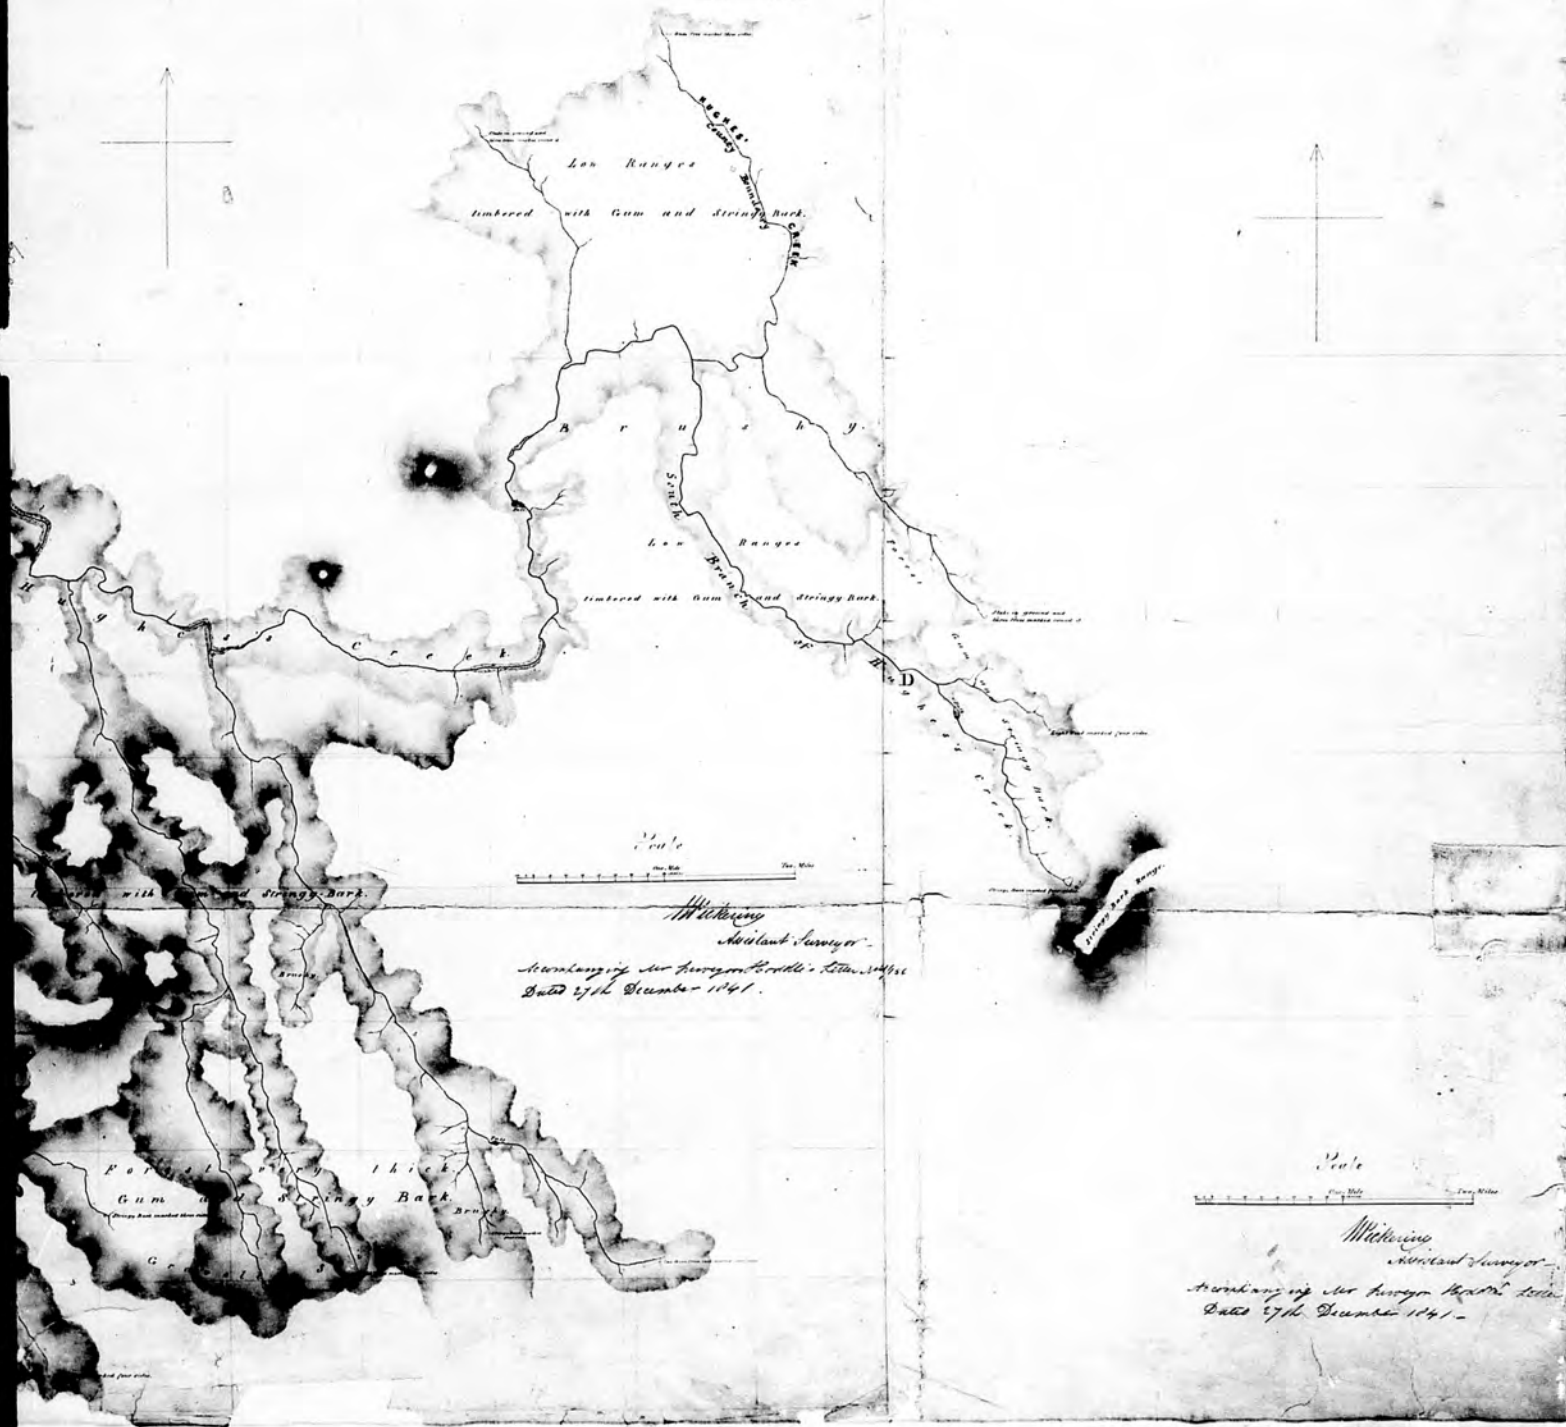
**Appendix 7 'Survey of the Sydney Road
between Hughes's Creek and the Violet Ponds.
Sydney Road No. 2. Surveyor W Pickering, State
Library of Victoria Old Roads S3 and S4. 18
September 1843.'**
