## Appendix B: Warrego River Hydrology

The Hydrology indicator provides information on the degree of hydrological connection (channel and floodplain) maintained through the Selected Area during the 2019-20 water year. This particular chapter focusses on hydrological connection through the Warrego channel and the inundation experienced on the Western Floodplain.

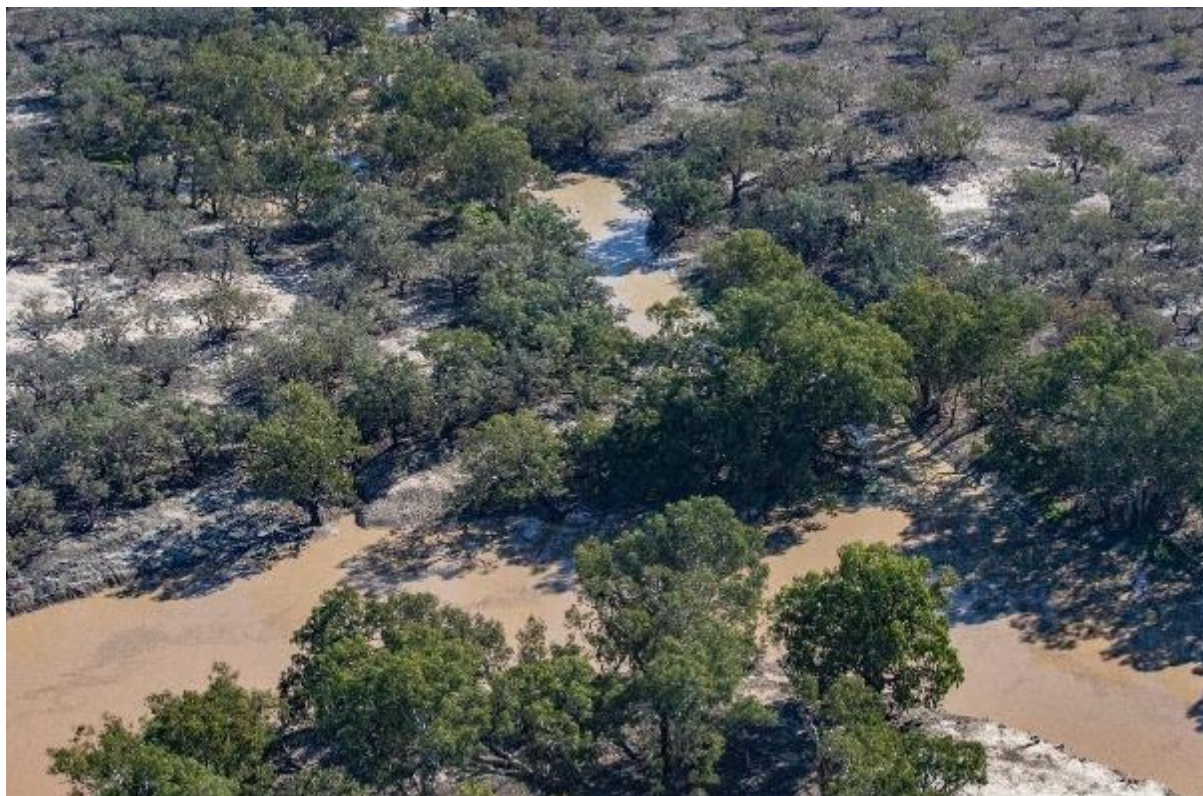
*Figure 7 Connection of Western Floodplain to Darling River at Talowla 26 April 2020 (Photograph provided by Sonya Ardill courtesy of NPWS).*

Field based evidence provided by Sonya Ardill (personal communications via email) confirmed that the Western Floodplain was connected to the Darling River at Talowla on the 26 April 2020 (Figure 7) and that the landowners (Junks) noted that connected had ceased by mid to late May 2020 although they considered that date to be approximate.
