THE WARREGO

Quarter 2 | Oct - Dec 2021

Water for the environment

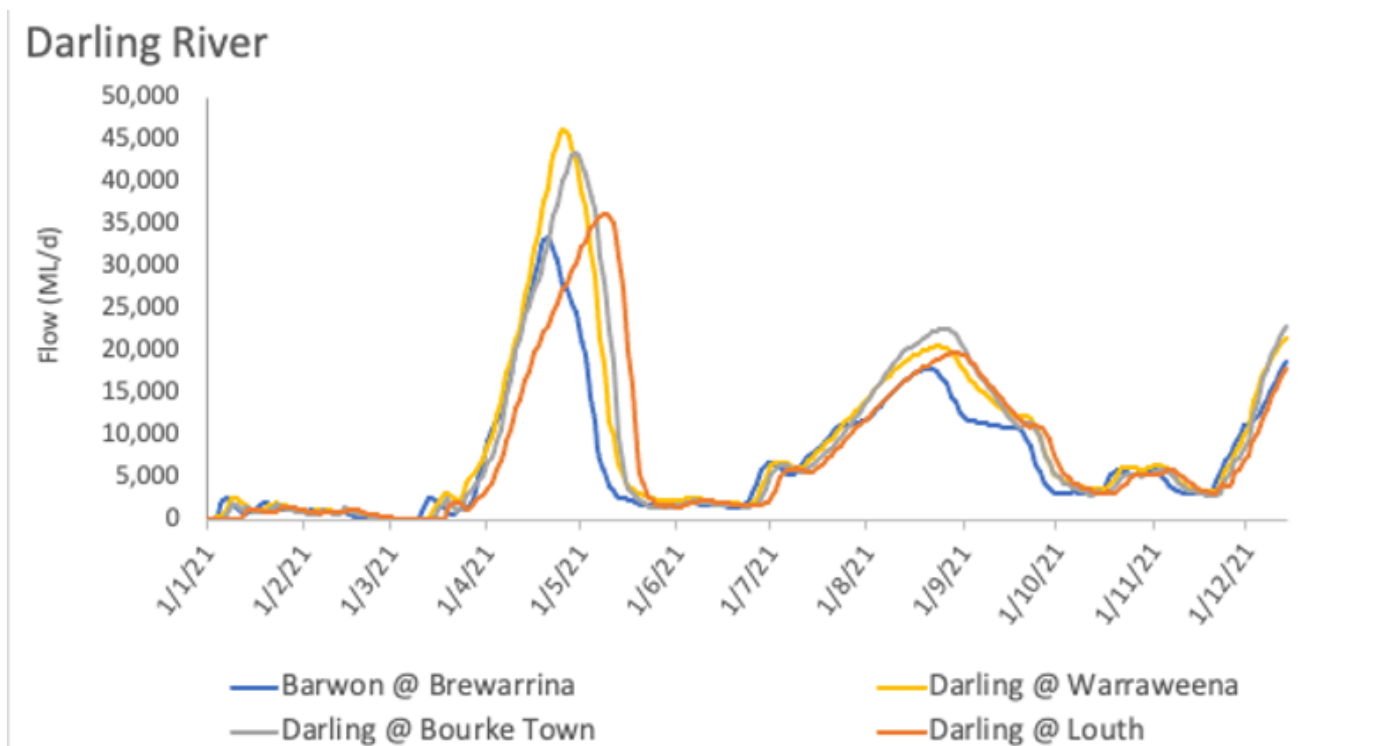
Flows resulting from the significant and widespread rainfall in mid-November are making their way through the Darling system late this quarter, although the peak of this event is yet to occur in the Darling, with the flow peak currently upstream of Brewarrina. A total of 1,043,490 ML has flowed through the Darling River past Bourke this quarter, against the long-term average of 228,084 ML for this time of year.
