Proposed monitoring  
program to assess bank  
erosion at Yellow Water,  
Kakadu National Park,  
Northern Territory

M Saynor

January 2008

Work and report completed December 2002

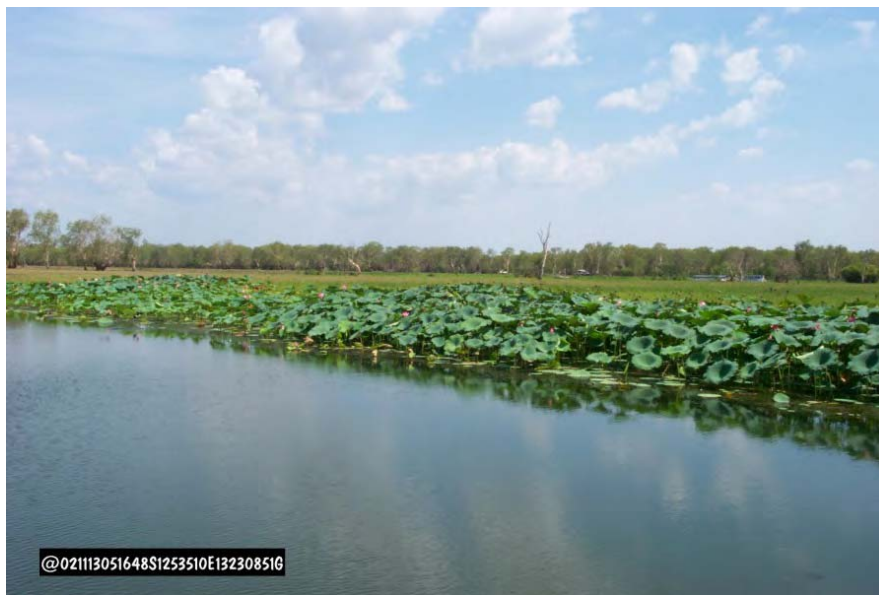
**Figure 1** Lilies along the bank of the Main South Alligator Channel Yellow Water 13-11-02

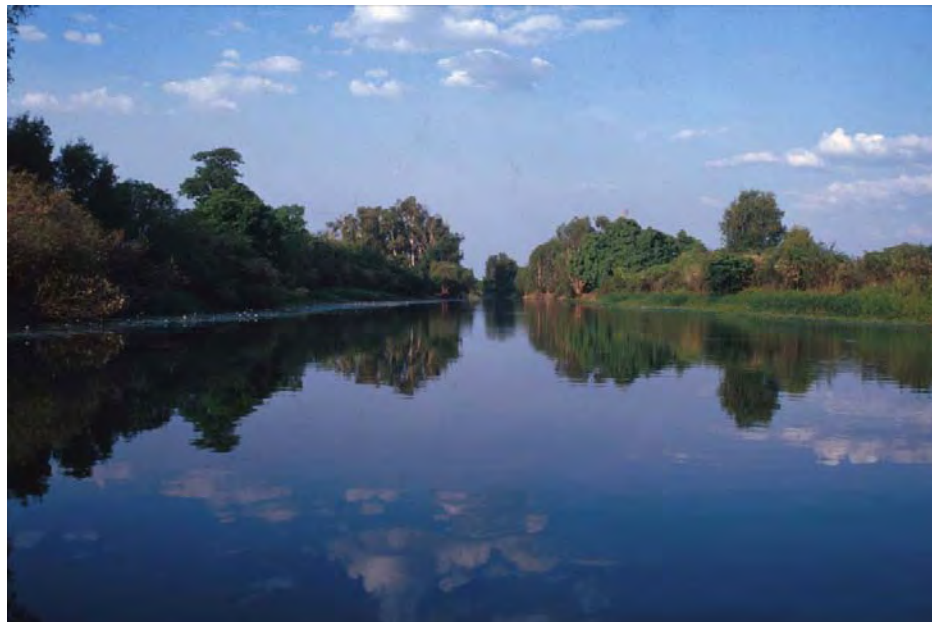
Sources of historical photographs should be investigated and, if date and location can be identified, they could be re photographed and comparisons made. Figure 11 is a photograph taken of a section on Fisherman's Gully on October 1993.

**Figure 11** Looking downstream along Fisherman's Gully in October 1993 (Photo M Saynor)
