Investigation of

tailings water leak

at the Ranger

uranium mine

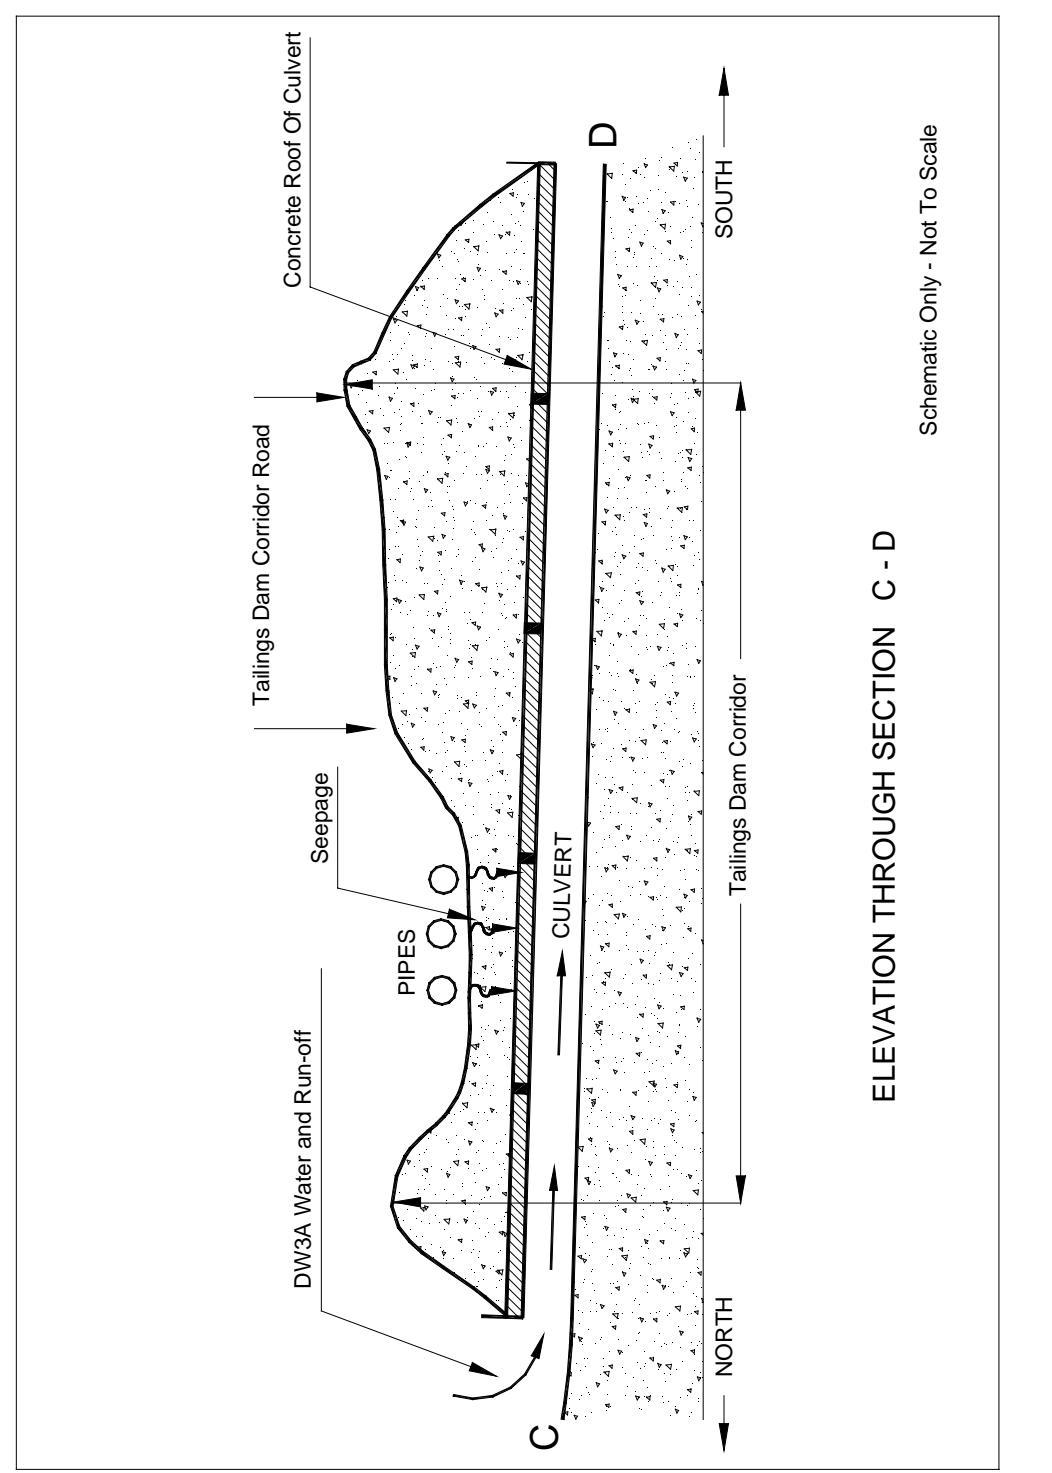
Figure 5 Schematic representation of the Tailings Dam Corridor at the VLGCRC

that a proportion of the water seeped into the VLGCRC which flows under the Tailings Dam Corridor, approximately 250 m from the leaking flange. Figures 5 and 6 are schematic representations of the Tailings Dam Corridor at the VLGCRC. Figures 7 and 8 are photographs of the VLGCRC looking south and north respectively.

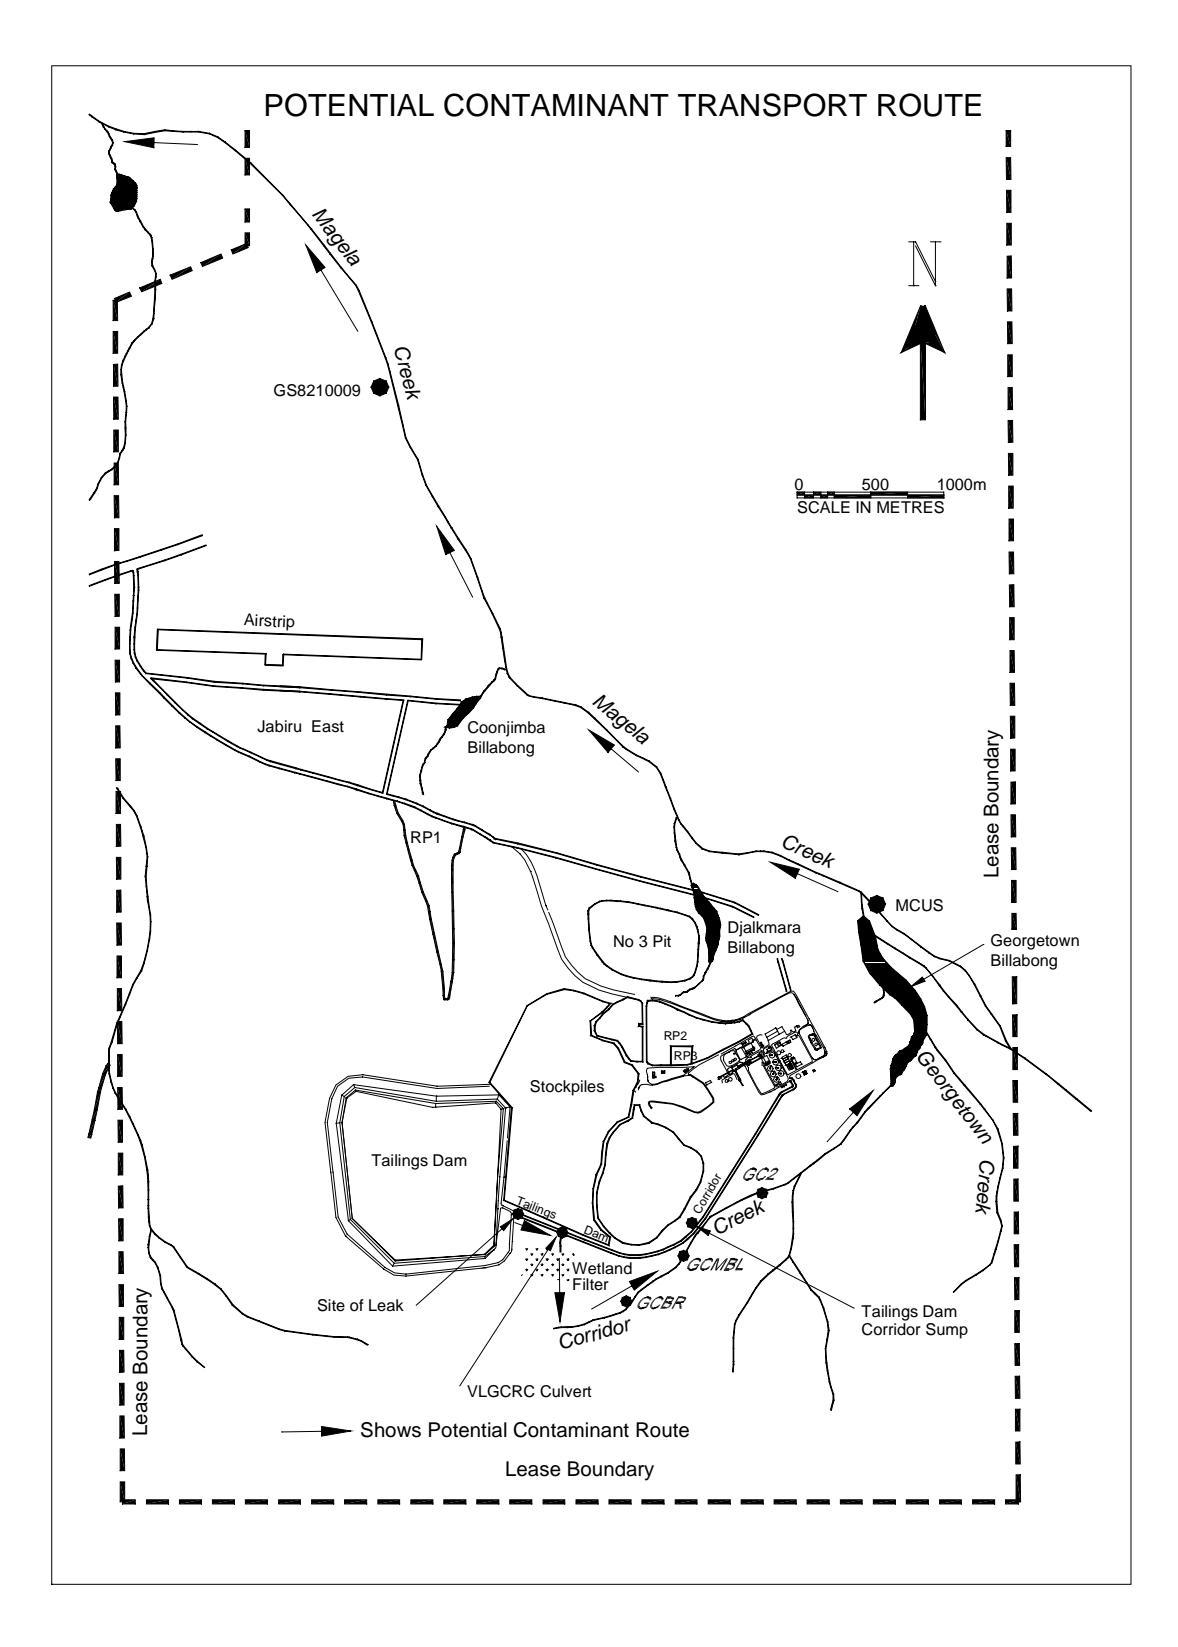
Figure 9 Potential transport pathway between the source of the leak and Kakadu National Park

The surface water pathway between the source of the tailings water leak at the Ranger Mine and the entry point to Kakadu National Park is shown in figure 9.

The principal monitoring point for the Ranger mine is at the gauging station (GS8210009) located on Magela Creek just before the creek enters Kakadu National Park (Figure 9). At this point a statutory chemical monitoring program is conducted by ERA and a non-statutory biological monitoring program (which was developed and conducted by *eriss* until 1996) is conducted by ERA in cooperation with *eriss*. The results obtained in these programs have been used to assess the ecological impact of the leak of tailings water on Kakadu National Park.

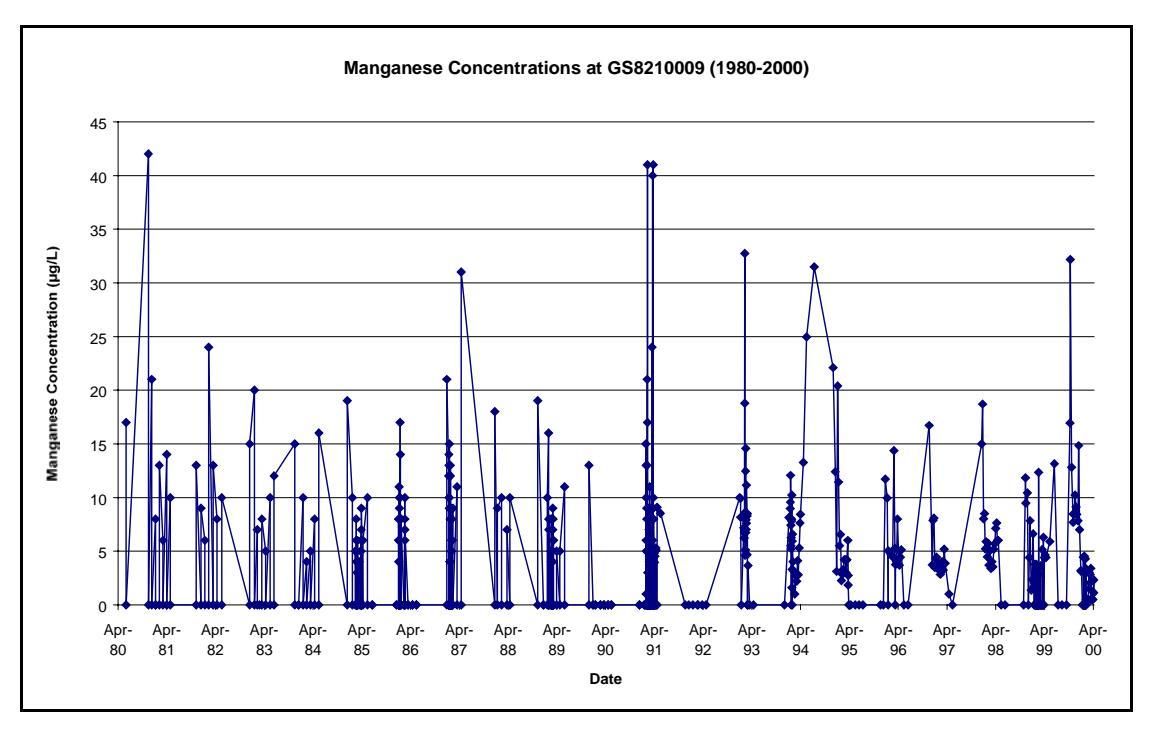
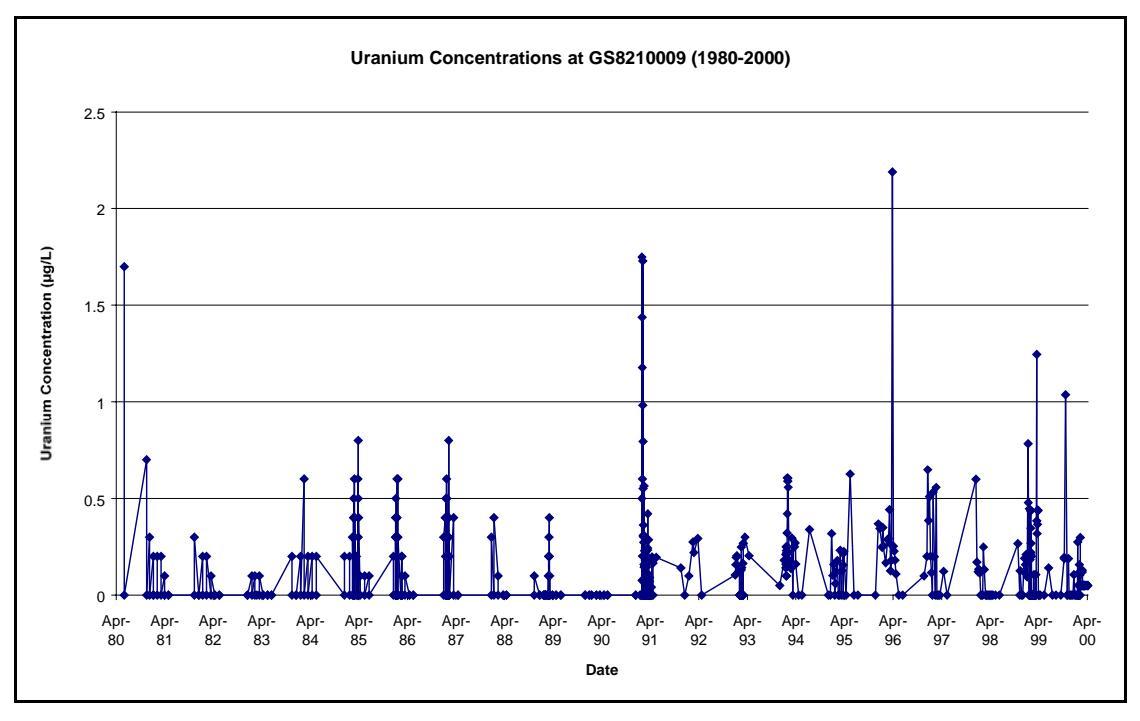
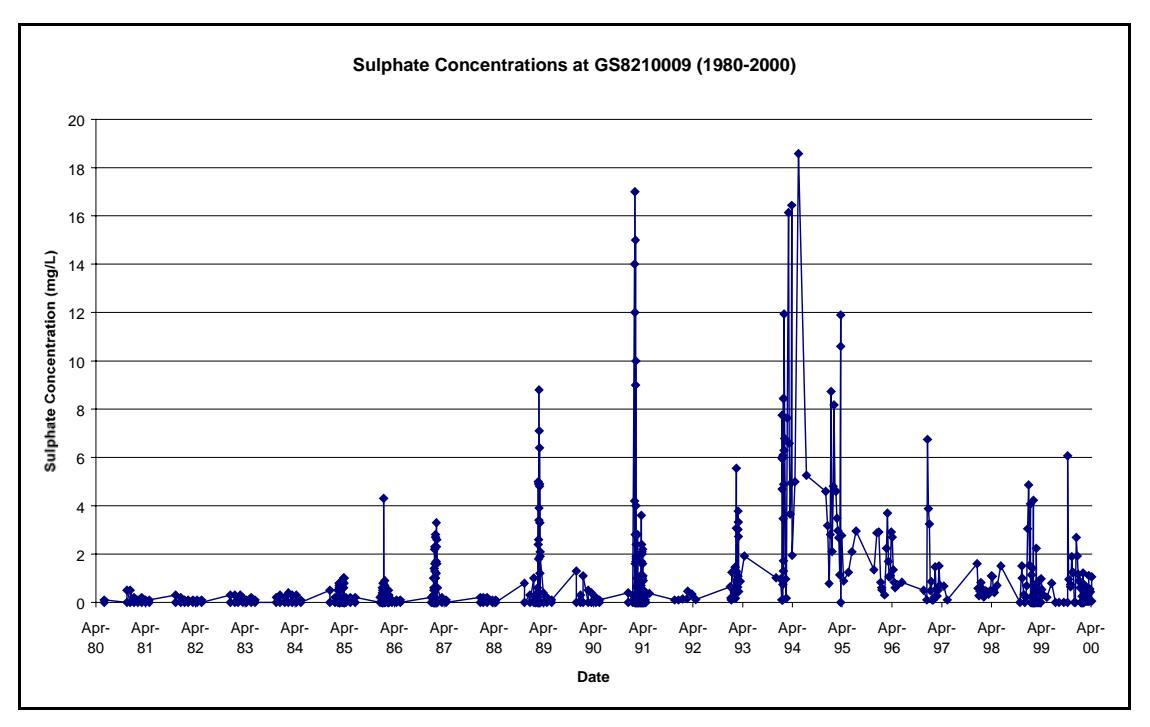
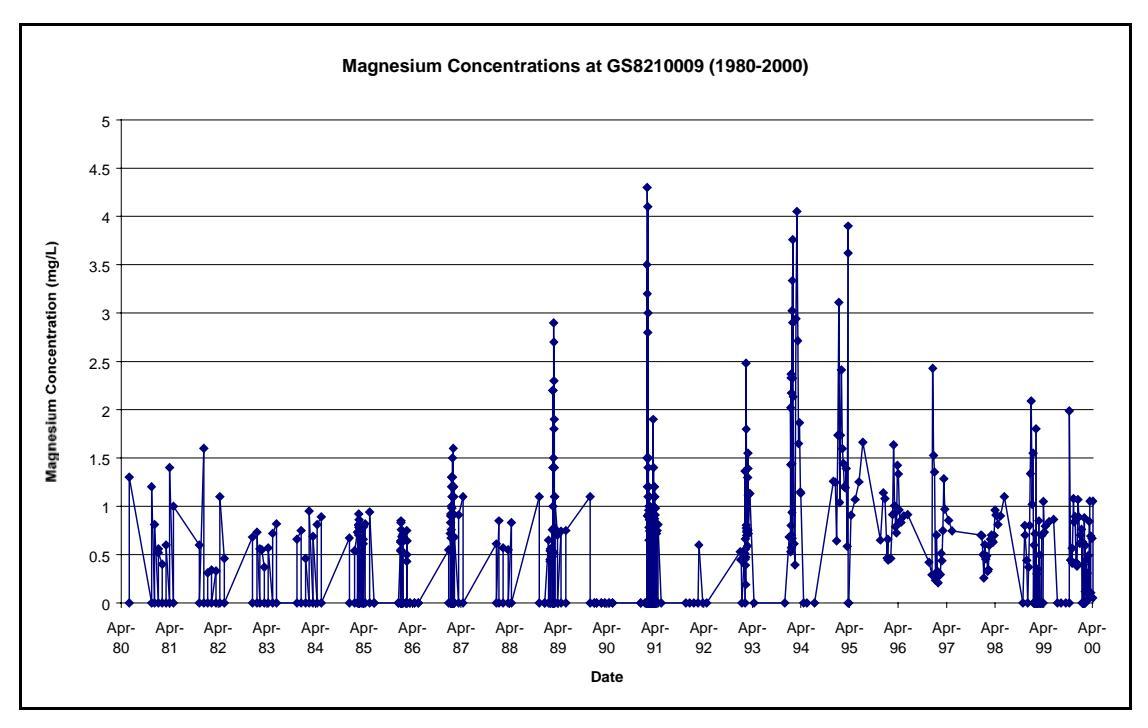
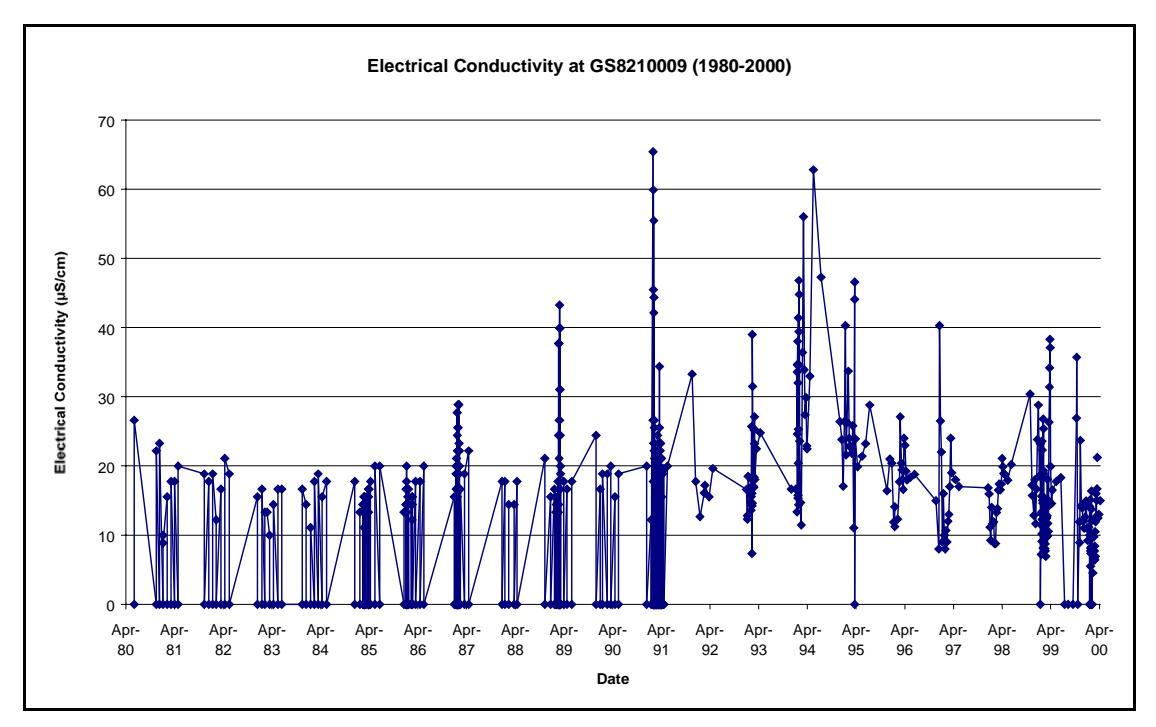
The water chemistry data for the principal constituents of interest (Manganese, Uranium, Sulphate, Magnesium) and electrical conductivity at GS8210009 are shown as time series data in figures 10–14. The data clearly demonstrate that no discernable change in water quality occurred during the 1999/2000 wet season compared with any previous year.

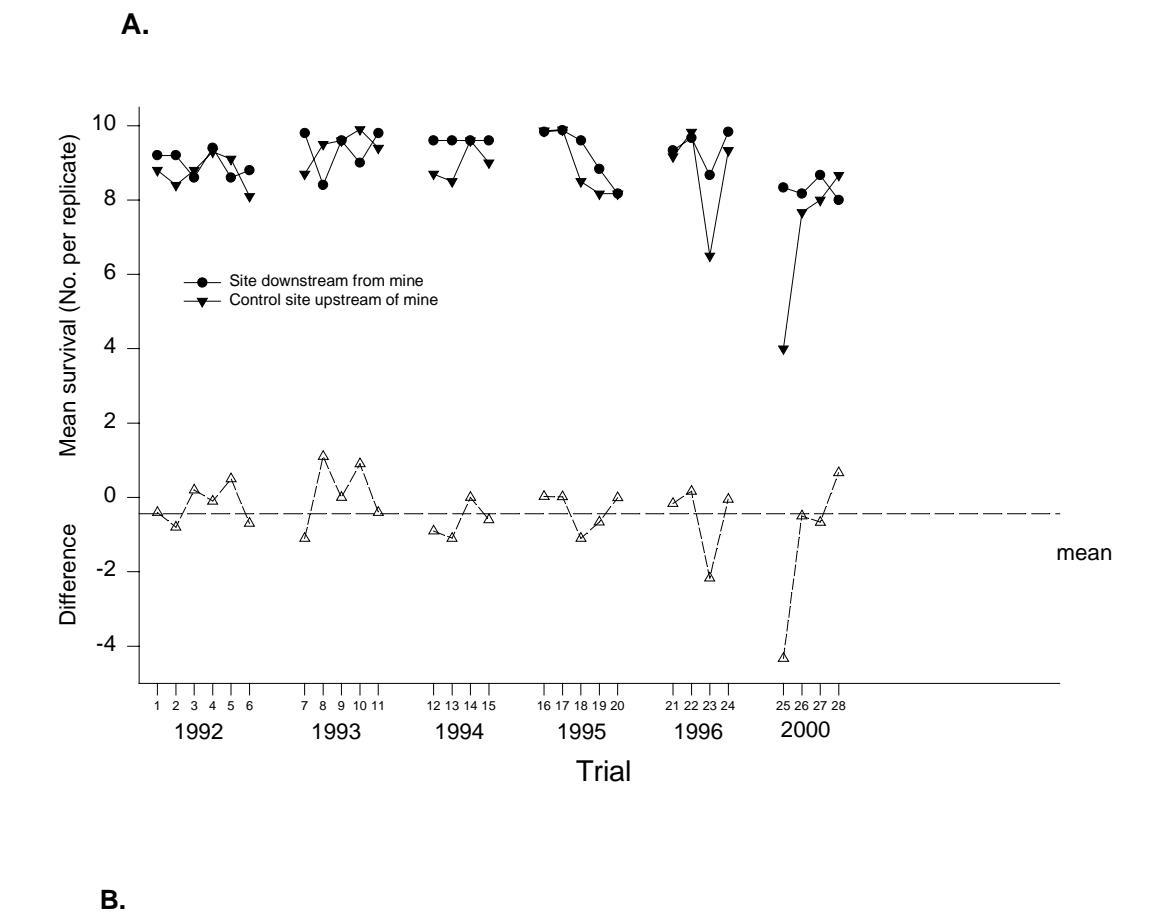
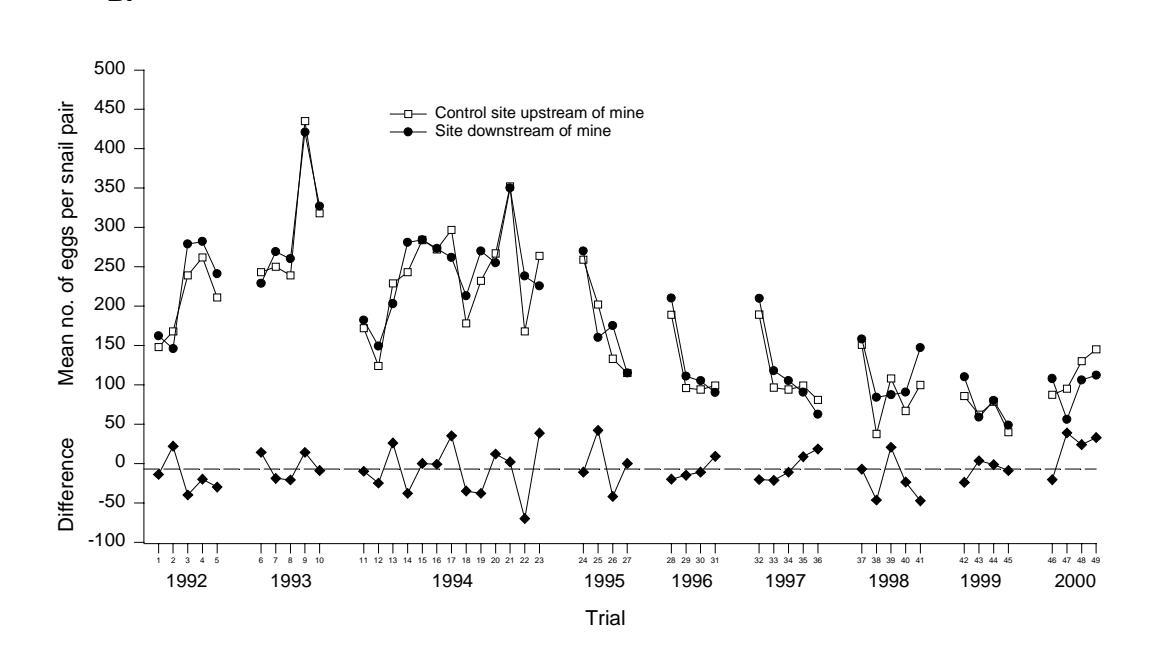
Figure 15 Creekside monitoring results for A larval black-striped rainbowfish survivial, and B freshwater snail egg production, for wet seasons between 1992 and 2000

The results of the creekside trials are plotted as part of a continuous time series of such data in figure 15A for fish survival data, and in figure 15B for snail egg production. When data from the upstream site are subtracted from those at the downstream site, a set of 'difference' values can be derived – as shown in figure 15. These difference values may be compared statistically for different parts of the time-series. For example, the 1999–2000 difference data may be compared with those from previous years; if they differ significantly, using a Student's *t* test, it may indicate a mine-related change (Humphrey et al 1995). Such statistical tests were conducted on the data shown in figure 15. The results showed no significant difference in the 'difference' values of 1999–2000 data compared with data from previous years (P>0.05). (Note that in the first fish trial (fig 15a), there is poor survival at the upstream control site. The data for this trial are included to illustrate the high survival at the downstream site (and hence no adverse effects arising from mine waste waters at this time.) The data for this trial were not included in the statistical analyses referred to above.)

From these results, it is concluded that there were no adverse effects of mine waste waters on any of the test species over the 1999–2000 wet season. This finding is consistent with the chemical results presented previously.

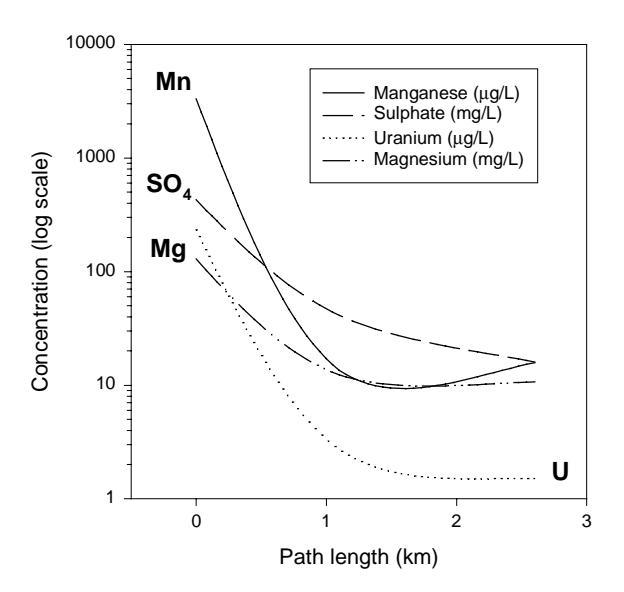
Figure 16 Mean changes (March–April 2000) in the concentration of contaminants as a function of path length through the Corridor Creek wetlands (note the logarithmic scale)

Changes in the concentration of Mn, SO_4 and U in response to distance traveled through the wetlands subsequent to process water entering Corridor Creek are shown in figure 16. Sulphate behaves conservatively¹ in wetland systems at Ranger. That is, sulphate is not lost from the water column (attenuated) due to chemical or biological processes. The relative change in the concentration of sulphate can be used as an estimate of dilution during transport through a surface water system. Figure 16 shows that over a 2.6 km path length down Corridor creek, the concentration of sulphate reduces by a factor of approximately 25. This can all be assumed to be due to dilution. The decrease in concentration of the other contaminants beyond a factor of 25 is due to attenuation.

Considering that dilution accounts for a reduction in the concentration of all contaminants by a factor of 25 over a distance of 2.6 km down Corridor creek, Mn and U are indicated to be attenuated by 90% and 80% respectively. That is, approximately 90% of the Mn and 80% of the U are removed from the water column as the water travels through a distance of 2.6 km down Corridor creek. These estimates are in good agreement with previous studies at Ranger² which have shown that around 70–90% of Mn and 50–80% of U are attenuated when mine water is passed through wetland filters.

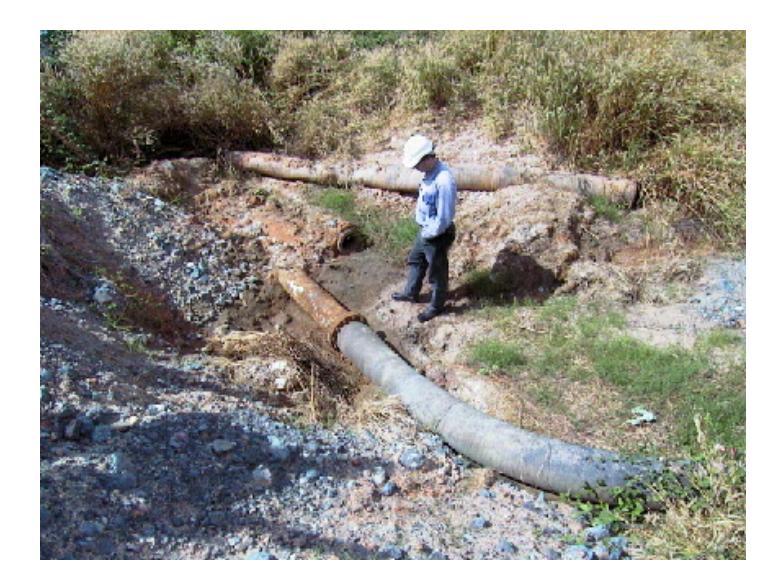
The process water return pipeline carries tailings water to the mill for re-use in the refining process. This pipeline runs from the top of the TD, through a pump, to the mill, passing over the corridor road culvert with a global low point above the corridor road sump (see figure 2). The pipeline is one of four situated between two earthen bunds which are designed to retain liquid which may leak from the pipelines. Any such liquid is then delivered to the road sump where it can be pumped back into the system or overflow into the pit. The pipeline is exposed throughout its length except for one point where it is crossed by an access road near the TD. It is at this point where a leak from the pipeline has occurred. This leak has been the result of a separation of a flange joint, most likely due to corrosion. Given that the pipeline is covered by sediment, it is apparent that a small leak could remain undetected for some time, especially during the wet season when the area tends to remain saturated (figure 3). The leak was observed on 3 April and repaired on 5 April. It seems unlikely that the leak has been present for a significant time and certainly unlikely that it was present in the previous dry season.
