**Evaluation of alleged
deficiencies in
management of the
Ranger Uranium Mine
between 1996 and 1998**

**Supervising Scientist &
Northern Territory Department
of Business, Industry and
Resource Development**

Supervising Scientist & Northern Territory Department of Business, Industry and Resource Development 2002. *Evaluation of alleged deficiencies in management of the Ranger Uranium Mine between 1996 and 1998*. Supervising Scientist Report 171, Supervising Scientist, Darwin NT.

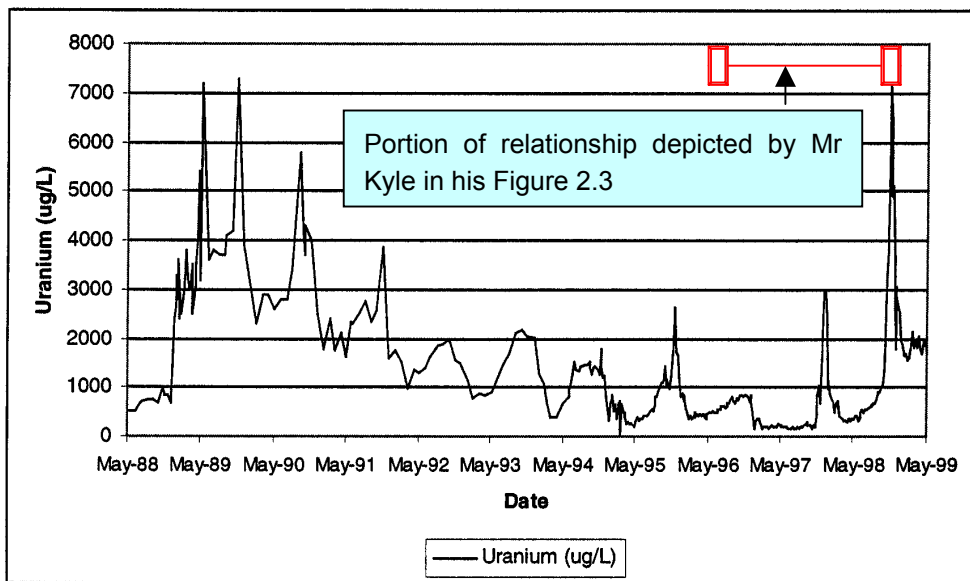
In most years RP2 experiences a sudden increase in uranium concentration early in the wet season. This expected first flush effect was greater this year than the last few years. The uranium concentration peaked at 7300 µg/L on 29 October 1998, a similar level to that of the 1987/88 wet season. By November values of 5000 µg/L were measured and the downward trend continued through the wet season (see figure 3.5)...

The principal reason for this higher level was transfer of water from Ranger #3 pit which had leached through approximately 1,000,000 tonnes of blasted broken material including some high grade ore. This material was still located in the base of the pit when heavier than normal early rains fell in October.

Figure 3.5 from Energy Resources of Australia Ltd (1999) is reproduced here as figure 4. As ERA stated, similar high values had been found on previous occasions but were not included in the data presented for RP2 by Mr Kyle in his submission (his figure 2.3). While such previous high uranium values in RP2 do not make such occurrences acceptable, they do highlight that ERA was continuously monitoring the situation and understood what was happening.

Figure 4 Uranium concentrations in RP2 between 1988 and 1999 (Source: Energy Resources of Australia 1999, figure 3.5 on p 35)

Thus, Mr Kyle's implication that overflow or pumping from the tailings road sump to RP2 was the source of the high uranium in the pond is in error for two reasons. Firstly, overflow or pumping from the tailings corridor sump to RP2 did not occur at this time. Secondly, the source of the high uranium concentrations in RP2 was clearly identified by ERA at the time. It was caused by the transfer of water from Ranger Pit 3 which had leached through approximately 1,000,000 tonnes of blasted broken material including some high grade ore. This material was still located in the base of the pit when heavier than normal early rains fell in October 1998.

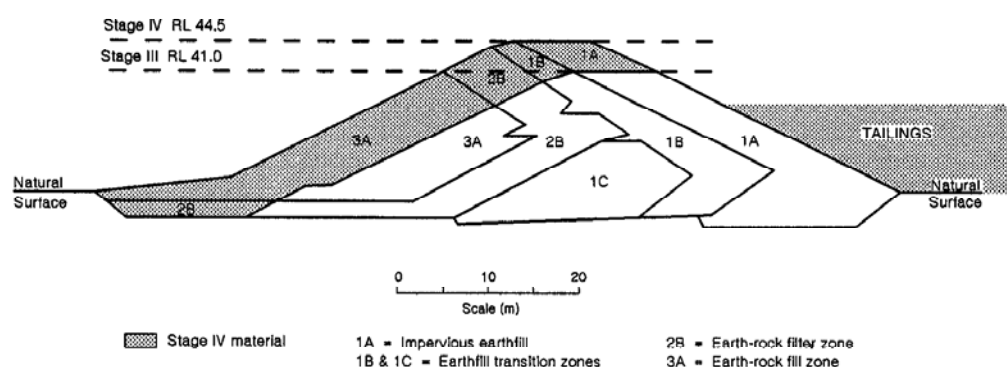
Figure 5 Tailings dam showing the area changed by the stage IV lift in 1990

As part of this annual assessment process, it was proposed (Coffey Partners International Pty Ltd 1997) that toe loading of the south wall of the tailings dam should be undertaken as a stability measure to reduce artesian pressures observed in the piezometer data for the south wall region of the dam. Similar toe loading of the west wall area of the tailings dam prevented a rise in piezometric pressures to the point where they became artesian (Coffey Partners International Pty Ltd 1997).

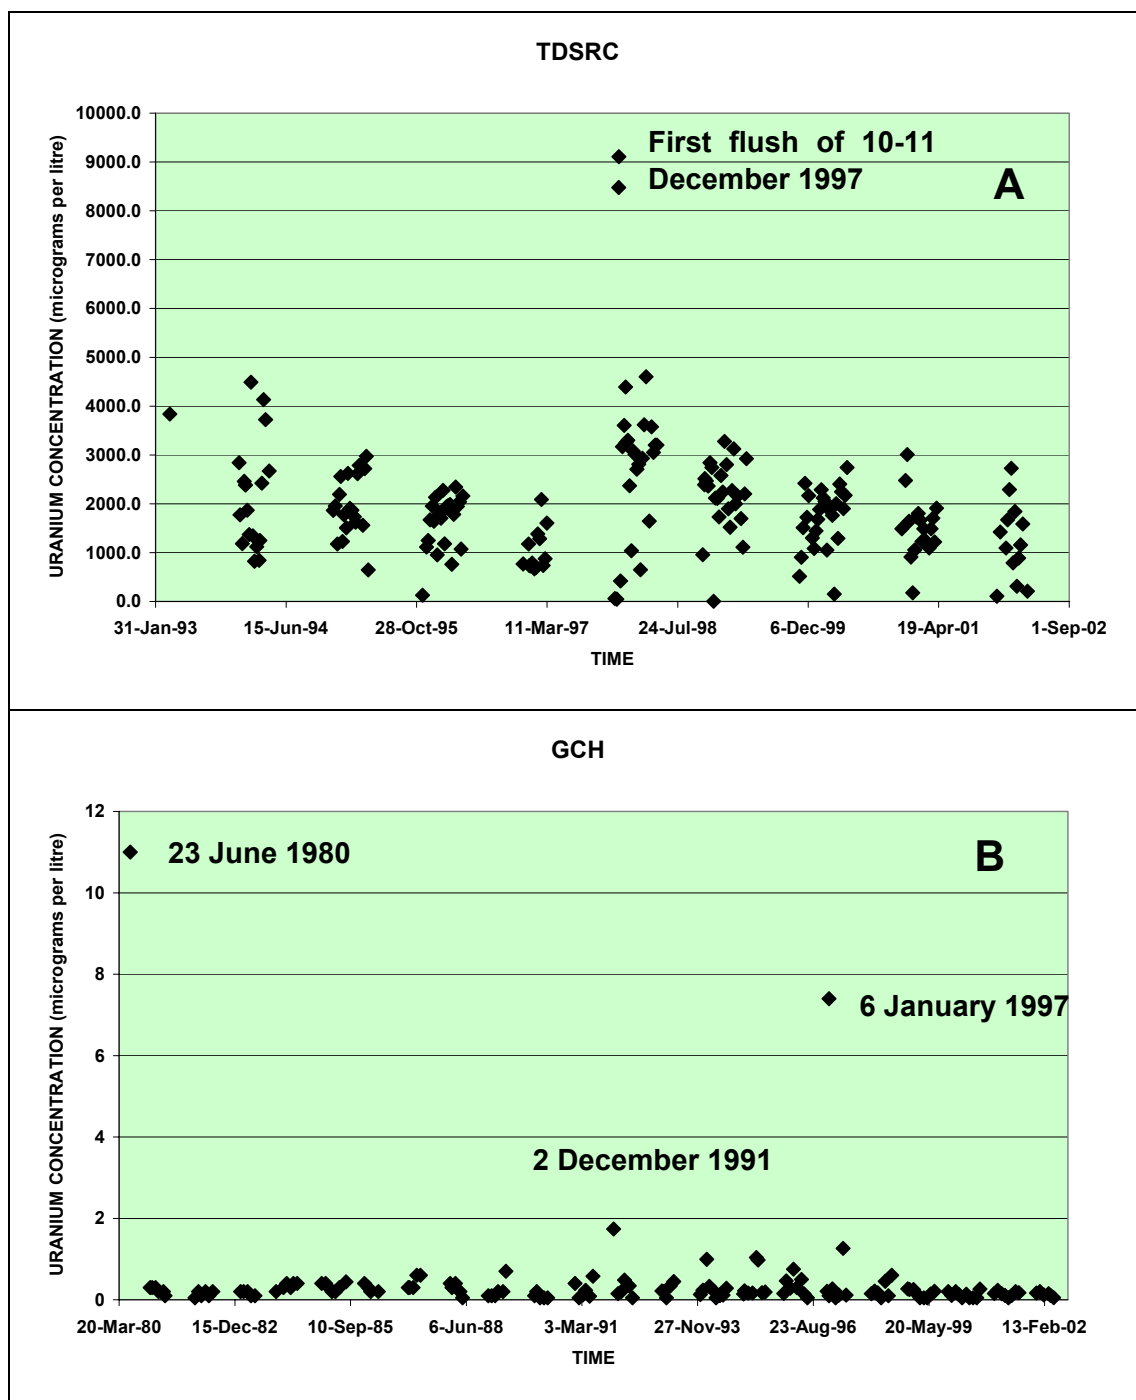
Figure 9A shows all the uranium concentrations measured by ERA at TDSRC and clearly demonstrates that a substantial increase occurred on 10–11 December 1997 (about 8500 and 9100 $\mu\text{g/L}$ respectively) immediately after the completion of toe loading. The first flush effect was very short-lived (one week at most) and uranium concentrations rapidly declined. They did not exceed 4600 $\mu\text{g/L}$ for the remainder of the 1997-98 Wet season and have not exceeded 3300 $\mu\text{g/L}$ during subsequent Wet seasons (figure 9A). This first flush event occurred 11 months after Mr Kyle's record of 7.4 $\mu\text{g/L}$ uranium at GCH (figure 9B) and was not causally related, as the reader might infer from Mr Kyle's report.

Figure 9 Complete data on uranium concentrations at TDSRC (A) and GCH (B). ERA data and reproduced with permission. All values below the detection limit were set at 0.05 µg/L.
Compare (A) with figure 1.3 in Appendix 1.

The full data set of uranium concentrations at the downstream monitoring point in Gulungul Creek (1980–2002) are shown in figure 9B. Apart from the first measurement recorded in June 1980 and the measurement on 6 January 1997 (discussed in the next section), all measurements gave results that were below the Supervising Scientist's recommended receiving water standard at the time (10 µg/L) and the NT Minister's Maximum Allowable Addition for Magela Creek (3.8 µg/L). In his interview, Mr Ryan outlined the internal procedures adopted by ERA in regularly reviewing all environmental data. ERA was (and is) also required to provide interpretative annual reports on these data. In addition, when discussing at interview the uranium result at the Gulungul Creek monitoring point for 6 January 1997 (see next section) both Mr Ryan and Mr Nolan immediately referred to a possible result of 7.4 µg/L as a 'high result' for Gulungul Creek that would need to be checked thoroughly. It is clear, therefore, that senior ERA environmental staff were well aware that the historical uranium concentrations for Gulungul Creek had always been low throughout the period when results at TDSRC were often greater than 2000 µg/L.

The overall chemical analysis results for uranium in Gulungul Creek have already been discussed. The results are presented in figure 9. Throughout the entire period of mining at Ranger, only two data points have exceeded the current recommendation of the Supervising Scientist for uranium in freshwaters of the Alligator Rivers Region, namely 5.8 µg/L.

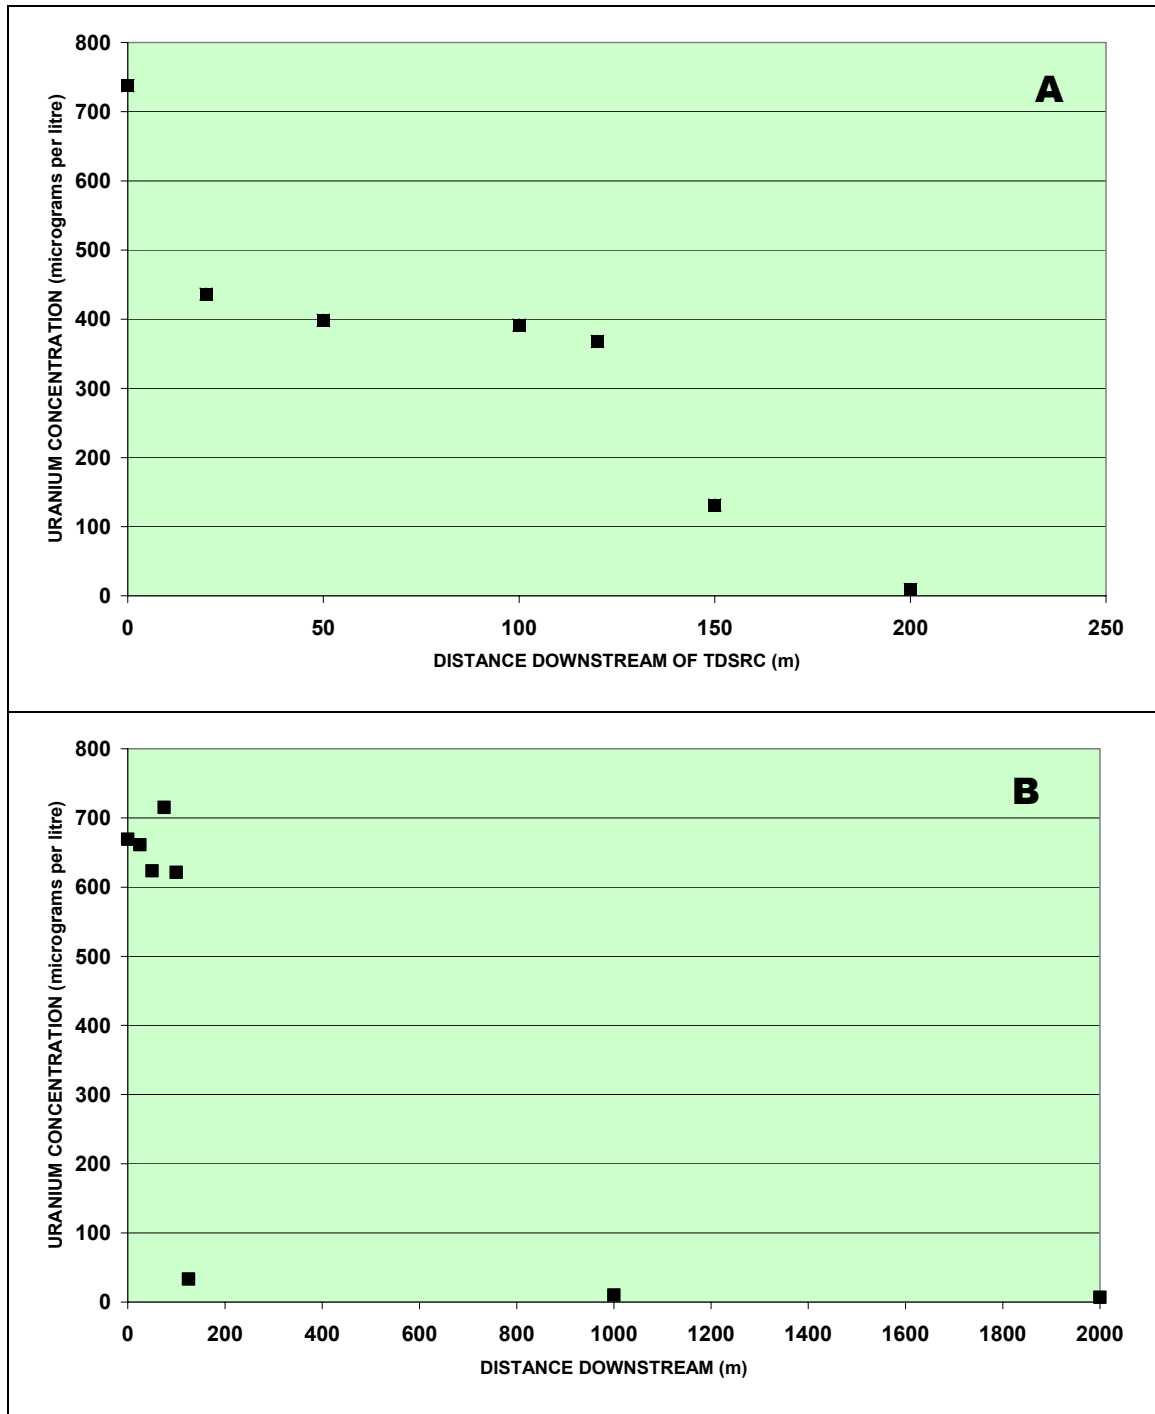
The results of Mr Kyle's survey of 21 January downstream of TDSRC are shown in figure 11B. A rapid decrease in concentrations of uranium is observed over the first 200 m from TDSRC similar to that in the data in figure 11A. However, there is an indication that attenuation beyond that point is less severe and that a residual concentration of uranium, about 9 µg/L, remains when the overland flow enters the tributary of Gulungul Creek at a distance of 2000 m from TDSRC.

Figure 10 Downstream reductions in uranium concentration below TDSRC on 2 January 1997 (**A**) and 21 January 1997 (**B**)

According to the watercourse information shown on the 'Mount Brockman' 1:50000 topographic map produced by the Army Topographic Support Establishment in 1997, the drainage feature at TDSRC flows into two channels before reaching an anabranch of Gulungul Creek. It is then 5 km by channel to the GCH sample site. Clearly, dilution by flows in Gulungul Creek and attenuation would further greatly reduce the uranium concentration at the GCH sample site. Gulungul Creek between the tailings dam tributary and GCH is characterised by a single sand-bed main channel and by a series of shallower anabranches on a wide, well vegetated floodplain. Overbank flows would also provide significant opportunities for substantial uranium attenuation. The ratio of catchment area of Gulungul Creek to the total for the whole southern tailings dam tributary at their junction is about 16:1 and this can be used as an estimate of dilution.

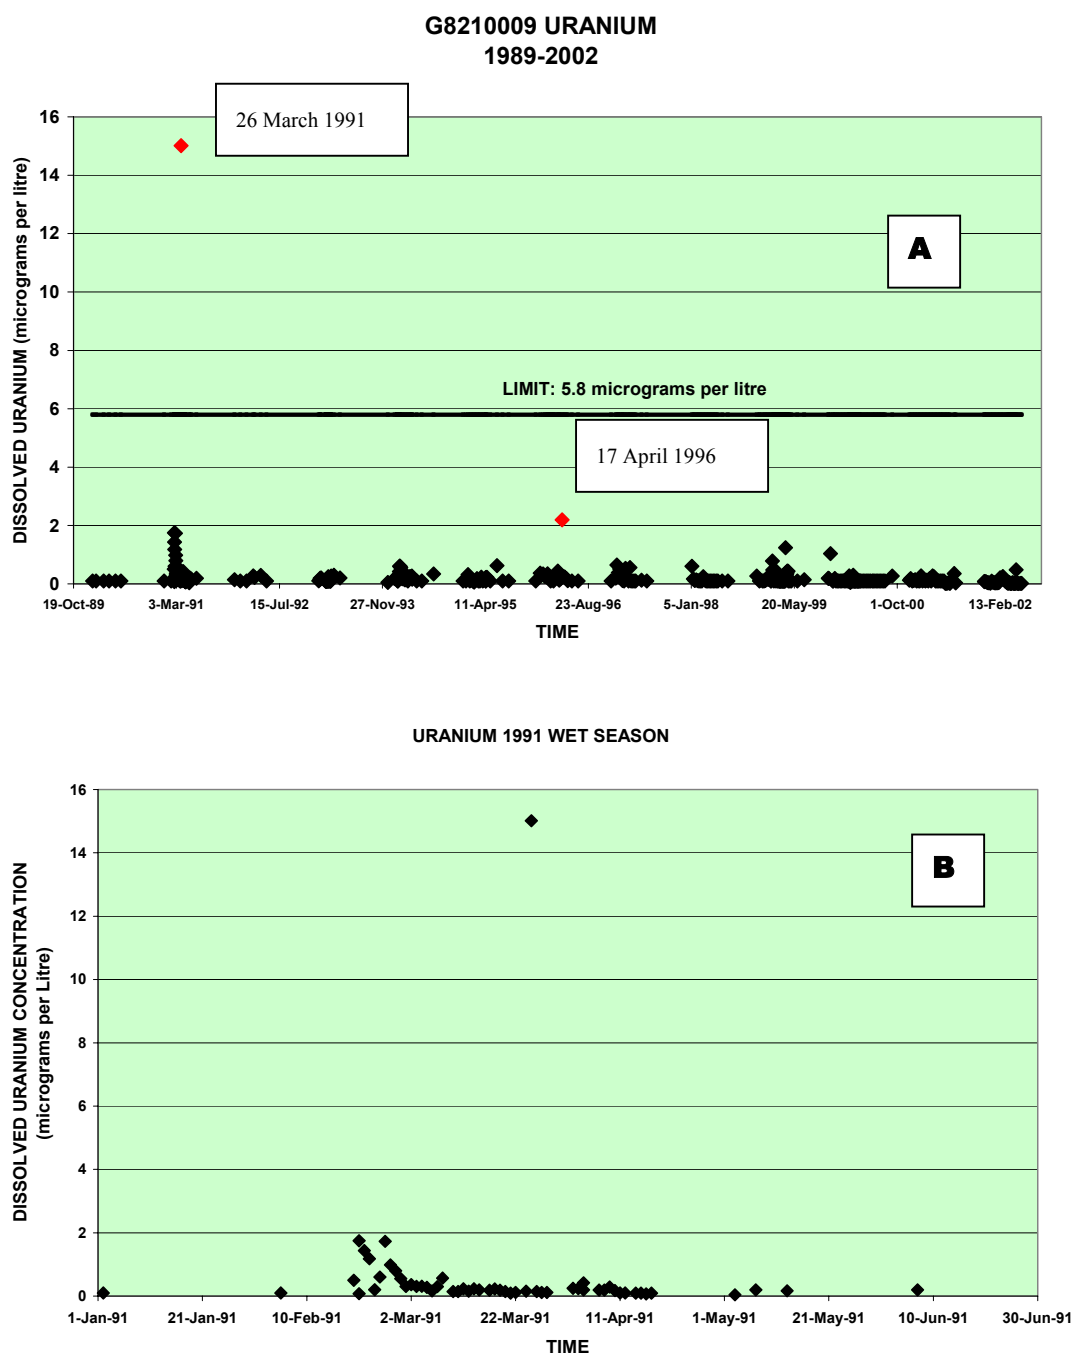
Examples of extracts from the current ERA water quality database for uranium analyses in Magela Creek downstream of Ranger (G8210009) are shown in figure 11. There are two high uranium values recorded (highlighted in red in figure 11A), one of which exceeds the current limit of 5.8 µg/L (figure 11). These high values are believed, by ERA and the authorities, to have arisen from sample contamination.

Figure 11 Dissolved uranium values at GS8210009, downstream of Ranger mine (A) Full data set 1989-2002 and (B) Expanded data set for the 1991 Wet season. The values highlighted in red are high values which are discussed in the text.

For example, the data for the 1991 Wet season are expanded in figure 11B. The value of 15 µg/L on 26 March 1991 is clearly an outlier with results obtained immediately before and after this date being very low. The 1991 uranium data were discussed in detail in the Supervising Scientist's Annual Reports for 1990–1991 and 1991–1992 within the context of investigation of the unplanned discharge of water originating from the Ranger high grade ore stockpile. In both reports, the Supervising Scientist quotes the maximum value for the uranium concentration for the 1990–91 Wet season as being 1.7 µg/L which occurred on two occasions on 20 and 25 February 1991. Thus the Supervising Scientist, in making his assessment of the significance of uranium concentrations in Magela Creek during 1991, did not consider the value of 15 µg/L on 26 March 1991 because it was considered to have arisen from sample contamination. Nevertheless, this value and the less high value of 2.2 µg/L on 17 April 1996 have not been deleted from ERA's database.
