Investigation of radiation  
clearance procedures for  
vehicles leaving the  
Ranger mine

Supervising Scientist

Supervising Scientist 2004. *Investigation of radiation clearance procedures for vehicles leaving the Ranger mine*. Supervising Scientist Report 185, Supervising Scientist, Darwin NT.

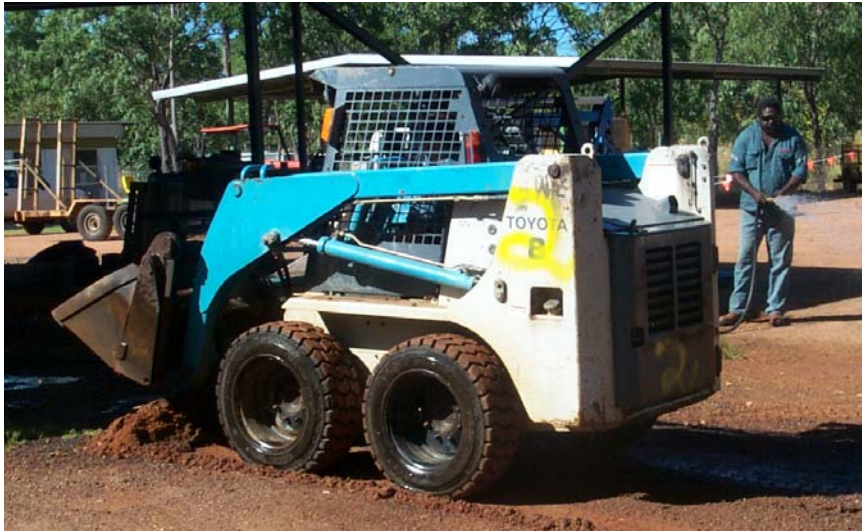
**Figure 1** Bobcat excavator at work in the CDEP Yard, Jabiru

ERA has regularly contracted the Community Development and Employment Project (CDEP) based in Jabiru to provide staff and equipment to assist in operations at the Ranger uranium mine. The Project is managed by the Djabulukgu Association and operates from a yard at the Jabiru Industrial Area. The vehicles most often employed have been two small earthmoving machines known as 'bobcats' (see figure 1), and a Hino tipper truck (see figure 2).

Upon delivery to the CDEP yard, the bobcat was placed under a carport. That day, the CDEP mechanic removed the 'belly plate' from the bobcat resulting in approximately 20 litres of 'grey mud' dropping from the bobcat onto the ground. The mechanic collected this material and placed it in a pile under the carport.

Soon after its return to the CDEP yard, probably on 29 November 2003, the bobcat was moved from the carport to the workshop area in the CDEP yard. The CDEP mechanic removed the engine of the bobcat, washed it down, and sent it into Darwin for repair. The CDEP mechanic continued to work on other elements and systems of the machine until the engine was returned to Jabiru shortly after completion of its repair on 18 December 2003. These activities resulted in more material, estimated to be up to 100 L, falling to the ground in the workshop area. The mechanic refitted the engine during January 2004, after the Christmas break. The exact date is unclear. Following installation of the repaired engine, the bobcat was removed from the workshop area to the carport where it remained until 5 February 2004.

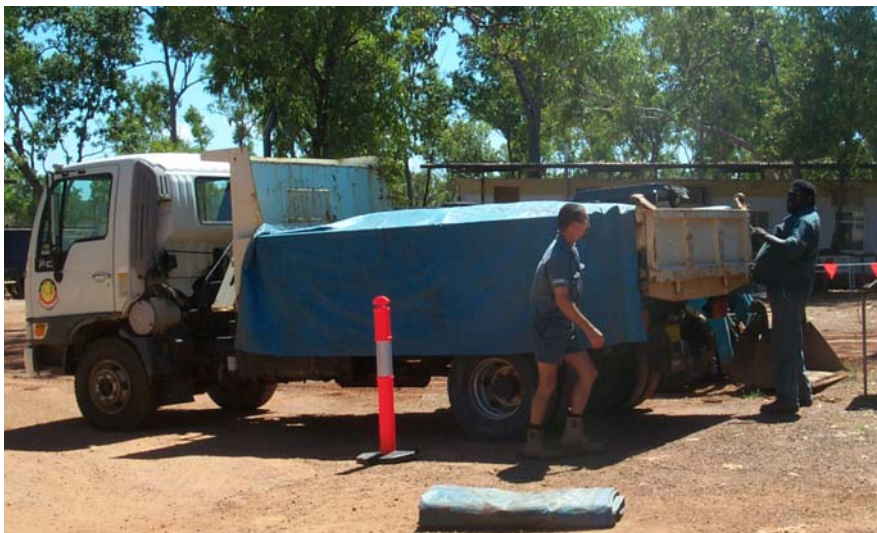
**Figure 2** Hino tipper truck at work in the CDEP yard

During the inspection of the bobcats in the CDEP yard on 30 March 2004 by SSD staff, the Hino truck was returned to the yard. The visual appearance gave rise to concerns that it had not been adequately cleaned (see figure 5) although it did have a radiation clearance certificate issued on that day. A check by SSD personnel showed that there was detectable radioactive contamination in the cab and on other parts of the truck as well as the visible contamination. The truck was returned to Ranger for further cleaning. Subsequently the truck failed to obtain a radiation clearance on two occasions, despite further washing. Eventually it was necessary to modify the truck to assist the cleaning of internal parts and the tray was sandblasted before radiation clearance was obtained.

During the SSD inspection and survey of the CDEP Yard on 30 March 2004 (~1230 hrs), a Hino tip truck returned to the CDEP yard from Ranger and was observed to be dirty, both externally (see figure 5) and on the floor of the driver's cabin. Radiation scanning of the truck by SSD staff confirmed that contamination was present. Samples were collected from the exterior of the truck and from the floor of the driver's cabin and were sent to the *eriss*

The results of these analyses are also presented in table 1. The results show that the material collected from the exterior of the truck (sample JT04004) and the material collected from the floor of the driver's cabin (sample JT04005) was partially leached uranium ore. It has been concluded that the radiation clearance process for this vehicle had also been inadequate.

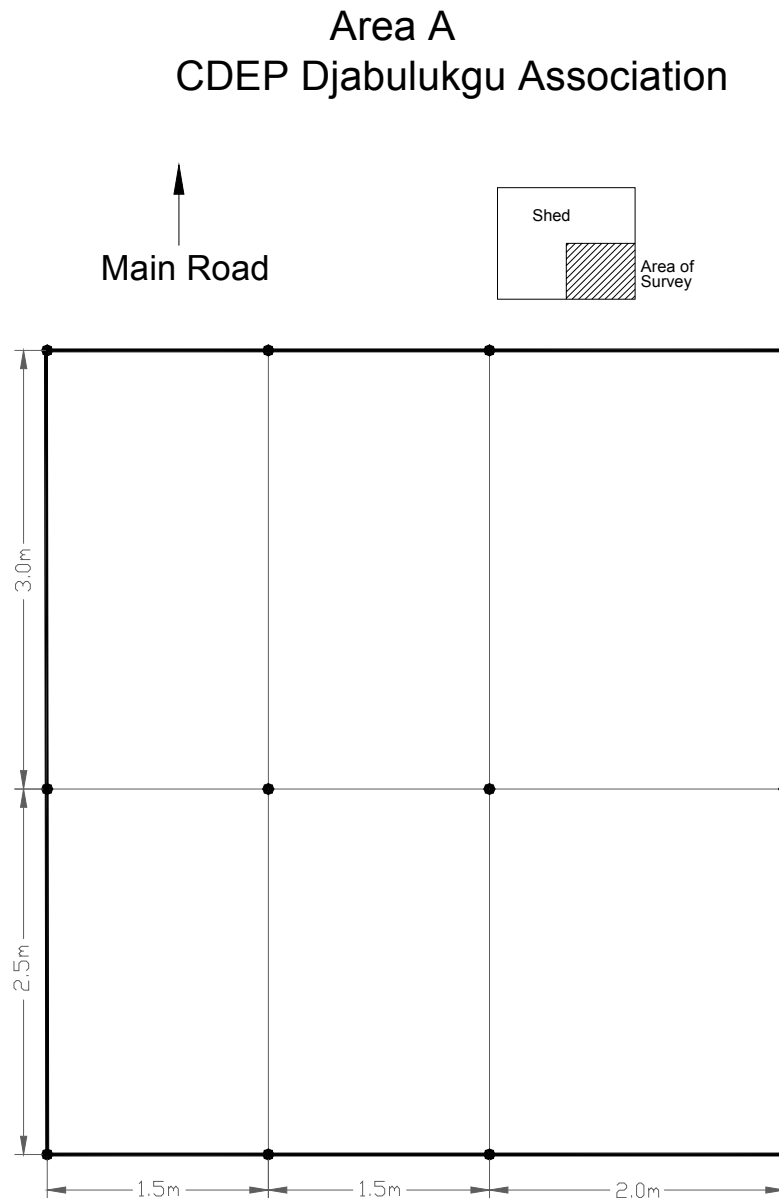
**Figure A2** Site plan of survey site A CDEP workshop Djabulukga Association, Jabiru NT

Undercover work area, some hydrocarbon contamination, machinery and car parts litter site. Small 1 metre by 1 metre portion of area where work was carried out slightly elevated (see table position 0,3)

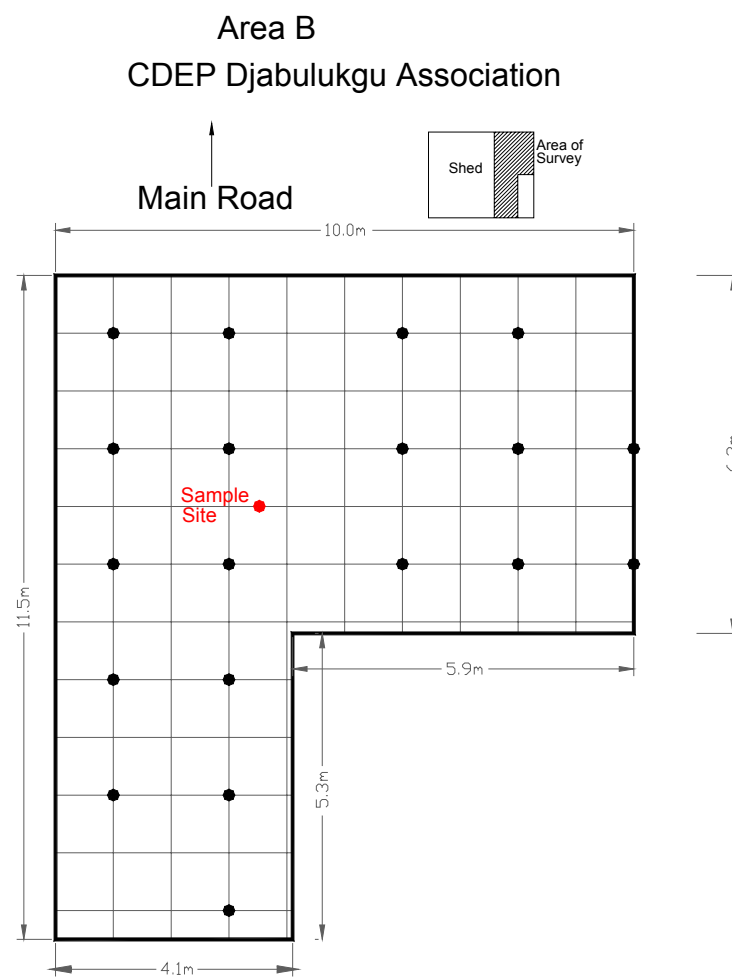
**Figure A6** Site plan of survey site B CDEP workshop Djabulukga Association, Jabiru NT

There has been a significant amount of time from the time of cleanup to the time of this survey. There are slightly elevated signals from the surface contamination meter following the drainage line from the work area in Site B. This signal covers two metres approximately and indicates some small amounts of residual fine material mixed in with the ground cover.
