FIELD MONITORING INFORMATION FOR THE SWIFT (NGARRADJ) CREEK CATCHMENT NORTHERN TERRITORY

M.J. Saynor, K.G Evans, B.L. Smith, E Crisp & G Fox.

Erosion and Hydrology Group.
Environmental Research Institute of the Supervising Scientist
Locked Bag 2
Jabiru NT 0886

January 2001

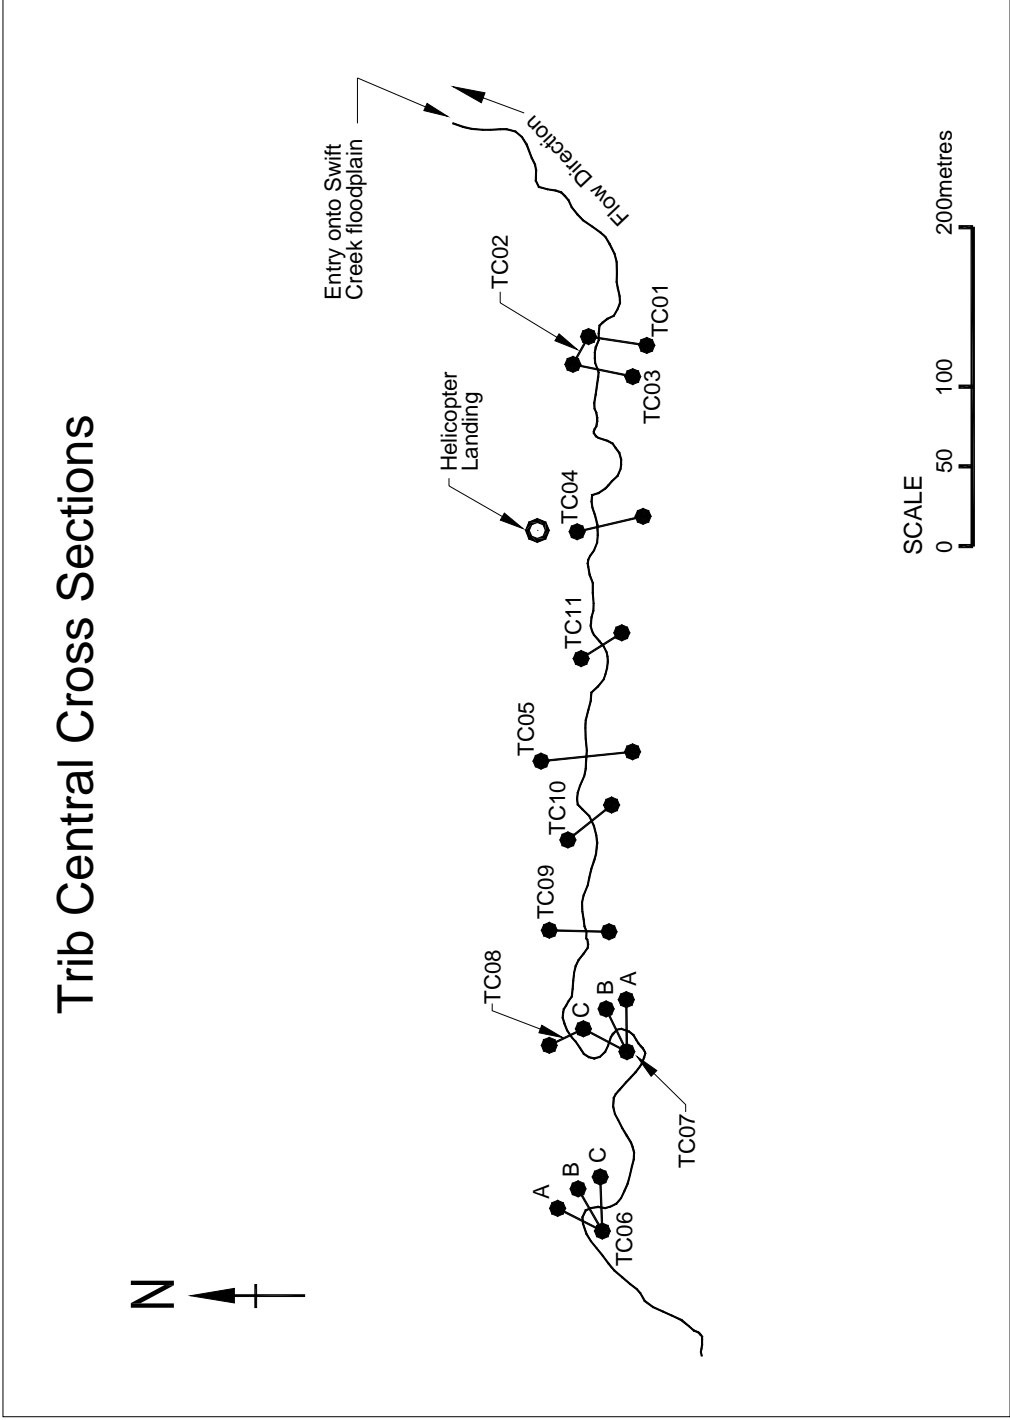
Figure 6: Location of the cross sections along Tributary Central.

The locations of the sections along each of the reaches are shown in the figures at the end of each of the sections 3.2 to 3.6. It must be noted that the cross-sections are not always numbered sequentially downstream. This has occurred as the sections were numbered as they were installed and in some instances it was decided to install additional cross sections. Table 5 shows the abbreviations used for each of the reaches in the Swift Creek catchment which have cross sections installed on them.
