## **MOUNT LYELL REMEDIATION**

**Remediation options  
for tailings deposits in  
the King River and  
Macquarie Harbour**

**Mount Lyell Remediation  
Research and  
Demonstration Program**

This report describes research that is part of the Mt Lyell Remediation Research and Demonstration Program, a joint program between the Supervising Scientist and the Department of Environment and Land Management, Tasmania.

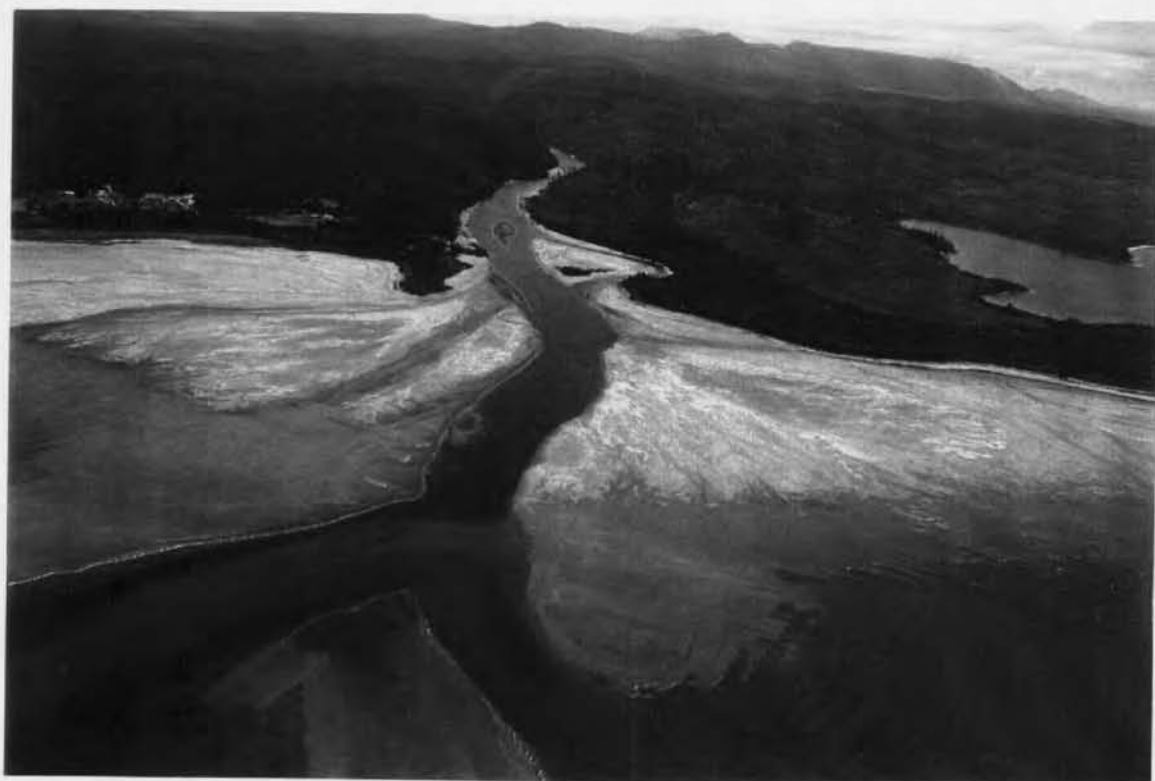
**Plate 1** Aerial oblique view of King River delta, showing tailings material being removed from the harbour edge of the delta

The delta is bisected by a narrow channel through which the King River flows (plate 1), and shallow channels traverse the surface of both the north and south lobes. These smaller waterways convey tidal and overflowing river water and incident rainfall off the delta towards the harbour.

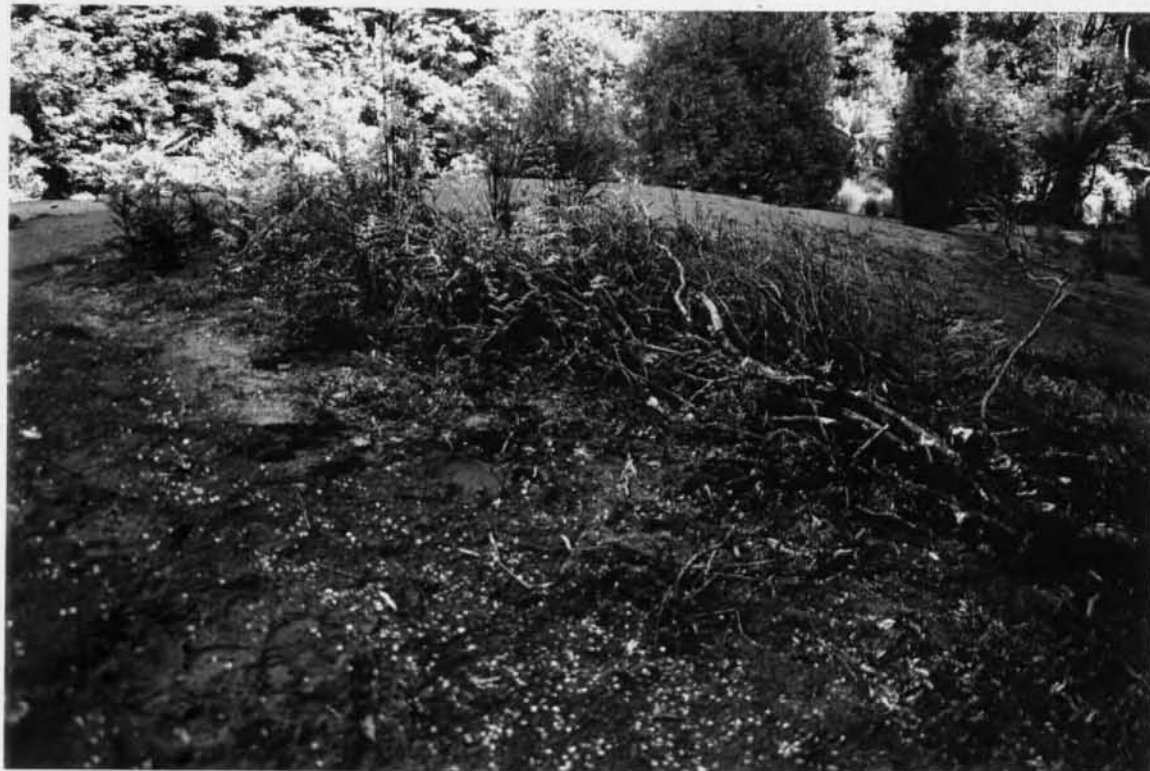
**Plate 2** Fallen branch on tailings bank near Teepookana Bridge. Note the vigour and variety of plant growth in the area sheltered by fine stems and leaves of the fallen branch.

The barriers to natural revegetation include physical effects such as exposure, sand blasting with wind blown particles, surface instability and browsing pressure from wildlife. Observation has revealed that in areas that are sheltered due to aspect, topography or even fallen branches, natural colonisation is taking place (see plate 2).

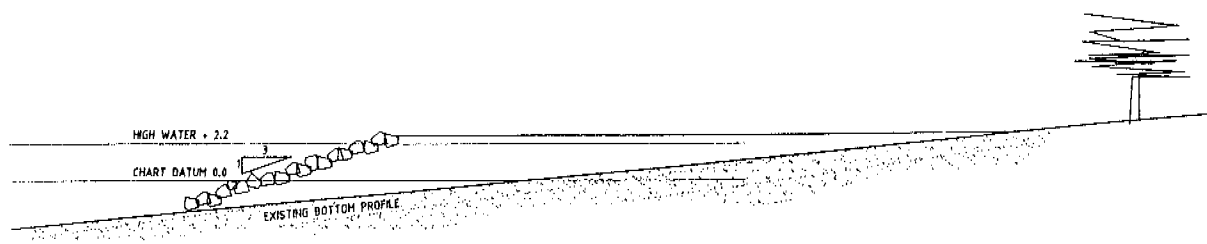
Taking the maximum wave height as 1 m, the armour rock would be approximately 750 kg, or about 0.28 cubic metres taking a specific gravity of 2.65. This equates approximately to a rock of 0.65 cubic metres.

The extent of the rock protection would be approximately 2 m vertically above high water down to 2 m vertically below low water, as shown in the diagram below.
