# Machinery Cleaning Guide - Komatsu Dozers

**Biosecurity**

April 2016

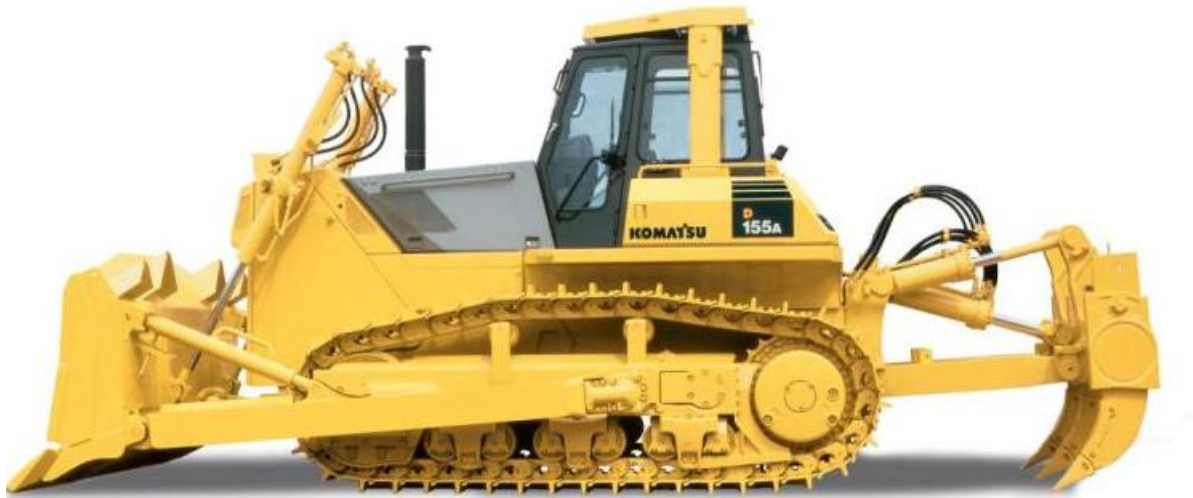
Landscape shot of a typical Komatsu Dozer. Structurally, the larger dozers (D51 to D375) are basically the same except for small variations and obviously size differences. The smaller Komatsu Dozers (D21 to D39) are a different style as shown below.

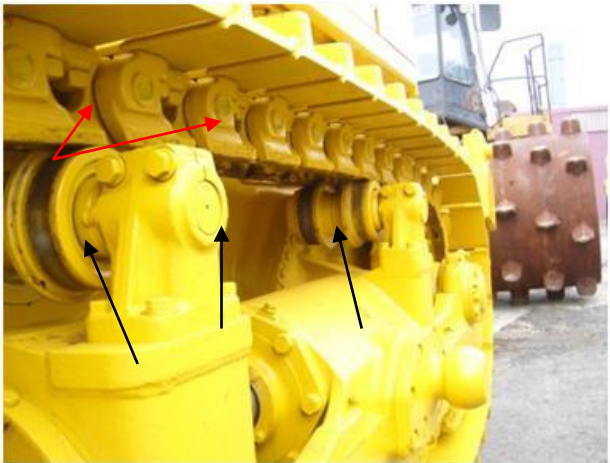
| Description | Images |
|---|---|
| <p>The individual track links (red arrows) need to be inspected and flushed if required. Easier to do when rotating the tracks when moving the machine off the pad. Also flush the inside track carrier rollers and supports (black arrows) on all sides.</p> | |

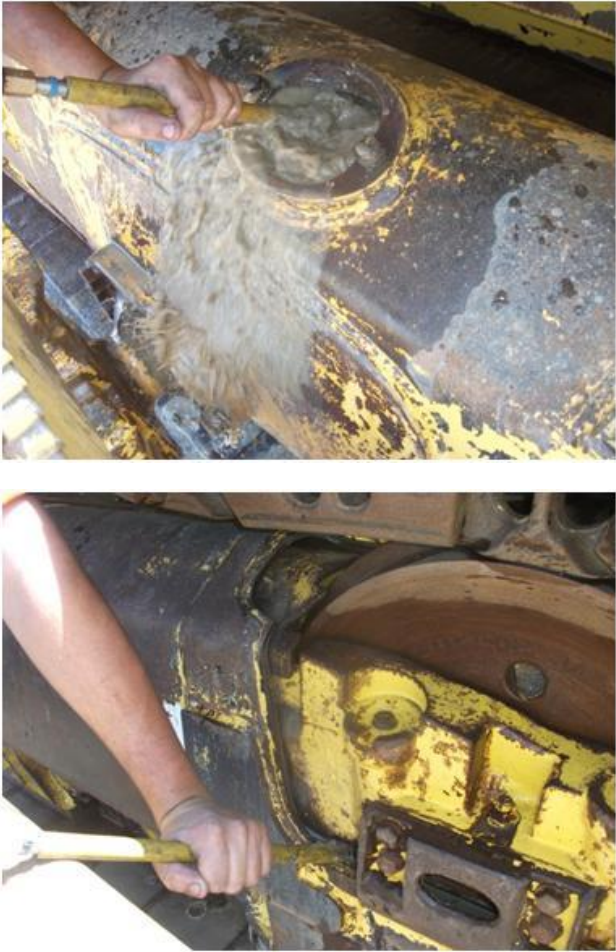
| Description | Images |
|---|---|
| <p>Some models e.g. D65, D85 have an access point (cover normally has 2 bolts) on the topside of the track frame. Once removed a thorough inspection and flush is required from both access points as this is a large hollow section.</p> | |

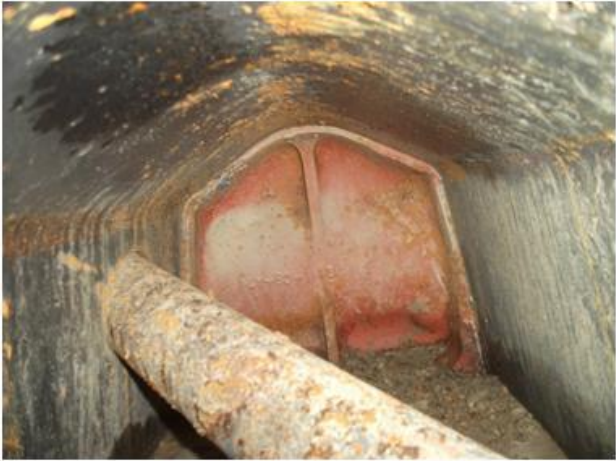
| Description | Images |
|---|---|
| <p>After flushing a visual inspection is required to ensure all biosecurity risk material has been removed.</p> | |

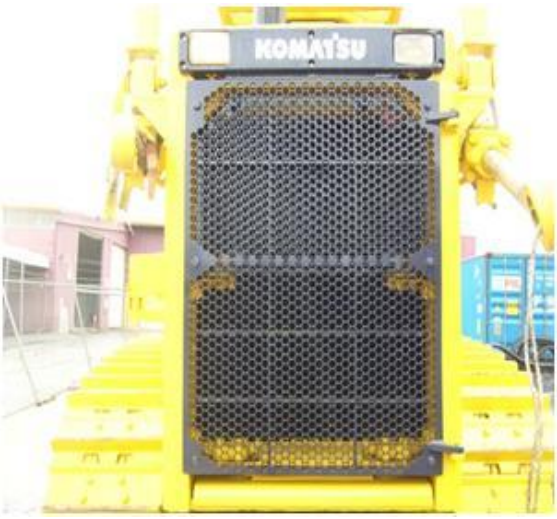
| Description | Images |
|---|---|
| <p>The radiator grill must be opened, allowing full access to the radiator and surrounds</p> | <p>A photograph showing the front of a yellow Komatsu dozer. The radiator grill is open, revealing the internal radiator and surrounding components. The word 'KOMATSU' is visible on the top of the grill frame.</p> |

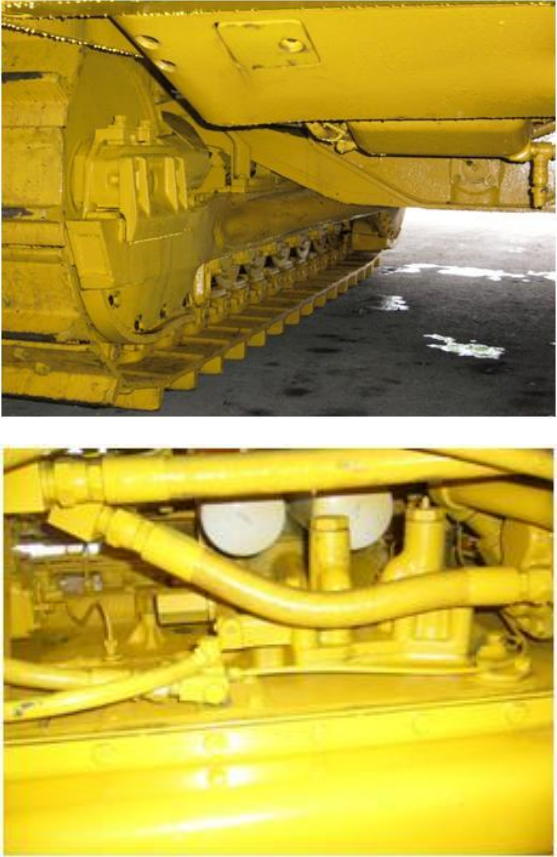
| Description | Images |
|---|---|
| <p>Make sure the belly pans are removed. A visual inspection of all accessible areas under the machine is required and flushing of all channels identified. Particular attention should be applied to any hydraulic hoses, bolts, electrical conduit, parts that are bolted to the frame, engine block, bolts and bolt holes and pivot points.</p> | |

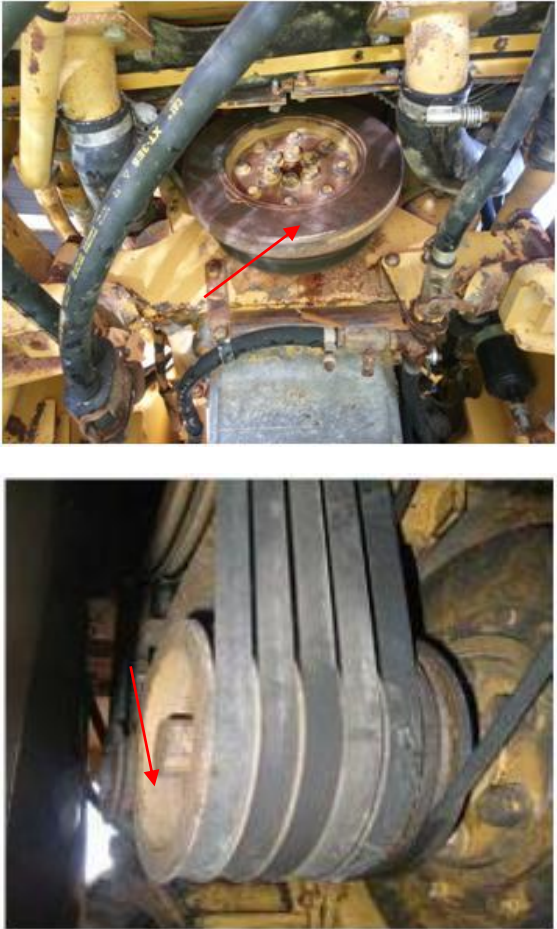
| Description | Images |
|---|---|
| <p>Harmonic Balancers are found at the front of the engine block. These areas are generally hollow and can harbour contamination. Also check pulleys and all parts associated with the engine for biosecurity risk material.</p> | |

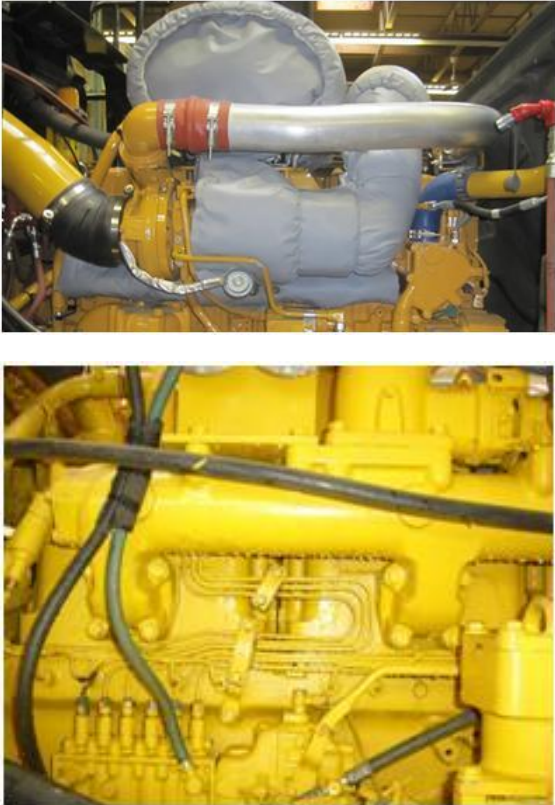
| Description | Images |
|---|---|
| <p>On some models there is a fibrous heat shield around the turbo or exhaust vents, they must be removed and cleaned. Air filter must be removed and if required cleaned with high pressure air.</p> | |

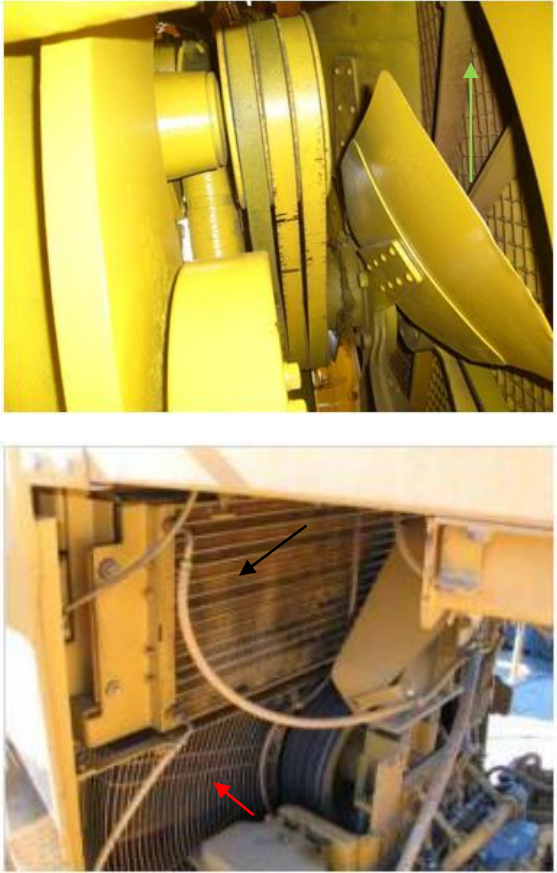
| Description | Images |
|---|---|
| <p>Some models could have a radiator grill (red arrow), as shown below, and must be removed for access. The radiator shroud (green arrow) has to be flushed, specifically towards the corners top and bottom. Any oil coolers (black arrow) present must be flushed in the presence of the officer.</p> | |

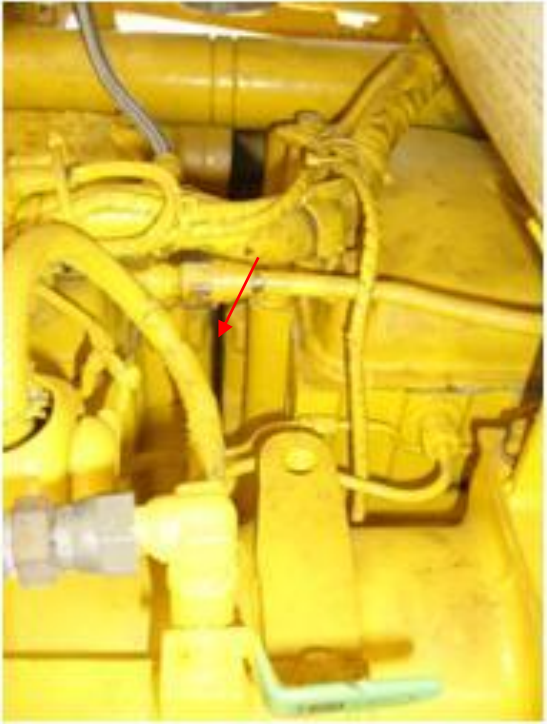
| Description | Images |
|---|---|
| <p>The topside of a typical dozer block. Check between each tappet cover (red arrow) and along the centre of the block. Best to flush these areas after visual inspection to ensure all contamination has been removed. All ancillary items must be six sided inspected, specific attention must be made to all hoses, bolts and clamps.</p> | |

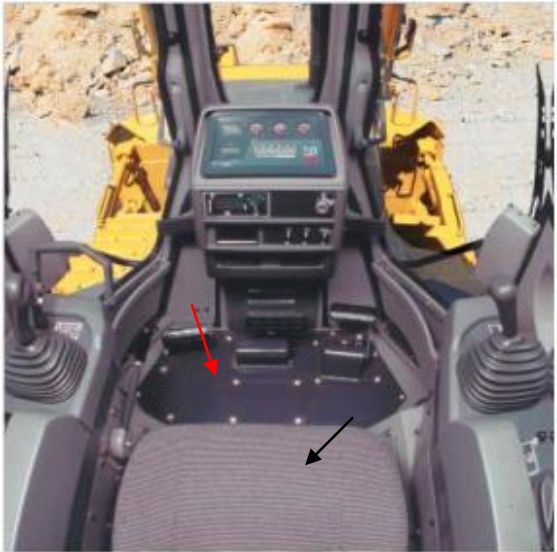
| Description | Images |
|---|---|
| <p>Note the floor pans and seat are still attached and need to be removed for cleaning and access to the transmission area under the floor. All rubber boots, vents, clamps and box channels must be verified clean.</p> | |

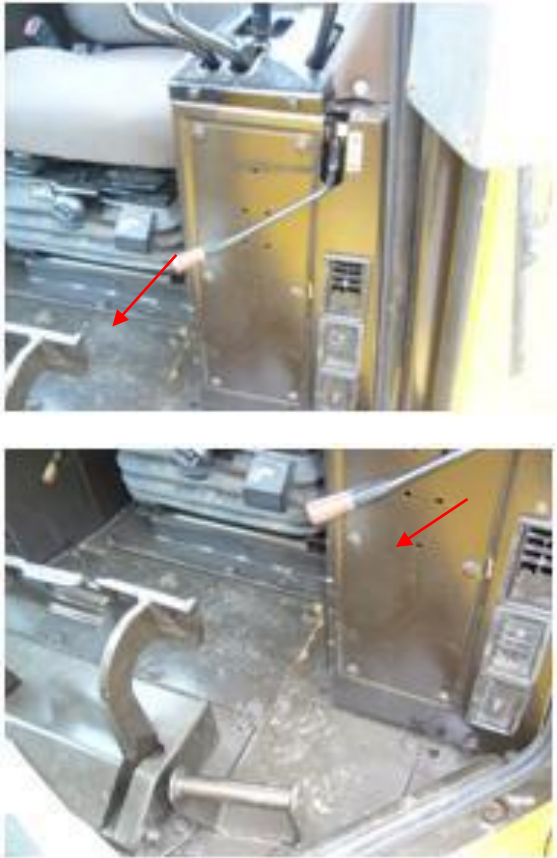
| Description | Images |
|---|---|
| <p>As shown, all non affixed panels must be removed</p> | |

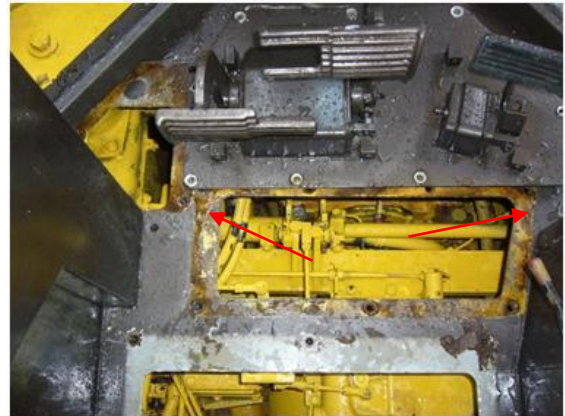
This picture shows the above panel removed. Once the panel is removed some models have hollow box channels that support the cabin floor area frames (red arrows) around the lip for strength. If the box channel is identified then flushing is required. The use of mirror and torch is a useful aid to ensure no biosecurity risk material is below and/or underneath the floor pans. All hoses, clamps, blocks and bolts must be inspected.

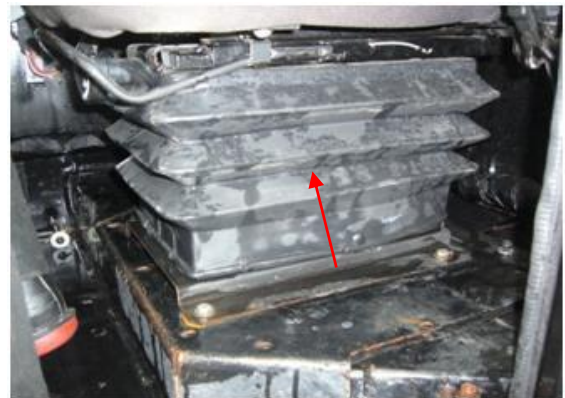
The seat has to be removed to allow access to the top of the transmission and to any compartments that are behind the seat. Once the seat has been removed, ensure the rubber seat shroud is clean inside.

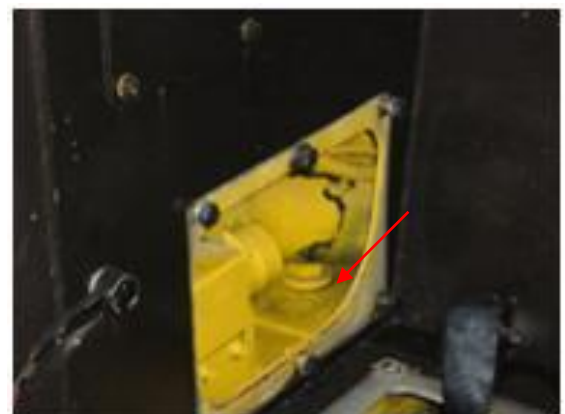
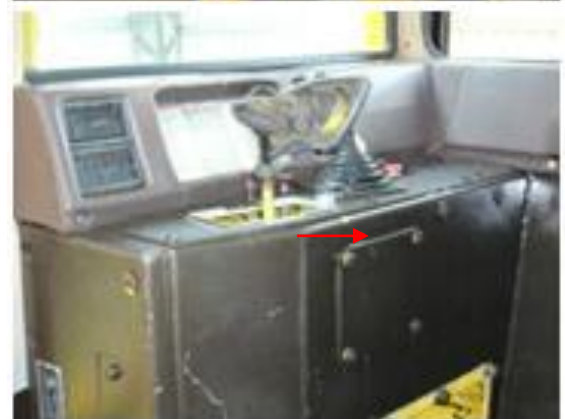
These pictures are examples of compartments behind the seat that must be opened and inspected. Look and check for cabin air filters and hollow areas behind these filters.

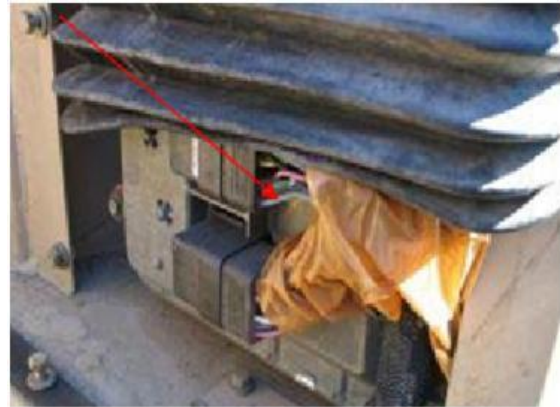
These pictures illustrate the various compartments found under the seat and around the seat. All non-affixed panels have been removed, allowing access for cleaning and inspection. These areas sometimes have ledges inside which can harbor biosecurity risk material and need to be thoroughly inspected. Care must be taken when inspecting electronics in this area.

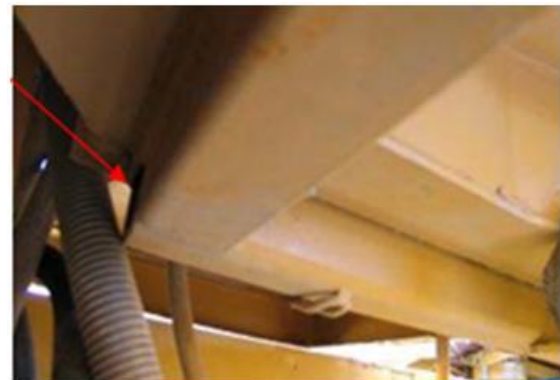
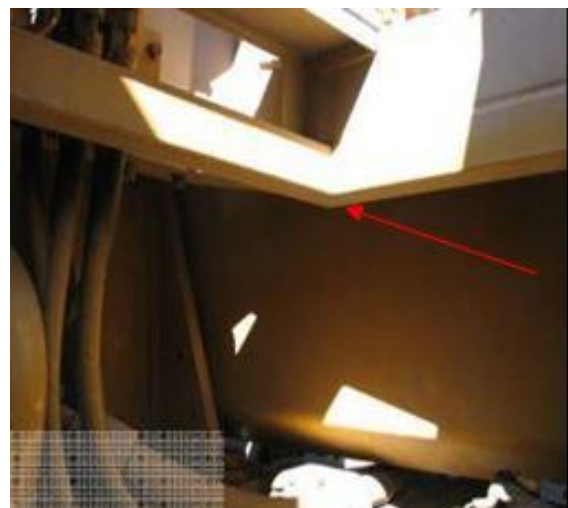
Some models have structural box channels below the floor pan, as shown below. All box channels must be identified and checked for openings/drainage holes and flushed to ensure there is no biosecurity risk material.

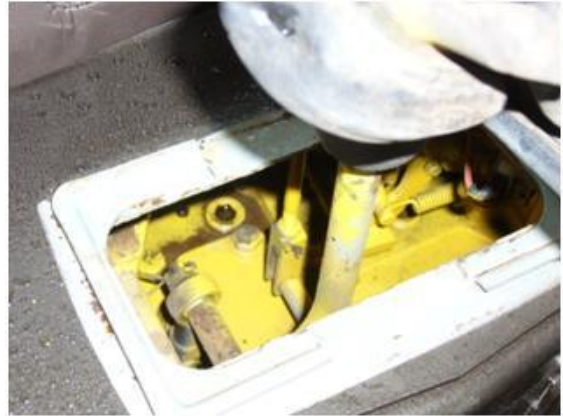
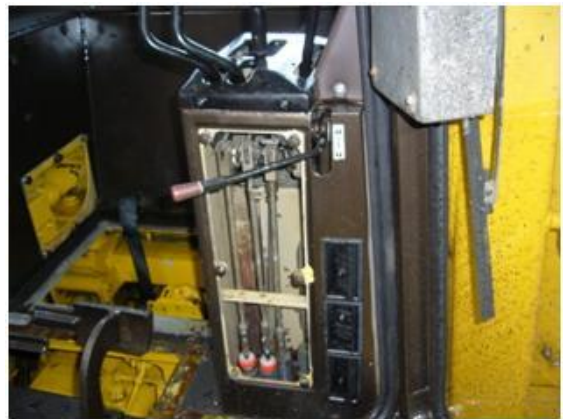
It is vital that all removable panels be removed and thoroughly inspected for biosecurity risk material. Particular attention must be paid to the air-conditioning vents and filter.

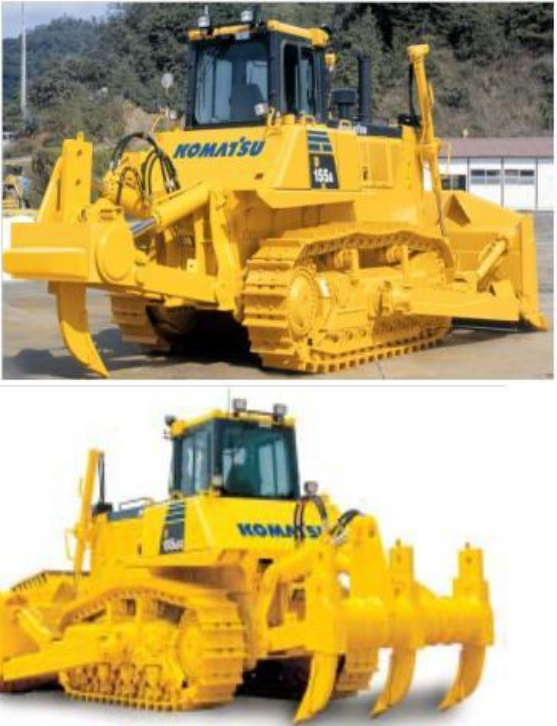
| Description | Images |
|---|---|
| <p>Images of two different ripper versions that are commonly imported. The inspection regime is virtually the same as detailed in the below pictures.</p> | <p>The image shows two yellow Komatsu bulldozers equipped with rear-mounted rippers. The top photo shows a bulldozer from a side-rear perspective, highlighting the ripper attachment at the back. The bottom photo shows a bulldozer from a front-three-quarter view, also showing the ripper attachment. Both machines have 'KOMATSU' and '195A' visible on their sides.</p> |

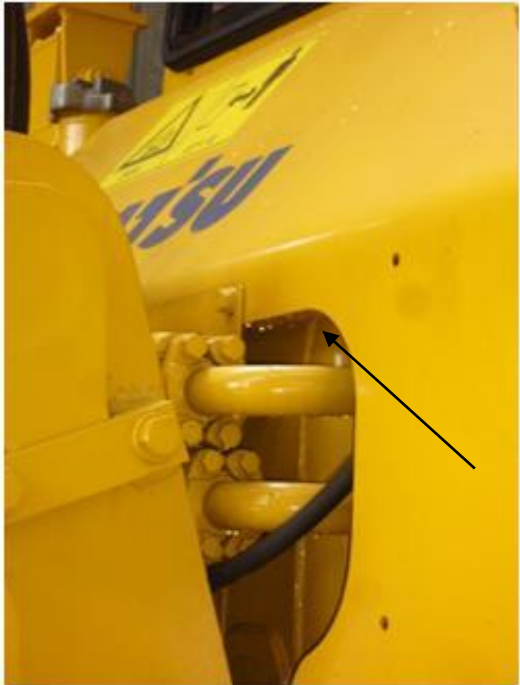
| Description | Images |
|---|---|
| <p>The first part of the inspection of the rear end should include the fuel tanks, including cover plates (black arrows) and accompanying valves, hydraulic pipes and hoses and any lights.</p> | <p>A close-up photograph of the rear end of a yellow bulldozer. A black arrow points to a circular cover plate on the fuel tank. The cover plate has a blue 'KOMATSU' logo. Below the cover plate, there are various hydraulic pipes and hoses.</p> |

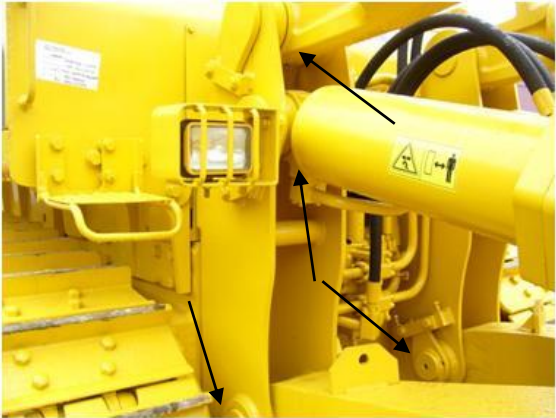
| Description | Images |
|---|---|
| <p>The frame for the ripper cradle has a number of hydraulic cylinders that pivot off the frame that must be flushed. Also various amounts of structural pivot points which all need to be visually inspected and flushed.</p> | |

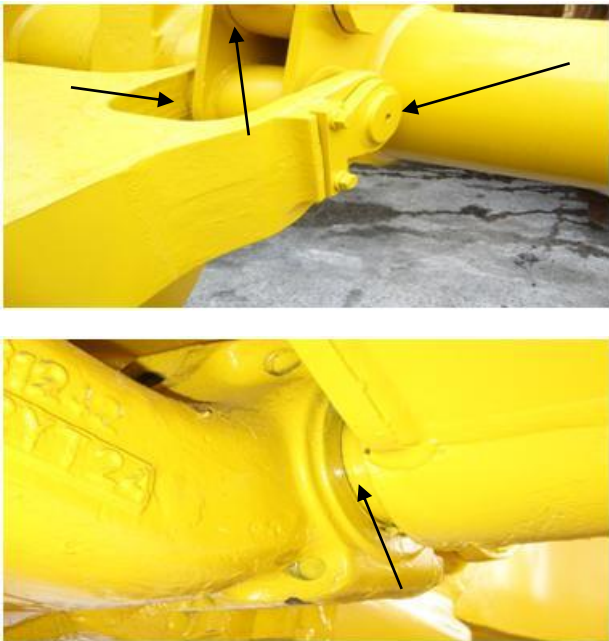
| Description | Images |
|---|---|
| <p>All the pivot points from the ripper cradle must be visually inspected and flushed to ensure cleanliness.</p> | |

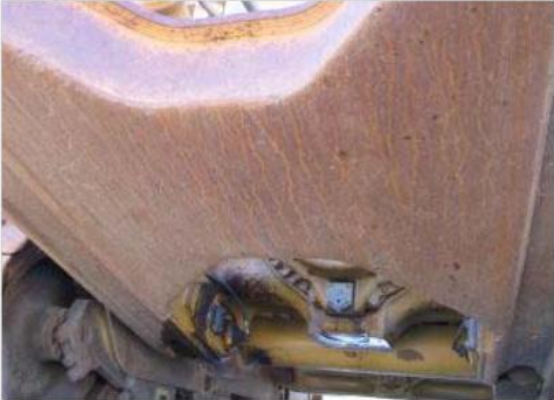
| Description | Images |
|---|---|
| <p>The middle of the ripper cradle is hollow and may not have any drainage holes. If no holes are located check carefully for cracks, splits or evidence of repairs. If there are any cracks/ seams or signs of repair then access will need to be provided to verify cleanliness.</p> | |

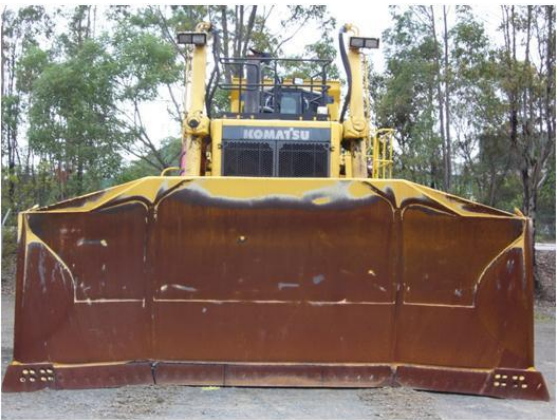
| Description | Images |
|---|---|
| <p>A typical dozer blade with a double skin. The entire blade including the underside must be thoroughly inspected for cracks, seam splits and signs of repair. If any are identified then access will be required to verify cleanliness.</p> | |

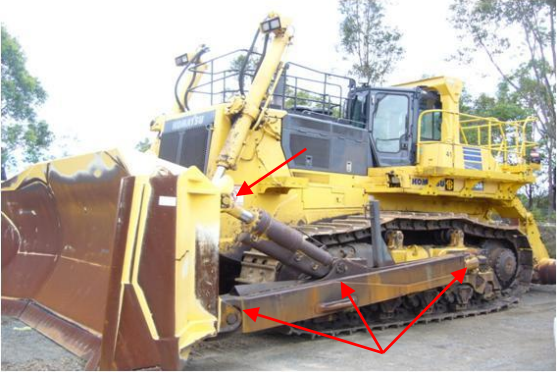
| Description | Images |
|---|---|
| <p>The push arms on a dozer are generally a sealed unit, but check for any cracks, splits or signs of repairs. Ensure all contaminated grease from pivot points is removed.</p> | |

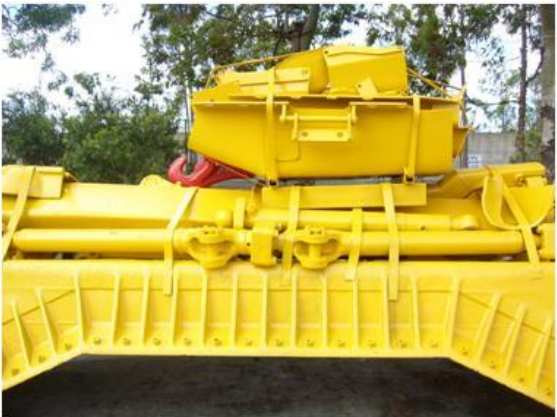
| Description | Images |
|---|---|
| <p>Blade pack as it's commonly imported.</p> <p>Ensure the parts that are welded to the blade are removed and individually inspected. If the blade pack is presented for inspection in this manner, request access to be provided for each individual piece and removed prior to re-inspection.</p> | |

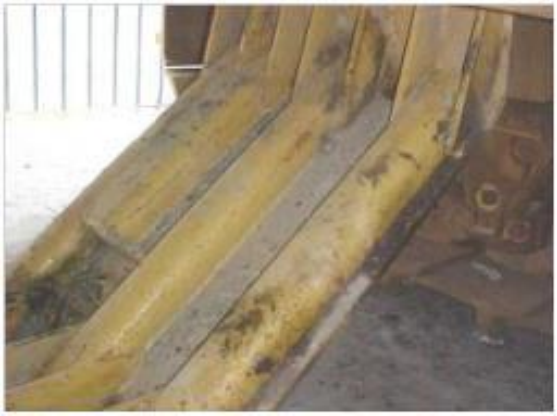
| Description | Images |
|---|---|
| <p>Most belly pans have hollow structural framework that might have drainage holes that require flushing. Check for cracks, splits or signs of repair.</p> | |

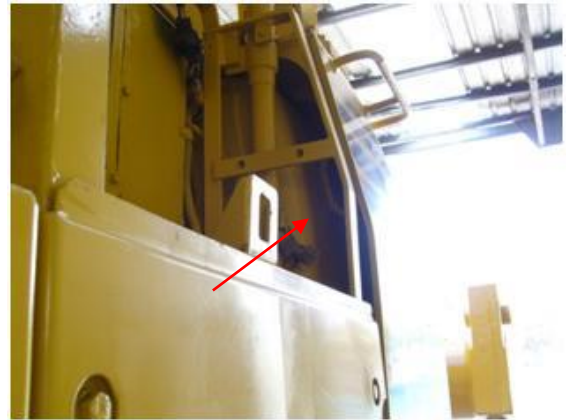
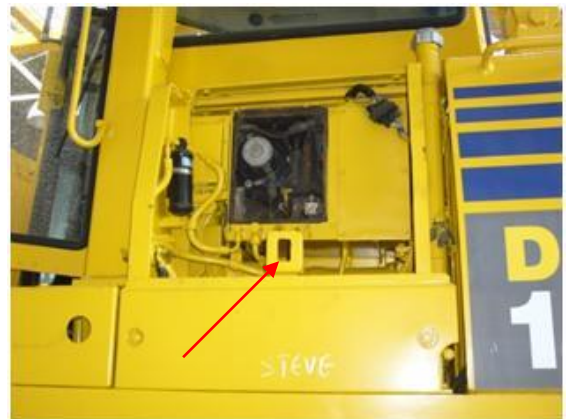
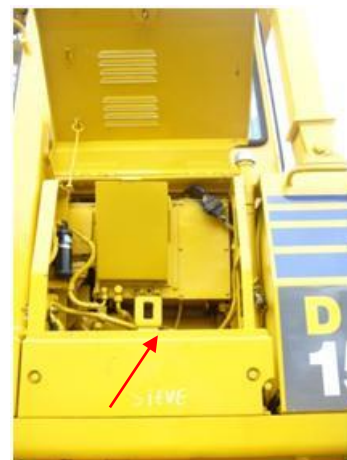
These pictures identify compartments along the side of the machine that require opening and full inspection. Thoroughly inspect all pipes, clamps, brackets and any hidden support channels for biosecurity risk material. Battery must be loosened and flushed underneath.

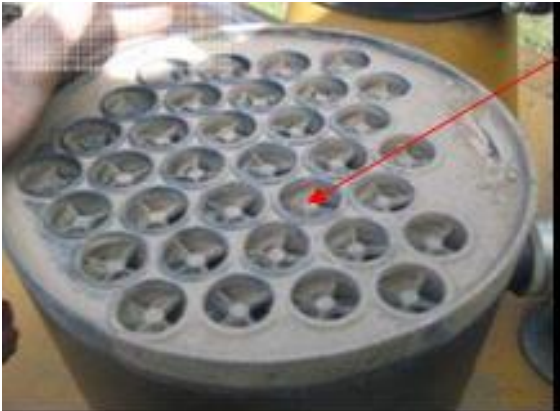
| Description | Images |
|---|---|
| <p>All pre-cleaners and air filters must be dismantled and thoroughly inspected</p> <p>If the air filter can't be air cleaned then an ATT must be obtained for destruction.</p> | A photograph of a circular air filter assembly, likely from a Komatsu Dozer. It features a grid of small, circular individual filters. A red arrow points to one of these filters, indicating it should be inspected or dismantled. |

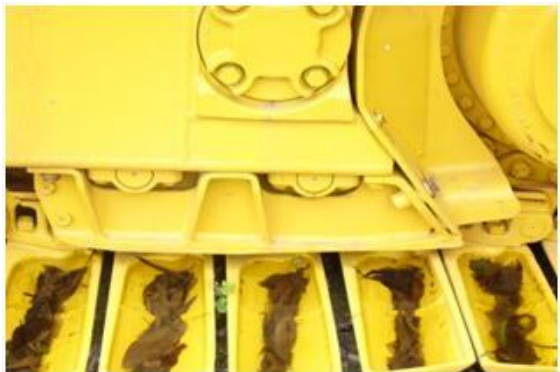
| Description | Images |
|---|---|
| <p>This picture illustrates a different version of the tracks that may be presented. It highlights the need to rotate the tracks prior to completion.</p> | A photograph showing a close-up of yellow tracks on a machine. The tracks are composed of multiple segments, and the image highlights the need to rotate them for proper alignment or completion. |

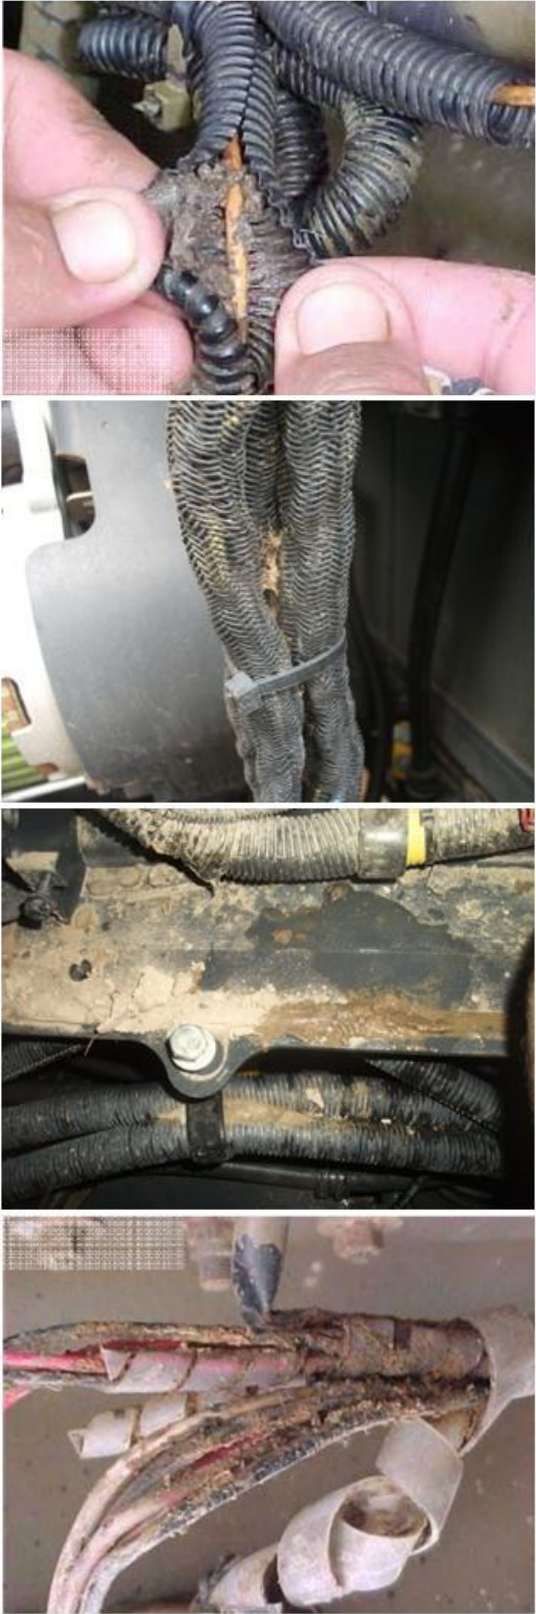
| Description | Images |
|---|---|
| <p>All hydraulic hose armour guard (protection for the hose against rubbing) and electrical wiring looming must be opened and carefully inspected and cleaned.</p> | <p>The images show four different locations on a Komatsu Dozer where the hydraulic hose armour guard and electrical wiring looming have been damaged. The top photo shows a close-up of a hand peeling back the black rubber armour guard, revealing the underlying braided metal hose. The second photo shows a similar damage on a hose running vertically. The third photo shows a hose running horizontally under a metal plate, with the armour guard missing in several places. The bottom photo shows a close-up of the electrical wiring looming, which is a bundle of wires wrapped in a protective sheath, showing significant wear and damage to the outer layer.</p> |

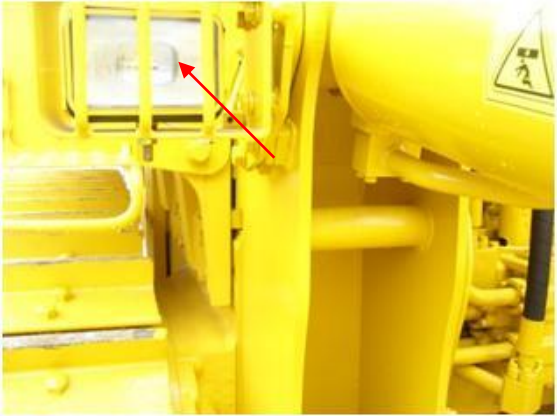
| Description | Images |
|---|---|
| All lights must be verified internally clean. | |

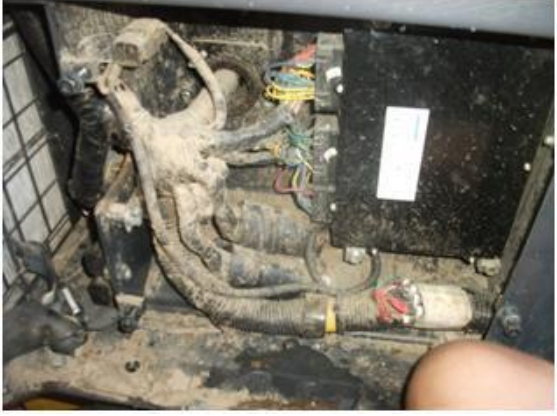
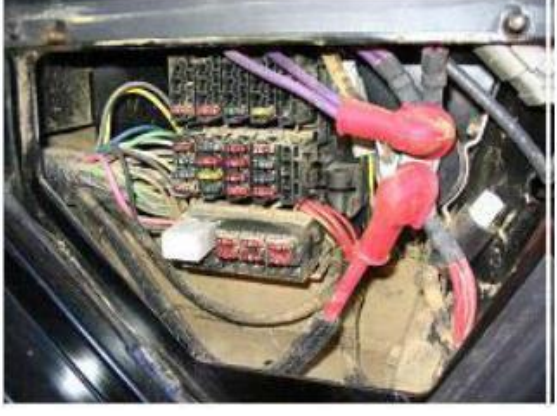
| Description | Images |
|---|---|
| The electrical areas must be inspected and any biosecurity risk material removed. | |
