The relationship between riparian vegetation, bank erosion and channel pattern, Magela Creek, Northern Territory

Thesis submitted in part fulfilment for Honours Degree, Bachelor of Science, School of Geosciences, University of Wollongong, 2002

Luke Erskine

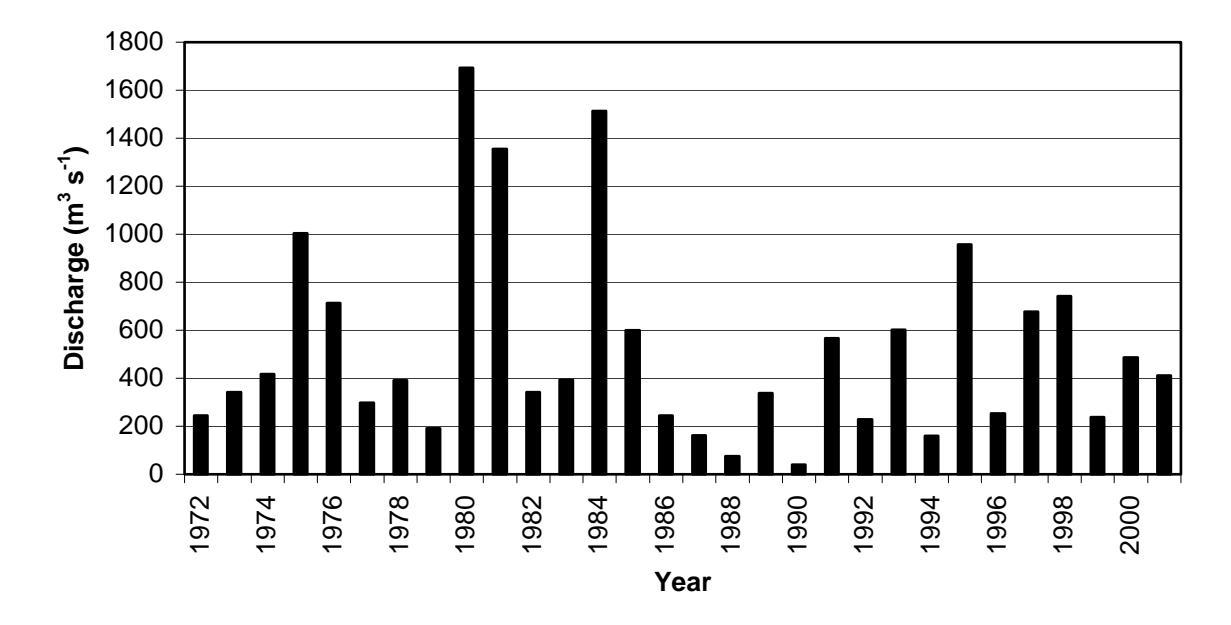
Figure 3.2: Maximum annual floods from 1972-2001. Note: Bankfull discharge is ~40 m<sup>3</sup> s<sup>-1</sup> (Northern Territory Department of Infrastructure, Planning and Environment 2002).

inundation occurs approximately 12 times per year for a total of 40 days above bankfull flow which is achieved at a discharge of ~ 40 m<sup>3</sup> s<sup>-1</sup> (Northern Territory, Department of Infrastructure, Planning and Environment, 2002). The Holocene trench is generally 110-190 m wide and extends up to 370 m close to Mudginberri Billabong (Jansen and Nanson, in prep.). The 2-year recurrence interval is approximately 10 times the bankfull discharge. Therefore, Magela Creek experiences a high degree of flow variability and this appears to be one of the most important aspects involved in the formation of anabranching rivers. The majority of annual flow is passed during the Wet, with 80 % during the wettest months (December to March) and the Creek ceases to flow during the Dry season (approximately 44 days per year) (Northern Territory, Department of Infrastructure, Planning and Environment, 2002). The sandy channels remain dry and the only permanent water is contained within several large billabongs (e.g. Mudginberri). The large amount of bare rock surfaces and thin soil, combined with the almost seasonal pattern of burning, promotes surface runoff that is usually rapid (Nanson *et al.*, 1993).

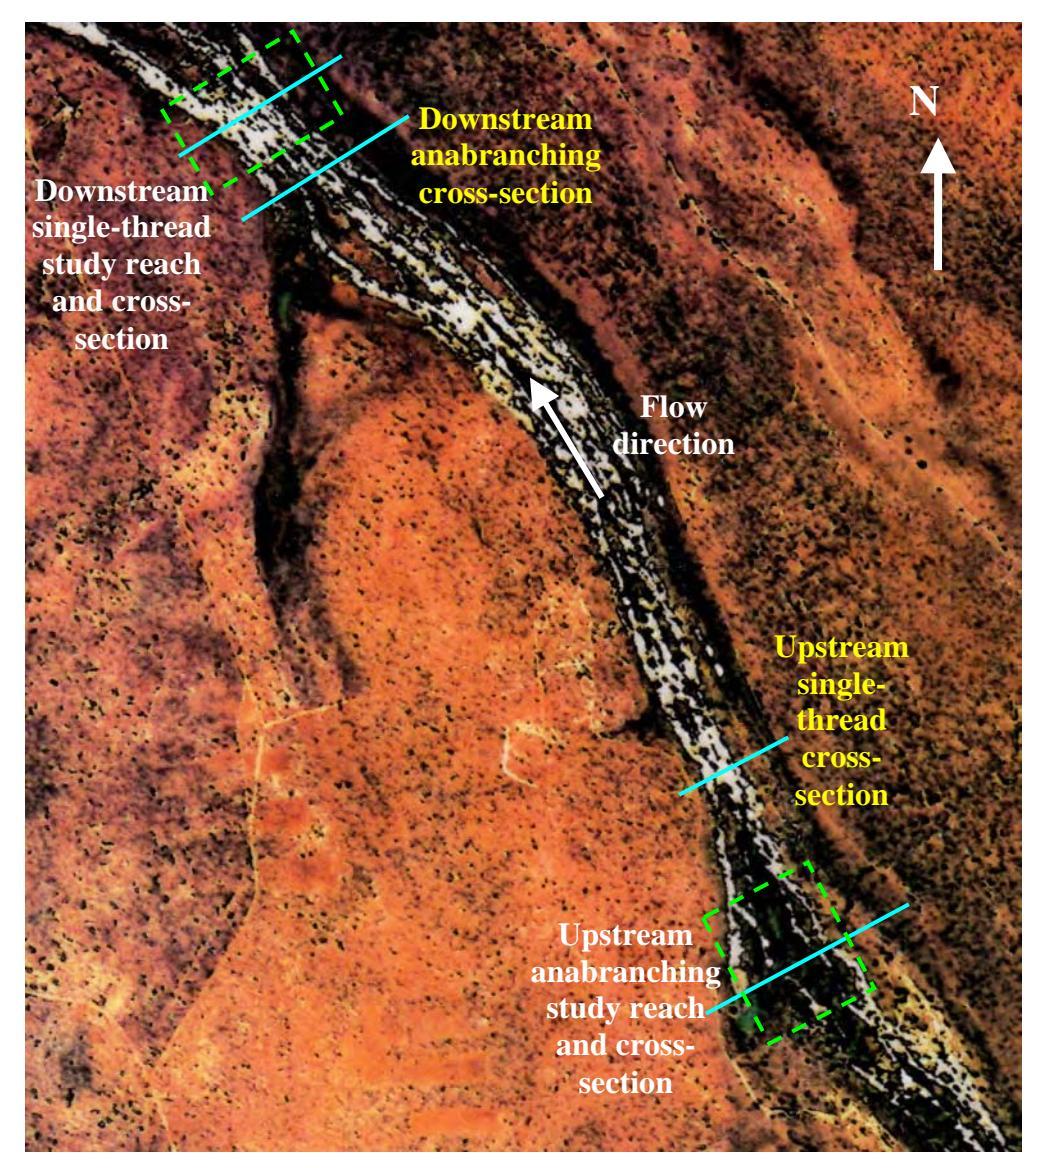
Figure 4.1: Detailed vegetation mapping and transect locations. Source: Airesearch Mapping, Jabiluka, Run 2 032-046, 29/8/97.

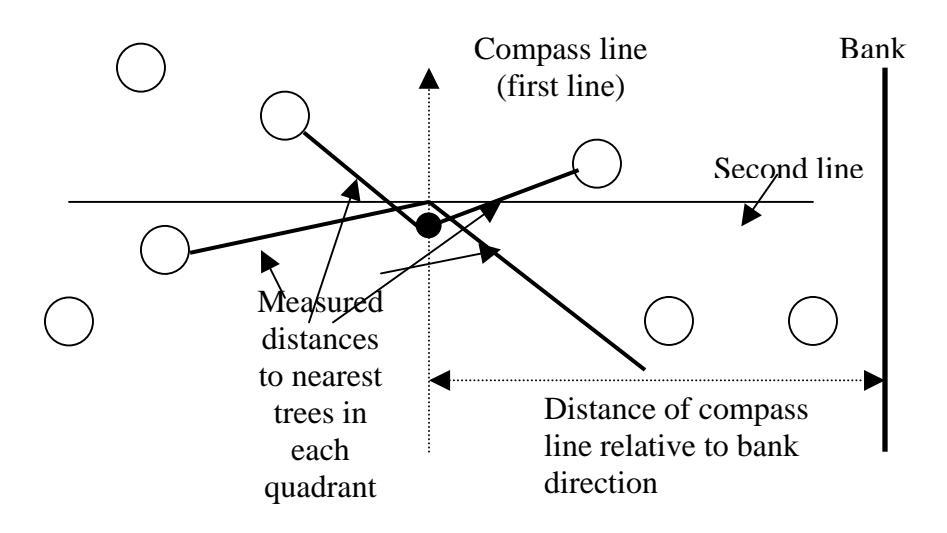
Figure 4.2: Point-centred quarter tree density method. (after: Mueller-Dombois and Ellenberg, 1974).

The density and basal area coverage of trees along the banks of the upstream anabranching and downstream single-thread study reaches were measured using the point-centred quarter method as outlined by Mueller-Dombois and Ellenberg (1974) (see Figure 4.2). Ten point-centred quarter measurements were taken along each bank at the single-thread site (40 points on each bank) and 5 point-centred quarters on each bank at the anabranching site (20 points on each bank, 40 points for each channel). The line of the bank was followed at a distance from the bank that varied between sites to allow tree measurements to be made on the channel side. A tape measure was extended along the bank and at 10 m intervals at the upstream anabranching and 15 m intervals at the downstream single-thread, a four-point measurement of the distance to the nearest tree in each quadrat was calculated (Figure 4.2). Care had to be taken not to measure the same tree twice and to leave a sufficient gap on the channel side to allow for trees to be measured. For each tree, the base and chest diameter were recorded, as well as the distance from the centre point of the plot.

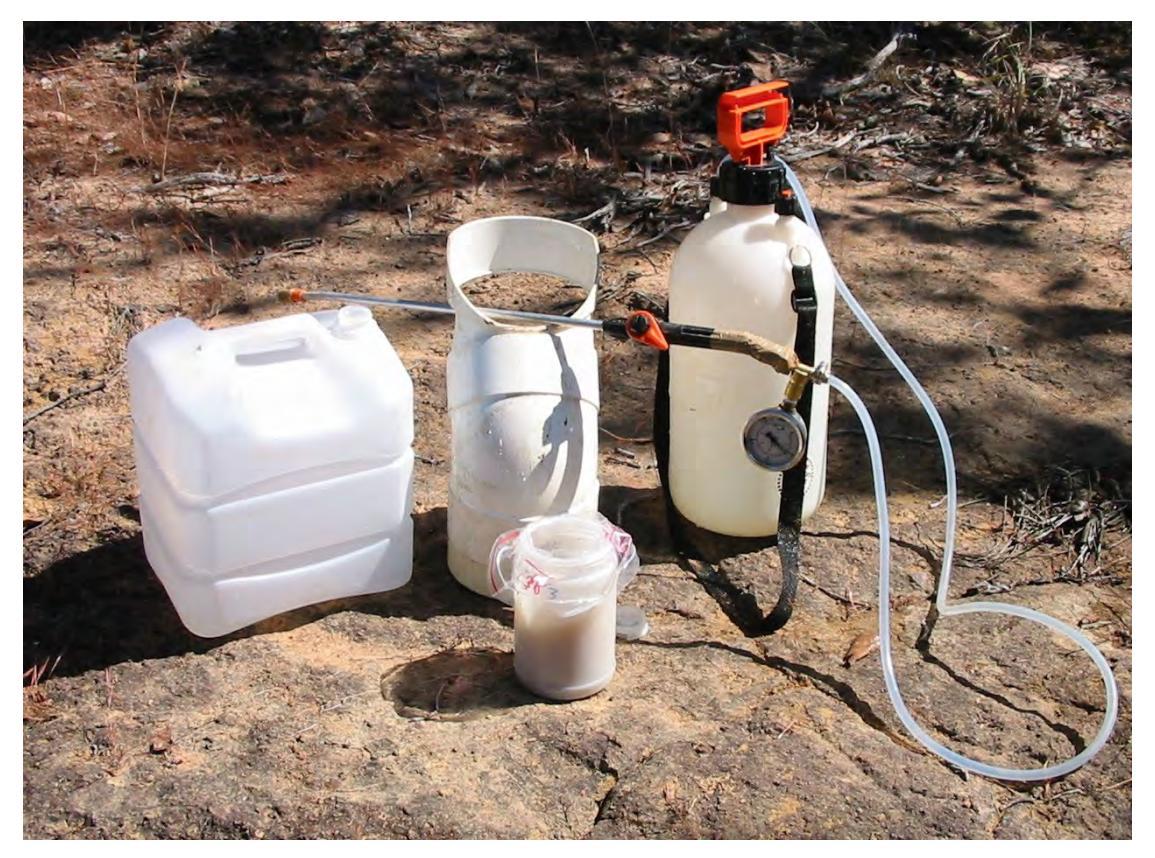
Figure 4.3: The pump pack with pressure gauge attached is on the right. The catcher standing in the upright position is in the middle. In the foreground is a plastic container with a sample bag inside (for added security). On the left is a 15-litre water drum used to carry water to areas where none was available.

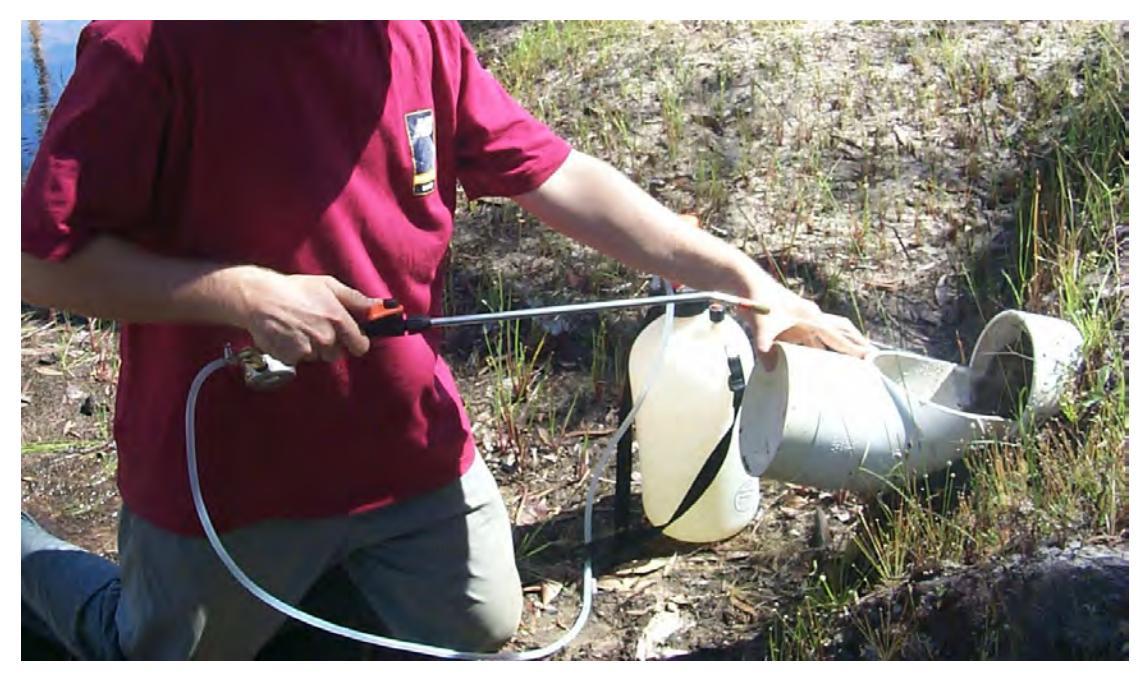
Figure 4.4: Side view of the hydro jet in operation on a root mat surface.

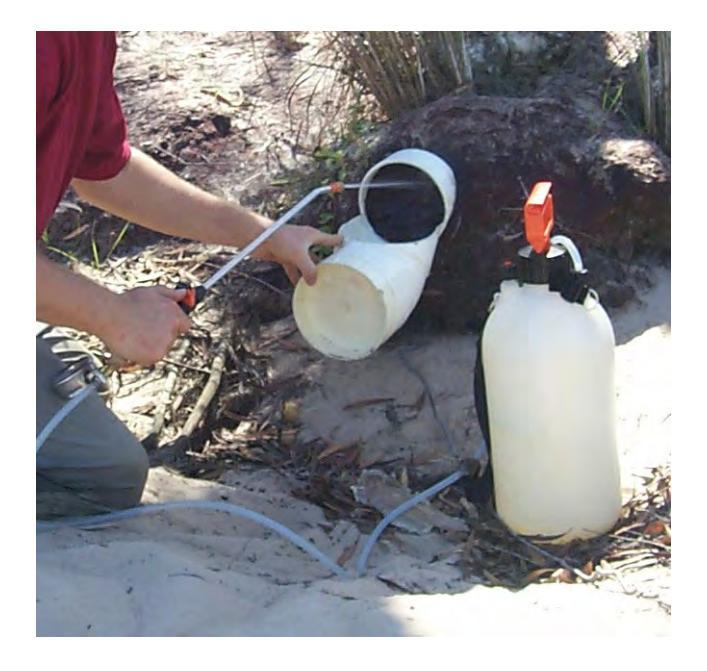
Figure 4.5: View from behind the hydro jet in operation on a root mat surface.

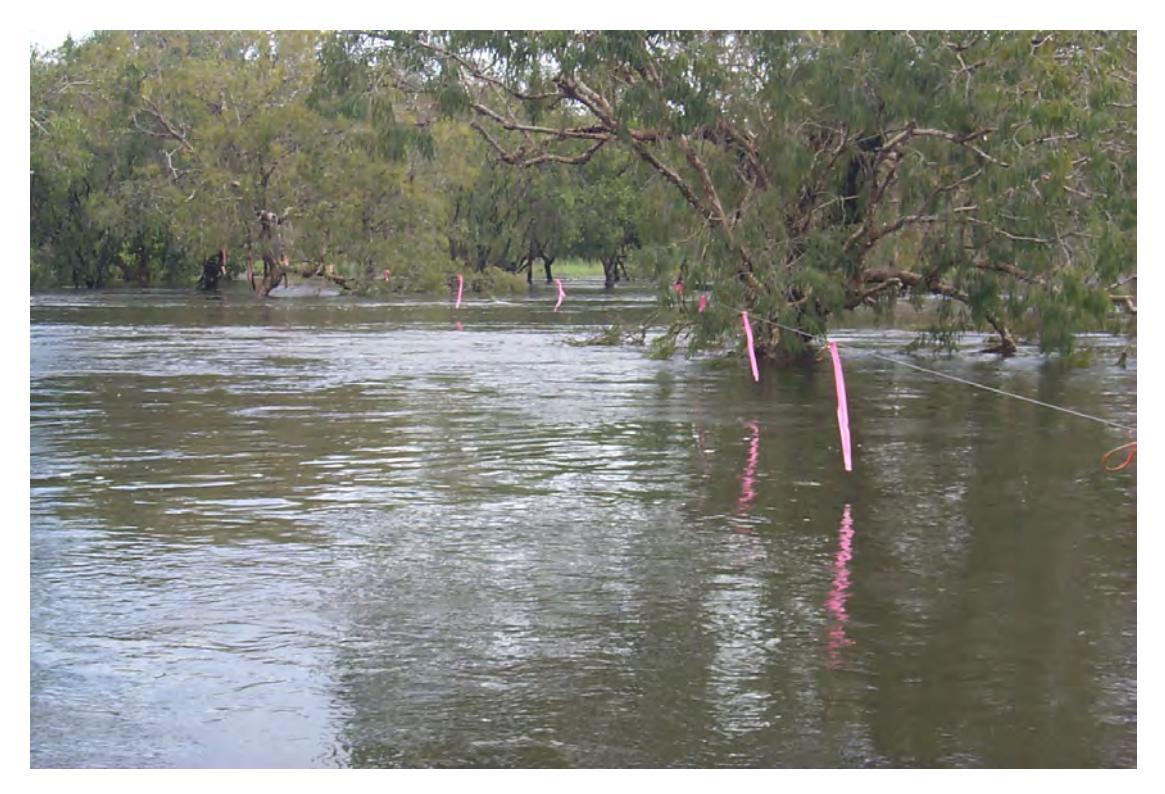
Figure 4.6: Location of the 5 m intervals between sites along the suspended cable at the downstream single-thread reach. Note: flow is from right to left. The left bank is 15 metres behind photographer and right bank is in the distance (grass is visible on the right bank through gaps in the trees).

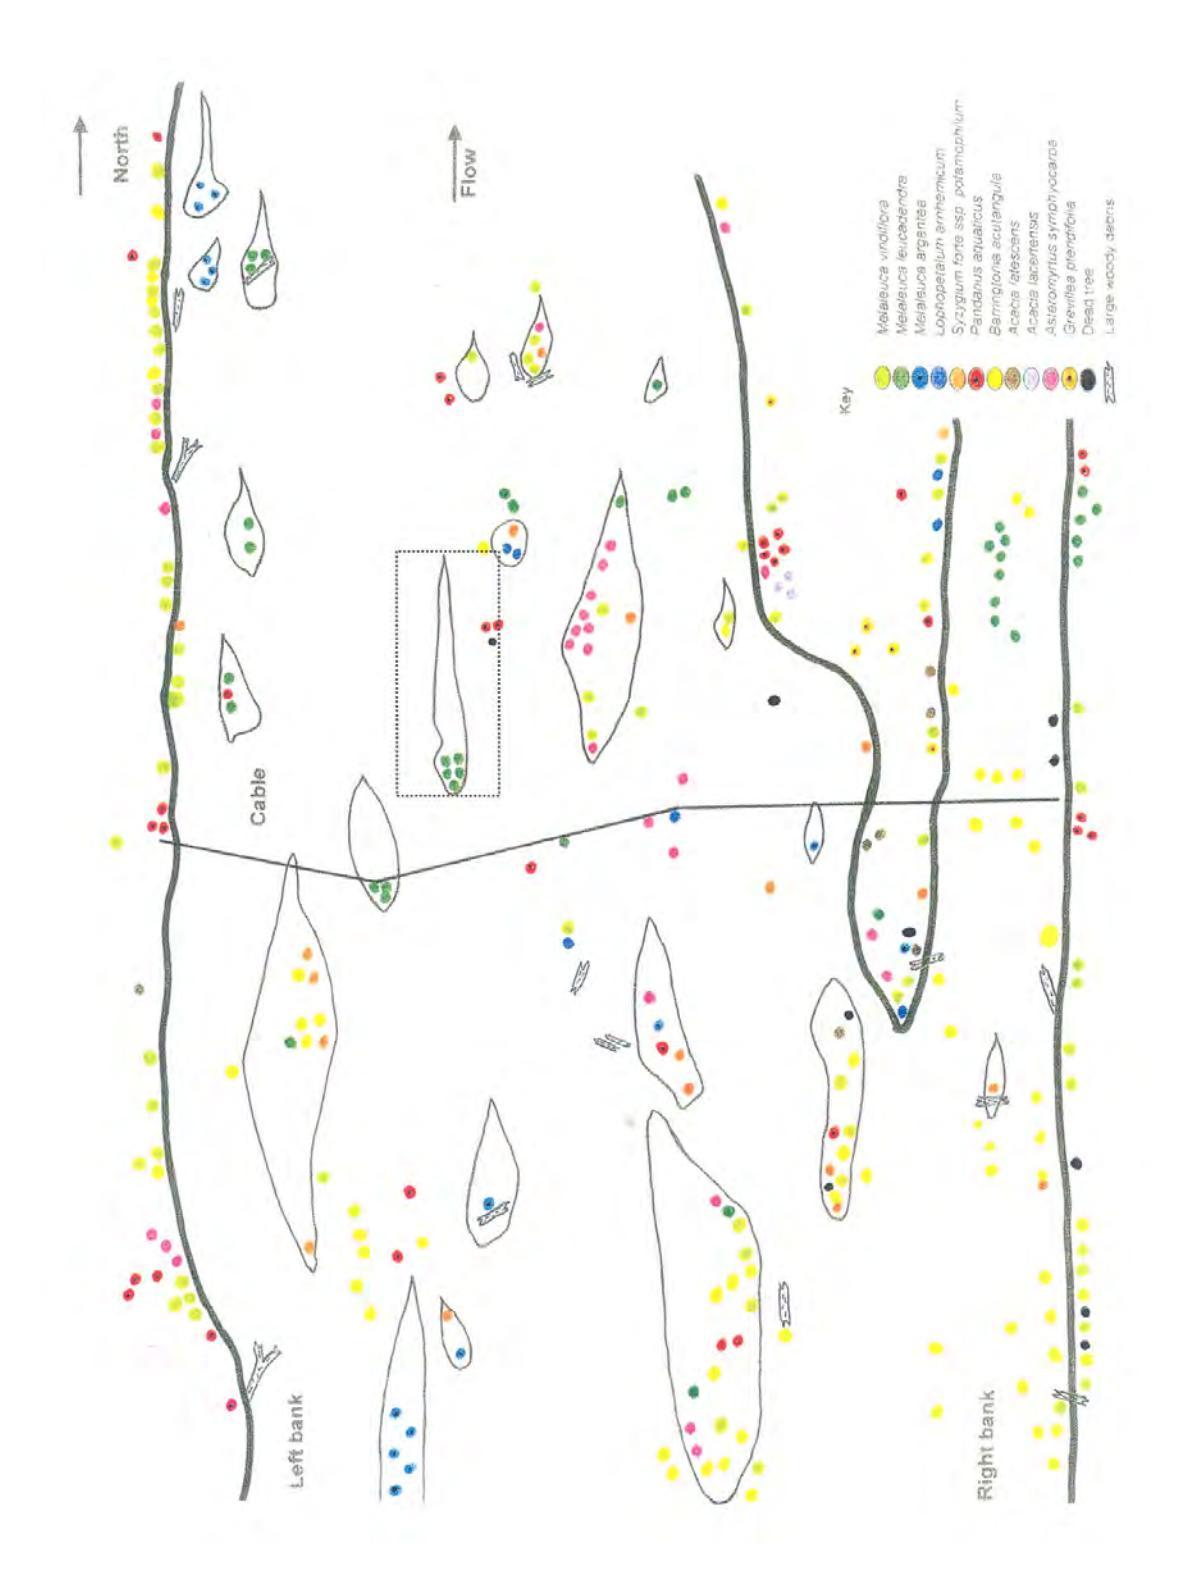
Figure 5.1: Single-thread vegetation map. The bold lines represent the areas that are at or above bankfull level. The highlighted bar shows the location of the velocity profiles in Figures 5.20 and 5.21.

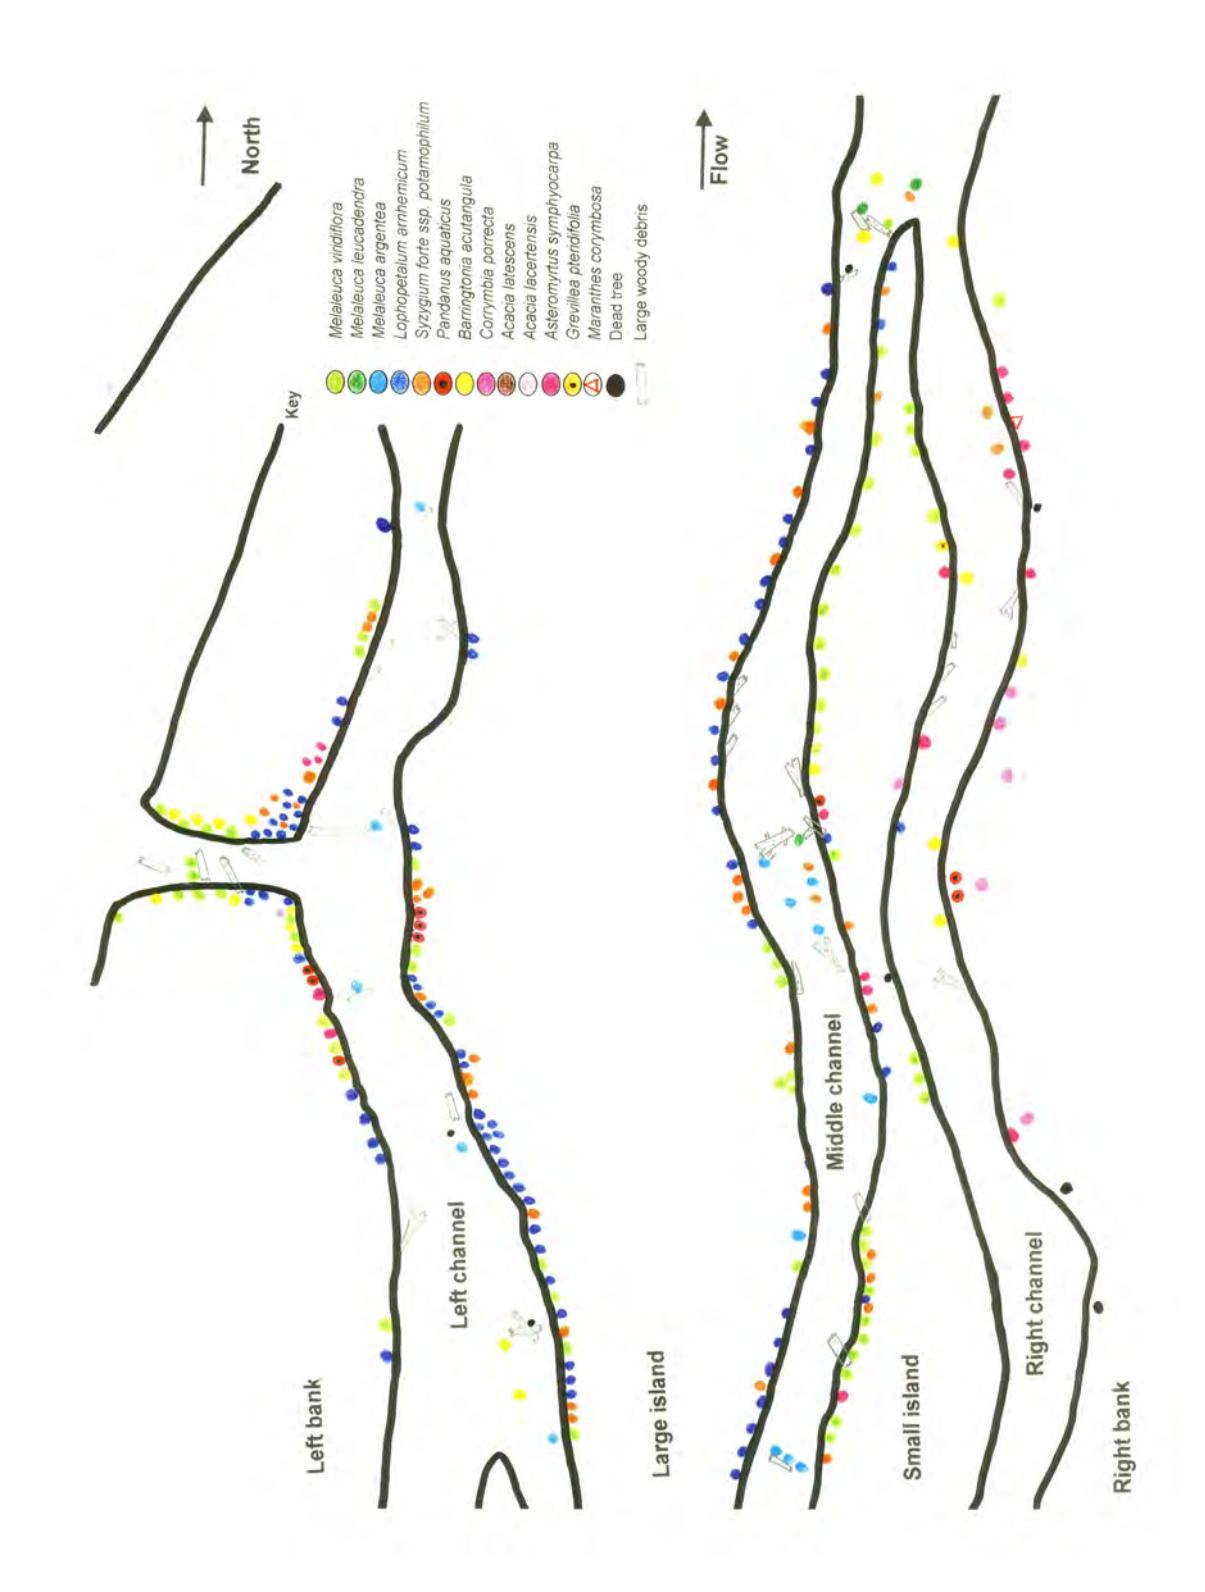
Figure 5.2: Anabranching study reach vegetation map. The bold lines represent the areas that are at or above bankfull level. The highlighted area in the left channel shows the location of the tree bank velocity profiles in Figure 5.18.

Figure 5.2 illustrates the distribution of tree species lining the banks of all three channels and the within-channel vegetation and LWD of the upstream

anabranching study reach. The anabranching reach had a higher density of trees lining the left and middle channels. The composition of dominant species reflected that of a monsoon riparian forest.

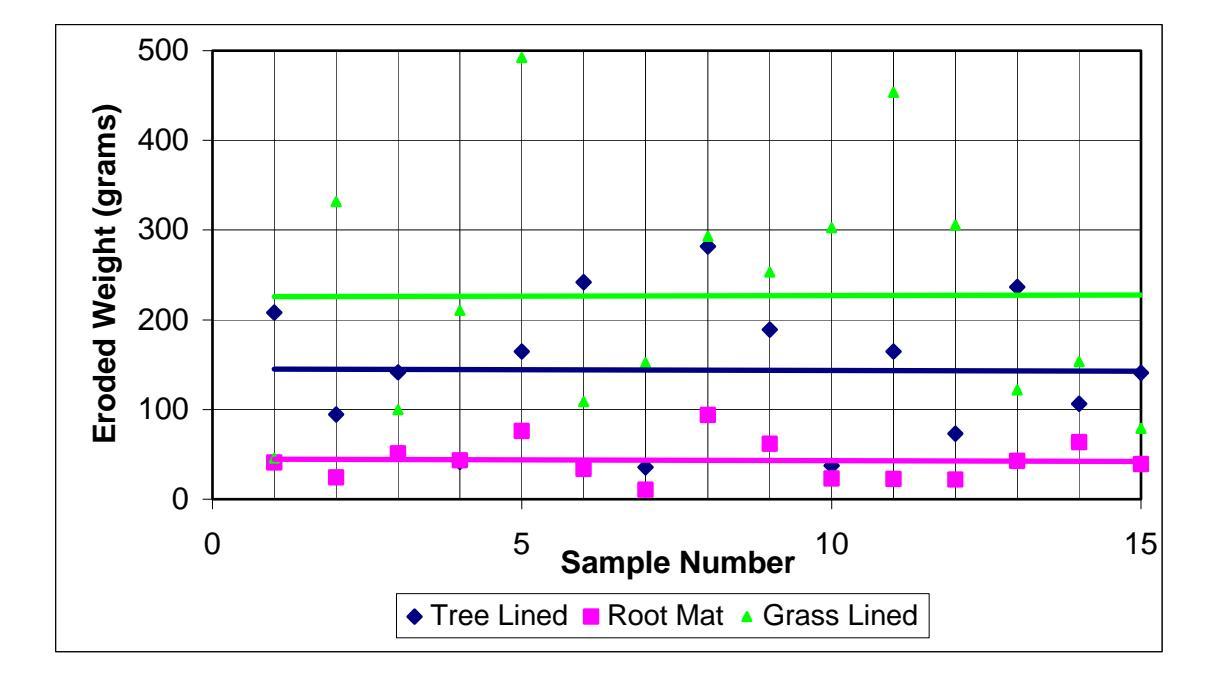
Figure 5.10: Hydraulic erosion jet measurements with averages fitted to each surface (Mean: Grass-lined = 227grams, Tree-lined = 144grams and Root mat = 43grams).

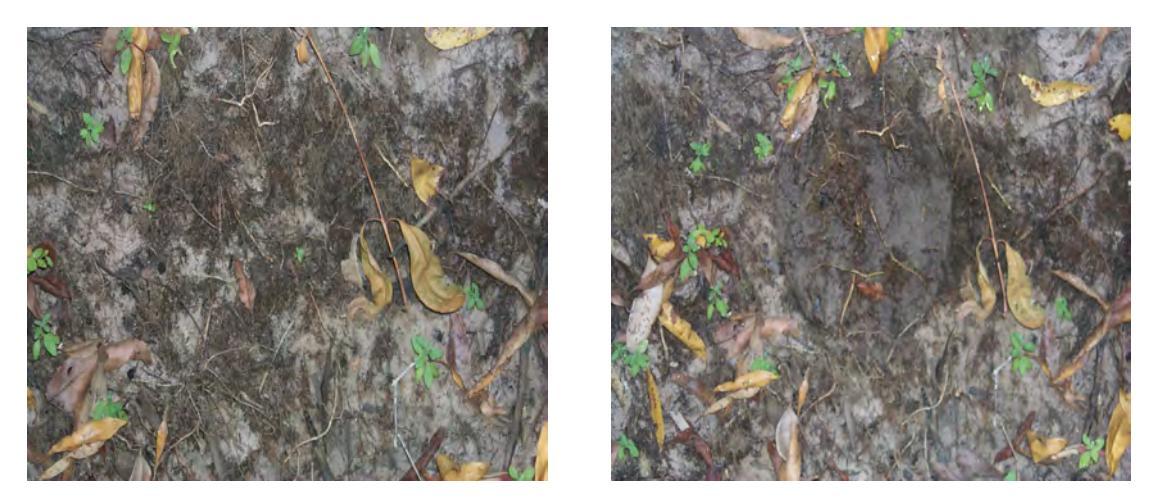
Figure 5.11A and B: Before and after erosion testing a tree-lined bank.

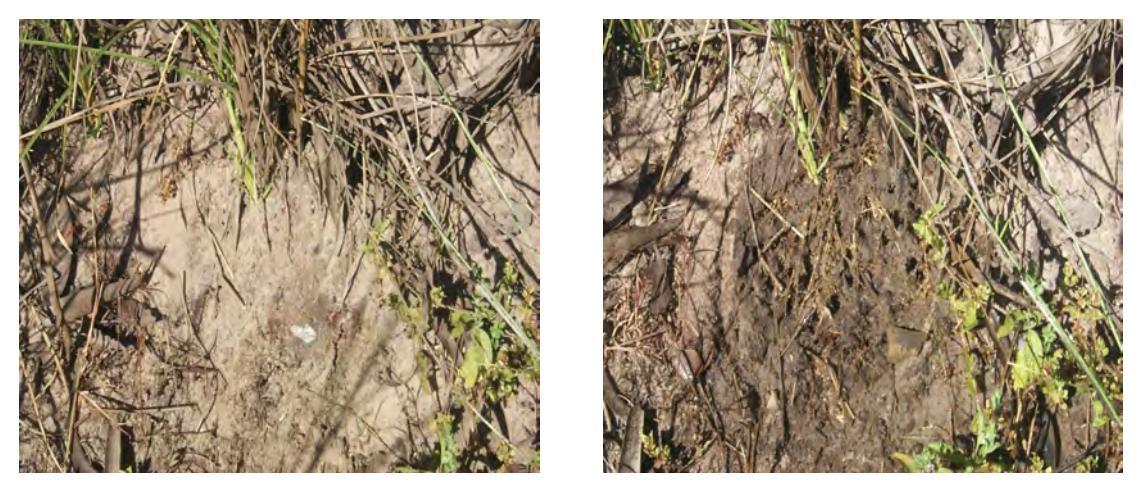
Figure 5.11C and D: Before and after erosion testing a grass-lined bank.

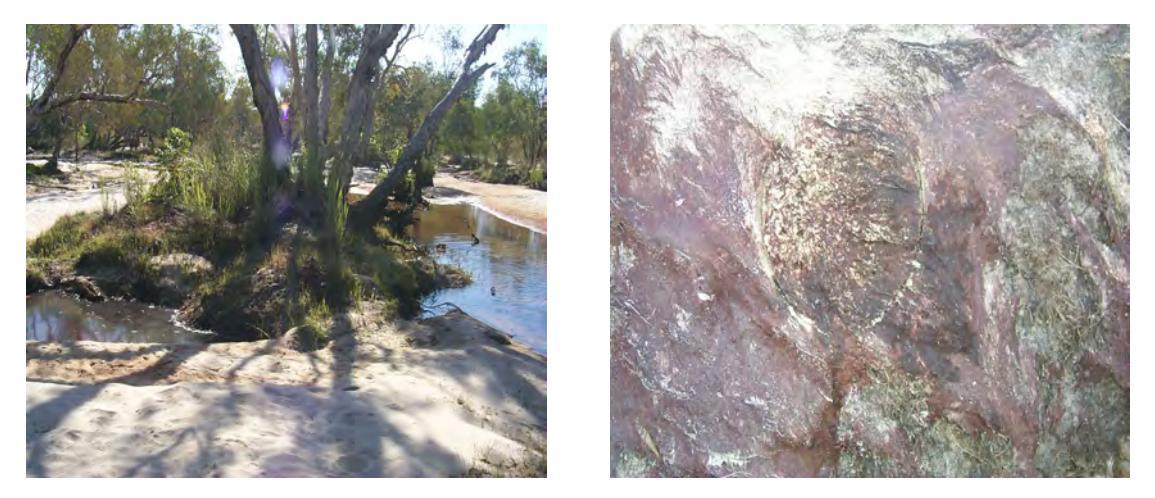
Figure 5.11E and F: Location of root mat tests at the head of bar (left) and after a root mat erosion test (right).

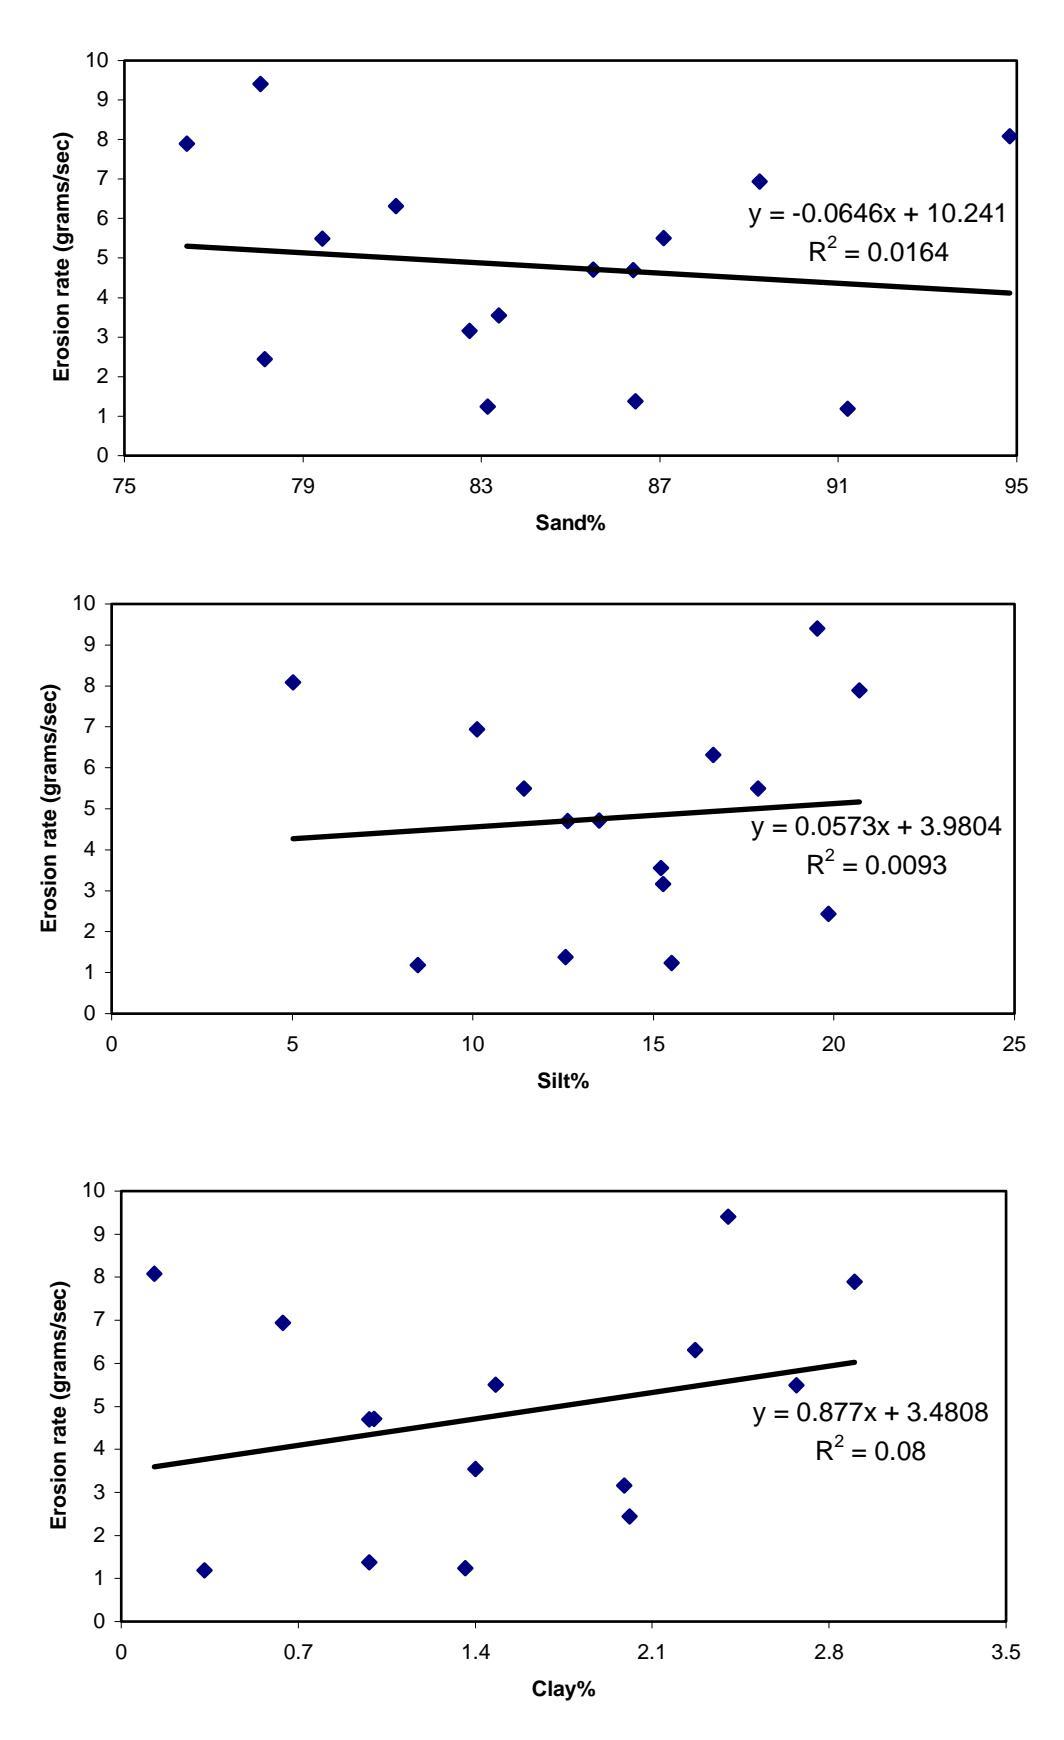
Figure 5.12: Sedimentology and erosion rate for tree-lined surfaces.

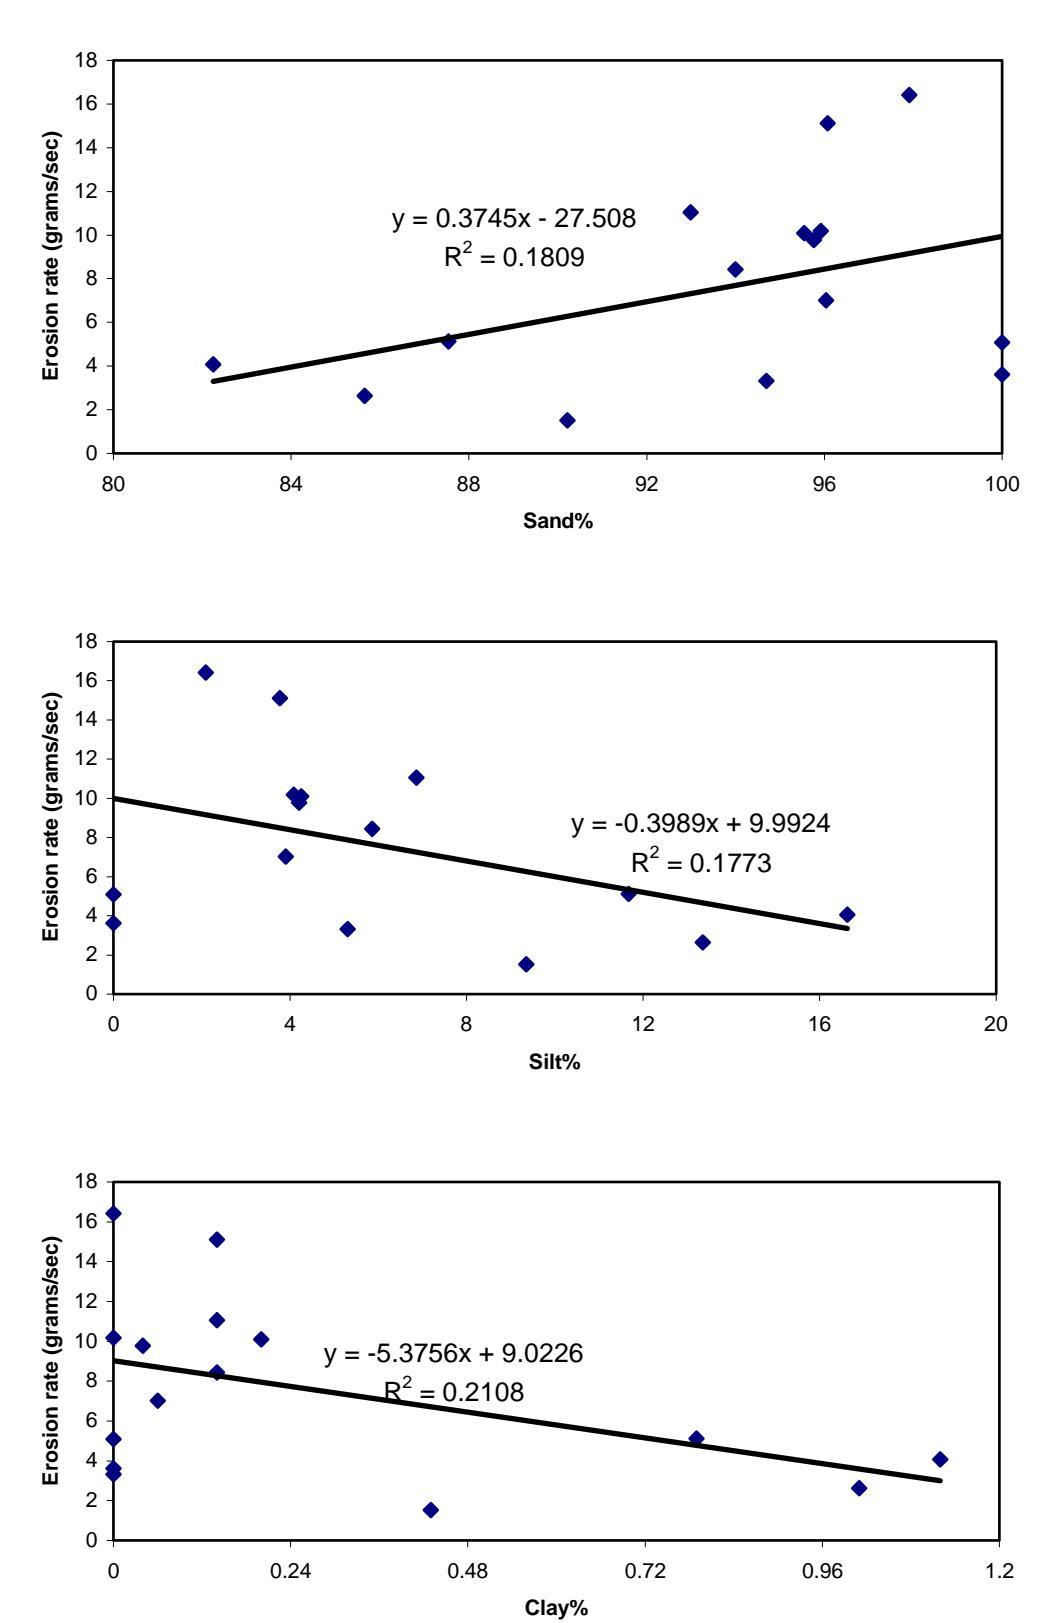
Figure 5.13: Sedimentology and erosion rate for grass-lined surfaces.

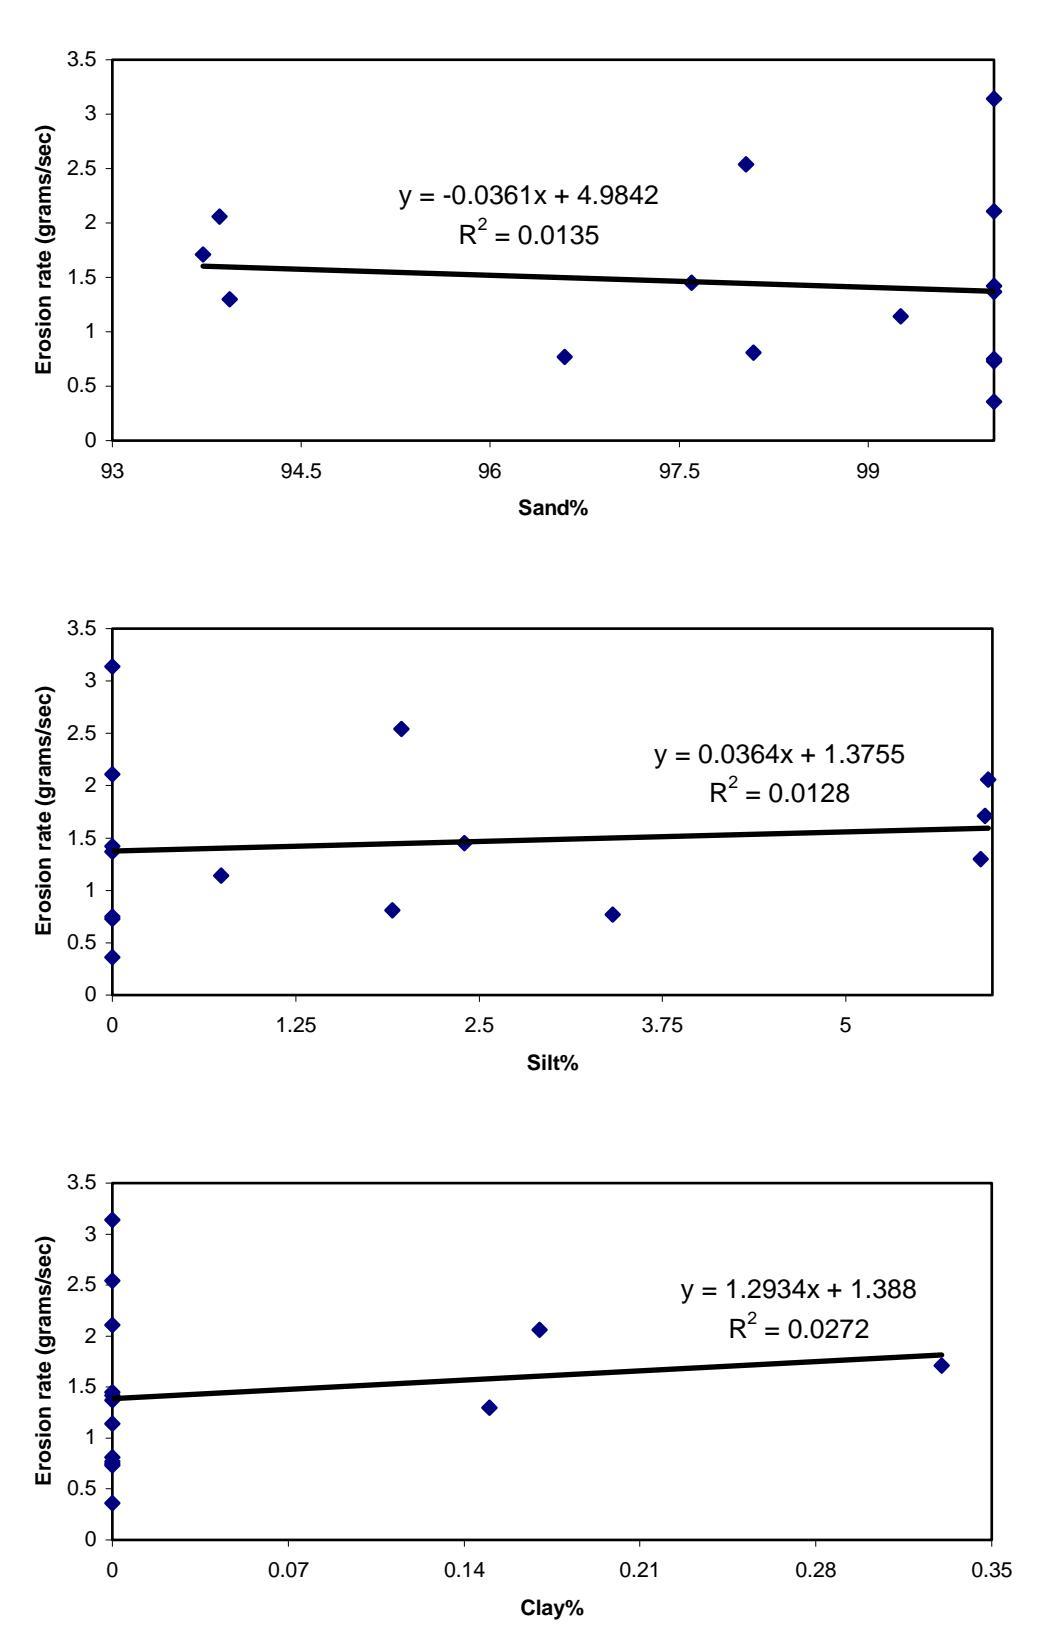
Figure 5.14: Sedimentology and erosion rate for root mat test surfaces.

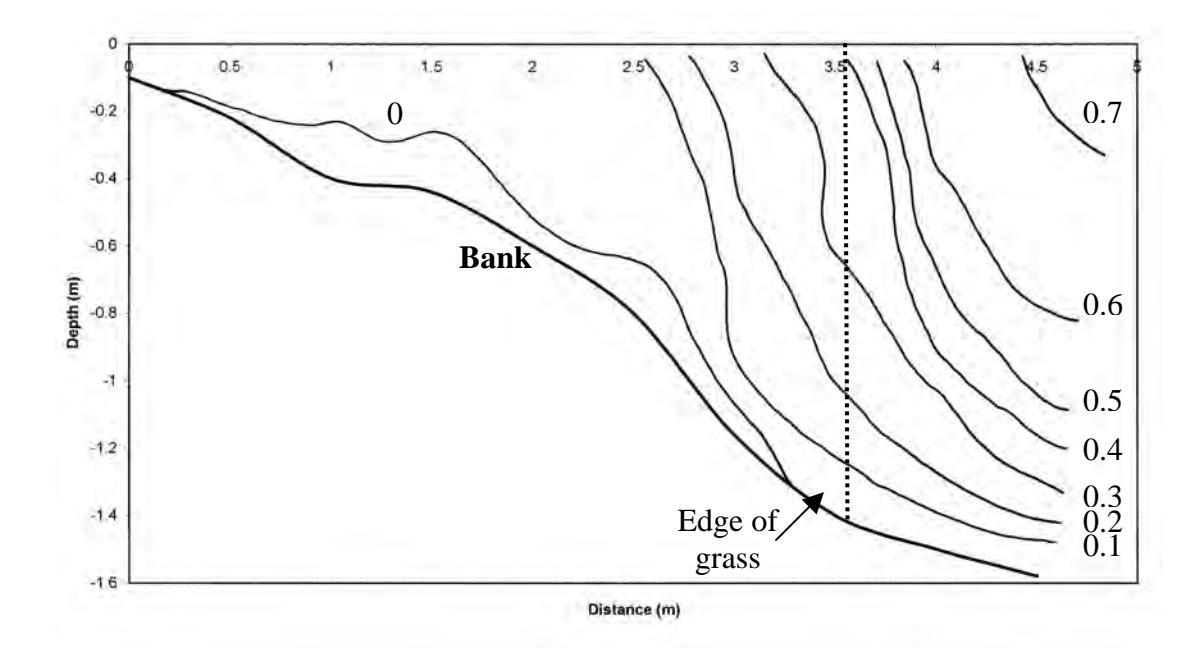
Figure 5.15: Grass velocity profile 1. Velocities are shown in m  $s^{-1}$ .

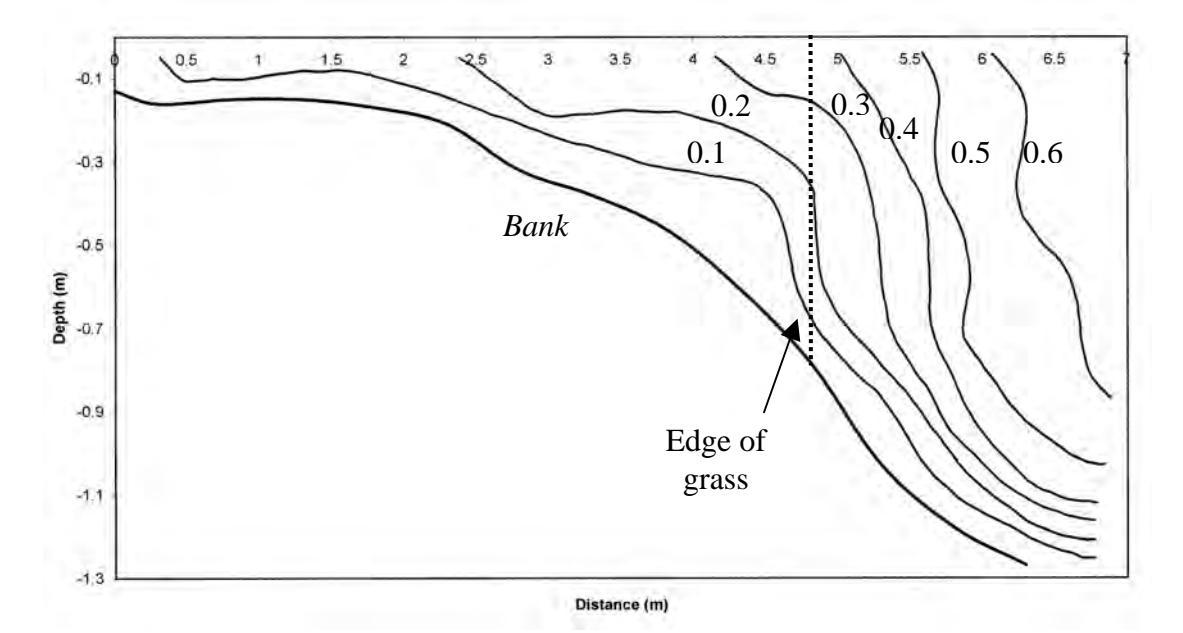
Figure 5.16: Grass velocity profile 2. This was located downstream of

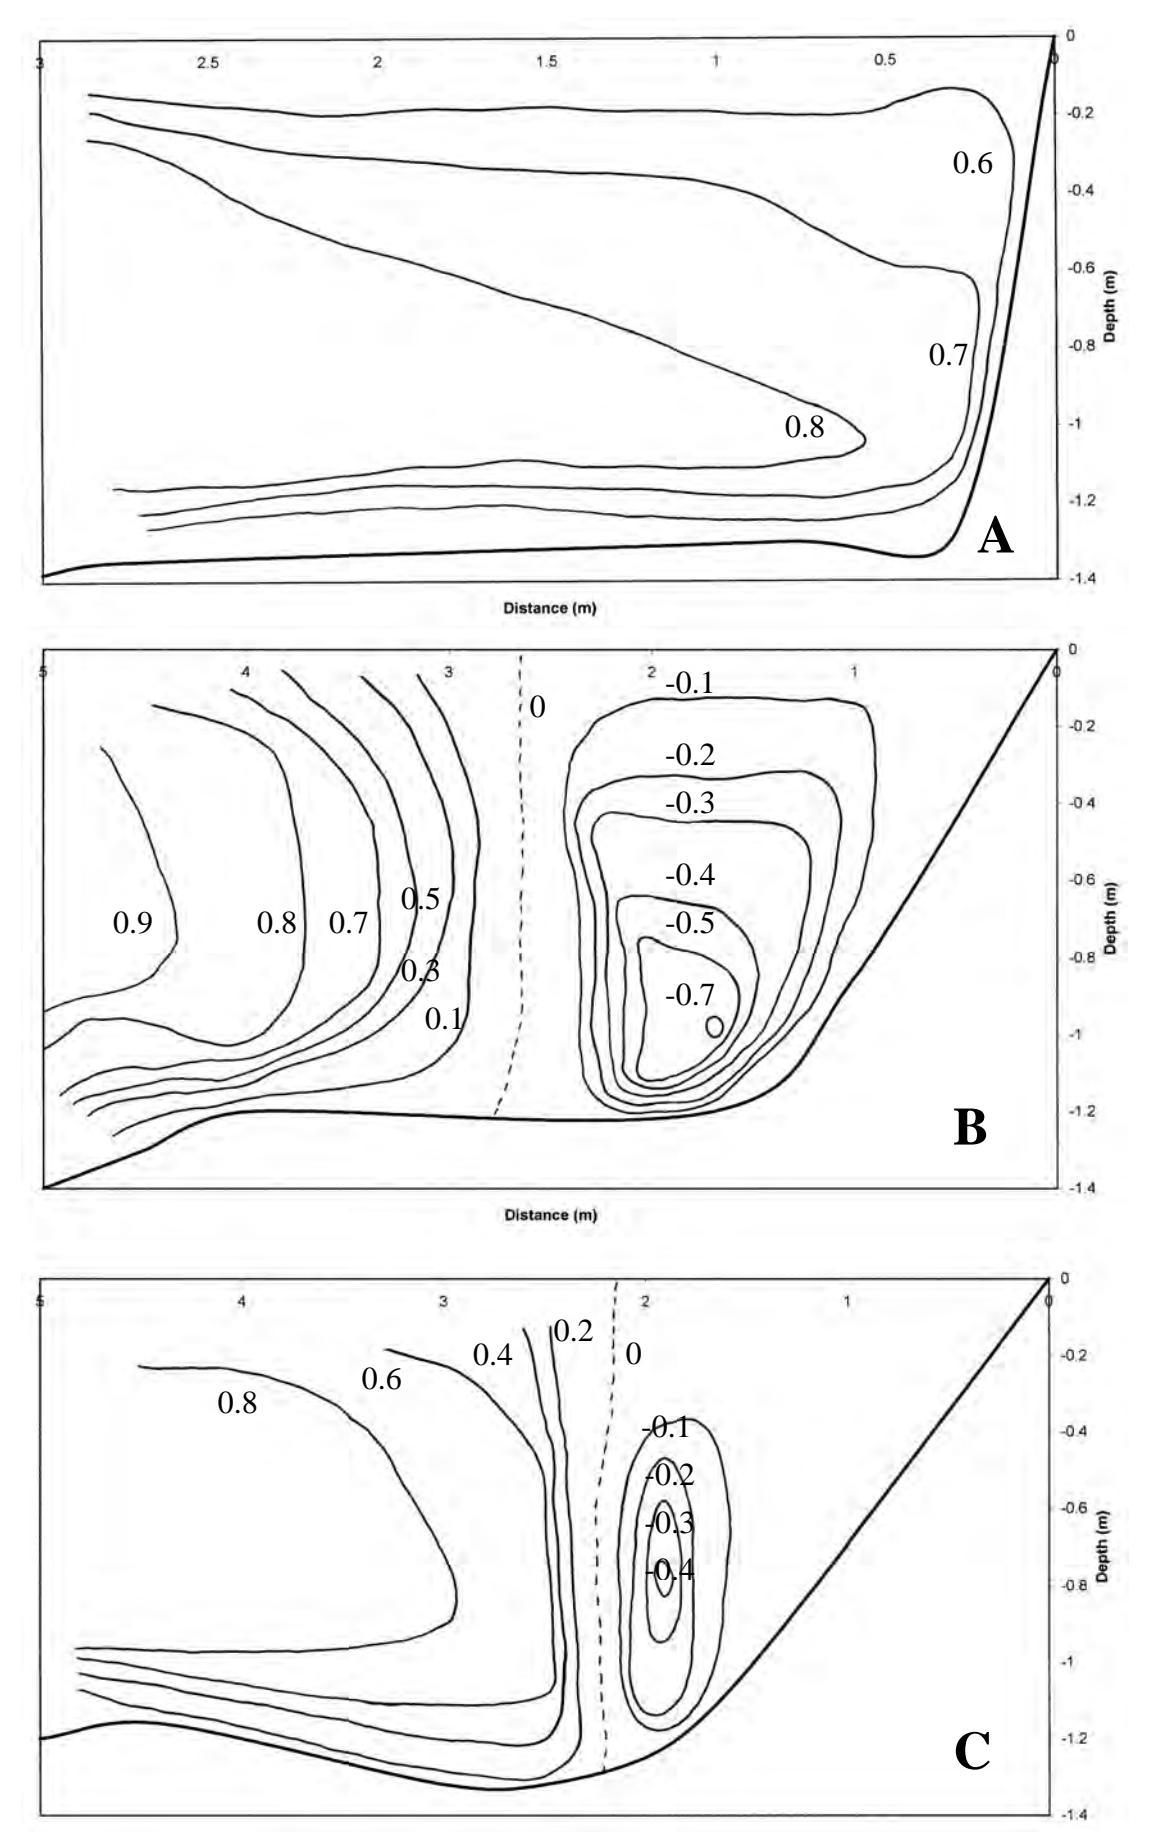
Figures 5.18 A, B and C: Velocity measurements adjacent to a tree-lined bank. 'A' is in the upstream end, 'C' the downstream. Velocities are shown in m s<sup>-1</sup>.
