The relationship between riparian vegetation, bank erosion and channel pattern, Magela Creek, Northern Territory

Thesis submitted in part fulfilment for Honours Degree, Bachelor of Science, School of Geosciences, University of Wollongong, 2002

Luke Erskine

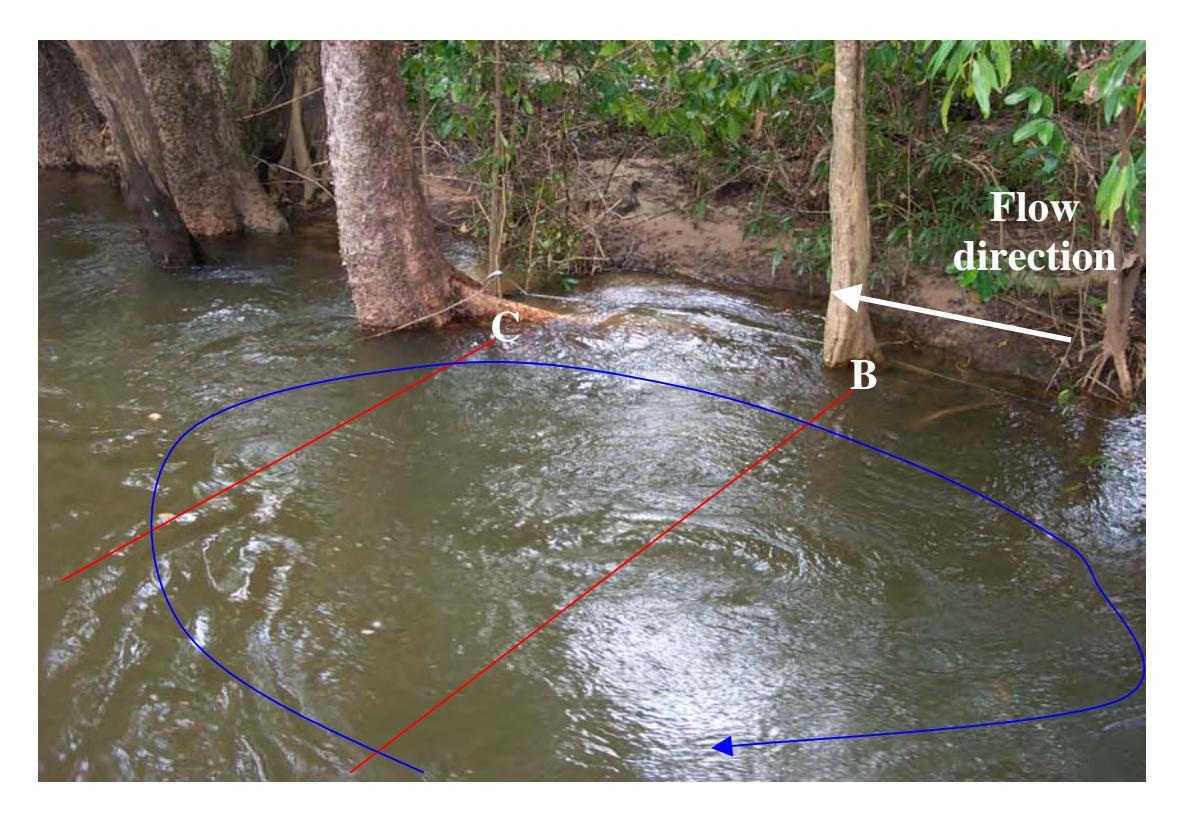
Figure 5.19 A: View of the tree-formed erosional alcove for which velocity measurements were made. The blue line indicates the movement of flow within the alcove. The velocity profiles are shown in Figure 5.18 B and C.

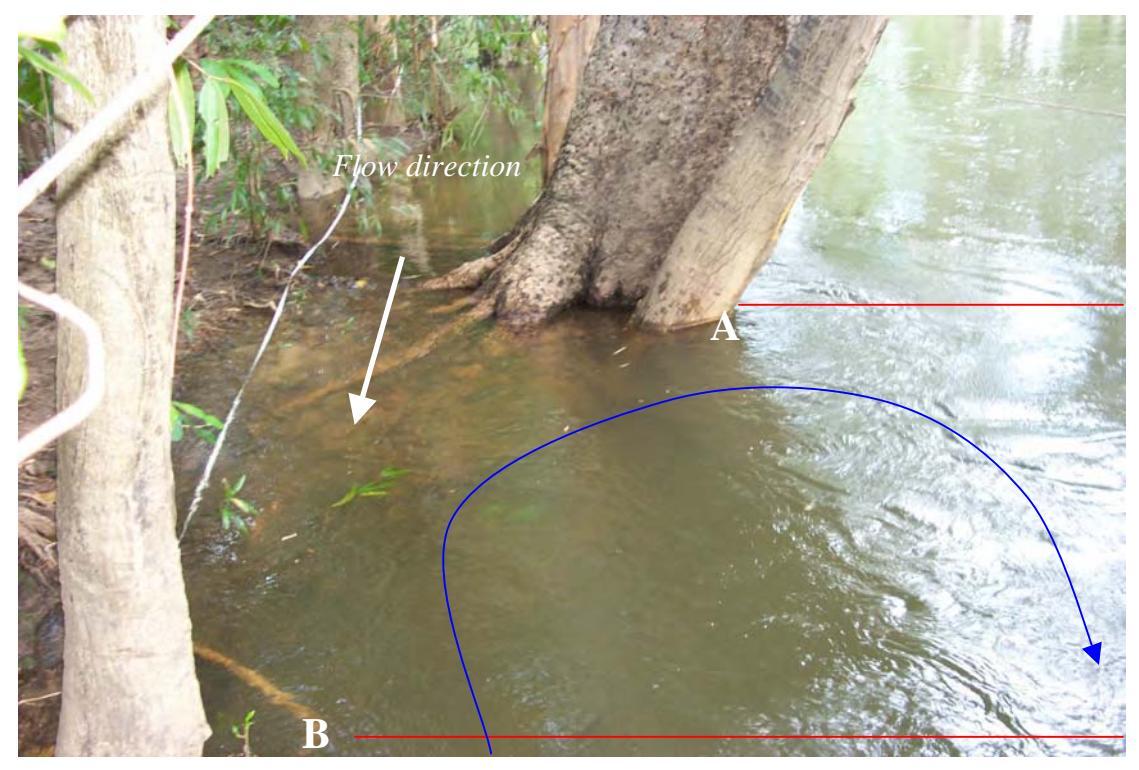
Figure 5.19 B: Location of velocity profiles adjacent to tree-formed alcove. The velocity profiles are shown in Figure 5.18 A and B.

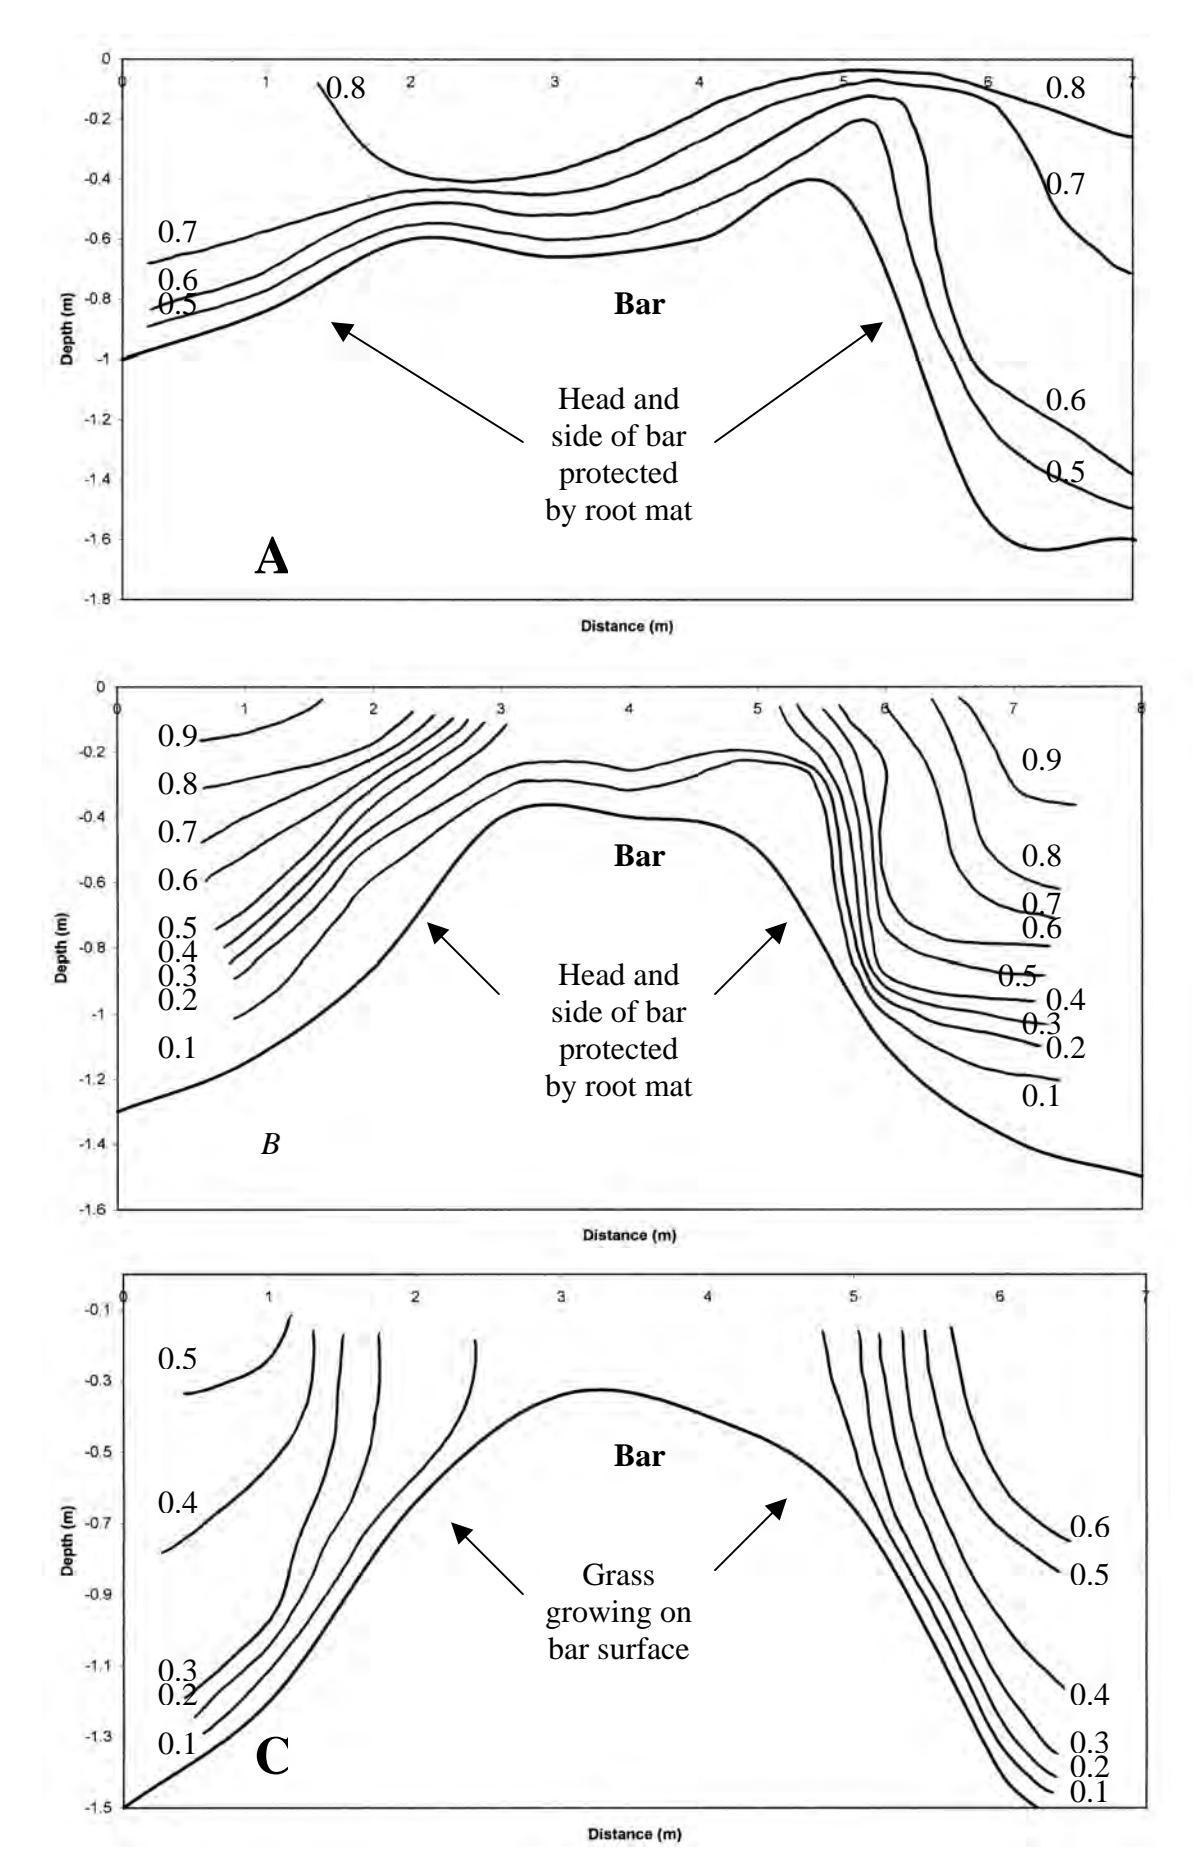
Figures 5.20 A, B and C: Bar velocity profiles heading in a downstream direction.

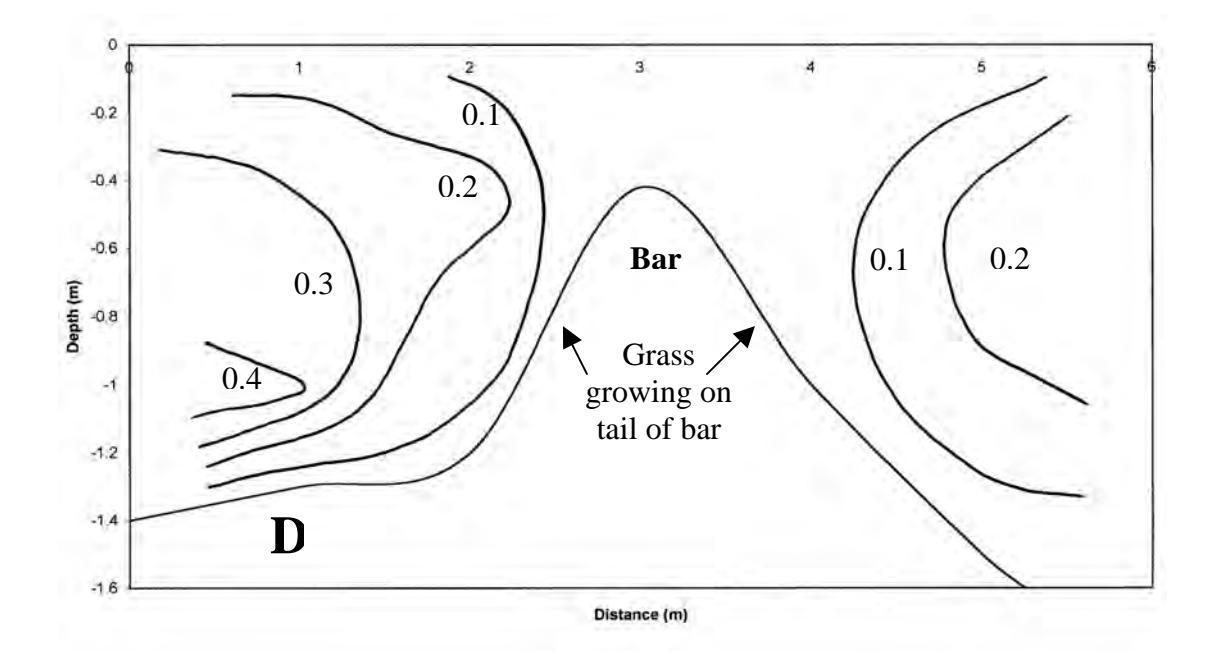
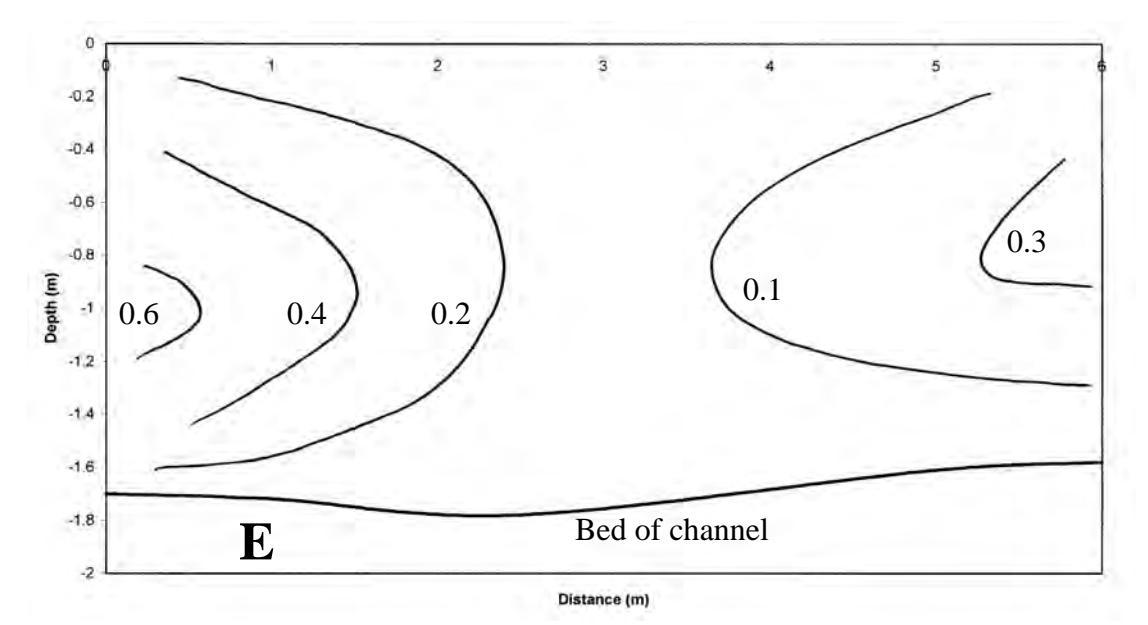
Figures 5.20 D and E: The top profile is across the tail of the bar and the bottom one is downstream of the top profile 10 m.

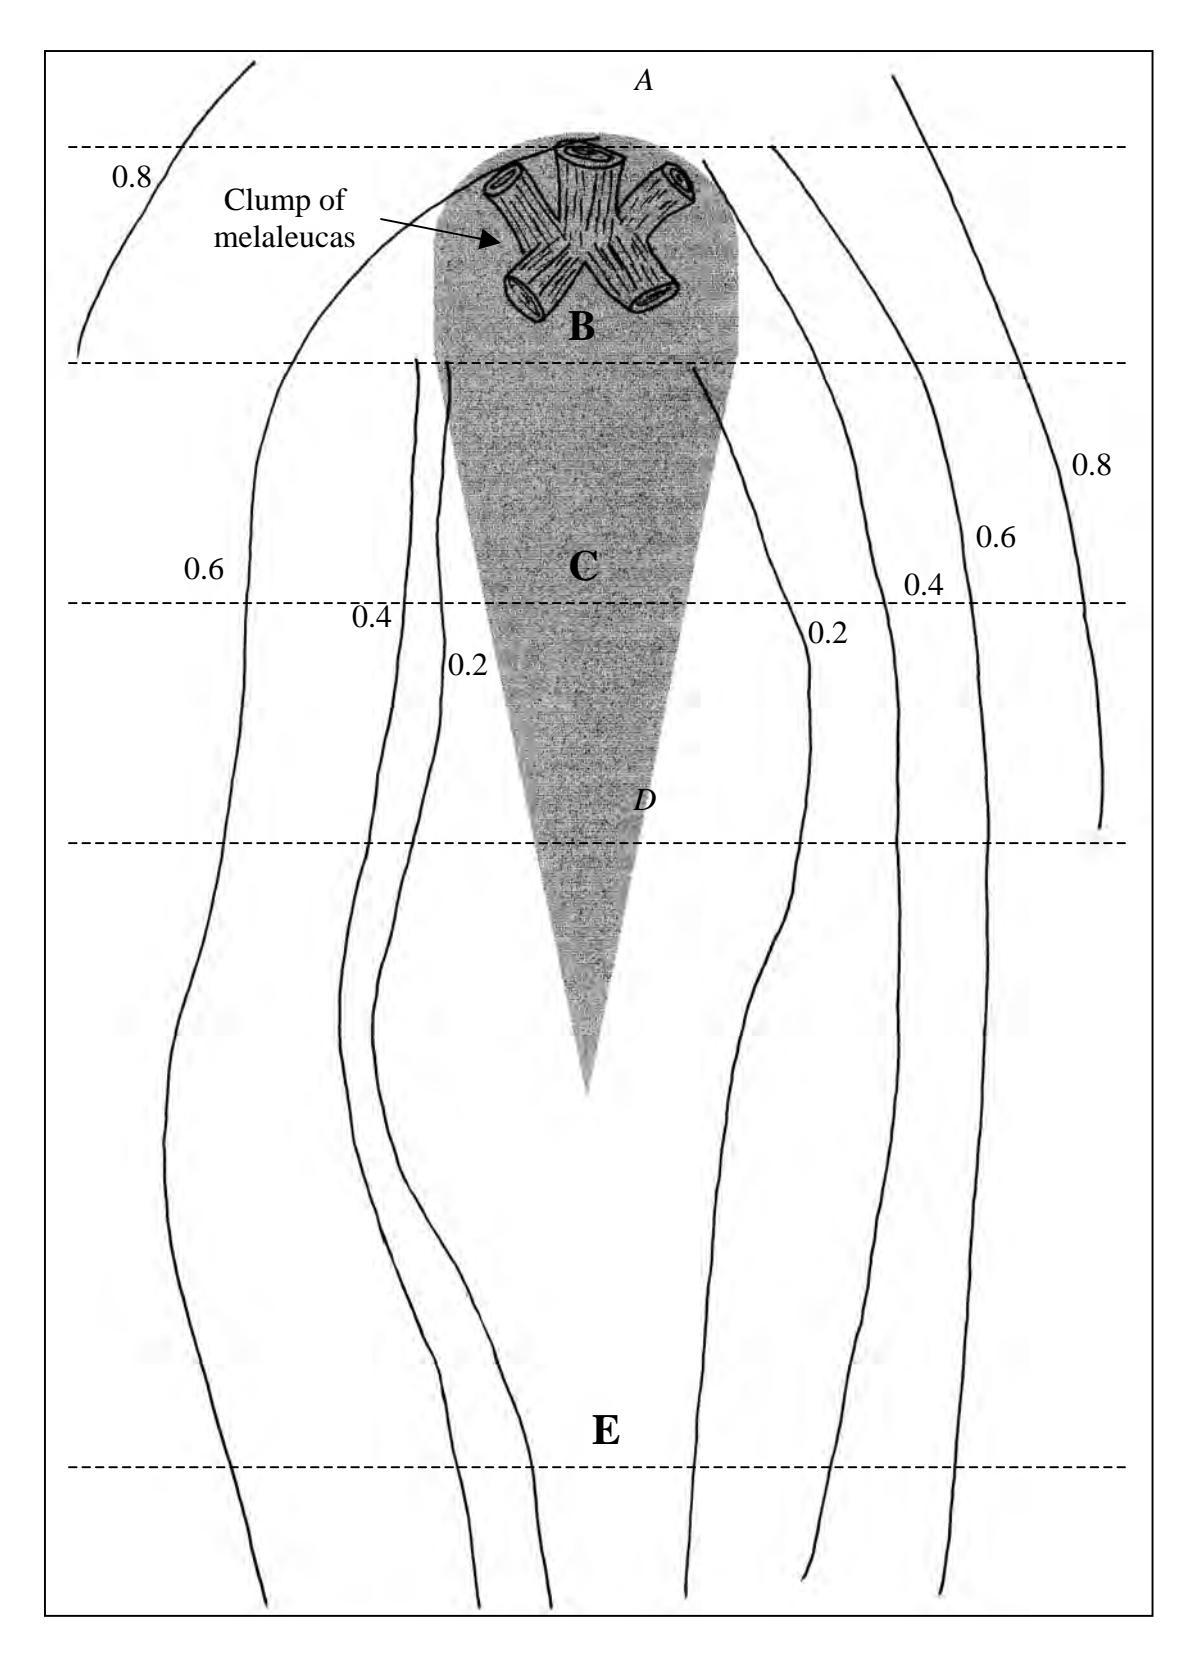
Figure 5.21: Plan view distribution of mean velocities around bar. The dashed lines represent the proposed velocity. The horizontal lines represent the velocity profiles shown in Figure 5.20.

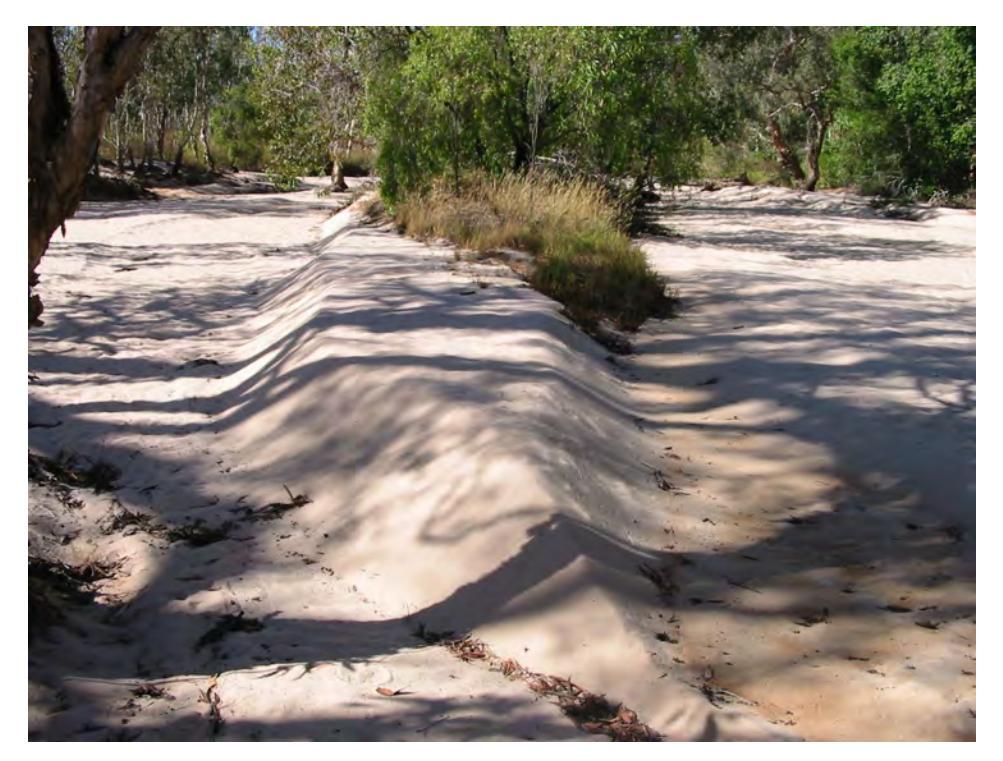
Figure 5.22: Looking upstream along a similar bar to the one sampled for velocity, showing the lee side deposition.

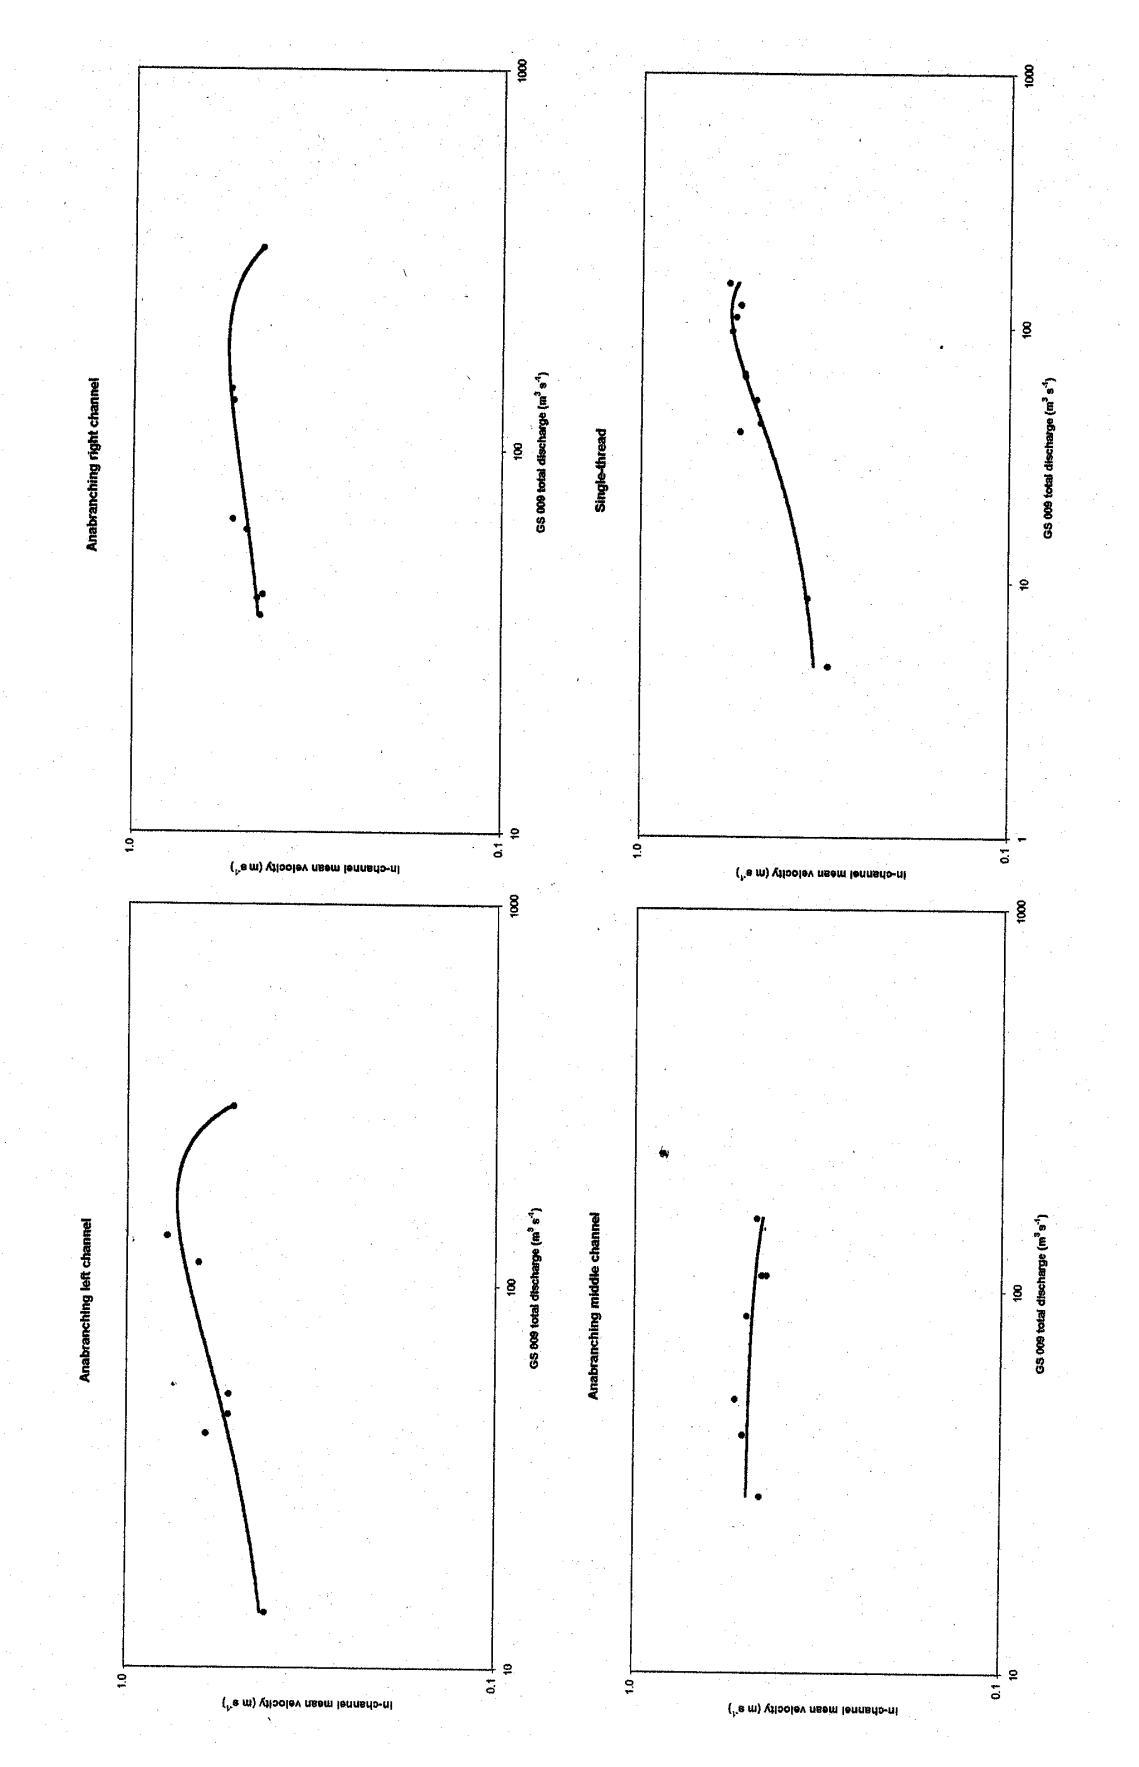
Figure 5.23: Relationship between discharge and in-channel velocities for the upstream anabranching and downstream single-thread sites (Jansen and Nanson, in prep)

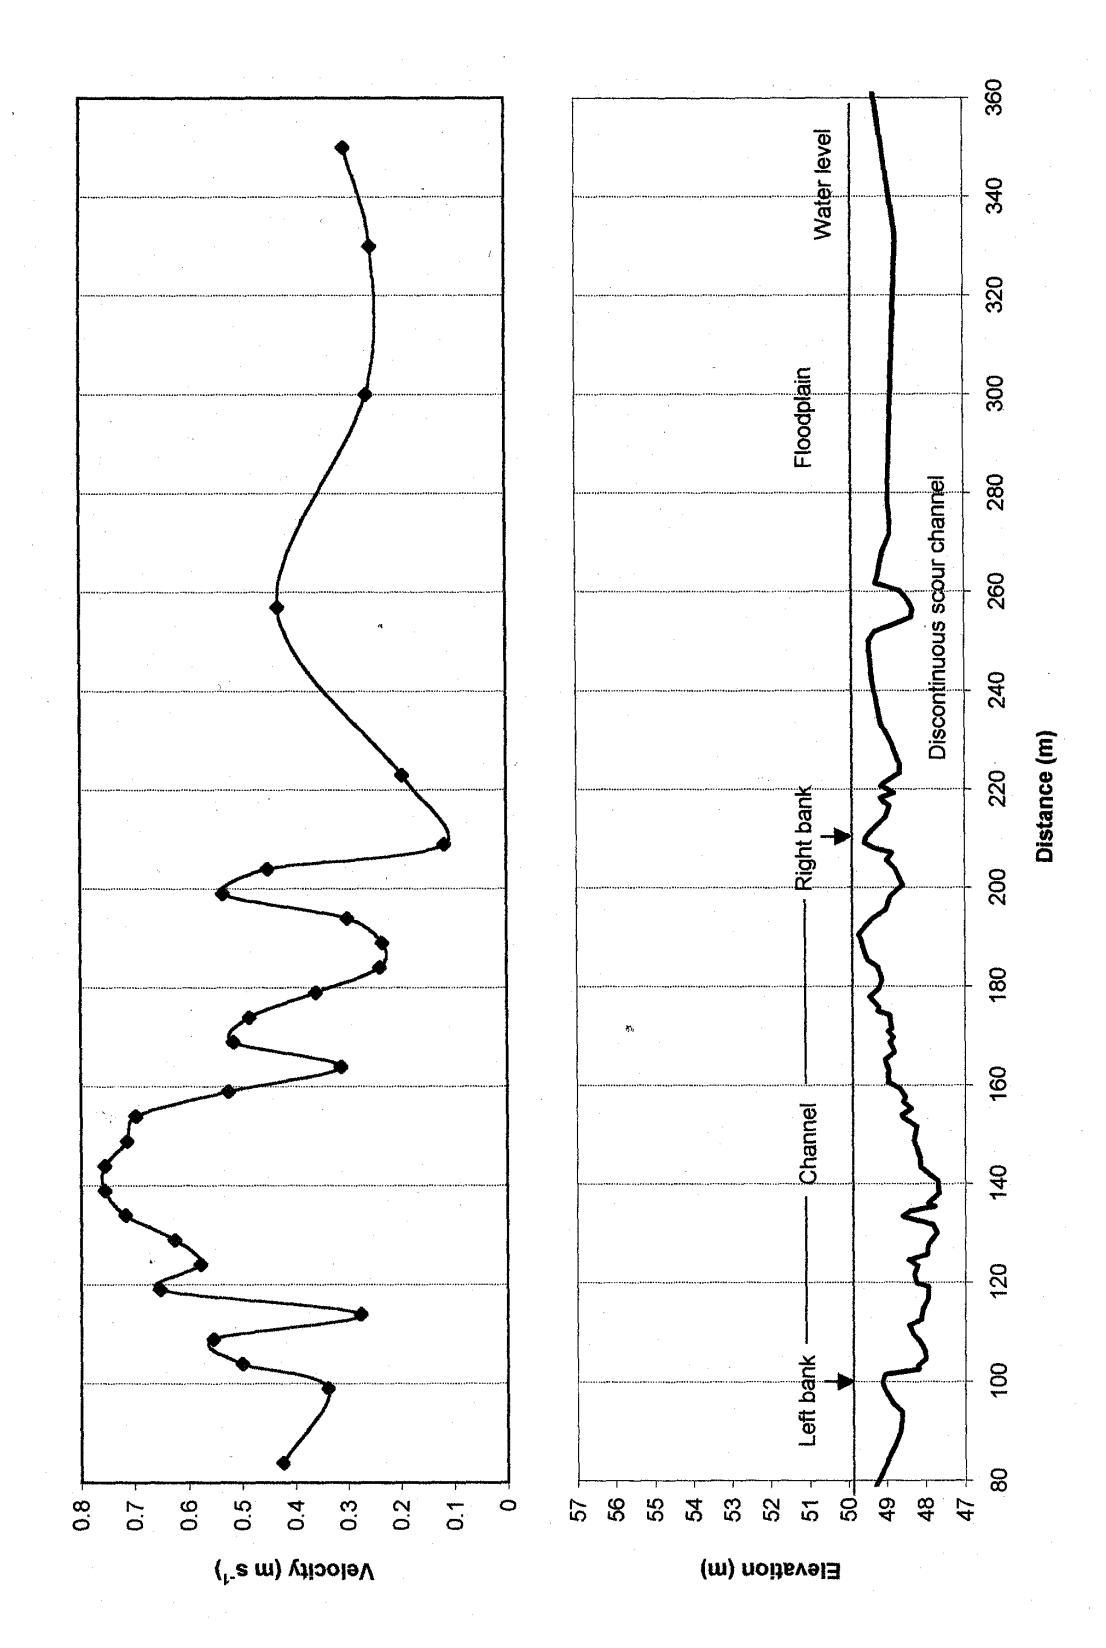
Figure 5.24: Downstream single-thread velocities at a discharge of 123 m<sup>3</sup> s<sup>-1</sup>

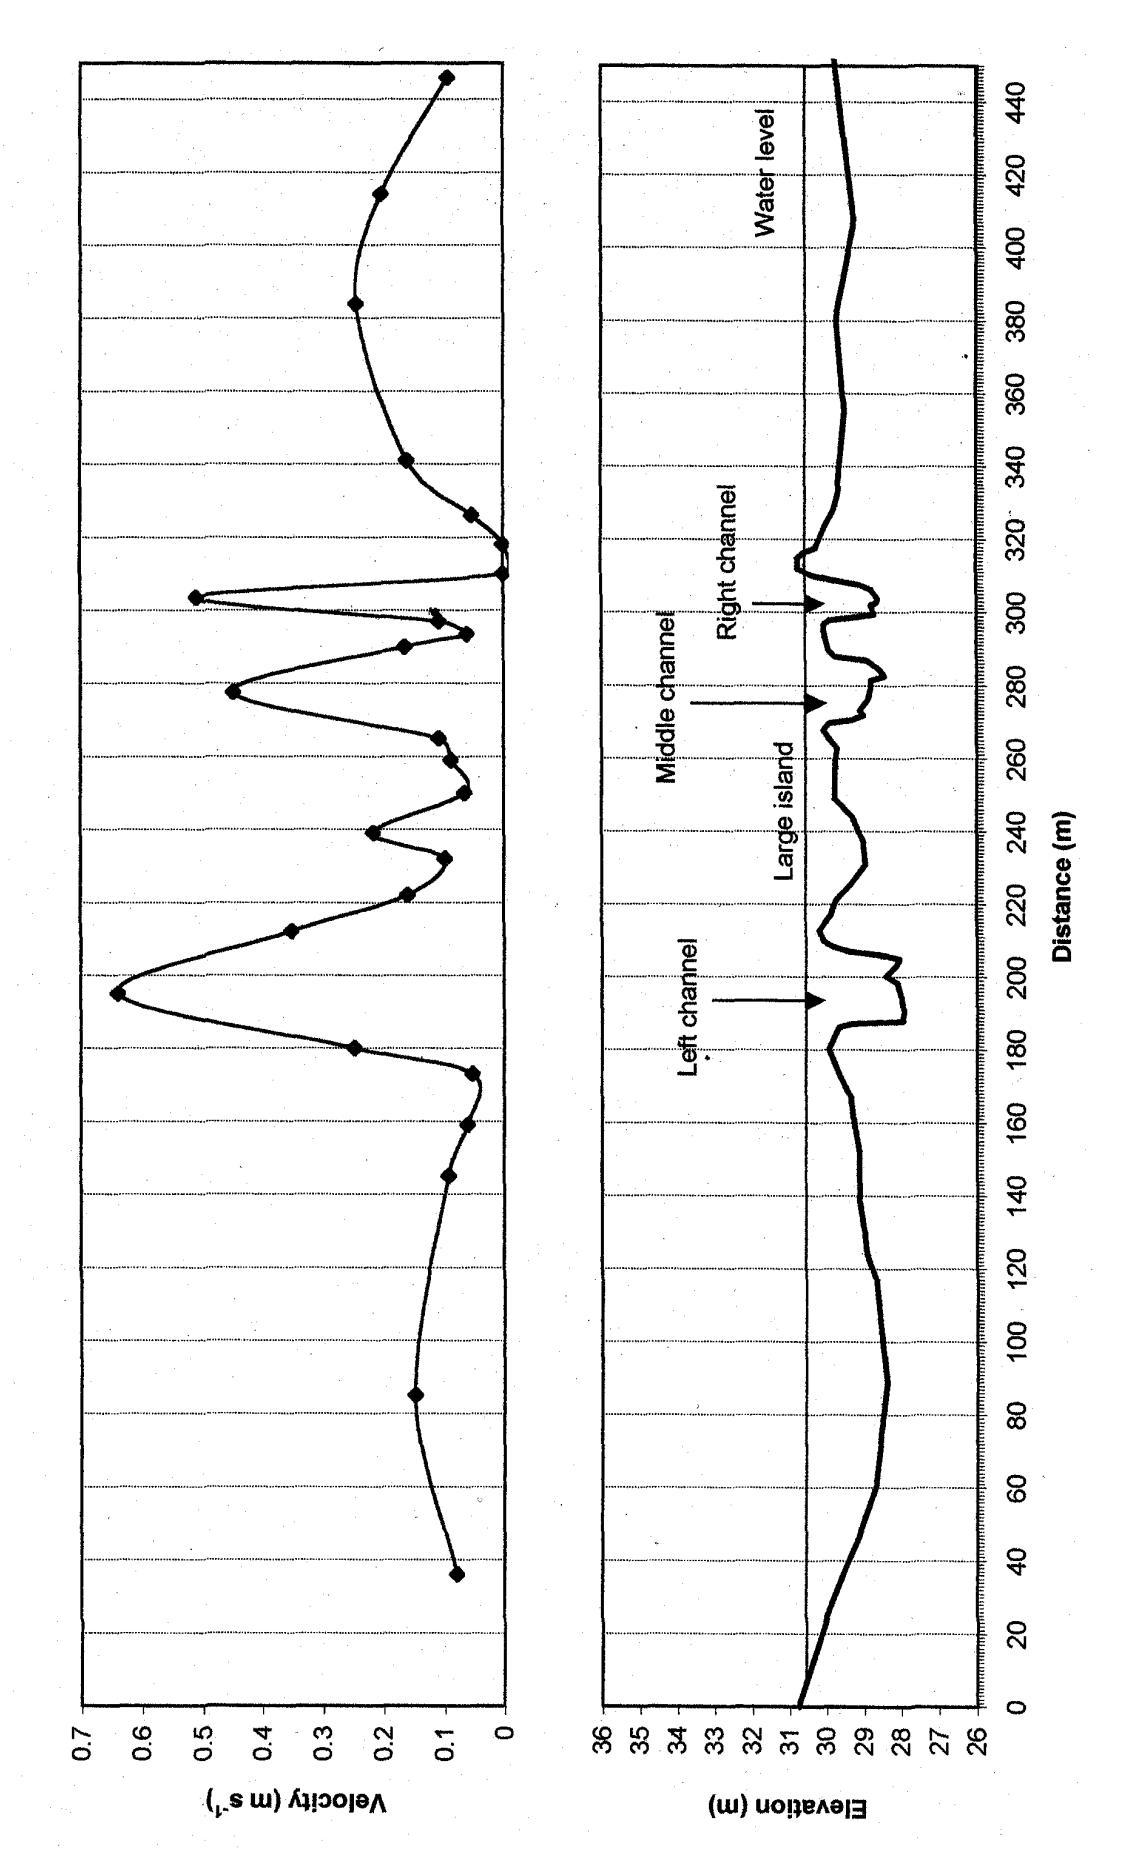
Figure 5.25: Upstream anabranching cross-section velocities at a discharge of 110 m<sup>3</sup>s<sup>-1</sup>

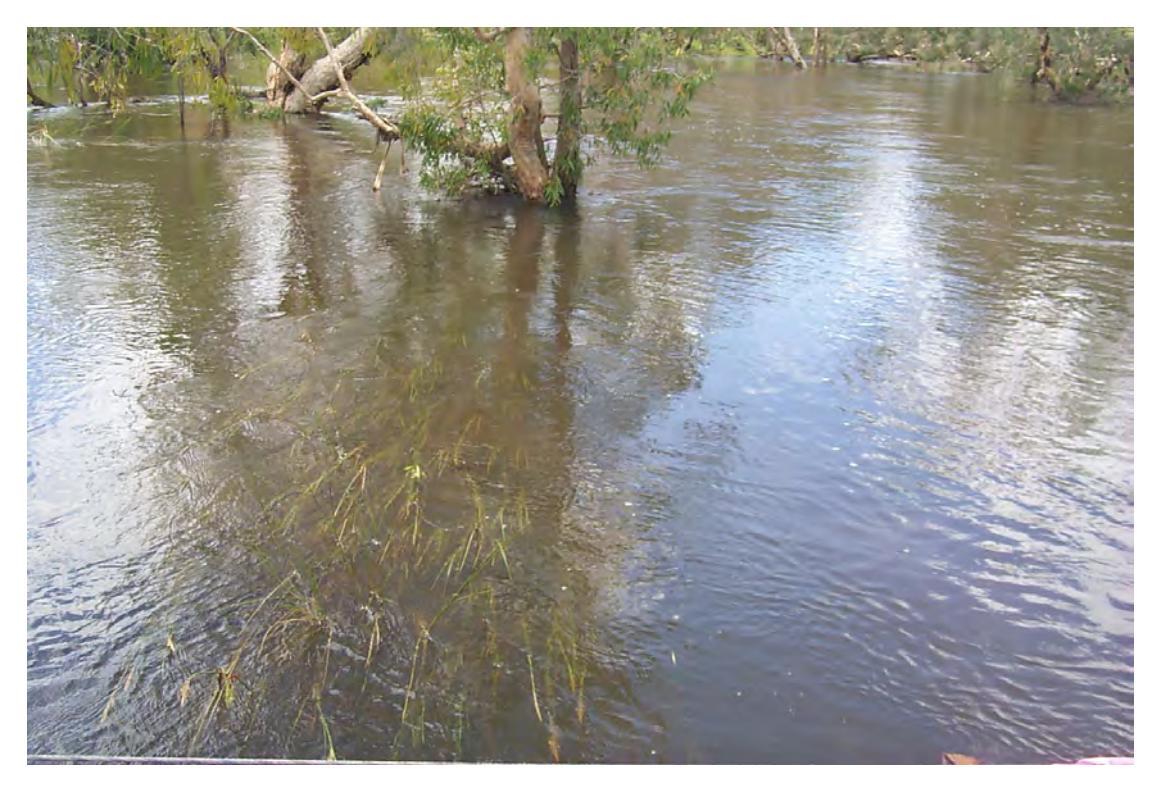
Figure 6.1: Grasses lying down with the flow (foreground) and trees in background still influencing flow.

deposited in the lee of the grass. This process operates both within the channel on bar surfaces (see Figure 6.1) and also on the banks, which are frequently overtopped each Wet season with approximately 12 bankfull flows per year. The frequent nature of burning reduces the grass cover by almost 100% in the single-thread reaches and the grass has to grow again at the beginning of the following Wet season. The inference being that in the initial period of flow at the beginning of the next Wet season, the bar and bank surfaces are likely to experience significant erosion due to decreased vegetation cover. However, this is only likely to occur if the Wet season rains start early and grasses do not yet protect large areas, something that rarely occurs. The "build up" usually precedes the Wet season when convectional storms produce rains that establish a grass cover early in the season.

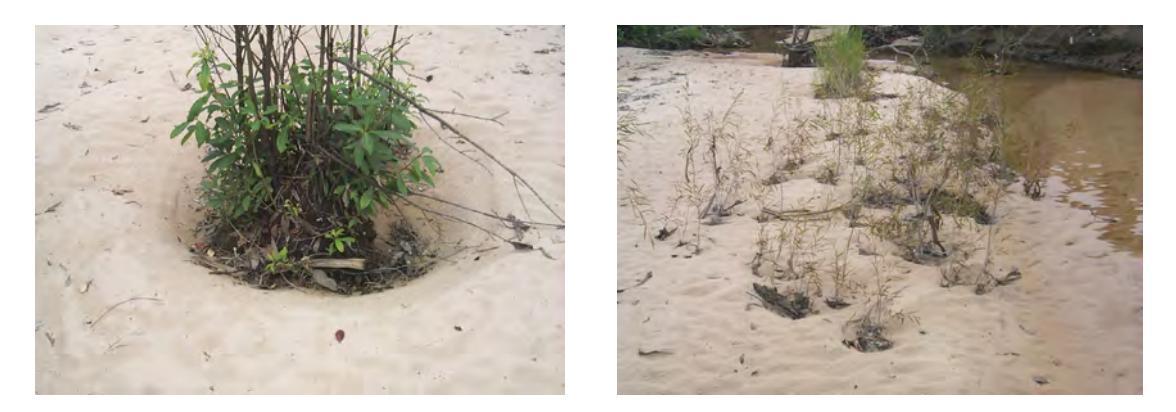
Figures 6.2 and 6.3: These photographs show Step 1: the growth of immature tree species in the bed of the channel. During this immature stage, scour can occur upstream and beside the obstruction.

amalgamation with other bars and this may lead to island growth. A simple, 3-stage model of bar growth has been devised for Magela Creek. Step 1 involves the initiation of seedling growth in the channel (Figure 6.2 and 6.3). Step 2 is the beginning of the sediment deposition in the lee of the obstruction that is beginning to influence downstream flow (Figure 6.4). Step 3 shows that, depending on the position of the tree within the flow; the bar may join with other bars and form a complex bar. This can support grass and several different mature and immature tree species as well as the original mature tree(s) (Figure 6.5).

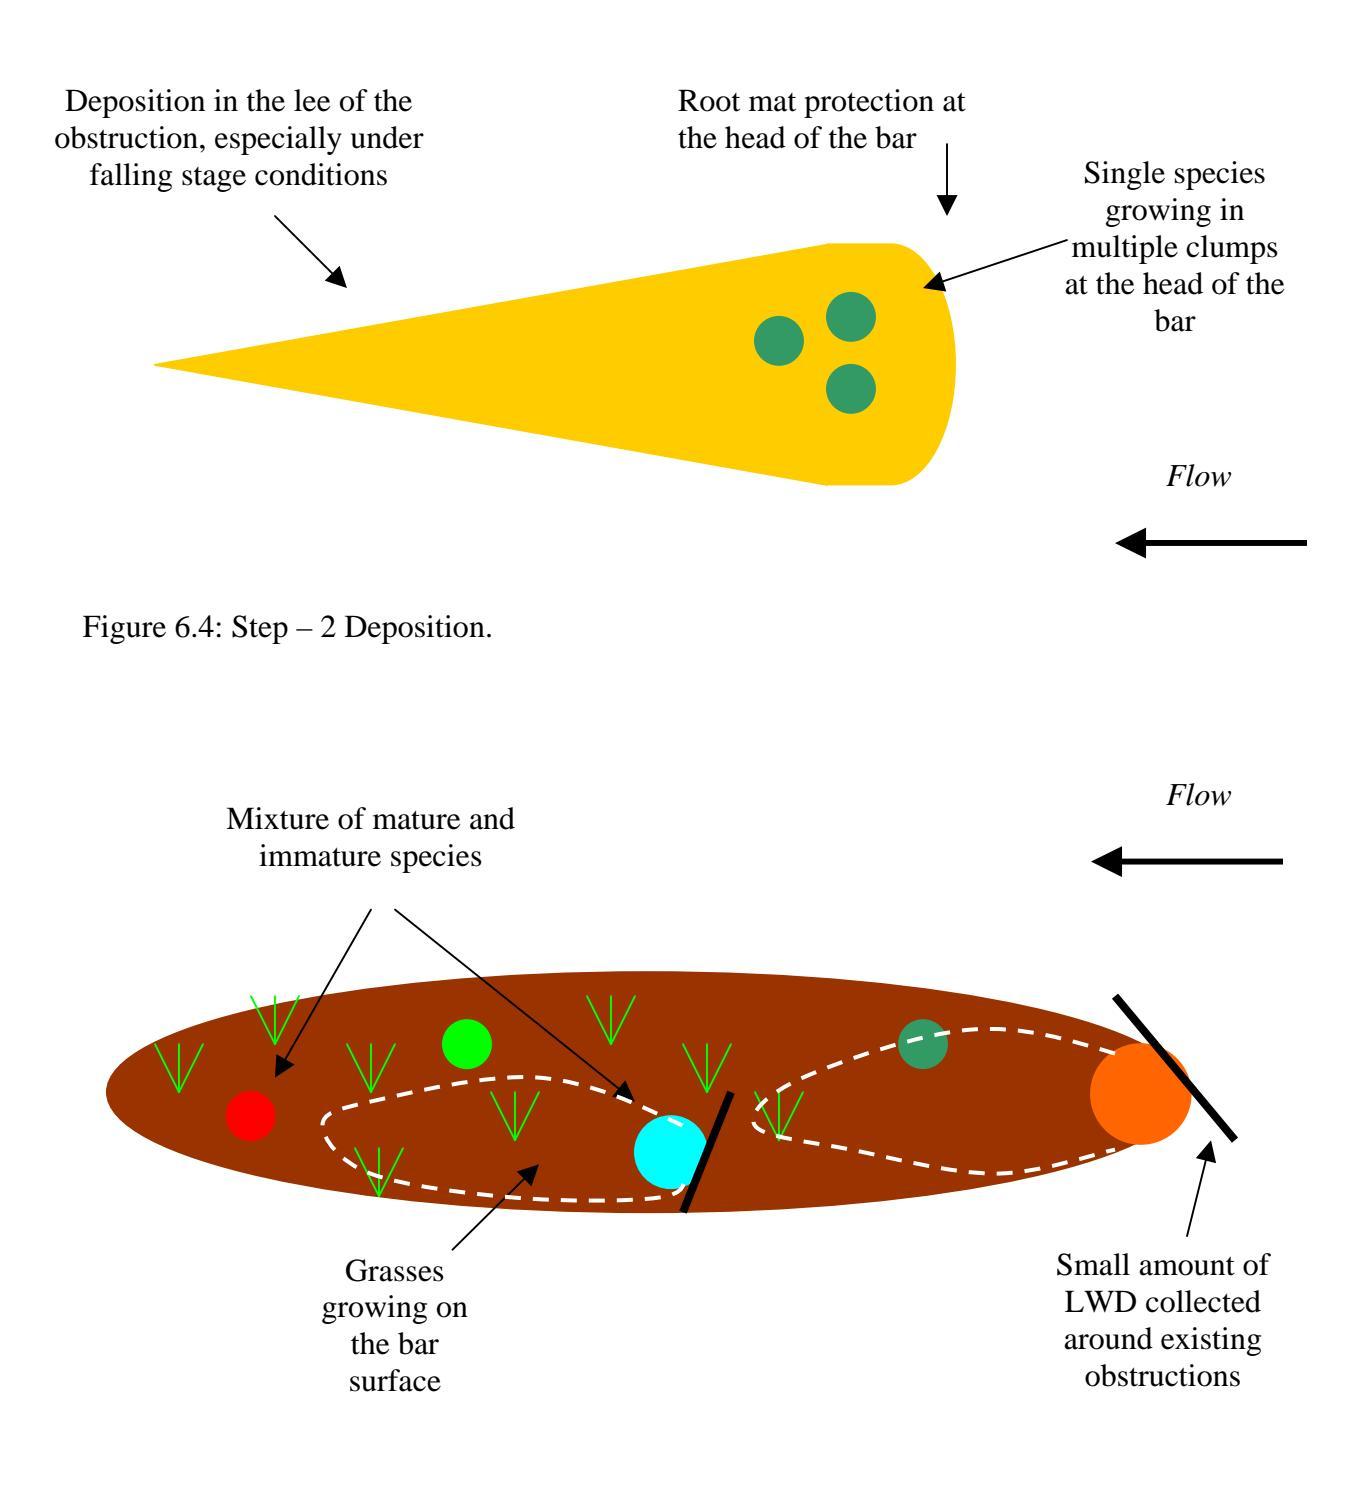
Figure 6.5: Step – 3 Amalgamation and species diversification and successional change. The dashed lines show the outline of the initial bars.

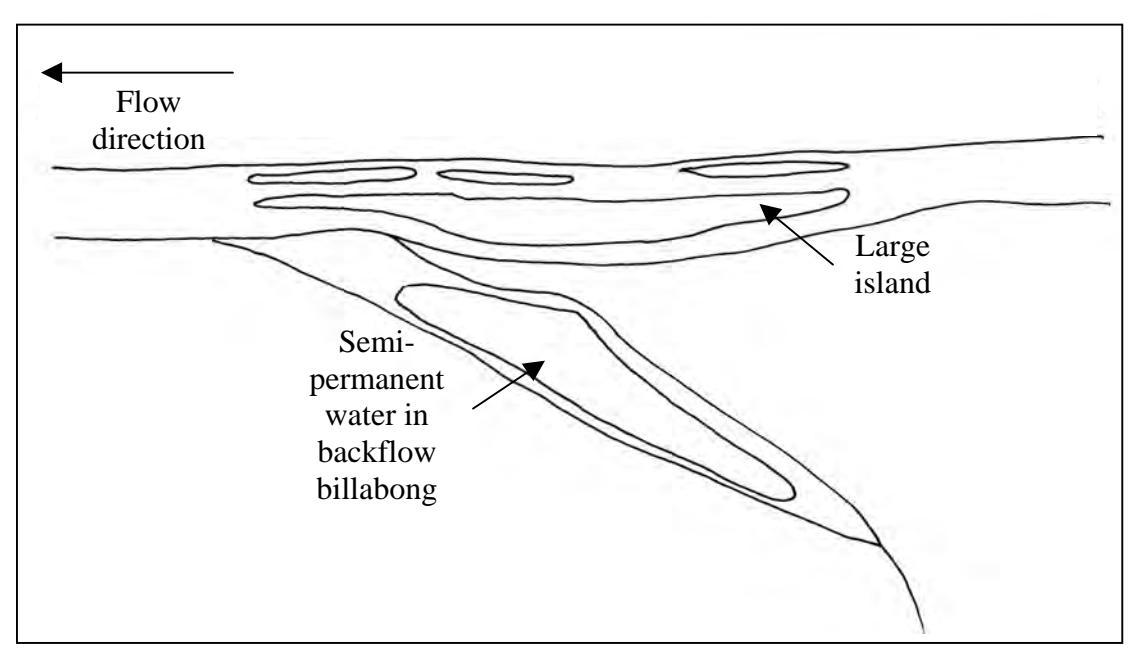
Figure 6.6: Stage 1 - post-fire. A backflow billabong located adjacent to a large island within the study area. This diagram shows the possible effects of a large fire, with all vegetation destroyed on the large island and adjacent areas.

The position of backflow billabongs within the reach may play a significant role in the initial growth and regeneration of monsoon species on the channel islands and on the floodplain following disturbance. Figure 6.6 shows a possible situation where the vegetation of the large island has been destroyed following a large fire. The combination of the backflow billabong and the seeds dispersed from significant pockets of monsoon species along the escarpment may lead to a reasonably short time span for post-fire recovery. Figure 6.7 shows the possible second phase of recovery. Substantial vegetative recovery may establish adjacent to the moisture provided by the billabong and vegetation successional changes lead to the maturity and density of trees increasing significantly. Figure 6.8 shows the climax monsoon vegetation on the large islands. Thick monsoonal vegetation increases the stability of an island through its influence over bank strength and hydrology. These areas then remain virtually unburnable over long time periods.
