Cross-sectional and

scour and fill changes in

the Ngarradj catchment

between 1998 and 2003

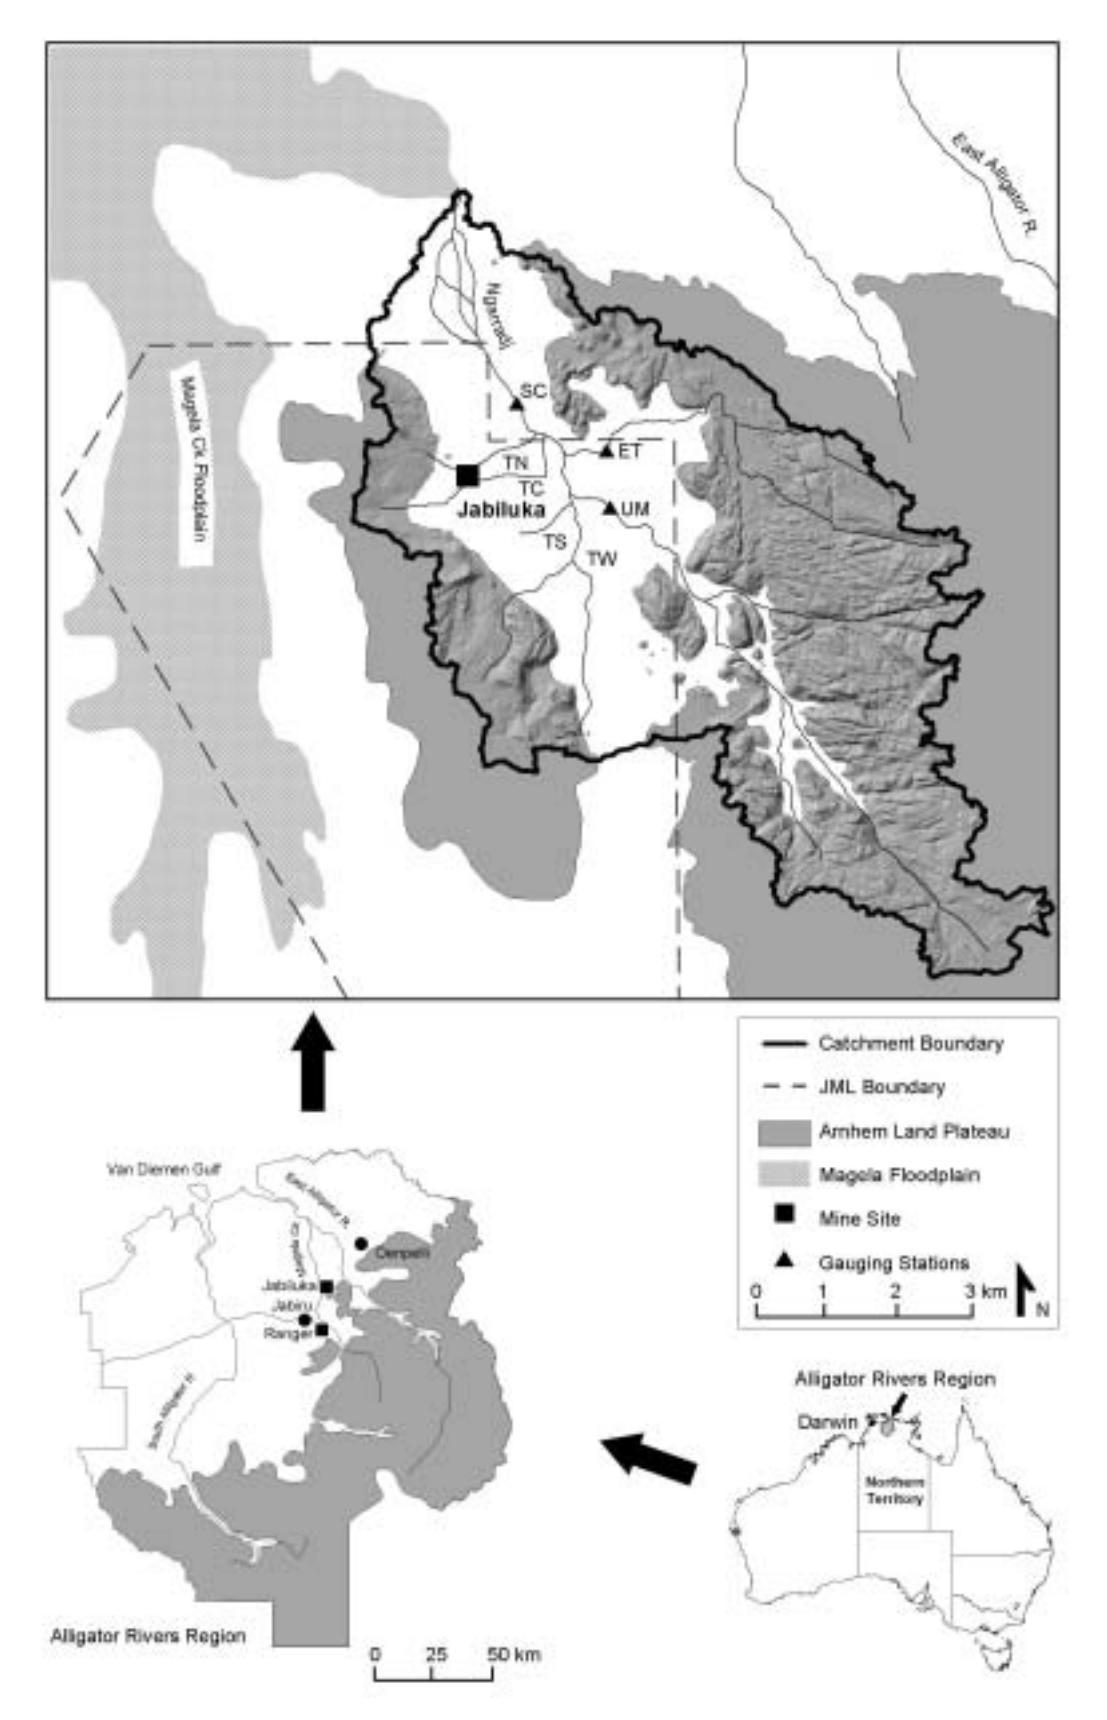
Figure 1 The Ngarradj catchment showing the Jabiluka Mineral Lease, *eriss*'s gauging stations and local creek names. SC refers to Swift Creek gauging station, TN Tributary North, ET East Tributary gauging station, TC Tributary Central, TS Tributary South, TW Tributary West and UM upper Swift Creek gauging station.

Cross sections and scour chains were installed at the three *eriss* gauging stations (fig 1). The catchment areas at the upper Swift Creek, Swift Creek and East Tributary gauges are 18.8, 43.6 and 8.5 km² respectively. Cross sections and scour chains were also installed on the mine site tributaries (Tributary North and Tributary Central). The total catchment areas of Tributary

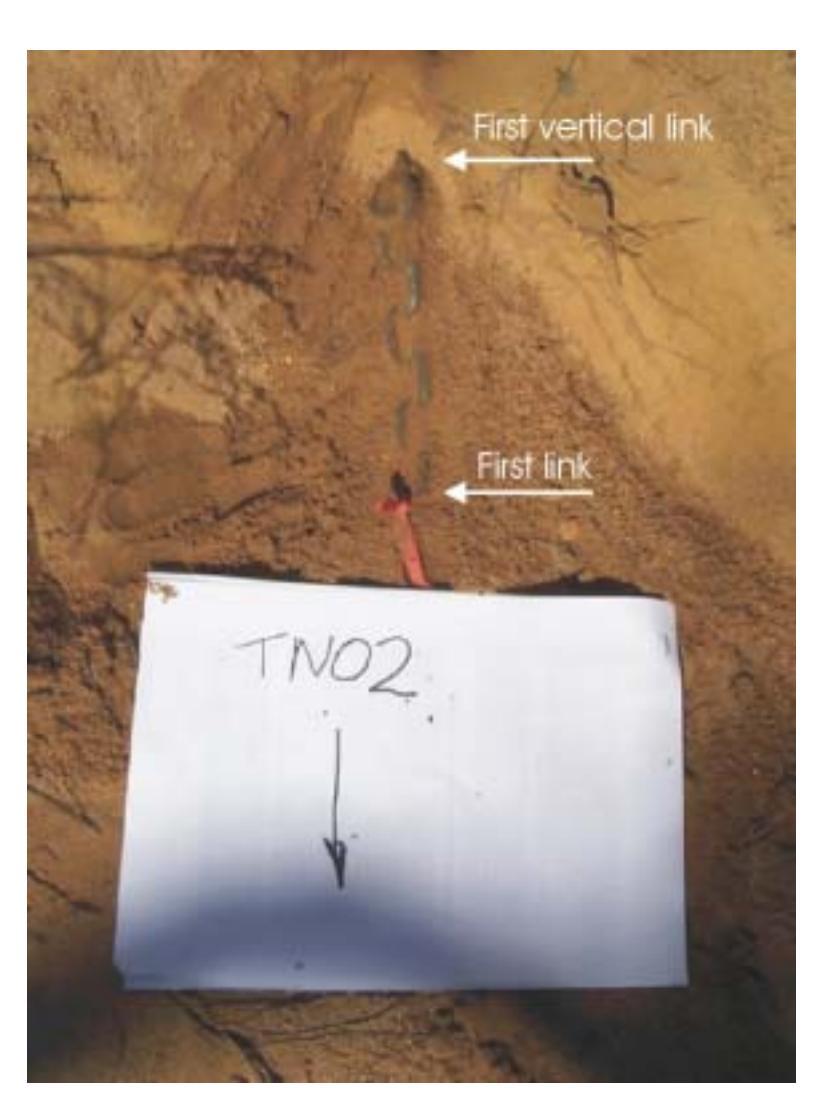
Figure 2 Scour chain orientated downstream at TN02 on 24 October 2000. Arrow indicates flow direction.

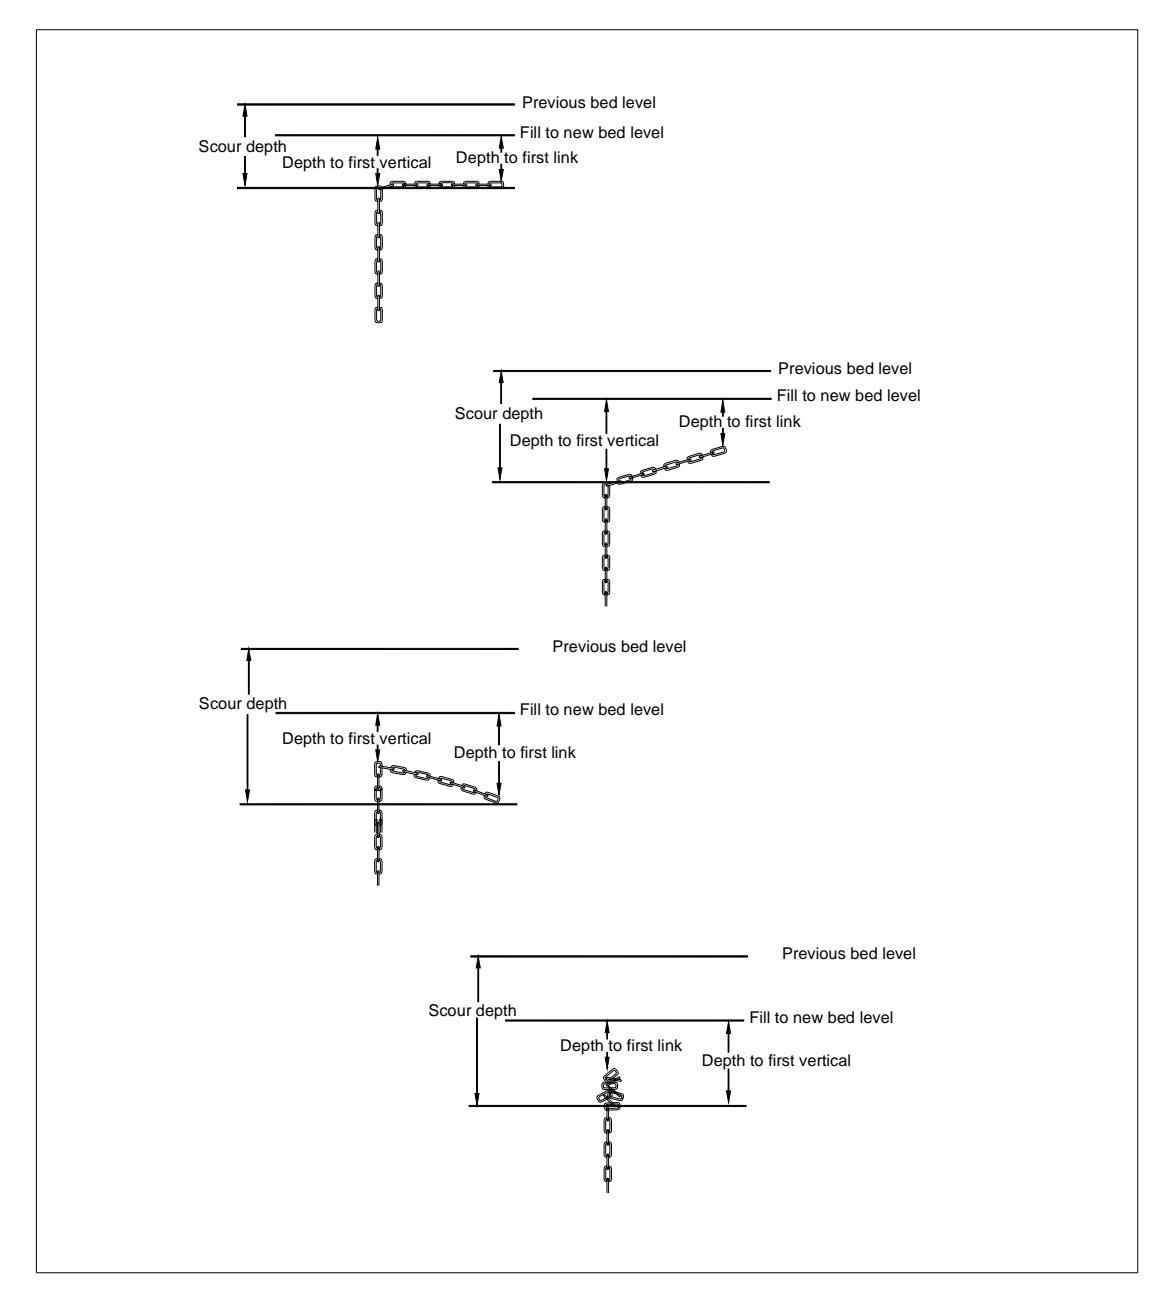
Figure 3 Diagrammatic representation of the full range of scour chain behaviour when there was net scour depicted by the middle example in figure 4. Net fill is shown by the top example in figure 4 and no change, by the lower example in figure 4.

Late in each dry season when the water table was at its lowest, the scour chains were relocated using the diagrams and measurements in Saynor et al (2001) and, more importantly, a metal detector. Measurements of the depth to the scour chain and the bed surface level were then obtained. A wooden board was positioned over the upstream face of the excavation and all measurements were taken to the bottom of this board which equated to the then bed level. A photograph was taken to show the position of the chain and the direction of flow was indicated by an arrow marked on paper or by a trowel, pen or ruler pointing downstream (fig 2). As the scoured part of the chain was not always lying horizontal, two measurements were taken to determine the scour depth (fig 3):

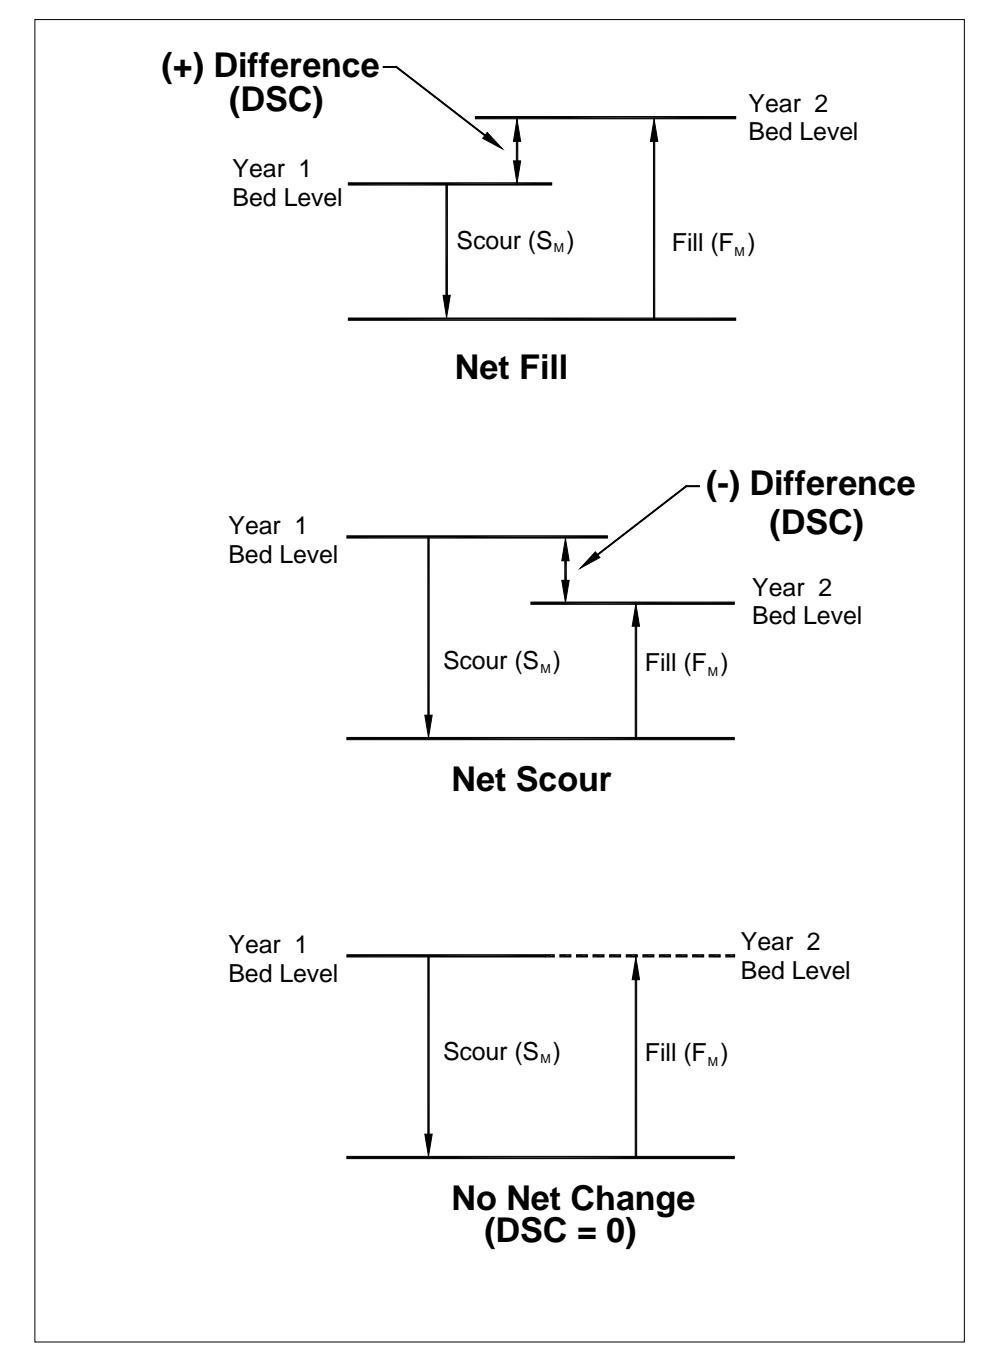
Figure 4 Three examples of net channel bed change during the wet season measured by scour chains. Net fill occurs when the bed level for the 2nd year is higher than for the 1st (top). Net scour occurs when the bed level for the 2nd year is lower than for the 1st (middle). No net change occurs when the bed level for the 1st and 2nd years is the same (bottom).

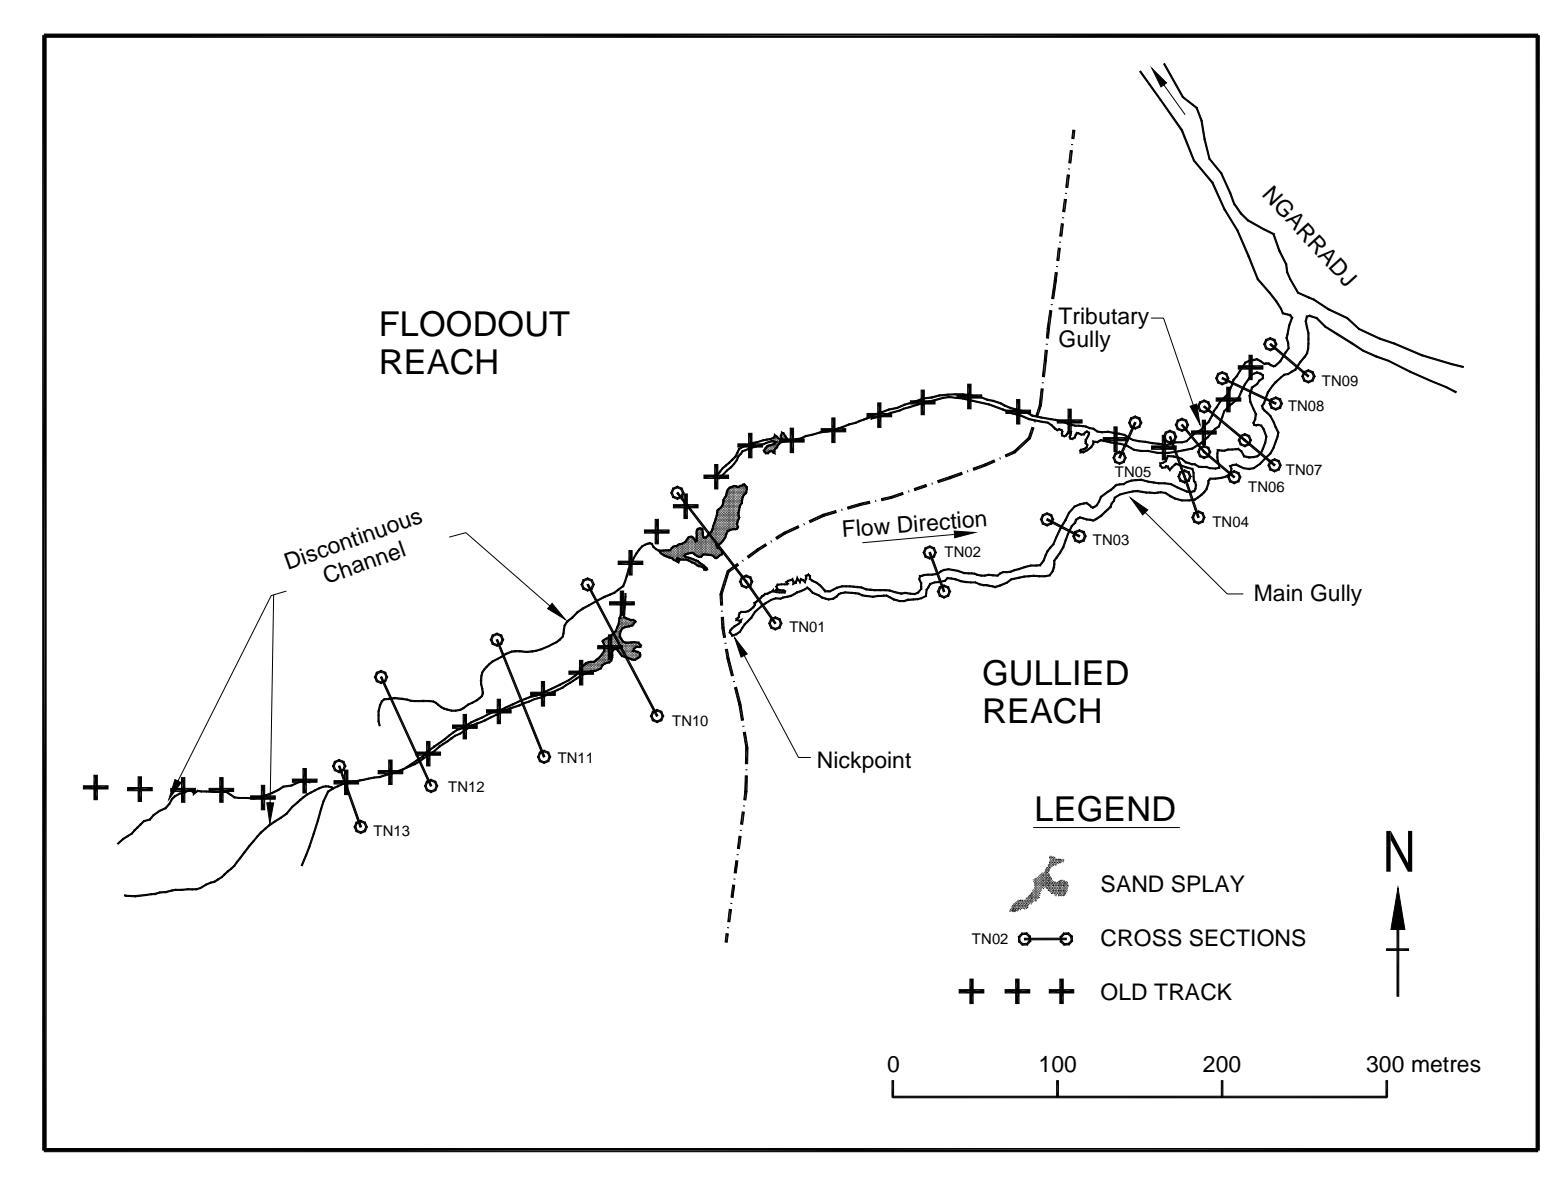
Figure 5 Location of the permanently marked cross sections and river reaches of Erskine et al (2001) on Tributary North

A total of 17 cross sections was installed (fig 5) downstream of the Jabiluka mine in the Floodout and Gullied Reaches of Erskine et al (2001). Four cross sections (TN10, TN11, TN12 & TN13) of the Floodout Reach (fig 6) are presented in Appendix A but no hydraulic geometry parameters have been calculated because there were multiple poorly defined channels. Bankfull stage has no relevance to these channels in a floodout zone where sand deposition is active and channels are decaying. Eight cross sections are located across the downstream main gully (fig 5 & 7). A tributary gully joins Tributary North on the left bank approximately 30 m upstream of the confluence with Ngarradj. Five cross sections were surveyed across the tributary gully (fig 5). Both the main and tributary gullies are incised and have never been observed to flow overbank during the study period, unlike those at the three *eriss* gauging stations. Therefore, the bankfull channel is not flanked by a floodplain and the frequency of bankfull discharge decreases greatly between the Floodout and Gullied Reaches. In both the main and tributary gully of Tributary North, bed sediments to a depth of 1.5 m are dominated by slightly granular fine-coarse sand (Erskine et al 2003), according to Folk's (1954, 1974) textural classification scheme.

- There was no gully on Tributary North in 1950, only a series of grassed swales in a broad drainage depression.
- The Floodout Reach with its sand deposits was present in 1964.
- A track ('old track' in fig 5) in the general area of Tributary North had been formed by 1975.
- The main gully on the lower section of Tributary North was initiated at the junction with Ngarradj between 1975 and 1981, and eroded about 100 m upstream of Ngarradj over this time period.
- This gully had eroded about a further 200 m upstream by 1984.
- The downstream section of the 'old track' (fig 5) had gullied by 1987 forming the tributary gully.

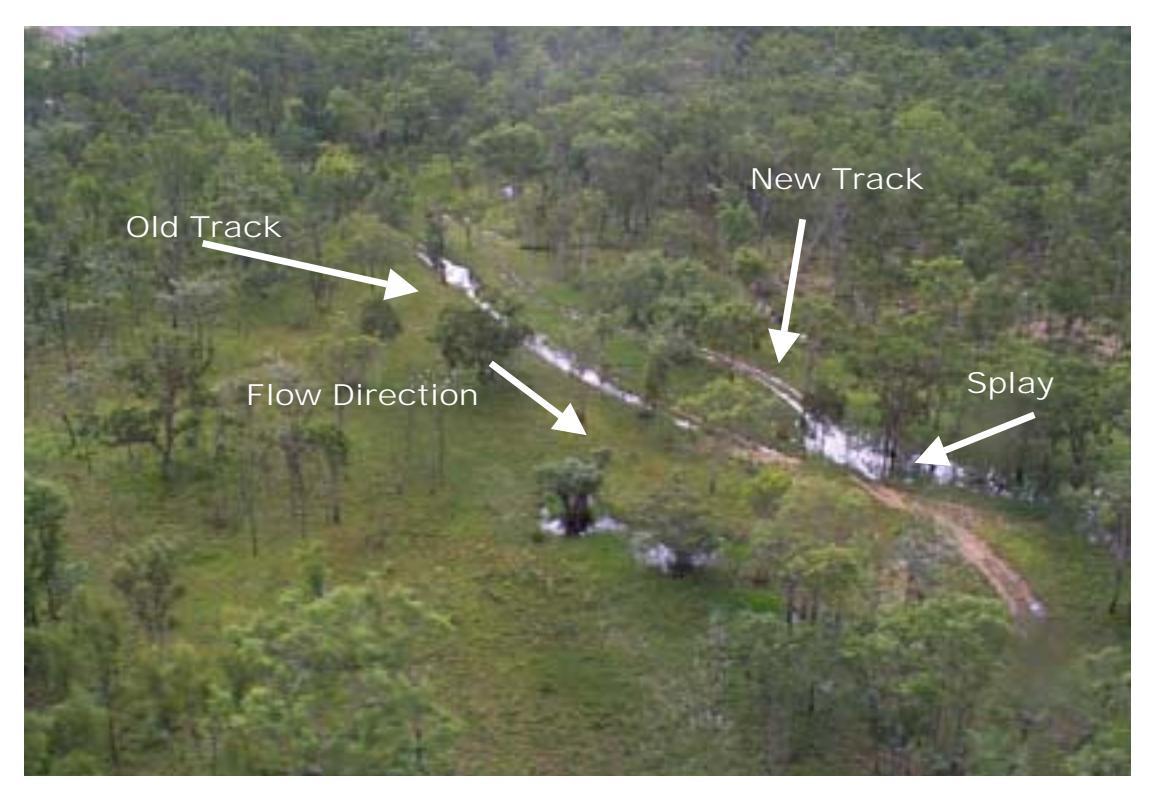
Figure 6 Floodout Reach of Tributary North showing flowing water in wheel ruts of the old track at cross sections TN11 and TN12, and splay at cross section TN10

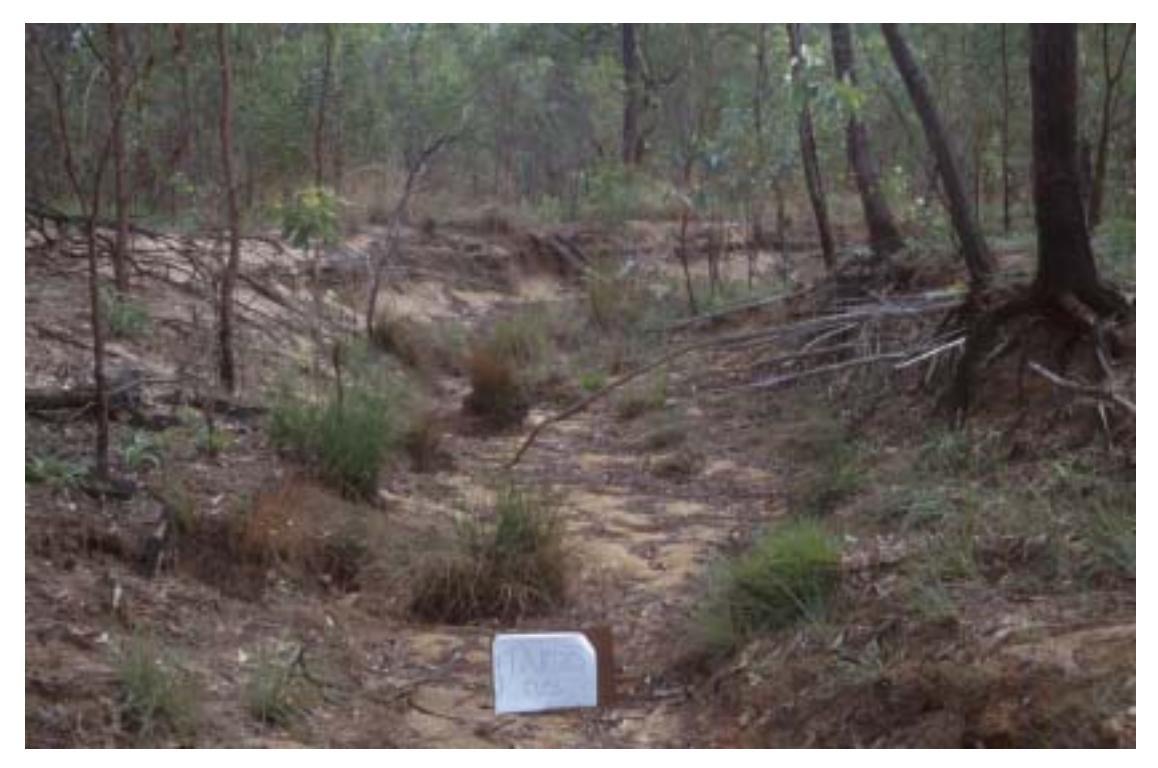
Figure 7 Main gully of Tributary North at cross section TN03

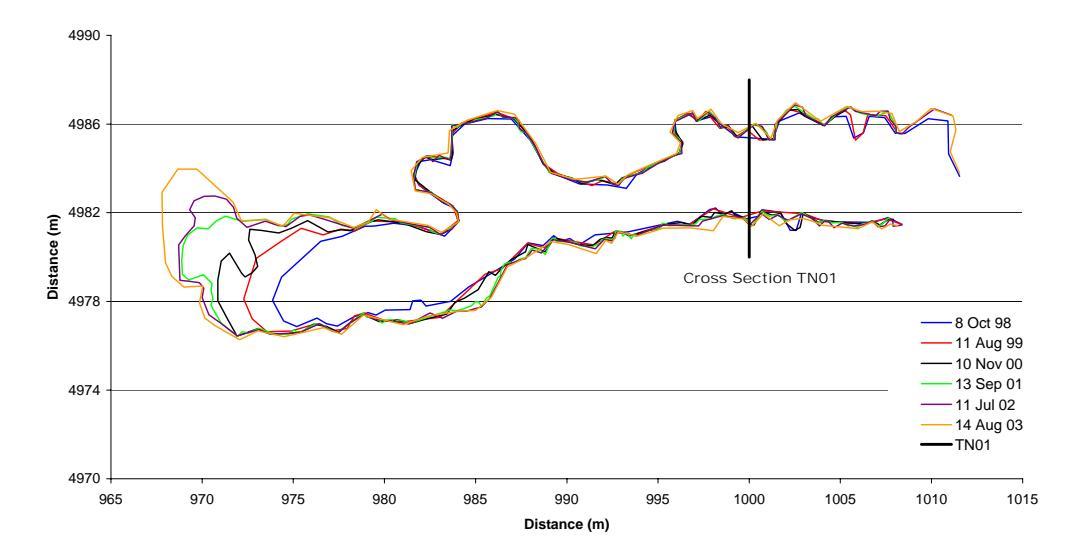
Figure 8 Annual surveys of the primary nickpoint at the head of Erskine et al's (2001) gullied reach on the main gully of Tributary North

Therefore, it is clear that the Jabiluka mine was developed after the formation of the Floodout and Gullied Reaches of Erskine et al (2001) on Tributary North. The nickpoint migration rate between 1975 and 1984 was about 30.0 m/a but had decreased to 1.56 m/a between 1998 and 2003.

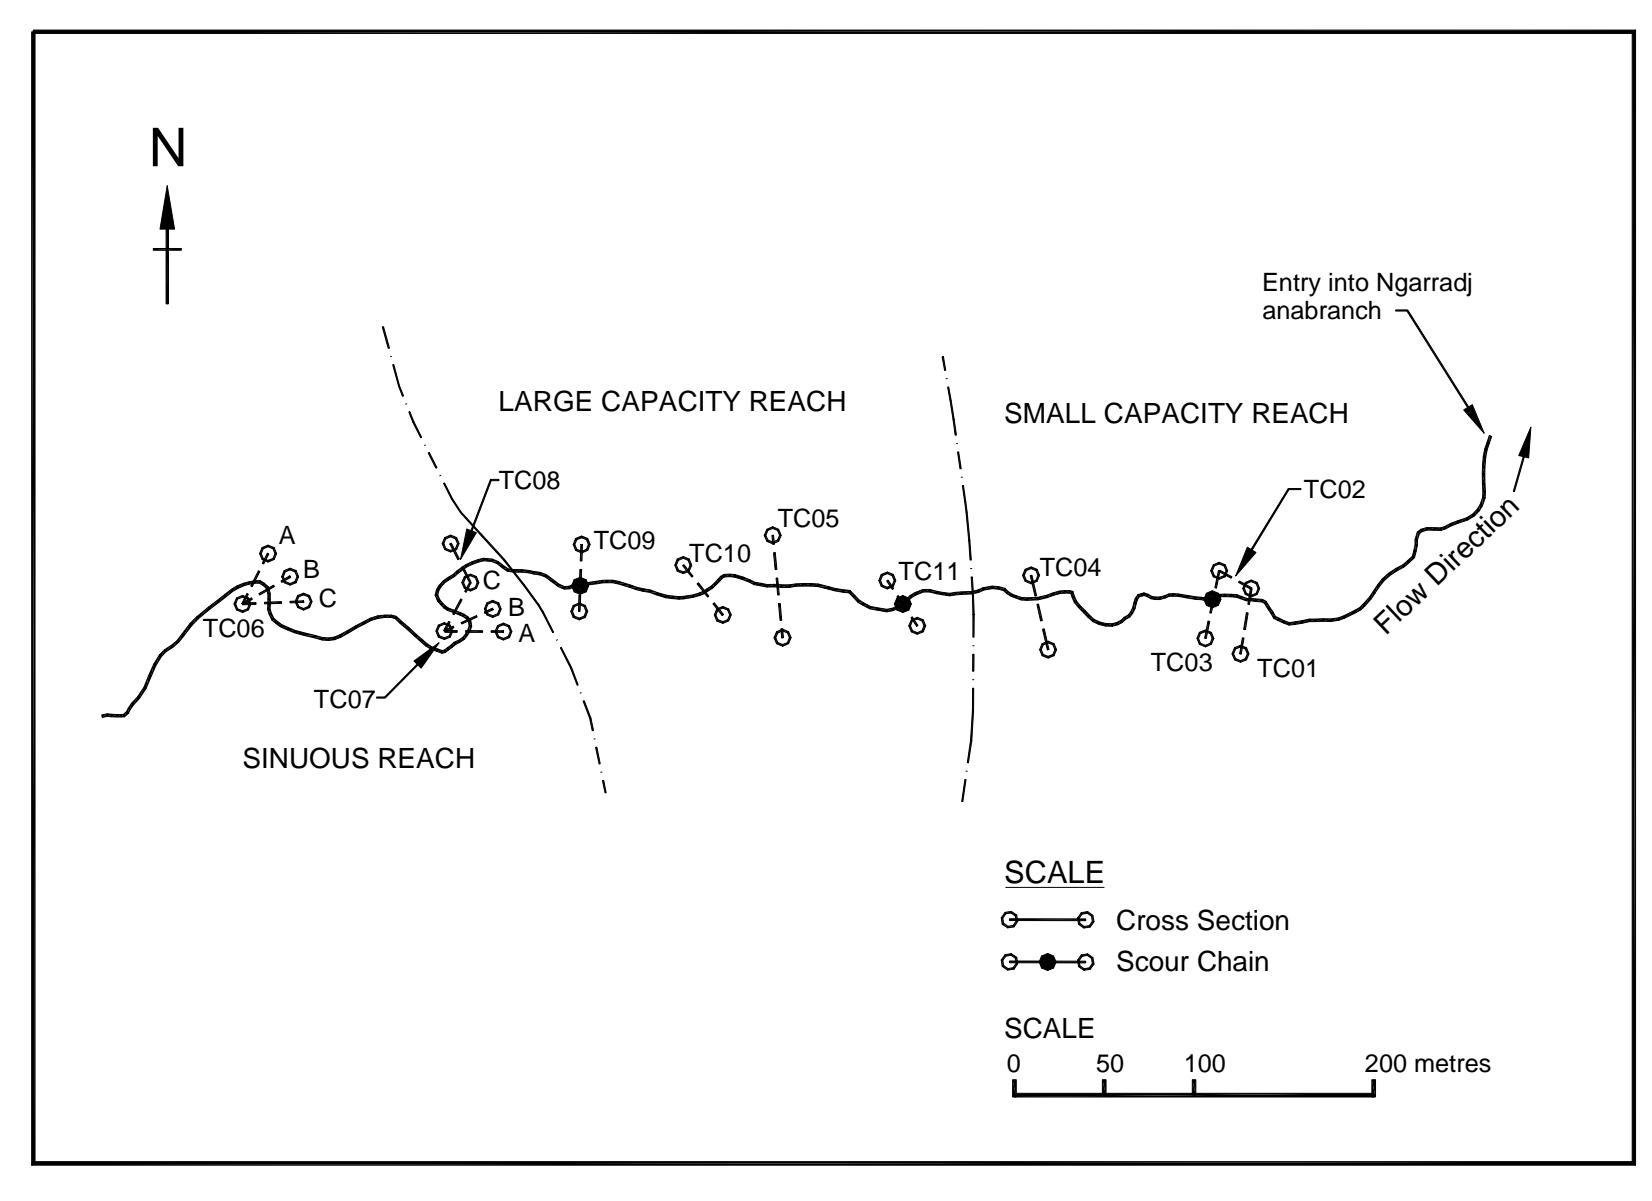
Figure 9 Location of the permanently marked cross sections and the river reaches of Erskine et al (2001) on Tributary Central

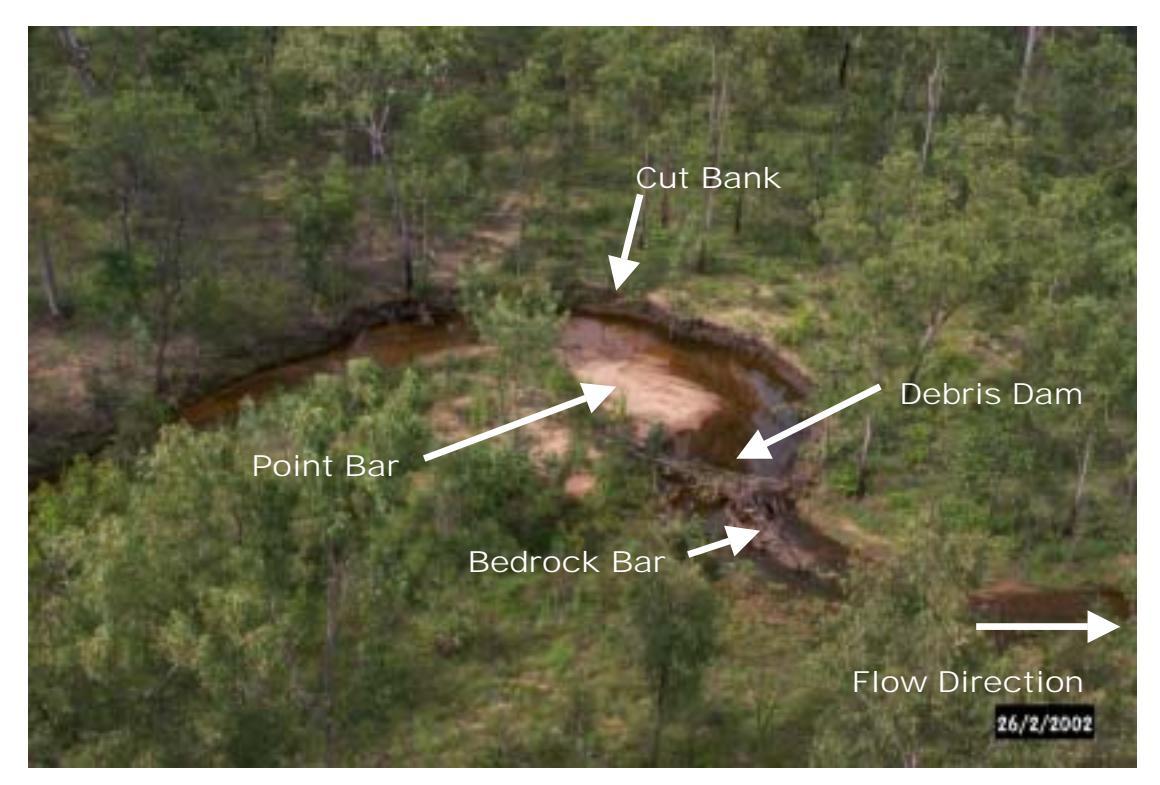
Figure 10 Sinuous Reach of Tributary Central at cross sections TC06A, B and C

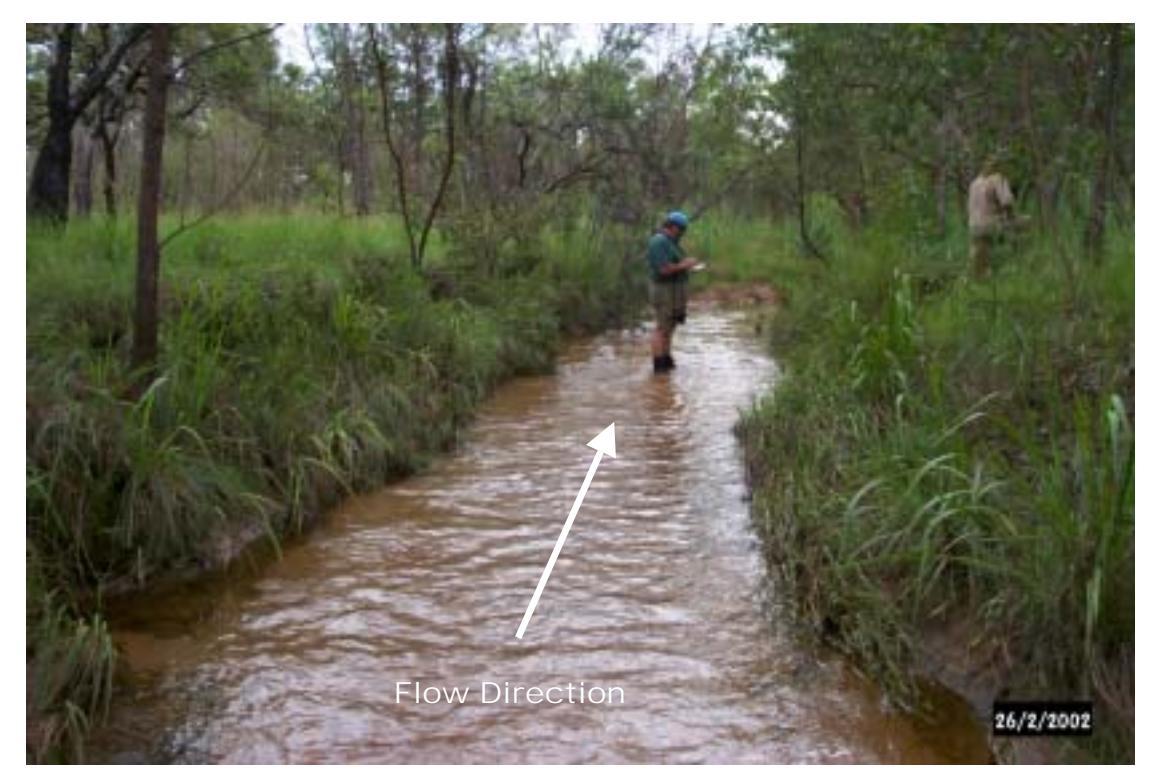
Figure 11 Large Capacity Reach of Tributary Central at cross section TC05

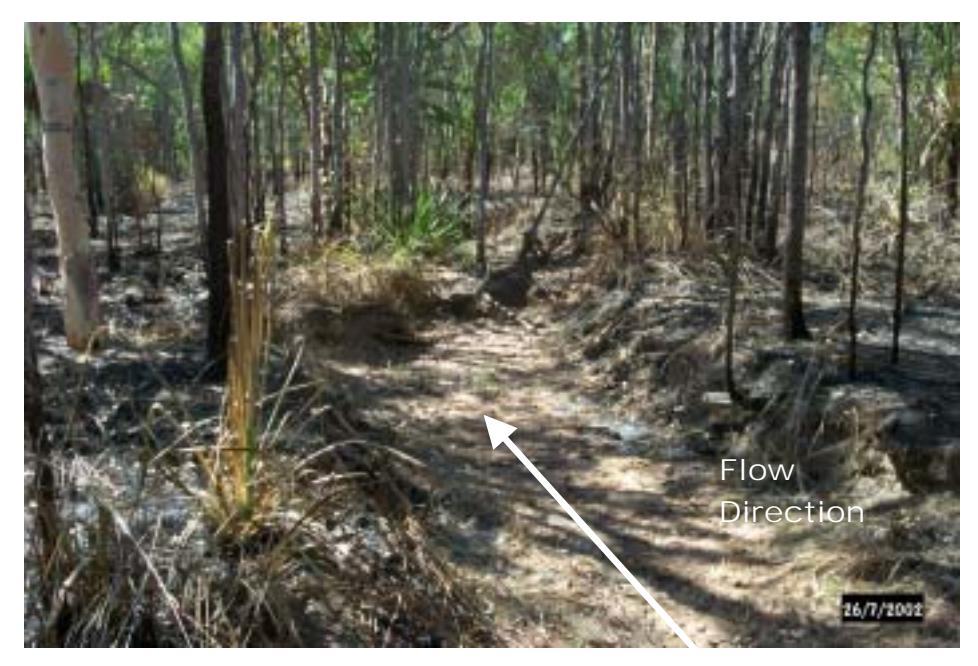
Figure 12 Small Capacity Reach of Tributary Central at cross section TC01 after a dry season fire. Note the low banks.

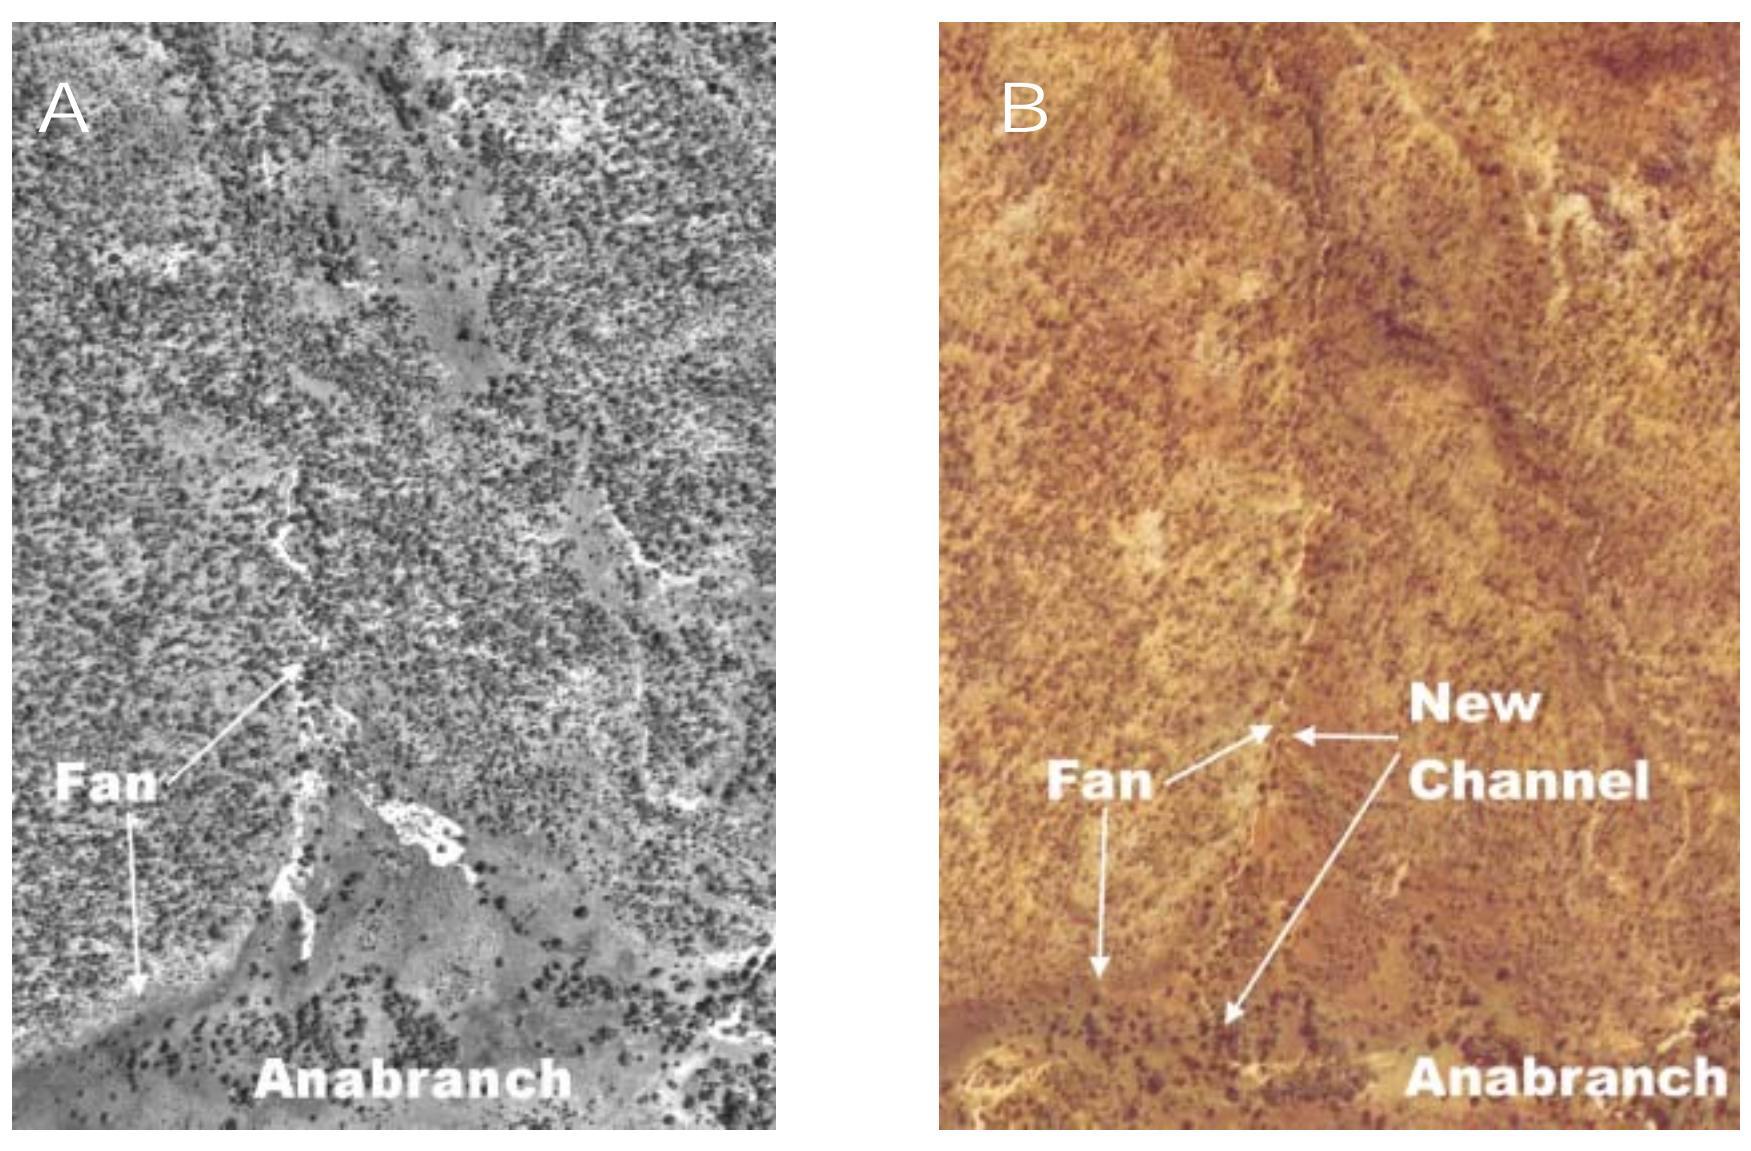
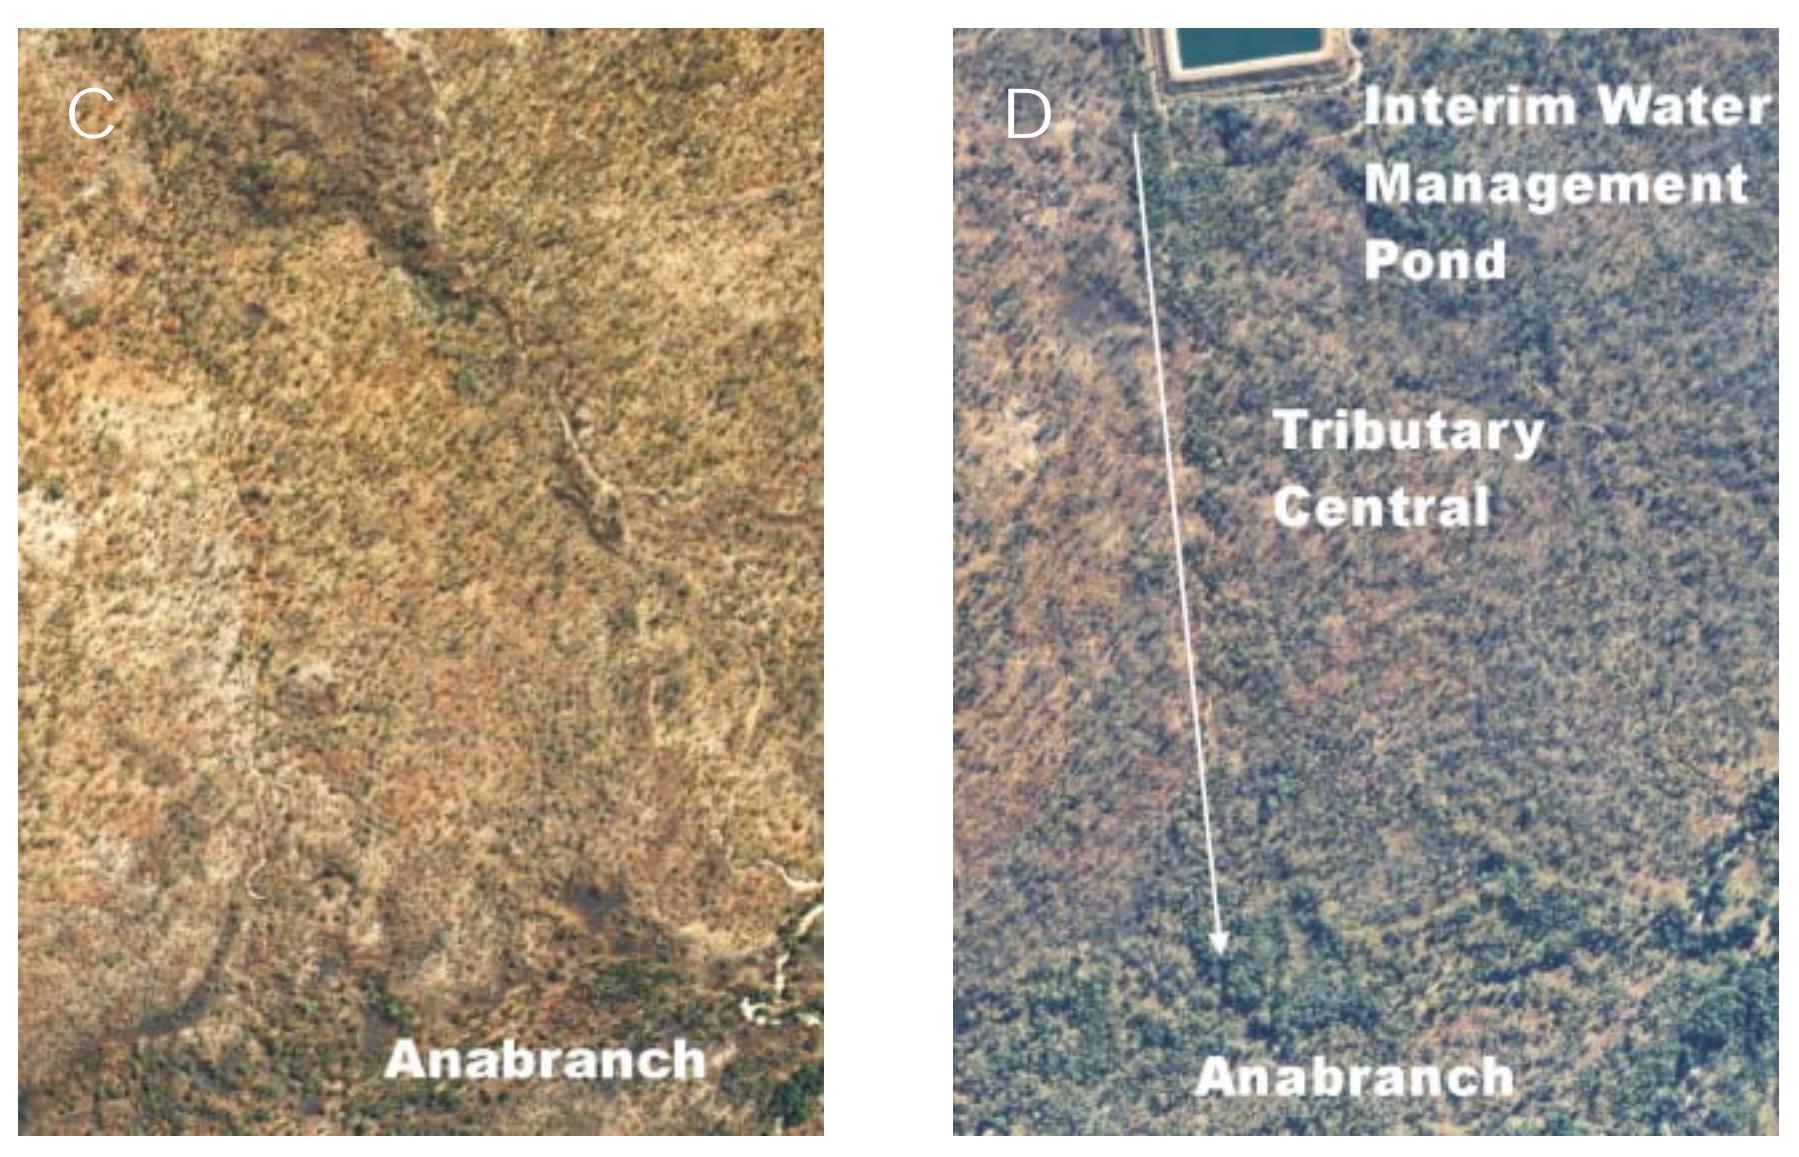
Figure 13 Vertical air photographs of Tributary Central (A) 1964. (B) 1978

Figure 13 (continued) Vertical air photographs of Tributary Central (C) 1991. (D) 2001

- By 1991, the loop at site TC07 had migrated rapidly downstream and the channel had evolved to its current location (fig 13C).
- By 2001, the woodland vegetation had greatly increased in density obscuring most of the channel (fig 13D).

Clearly channel erosion was initiated between 1950 and 1964, and rapidly developed up to 1975. Therefore, the initiation of channel erosion occurred before the construction of the Jabiluka mine and current channel erosion rates are lower than in the 1960s and 1970s. Furthermore, all the sand generated by channel erosion is stored in the channel, alluvial fan and anabranch without reaching Ngarradj. This lack of connectivity means that Tributary Central is currently functioning as a distinct sand compartment not integrated with the main channel.

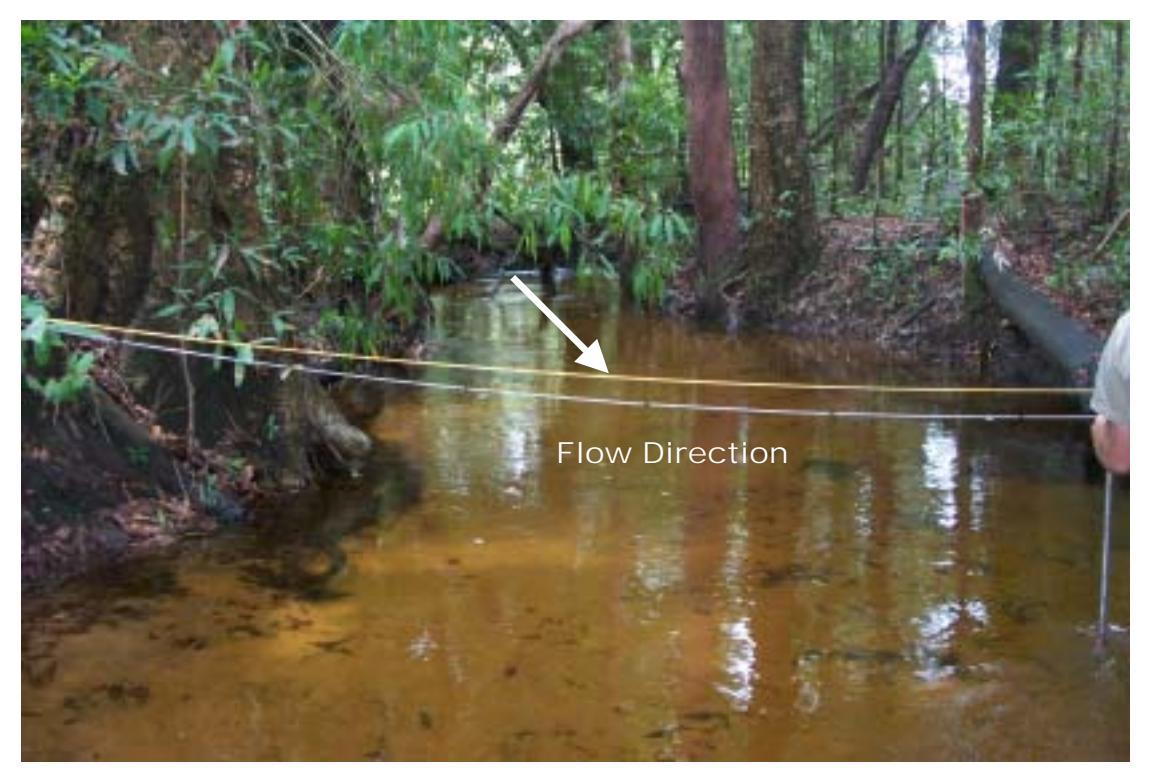
Figure 14 East Tributary upstream of the gauging wire showing riparian vegetation and sand bed
