Cross-sectional and

scour and fill changes in

the Ngarradj catchment

between 1998 and 2003

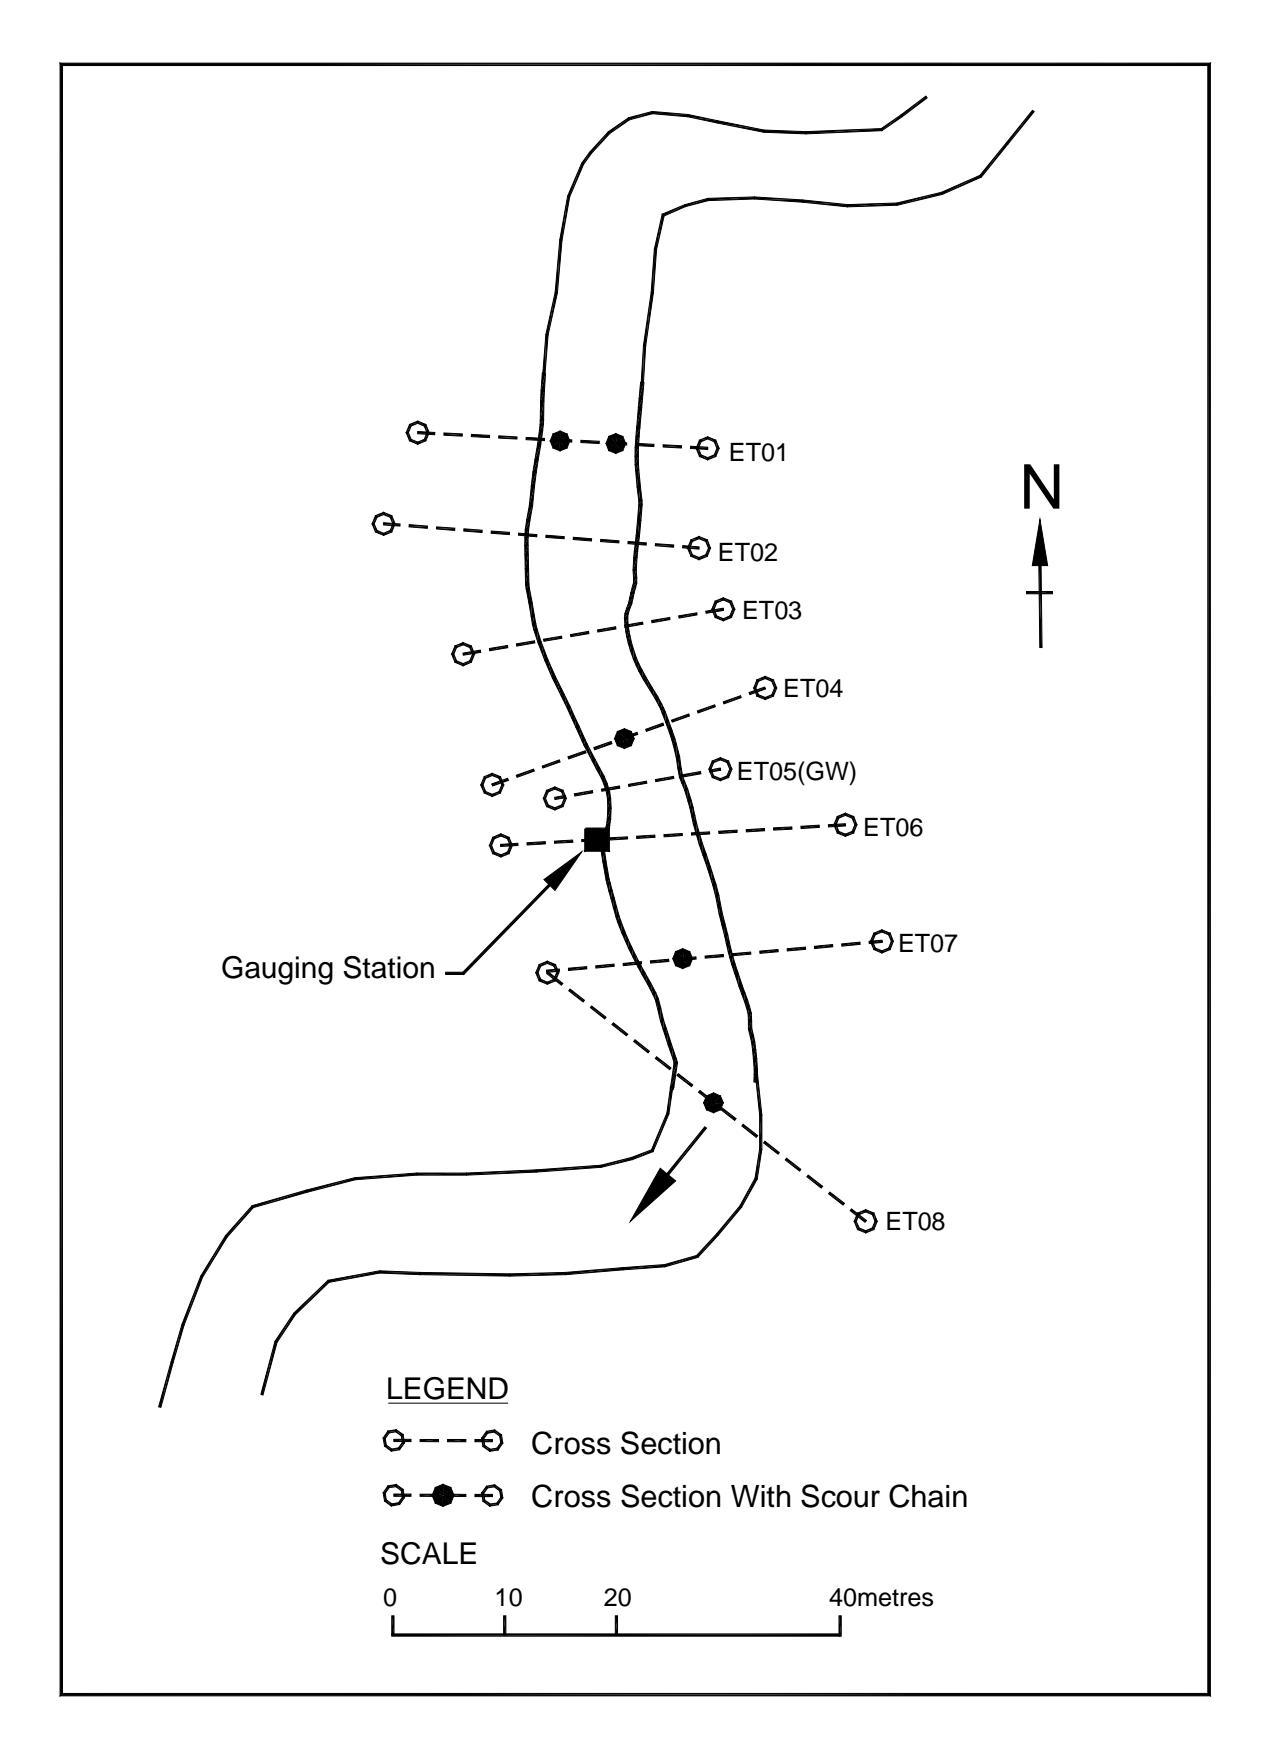
Figure 15 Location of the cross sections on East Tributary at the *eriss* gauging station

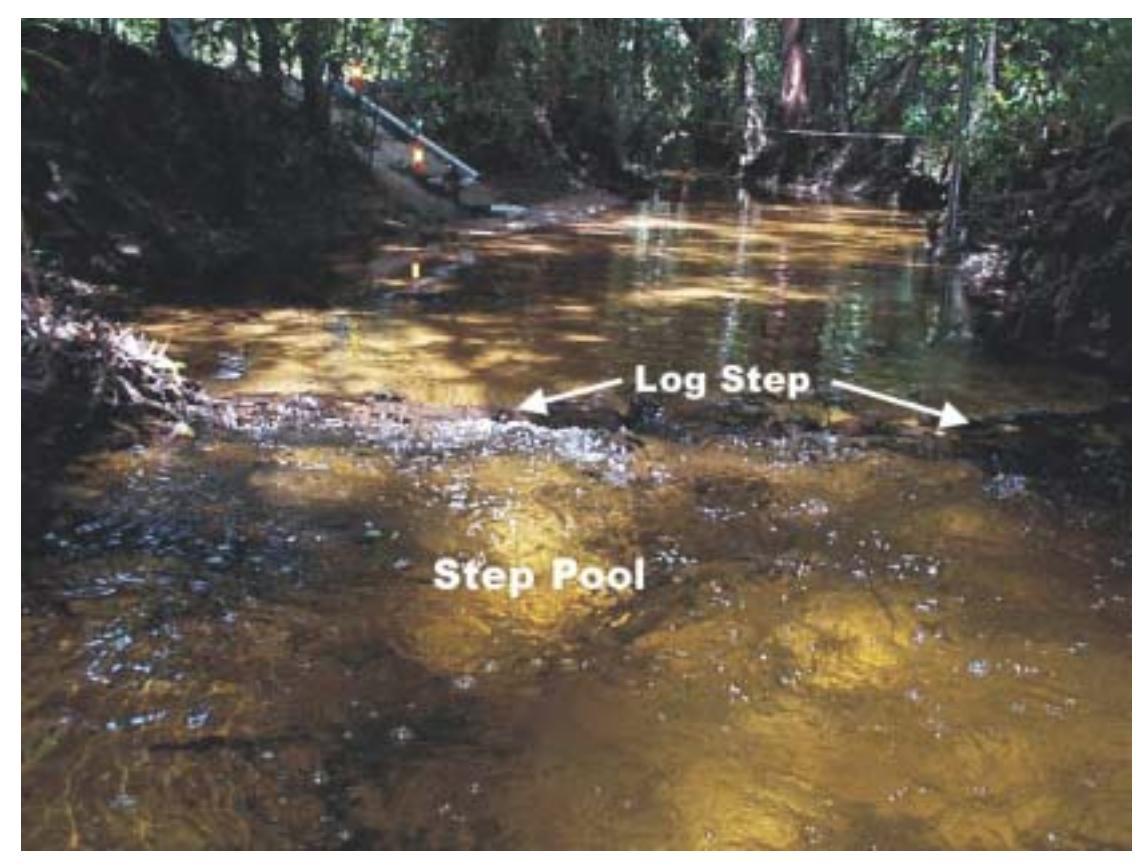
Figure 16 A log step and step pool in the bed of East Tributary downstream of the gauge. Log steps are important for energy dissipation in sand-bed streams.

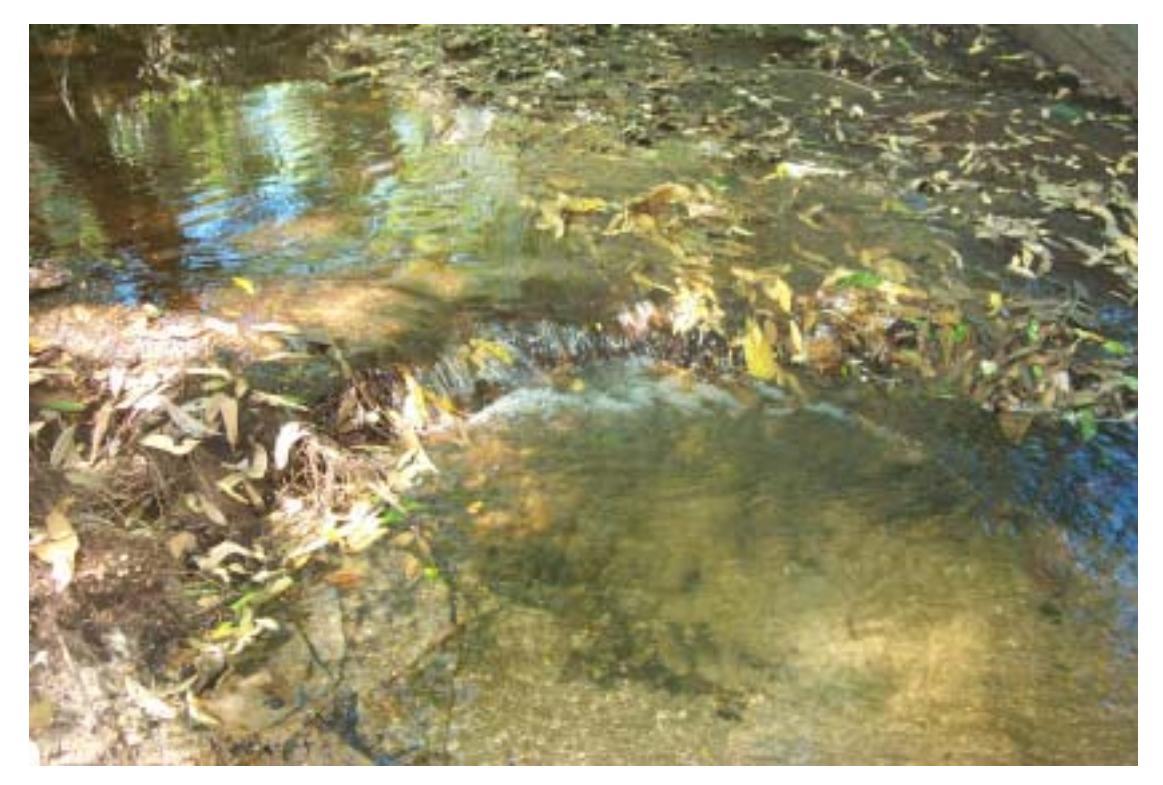
Figure 17 Root mat step just upstream from cross section ET02 which stabilises the sandy bed material and reduces sand fluxes

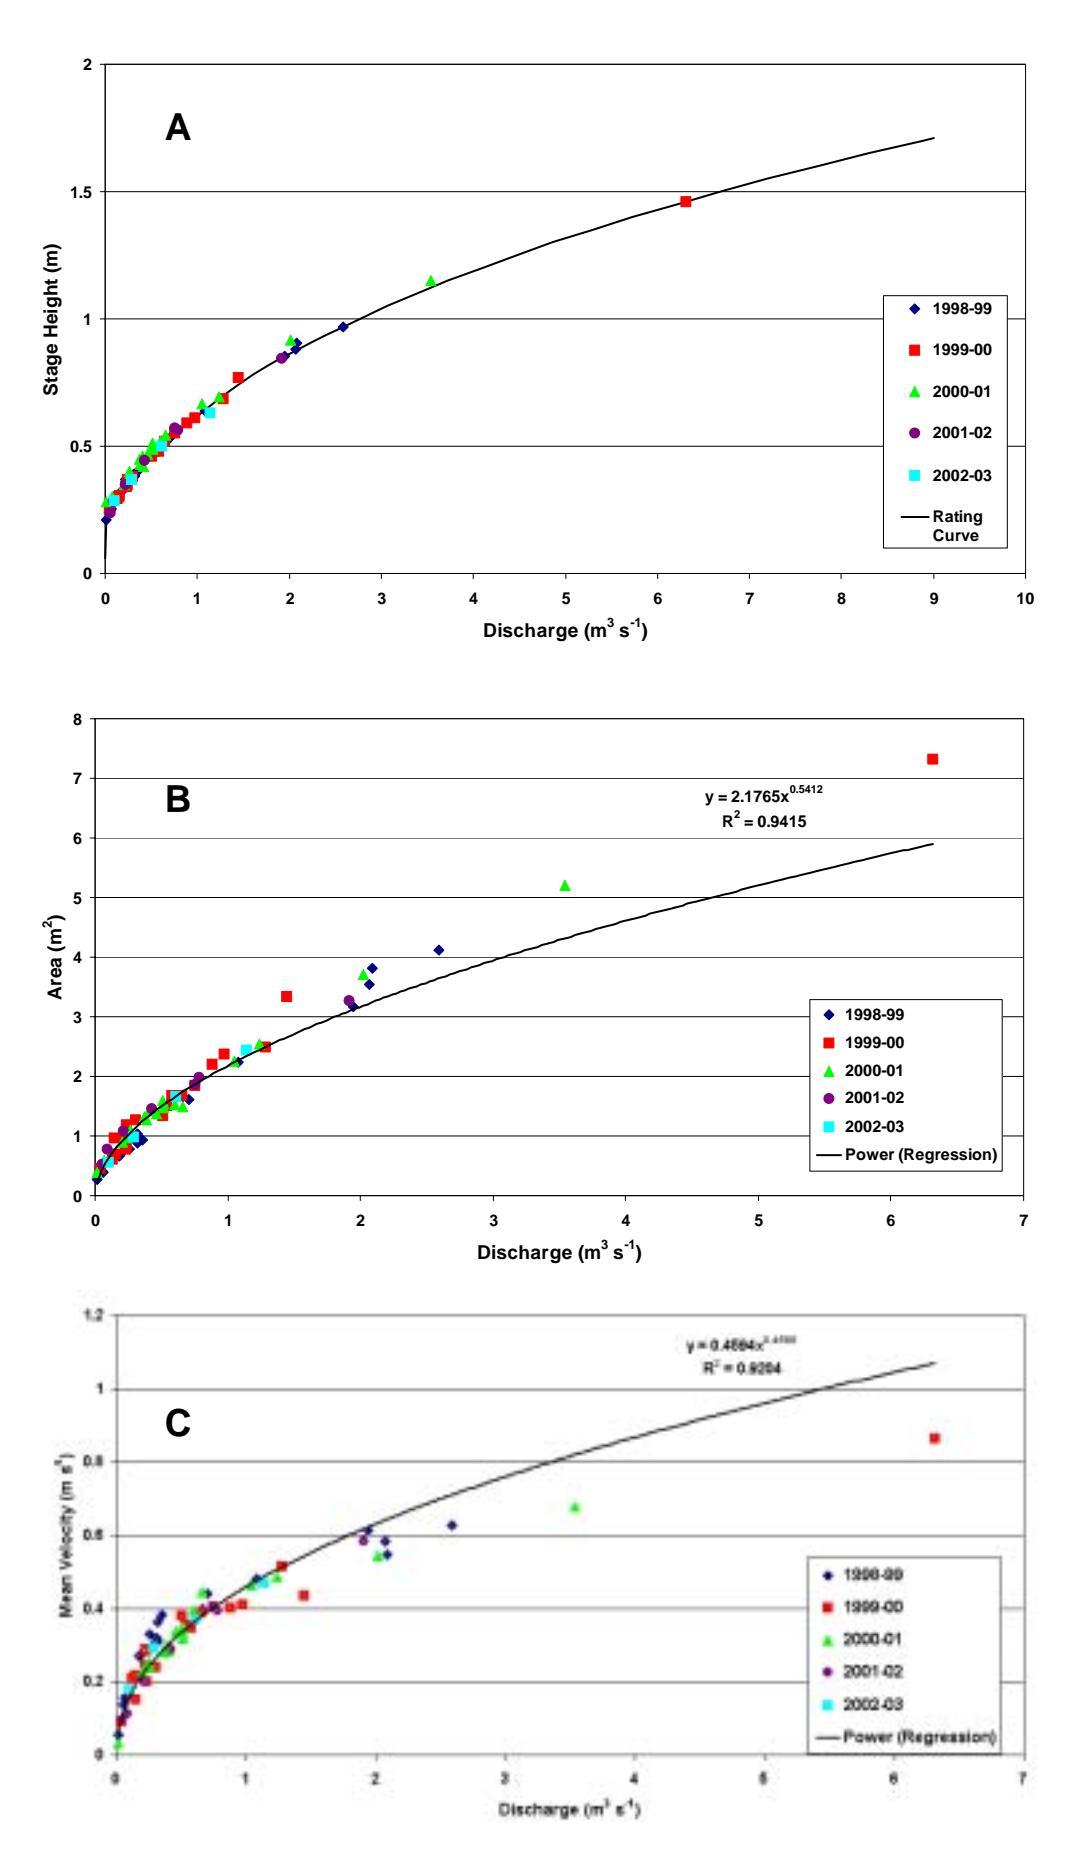
Figure 18 (A) Rating curve fitted to all velocity-area gaugings undertaken between 1998 and 2003 at the East Tributary gauge. (B) Hydraulic geometry data for area-discharge relationship between 1998 and 2003. (C) Hydraulic geometry data for mean velocity-discharge relationship between 1998 and 2003.

A total of 69 velocity-area gaugings were undertaken during the study period to establish and check for temporal shifts in the rating curve at the East Tributary gauge. All gaugings were conducted at the gauging wire which is located at cross section ET05 (fig 15). As shown in Figure 18A, all gaugings for all five years of the study period plot tightly around the fitted rating curve. This demonstrates that the minor channel changes outlined above have not resulted in a change in rating between 1998 and 2003. Furthermore, there have only been two gaugings at about bankfull stage and so variations in bankfull discharge over time cannot be assessed at this time. Nevertheless, the hydraulic geometry equations (Leopold & Maddock 1953) derived from the velocity-area gaugings for area and mean velocity (fig 18B & C) were used to check the reliability of the estimates from the cross-sectional surveys. The mean area and velocity at cross section ET05 between 1998 and 2003 were 5.01 m² and 0.86 m/s and agree closely with the values of 4.80 m² and 0.90 m/s respectively derived from the hydraulic geometry equations.

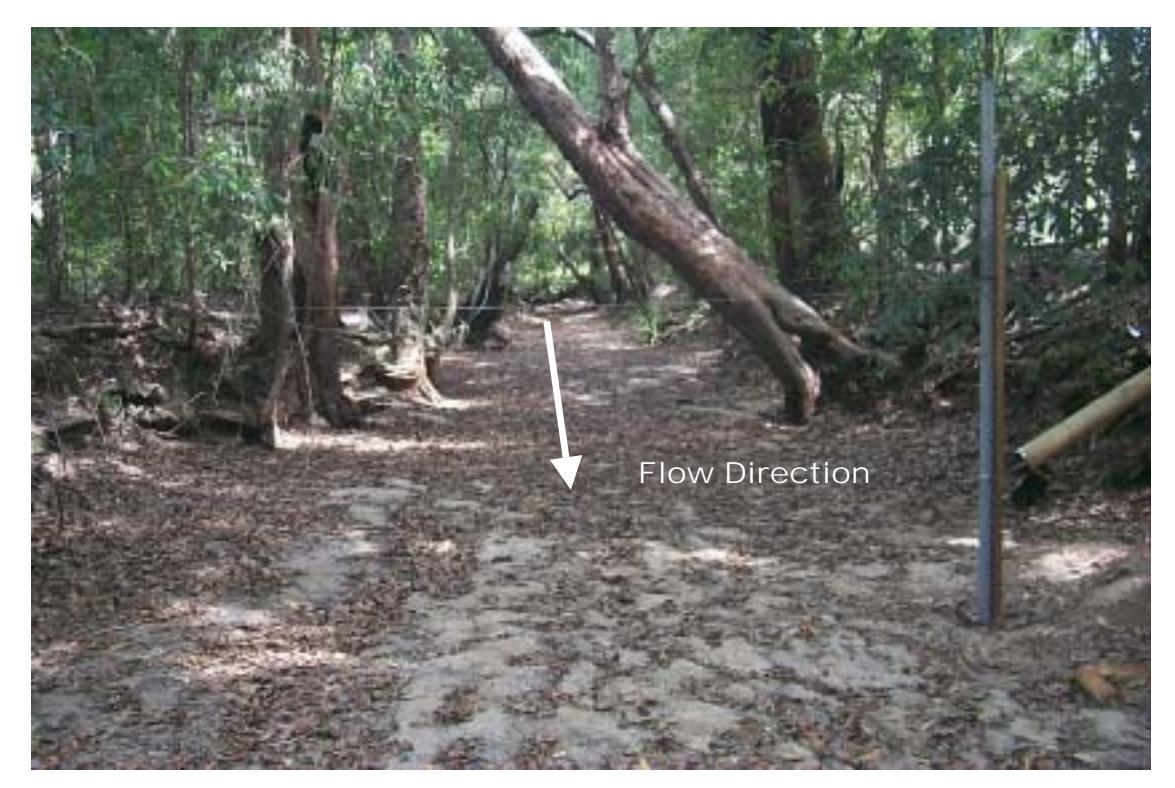
Figure 19 The upper Swift Creek gauging station showing the riparian vegetation and the deposition of coarse particulate organic matter during the dry season

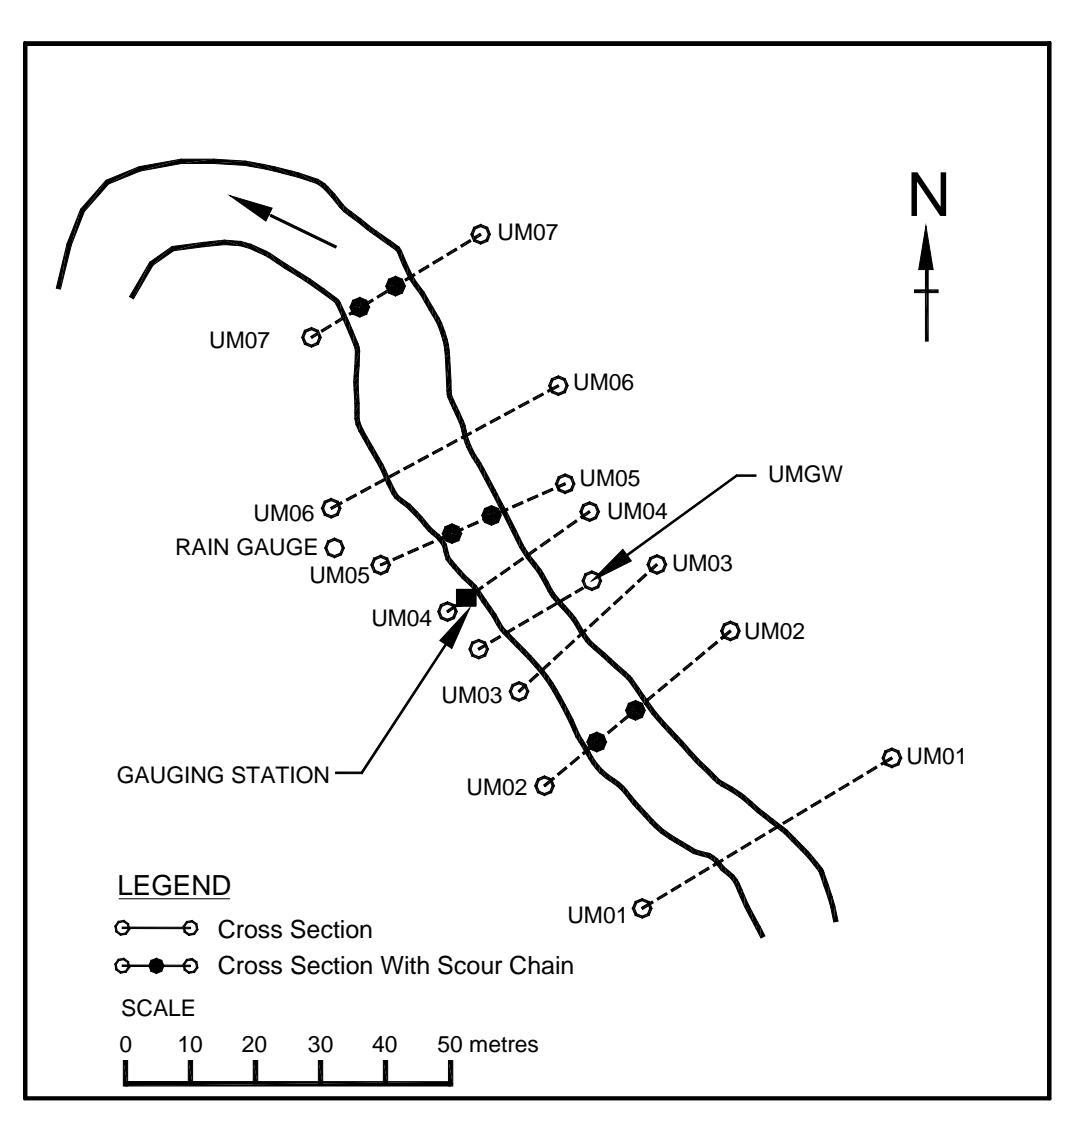
Figure 20 Location of the cross sections at the upper Swift Creek gauge

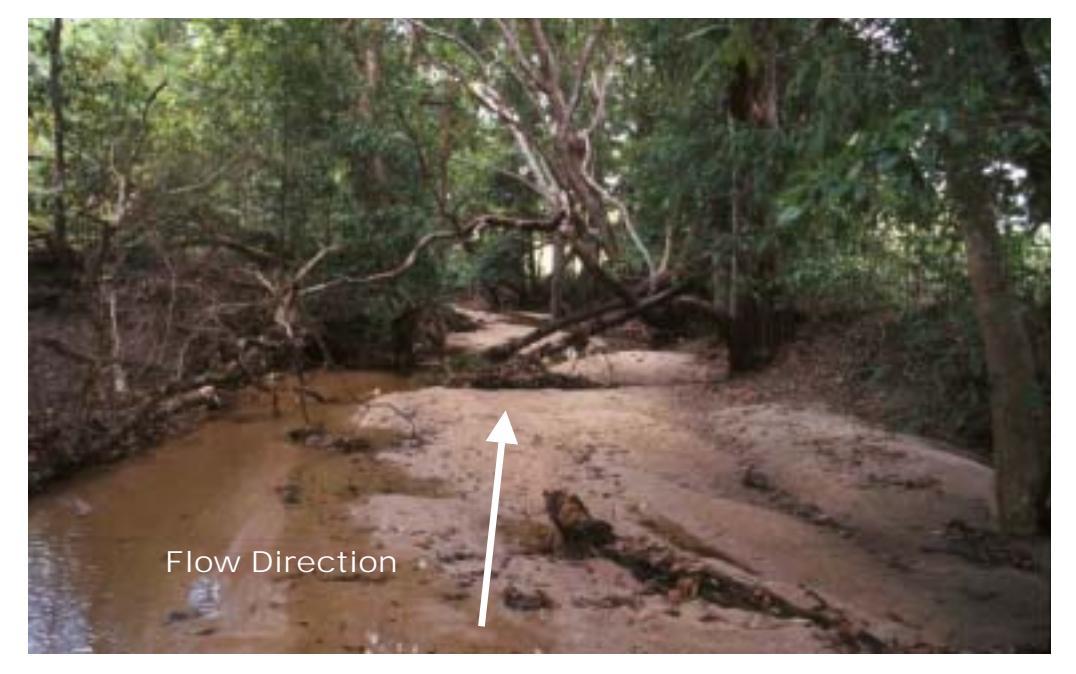
Figure 21 Large woody debris and trees in the upper Swift Creek gauge reach

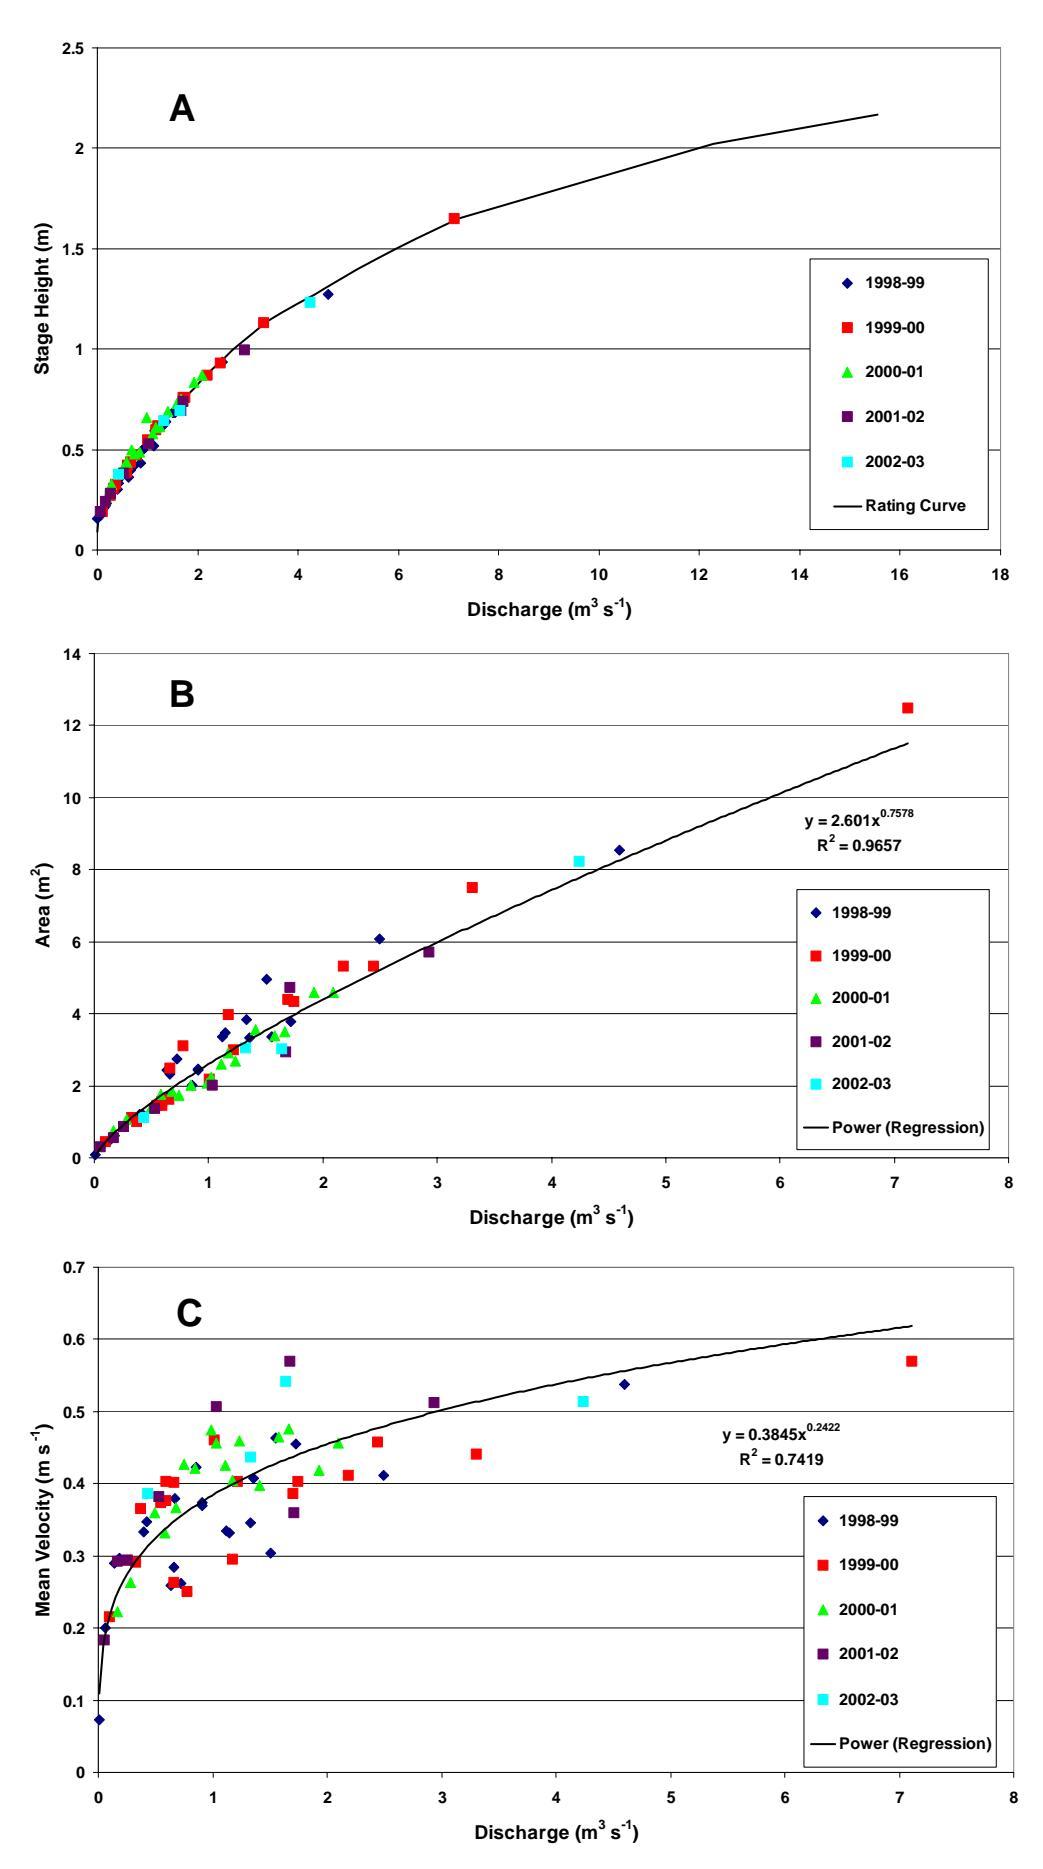
Figure 22 (A) Rating curve fitted to all velocity-area gaugings undertaken between 1998 and 2003 at the upper Swift Creek gauge. (B) Hydraulic geometry data for area-discharge relationship between 1998 and 2003. (C) Hydraulic geometry data for mean velocity-discharge relationship between 1998 and 2003.

A total of 71 velocity-area gaugings were undertaken during the study period to establish and check for temporal shifts in the rating curve at the upper Swift Creek gauge. All gaugings were conducted at the gauging wire which is located at cross section UMGW (fig 20). As shown in Figure 22A, all gaugings for all five years of the study period plot tightly around the fitted rating curve. This demonstrates that the aggradation outlined above has not resulted in a change in rating between 1998 and 2003. Furthermore, there have only been three gaugings at about bankfull stage and so variations in bankfull discharge over time cannot be assessed at this time. Nevertheless, the hydraulic geometry equations (Leopold & Maddock 1953) derived from the velocity-area gaugings for area and mean velocity (fig 18B & C) were used to check the reliability of the estimates from the cross-sectional surveys. The mean area and velocity at cross section UMGW between 1999 and 2003 were 9.47 m² and 0.46 m/s and are in reasonable agreement with the values of 7.86 m² and 0.55 m/s respectively derived from the hydraulic geometry equations.

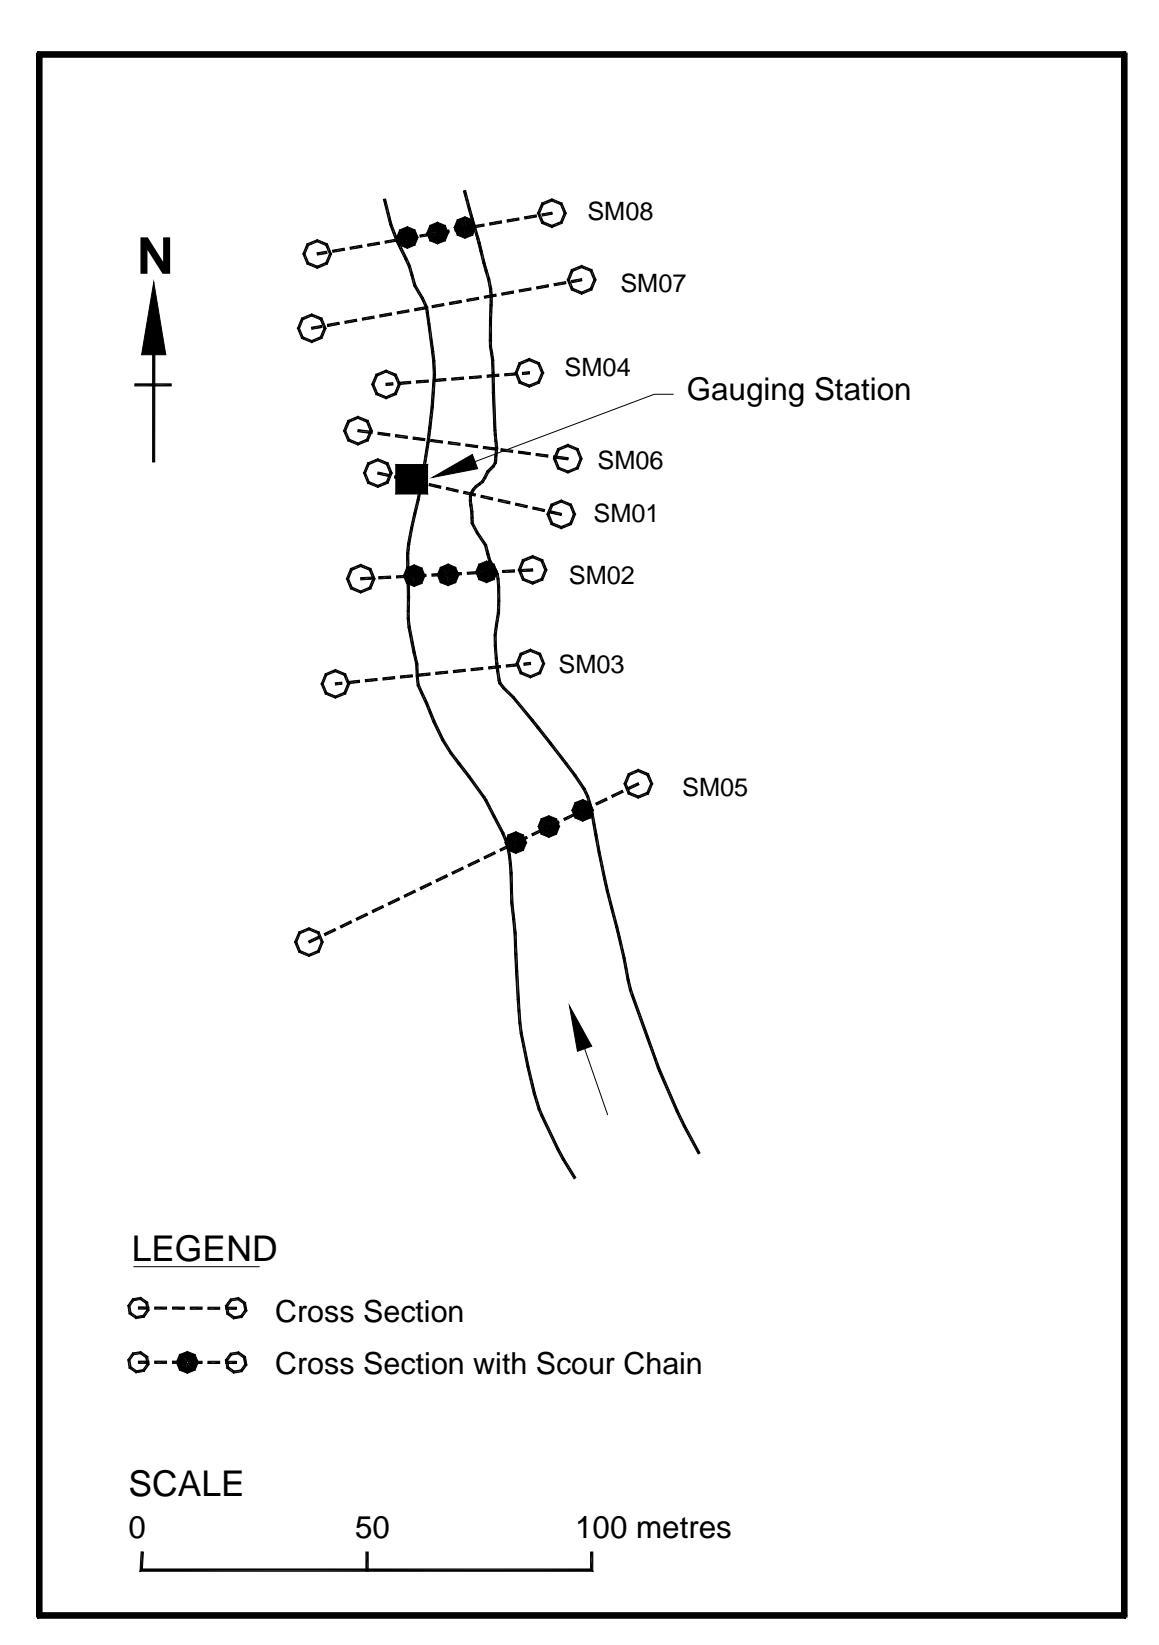
Figure 24 Location of cross sections at the Swift Creek gauge

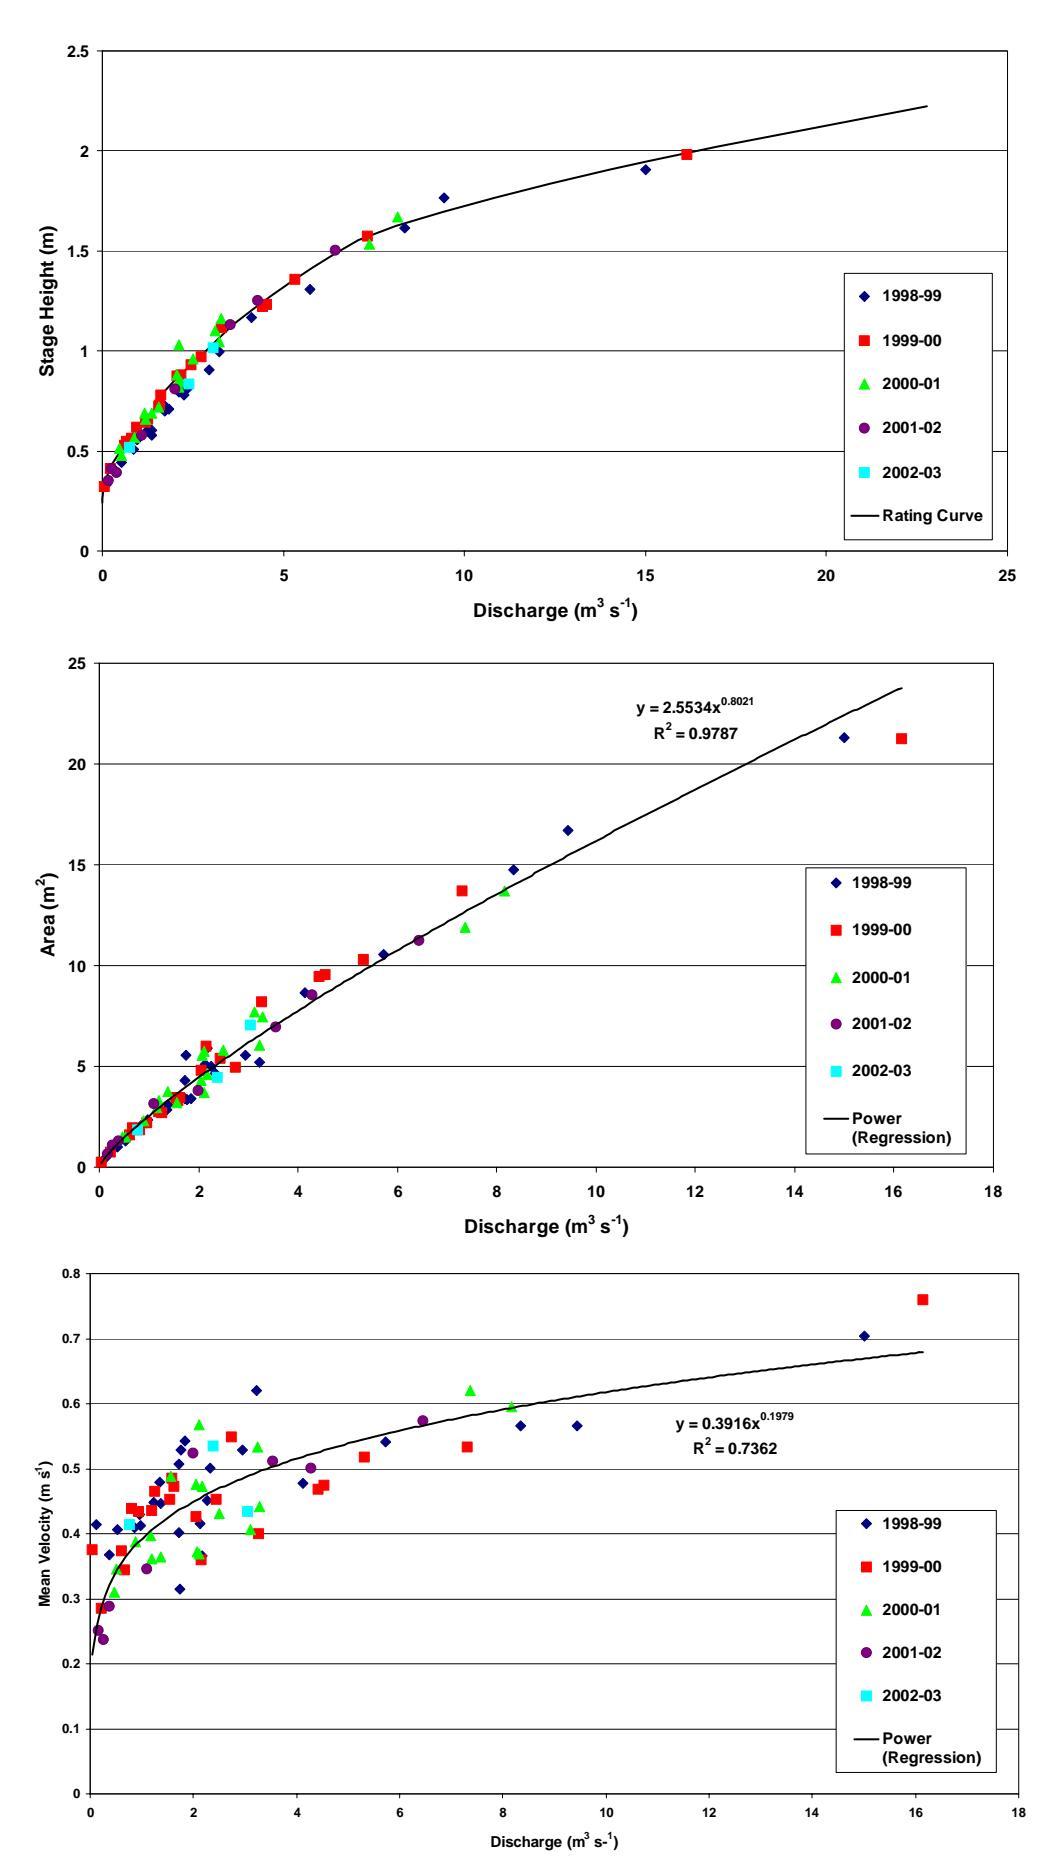
Figure 25 (A) Rating curve fitted to all velocity-area gaugings undertaken between 1998 and 2003 at the Swift Creek gauge. (B) Hydraulic geometry data for area-discharge relationship between 1998 and 2003. (C) Hydraulic geometry data for mean velocity-discharge relationship between 1998 and 2003.

A total of 75 velocity-area gaugings were undertaken during the study period to establish and check for temporal shifts in the rating curve at the Swift Creek gauge. All gaugings were conducted at the gauging wire which is located at cross section SM06 (fig 24). As shown in Figure 25A, all gaugings for all five years of the study period plot tightly around the fitted rating curve. This demonstrates that the aggradation outlined above has not resulted in a change in rating between 1998 and 2003. Furthermore, there have only been two gaugings at about bankfull stage and so variations in bankfull discharge over time cannot be assessed at this time. Nevertheless, the hydraulic geometry equations (Leopold & Maddock 1953) derived from the velocity-area gaugings for area and mean velocity (fig 25B & C) were used to check the reliability of the estimates from the cross-sectional surveys. The mean area and velocity at cross section SM06 between 1998 and 2003 were 17.3 m² and 0.86 m/s and are in reasonable agreement with the values of 22.3 m² and 0.67 m/s respectively derived from the hydraulic geometry equations.

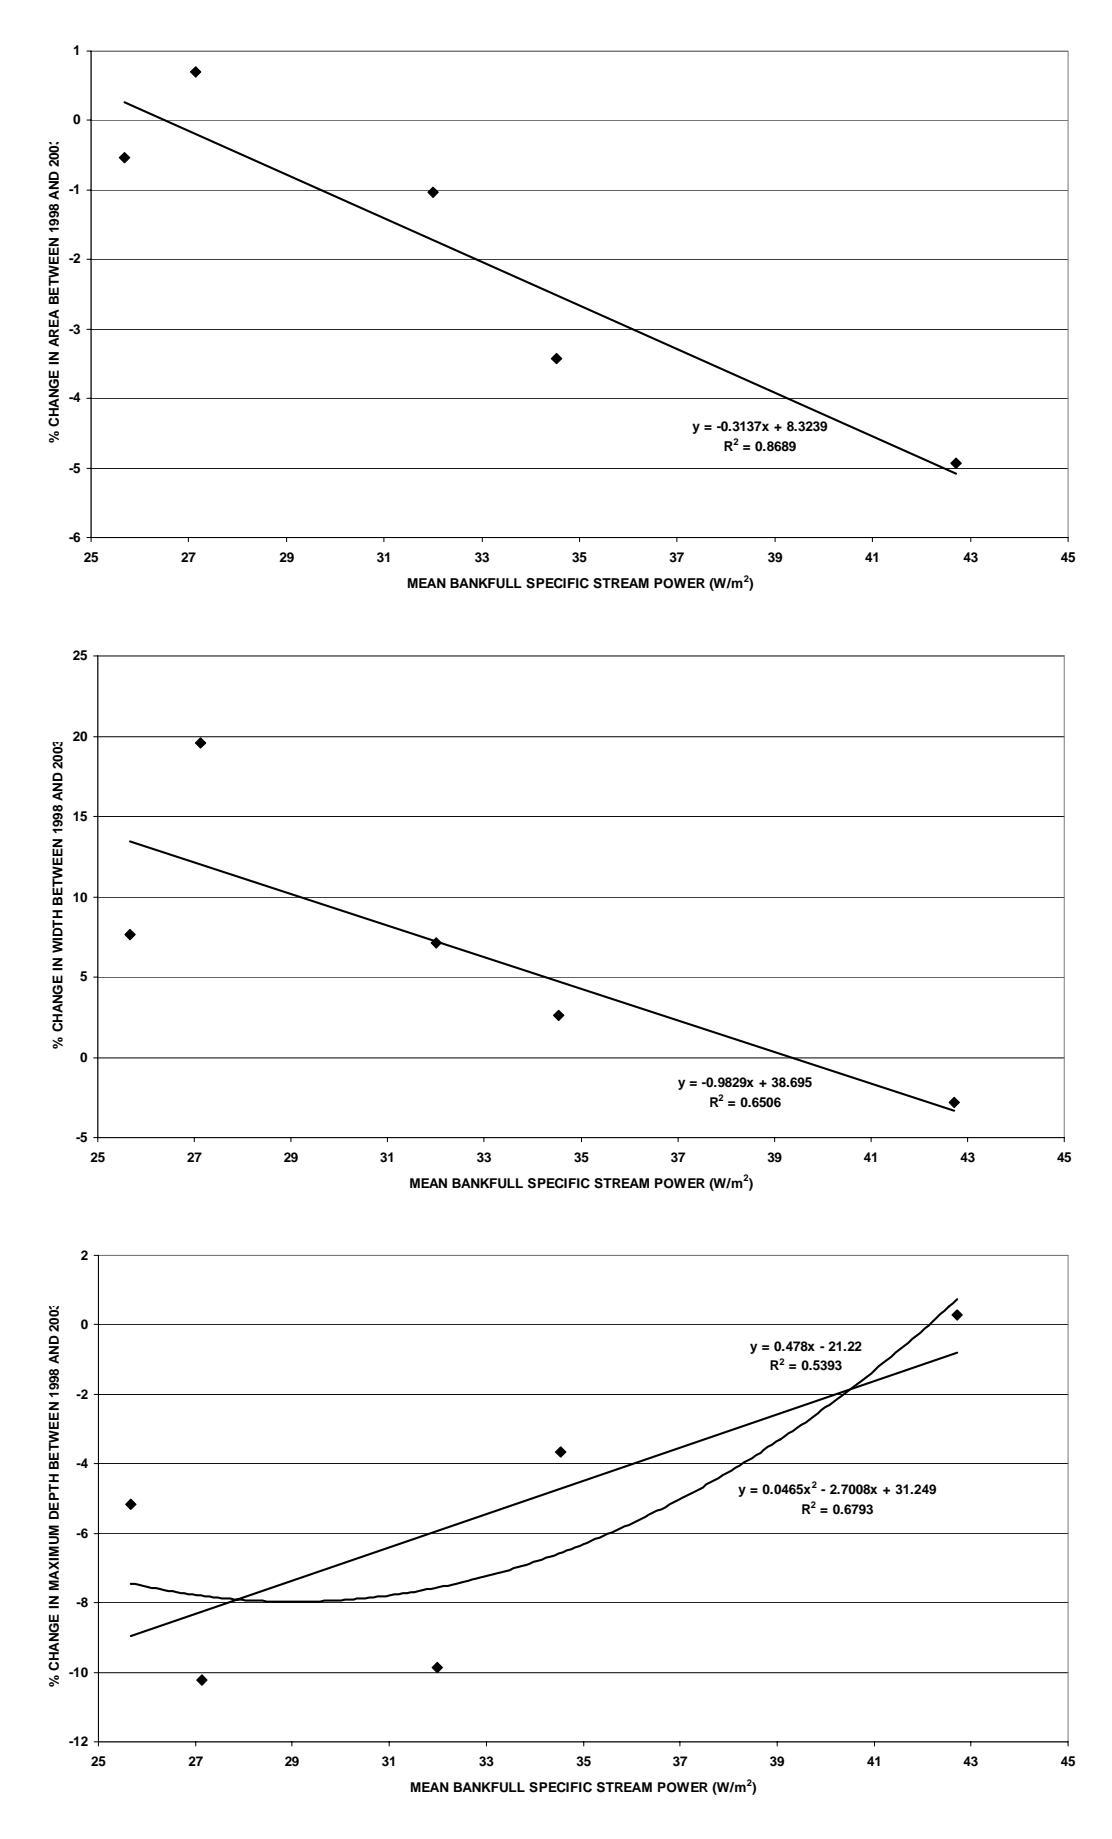
Figure 26 Regressions of average bankfull specific stream power on percentage change in area, width and maximum depth between 1998 and 2003 on Tributary North tributary gully

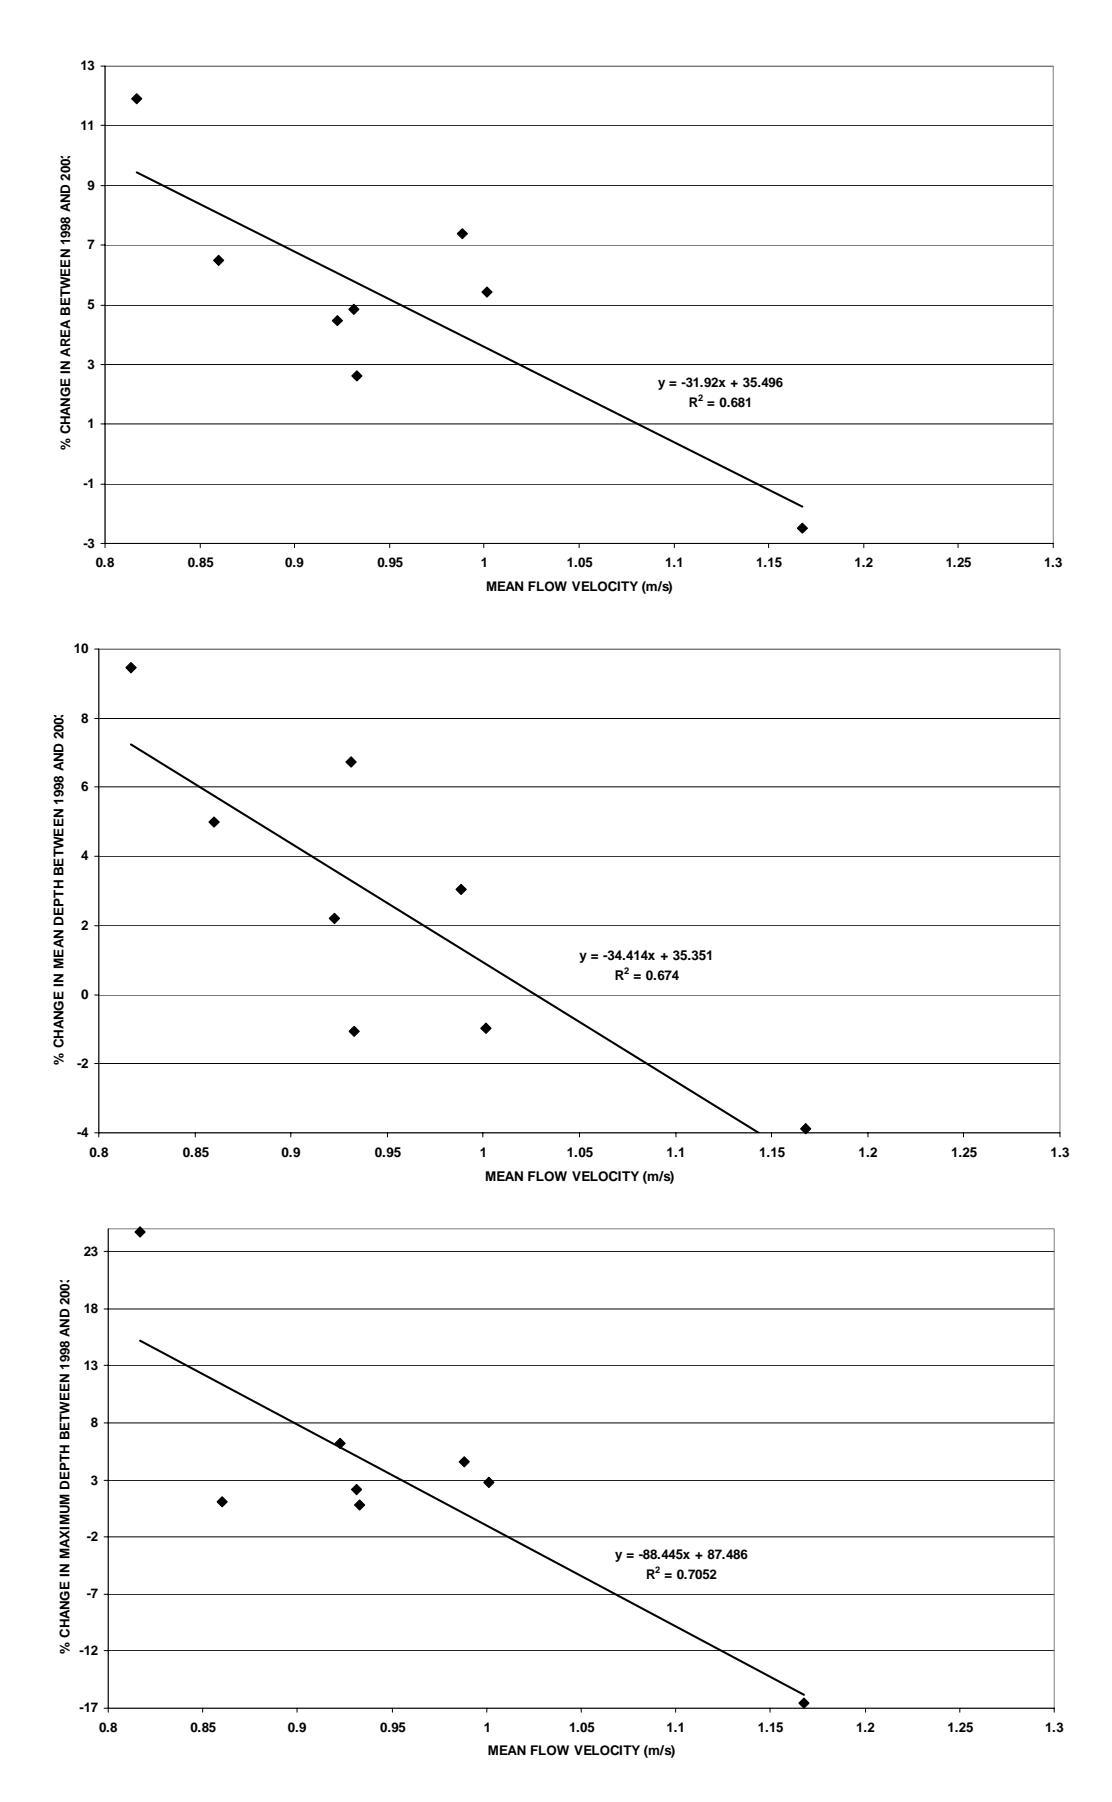
Figure 27 Regressions of average bankfull mean flow velocity and percentage change in area, mean depth and maximum depth between 1998 and 2003 at the East Tributary gauge. Note the two extreme flow velocity values, one low and one high, and their influence on the regression.

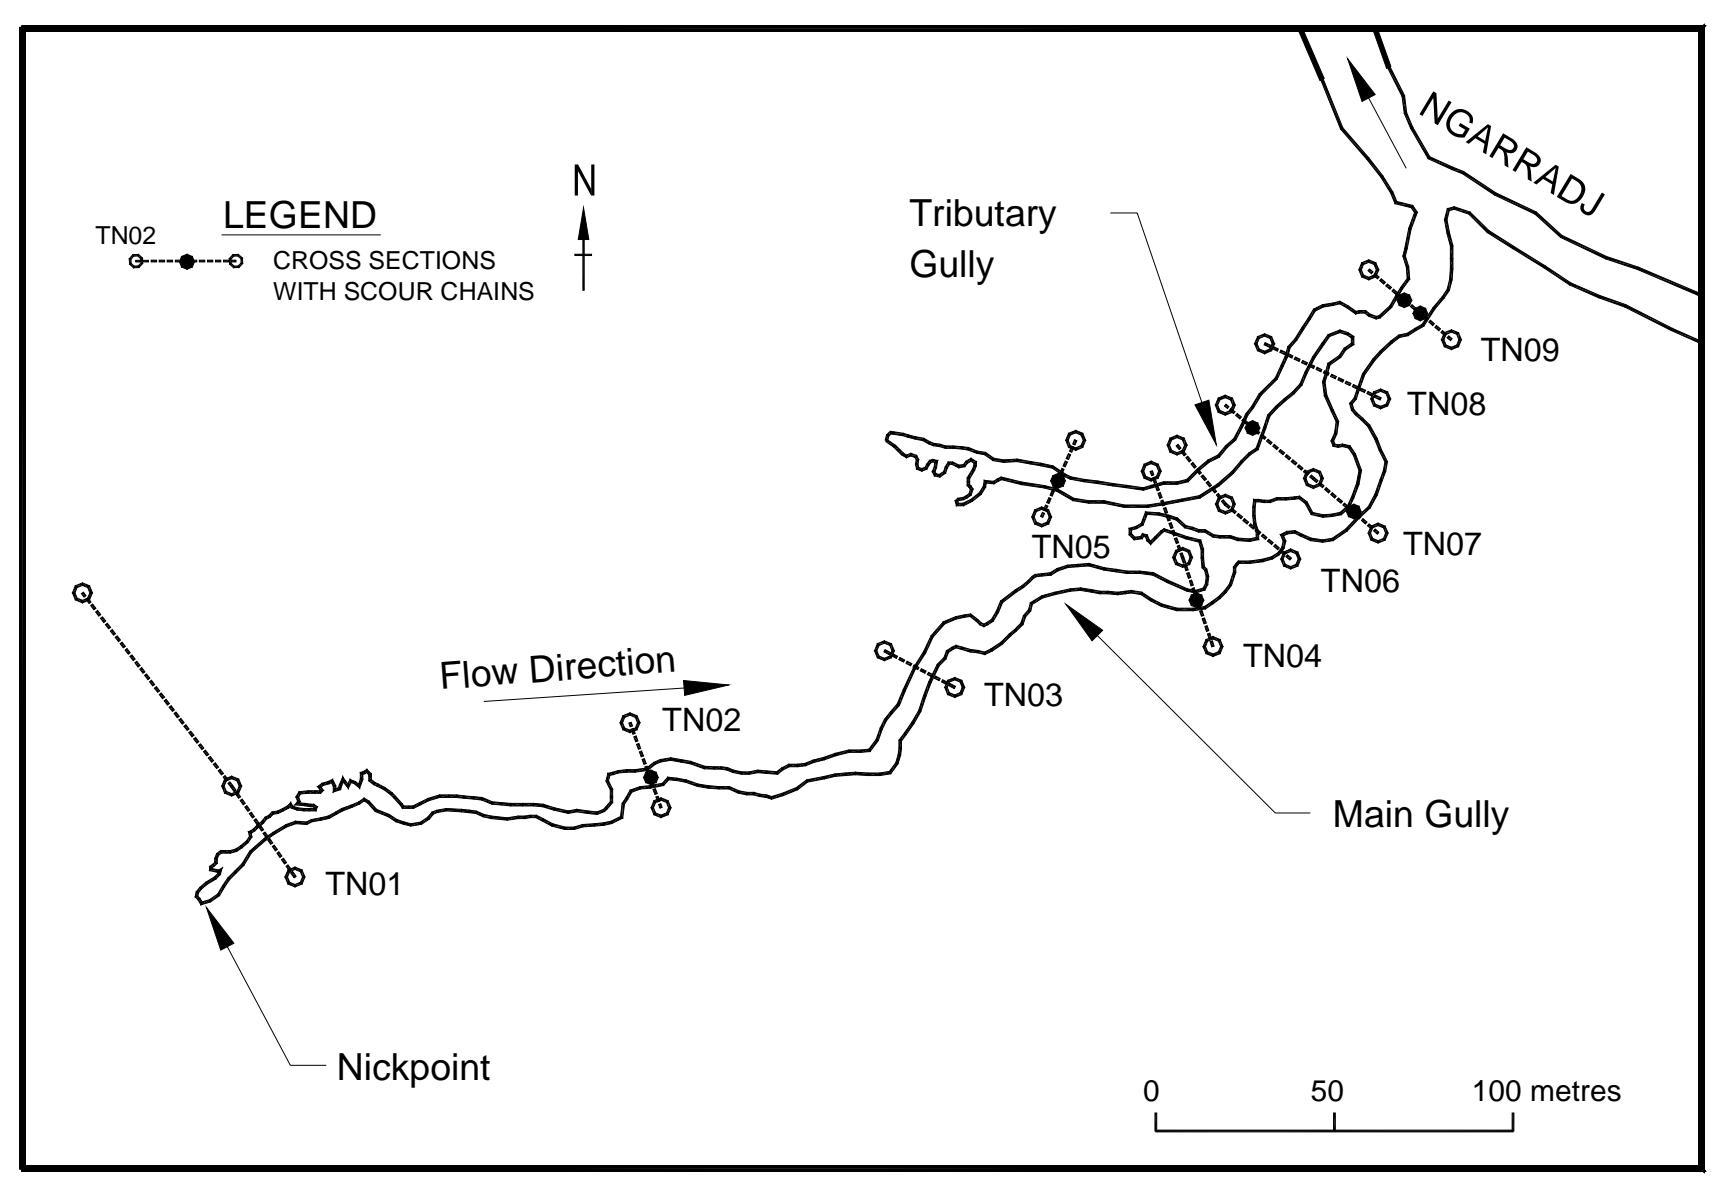
Figure 28 Location of the scour chains in the Gullied Reach of Tributary North

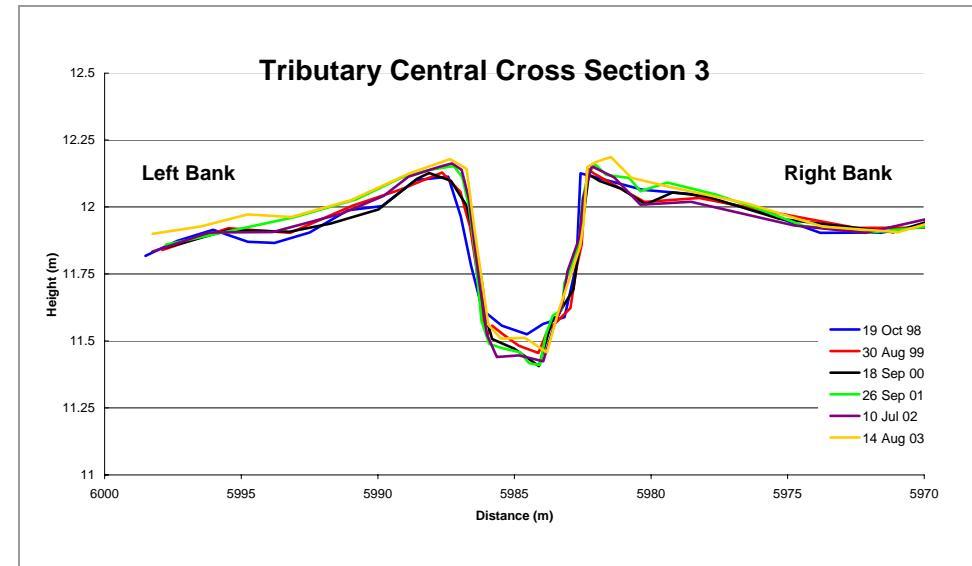
Figure B.13 Tributary Central Cross Section 3 in the Small Capacity Reach
