Cross-sectional and

scour and fill changes in

the Ngarradj catchment

between 1998 and 2003

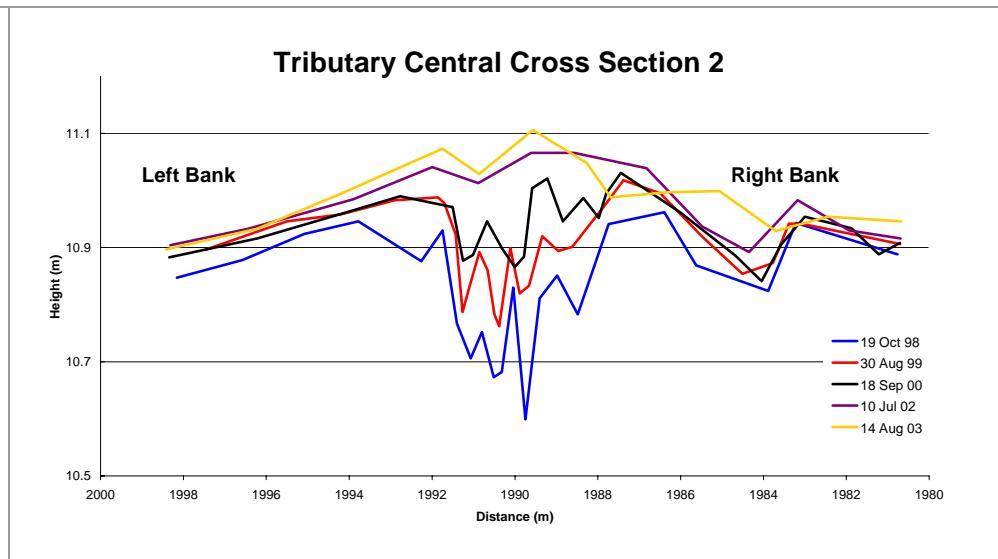
Figure B.14 Tributary Central Cross Section 2 on a distributary of the main channel in the Small Capacity Reach

For the determination of the values of the hydraulic geometry parameters in table 6, the slope used was 0.00226 m/m (2.26 m/km) which was measured from a longitudinal bed survey using differential GPS during the 1998 dry season. The Manning's n value used was 0.04. No velocity-area gaugings were undertaken on Tributary Central to check the accuracy of the estimated roughness coefficients. However, where velocity-area gauging data are available at the *eriss* stations, close correspondence between estimated and measured values was found (see below). No channel geometry results are presented for cross section TC02 because it was completely infilled with sediment during the measurement period (fig B.14, Appendix B).
